PHOTOGRAPHS

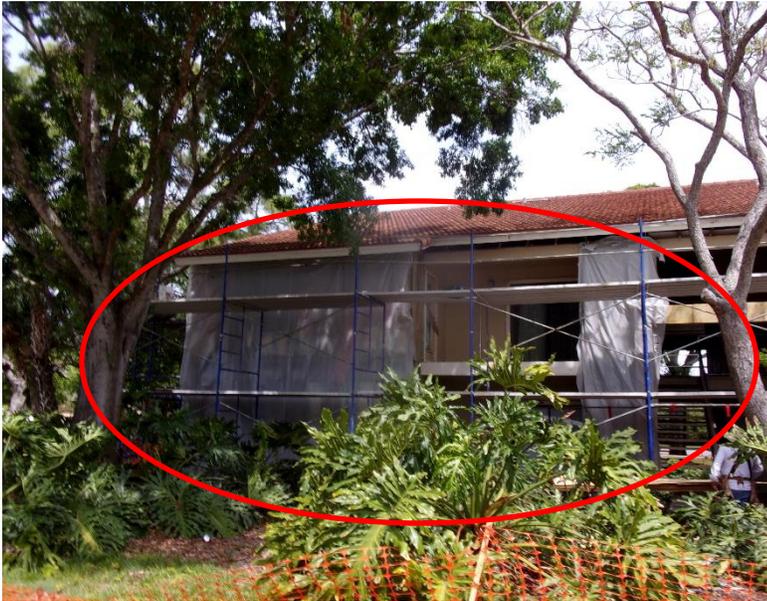
PHOTOGRAPH #1

**BUILDING 7
SECTION A**

Framing repairs, Simpson Strong-Tie connectors and termite treatment is complete. Contractor has covered with plastic to protect open walls from weather damage.

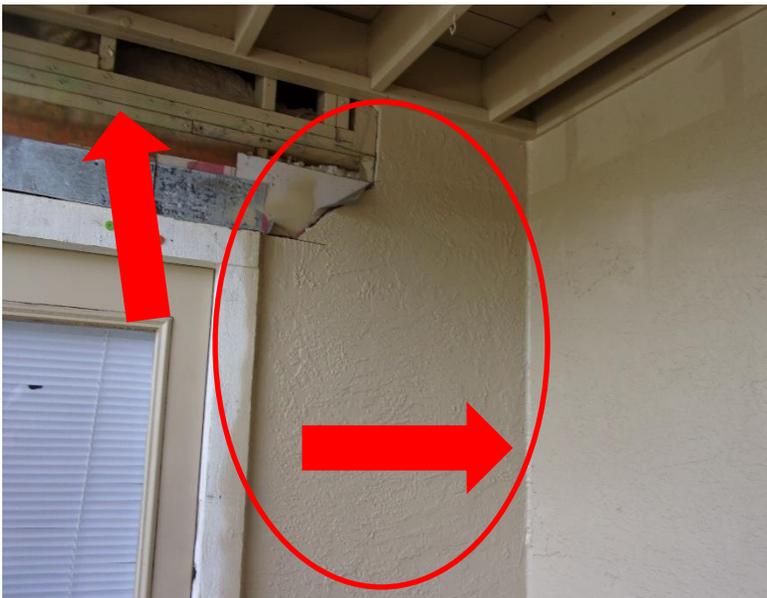
PHOTOGRAPH #2

**BUILDING 7
SECTION A**

Additional framing repairs will require full stucco removal and replacement at Lanai return wall to the inside corner.

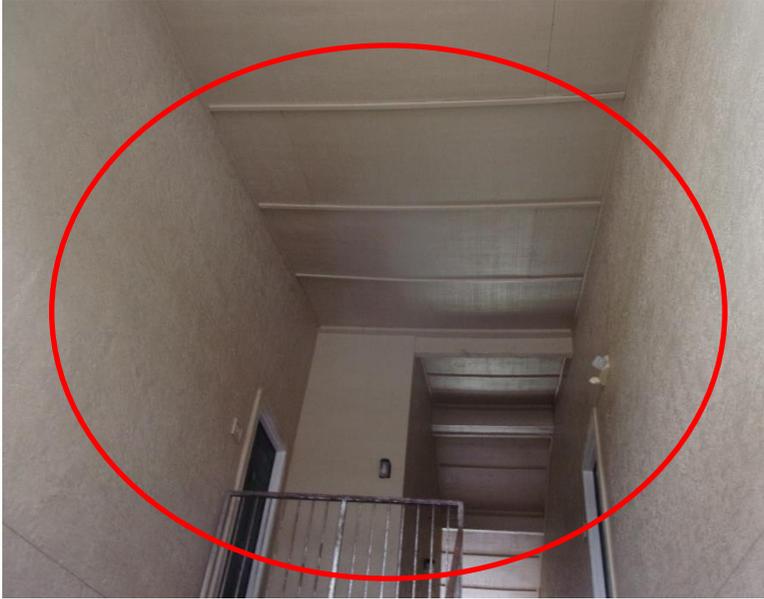
PHOTOGRAPH #3

**BUILDING 7
SECTION A**

Breezeway stucco and ceiling primed, and finish painted with Scott Paint Ultra Exterior Supercoat Acrylic.

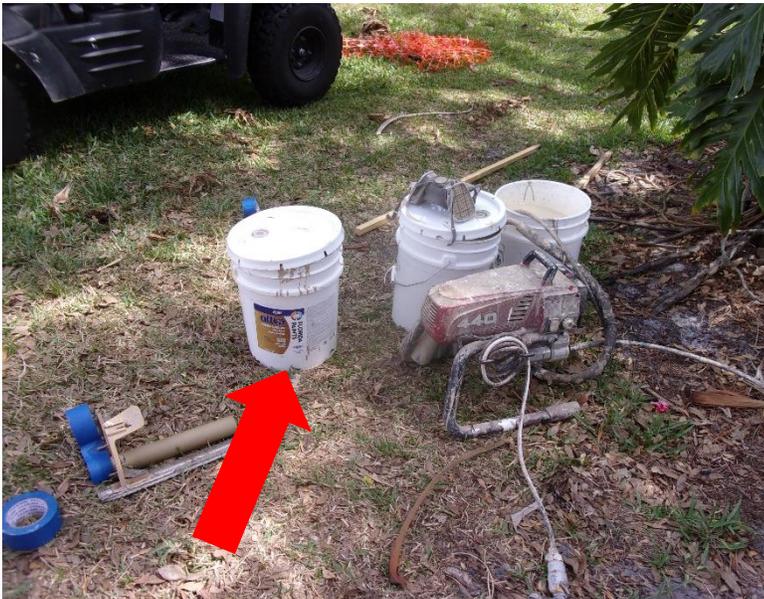
PHOTOGRAPH #4

**BUILDING 7
SECTION A**

Breezeway stucco and ceiling primed, and finish painted with Scott Paint Ultra Exterior Supercoat Acrylic.

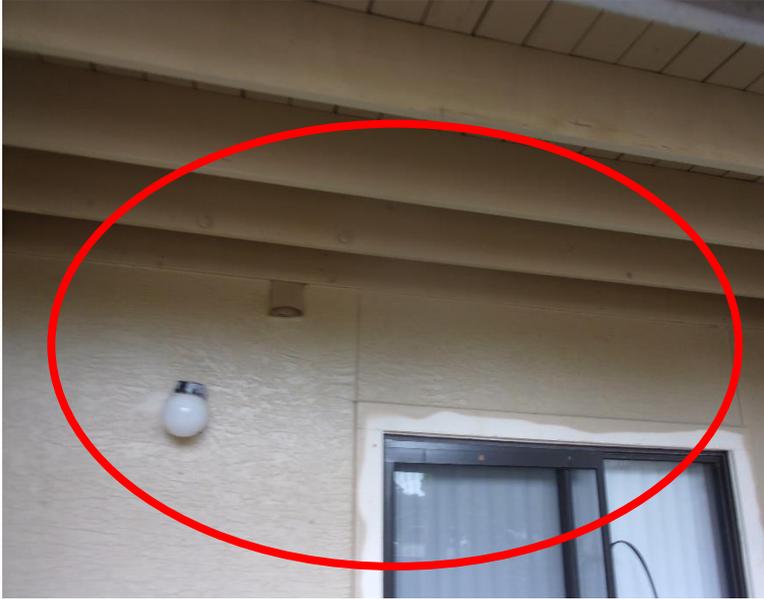
PHOTOGRAPH #5

**BUILDING 7
SECTION B**

Lanai stucco and ceiling primed, and finish painted with Scott Paint Ultra Exterior Supercoat Acrylic.

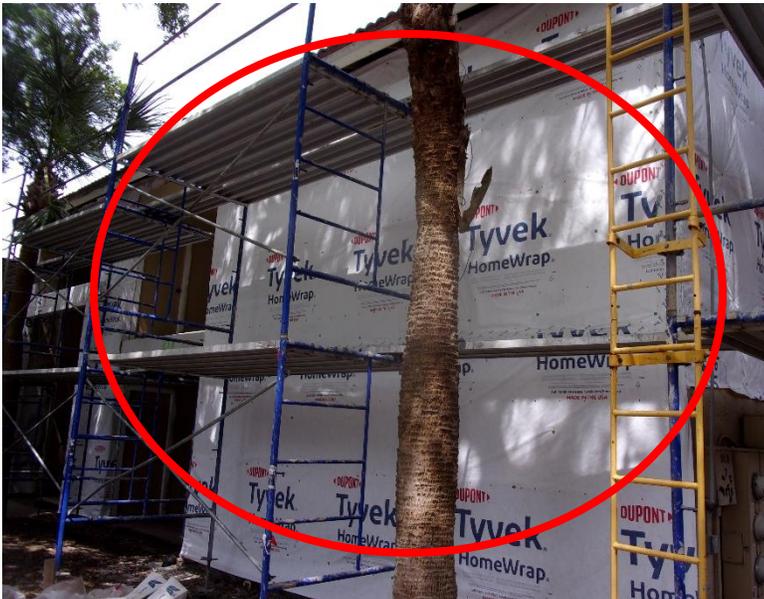
PHOTOGRAPH #6

**BUILDING 7
SECTION C**

Contractor has applied Dupont Tyvek HomeWrap water resistant barrier over new Plywood Sheathing.

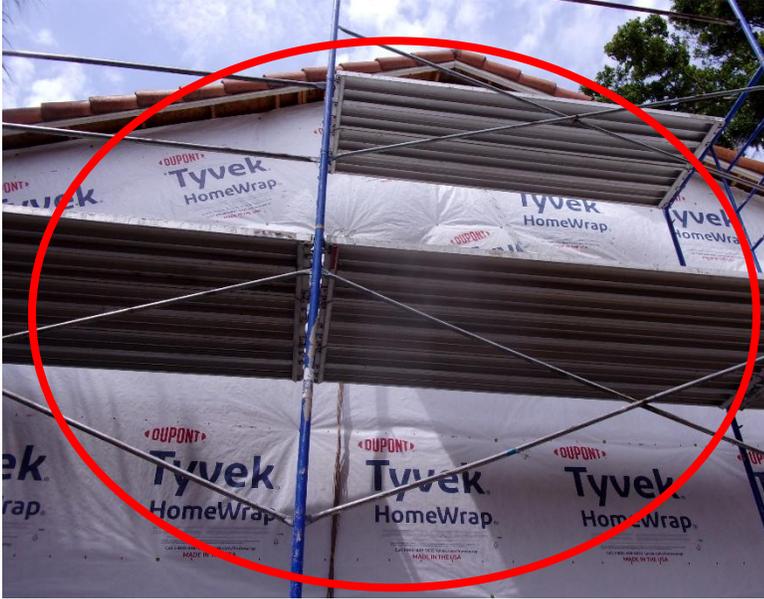
PHOTOGRAPH #7

**BUILDING 7
SECTION D**

Contractor has applied Dupont Tyvek HomeWrap water resistant barrier over new Plywood Sheathing.

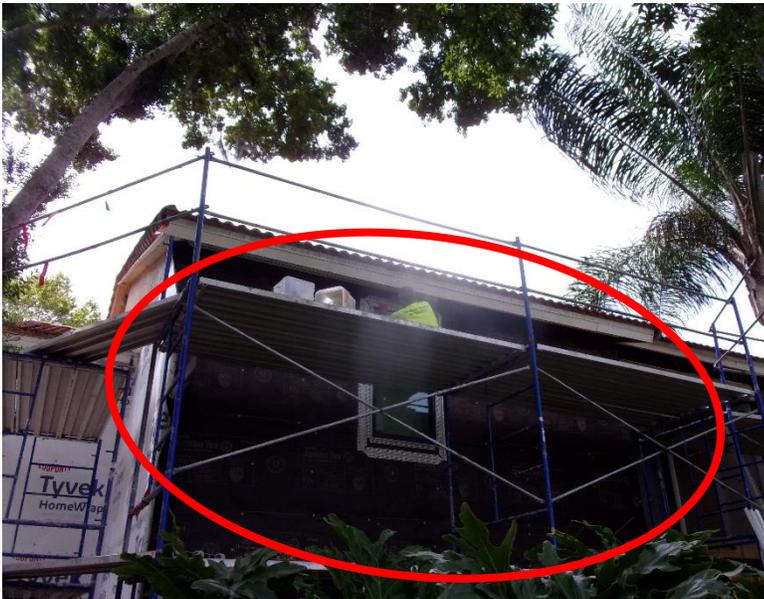
PHOTOGRAPH #8

**BUILDING 7
SECTION E**

Stucco sub-contractor has applied second water resistant barrier and begun to install vinyl stucco accessories at windows and soffit transition.

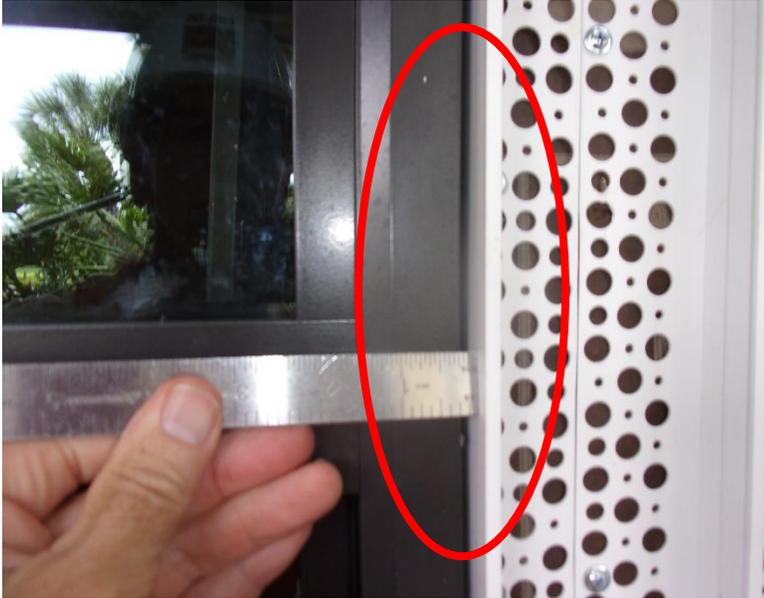
PHOTOGRAPH #9

**BUILDING 7
SECTION E**

"J" channel Vinyl stucco stop accessories set to provide $\frac{1}{4}$ " gap for new sealants at window perimeters.

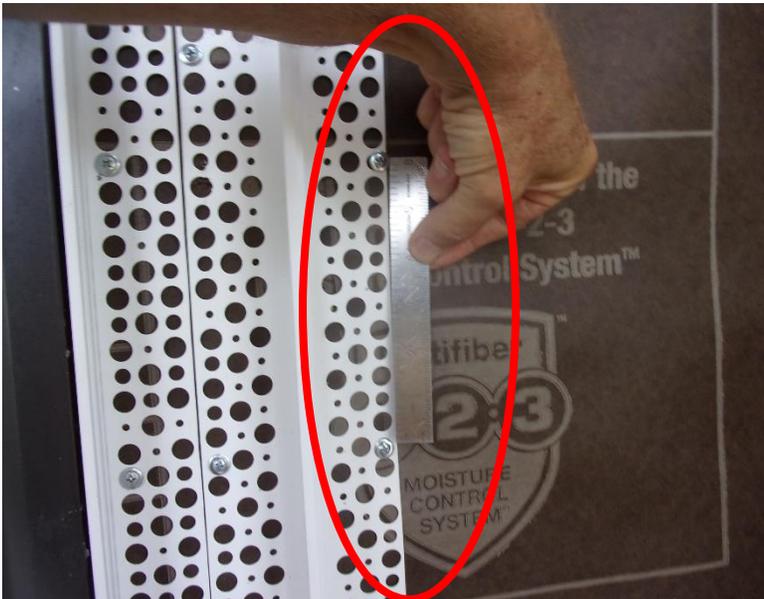
PHOTOGRAPH #10

**BUILDING 7
SECTION E**

"J" channel Vinyl stucco stop accessories secured at no more than seven-inch intervals as per ASTM C1063 standards.

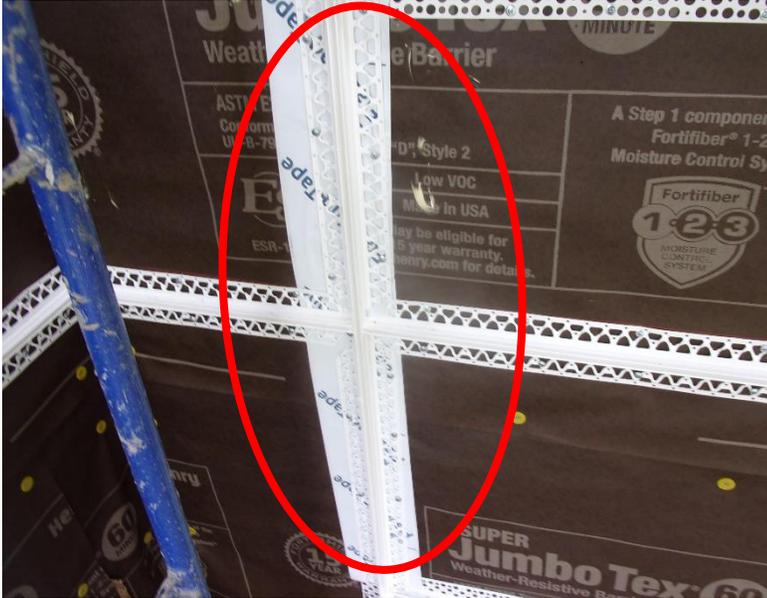
PHOTOGRAPH #11

**BUILDING 7
SECTION F**

Continuous vertical self-adhering Dupont straight flash applied over WRB prior to installation of new control joint accessories as per project drawings.

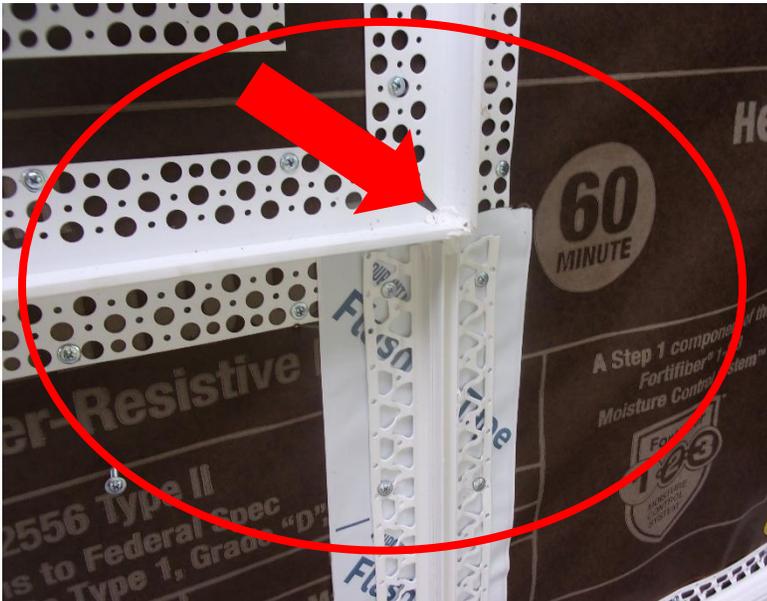
PHOTOGRAPH #12

**BUILDING 7
SECTION F**

New urethane sealant installed at all stucco accessory corner and butt joints transitions.

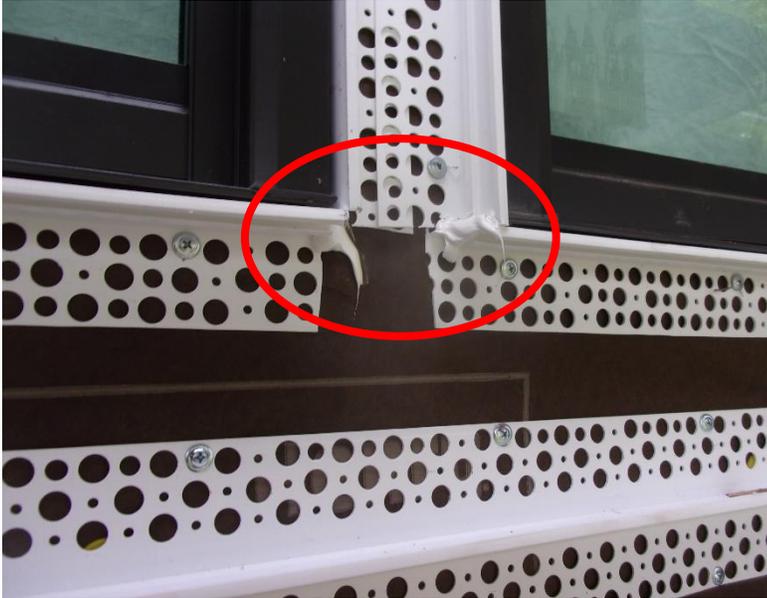
PHOTOGRAPH #13

**BUILDING 7
SECTION F**

New urethane sealant installed at all stucco accessory corner and butt joints transitions.

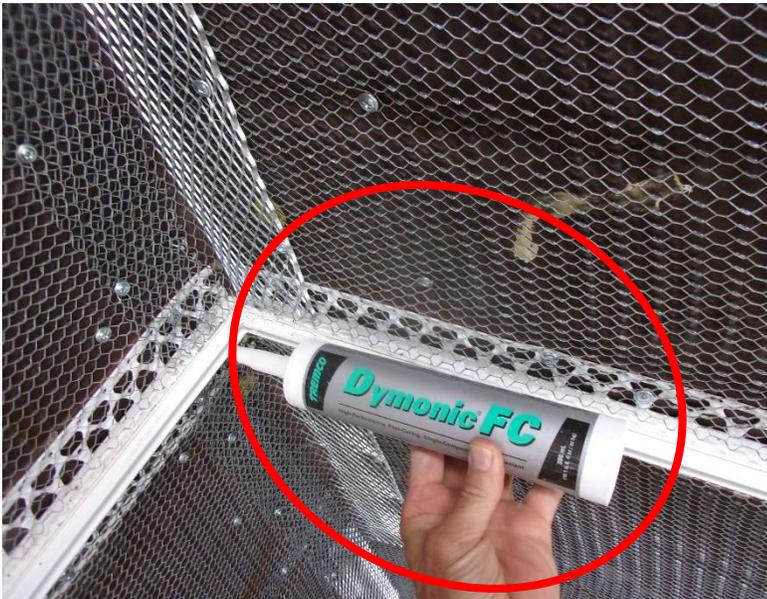
PHOTOGRAPH #14

**BUILDING 7
SECTION F**

New urethane sealant installed at all stucco accessory corner and butt joints transitions.

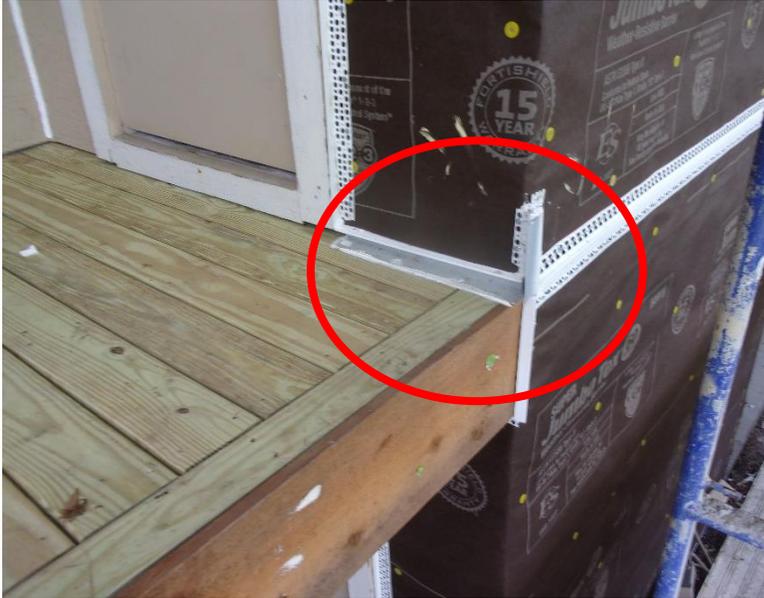
PHOTOGRAPH #15

**BUILDING 7
SECTION G**

New galvanized kick out flashing installation in progress at balcony decks.

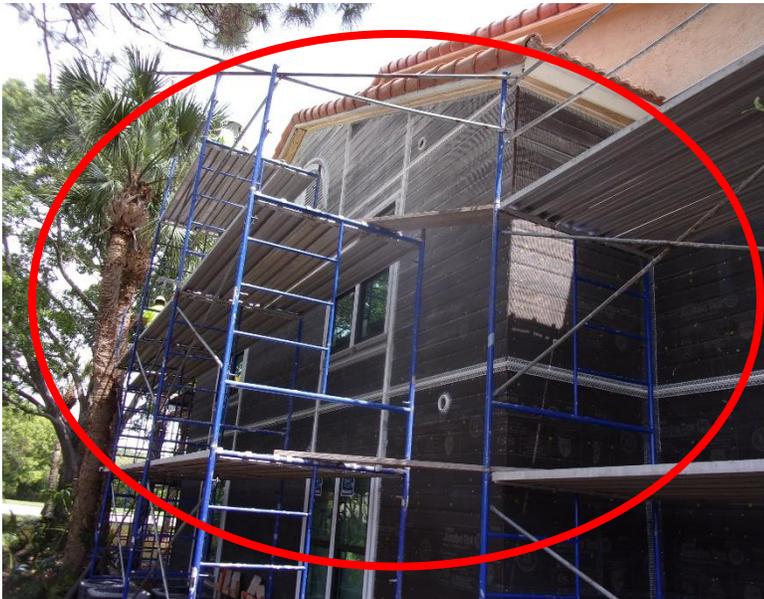
PHOTOGRAPH #16

**BUILDING 7
SECTION H**

Stucco subcontractor has installed vinyl stucco accessories over secondary water-resistant barrier and installed galvanized metal lathing as per drawings and specifications.

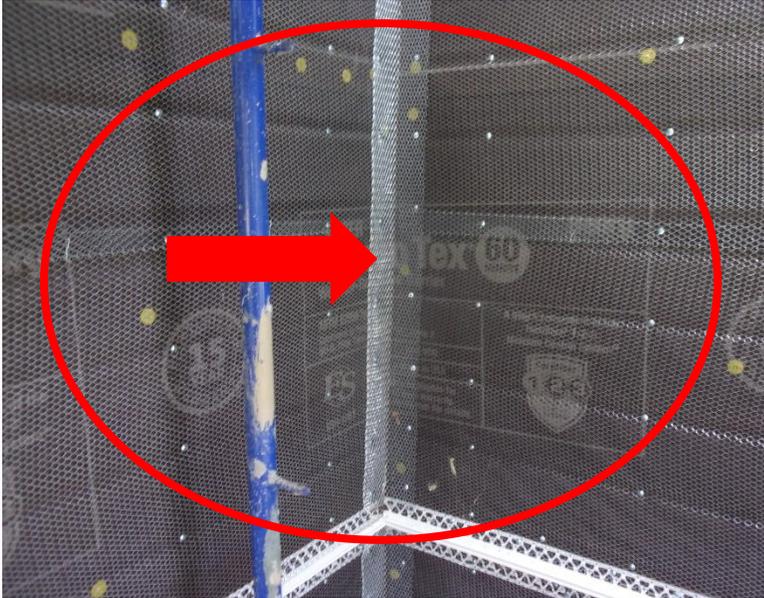
PHOTOGRAPH #17

**BUILDING 7
SECTION H**

“L” shaped four galvanized self-furring lath strips used at inside corners for best application of new stucco.

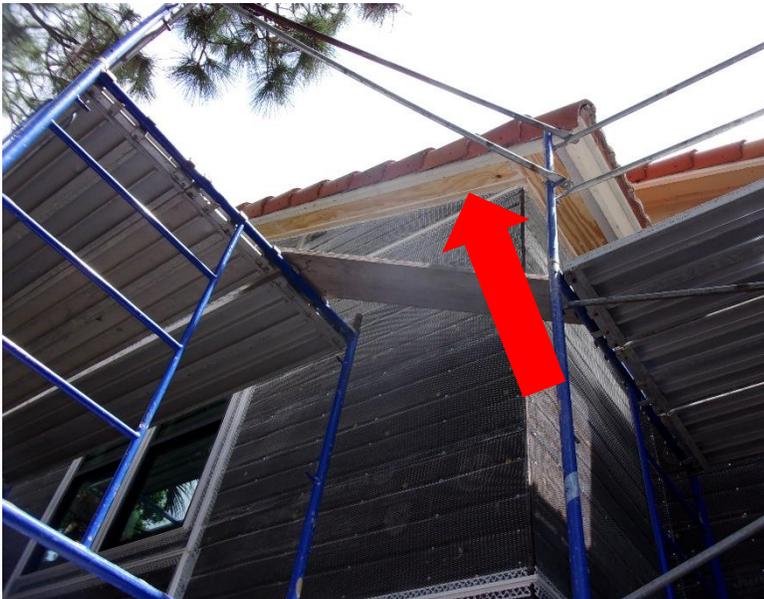
PHOTOGRAPH #18

**BUILDING 7
SECTION H**

Contractor has installed new wood soffit and vinyl venting as per drawings and specifications.

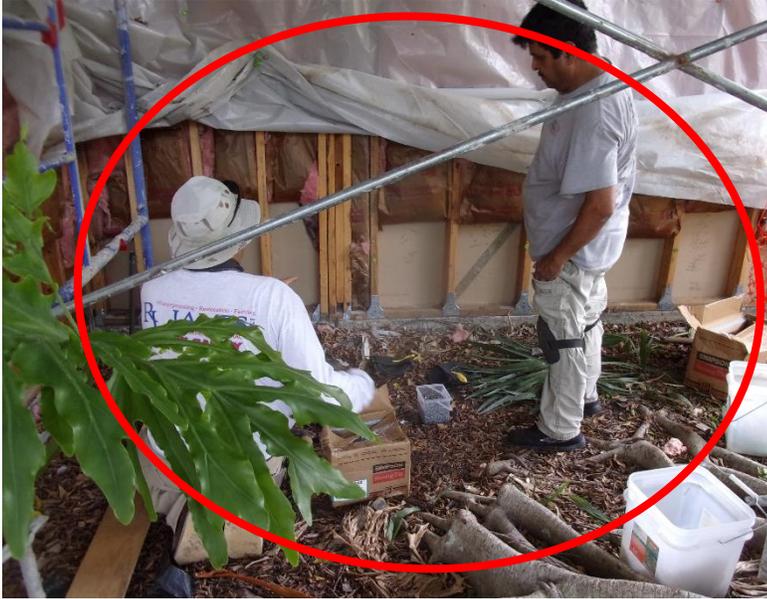
PHOTOGRAPH #19

**BUILDING 8
SECTION H**

Contractor in process of installing new Simpson strong- Tie connectors and hardware at gable end wall.

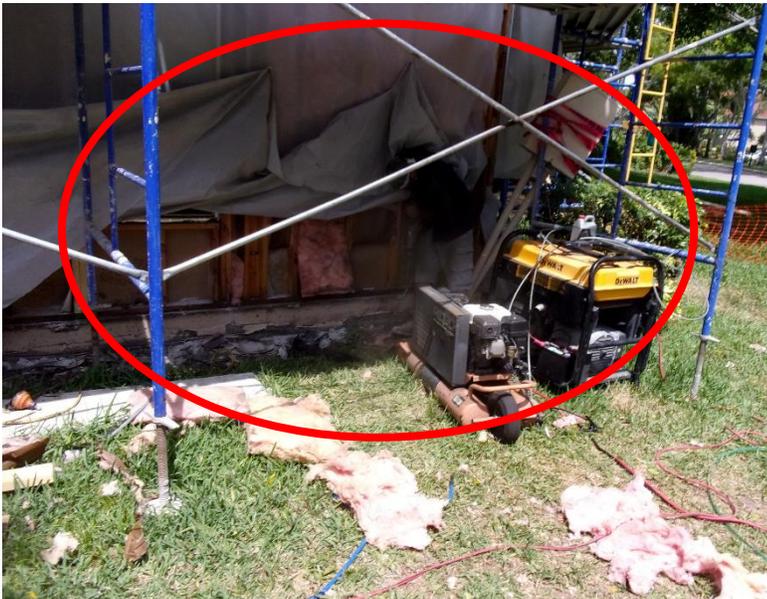
PHOTOGRAPH #20

**BUILDING 8
SECTION G**

Contractor in process of installing new 5/8" Simpson Strong- Tie Titen HD fasteners at base plate.

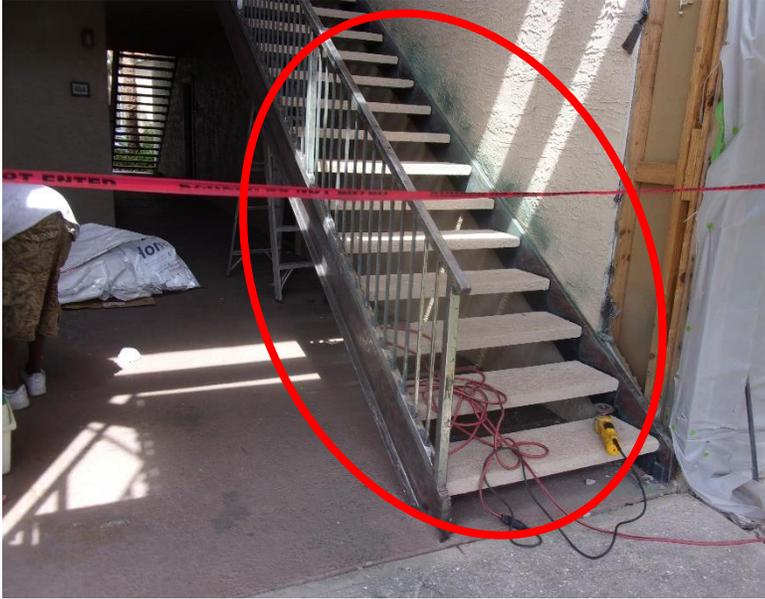
PHOTOGRAPH #21

**BUILDING 8
SECTION G**

Breezeway railings in process of surface preparation (removing loose paint and rust) with hand grinders.

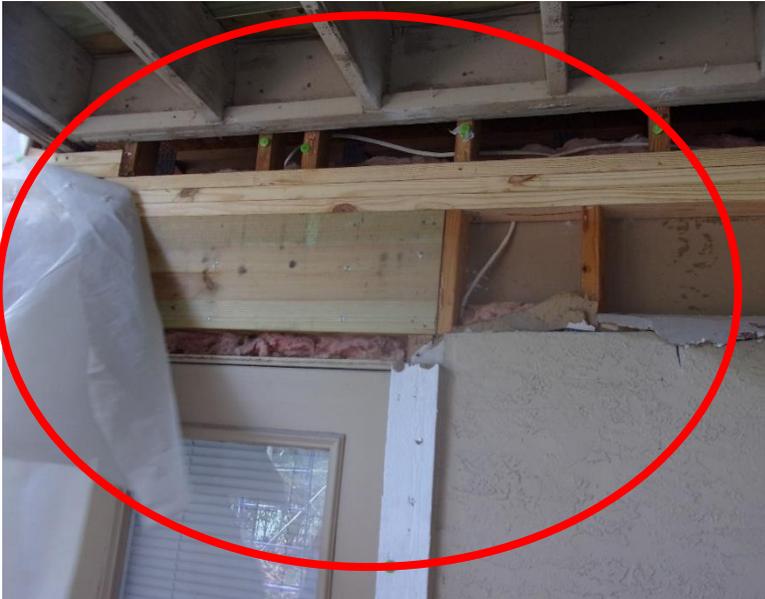
PHOTOGRAPH #22

**BUILDING 8
SECTION F**

Additional header and top plate repairs in progress above door at Lanai.

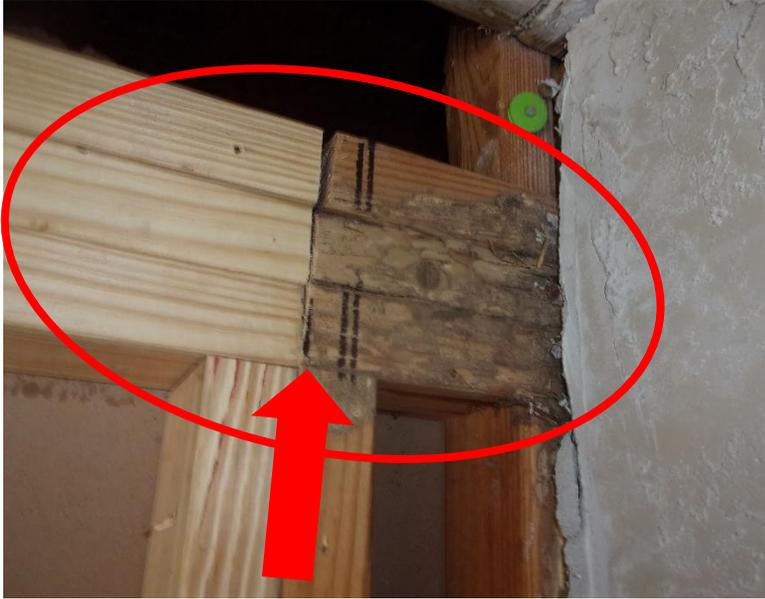
PHOTOGRAPH #23

**BUILDING 8
SECTION F**

Top plate repair has stopped short of damage and top plate repair is not properly staggered for support on framing studs.
