PHOTOGRAPHS

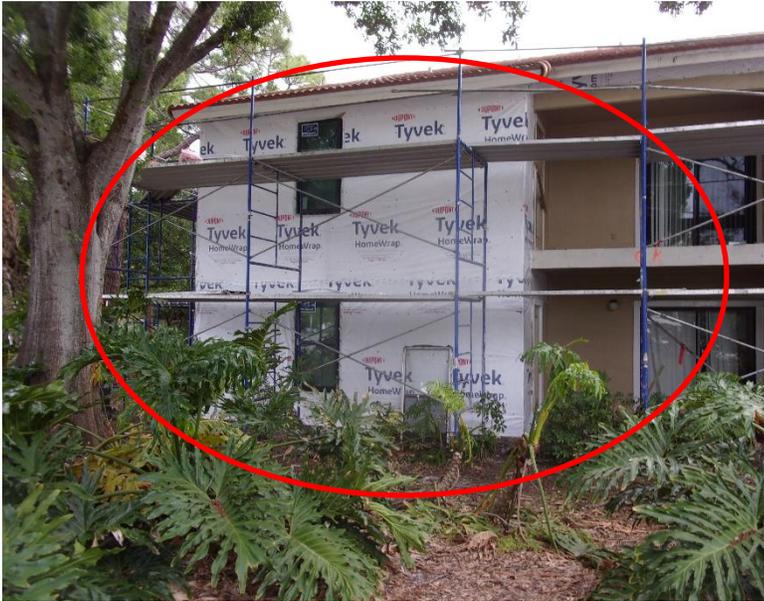
PHOTOGRAPH #1

**BUILDING 7
SECTION A**

Contractor has applied Tyvek HomeWrap water resistant barrier and installed new PGT single Hung windows as per specifications and manufacturers installation instructions.

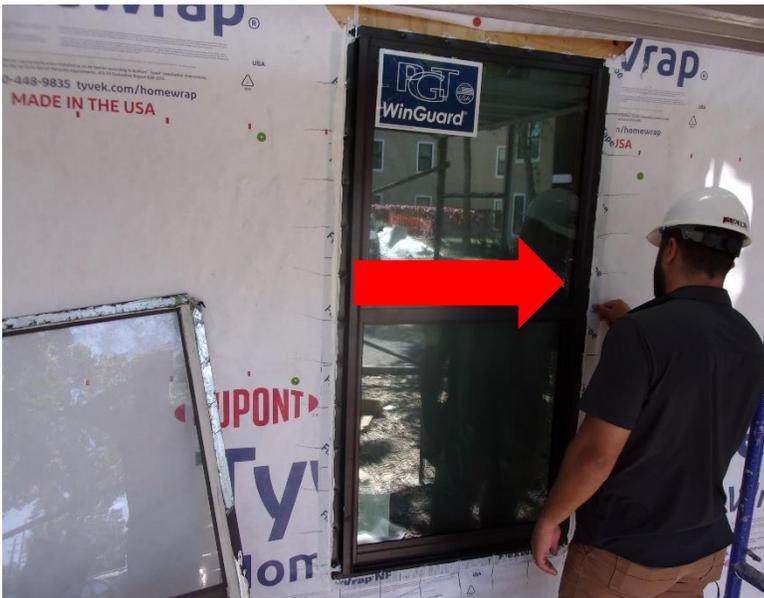
PHOTOGRAPH #2

**BUILDING 7
SECTION A**

New PGT SH7700A windows inspected for installation procedures and fastening.

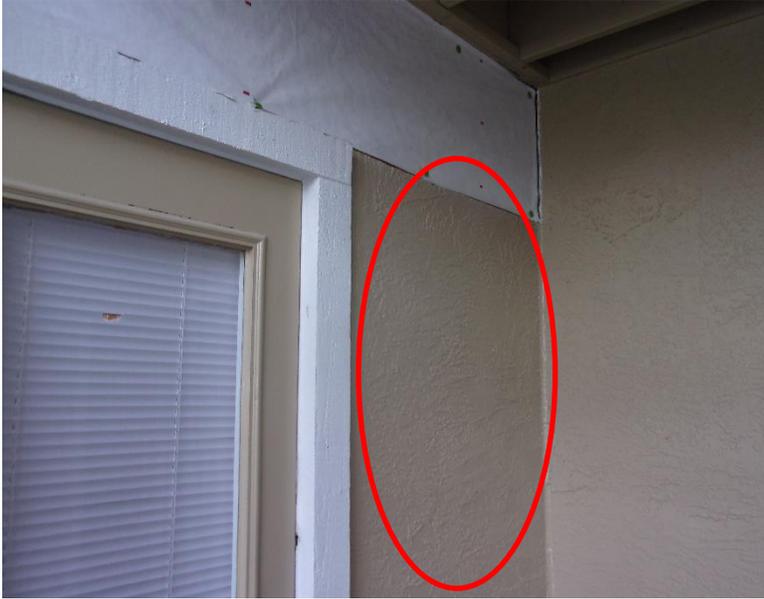
PHOTOGRAPH #3

**BUILDING 7
SECTION A**

Additional stucco removal and replacement at Lanai return wall to the inside corner has not been performed.

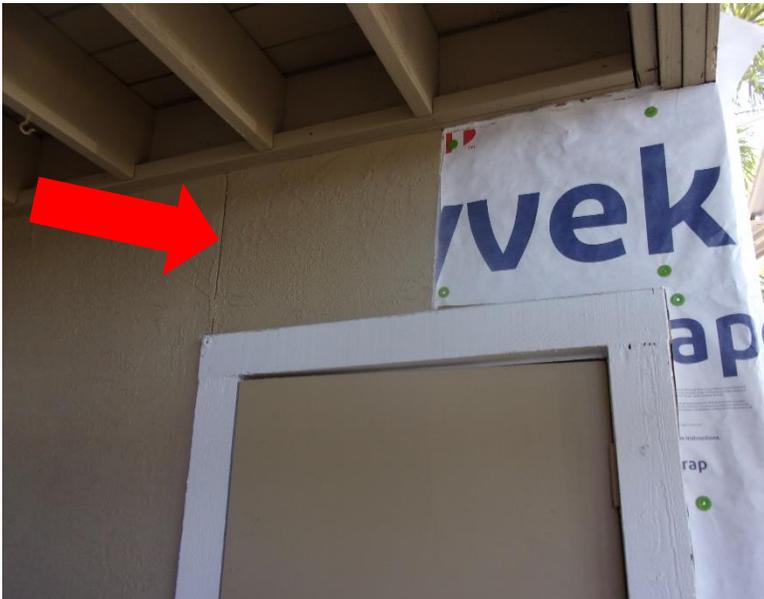
PHOTOGRAPH #4

**BUILDING 7
SECTION A**

Additional stucco removal and replacement at header over door on Lanai is required to the control joint.

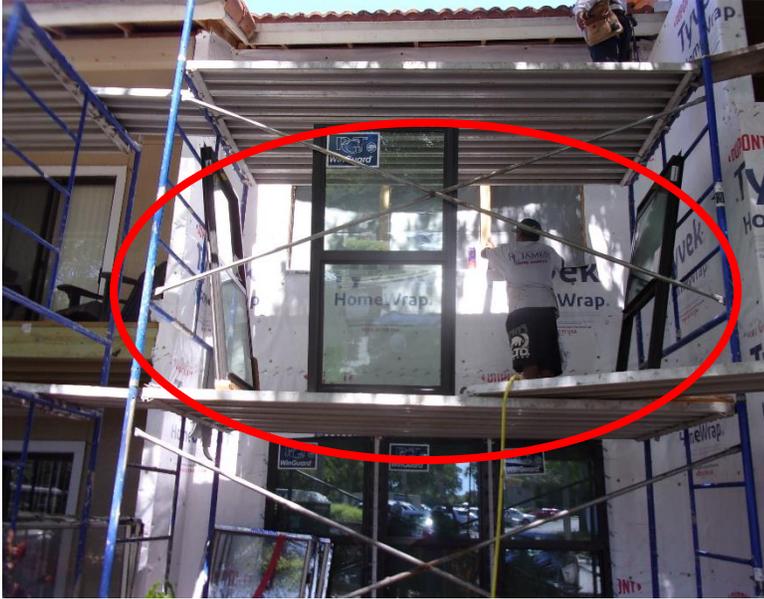
PHOTOGRAPH #5

**BUILDING 7
SECTION B**

New PGT SH7700A windows installation in progress at second floor triple window openings.

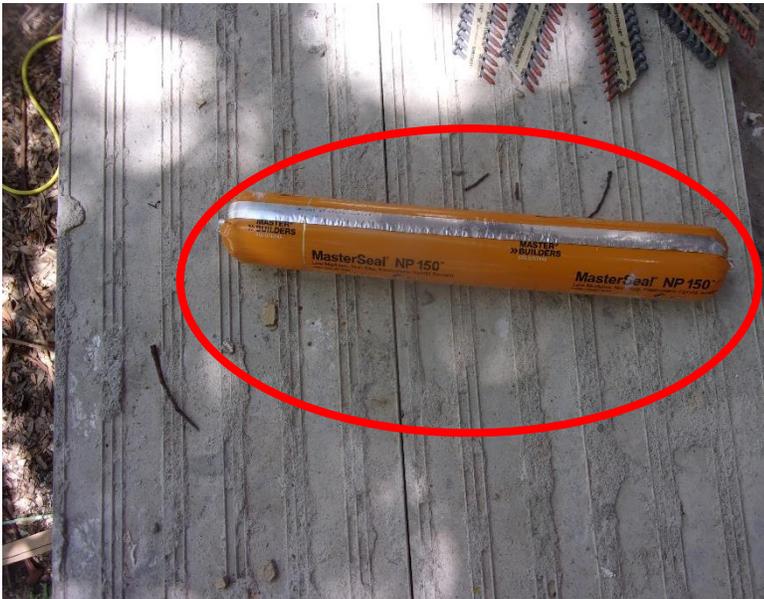
PHOTOGRAPH #6

**BUILDING 7
SECTION B**

MasterSeal NP150 used at window flange to window opening as per specifications.

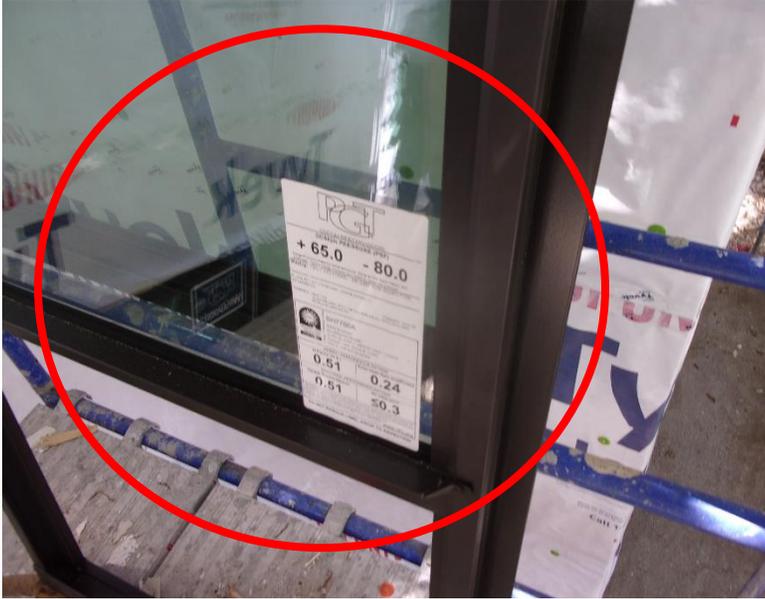
PHOTOGRAPH #7

**BUILDING 7
SECTION B**

New PGT SH7700A windows inspected for installation procedures and fastening.

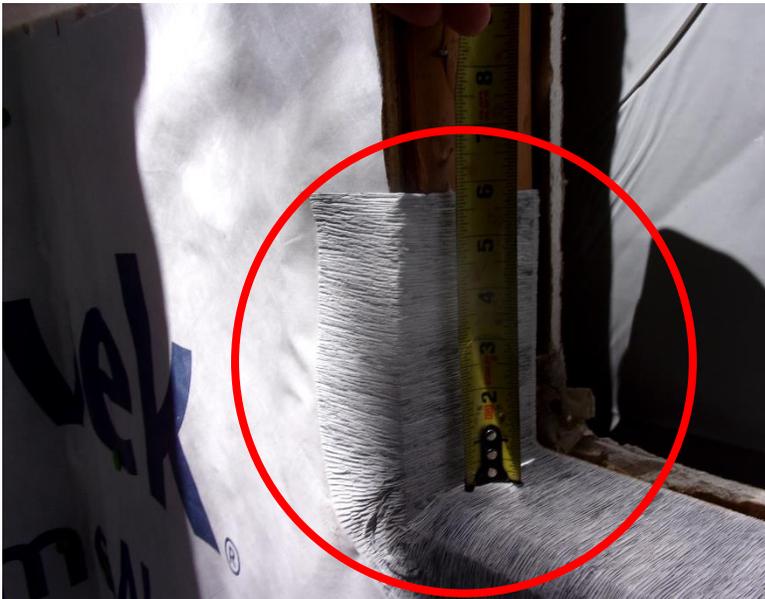
PHOTOGRAPH #8

**BUILDING 7
SECTION B**

Dupont Tyvek FlexWrap flashing installed at windowsill opening and up Jamb 6" as per specifications.

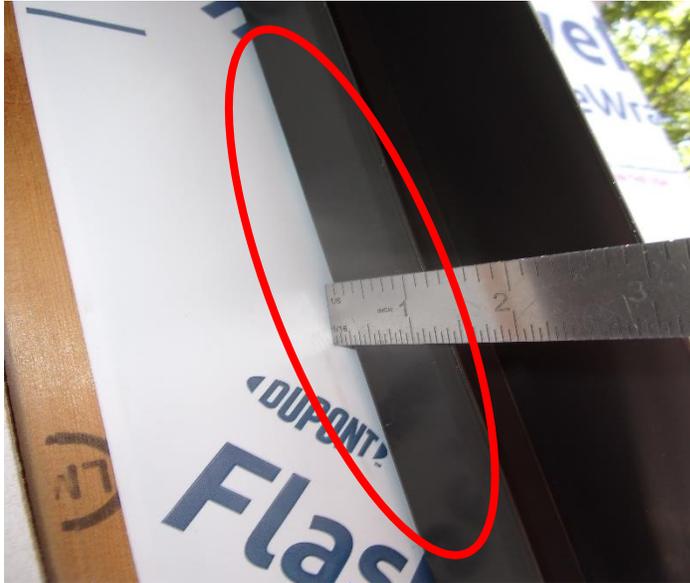
PHOTOGRAPH #9

**BUILDING 7
SECTION B**

Gaps from edge of window frame to window jams do not exceed maximum allowed 5/16" as per manufactures NOA.

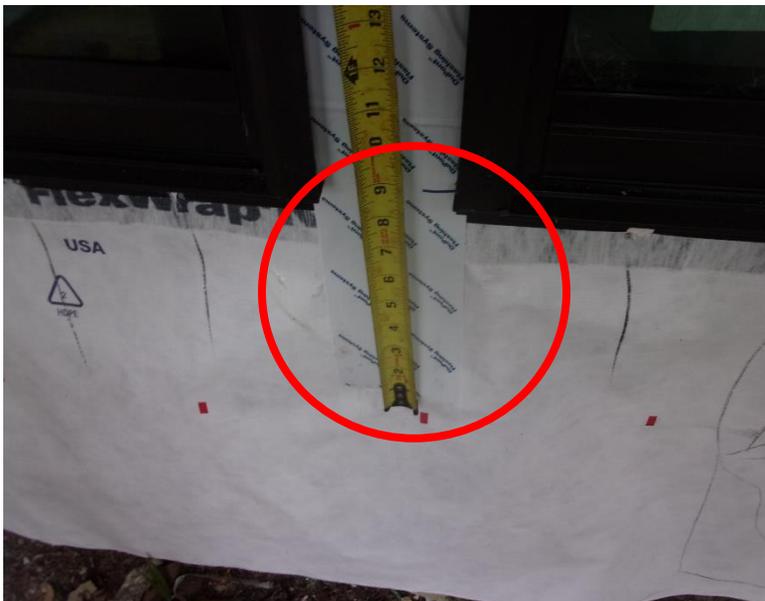
PHOTOGRAPH #10

**BUILDING 7
SECTION B**

Dupont Tyvek StraightFlash flashing installed over window flanges extends past window framing over FlexWrap flashing 6" as specified.

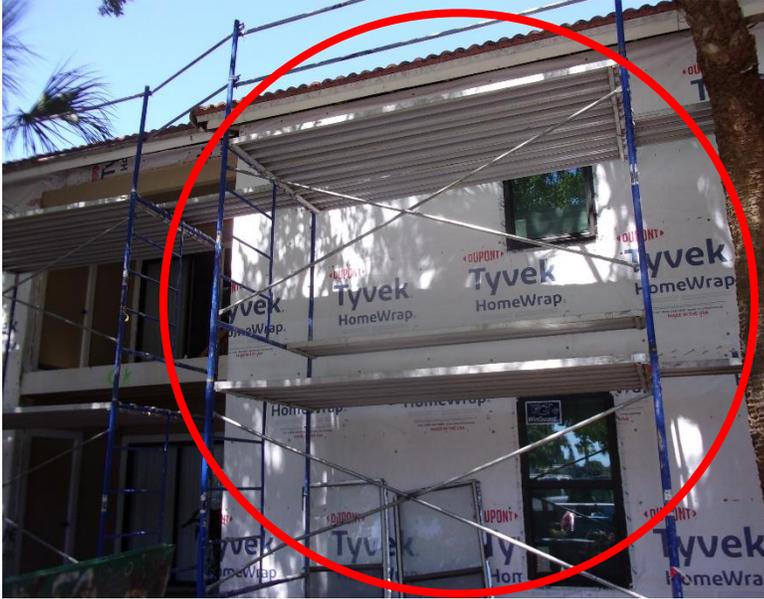
PHOTOGRAPH #11

**BUILDING 7
SECTION C**

Contractor has applied Tyvek HomeWrap water resistant barrier and installed new PGT single Hung windows as per specifications and manufacturers installation instructions.

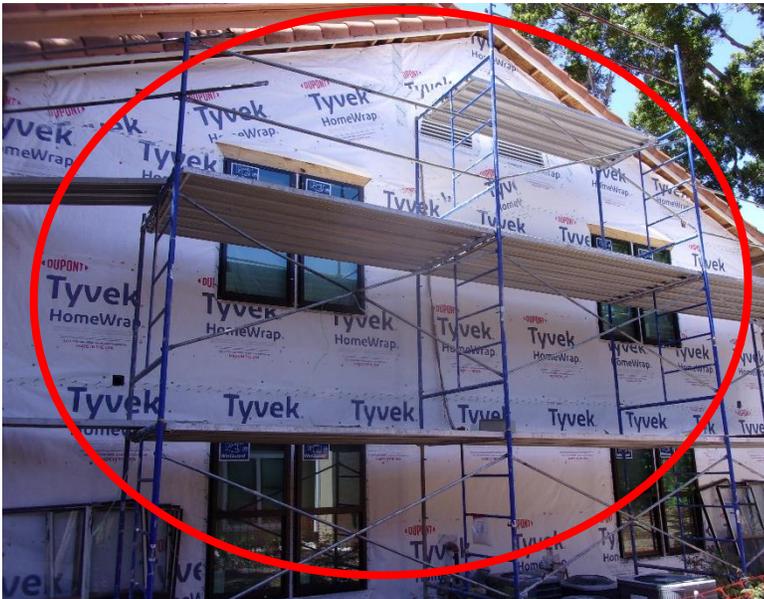
PHOTOGRAPH #12

**BUILDING 7
SECTION D**

Contractor has applied Tyvek HomeWrap water resistant barrier and installed new PGT single Hung windows as per specifications and manufacturers installation instructions.

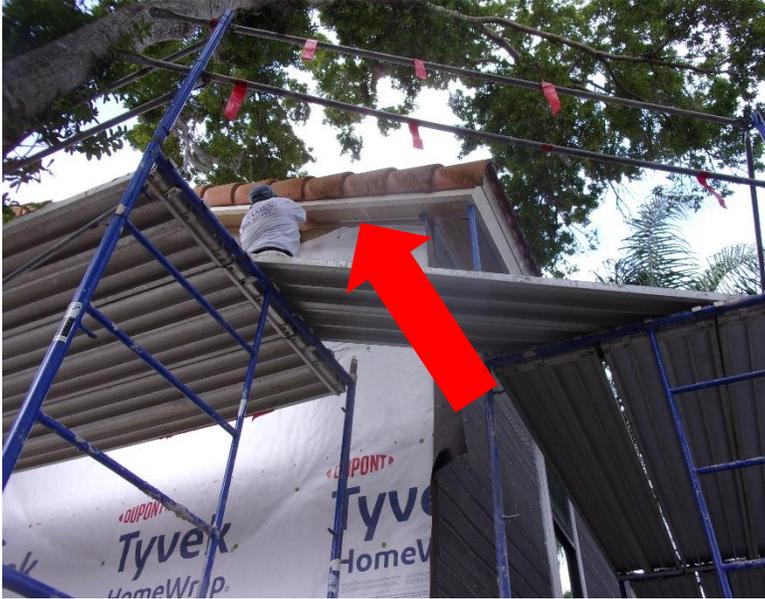
PHOTOGRAPH #13

**BUILDING 7
SECTION D**

New Soffit installed and prepared for painting at gable end wall.

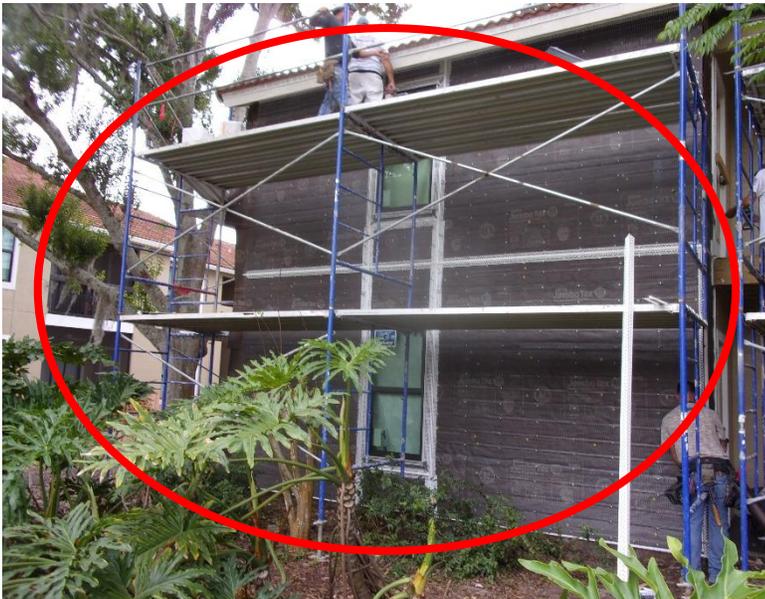
PHOTOGRAPH #14

**BUILDING 7
SECTION E**

Stucco subcontractor in process of installing galvanized metal lathing over secondary water-resistant barrier as per drawings and specifications.

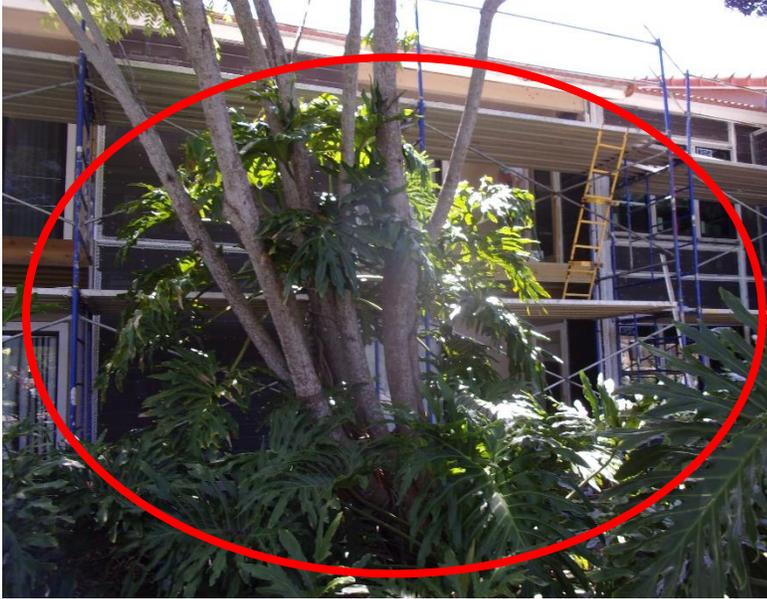
PHOTOGRAPH #15

**BUILDING 7
SECTION F**

Stucco sub-contractor has completed installation of stucco accessories and metal lathing for application of new stucco.

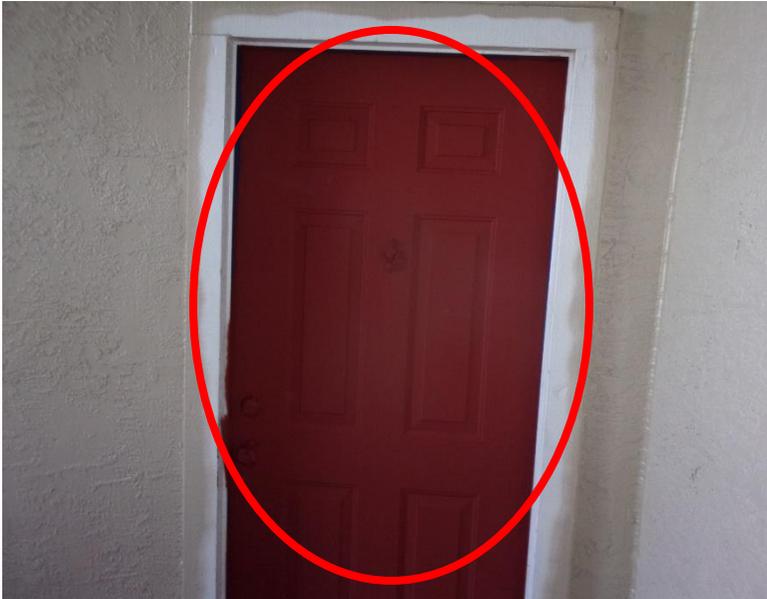
PHOTOGRAPH #16

**BUILDING 7
SECTION G**

Contractor has prepped and primed metal front doors with Florida Paints red oxide Alkyd Metal Primer.

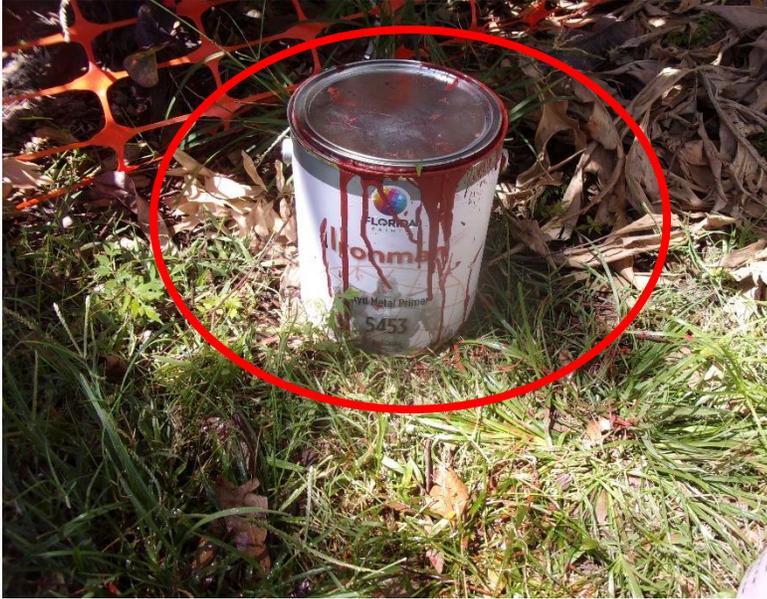
PHOTOGRAPH #17

**BUILDING 7
SECTION G**

Contractor has prepared and primed metal front doors with Florida Paints red oxide Alkyd Metal Primer.

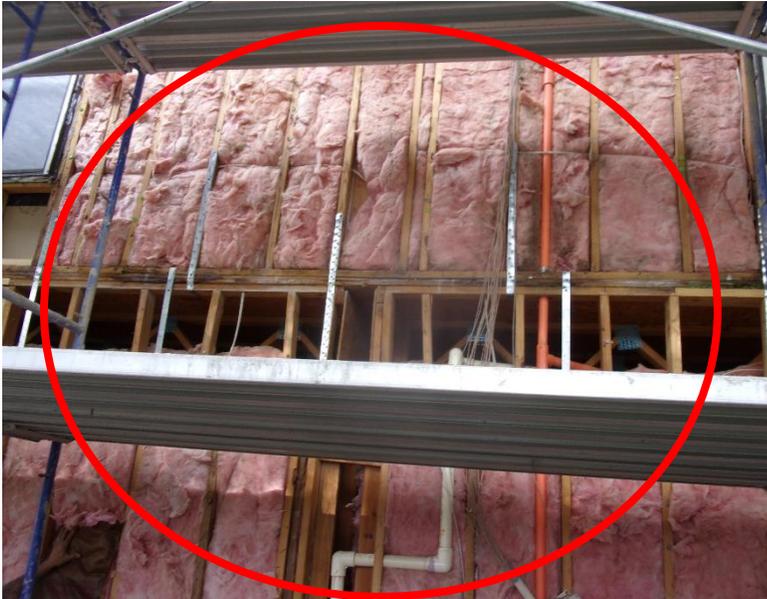
PHOTOGRAPH #18

**BUILDING 8
SECTION H**

Contractor has installed Simpson Strong-Tie connectors and hardware at gable end wall as per drawings and specifications.

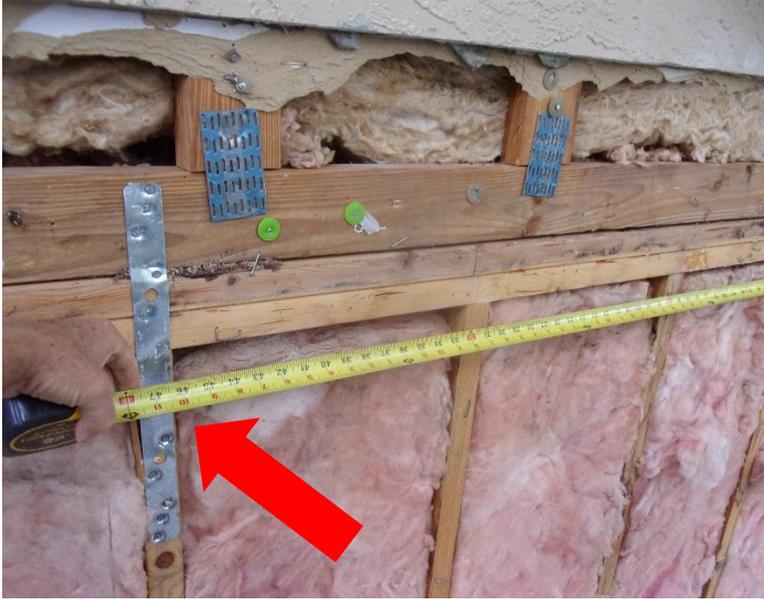
PHOTOGRAPH #19

**BUILDING 8
SECTION H**

Contractor has installed new Simpson Strong-Tie #LSTA-15 strap at stud to truss connections 48" O.C. per drawings.

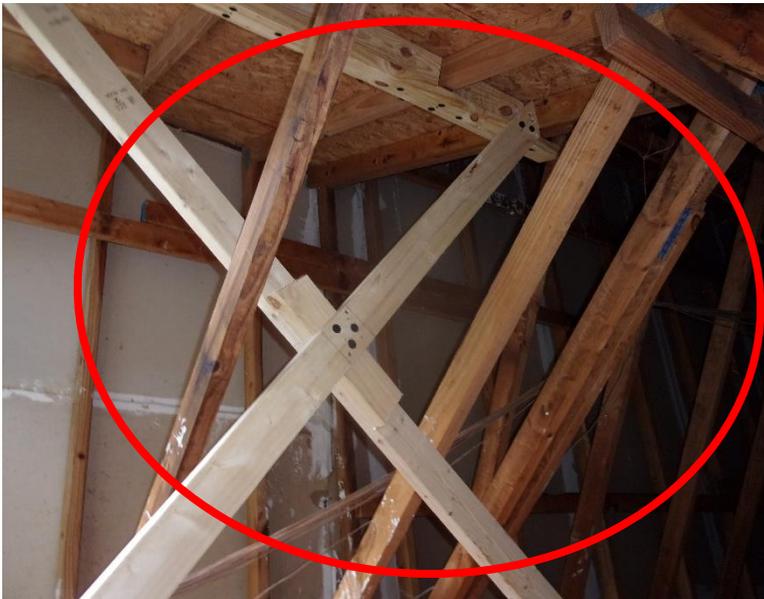
PHOTOGRAPH #20

**BUILDING 8
SECTION H**

Contractor has performed cross bracing repairs at gable end wall.

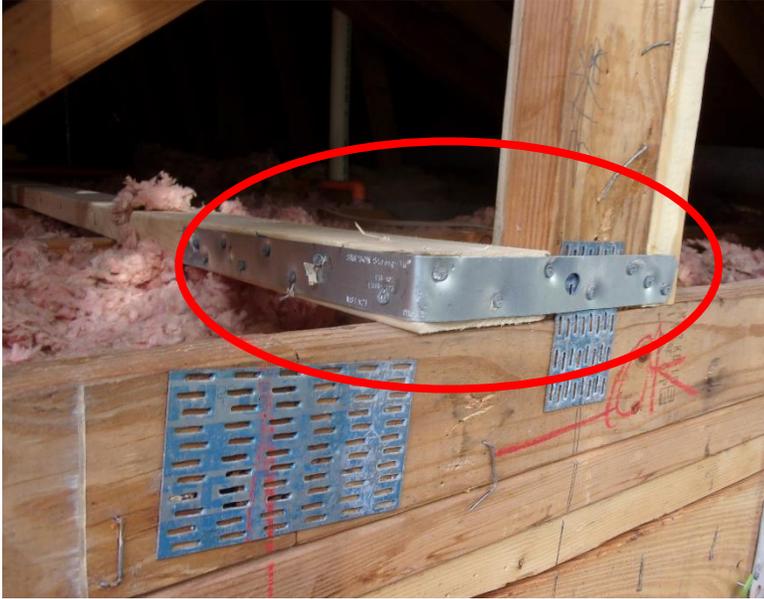
PHOTOGRAPH #21

**BUILDING 8
SECTION H**

Contractor has installed new Simpson Strong-Tie #LSTA-21 strap at end of lateral braces to retrofit Studs as per drawings.

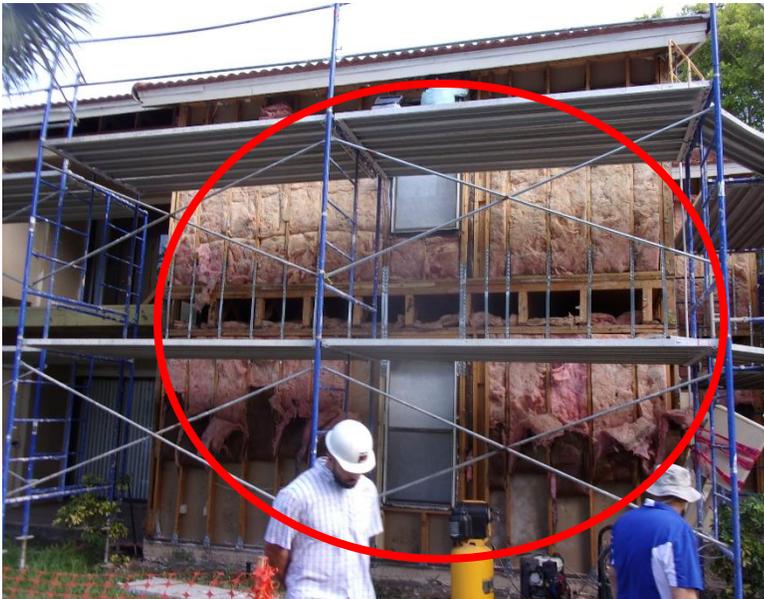
PHOTOGRAPH #22

**BUILDING 8
SECTION G**

Contractor in process of installing Simpson Strong-Tie connectors and hardware at load bearing wall as per drawings and specifications.

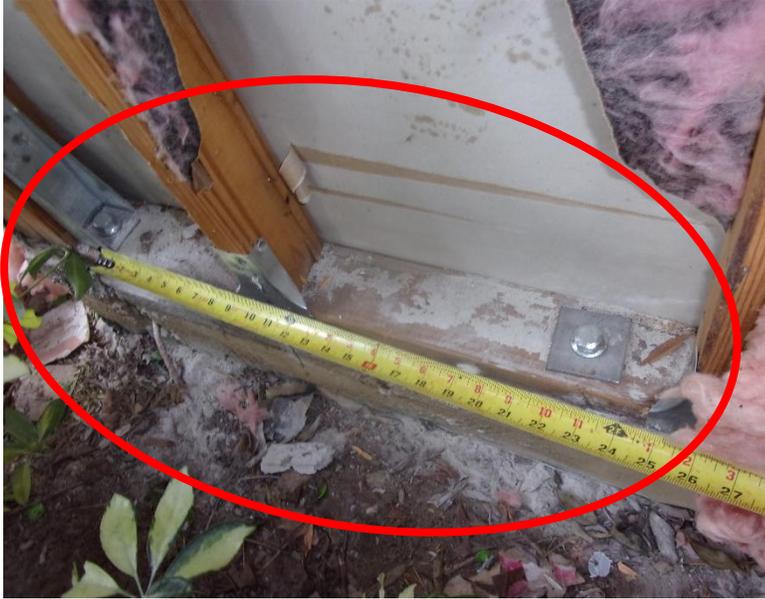
PHOTOGRAPH #23

**BUILDING 8
SECTION G**

Contractor has installed new 5/8" Simpson Strong-Tie Titen HD fasteners at base plate as per drawings and specifications.

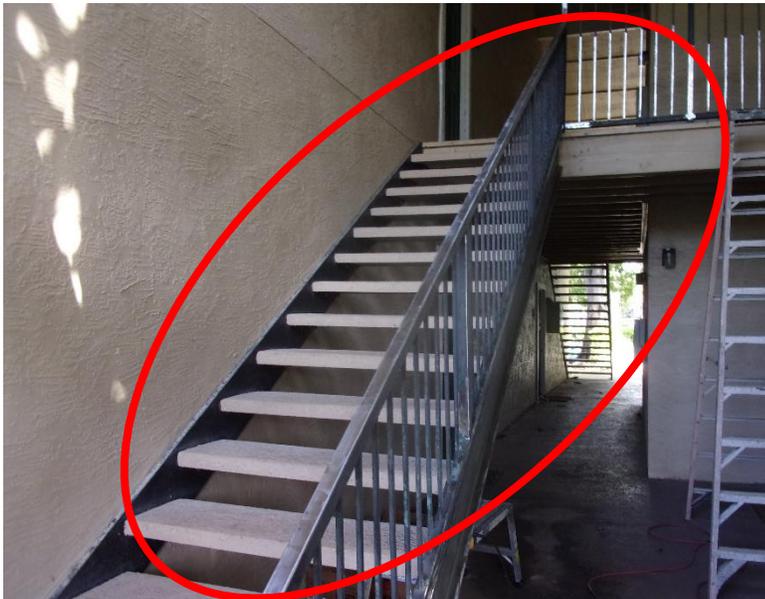
PHOTOGRAPH #24

**BUILDING 8
SECTION G**

Breezeway railings in process of surface preparation (removing loose paint and rust) with hand grinders.
