PHOTOGRAPHS

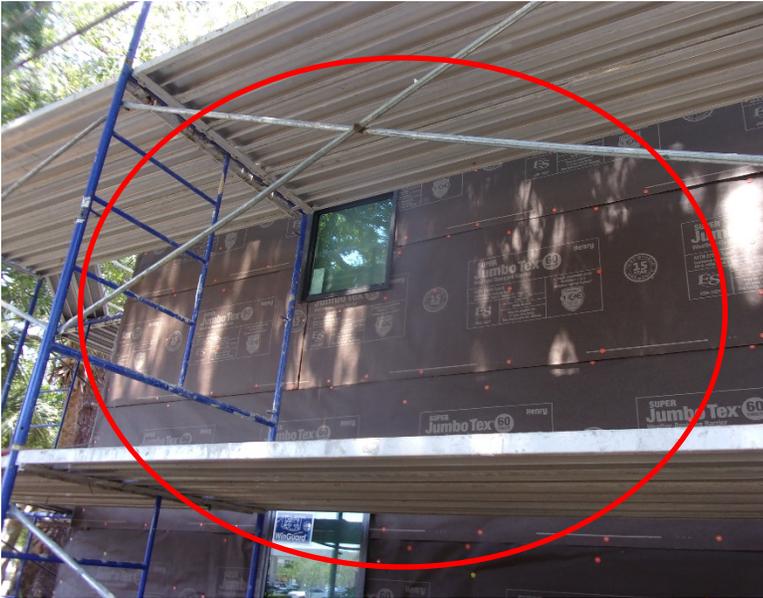
PHOTOGRAPH #1

**BUILDING 7
SECTION A**

Contractor has applied JumboTex water resistant barrier over Tyvek HomeWrap.

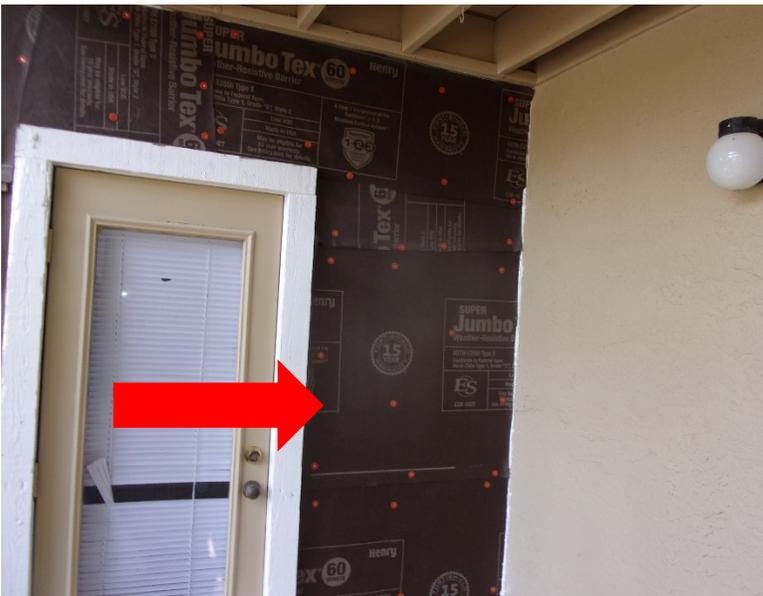
PHOTOGRAPH #2

**BUILDING 7
SECTION A**

Additional stucco removed, re sheathed and covered with JumboTex past Lani door to corner of Lani as required from action items.

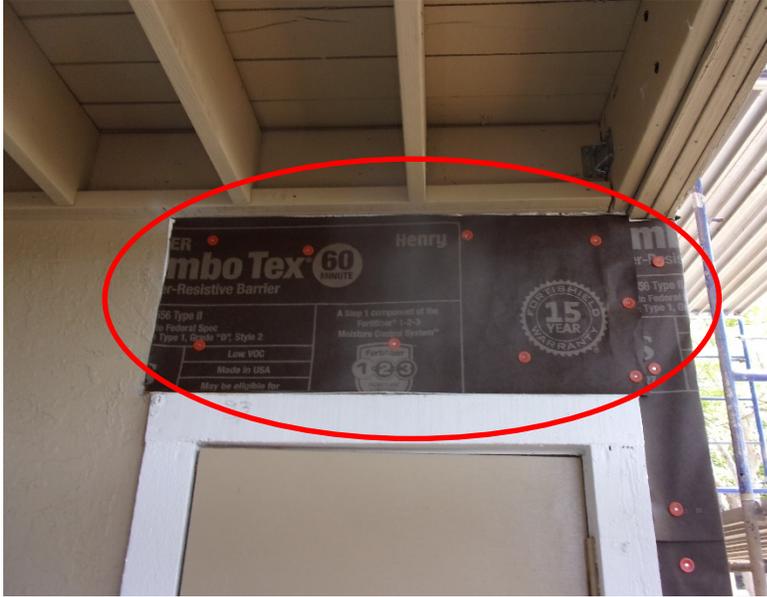
PHOTOGRAPH #3

**BUILDING 7
SECTION A**

Additional stucco removed, re sheathed and covered with JumboTex at header over Lanai door as required from action items.

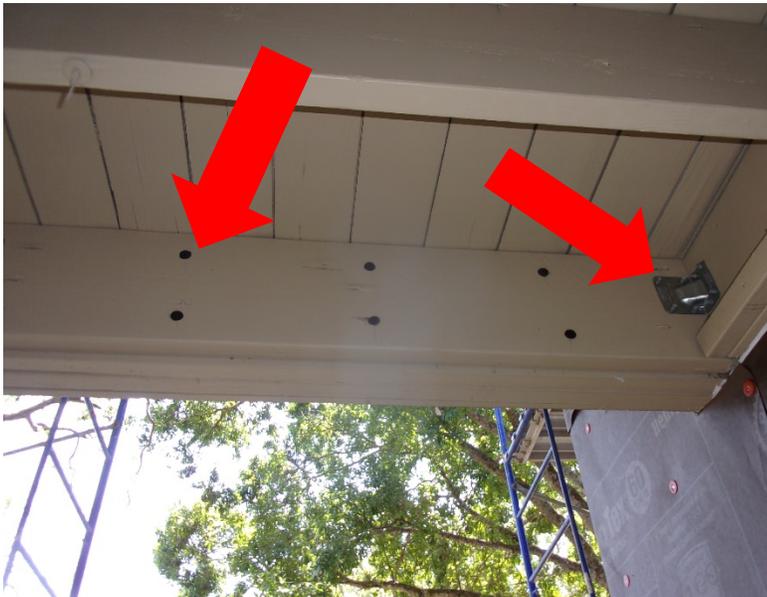
PHOTOGRAPH #4

**BUILDING 7
SECTION A**

Simson Strong-Tie #SDW22458 screws and shear clip installed at built up beam as per drawings.

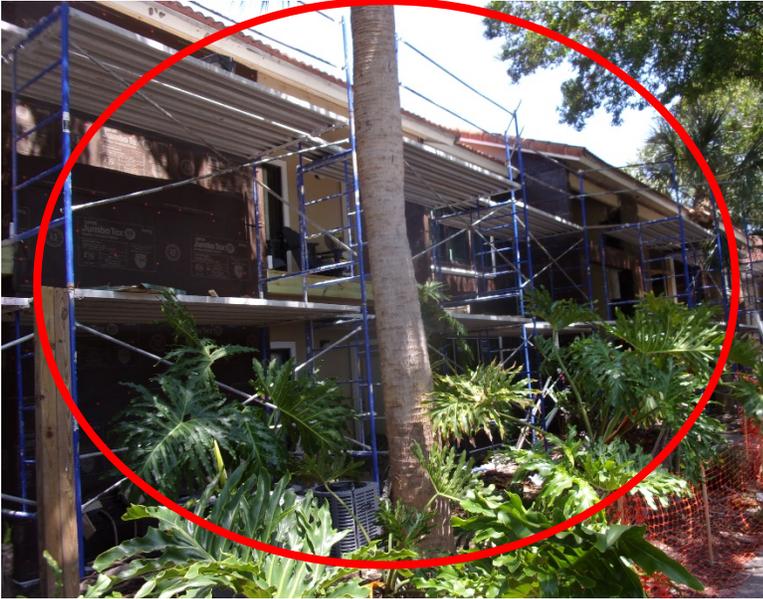
PHOTOGRAPH #5

**BUILDING 7
SECTION B**

JumboTex 60 Water resistant barrier applied over Tyvek HomeWrap.

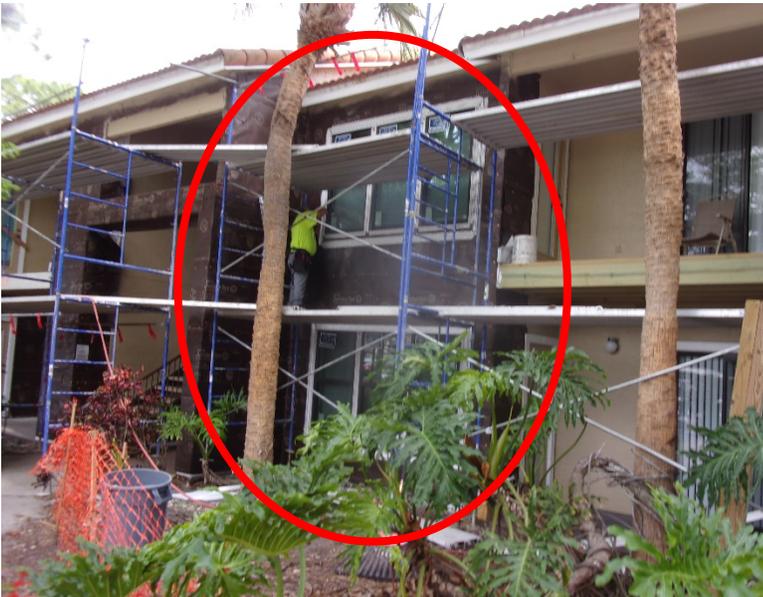
PHOTOGRAPH #6

**BUILDING 7
SECTION B**

Contractor installing vinyl stucco accessories at new windows.

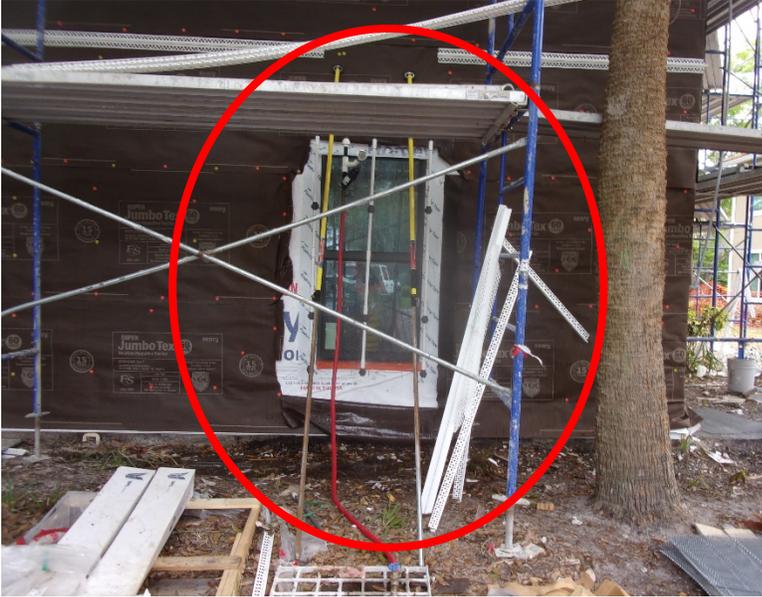
PHOTOGRAPH #7

**BUILDING 7
SECTION C**

Unit #717 - Independent Testing agency performed AAMA 502 water testing at single window with no leaks or failures.

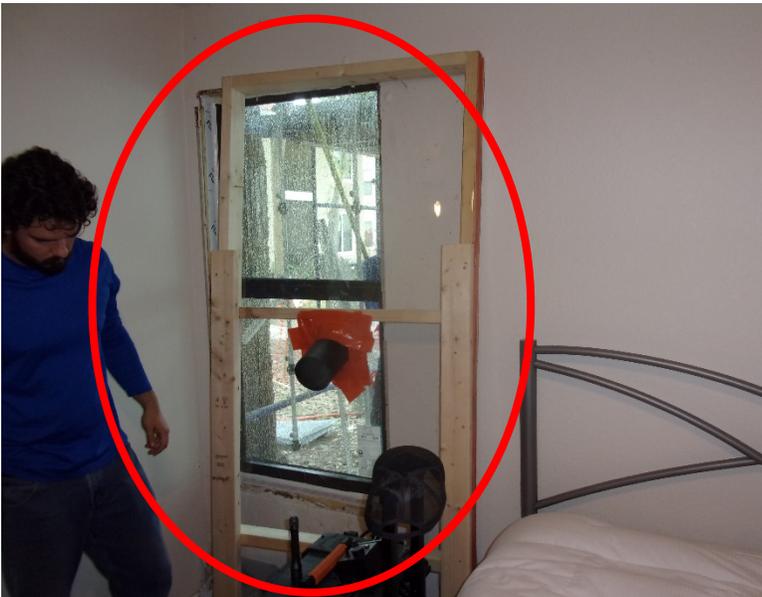
PHOTOGRAPH #8

**BUILDING 7
SECTION C**

Unit #717 - Independent Testing agency performed AAMA 502 water testing at single window with no leaks or failures

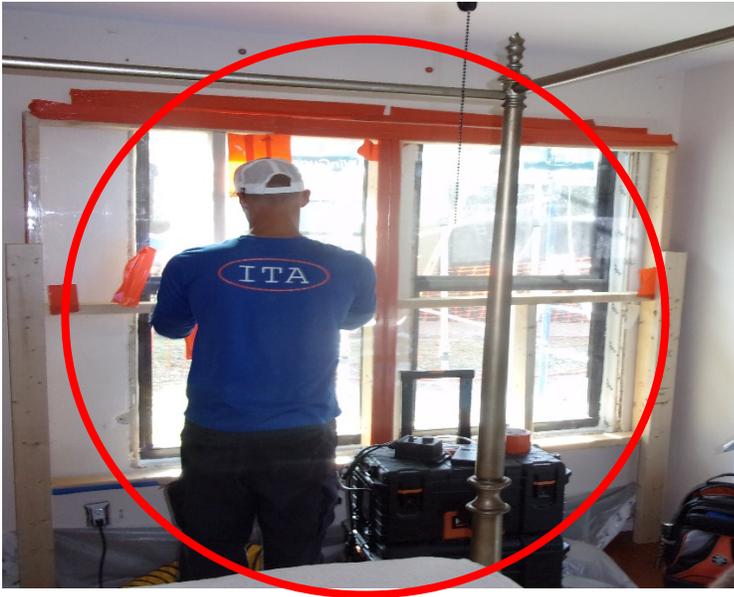
PHOTOGRAPH #9

**BUILDING 7
SECTION D**

Unit #717 - Independent Testing agency performed AAMA 502 water testing at double windows with leak failure at lower left corner sill.

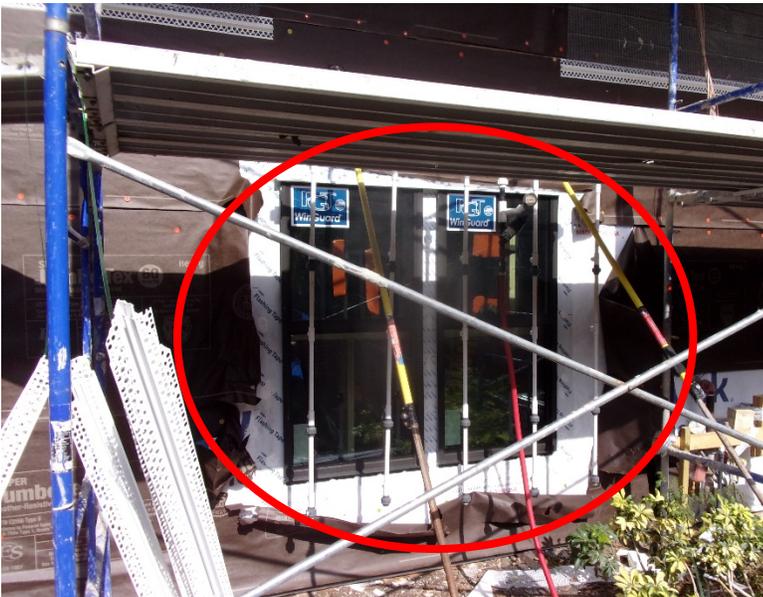
PHOTOGRAPH #10

**BUILDING 7
SECTION D**

Unit #717 - Independent Testing agency performed AAMA 502 water testing at Double windows with leak failure at lower left corner sill.

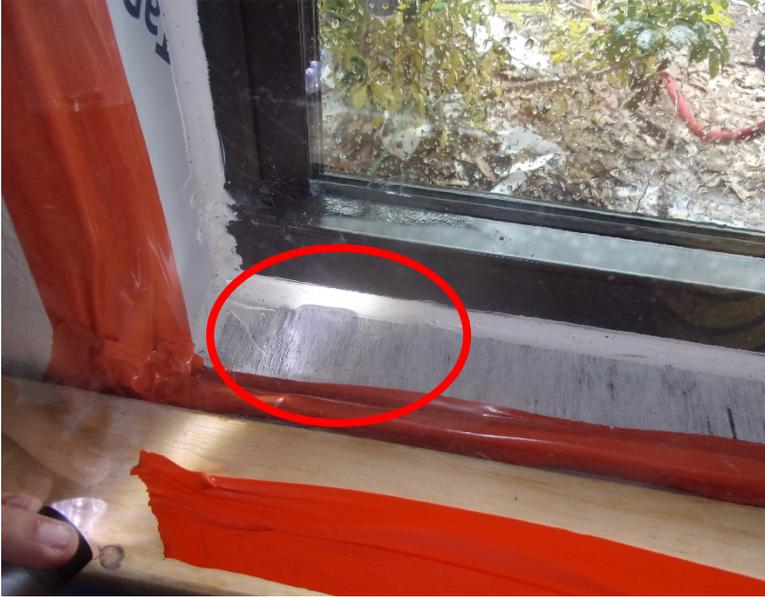
PHOTOGRAPH #11

**BUILDING 7
SECTION D**

Unit #717 - Independent Testing agency performed AAMA 502 water testing at Double windows with leak failure at lower left corner sill.

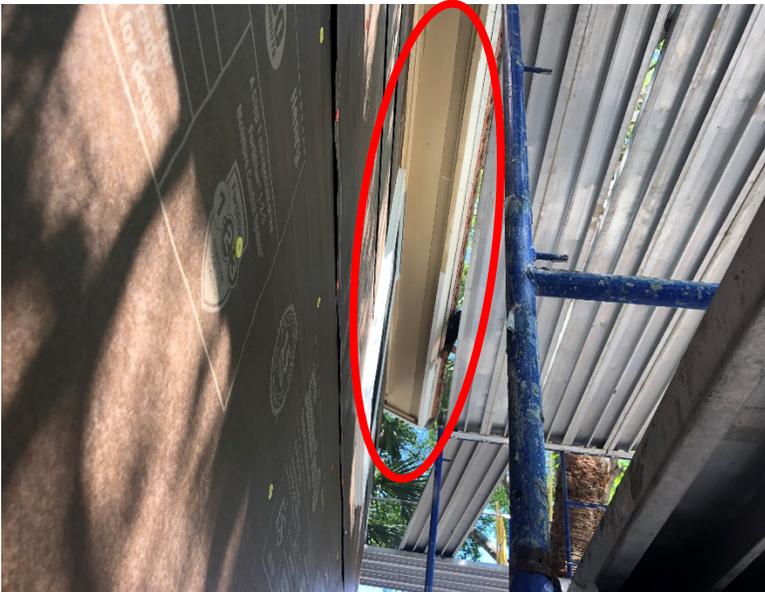
PHOTOGRAPH #12

**BUILDING 7
SECTION D**

Contractor has installed prepared and primed new wood soffit and vinyl venting at soffit as per drawings.

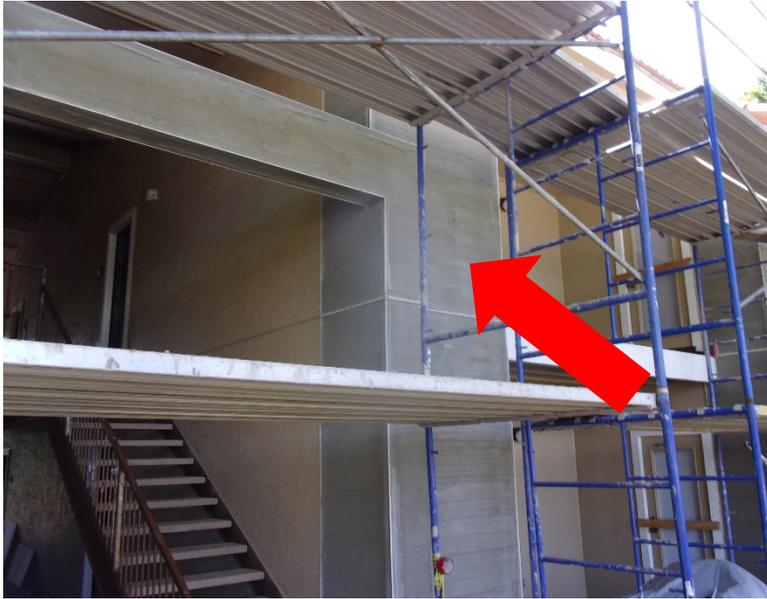
PHOTOGRAPH #13

**BUILDING 7
SECTION E**

Stucco sub-contractor has applied scratch coat of stucco over self-furring galvanized metal lath.

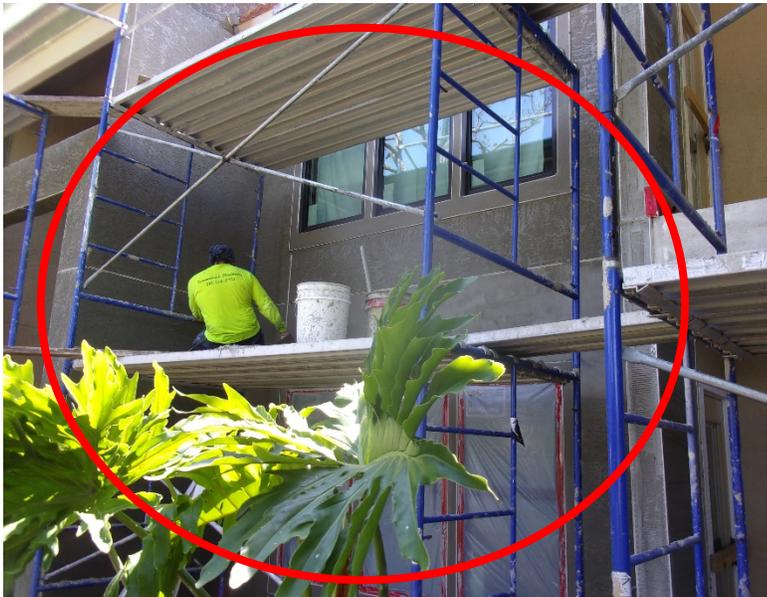
PHOTOGRAPH #14

**BUILDING 7
SECTION F**

Stucco subcontractor in process of applying 7/8" three coat stucco system.

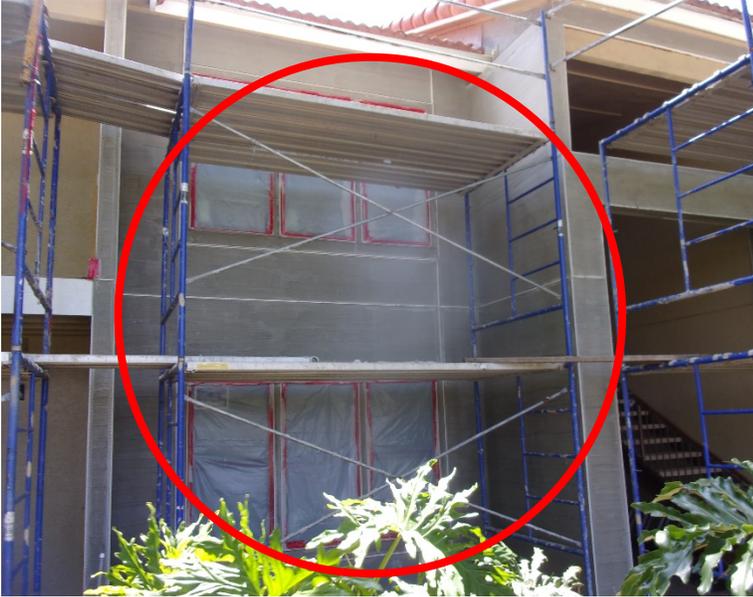
PHOTOGRAPH #15

**BUILDING 7
SECTION F**

Stucco sub-contractor has applied scratch coat of stucco over self-furring galvanized metal lath.

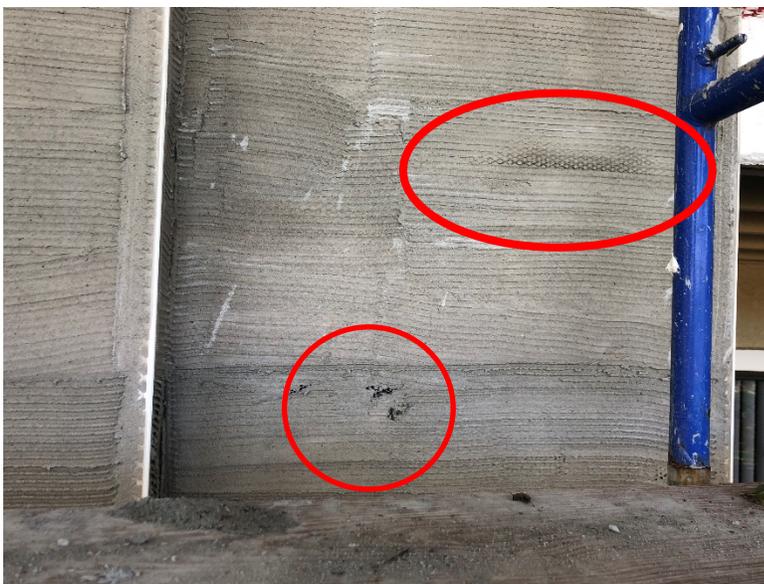
PHOTOGRAPH #16

**BUILDING 7
SECTION G**

Metal lathing exposed thru scratch coat and holes in scratch coat exposing metal lathing.

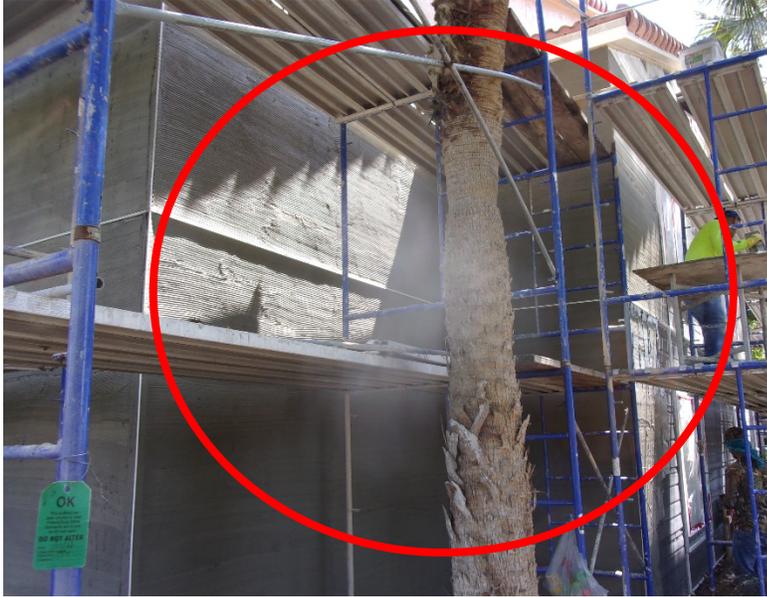
PHOTOGRAPH #17

**BUILDING 7
SECTION H**

Stucco sub-contractor applying scratch coat of stucco over self-furring galvanized metal lath.

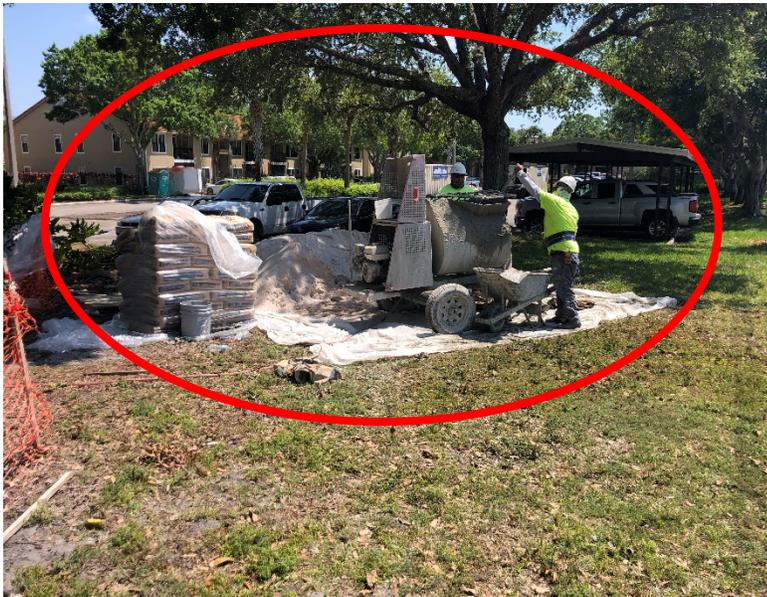
PHOTOGRAPH #18

**BUILDING 7
SECTION H**

Stucco contractor mixing Broco bagged stucco cement with sand on site.

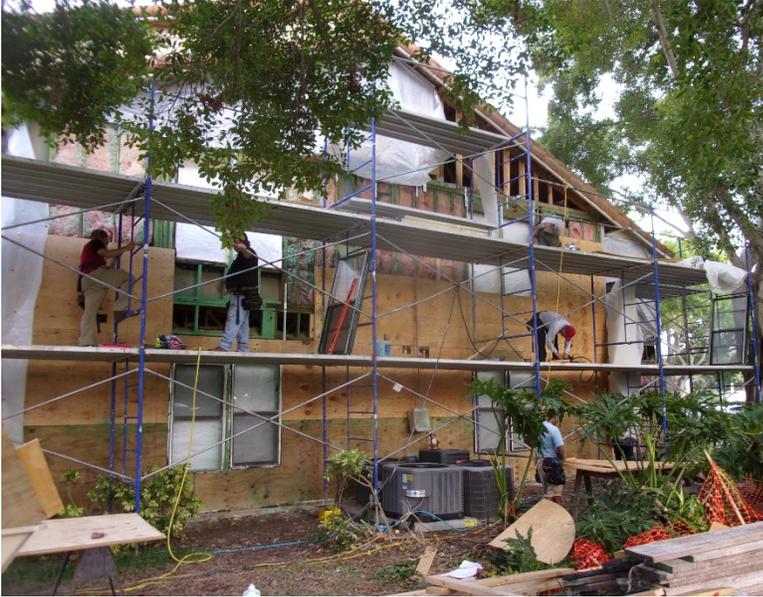
PHOTOGRAPH #19

**BUILDING 8
SECTION H**

Contractor has begun installing 15/32" plywood sheathing at gable end wall.

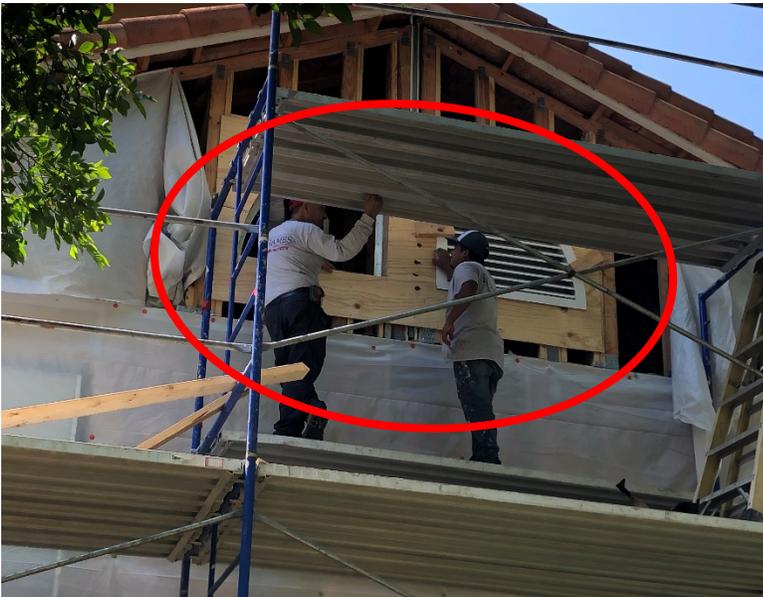
PHOTOGRAPH #20

**BUILDING 8
SECTION H**

New GreenHeck Louvers being installed at gable end attic space.

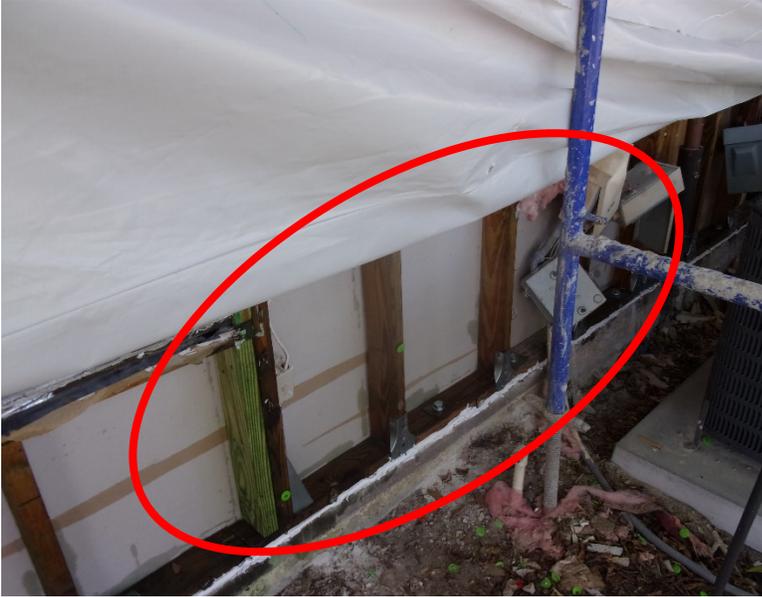
PHOTOGRAPH #21

**BUILDING 8
SECTION H**

Copper Green wood preservative has been applied at bottom plate and framing studs.

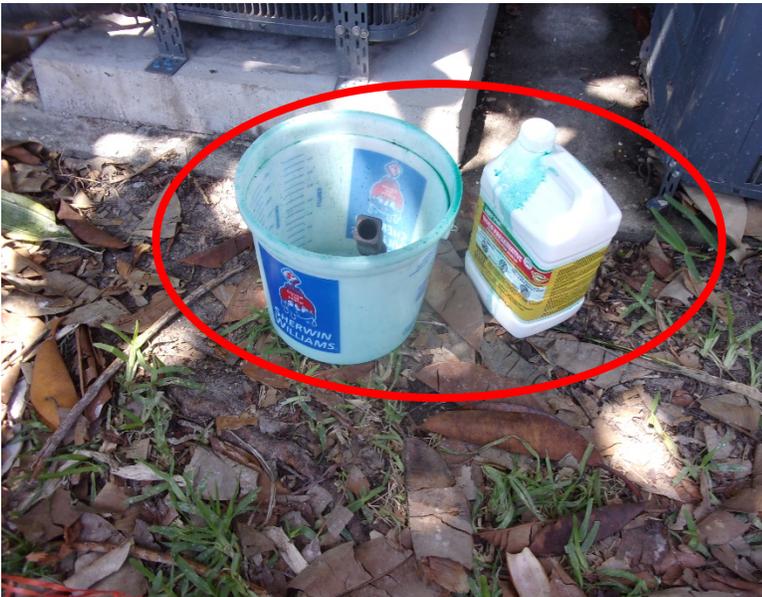
PHOTOGRAPH #22

**BUILDING 8
SECTION H**

Copper Green wood preservative has been applied at bottom plate and framing studs.

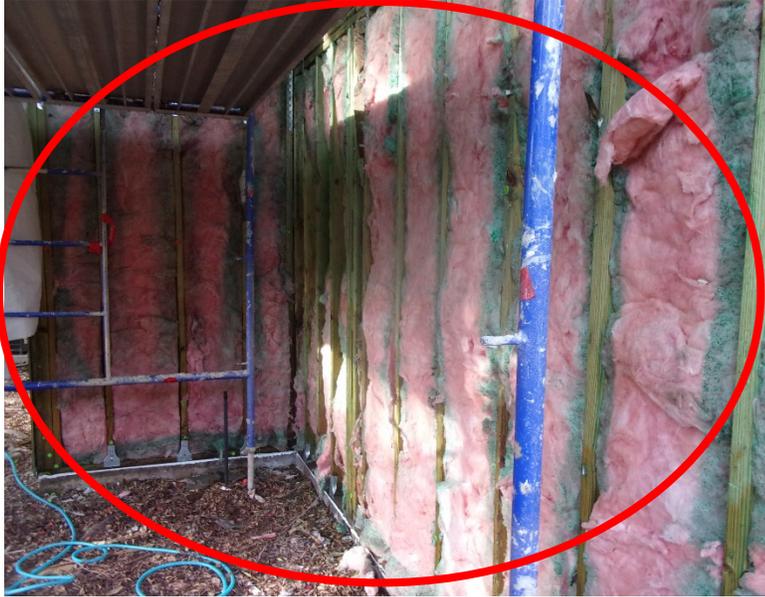
PHOTOGRAPH #23

**BUILDING 8
SECTION H**

Bora Care termite treatment has been applied to gable end wall framing as per specifications.

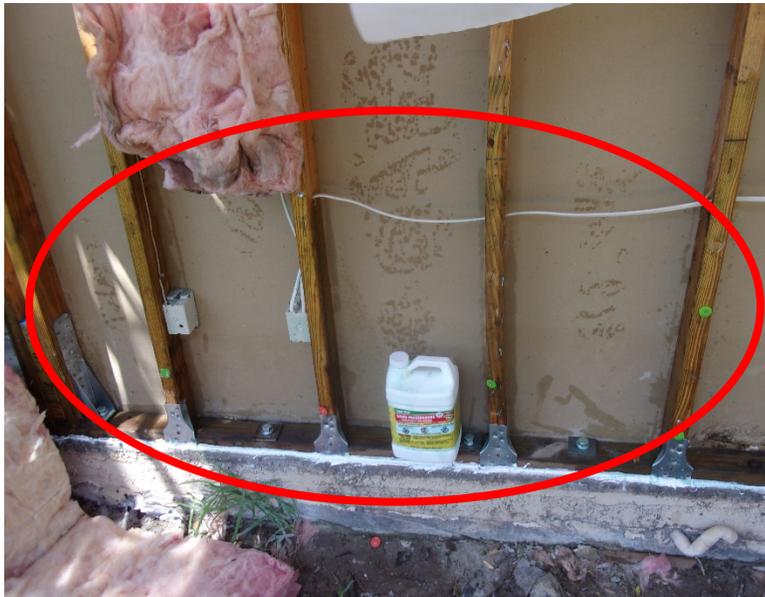
PHOTOGRAPH #24

**BUILDING 8
SECTION G**

Copper Green wood preservative has been applied at bottom plate and framing studs.

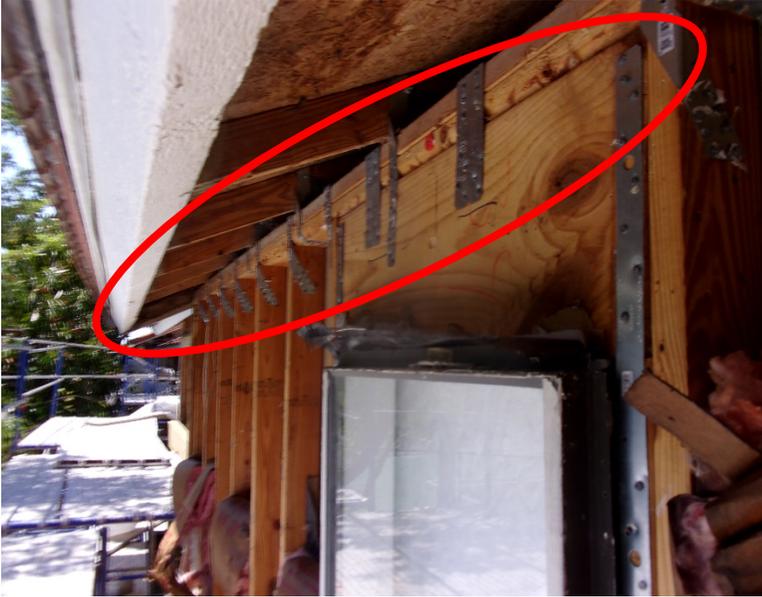
PHOTOGRAPH #25

**BUILDING 8
SECTION G**

Contractor has instilled Simpson Strong - Tie connection hardware at header to top plate, top plate to trusses and wall studs to top plate as per drawings.

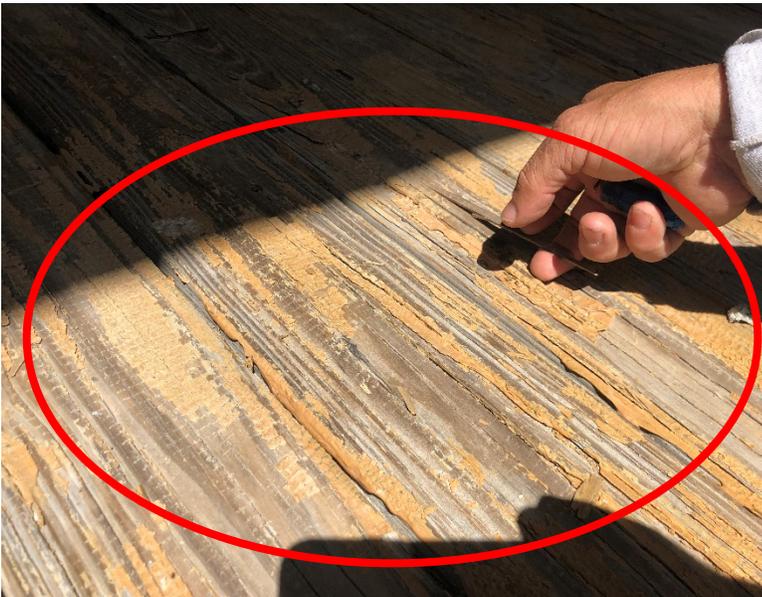
PHOTOGRAPH #26

**BUILDING 8
SECTION G**

Unit # 822- Balcony decking damaged by carpet covering will require replacement.

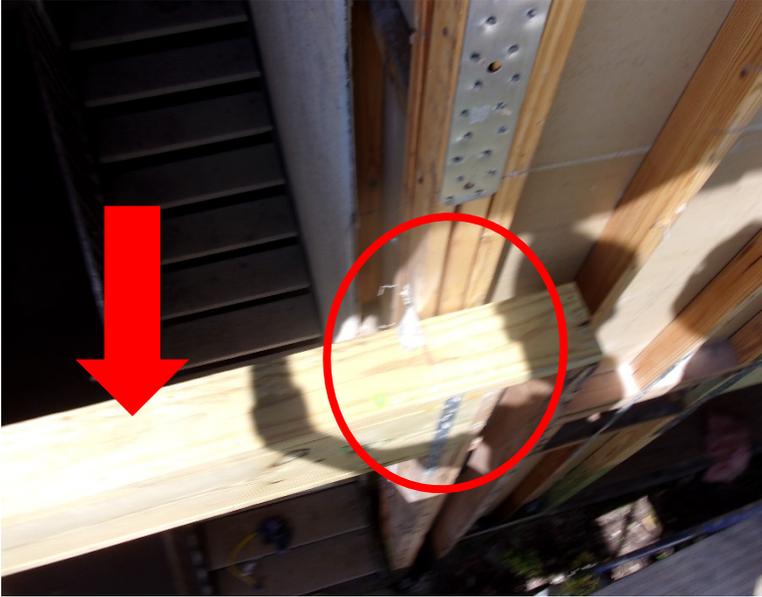
PHOTOGRAPH #27

**BUILDING 8
SECTION G**

New Breezeway box beam installed and Simpson Strong -Tie connectors in place per drawings.
