PHOTOGRAPHS

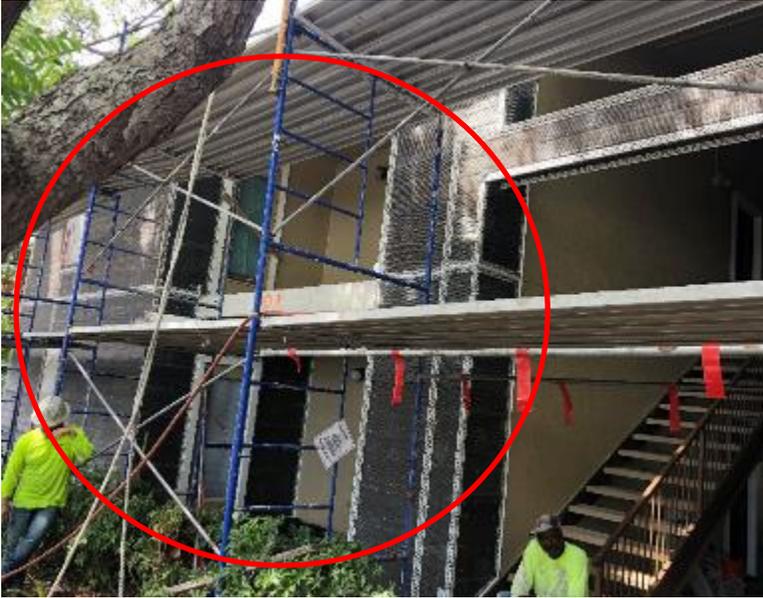
PHOTOGRAPH #1

**BUILDING 7
SECTION A**

Sub-Contractor has applied galvanized self-furring lathing and vinyl stucco accessories in preparation for new stucco system application.

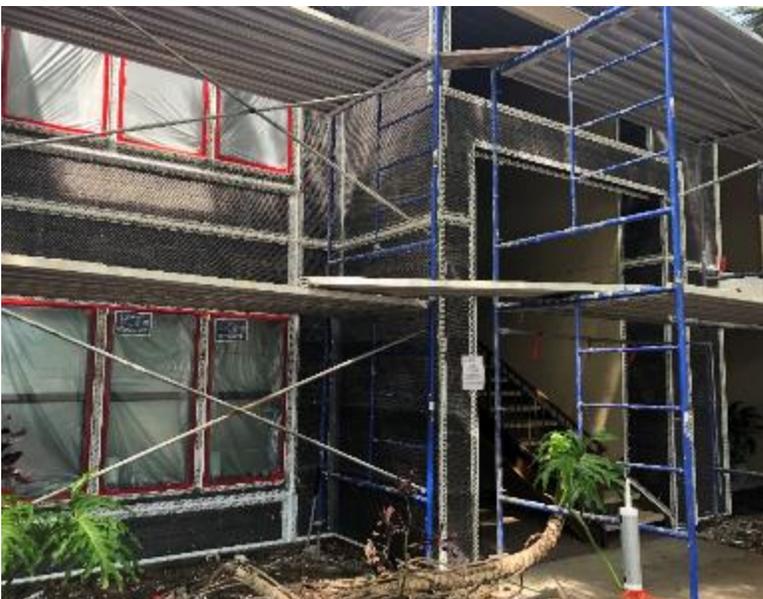
PHOTOGRAPH #2

**BUILDING 7
SECTION B**

Sub-Contractor has applied galvanized self-furring lathing, vinyl stucco accessories and covered new windows with plastic protection in preparation for new stucco system application.

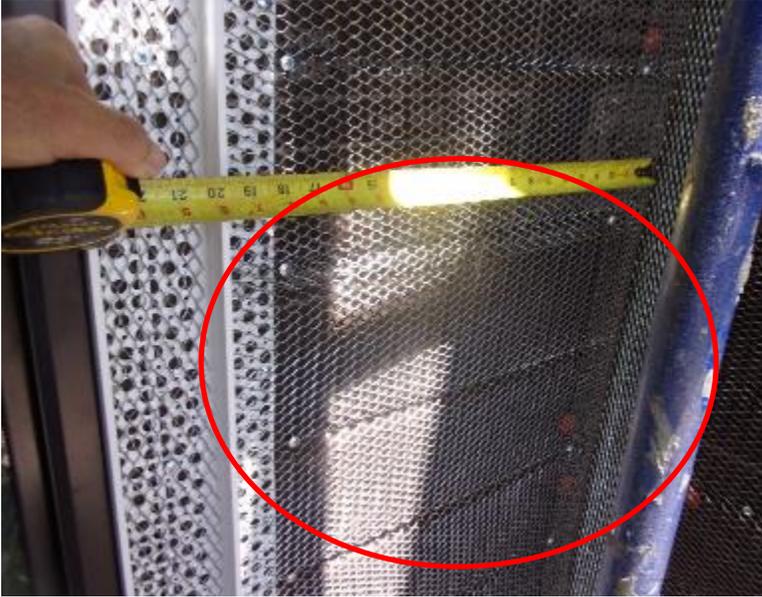
PHOTOGRAPH #3

**BUILDING 7
SECTION C**

New lathing attached at framing with waffle head self-tapping screws and tied at overlaps with SS wire.

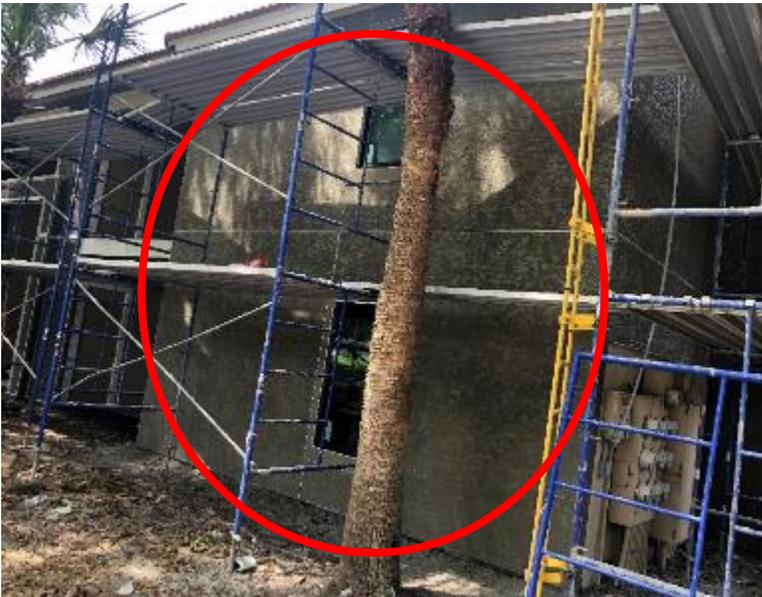
PHOTOGRAPH #4

**BUILDING 7
SECTION C**

New three coat stucco system applied at walls.

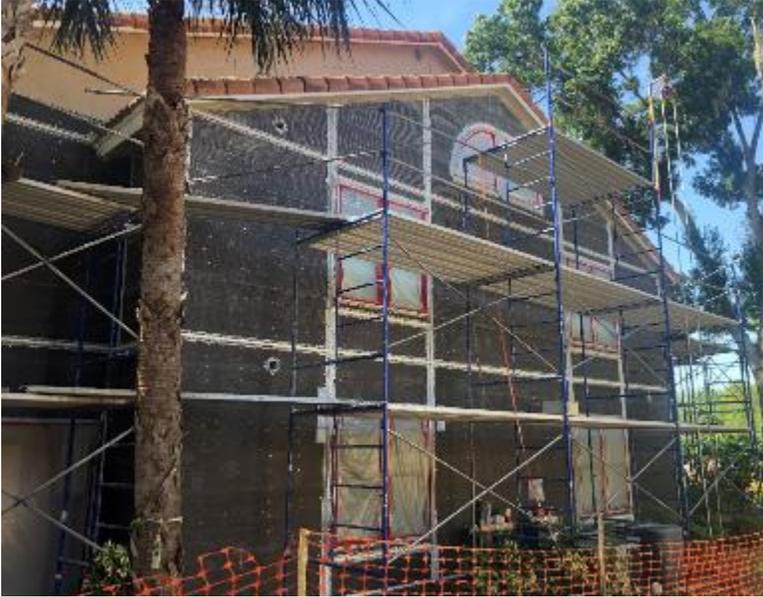
PHOTOGRAPH #5

**BUILDING 7
SECTION D**

Sub-Contractor has applied galvanized self-furring lathing, vinyl stucco accessories and covered new windows with plastic protection in preparation for new stucco system application.

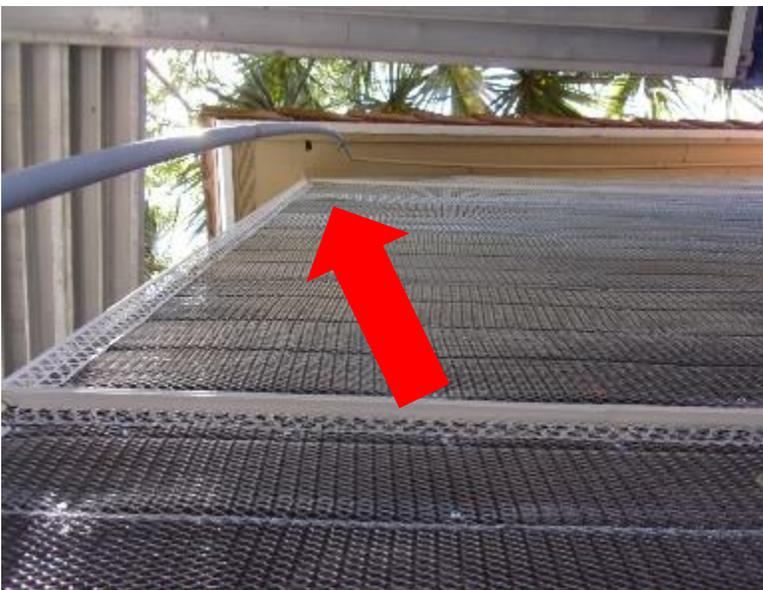
PHOTOGRAPH #6

**BUILDING 7
SECTION D**

Metal lathing bulging out at overlap pointed out for correction.

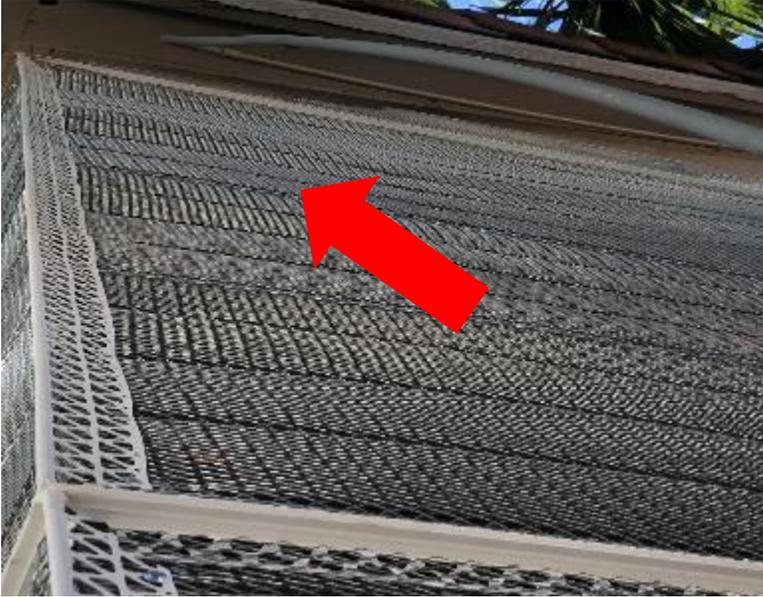
PHOTOGRAPH #7

**BUILDING 7
SECTION D**

Metal lathing corrected where bulged out at overlap.

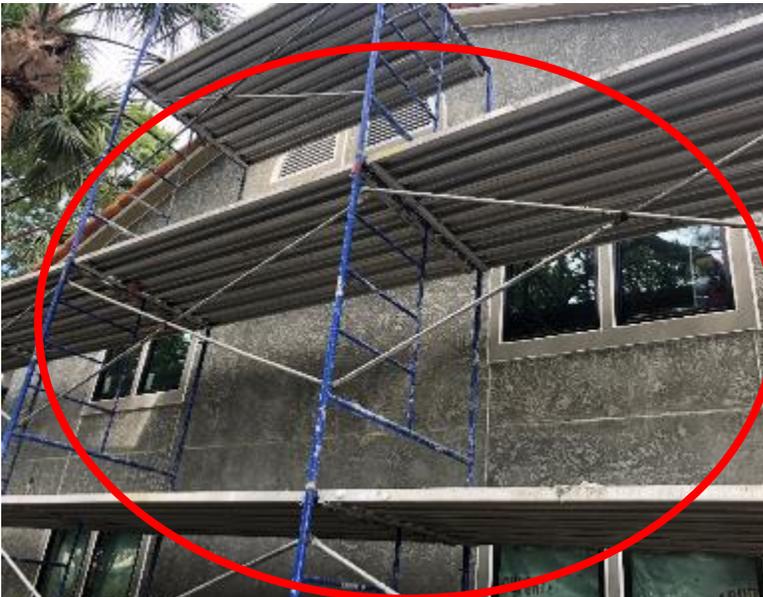
PHOTOGRAPH #8

**BUILDING 7
SECTION D**

New 7/8" three coat stucco system applied at gable end wall.

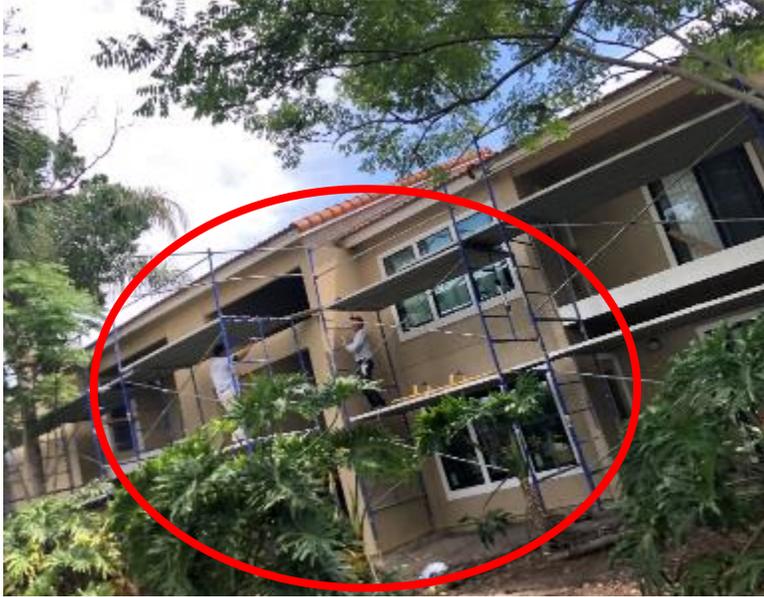
PHOTOGRAPH #9

**BUILDING 7
SECTION F**

Contractor applying new Florida Paints Ultra Exterior Supercoat Paint to new stucco.

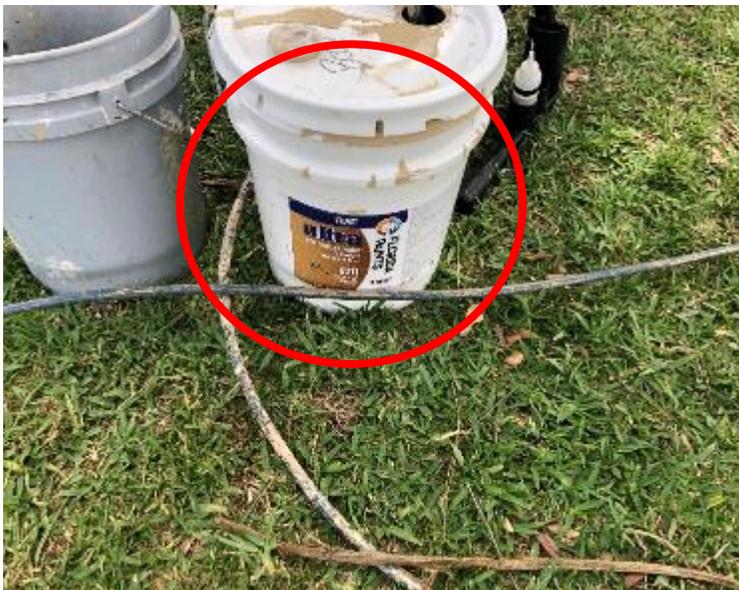
PHOTOGRAPH #10

**BUILDING 7
SECTION F**

Contractor applying new Florida Paints Ultra Exterior Supercoat Paint to new stucco.

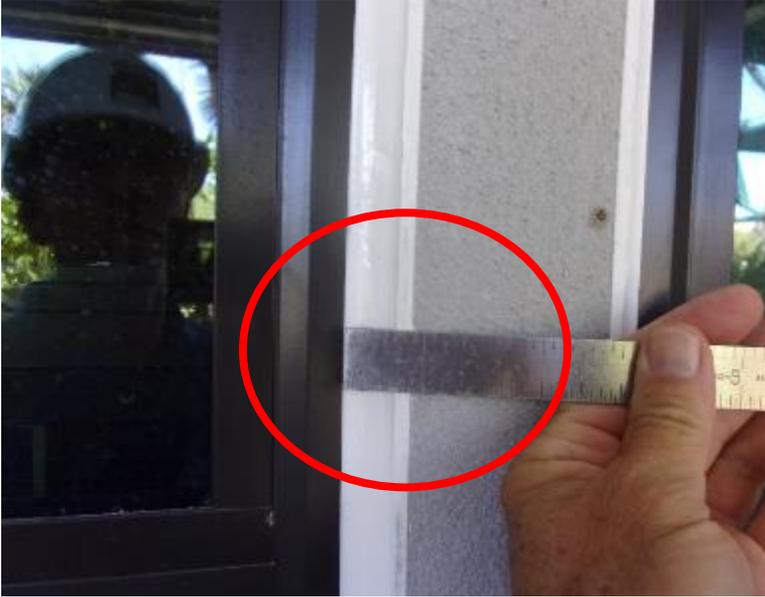
PHOTOGRAPH #11

**BUILDING 7
SECTION F**

New BASF 150 sealants applied at window frames to stucco measured at $\frac{3}{4}$ ".

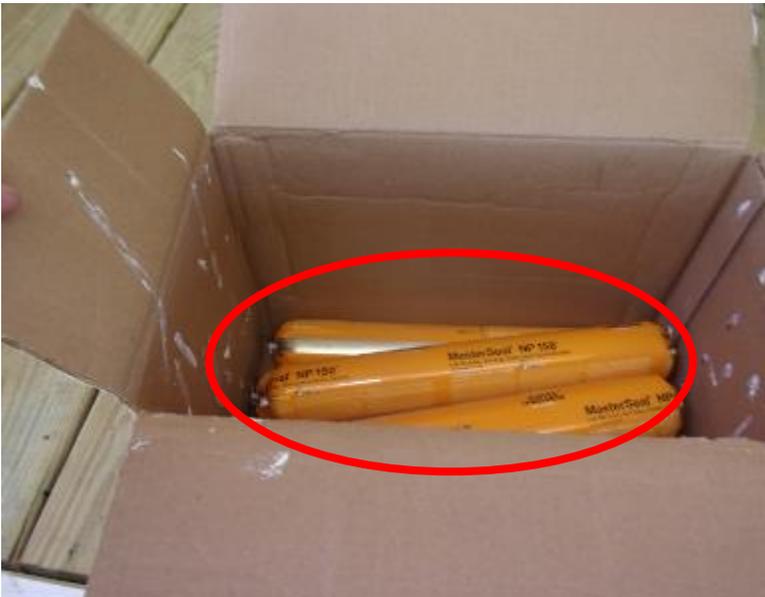
PHOTOGRAPH #12

**BUILDING 7
SECTION F**

New BASF 150 sealants applied at window frames to stucco measured at $\frac{3}{4}$ ".

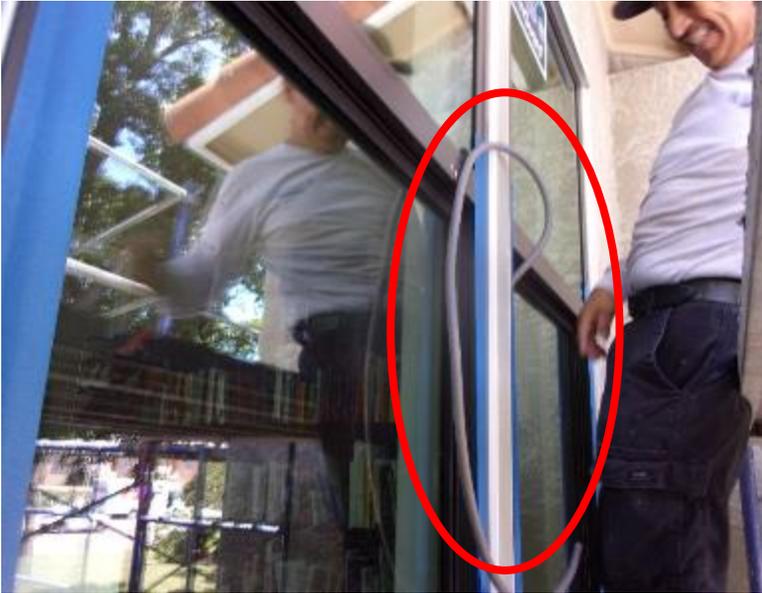
PHOTOGRAPH #13

**BUILDING 7
SECTION F**

Contractor has installed soft cell backing rod at window frame to stucco joint and masked edge for application of new sealants.

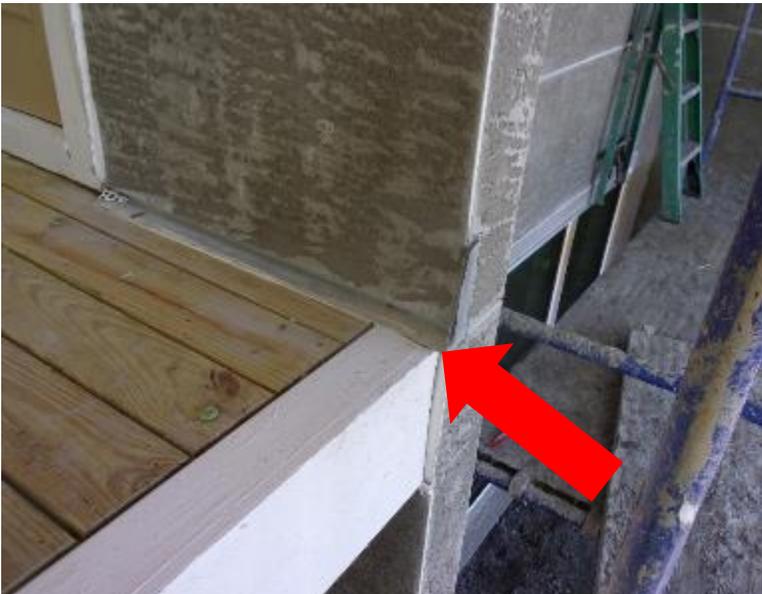
PHOTOGRAPH #14

**BUILDING 7
SECTION F**

New kick out galvanized metal flashing sealed to decking and built-up beam.

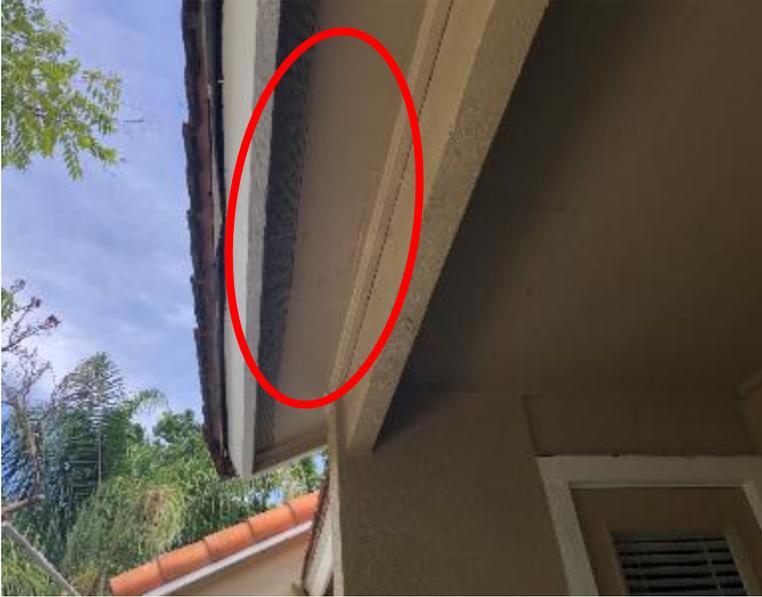
PHOTOGRAPH #15

**BUILDING 7
SECTION F**

New wood soffit appears delaminated or damaged.

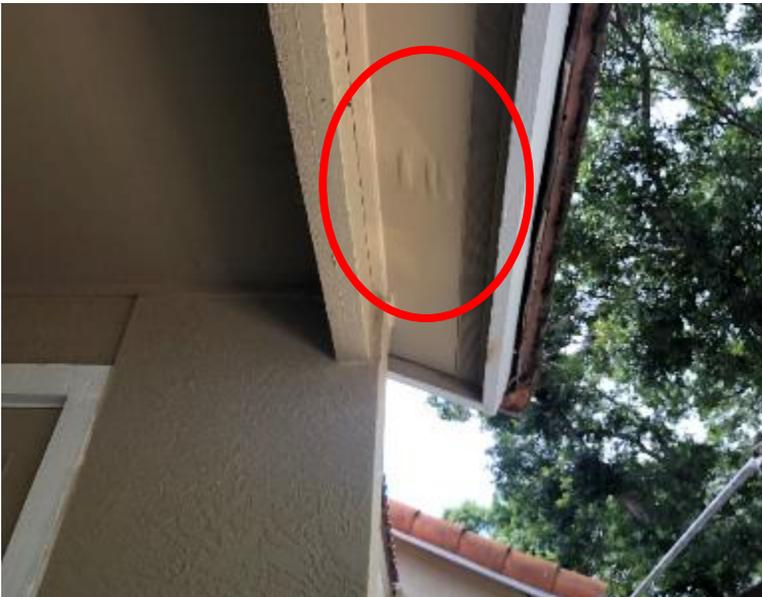
PHOTOGRAPH #16

**BUILDING 7
SECTION F**

New wood soffit appears delaminated or damaged.

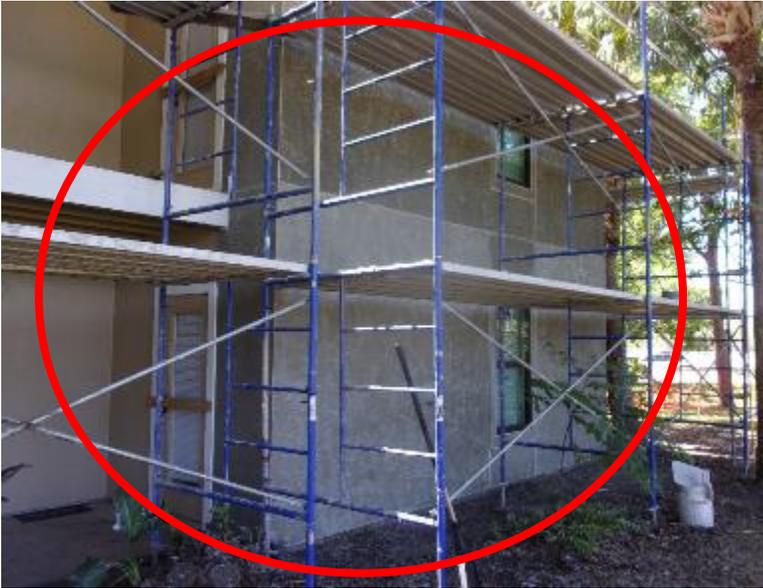
PHOTOGRAPH #17

**BUILDING 7
SECTION G**

New 7/8" three coat stucco system applied at bearing wall.

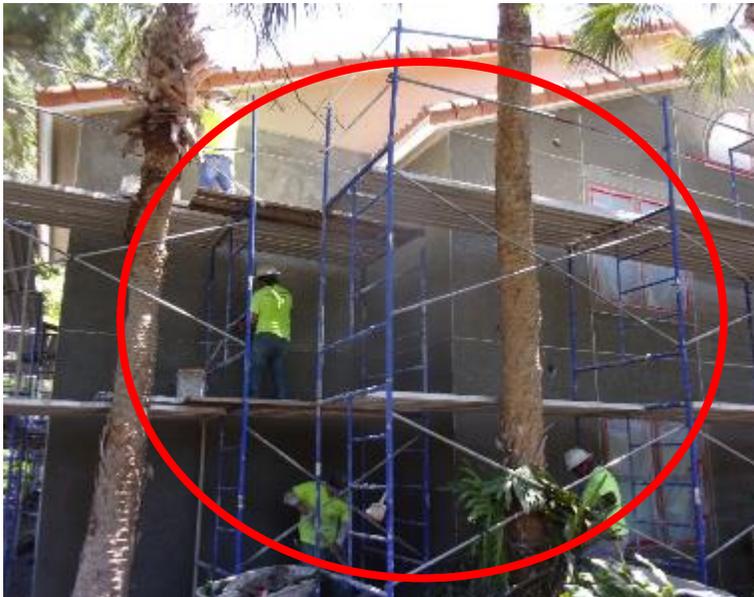
PHOTOGRAPH #18

**BUILDING 7
SECTION H**

Stucco sub-contractor applying brown and finish coats of stucco at gable end wall.

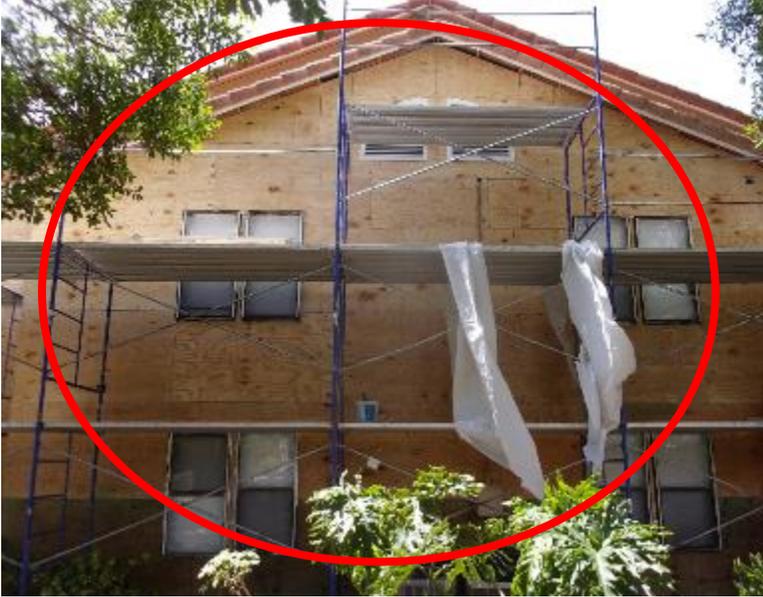
PHOTOGRAPH #19

**BUILDING 8
SECTION H**

New 15/32" plywood sheathing attached to framing with 10d nails.

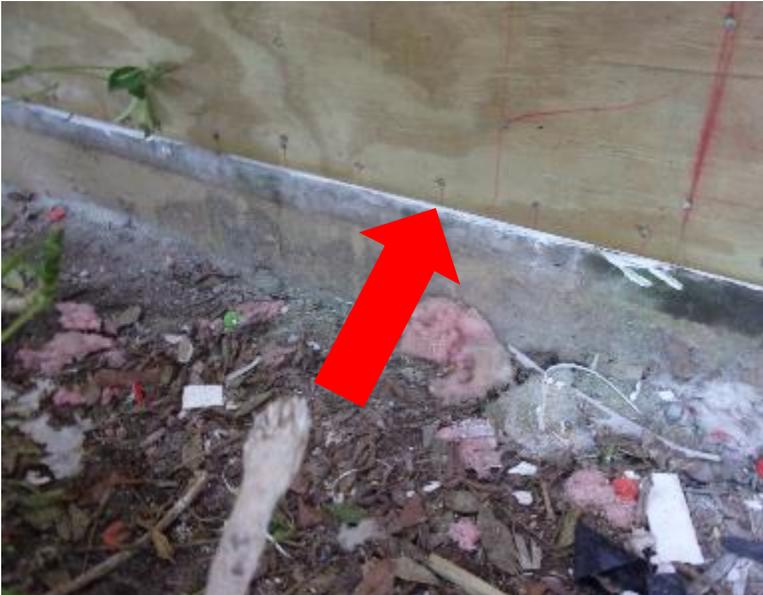
PHOTOGRAPH #20

**BUILDING 8
SECTION H**

Sealant at base of sheathing to bottom plate and bottom plate to concrete footing as per drawings.

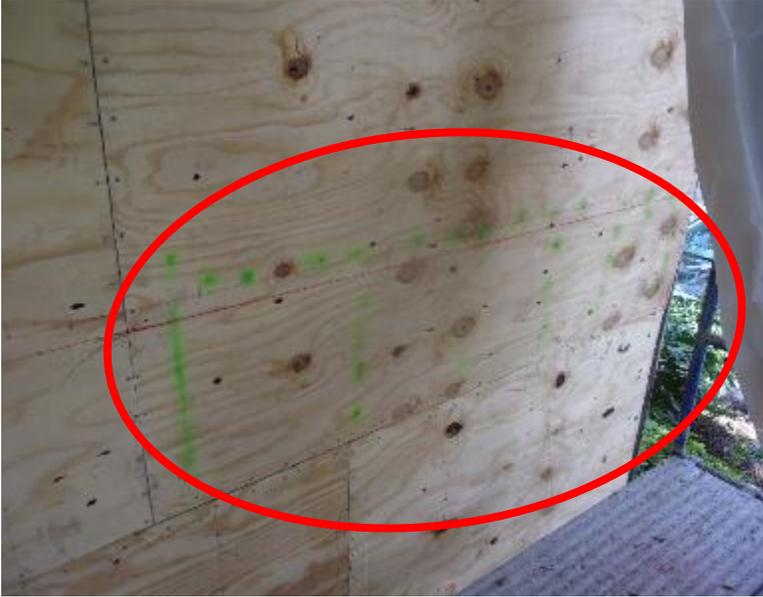
PHOTOGRAPH #21

**BUILDING 8
SECTION H**

Plywood sheathing not nailed to framing
marked for contractor correction.

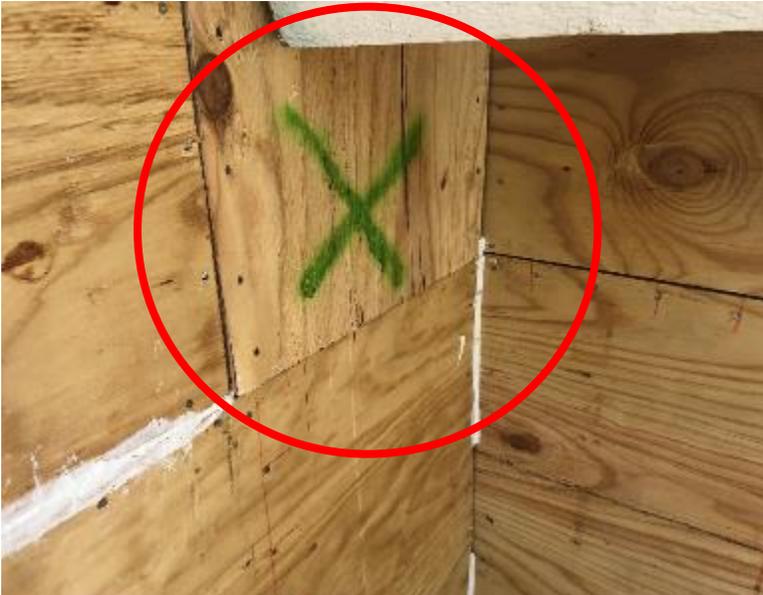
PHOTOGRAPH #22

**BUILDING 8
SECTION H**

Damaged plywood sheathing marked for
replacement.

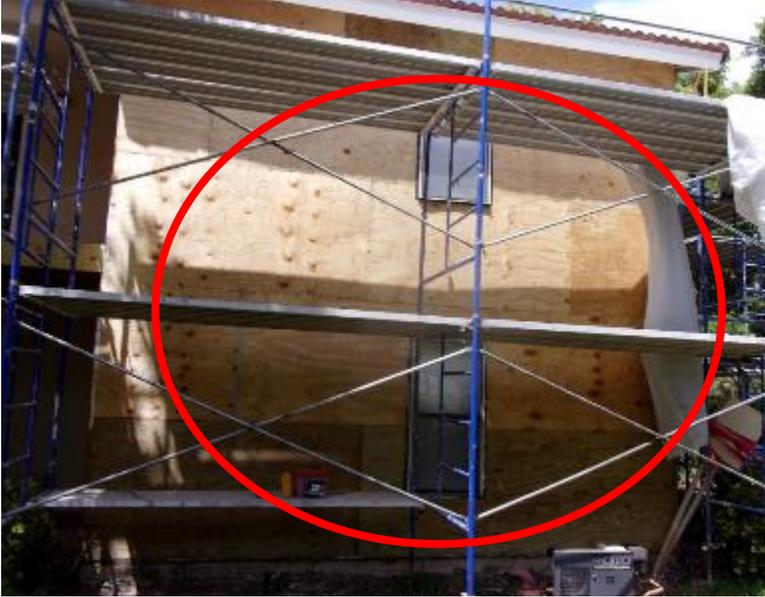
PHOTOGRAPH #23

**BUILDING 8
SECTION G**

New 15/32" plywood sheathing attached to framing with 10d nails.

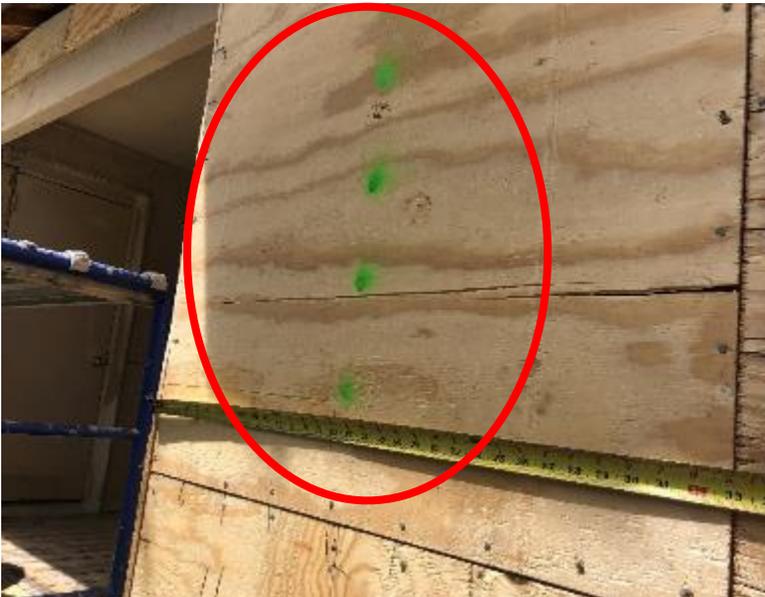
PHOTOGRAPH #24

**BUILDING 8
SECTION G**

Plywood sheathing not nailed to framing marked for contractor correction.

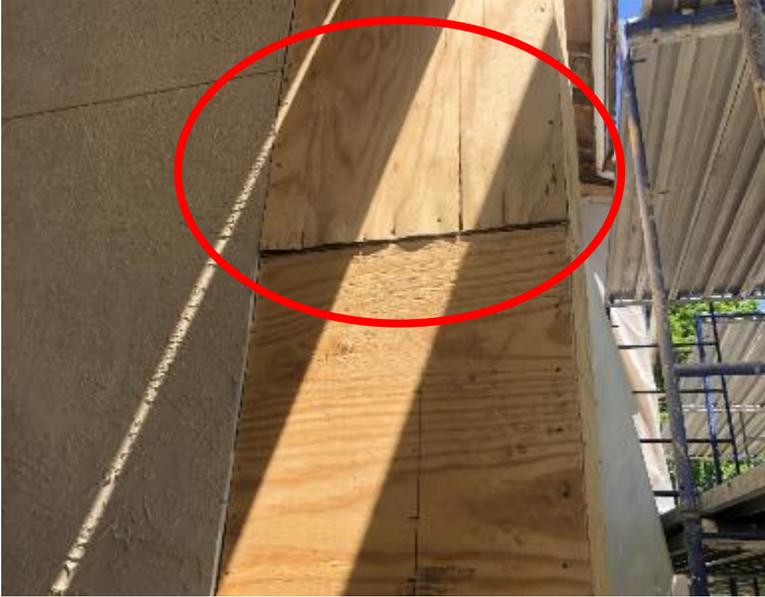
PHOTOGRAPH #25

**BUILDING 8
SECTION G**

Damaged plywood sheathing will require replacement.

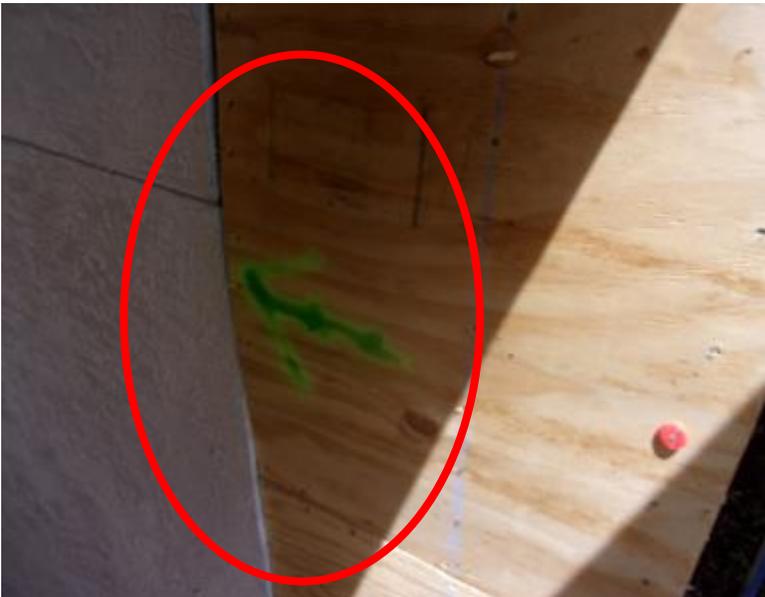
PHOTOGRAPH #26

**BUILDING 8
SECTION G**

New plywood sheathing bulging out at edge, marked for correction.

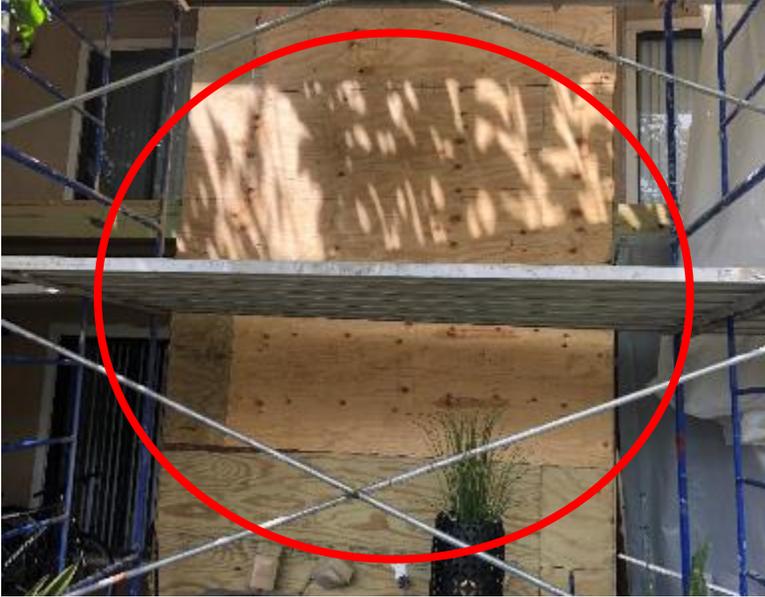
PHOTOGRAPH #27

**BUILDING 8
SECTION F**

New 15/32" plywood sheathing attached to framing with 10d nails.

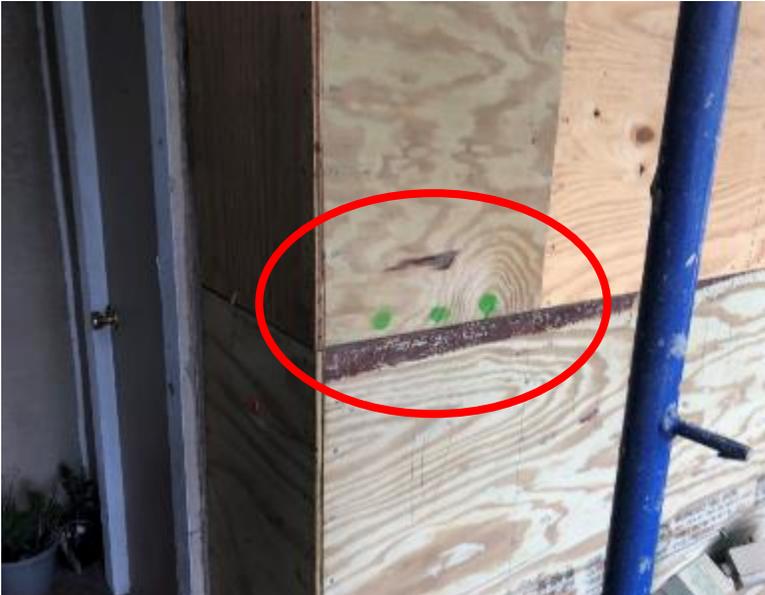
PHOTOGRAPH #28

**BUILDING 8
SECTION F**

Plywood sheathing not nailed to framing marked for contractor correction.

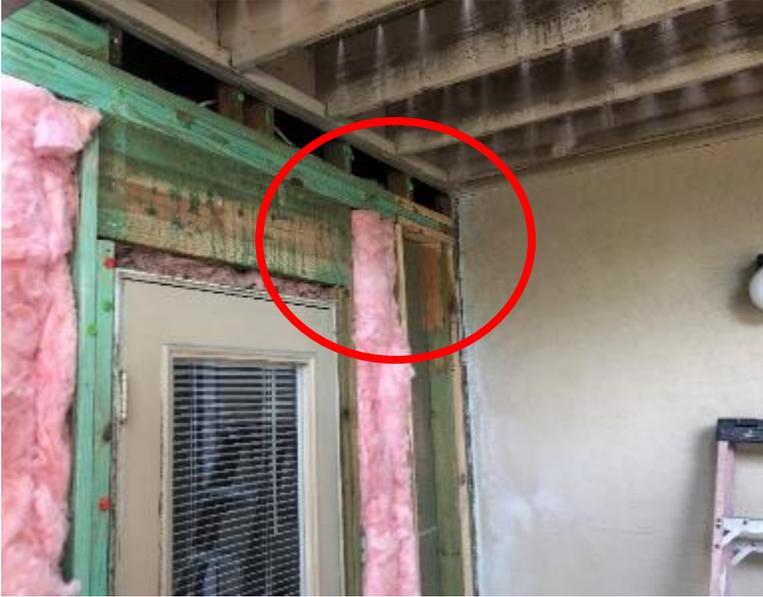
PHOTOGRAPH #29

**BUILDING 8
SECTION F**

Framing corrections made where stopped short of damage and not properly staggered for support on framing studs.

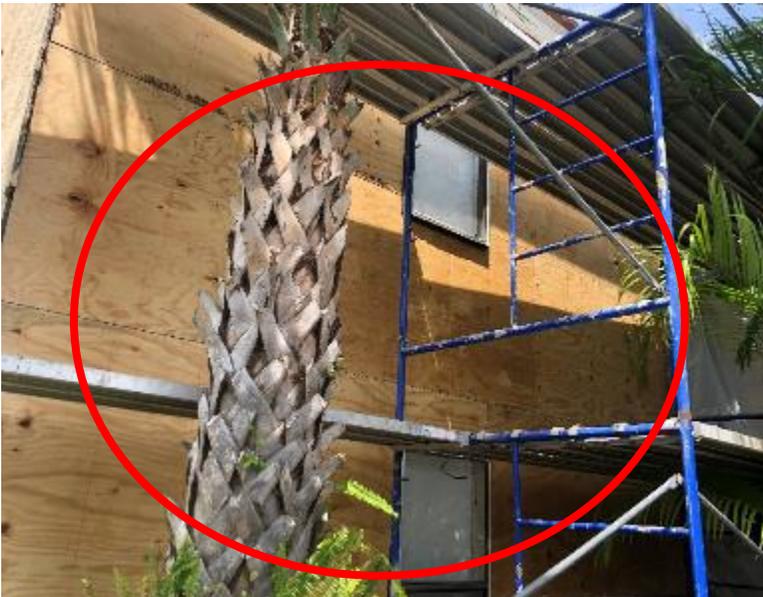
PHOTOGRAPH #30

**BUILDING 8
SECTION E**

New 15/32" plywood sheathing attached to framing with 10d nails.
