PHOTOGRAPHS

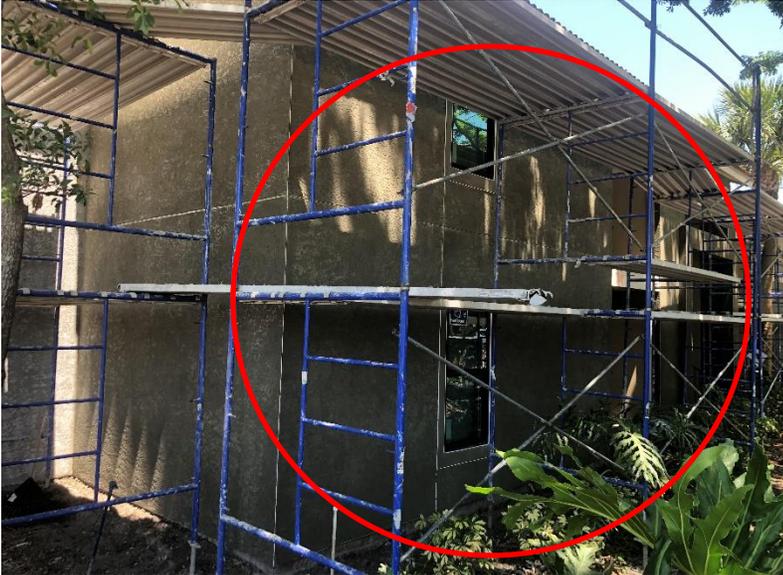
PHOTOGRAPH #1

**BUILDING 7
SECTION A**

Sub-Contractor has completed 3 coat 7/8" stucco system at bearing walls.

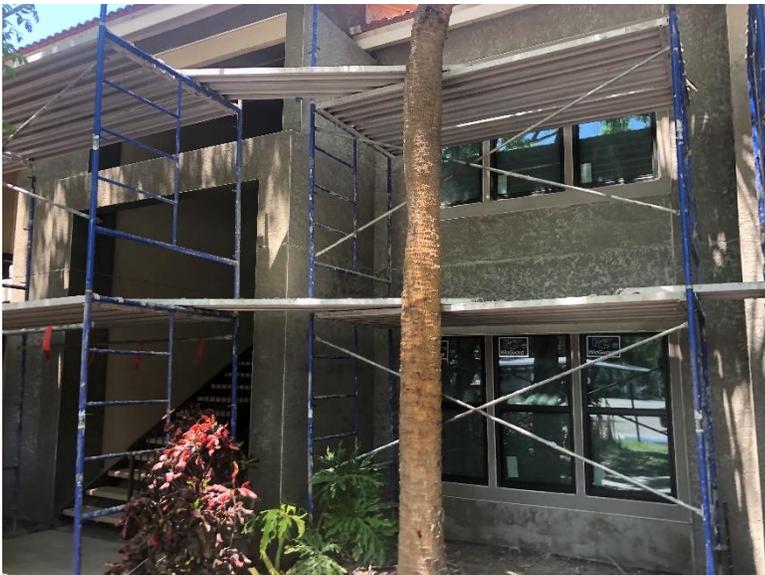
PHOTOGRAPH #2

**BUILDING 7
SECTION B**

Sub-Contractor has completed 3 coat 7/8" stucco system at bearing walls.

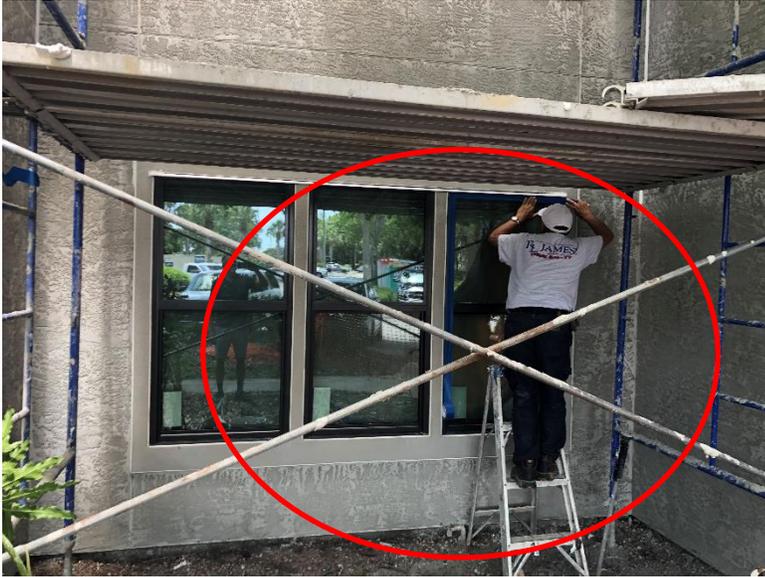
PHOTOGRAPH #3

**BUILDING 7
SECTION B**

New backing rod and BASF 150 sealants applied at window frames.

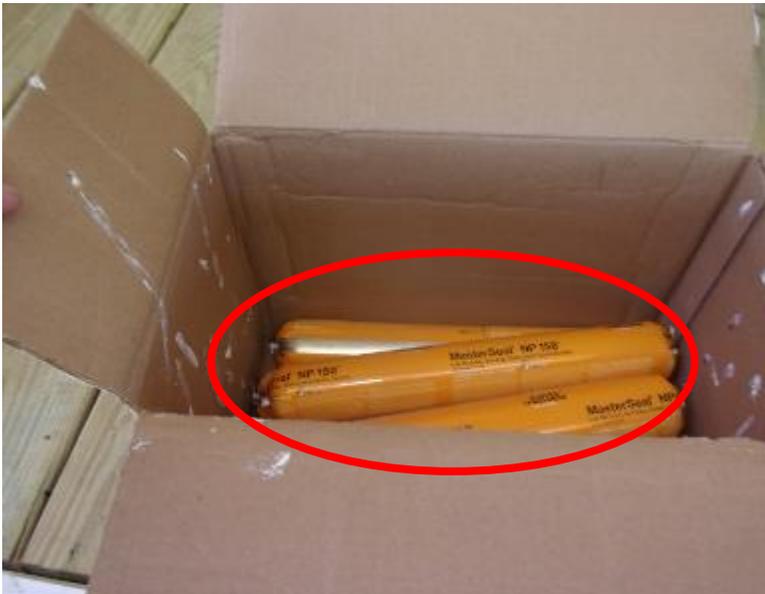
PHOTOGRAPH #4

**BUILDING 7
SECTION B**

New backing rod and BASF 150 sealants applied at window frames.

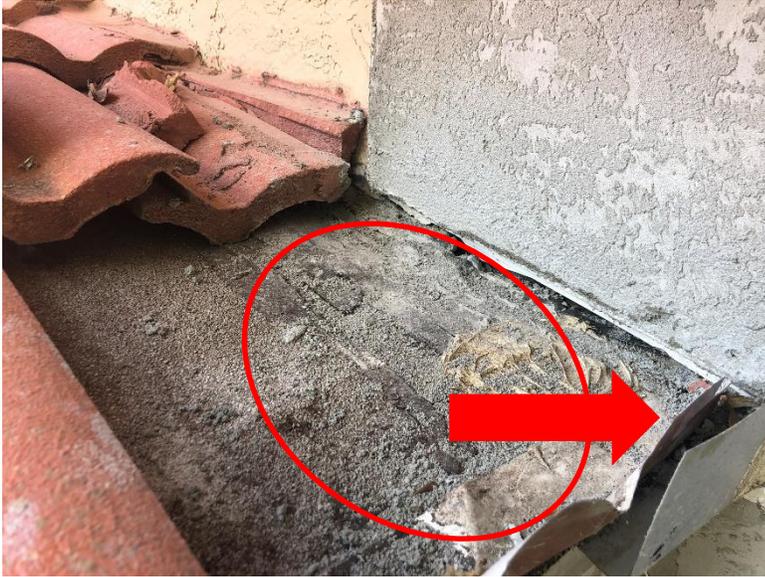
PHOTOGRAPH #5

**BUILDING 7
SECTION B**

Kick out roof flashing is lacking kick out angle, full bed of mastic and trimming away of eave closure metal at kick out.

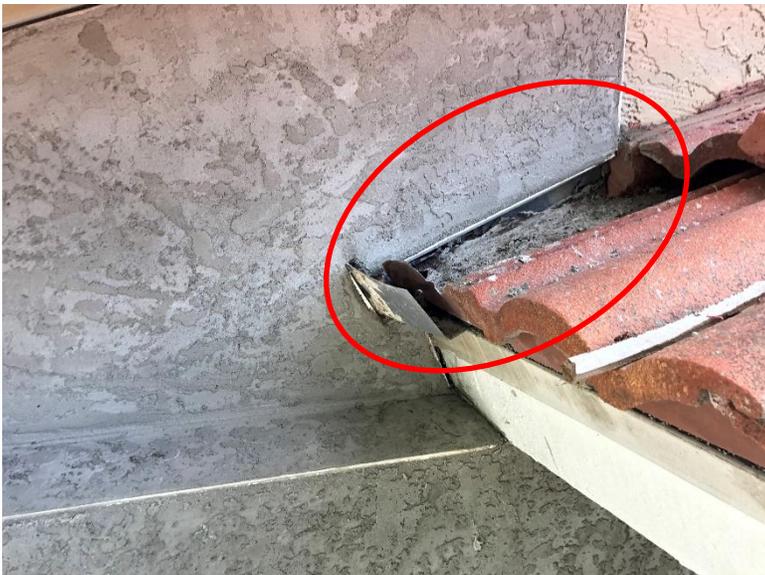
PHOTOGRAPH #6

**BUILDING 7
SECTION B**

Kick out roof flashing is lacking kick out angle, full bed of mastic and trimming away of eave closure metal at kick out.

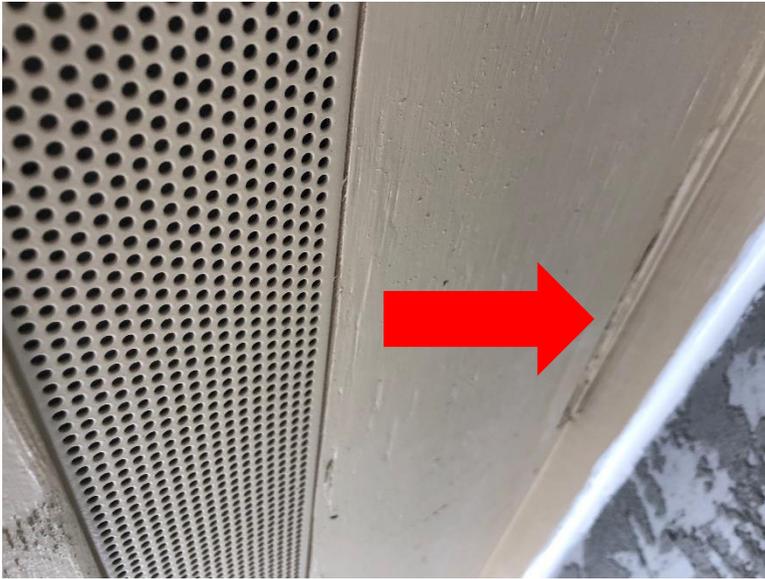
PHOTOGRAPH #7

**BUILDING 7
SECTION C**

New plywood installed at soffit is delaminated and damaged.

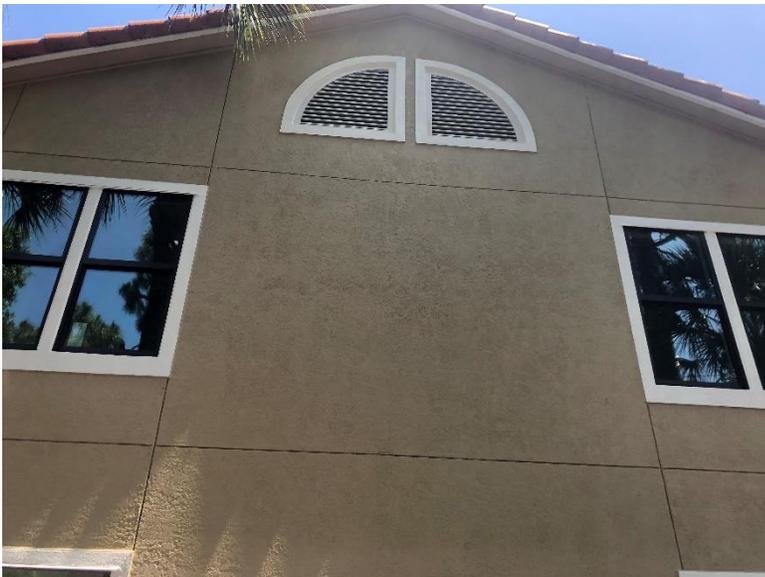
PHOTOGRAPH #8

**BUILDING 7
SECTION D**

Contractor applied new Florida Paints Ultra Exterior Supercoat Paint to new stucco.

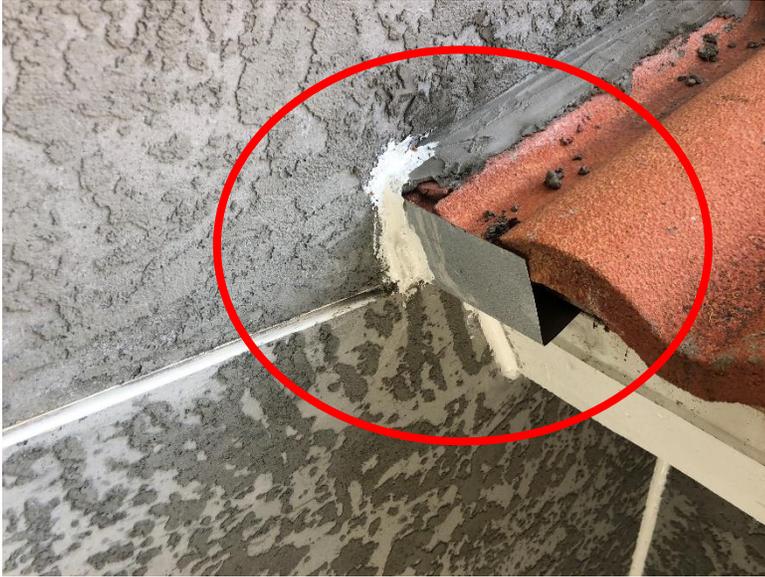
PHOTOGRAPH #9

**BUILDING 7
SECTION D**

Kick out roof flashing is lacking kick out angle and separation from edge of barrel tile.

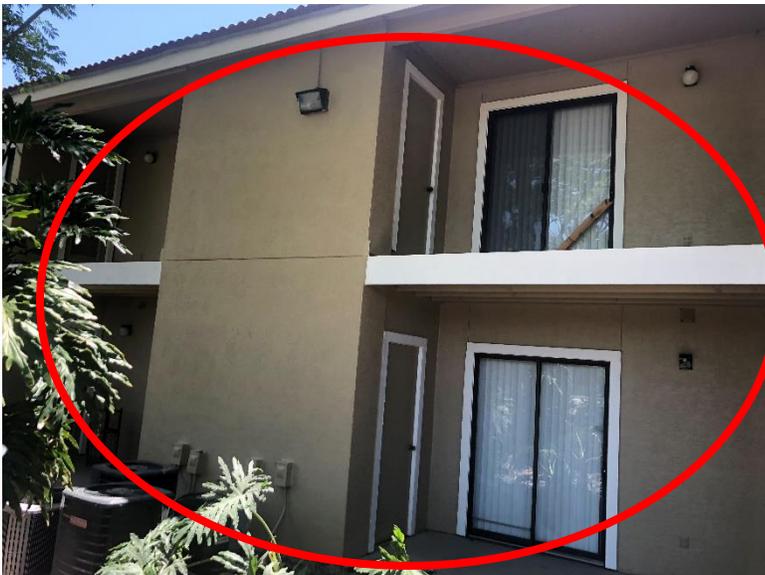
PHOTOGRAPH #10

**BUILDING 7
SECTION F**

Contractor applied new Florida Paints Ultra Exterior Supercoat Paint to new stucco, balcony walls and ceilings.

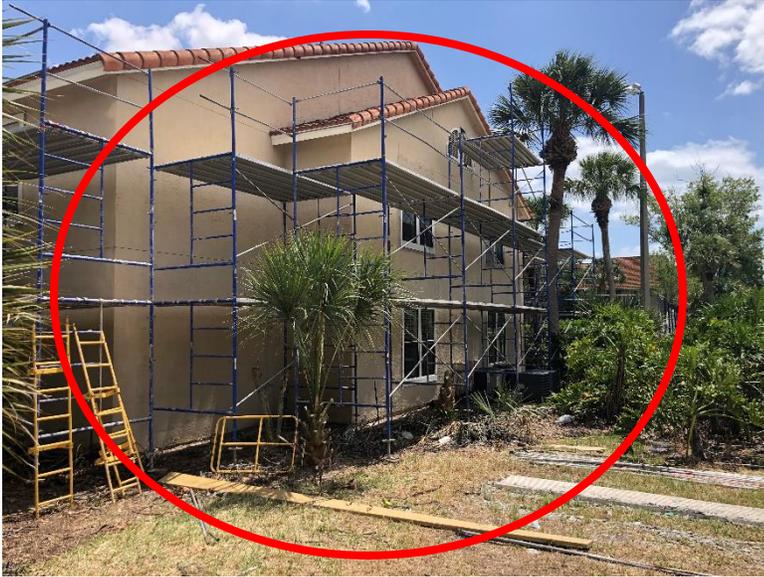
PHOTOGRAPH #11

**BUILDING 7
SECTION H**

Contractor applied new Florida Paints Ultra Exterior Supercoat Paint to new stucco at gable end walls.

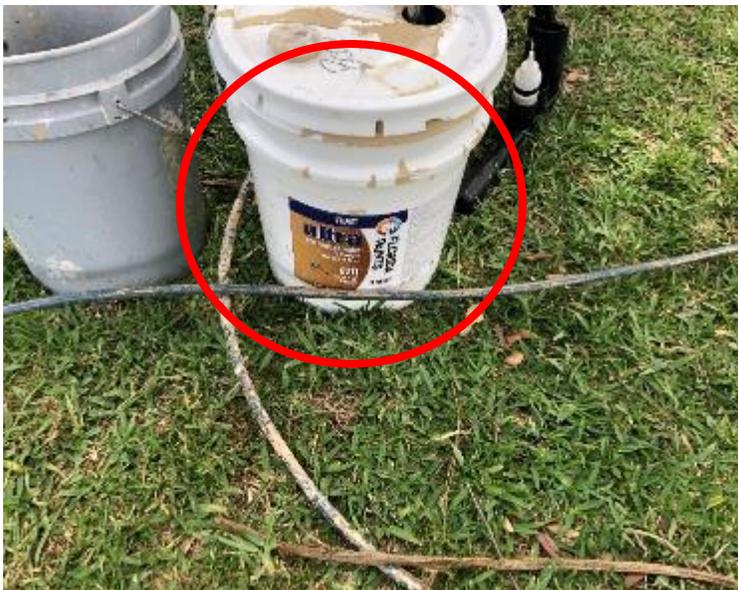
PHOTOGRAPH #12

**BUILDING 7
SECTION H**

Contractor applied new Florida Paints Ultra Exterior Supercoat Paint to new stucco.

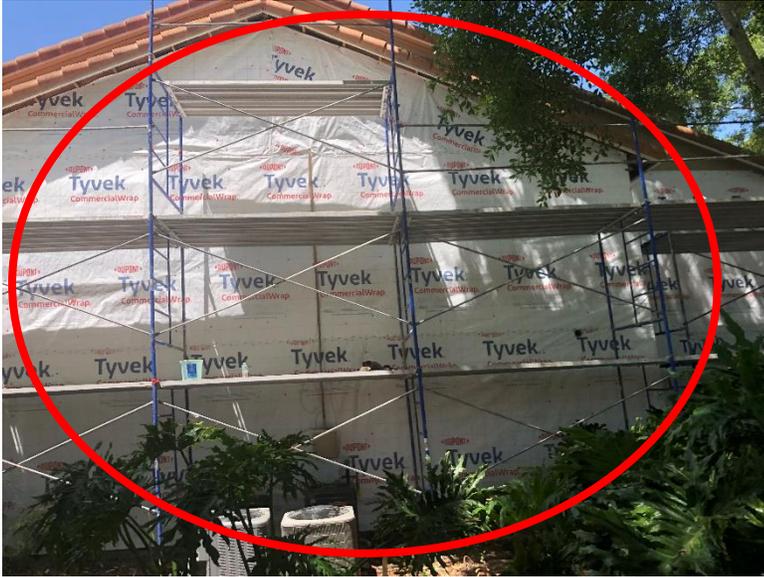
PHOTOGRAPH #13

**BUILDING 8
SECTION H**

Contractor has applied Tyvek CommercialWrap water resistant barrier over new plywood sheathing.

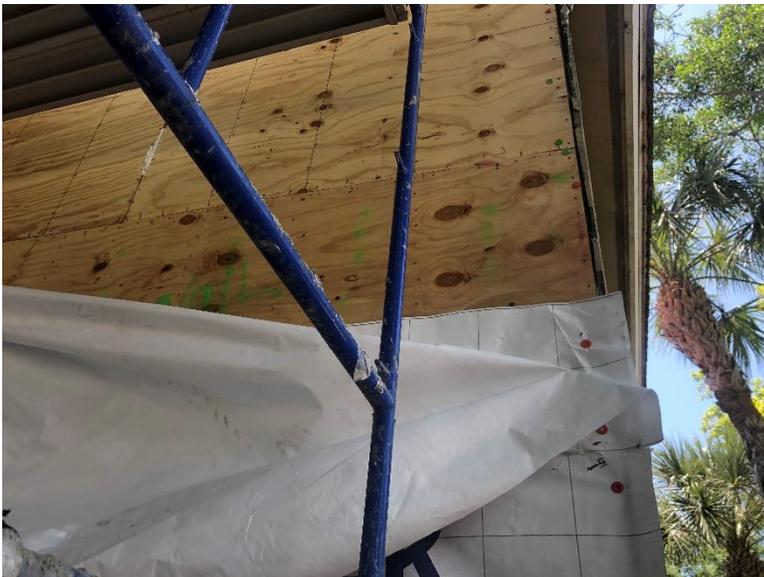
PHOTOGRAPH #14

**BUILDING 8
SECTION H**

Tyvek removed to view plywood fastening corrections noted from last visit. Corrections had been made at this location.

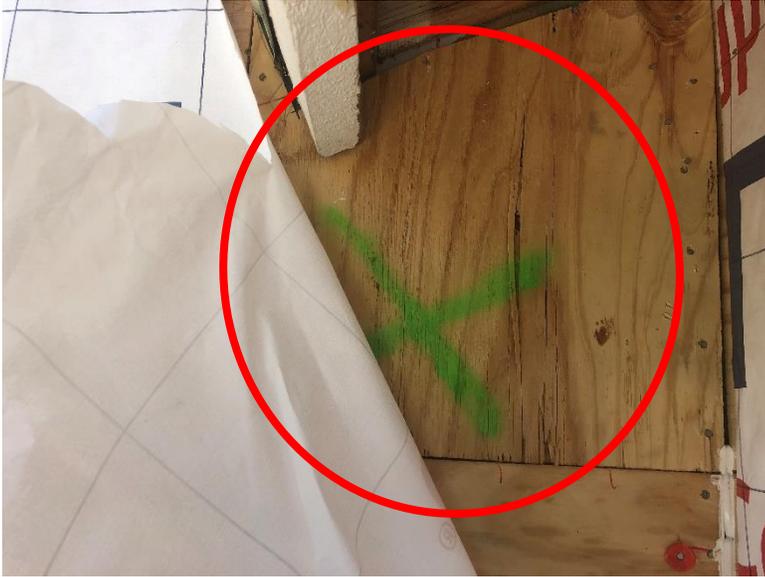
PHOTOGRAPH #15

**BUILDING 8
SECTION H**

Tyvek removed to view damaged plywood replacement noted from last visit. Corrections had not been made at this location.

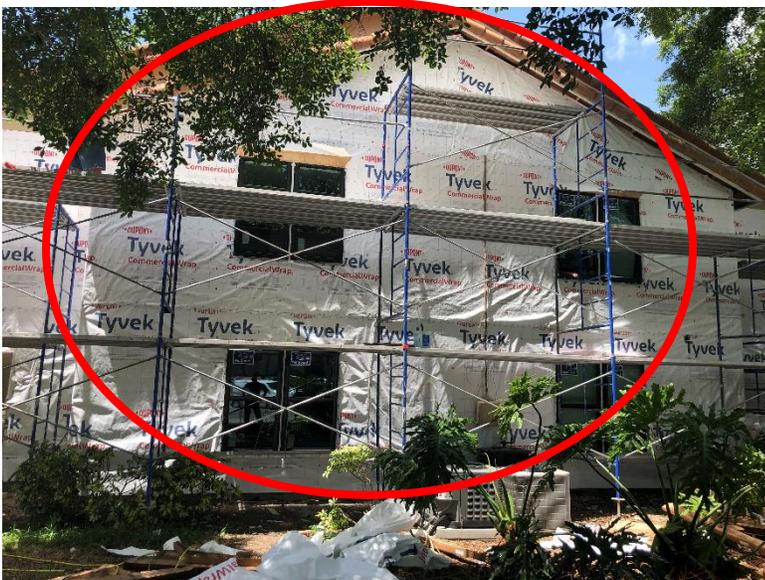
PHOTOGRAPH #16

**BUILDING 8
SECTION H**

New 770 series PGT windows installed at gable end wall.

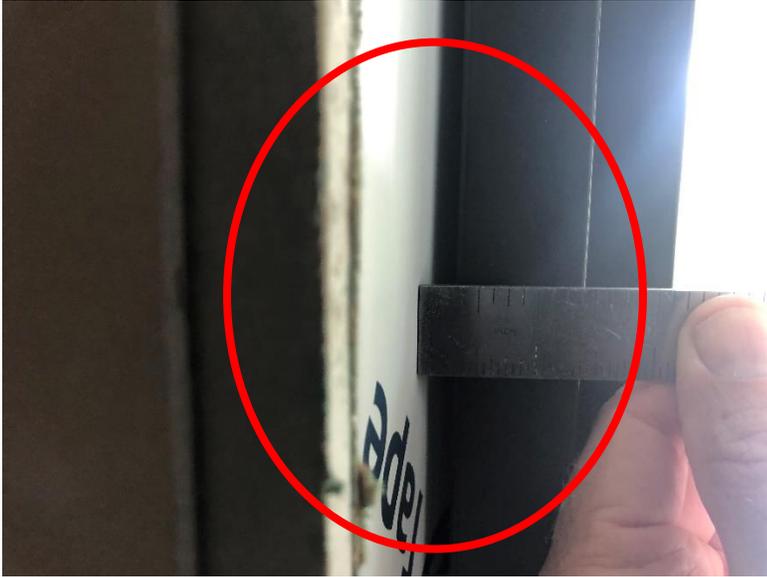
PHOTOGRAPH #17

**BUILDING 8
SECTION H**

Unit # 811 - Gaps measured from window frame to jamb meet drawing requirements for fin frame jamb installation.

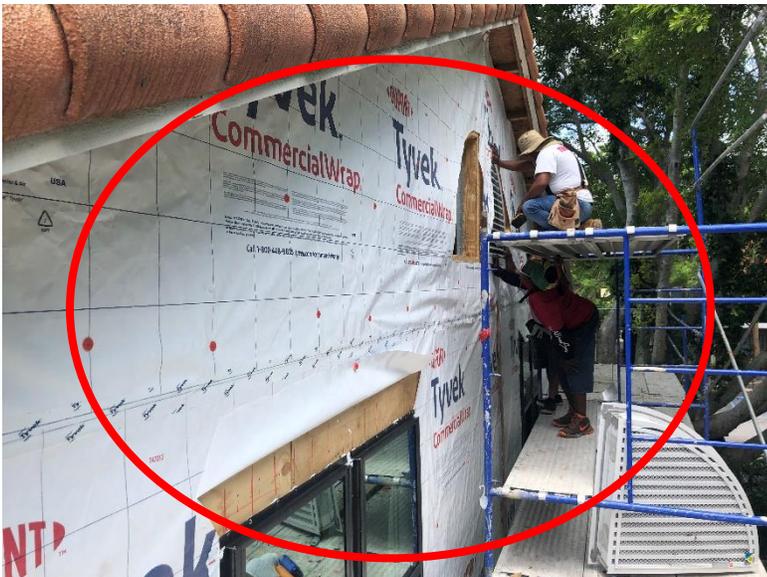
PHOTOGRAPH #18

**BUILDING 8
SECTION H**

Contractor installing and flashing new Green Heck louvers at attic space in gable end wall.

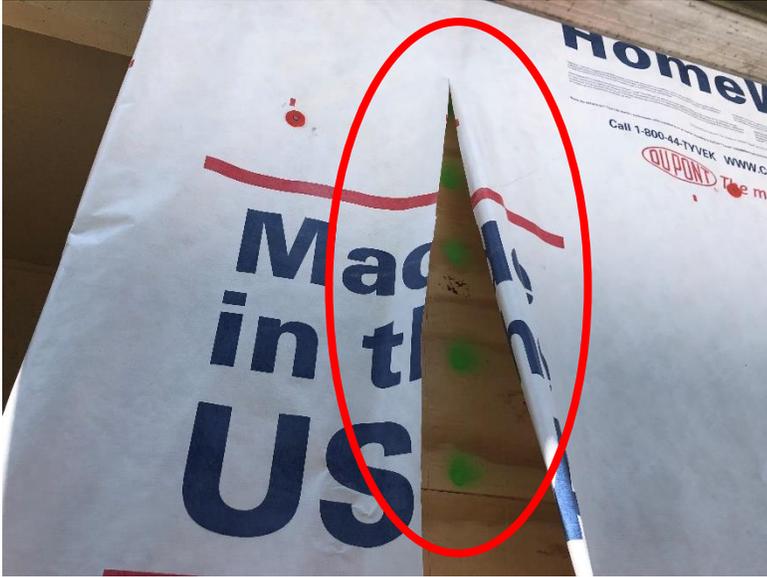
PHOTOGRAPH #19

**BUILDING 8
SECTION G**

Tyvek opened to view plywood fastening corrections noted from last visit. Corrections had not been made at this location.

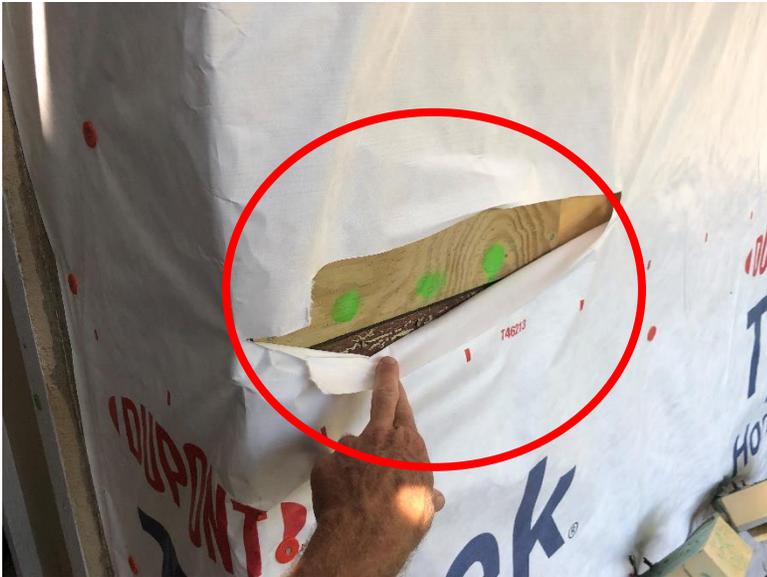
PHOTOGRAPH #20

**BUILDING 8
SECTION F**

Tyvek opened to view plywood fastening corrections noted from last visit. Corrections had not been made at this location.

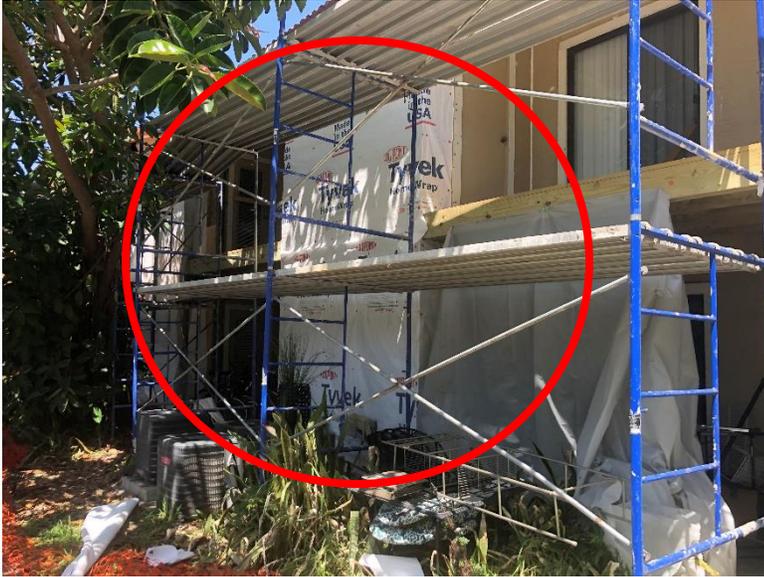
PHOTOGRAPH #21

**BUILDING 8
SECTION F**

Contractor has applied Tyvek HomeWrap water resistant barrier over new plywood sheathing.

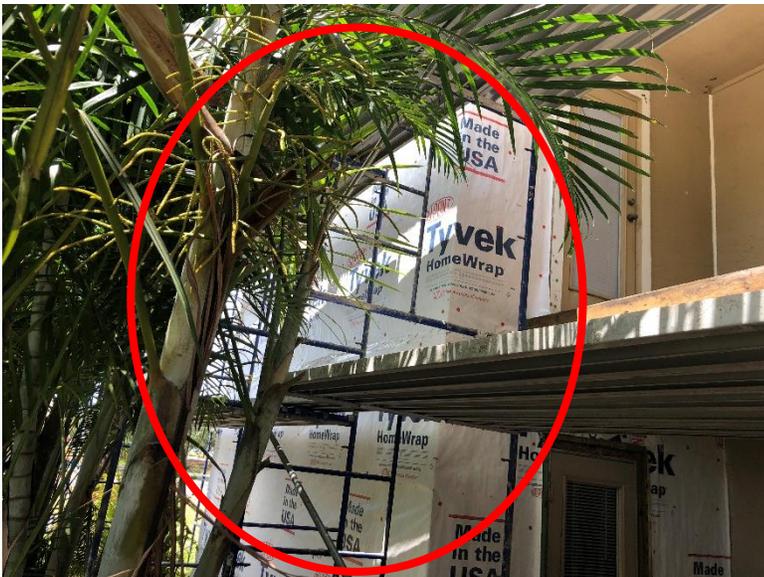
PHOTOGRAPH #22

**BUILDING 8
SECTION E**

Contractor has applied Tyvek HomeWrap water resistant barrier over new plywood sheathing.
