PHOTOGRAPHS

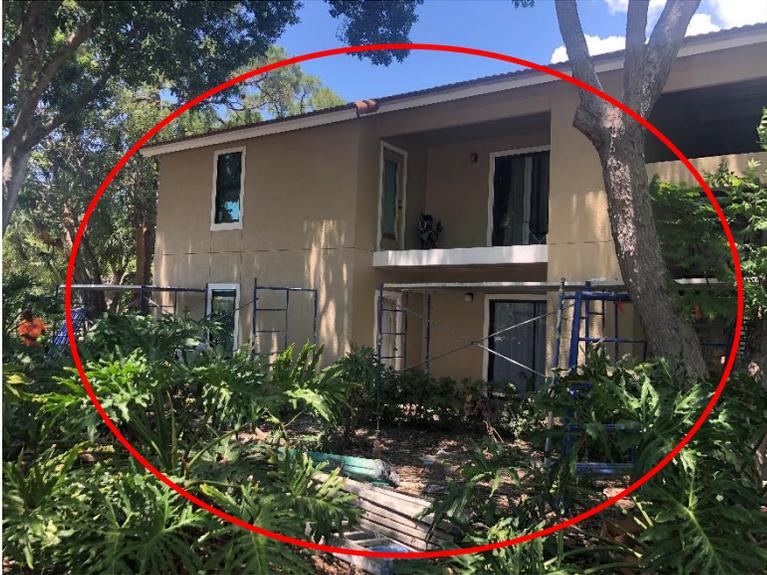
PHOTOGRAPH #1

**BUILDING 7  
SECTION A**

Contractor has painted new stucco and trim and begun to remove access scaffolding.

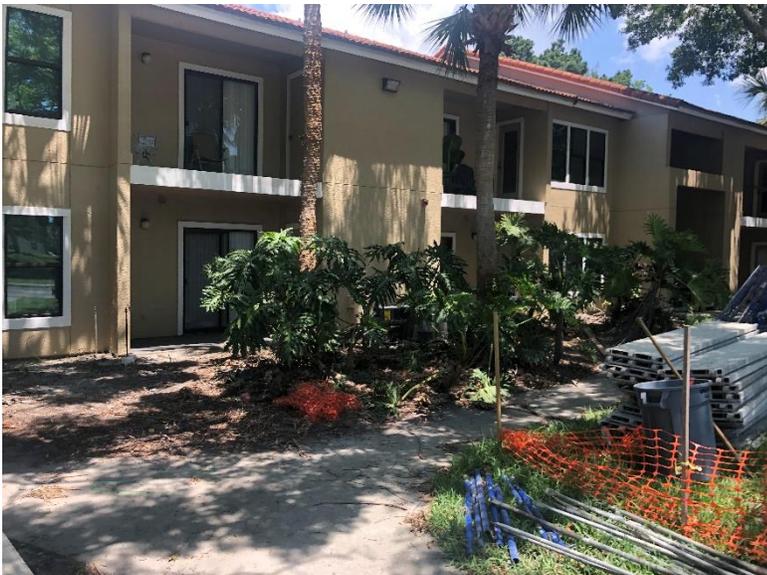
PHOTOGRAPH #2

**BUILDING 7  
SECTION B**

Contractor has painted new stucco and trim and begun to remove access scaffolding.

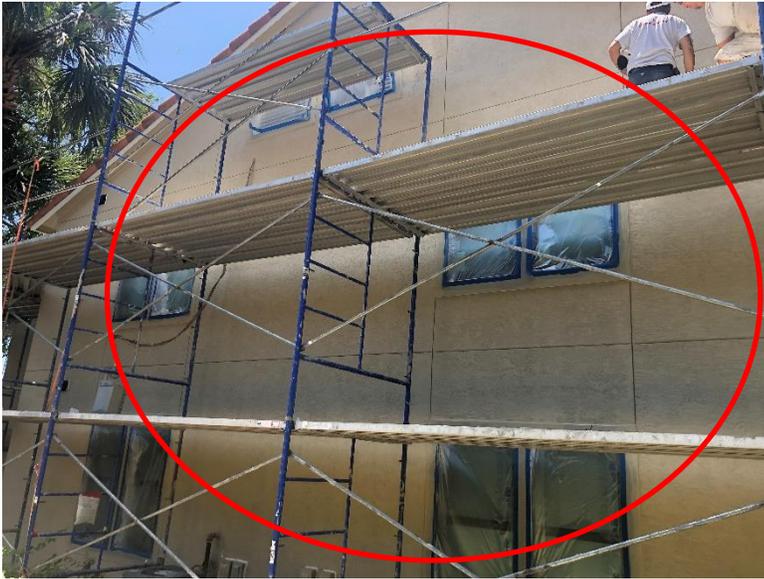
**PHOTOGRAPH #3**

**BUILDING 7  
SECTION D**

Contractor in process of priming new stucco. New windows have been covered to protect during paint applications.

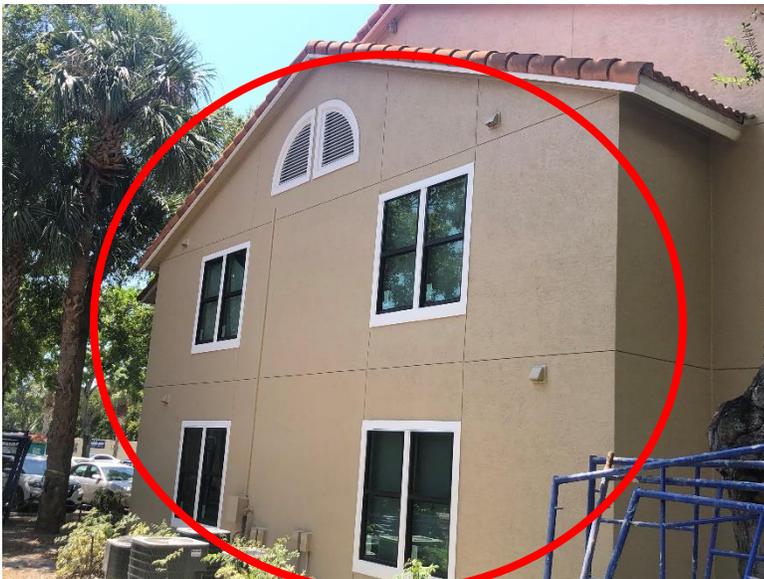
**PHOTOGRAPH #4**

**BUILDING 7  
SECTION D**

Contractor has painted new stucco and trim and begun to remove access scaffolding.

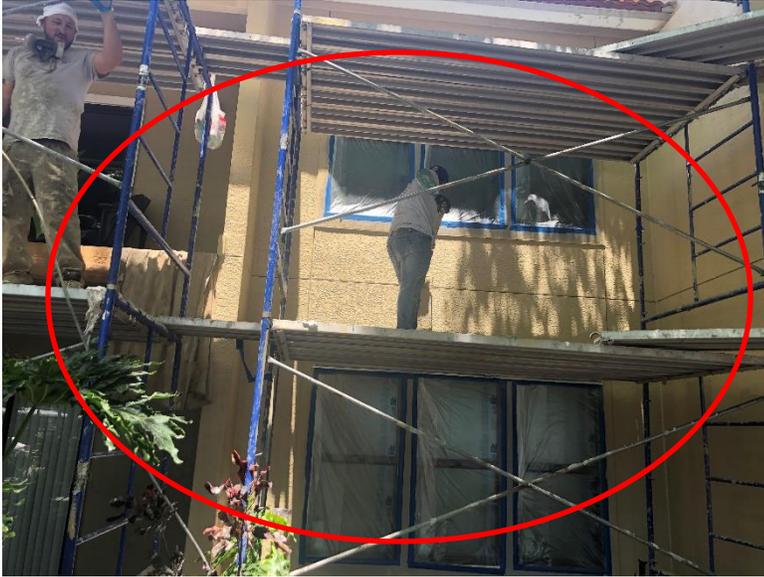
**PHOTOGRAPH #5**

**BUILDING 7  
SECTION F**

Contractor in process of priming new stucco. New windows have been covered to protect during paint applications.

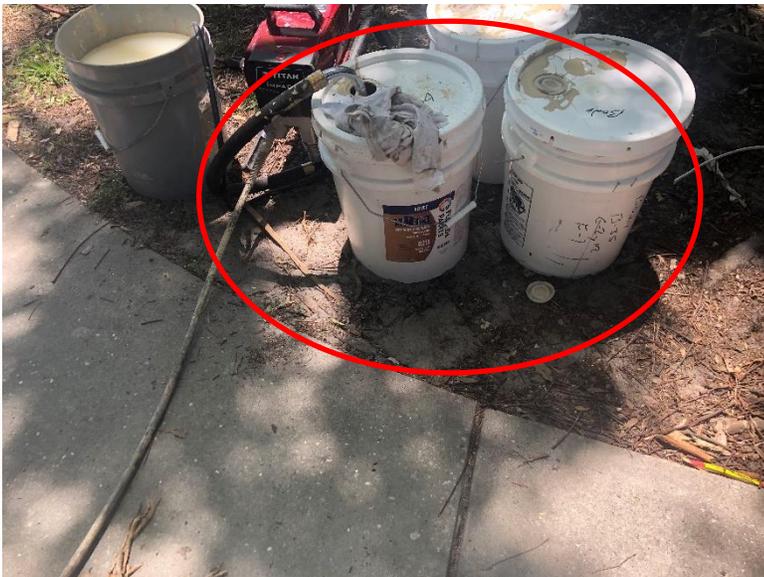
**PHOTOGRAPH #6**

**BUILDING 7  
SECTION F**

Florida Paints Ultra Exterior Supercoat applied to new stucco by airless spray and back rolling.

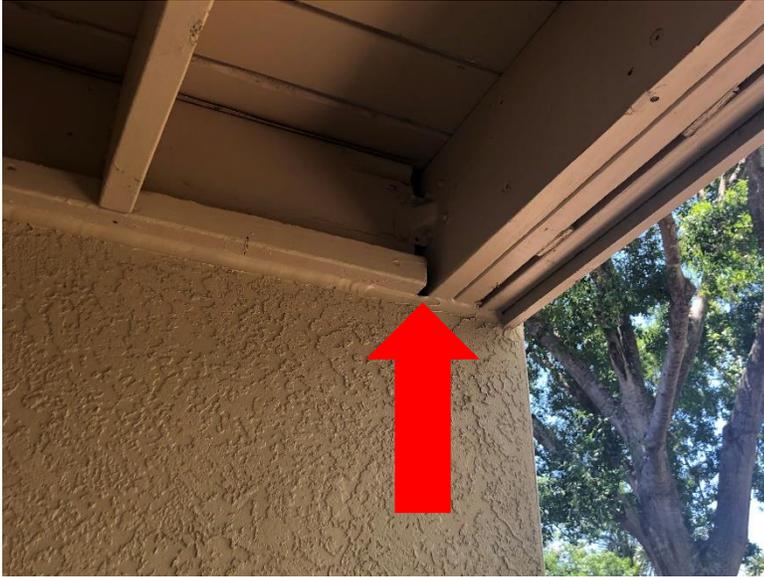
**PHOTOGRAPH #7**

**BUILDING 7  
SECTION F**

Gap at balcony support ledger to built up beam will require corrections and refinishing.

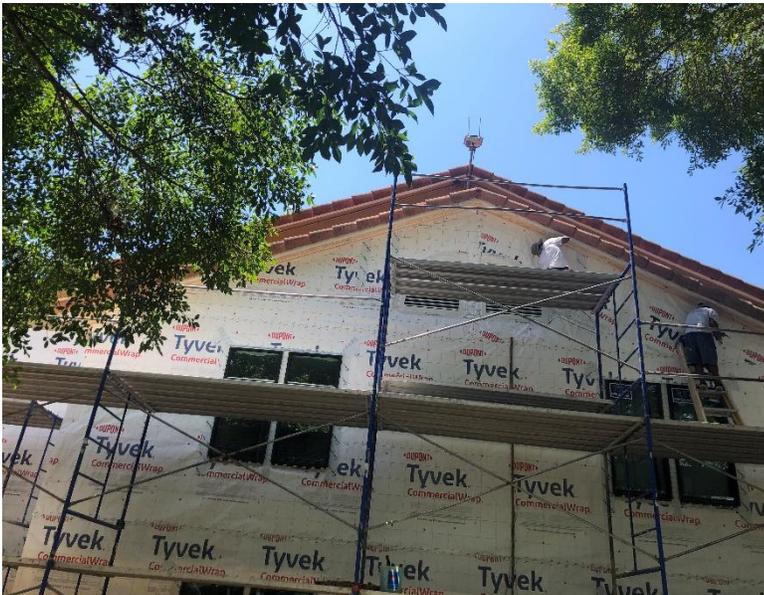
**PHOTOGRAPH #8**

**BUILDING 8  
SECTION H**

Contractor in process of installing and preparing for paint, new plywood at soffits.

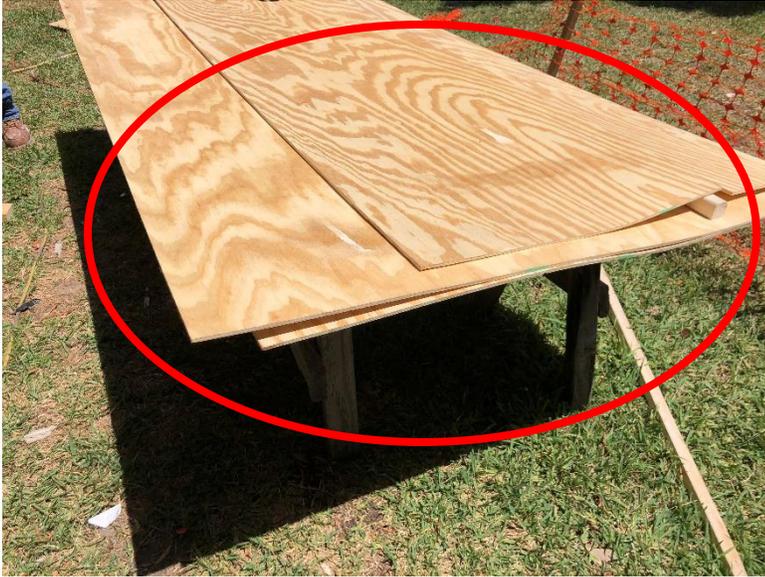
**PHOTOGRAPH #9**

**BUILDING 7  
SECTION H**

Contractor in process of installing and preparing for paint, new plywood at soffits

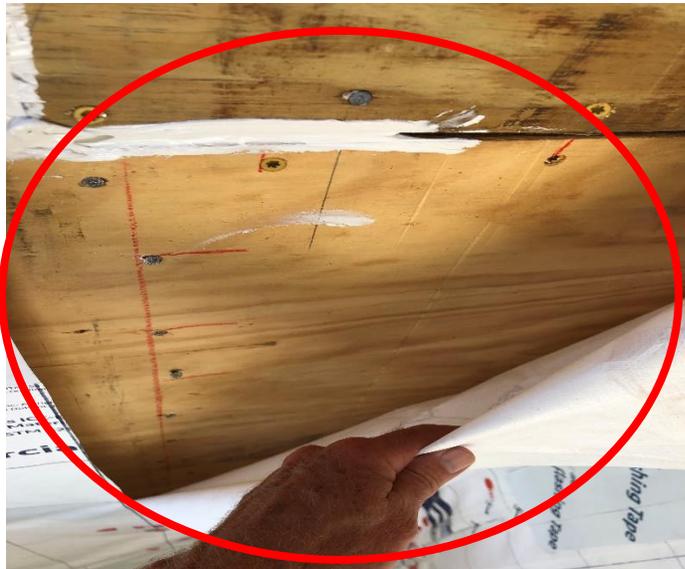
**PHOTOGRAPH #10**

**BUILDING 7  
SECTION H**

Contractor has replaced damaged plywood sheathing marked for replacement by Delta.

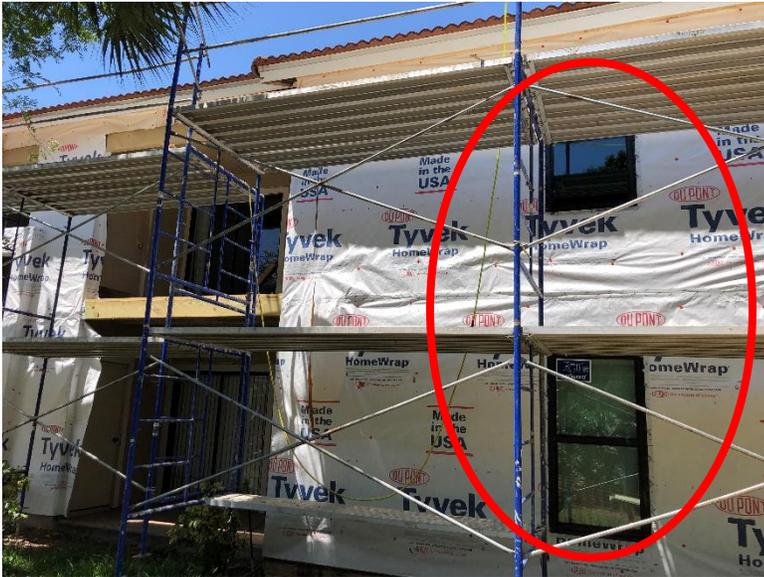
**PHOTOGRAPH #11**

**BUILDING 7  
SECTION G**

New 770 series PGT windows installed and flashed with Dupont flashing materials as per specifications and manufacturers guidelines.

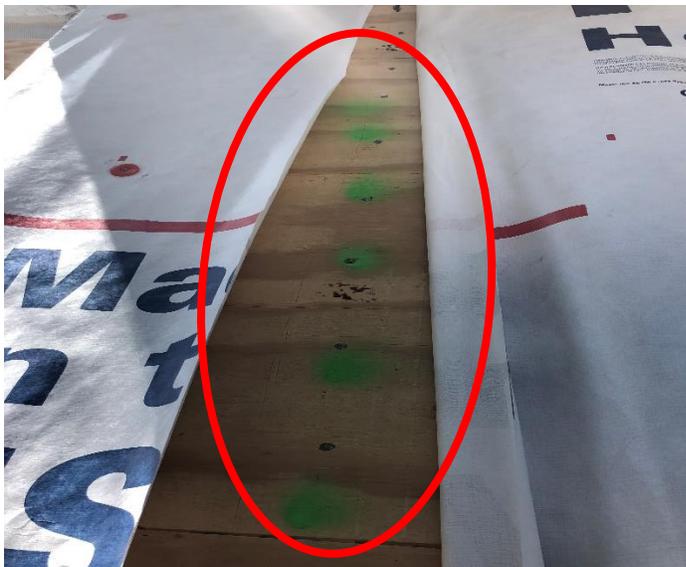
**PHOTOGRAPH #12**

**BUILDING 7  
SECTION G**

Contractor has fastened plywood sheathing to framing where marked for fastening by Delta.

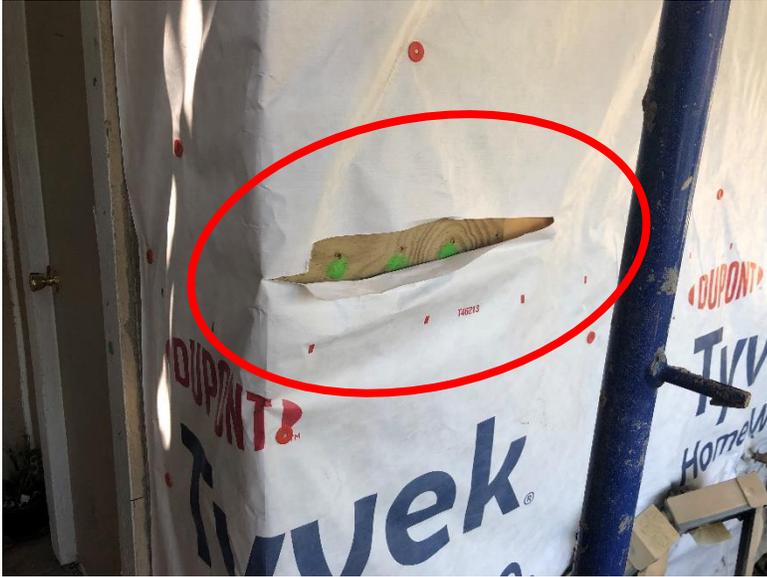
**PHOTOGRAPH #13**

**BUILDING 8  
SECTION F**

Contractor has fastened plywood sheathing to framing where marked for fastening by Delta.

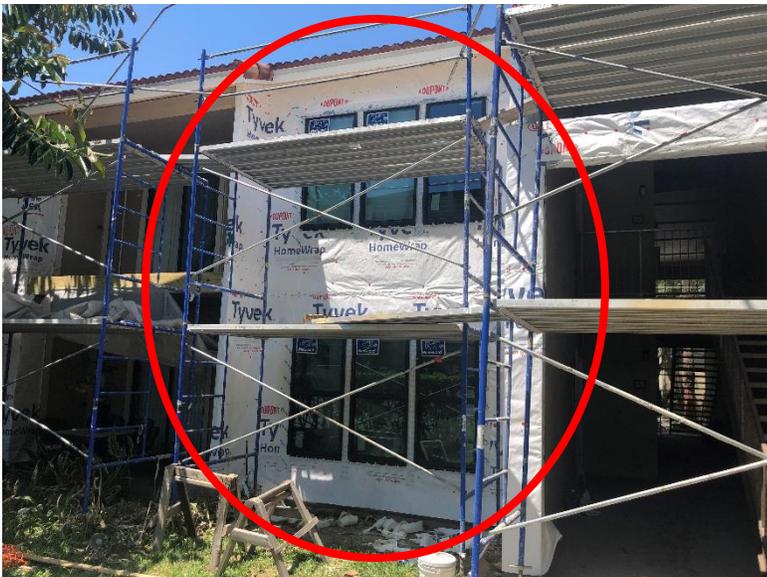
**PHOTOGRAPH #14**

**BUILDING 8  
SECTION F**

New 770 series PGT windows installed and flashed with Dupont flashing materials as per specifications and manufacturers guidelines.

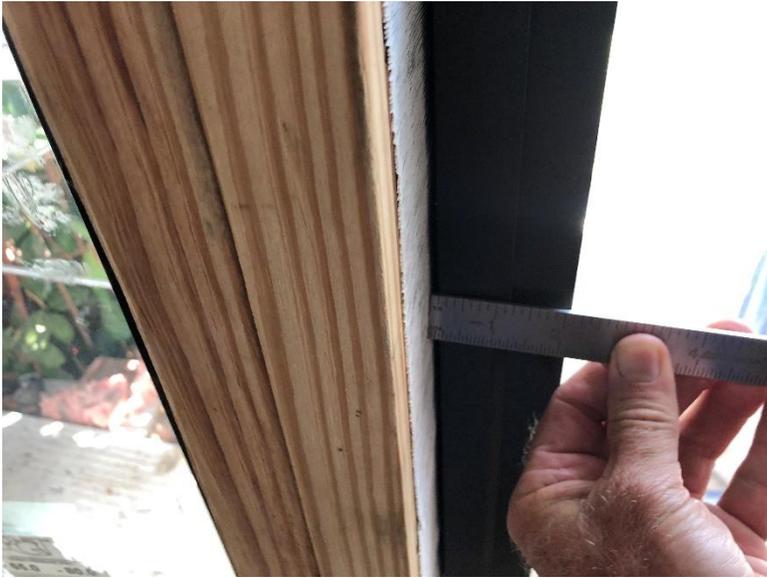
**PHOTOGRAPH #15**

**BUILDING 8  
SECTION F**

**Unit #826-** Gaps measured from window frame to jambs meet 5/16" maximum drawing requirements for fin frame jamb installation.

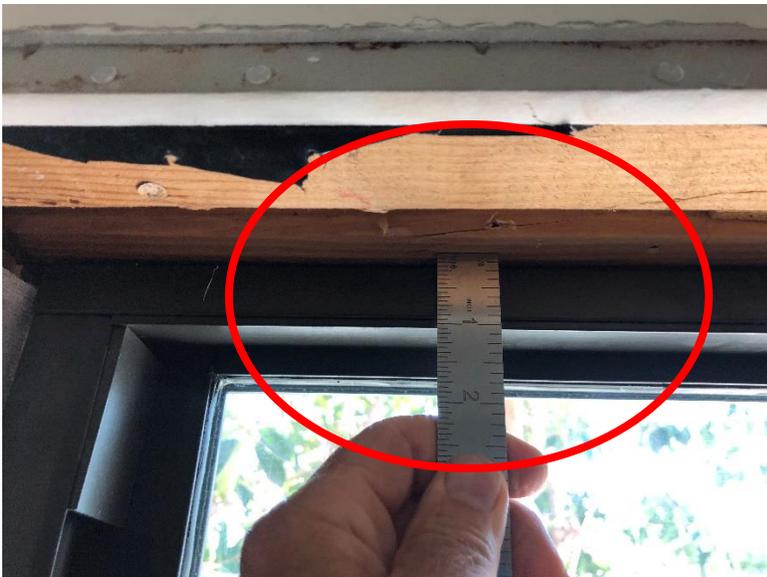
**PHOTOGRAPH #16**

**BUILDING 8  
SECTION F**

**Unit #826-** Gaps measured from window frame to header meet 5/16" maximum drawing requirements for fin frame jamb installation.

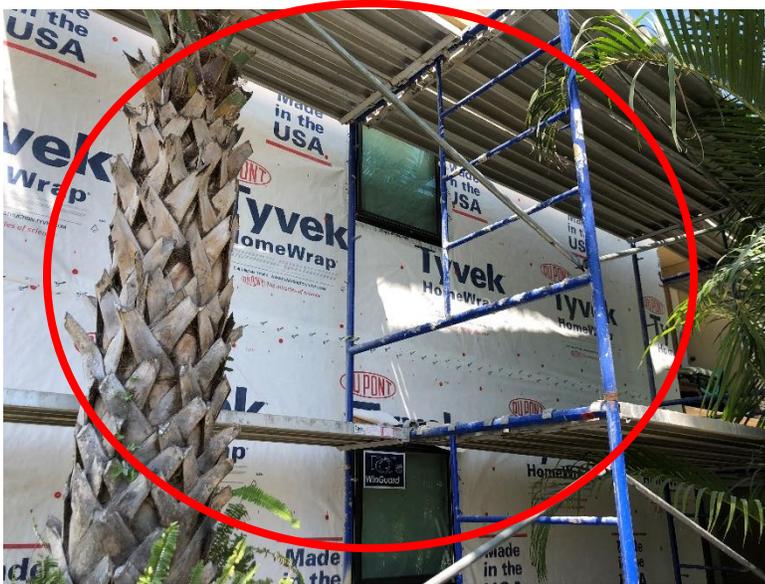
**PHOTOGRAPH #17**

**BUILDING 8  
SECTION E**

New 770 series PGT windows installed and flashed with Dupont flashing materials as per specifications and manufacturers guidelines.

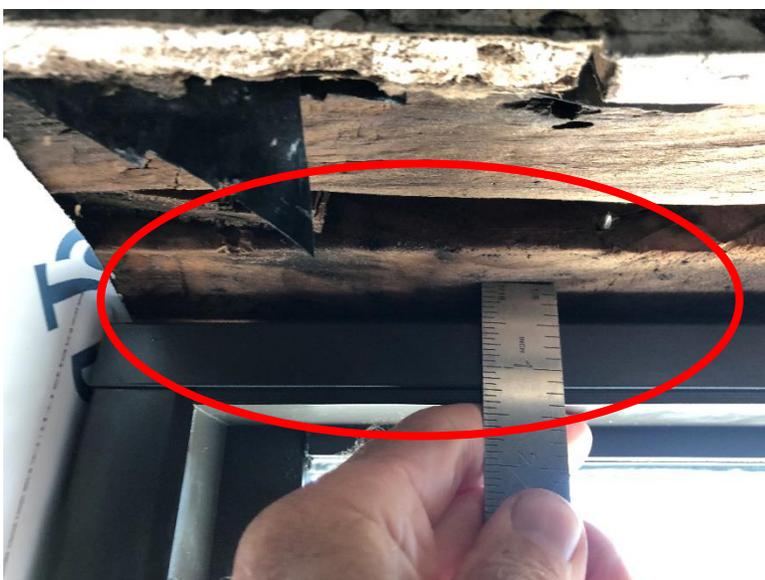
**PHOTOGRAPH #18**

**BUILDING 8  
SECTION H**

**Unit # 828** - Gaps measured from window frame to jamb do not meet 5/16" maximum drawing requirements for fin frame jamb installation.

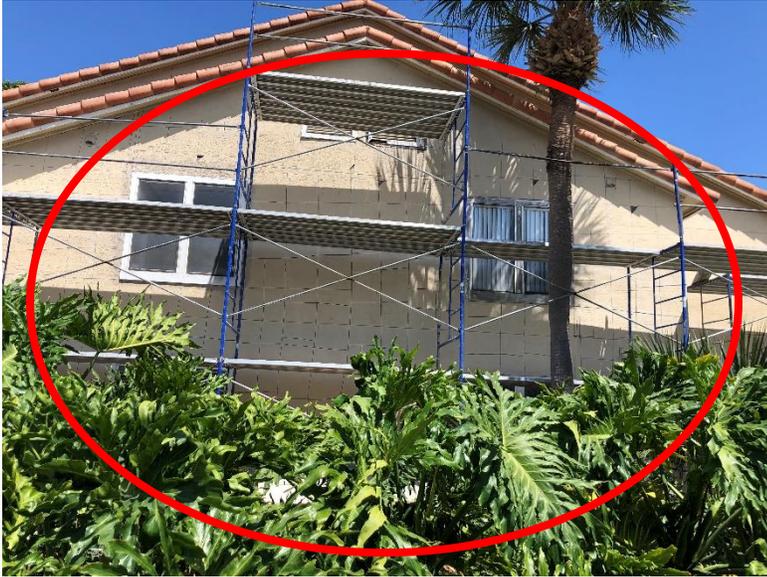
**PHOTOGRAPH #19**

**BUILDING 8  
SECTION D**

Contractor demo crew has cut existing stucco at 1" depth into squares for removal and handling.

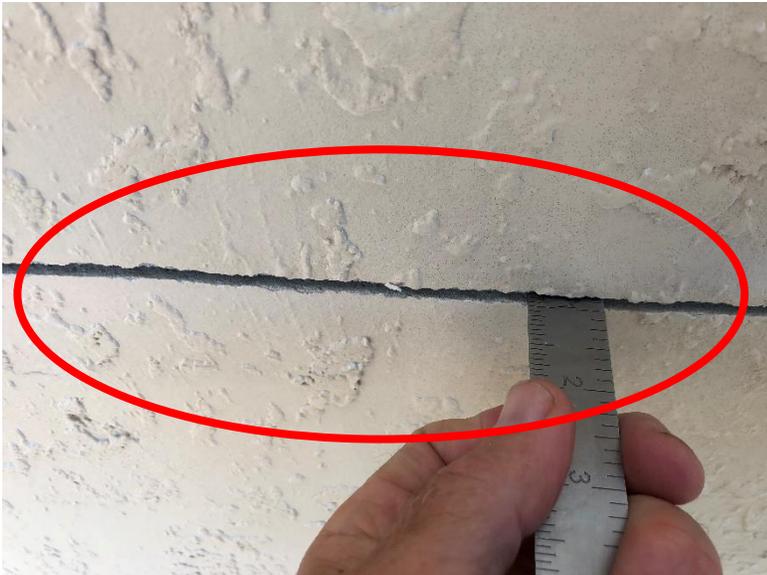
**PHOTOGRAPH #20**

**BUILDING 8  
SECTION D**

Contractor demo crew has cut existing stucco at 1" depth into squares for removal and handling.

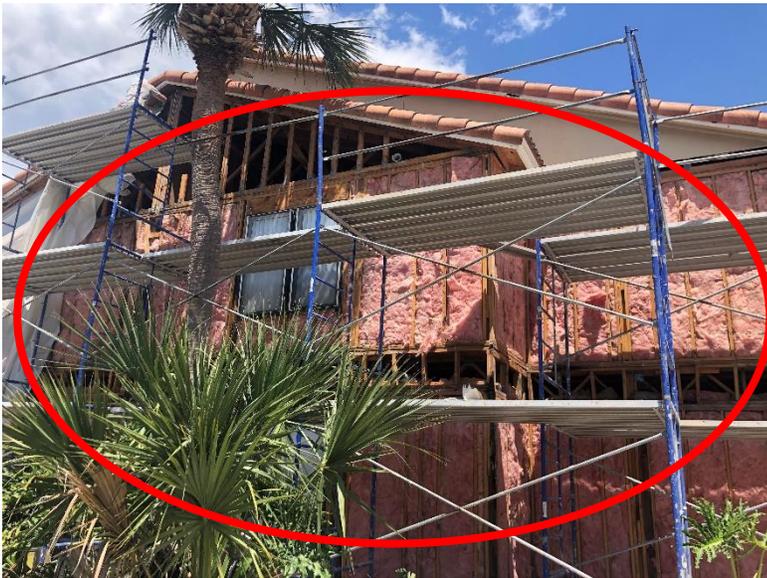
**PHOTOGRAPH #21**

**BUILDING 8  
SECTION D**

Contractor demo crew has removed stucco exposing framing for inspection and repairs.

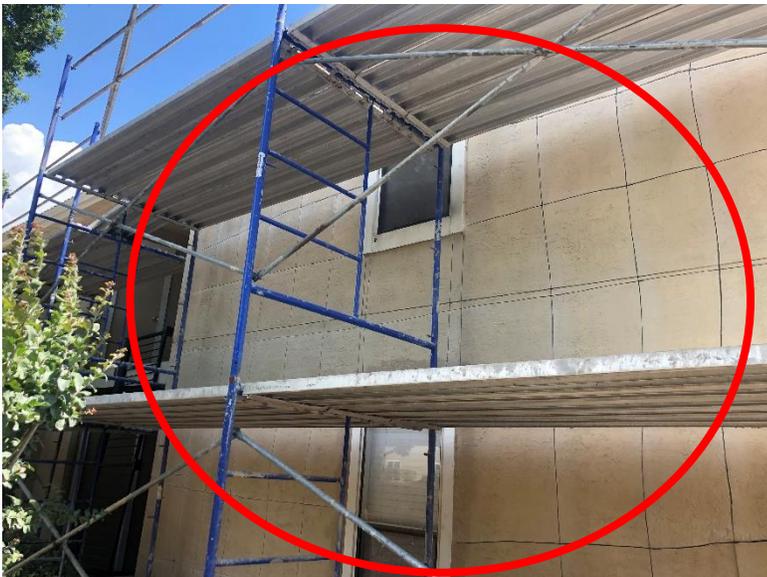
**PHOTOGRAPH #22**

**BUILDING 8  
SECTION C**

Contractor demo crew has cut existing stucco at 1" depth into squares for removal and handling.

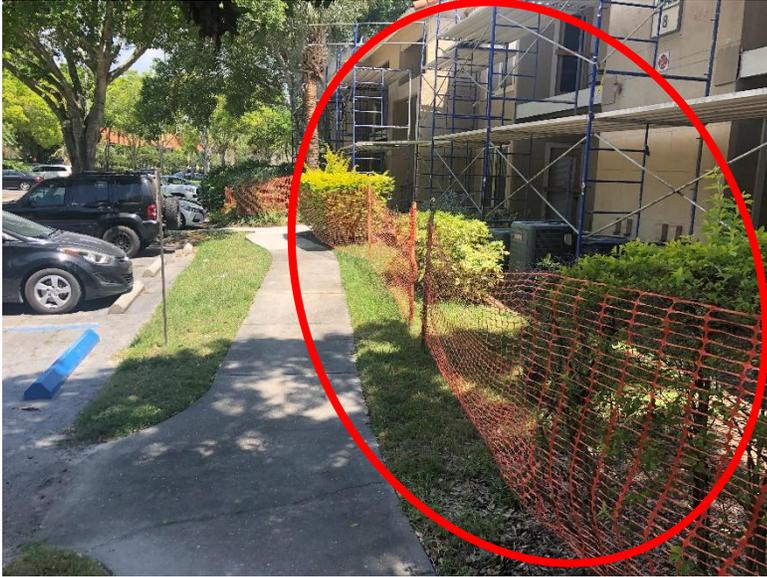
**PHOTOGRAPH #23**

**BUILDING 8  
SECTION B**

Construction areas designated and protected by orange construction fencing.
