PHOTOGRAPHS

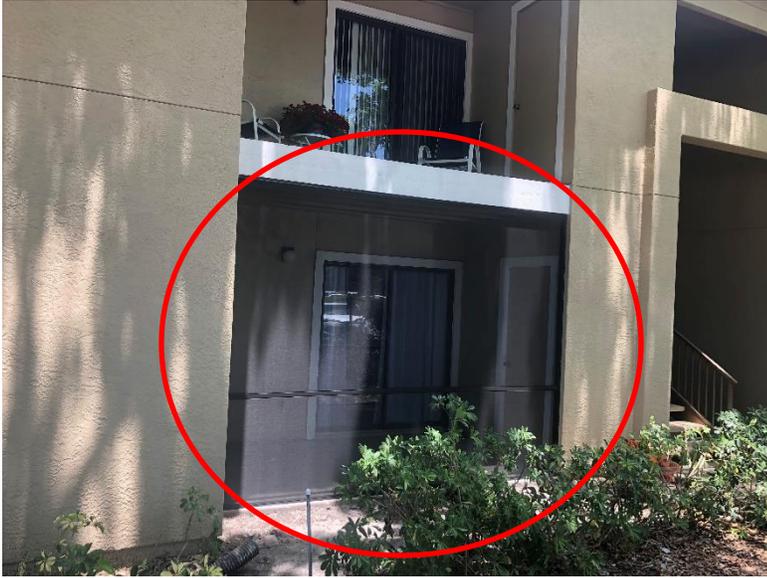
PHOTOGRAPH #1

**BUILDING 7
SECTION A**

Contractor installed new aluminum screen enclosures at ground level were removed for repairs.

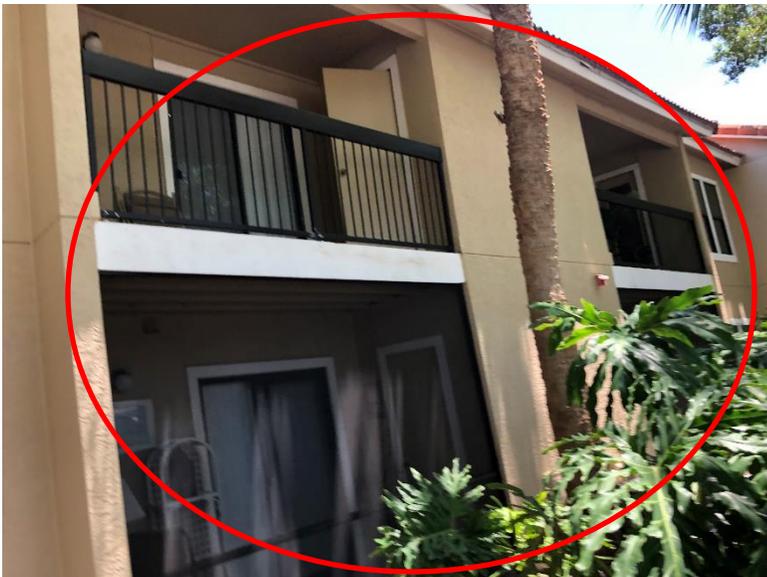
PHOTOGRAPH #2

**BUILDING 7
SECTION B**

Contractor installed new screen enclosures at lower Lani's and re installed newly painted steel railings at balconies.

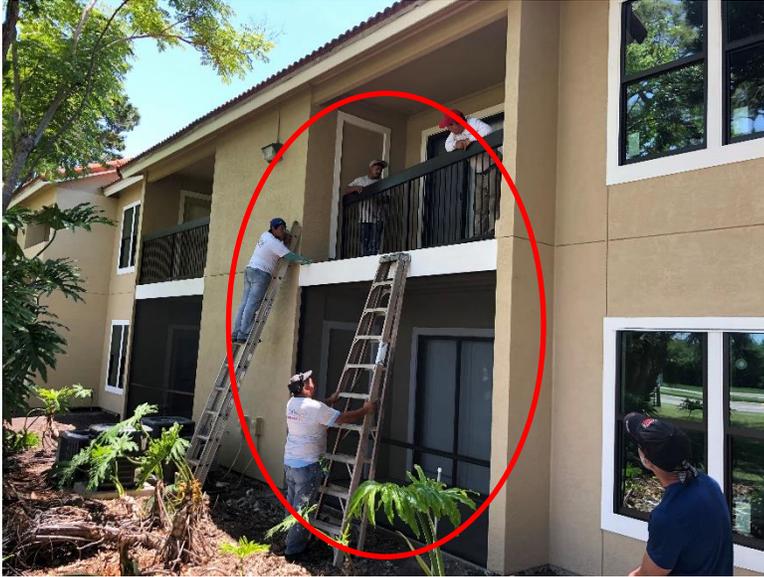
PHOTOGRAPH #3

**BUILDING 7
SECTION F**

Contractor in process of installing repainted steel railings at balconies with 3/8" X 4" galvanized lag bolts as per drawings and specifications.

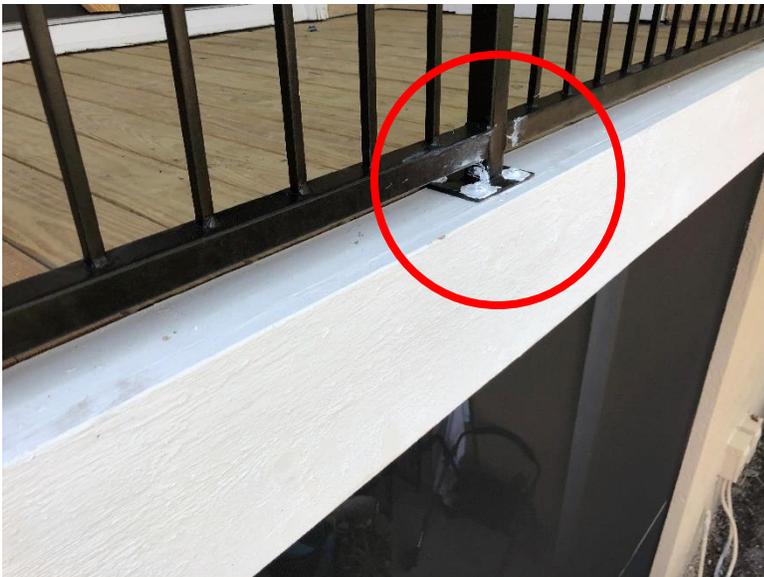
PHOTOGRAPH #4

**BUILDING 7
SECTION F**

Contractor in process of installing repainted steel railings at balconies with 3/8" X 4" galvanized lag bolts as per drawings and specifications.

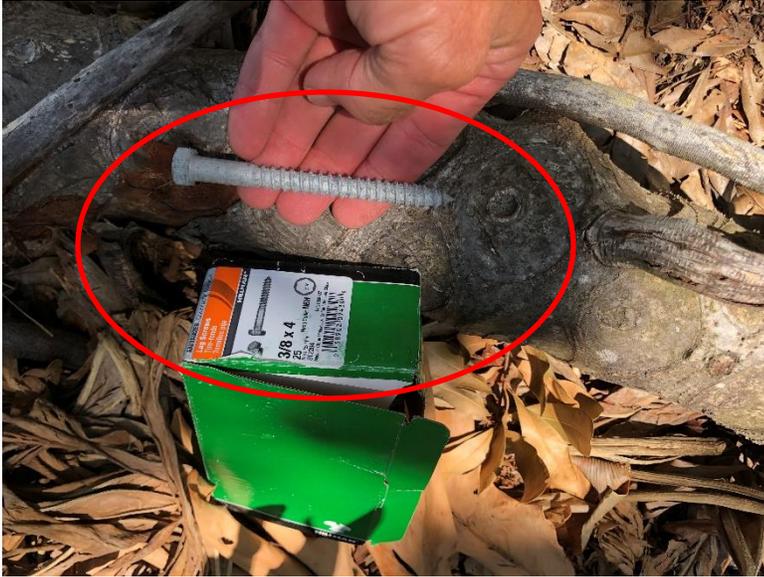
PHOTOGRAPH #5

**BUILDING 7
SECTION F**

Contractor in process of installing repainted steel railings at balconies with 3/8" X 4" galvanized lag bolts as per drawings and specifications.

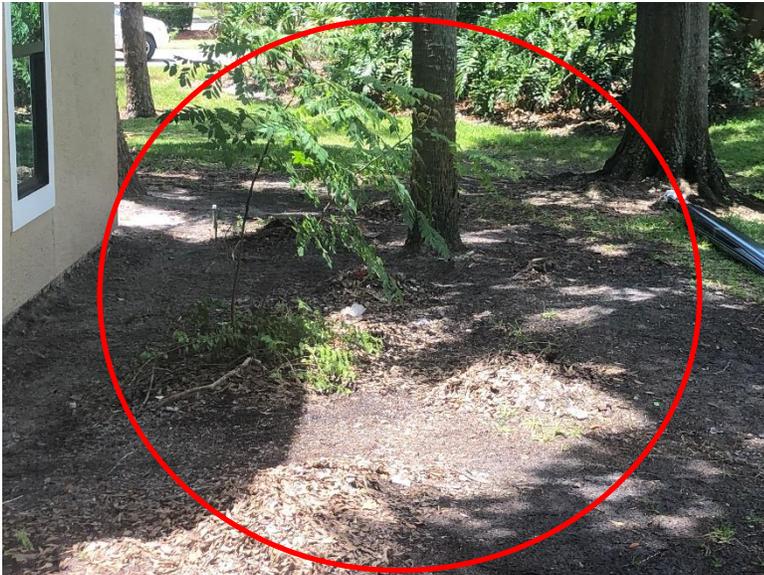
PHOTOGRAPH #6

**BUILDING 7
SECTION G**

Contractor has begun cleaning grounds and removing construction materials and fencing.

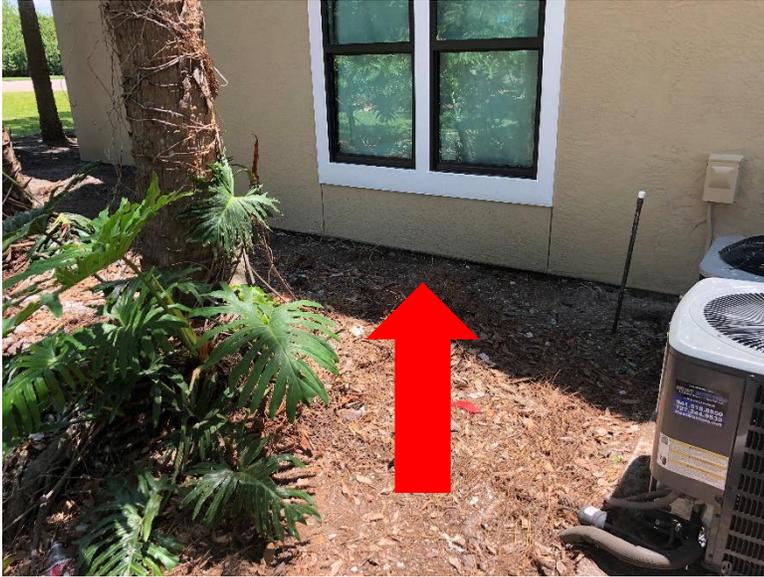
PHOTOGRAPH #7

**BUILDING 7
SECTION H**

Separation from ground to new stucco does not meet drawings requirements of 6" with slope away from foundation. Owners working with landscaping contractors for providing drainage.

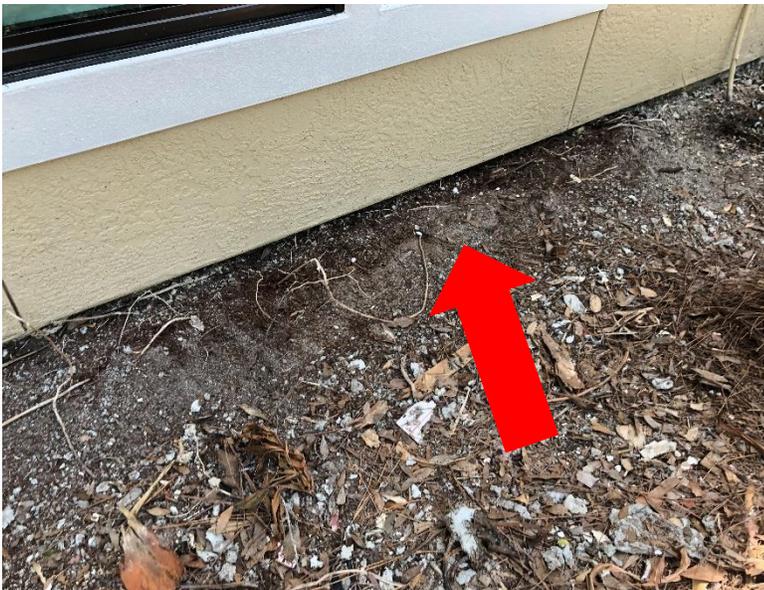
PHOTOGRAPH #8

**BUILDING 7
SECTION H**

Separation from ground to new stucco does not meet drawings requirements of 6" with slope away from foundation. Owners working with landscaping contractors for providing drainage.

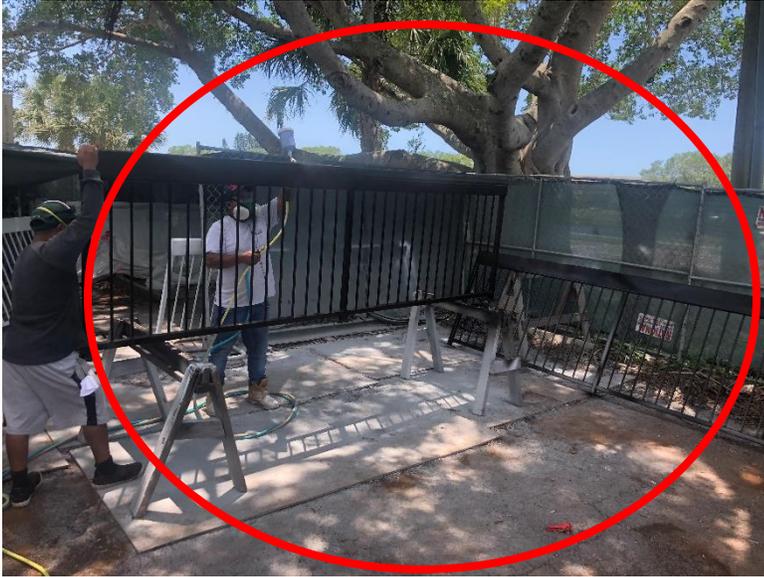
PHOTOGRAPH #9

**STORAGE AREA
PAINT ENCLOUSER**

Contractor in process of spraying Florida Paints Hi Performance two-part aliphatic urethane enamel finish on steel railings from balconies.

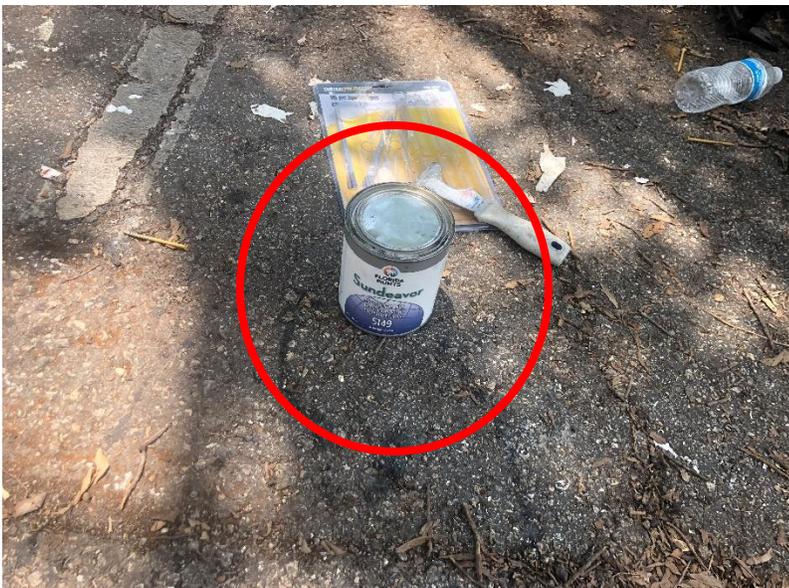
PHOTOGRAPH #10

**STORAGE AREA
PAINT ENCLOUSER**

Contractor in process of spraying Florida Paints Hi Performance two-part aliphatic urethane enamel finish on steel railings from balconies.

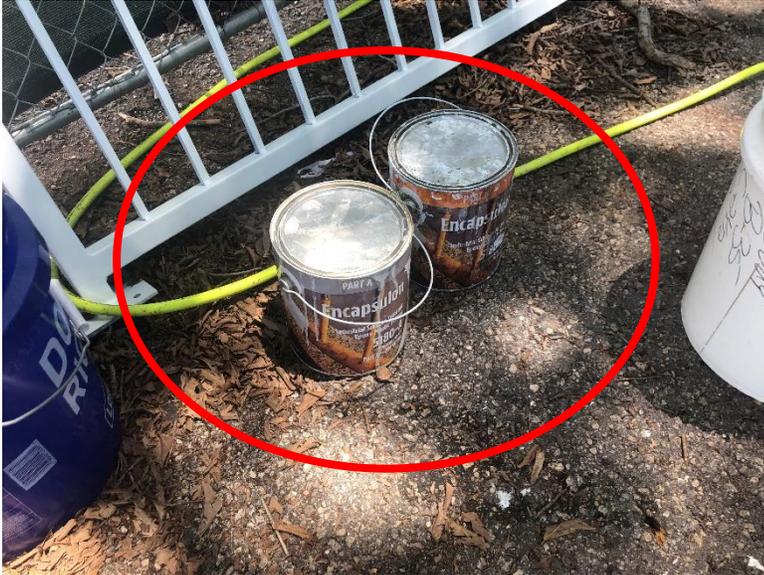
PHOTOGRAPH #11

**BUILDING 7
SECTION G**

Contractor has primed steel railings with Florida Paints Encapsulon Epoxy Mastic.

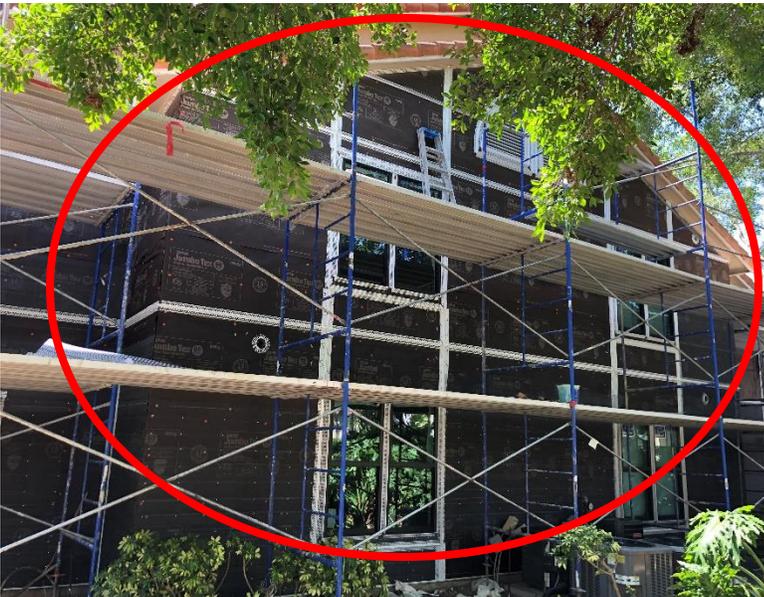
PHOTOGRAPH #12

**BUILDING 8
SECTION H**

Sub-Contractor has begun to install second water resistant barrier and stucco accessories at windows and control joints.

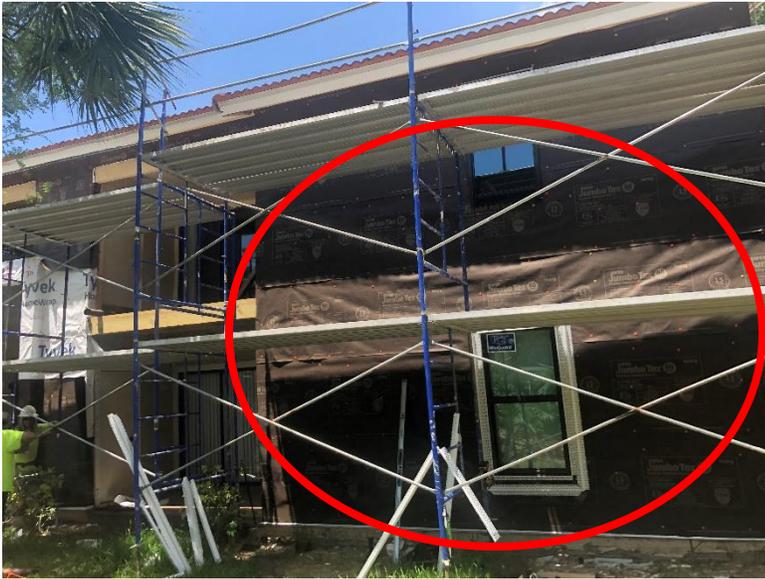
PHOTOGRAPH #13

**BUILDING 8
SECTION G**

Sub-Contractor has installed Super Jumbo Tex 60 Minutes water resistant barrier.

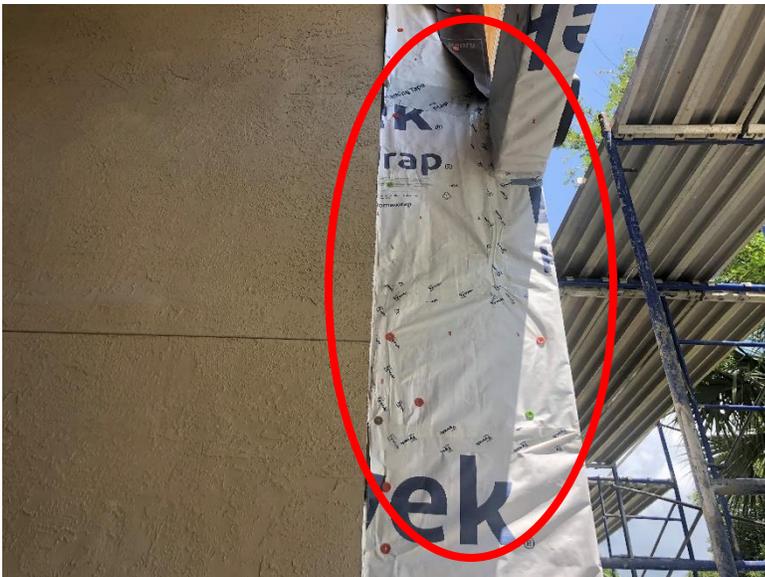
PHOTOGRAPH #14

**BUILDING 8
SECTION G**

Plywood sheathing (previously noted in action items) confirmed as corrected.

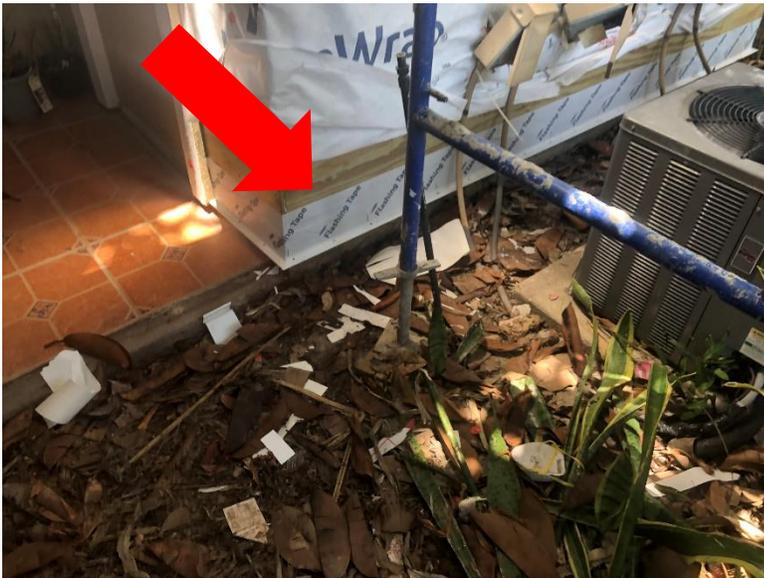
PHOTOGRAPH #15

**BUILDING 8
SECTION F**

Sub-contractor has attached new weep screed accessory at base of sheathing and flashed with Dupont Straight flashing.

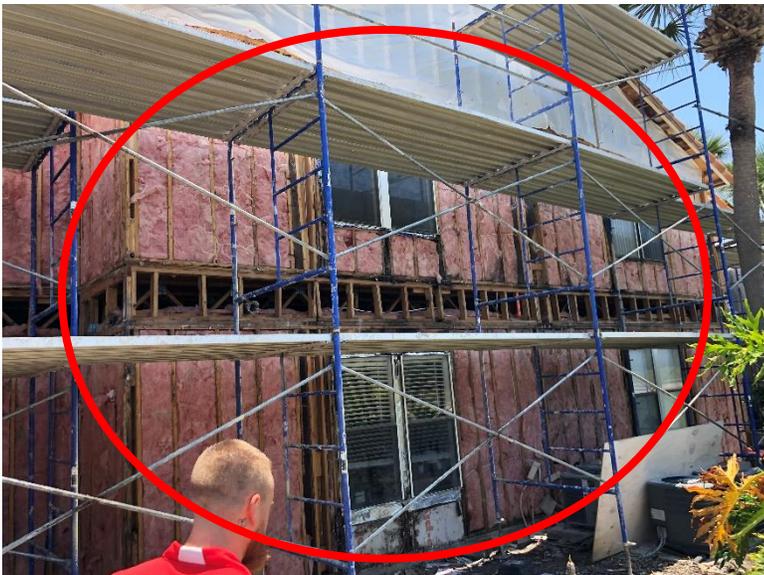
PHOTOGRAPH #16

**BUILDING 8
SECTION D**

Contractor has removed stucco and sheathing for observation and marking of framing repair areas.

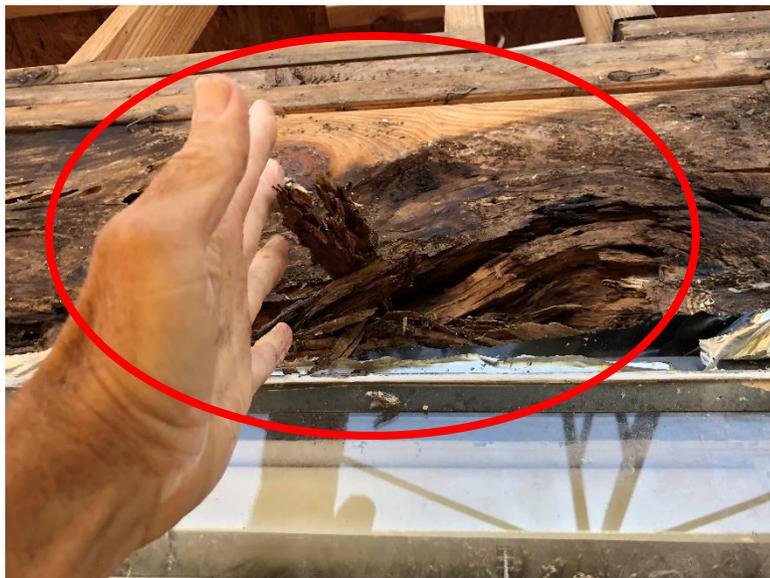
PHOTOGRAPH #17

**BUILDING 8
SECTION D**

Exposed window header framing damage (marked for removal and replacement) is at point of collapse.

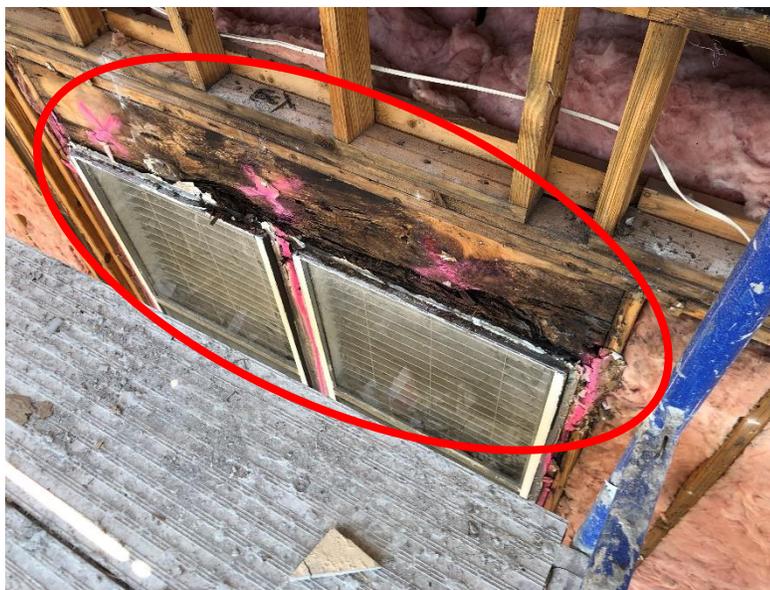
PHOTOGRAPH #18

**BUILDING 8
SECTION D**

Exposed window header framing damage (marked for removal and replacement) is at point of collapse.

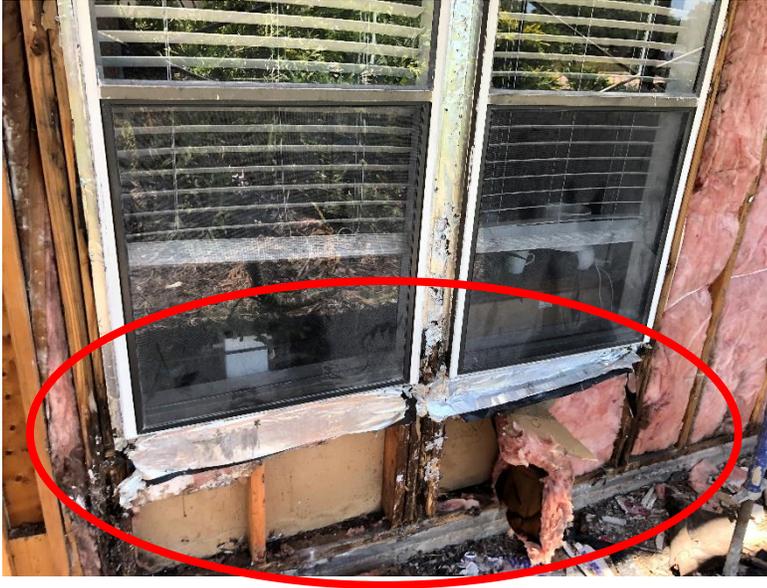
PHOTOGRAPH #19

**BUILDING 8
SECTION D**

Damaged wood window framing marked for removal and replacement.

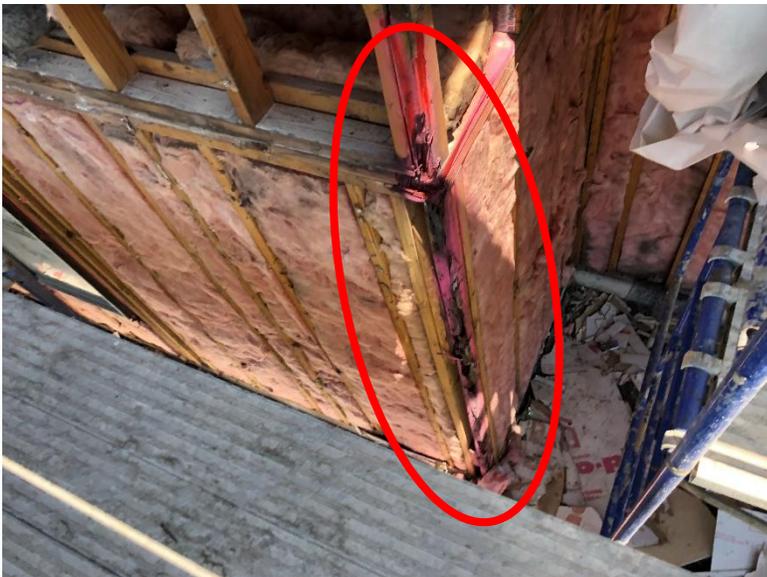
PHOTOGRAPH #20

**BUILDING 8
SECTION D**

Damaged wood corner post marked for removal and replacement.

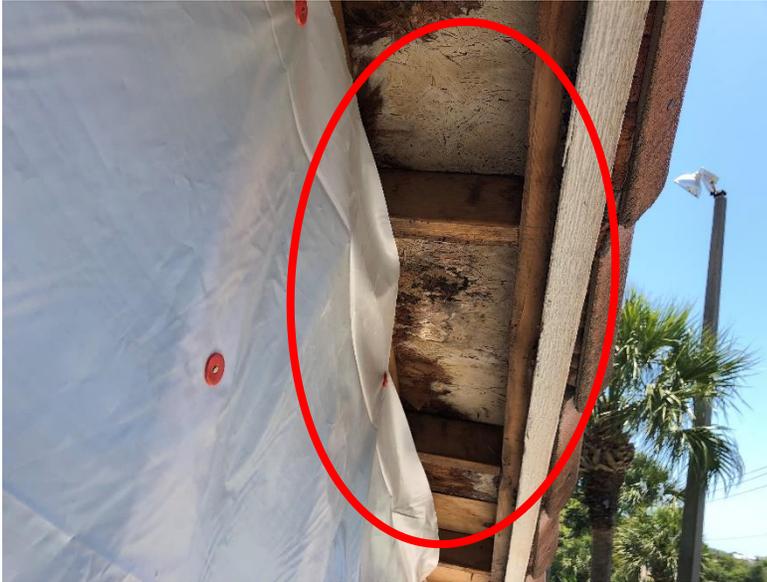
PHOTOGRAPH #21

**BUILDING 8
SECTION C**

Roof leaks at overhang have damaged roof sheathing. This repair outside contractors' scope of repairs.

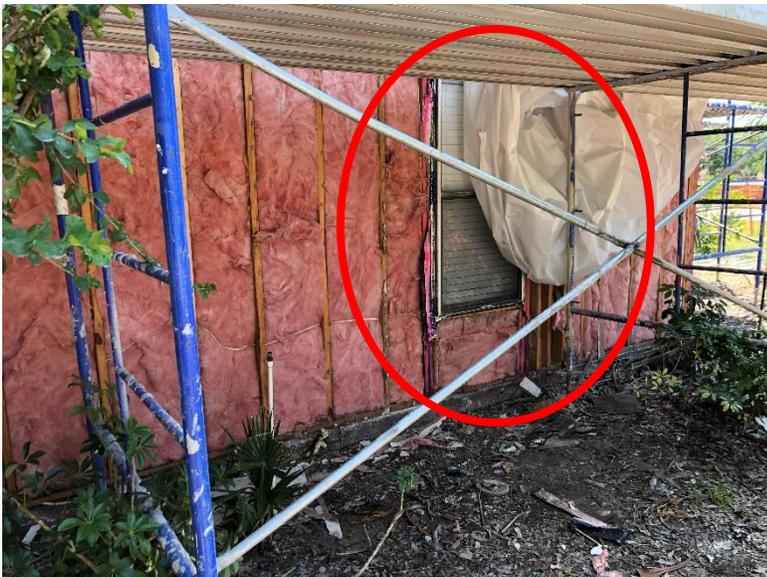
PHOTOGRAPH #22

**BUILDING 8
SECTION C**

Damaged wood framing at window marked for repairs.

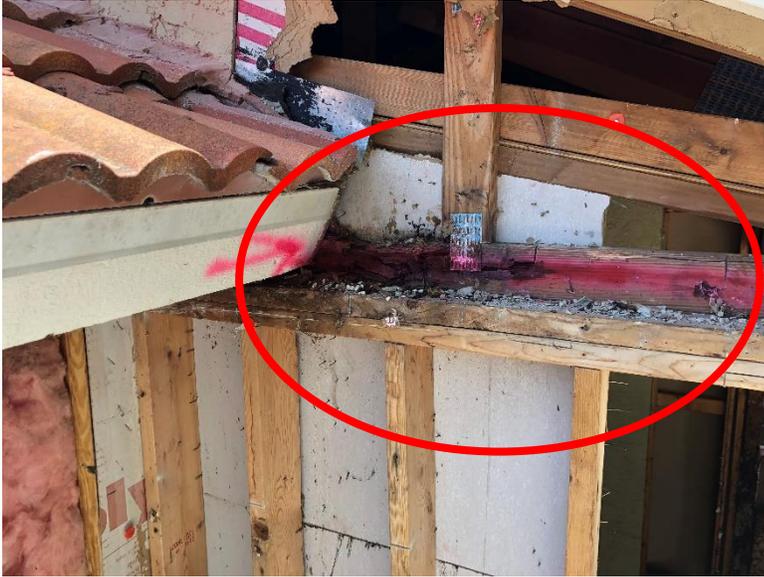
PHOTOGRAPH #23

**BUILDING 8
SECTION C**

Damaged wood framing at truss and top plate marked for repairs.

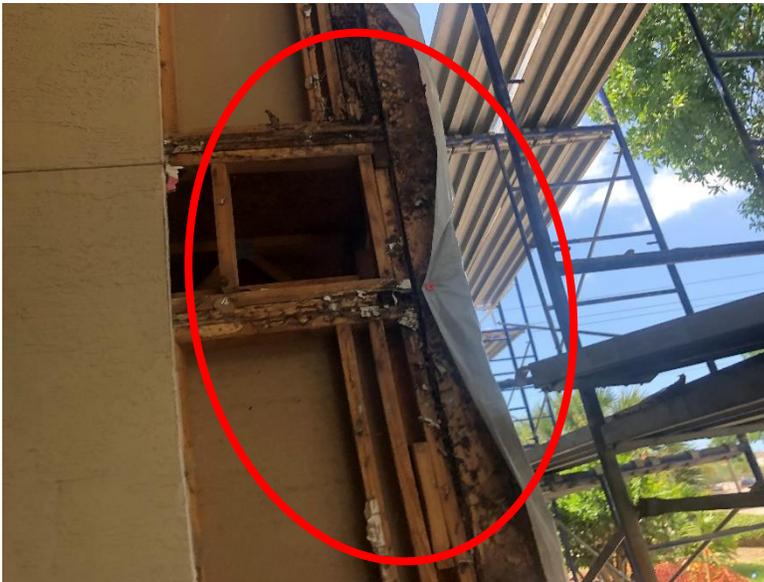
PHOTOGRAPH #24

**BUILDING 8
SECTION C**

Termite damaged wood framing at breezeway marked for repairs.

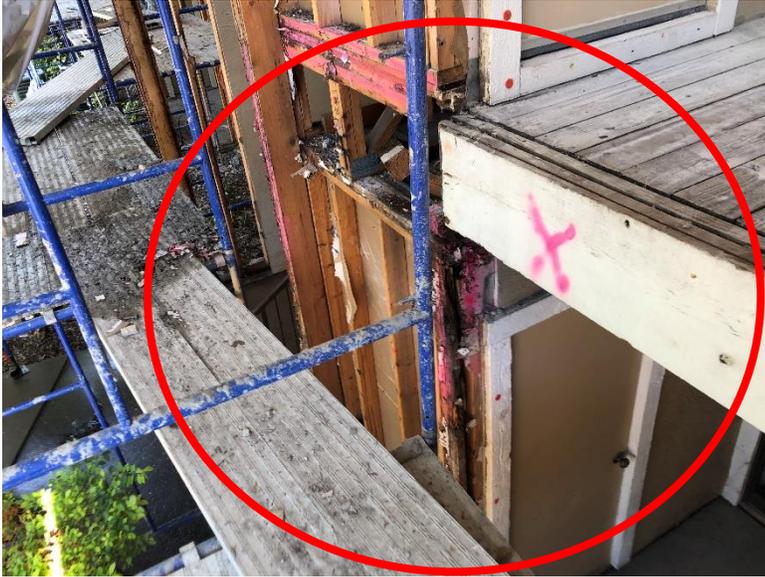
PHOTOGRAPH #25

**BUILDING 8
SECTION C**

Damaged wood framing at balcony built up beam and wall framing marked for repairs.

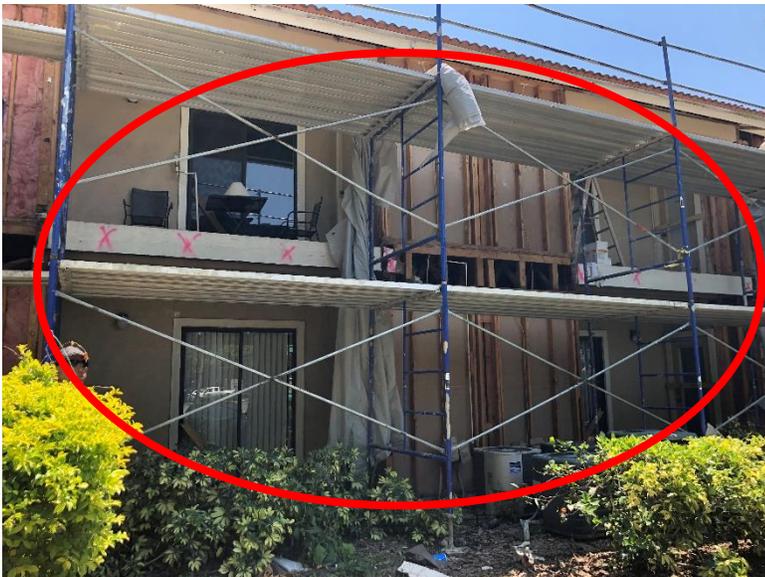
PHOTOGRAPH #26

**BUILDING 8
SECTION B**

Damaged wood framing at balcony built up beams and wall framing marked for repairs.

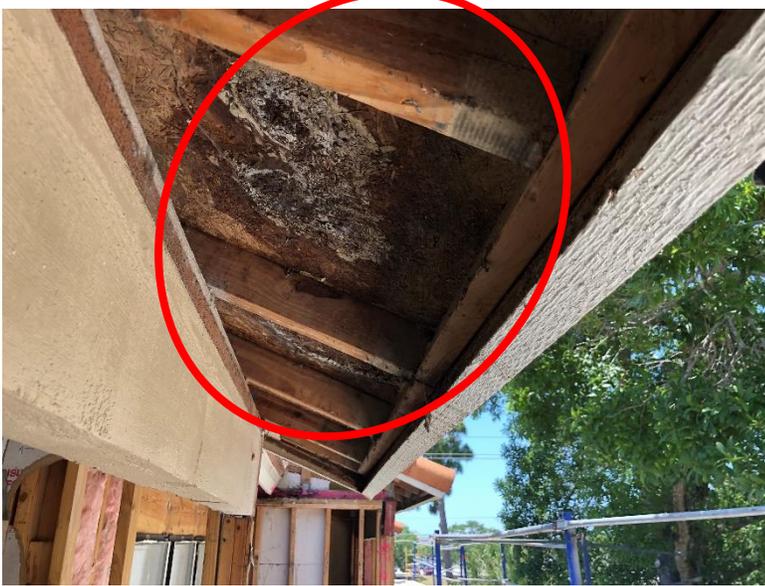
PHOTOGRAPH #27

**BUILDING 8
SECTION B**

Roof leaks at overhang have damaged roof sheathing. This repair outside contractors' scope of repairs.

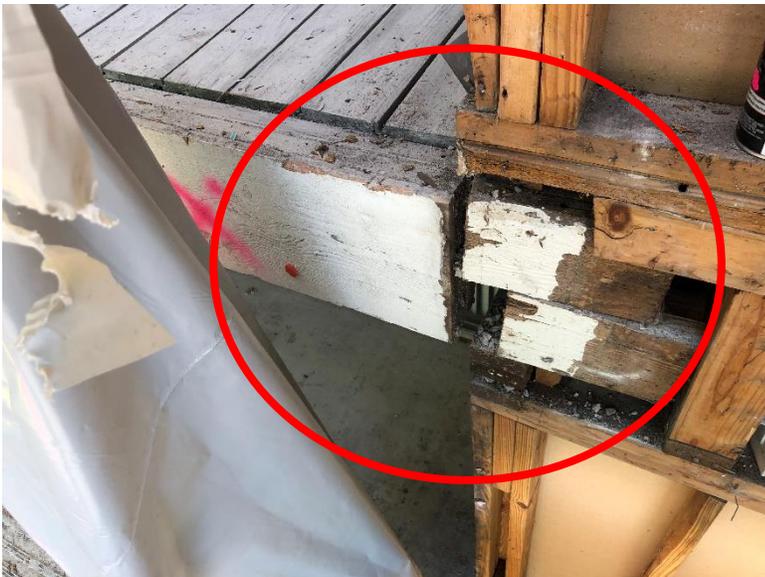
PHOTOGRAPH #28

**BUILDING 8
SECTION B**

Preexisting repairs at balcony built up beam were cut short and did not bear properly on framing post below.

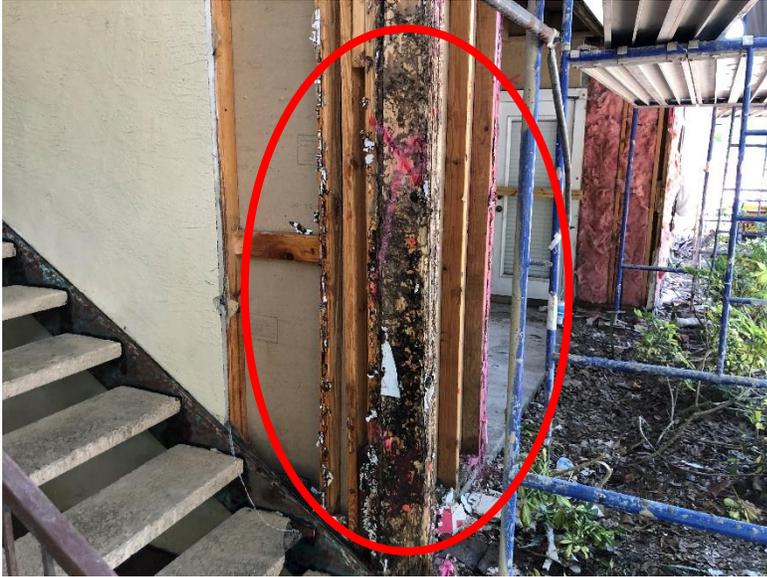
PHOTOGRAPH #29

**BUILDING 8
SECTION A**

Termite damaged wood framing at breezeway marked for repairs.

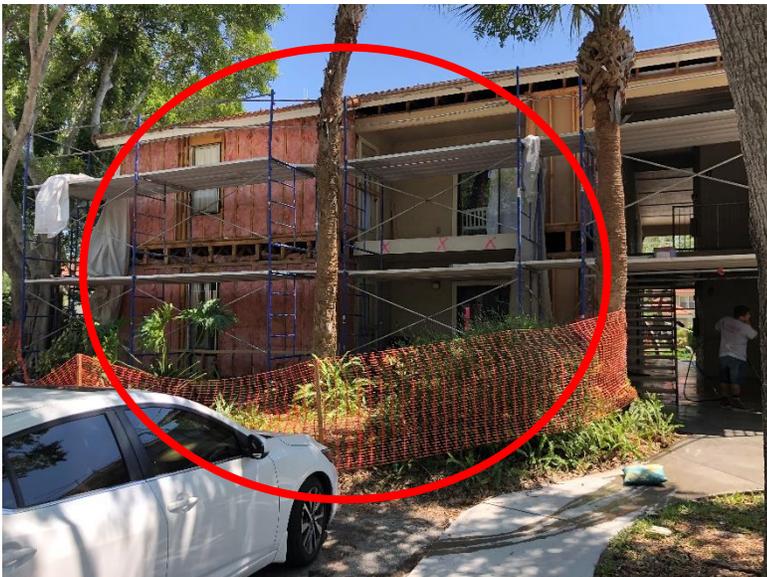
PHOTOGRAPH #30

**BUILDING 8
SECTION A**

Damaged wood framing at balcony built up beams, wall framing, and window framing marked for repairs.

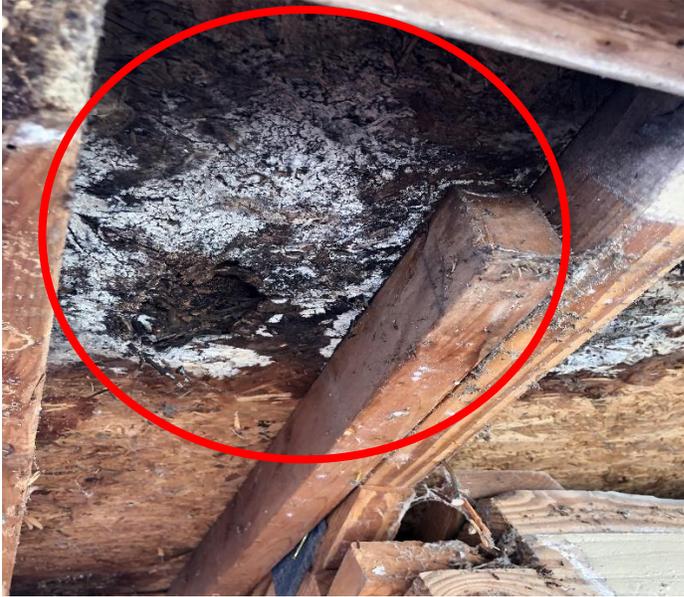
PHOTOGRAPH #31

**BUILDING 8
SECTION A**

Roof leaks at overhang have damaged roof sheathing. This repair outside contractors' scope of repairs.
