PHOTOGRAPHS

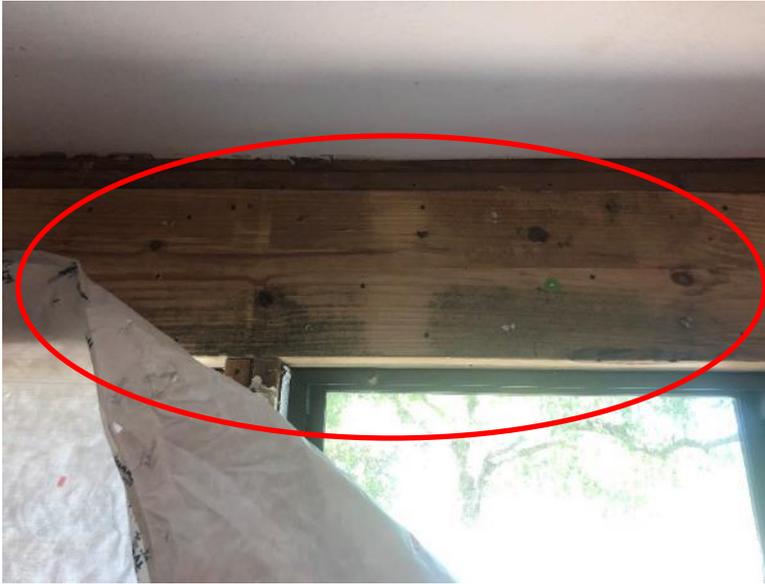
PHOTOGRAPH #1

**BUILDING 7
SECTION A**

Unit #711- Contractor has removed and replaced double window header from interior side.

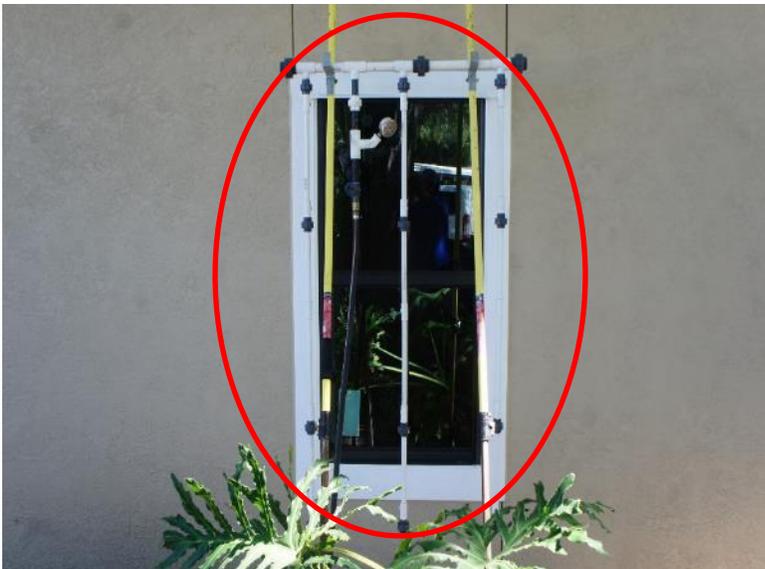
PHOTOGRAPH #2

**BUILDING 7
SECTION A**

Unit #711- Added Single window tested by Independent Testing Agency as per ASTM 502 passed with no leaks.

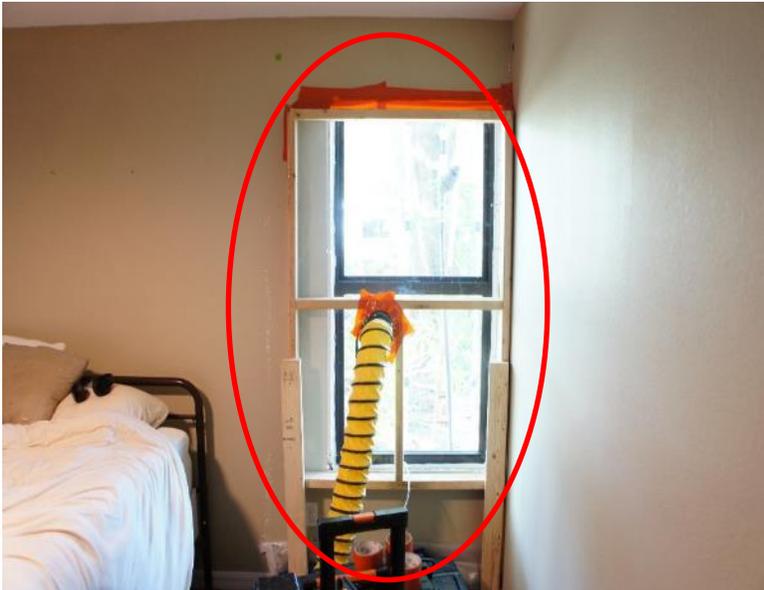
PHOTOGRAPH #3

**BUILDING 7
SECTION A**

Unit #711- Added Single window tested by Independent Testing Agency as per ASTM 502 passed with no leaks.

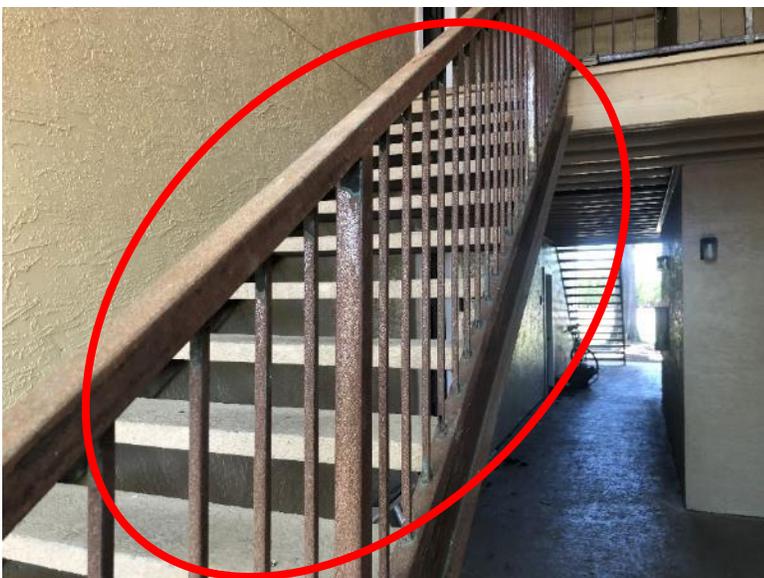
PHOTOGRAPH #4

**BUILDING 7
SECTION A**

Previously prepared steel railings have begun to show surface rust and will require light sanding and solvent wipe as per manufacturer's guidelines before priming.

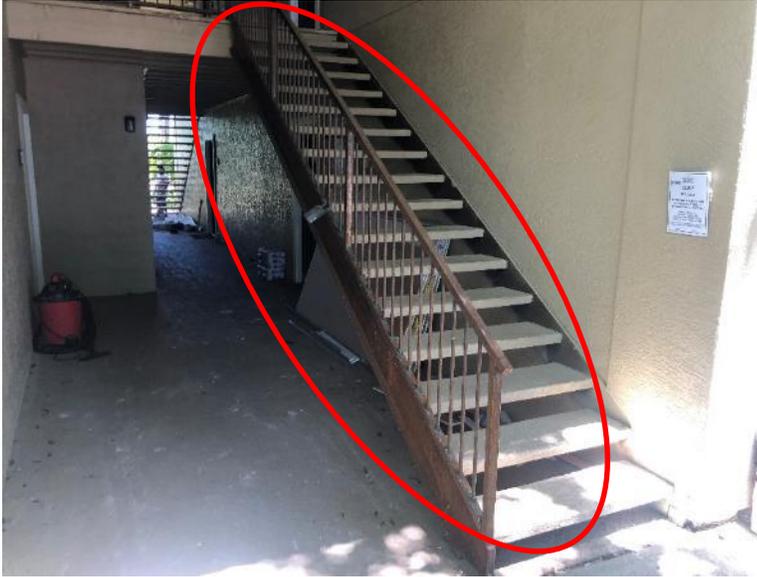
PHOTOGRAPH #5

**BUILDING 7
SECTION C**

Previously prepared steel railings have begun to show surface rust and will require light sanding and solvent wipe as per manufacturer's guidelines before priming.

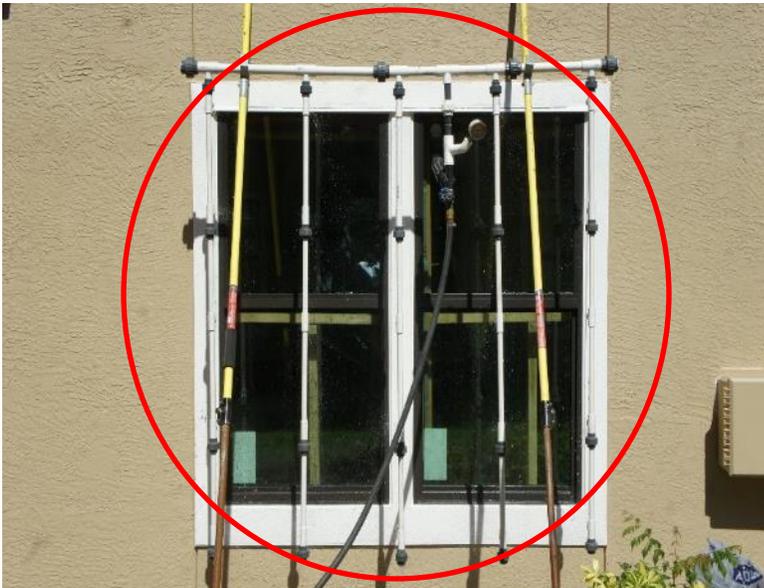
PHOTOGRAPH #6

**BUILDING 7
SECTION D**

Unit #717- Double window retested by Independent Testing Agency as per ASTM 502 passed with no leaks.

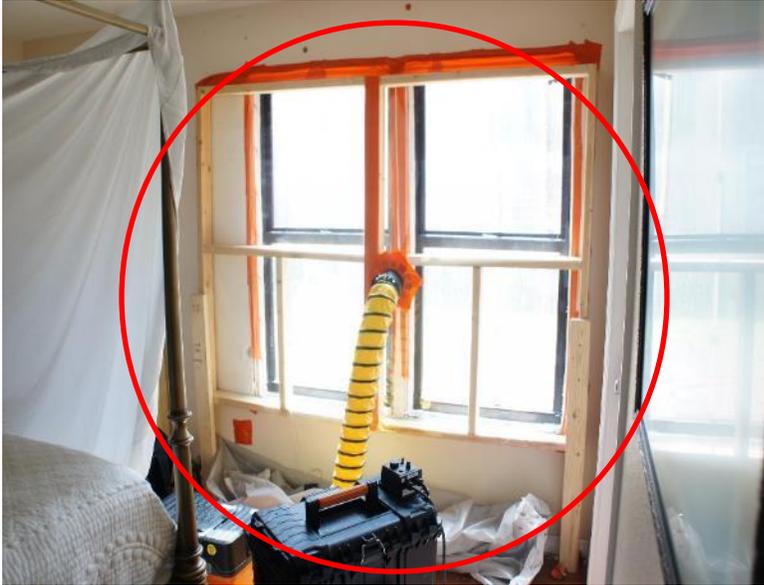
PHOTOGRAPH #7

**BUILDING 7
SECTION D**

Unit #717- Double window retested by Independent Testing Agency as per ASTM 502 passed with no leaks

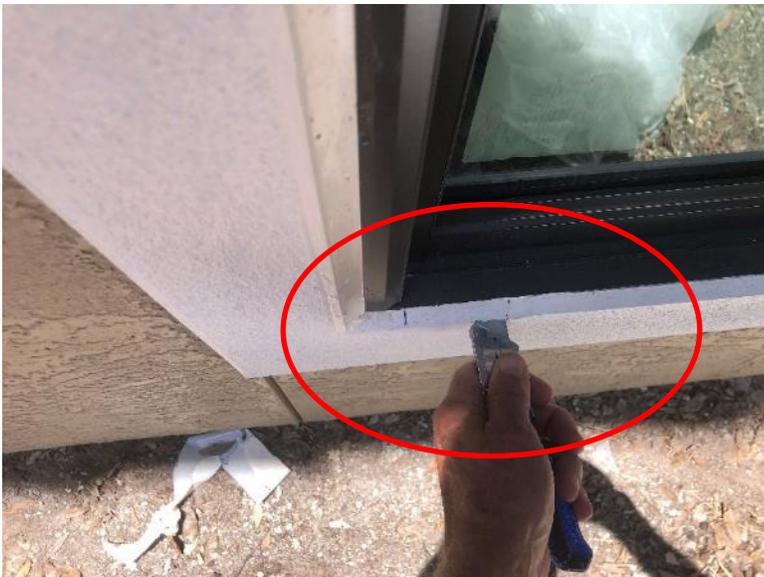
PHOTOGRAPH #8

**BUILDING 7
SECTION D**

Delta performed weather seal joint standard field adhesion test at bottom left ground floor double windows by marking and cutting sealant from substrates and hand pulling sealant to cohesive failure. Test passed with proper adhesion.

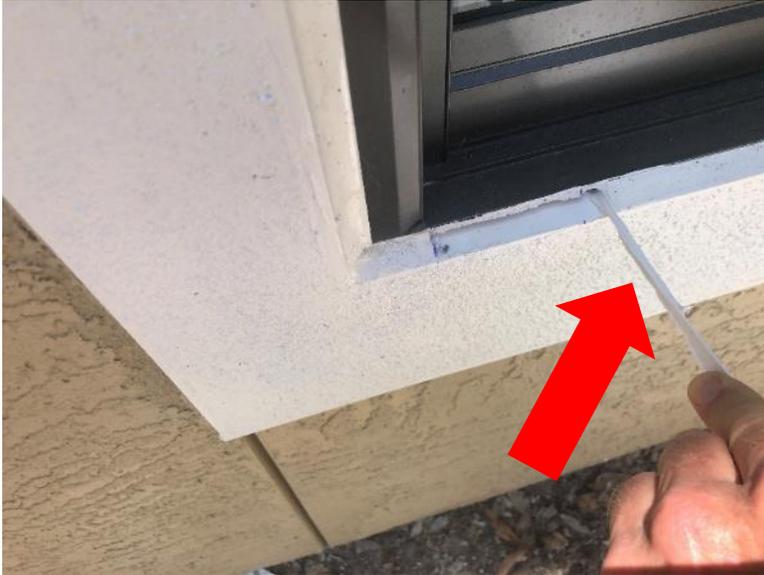
PHOTOGRAPH #9

**BUILDING 7
SECTION D**

Delta performed weather seal joint standard field adhesion test at bottom left ground floor double windows by marking and cutting sealant from substrates and hand pulling sealant to cohesive failure. Test passed with proper adhesion.

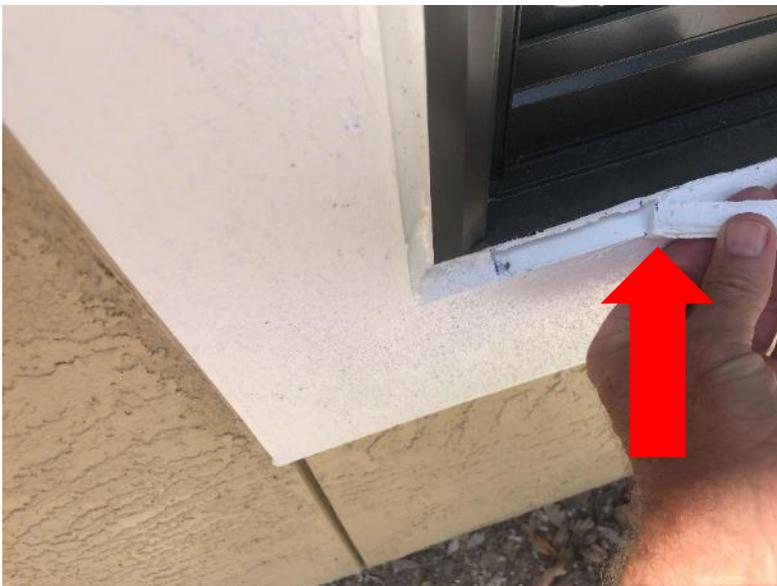
PHOTOGRAPH #10

**BUILDING 7
SECTION D**

Delta performed weather seal joint standard field adhesion test at bottom left ground floor double windows by marking and cutting sealant from substrates and hand pulling sealant to cohesive failure. Test passed with proper adhesion

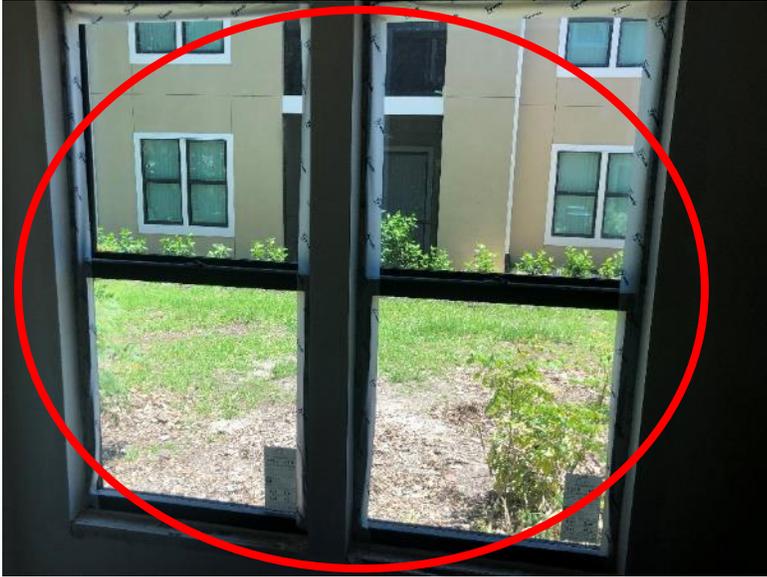
PHOTOGRAPH #11

**BUILDING 7
SECTION D**

Unit #718- Contractor in process of interior sealants and drywall repairs.

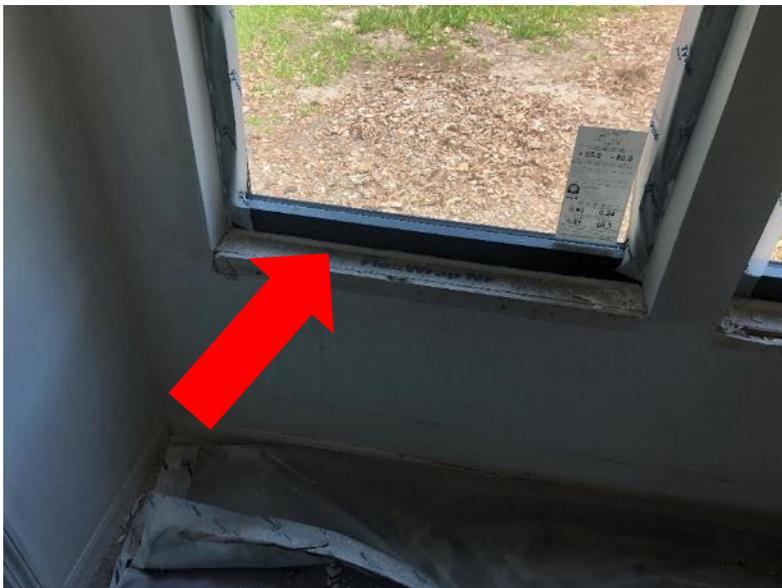
PHOTOGRAPH #12

**BUILDING 7
SECTION D**

Unit #718- New sealant applied at window perimeter from Dupont flashing to new PGT window.

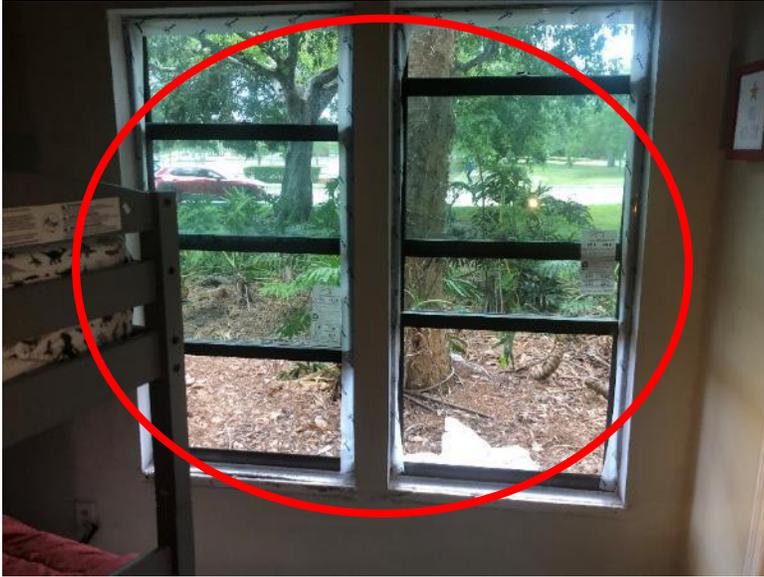
PHOTOGRAPH #13

**BUILDING 7
SECTION G**

Unit #712- Contractor in process of interior sealants and drywall repairs

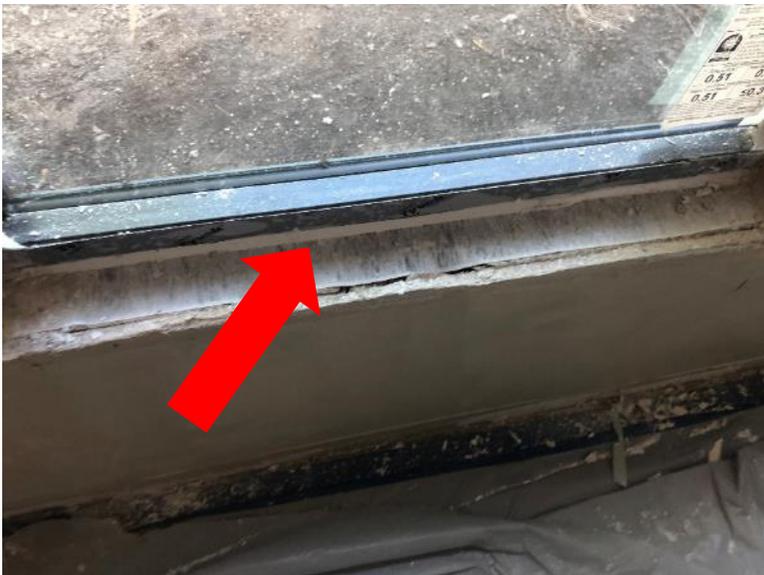
PHOTOGRAPH #14

**BUILDING 7
SECTION G**

Unit #712- New sealant applied at window perimeter from Dupont flashing to new PGT window.

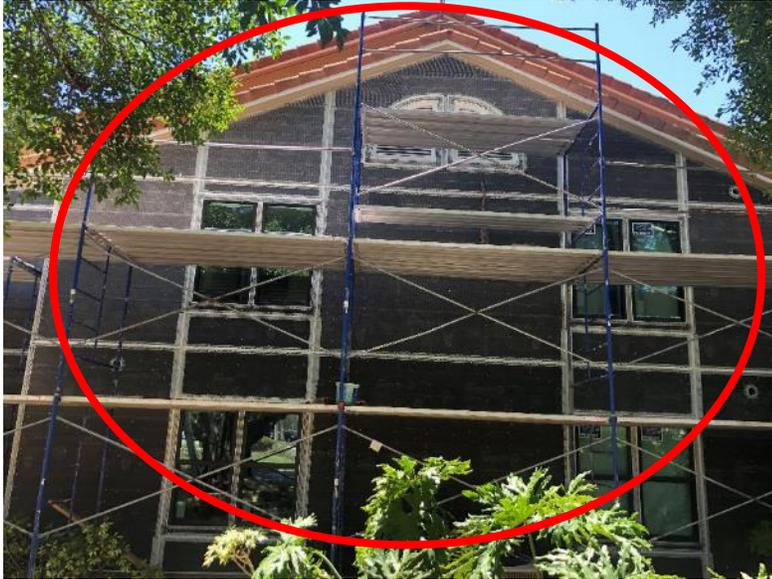
PHOTOGRAPH #15

**BUILDING 8
SECTION H**

Sub-Contractor has Installed self-furring galvanized metal lathing and Vinyl stucco accessories at Gable end wall.

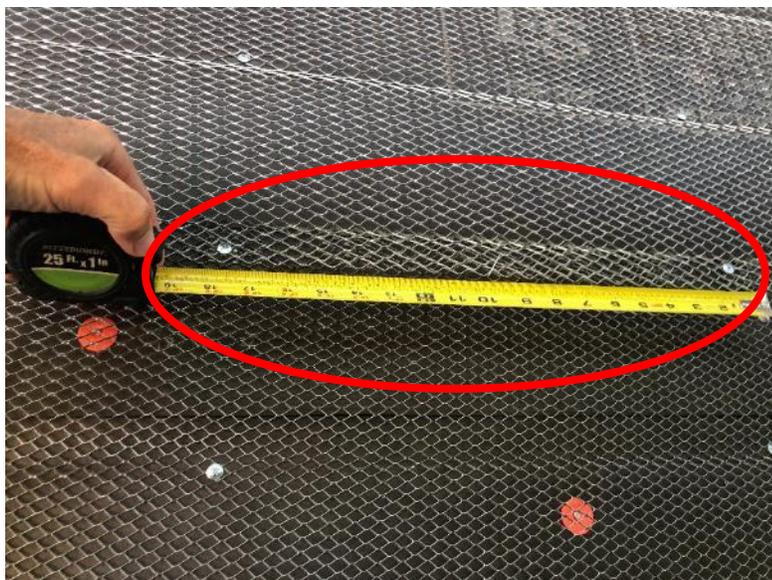
PHOTOGRAPH #16

**BUILDING 8
SECTION H**

Self-furring galvanized metal lathing attached at wall framing 16" O.C. and wired together at overlaps between framing members.

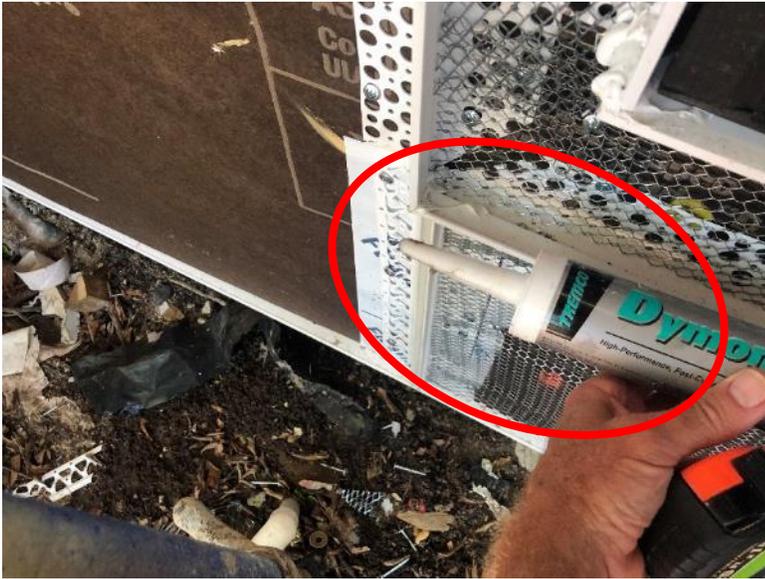
PHOTOGRAPH #17

**BUILDING 8
SECTION G**

Urethane sealant applied at new vinyl accessory intersections, transitions, and butt joints.

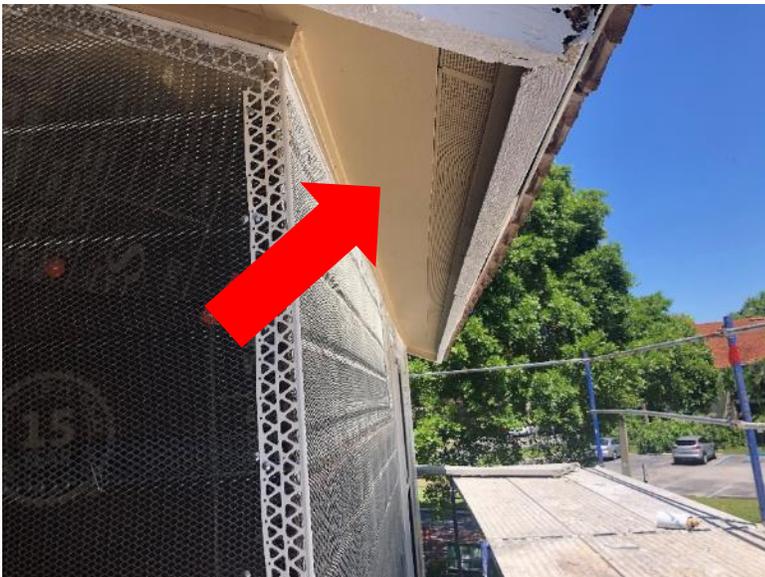
PHOTOGRAPH #18

**BUILDING 8
SECTION G**

Contactor has installed and painted new soffit and vinyl venting.

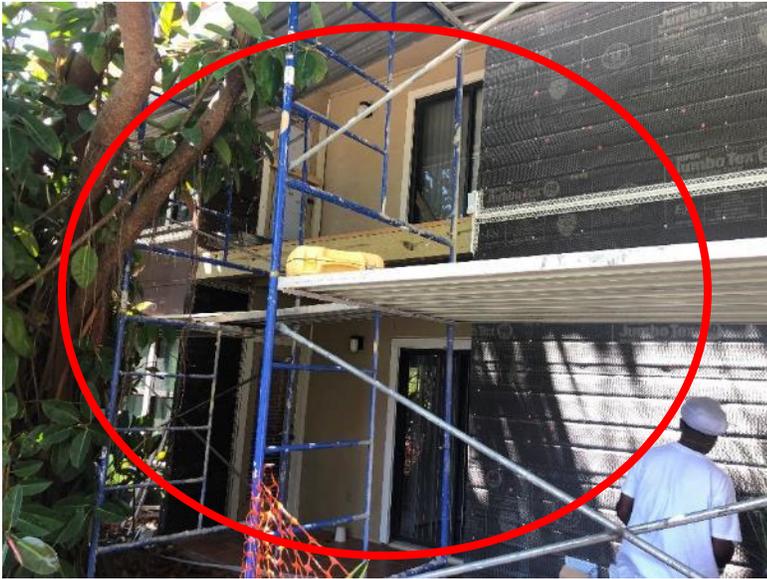
PHOTOGRAPH #19

**BUILDING 8
SECTION F**

Sub-Contractor installing self-furring galvanized metal lathing and Vinyl stucco accessories at exterior bearing walls.

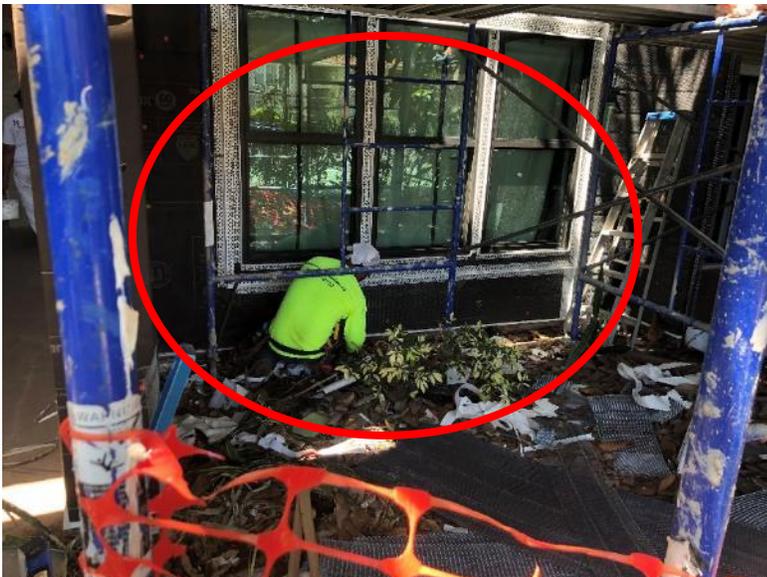
PHOTOGRAPH #20

**BUILDING 8
SECTION F**

Sub-Contractor installing self-furring galvanized metal lathing and Vinyl stucco accessories at exterior bearing walls.

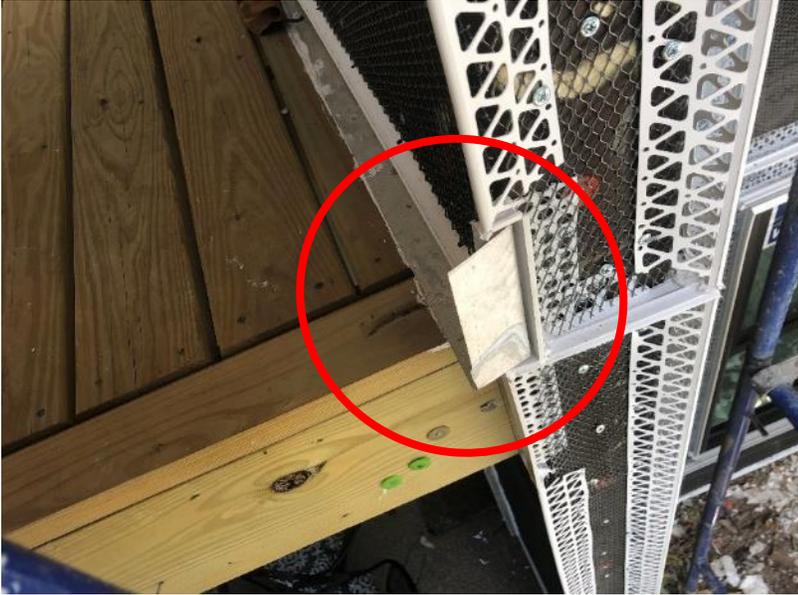
PHOTOGRAPH #21

**BUILDING 8
SECTION F**

New kick out flashing details installed at balcony decks as per PM drawings.

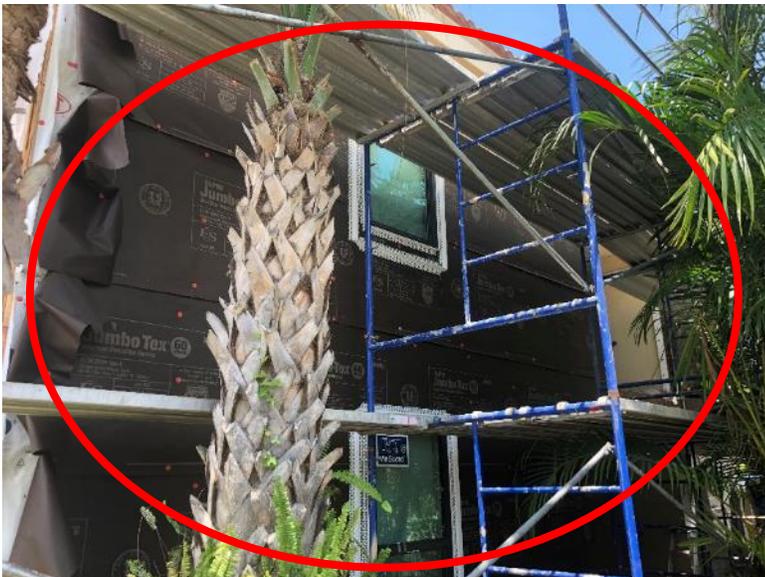
PHOTOGRAPH #22

**BUILDING 8
SECTION E**

Super Jumbo Tex 60 applied as second water resistant barrier.

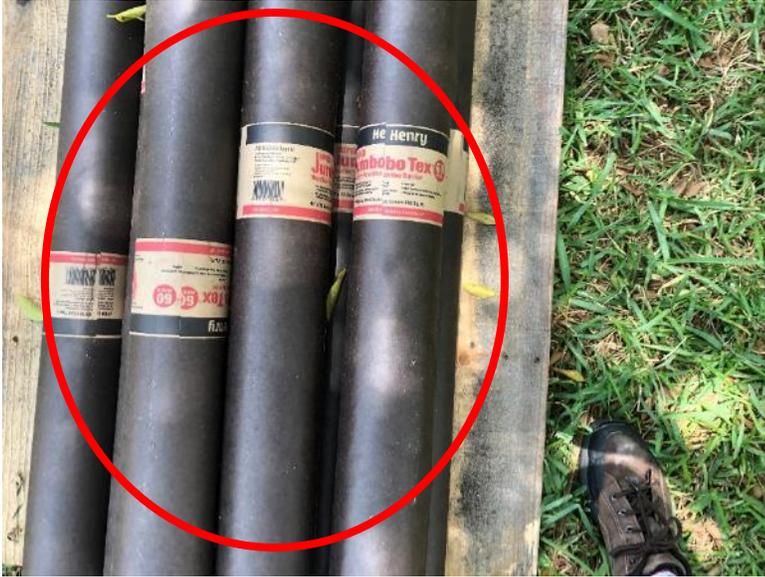
PHOTOGRAPH #23

**BUILDING 8
SECTION E**

Super Jumbo Tex 60 applied as second water resistant barrier.

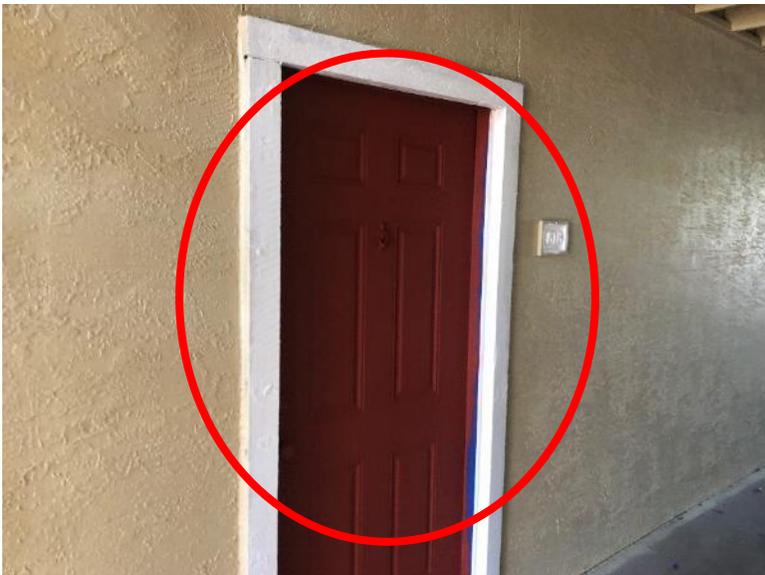
PHOTOGRAPH #24

**BUILDING 8
SECTION A**

Contractor has prepared and primed entrance doors with Florida Paints anti corrosive primer.

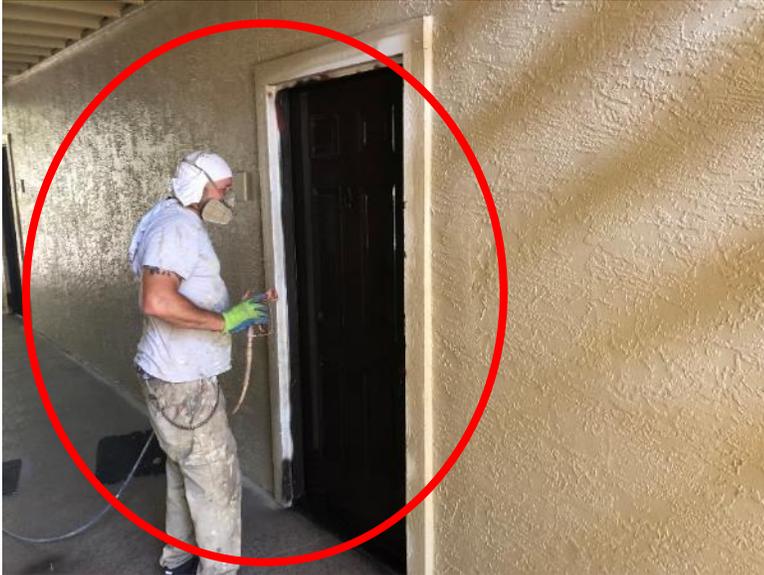
PHOTOGRAPH #25

**BUILDING 8
SECTION A**

Contractor spray painting entrance doors with All Grip exterior finish paint.

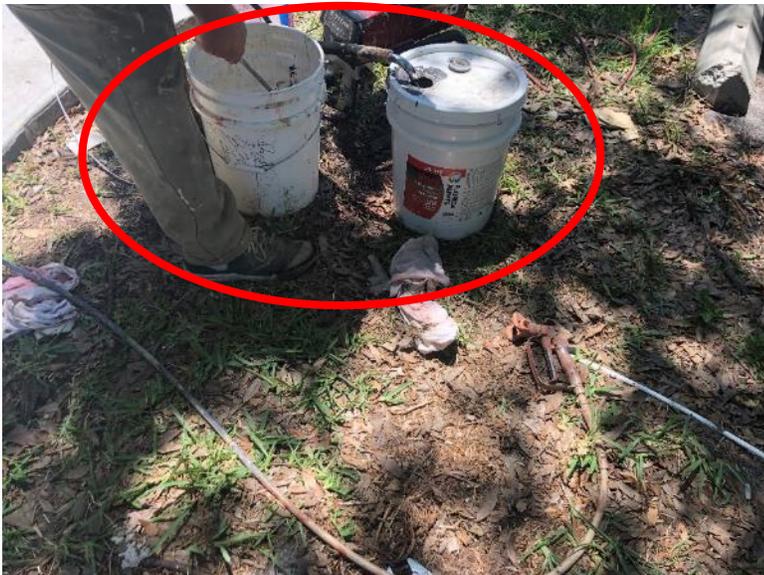
PHOTOGRAPH #26

**BUILDING 8
SECTION A**

Contractor spray painting entrance doors with All Grip exterior finish paint.

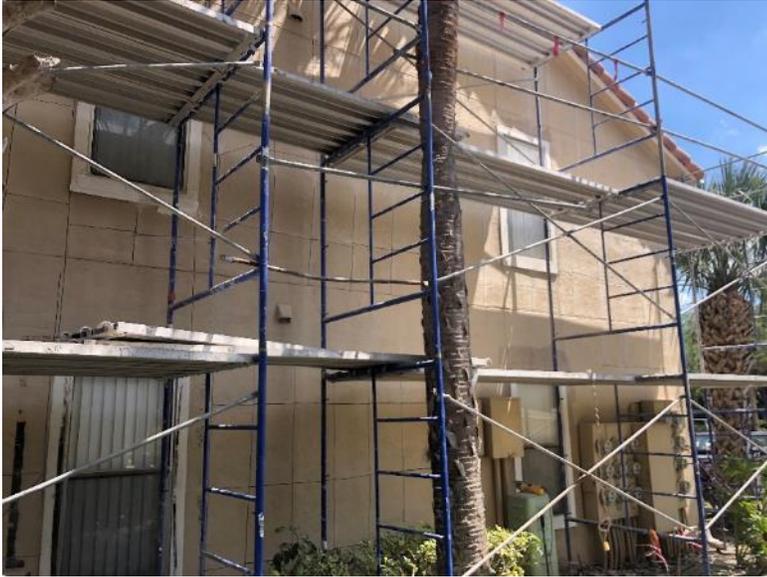
PHOTOGRAPH #27

**BUILDING 13
SECTION H**

Contractor has erected access scaffolding and begun cutting existing stucco for removal.

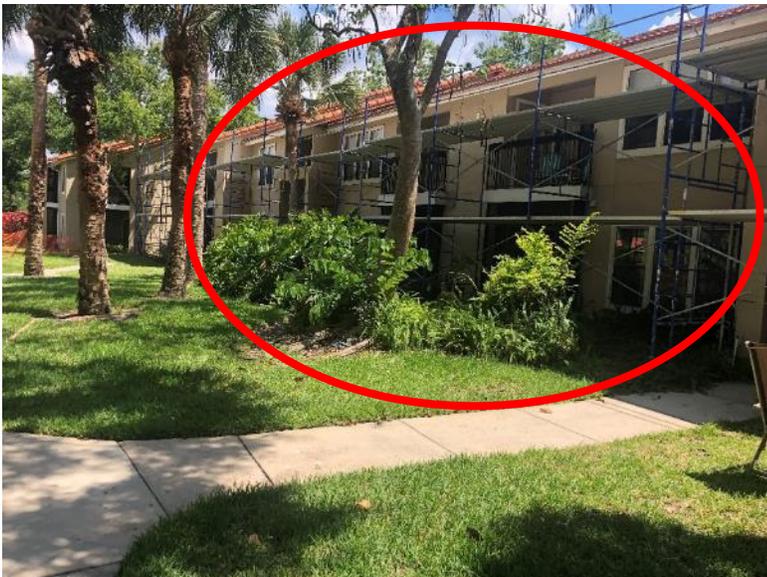
PHOTOGRAPH #28

**BUILDING 13
SECTION F**

Contractor has erected access scaffolding for repairs.

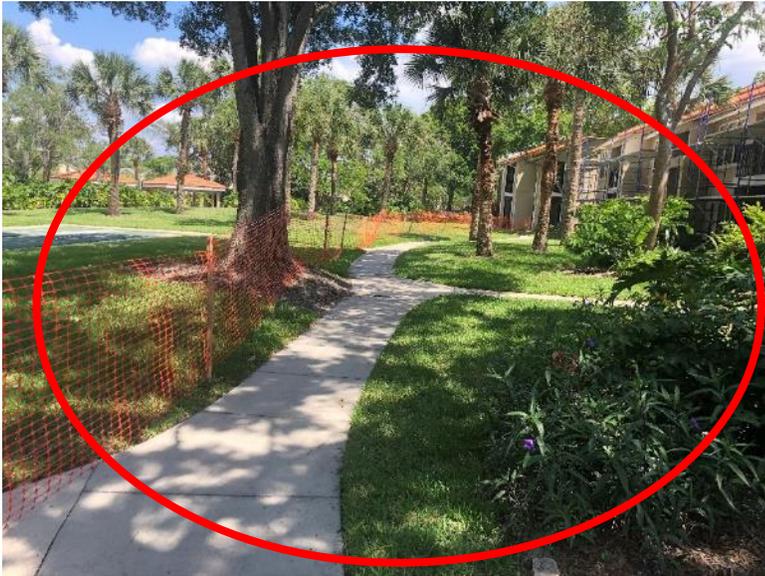
PHOTOGRAPH #29

**BUILDING 13
SECTION F**

Contractor has provided construction fencing designating hard hat construction areas.

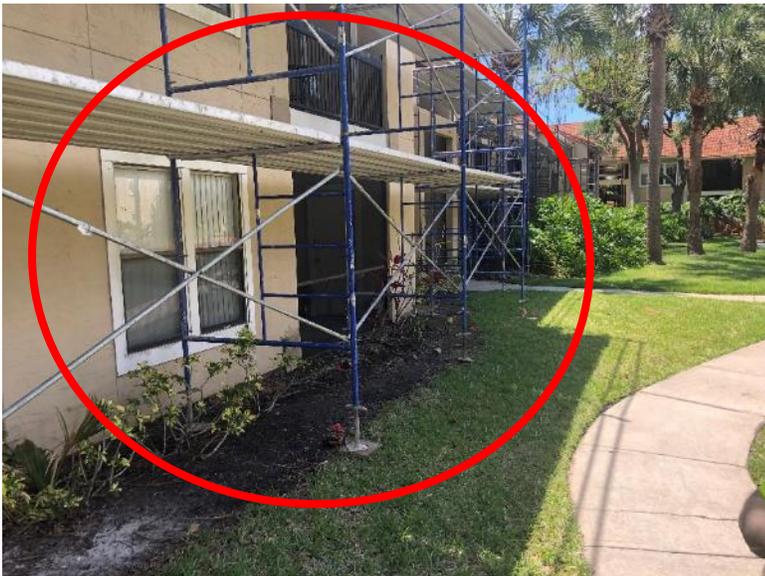
PHOTOGRAPH #30

**BUILDING 13
SECTION E**

Contractor has erected access scaffolding for repairs.
