PHOTOGRAPHS

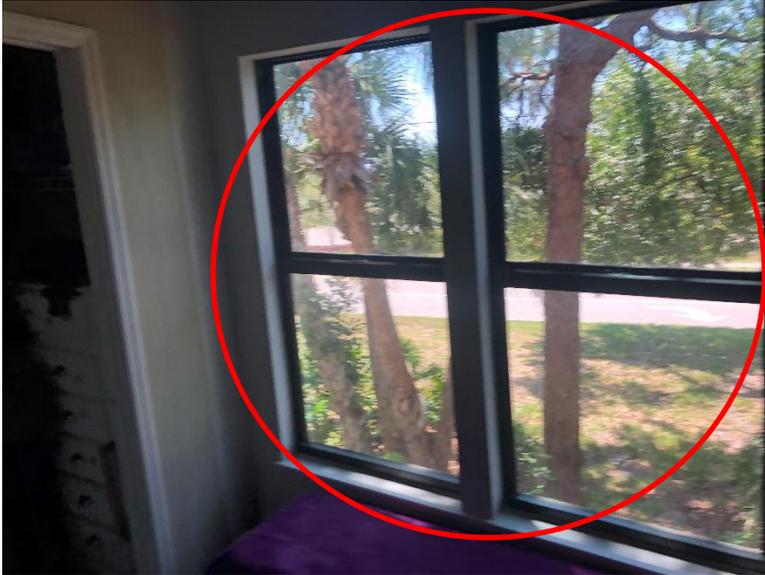
PHOTOGRAPH #1

**BUILDING 7
SECTION A**

Unit #721- Contractor has performed interior drywall, sill repairs and priming of new repairs surfaces.

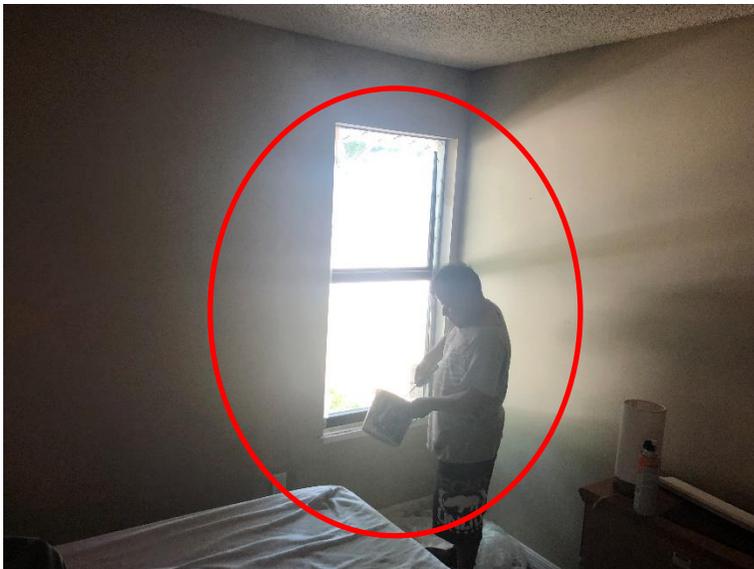
PHOTOGRAPH #2

**BUILDING 7
SECTION A**

Unit #721- Contractor has performed interior drywall, sill repairs and priming of new repairs surfaces.

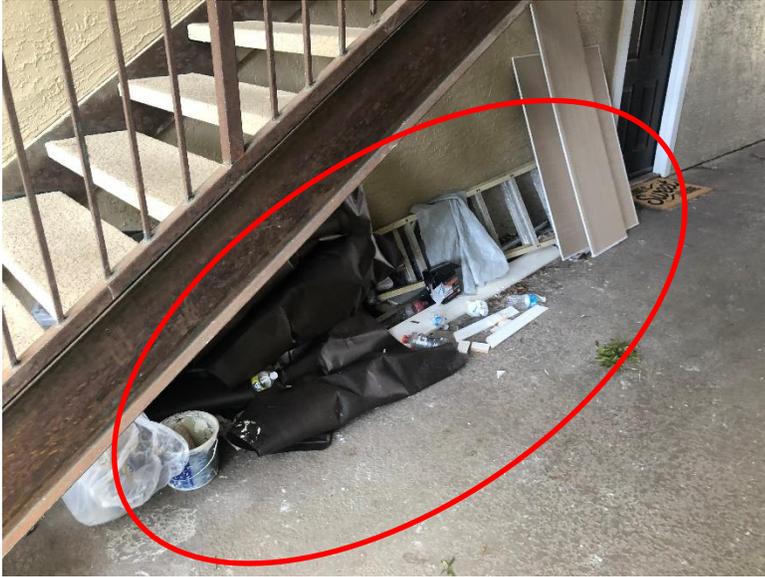
PHOTOGRAPH #3

**BUILDING 7
SECTION A- BREEZEWAY**

Contractor has left repair materials and debris in walk areas.

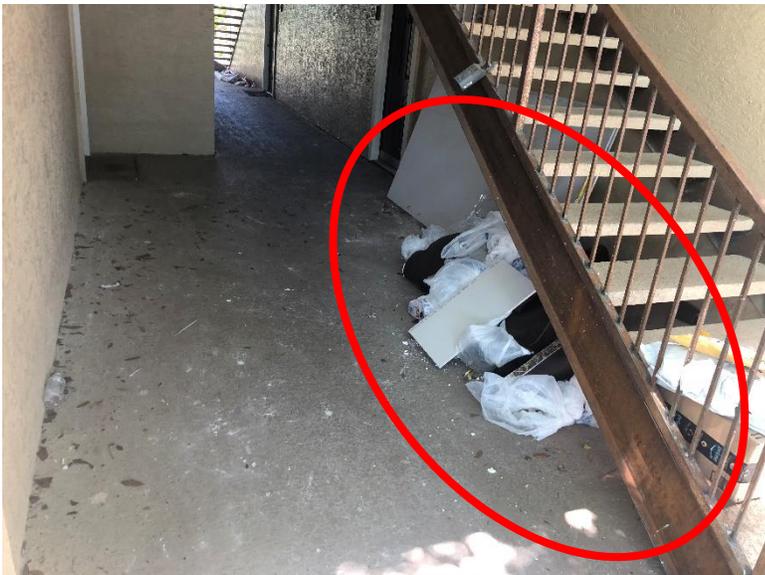
PHOTOGRAPH #4

**BUILDING 7
SECTION C- BREEZEWAY**

Contractor has left repair materials and debris in walk areas.

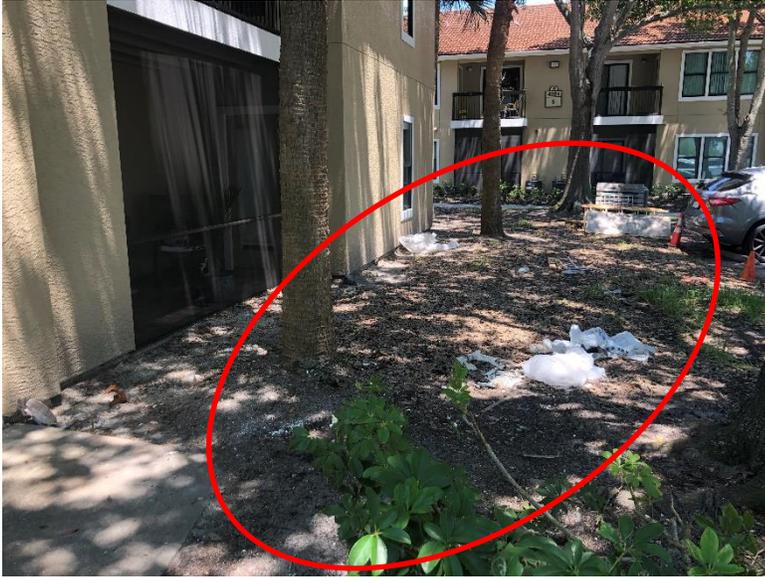
PHOTOGRAPH #5

**BUILDING 7
SECTION C**

Contractor has left repair materials and debris scattered around exterior grounds.

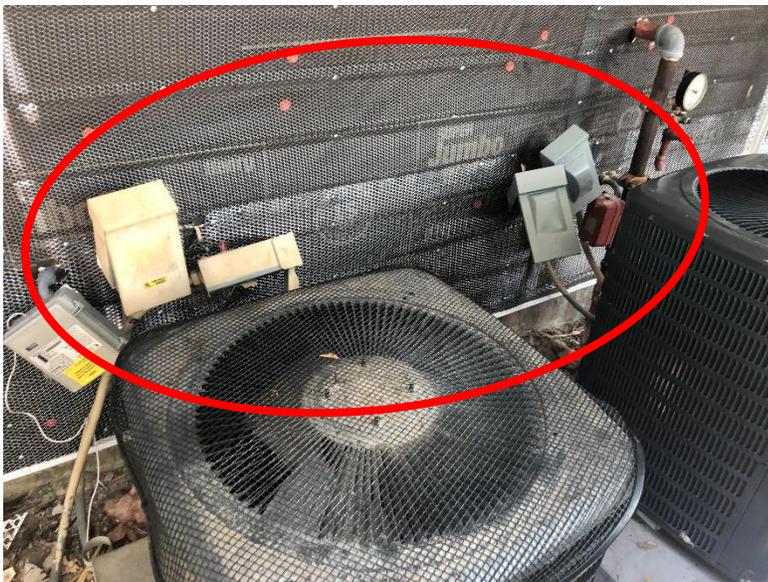
PHOTOGRAPH #6

**BUILDING 8
SECTION H**

Sub-Contractor has completed installing self-furring galvanized metal lathing and Vinyl stucco accessories around electrical boxes.

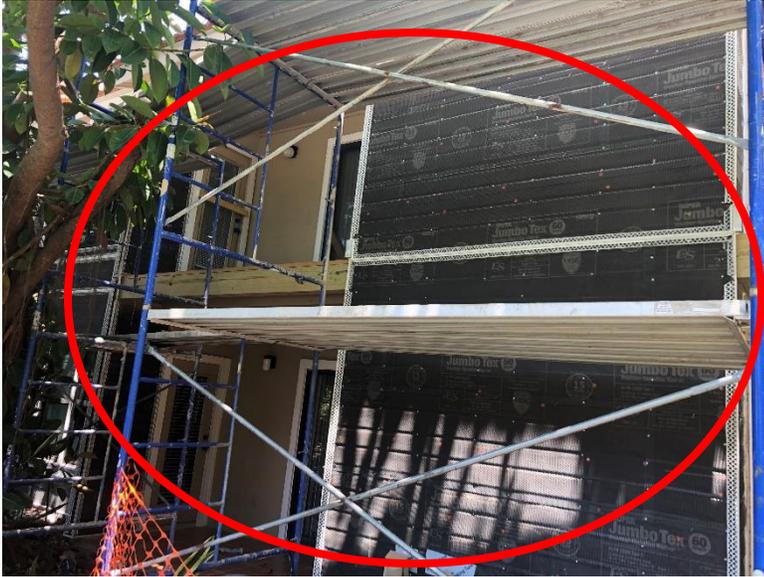
PHOTOGRAPH #7

**BUILDING 8
SECTION G**

Sub-Contractor has completed Installing self-furring galvanized metal lathing and Vinyl stucco accessories in preparation for stucco application.

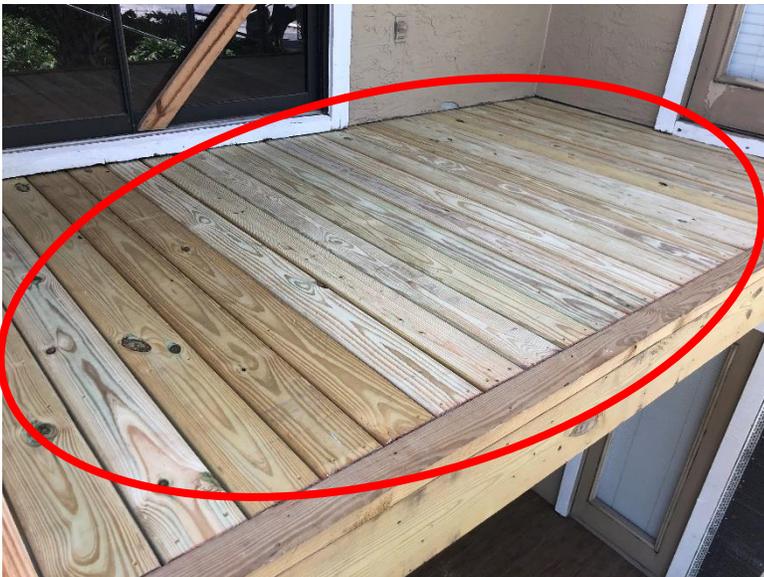
PHOTOGRAPH #8

**BUILDING 8
SECTION G**

Unit #822- New pressure treated 2"x6" decking installed to replace existing damaged decking.

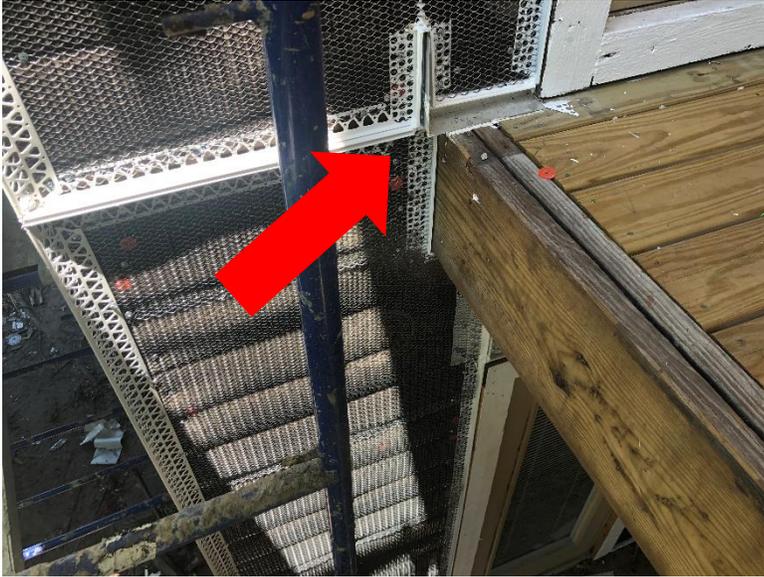
PHOTOGRAPH #9

**BUILDING 8
SECTION F**

New kick out flashing details and vinyl stucco accessories installed at balcony decks as per PM drawings.

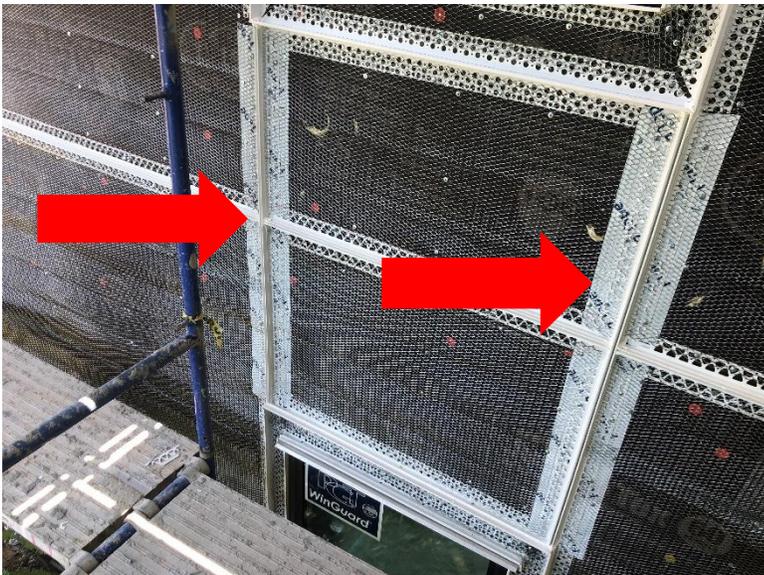
PHOTOGRAPH #10

**BUILDING 8
SECTION E**

Sub-Contractor installing self-furring galvanized metal lathing and Vinyl stucco accessories at exterior bearing walls has applied Dupont flashing behind vertical control joints as per drawings.

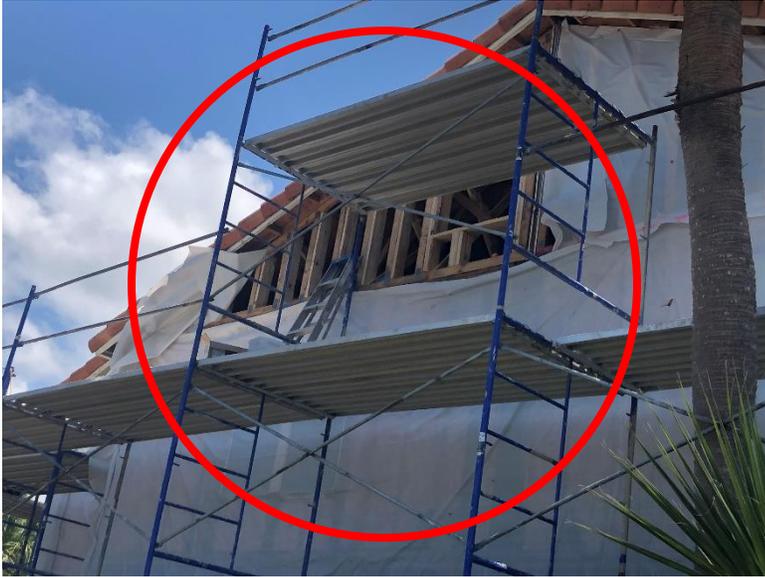
PHOTOGRAPH #11

**BUILDING 8
SECTION D**

Contractor has begun gable end reinforcement and wall bracing repairs.

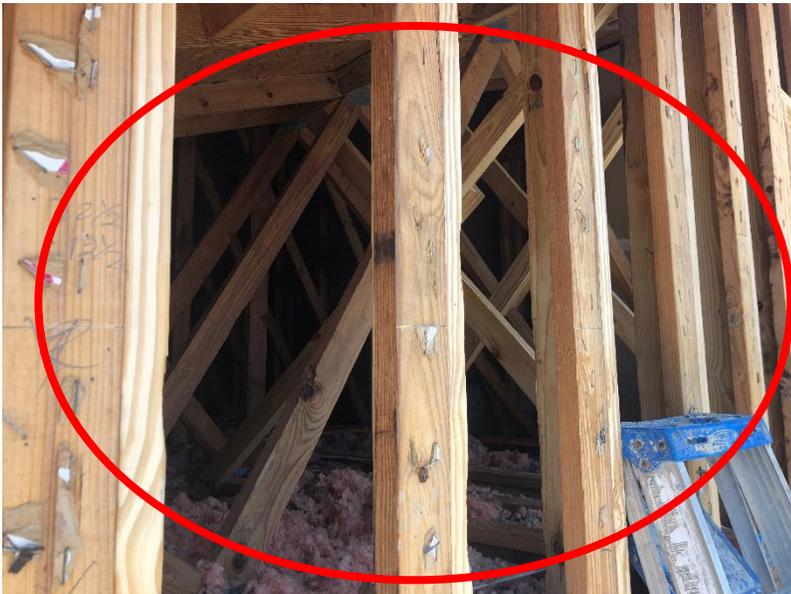
PHOTOGRAPH #12

**BUILDING 8
SECTION D**

Contractor has retrofit gable end studs with 2"X4" SYP and in process of installing cross braces in attic space as per drawings and specifications.

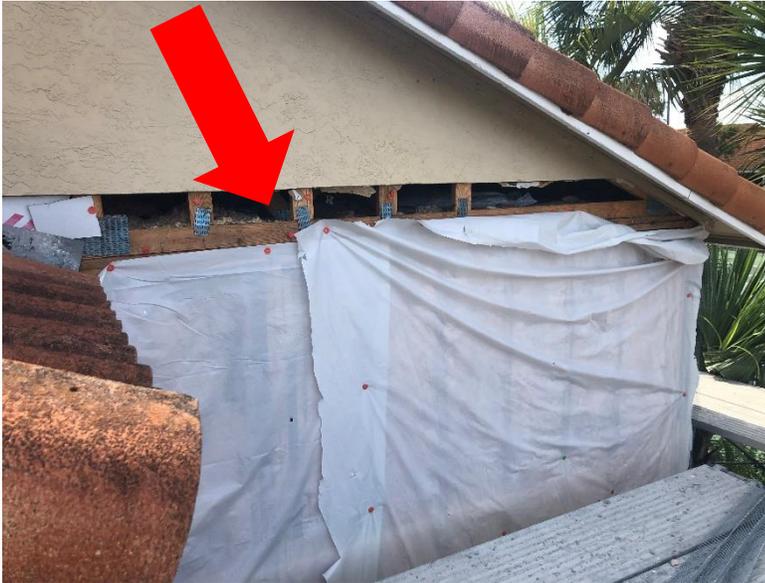
PHOTOGRAPH #13

**BUILDING 8
SECTION D**

Plastic tarps used for protection of open walls during construction, does not cover open gable end attic space.

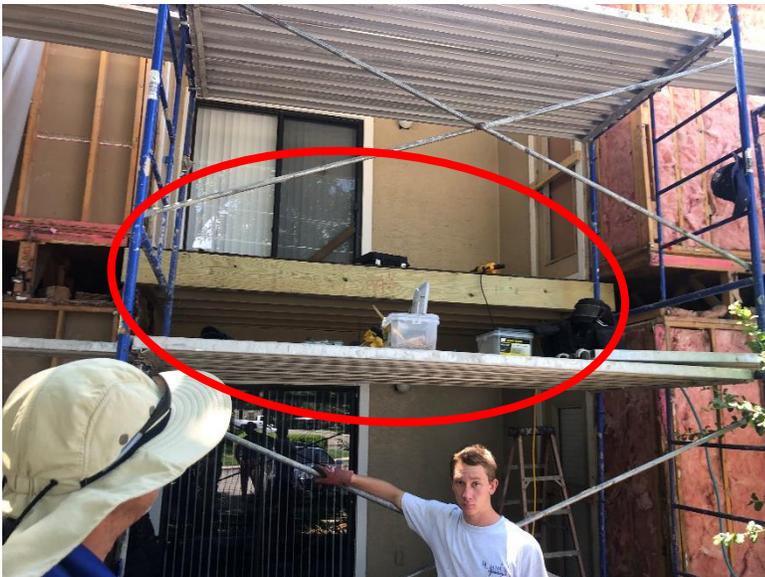
PHOTOGRAPH #14

**BUILDING 8
SECTION C**

Unit #828- Upper balcony repairs in progress at built up beam and support framing.

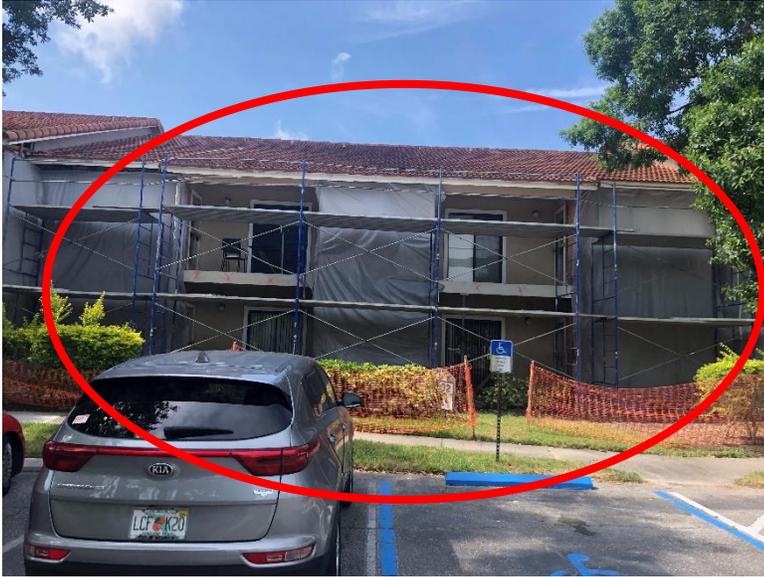
PHOTOGRAPH #15

**BUILDING 8
SECTION B**

Contractor has protected open walls with heavy plastic tarps during repairs.

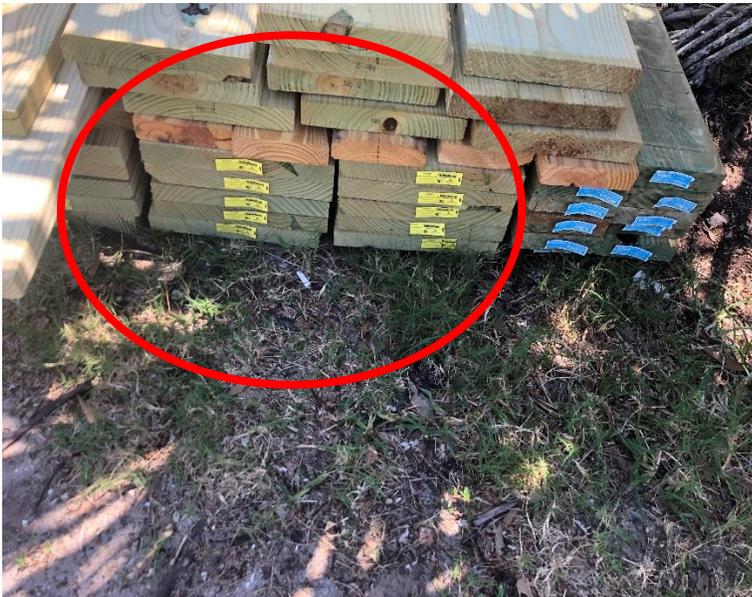
PHOTOGRAPH #16

**BUILDING 8
SECTION A**

Pressure treated 2"X10" SYP delivered to site for building new built-up beams at balconies.

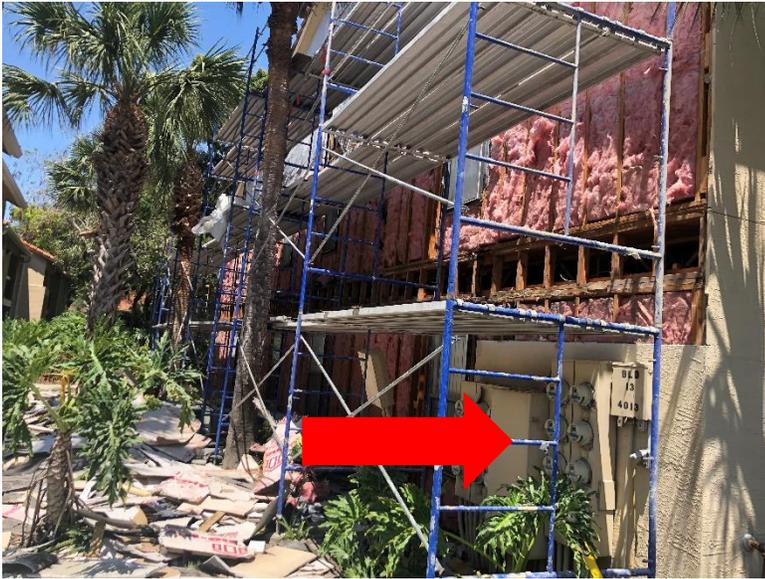
PHOTOGRAPH #17

**BUILDING 13
SECTION H**

Contractor has removed existing stucco at gable end wall leaving section behind electrical meters as per drawings.

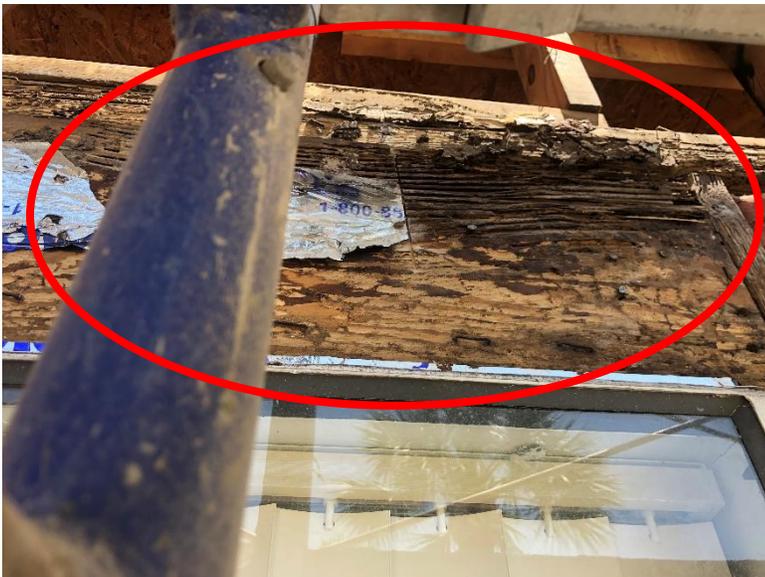
PHOTOGRAPH #18

**BUILDING 13
SECTION H**

Window header damaged by wood rot and termites exposed upon stucco removal.

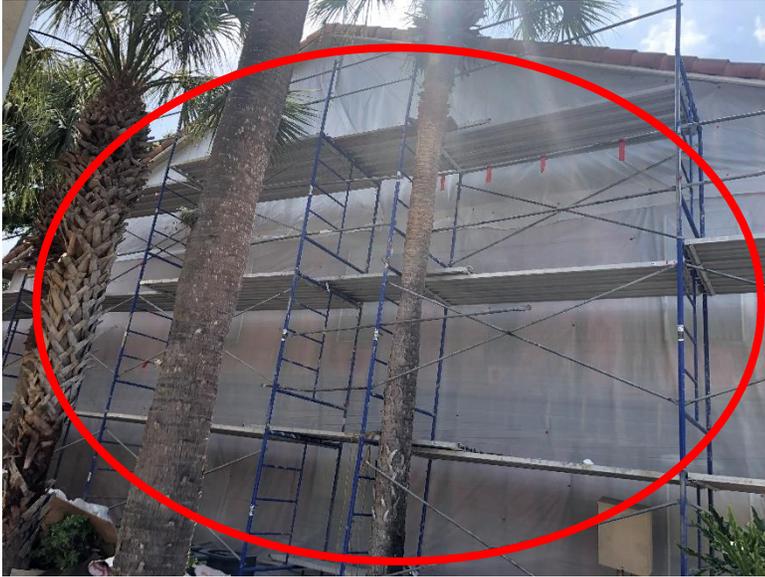
PHOTOGRAPH #19

**BUILDING 13
SECTION H**

Contractor has protected open walls with heavy plastic tarps during repairs.

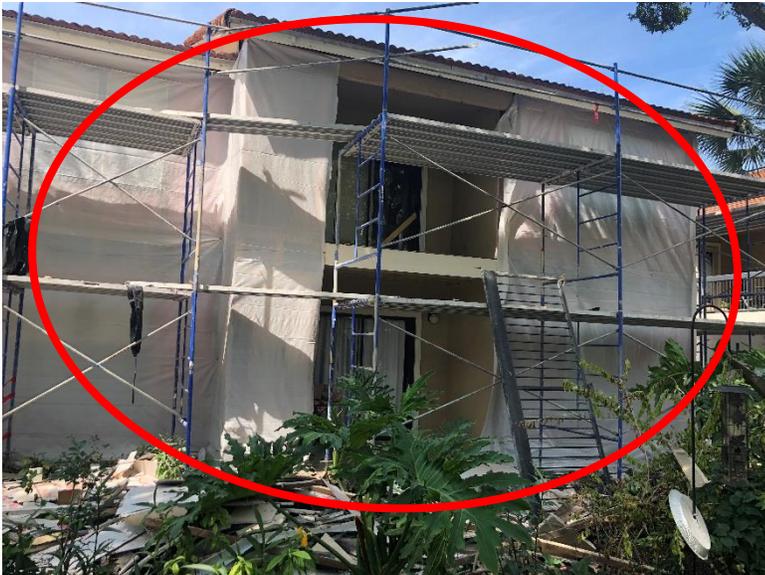
PHOTOGRAPH #20

**BUILDING 13
SECTION G**

Contractor has protected open walls with heavy plastic tarps during repairs.

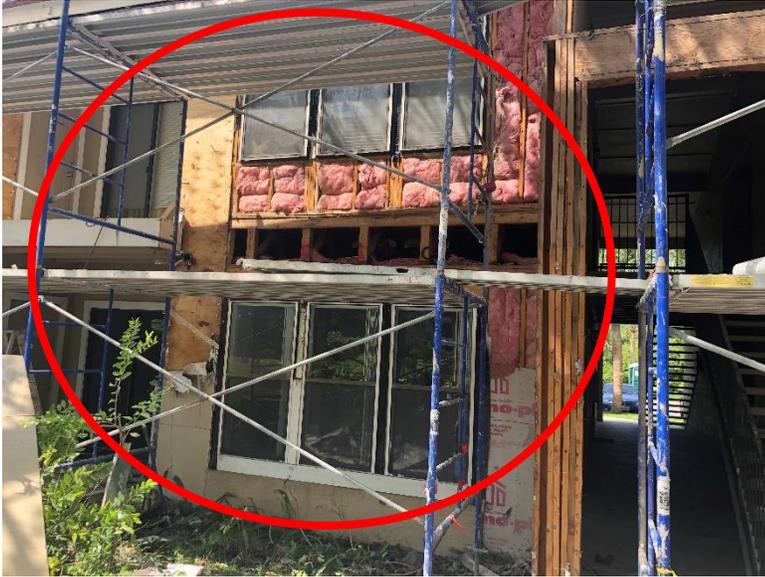
PHOTOGRAPH #21

**BUILDING 13
SECTION F**

Contractor in process of removing stucco and excising sheathing.

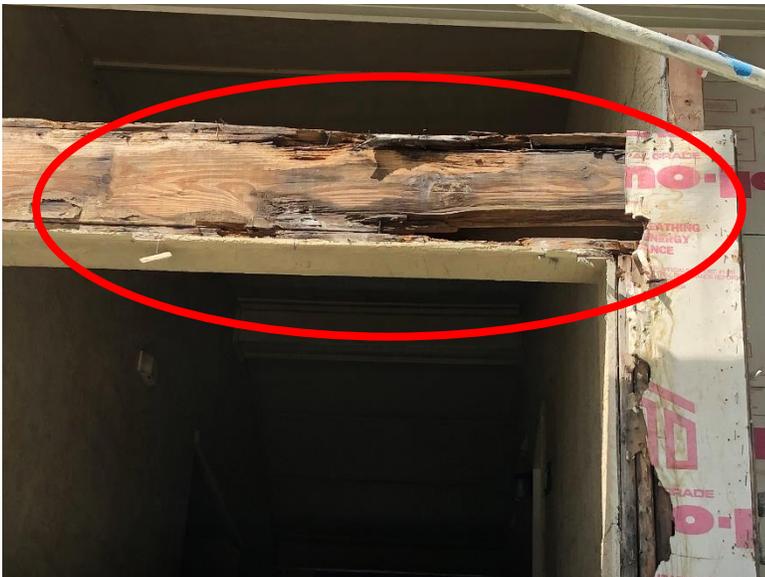
PHOTOGRAPH #22

**BUILDING 13
SECTION E**

Breezeway box beam damaged by wood rot and termites exposed upon stucco removal.
