PHOTOGRAPHS

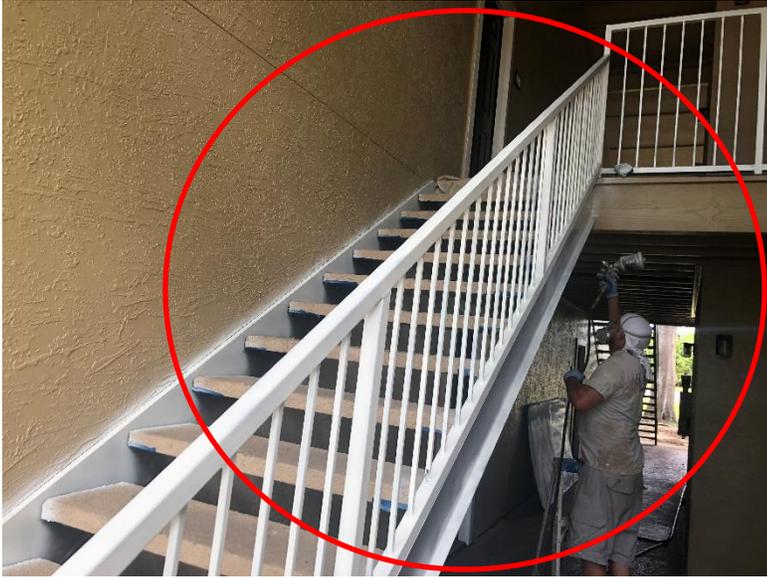
PHOTOGRAPH #1

**BUILDING 7
SECTION A- BREEZEWAY**

Contractor spray painting steel stairway railing with Florida Paints Encapsulon Epoxy Primer.

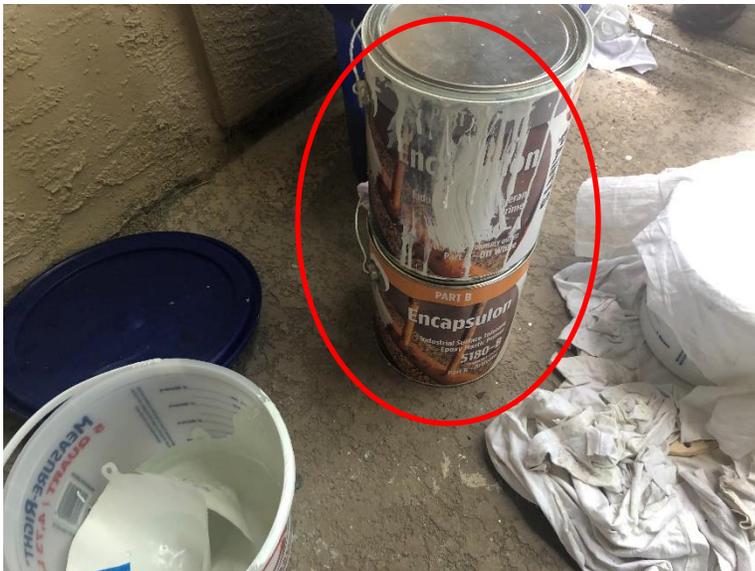
PHOTOGRAPH #2

**BUILDING 7
SECTION A- BREEZEWAY**

Contractor spray painting steel stairway railing with Florida Paints Encapsulon Epoxy Primer.

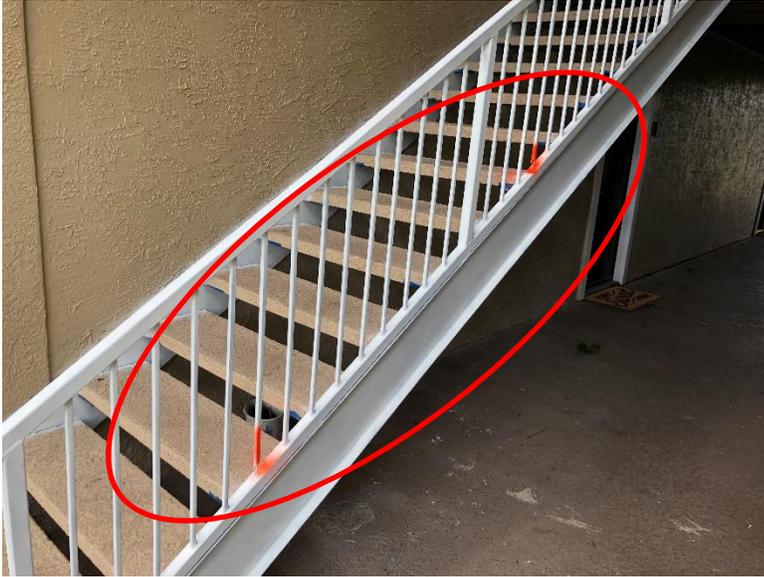
PHOTOGRAPH #3

**BUILDING 7
SECTION A- BREEZEWAY**

Steel railing pickets rusted and broken away from stairway stringer have been marked for repairs.

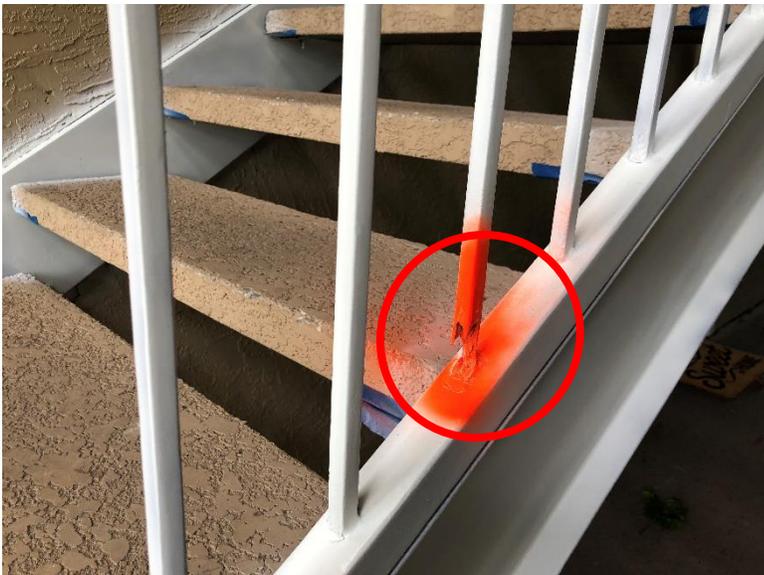
PHOTOGRAPH #4

**BUILDING 7
SECTION A- BREEZEWAY**

Steel railing pickets rusted and broken away from stairway stringer have been marked for repairs.

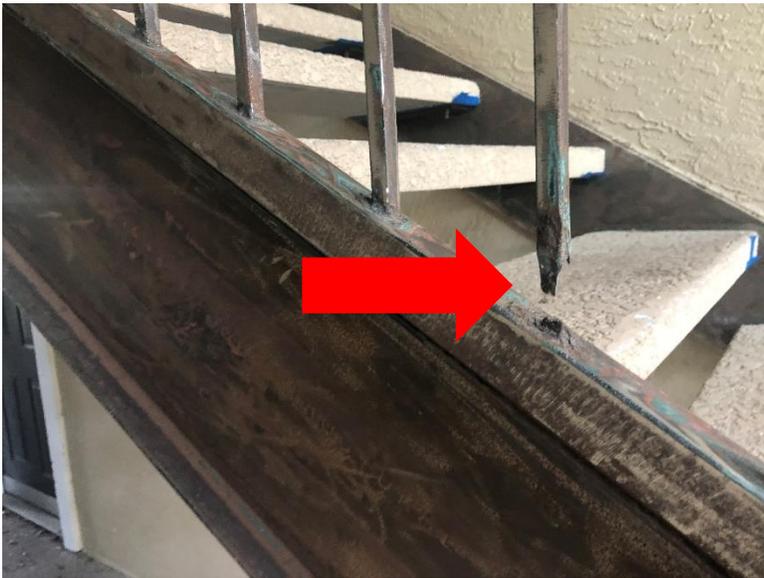
PHOTOGRAPH #5

**BUILDING 7
SECTION B**

Steel railing pickets rusted and broken away from stairway stringer have been marked for repairs.

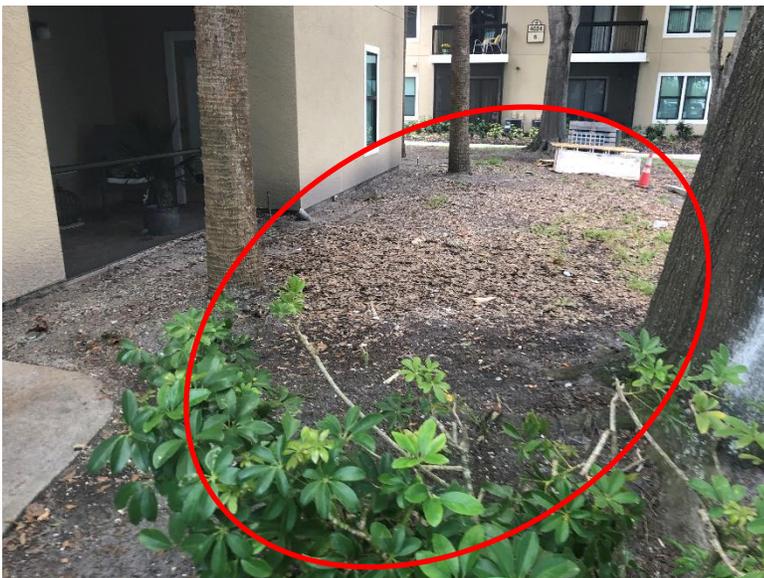
PHOTOGRAPH #6

**BUILDING 7
SECTION C**

Contractor has removed materials and debris scattered around exterior grounds.

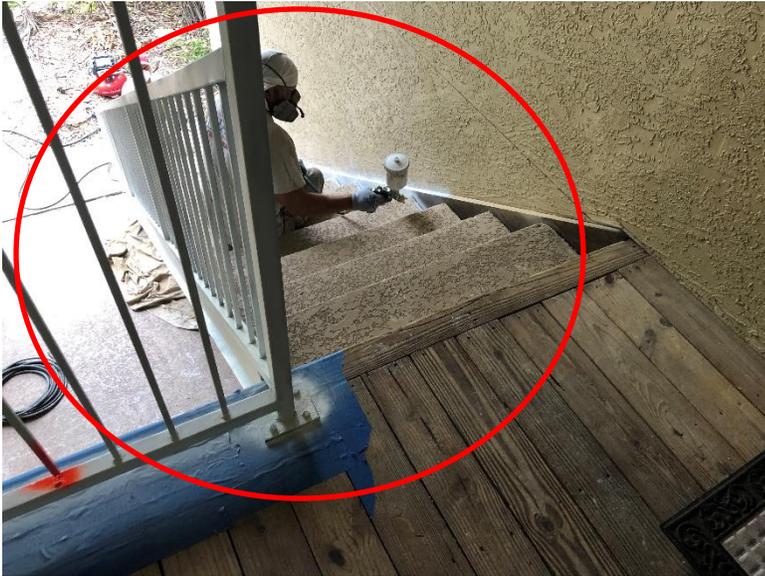
PHOTOGRAPH #7

**BUILDING 7
SECTION E**

Contractor spray painting steel stairway railing with Florida Paints Encapsulon Epoxy Primer.

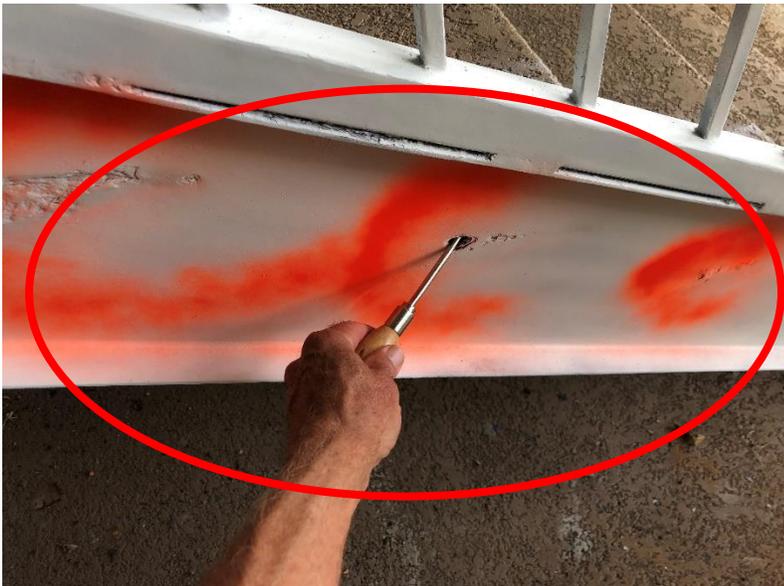
PHOTOGRAPH #8

**BUILDING 7
SECTION G**

Steel stairway stringer has rusted through and has been marked for repairs.

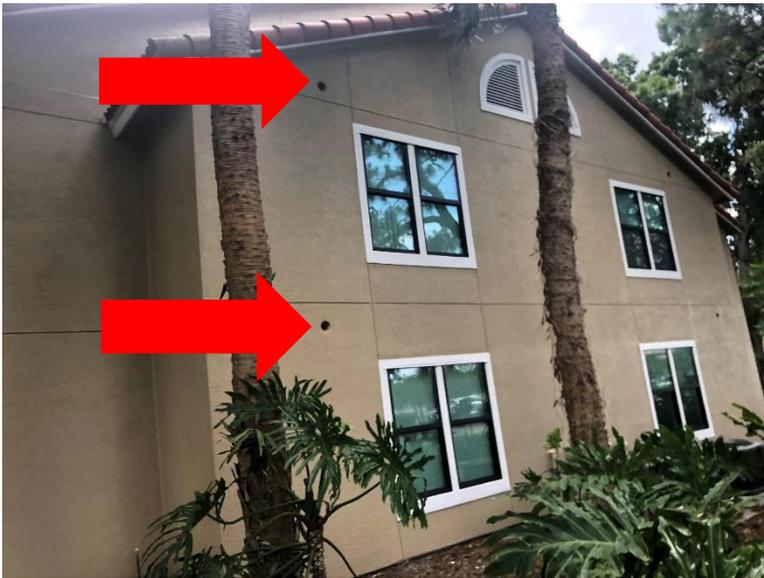
PHOTOGRAPH #9

**BUILDING 7
SECTION H**

Contractor has not replaced the dryer vents at gable end wall.

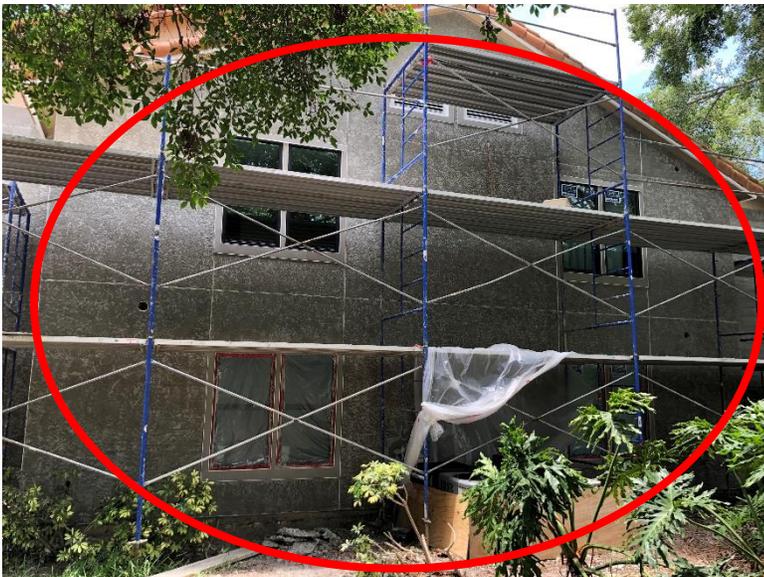
PHOTOGRAPH #10

**BUILDING 8
SECTION H**

Sub-Contractor has applied three coat 7/8" stucco system as per specifications and ASTM standards.

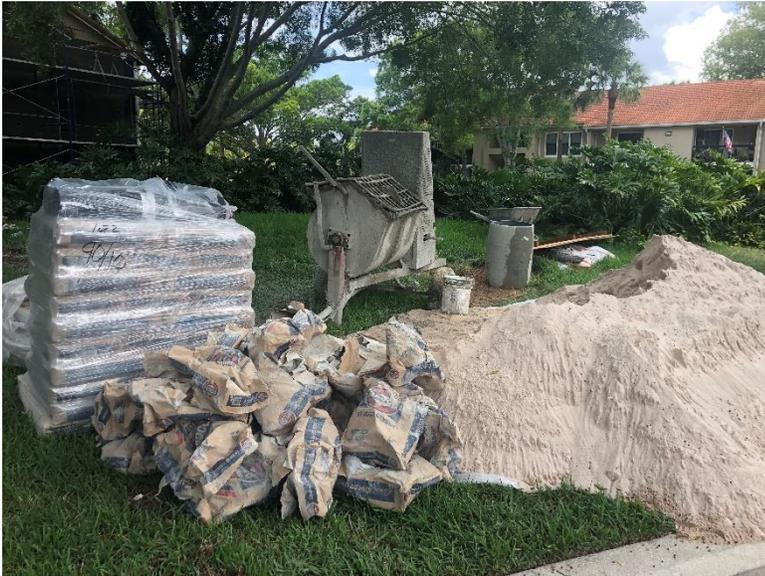
PHOTOGRAPH #11

**BUILDING 8
SECTION H**

Sub-Contractor mixing sand with approved bagged BROCO Stucco Cement.

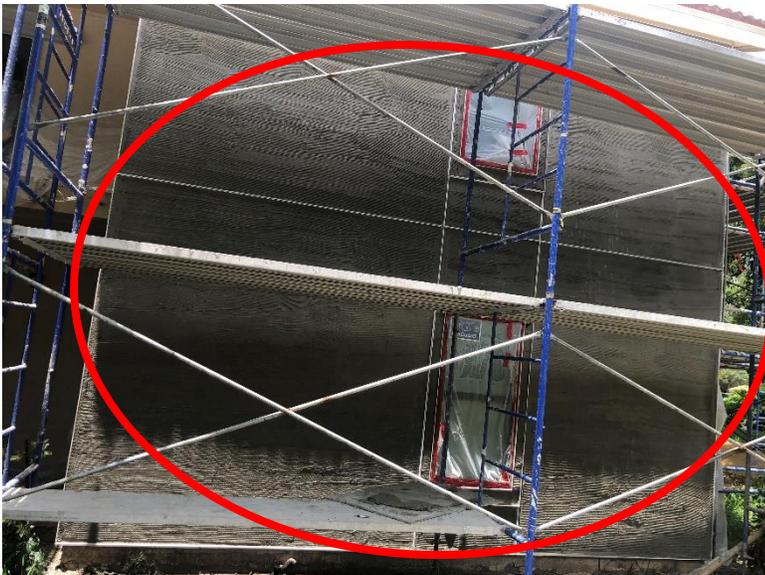
PHOTOGRAPH #12

**BUILDING 8
SECTION G**

Stucco Sub-Contractor has protected windows and adjacent surfaces then applied scratch coat of stucco.

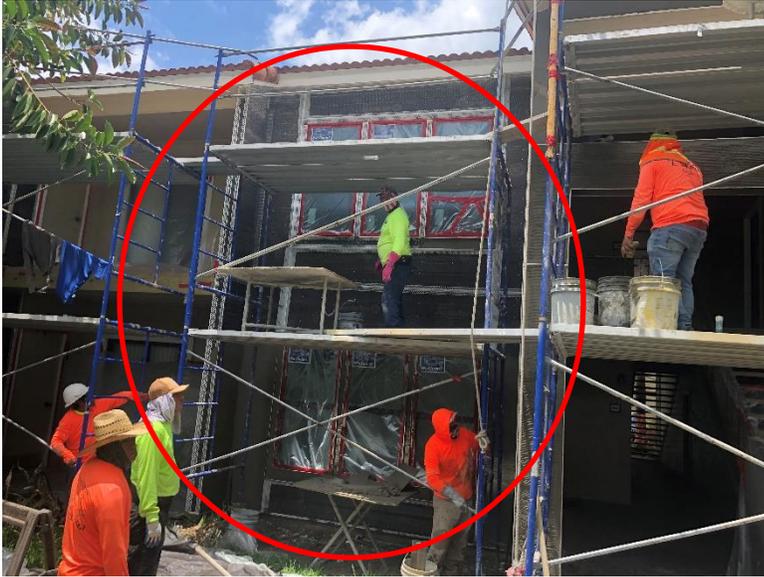
PHOTOGRAPH #13

**BUILDING 8
SECTION F**

Stucco Sub-Contractor has protected windows and adjacent surfaces then applied scratch coat of stucco.

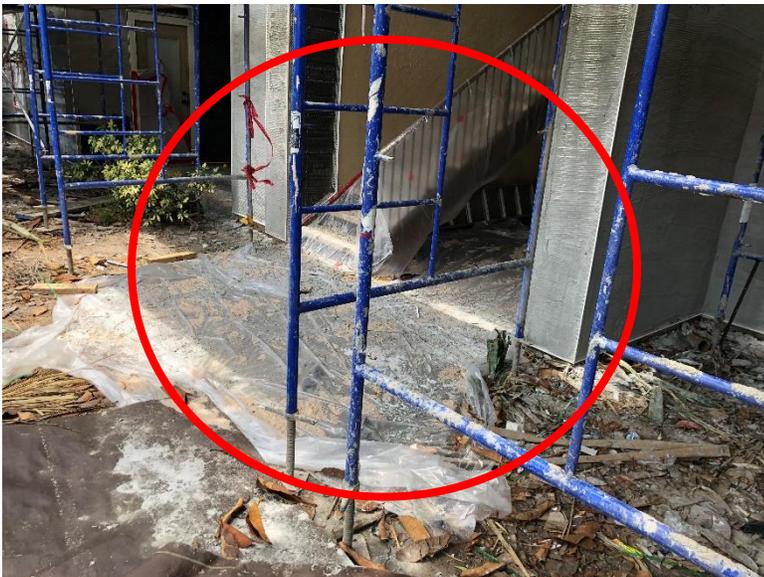
PHOTOGRAPH #14

**BUILDING 8
SECTION E**

Stucco Sub-Contractor has protected windows and adjacent surfaces then applied scratch coat of stucco.

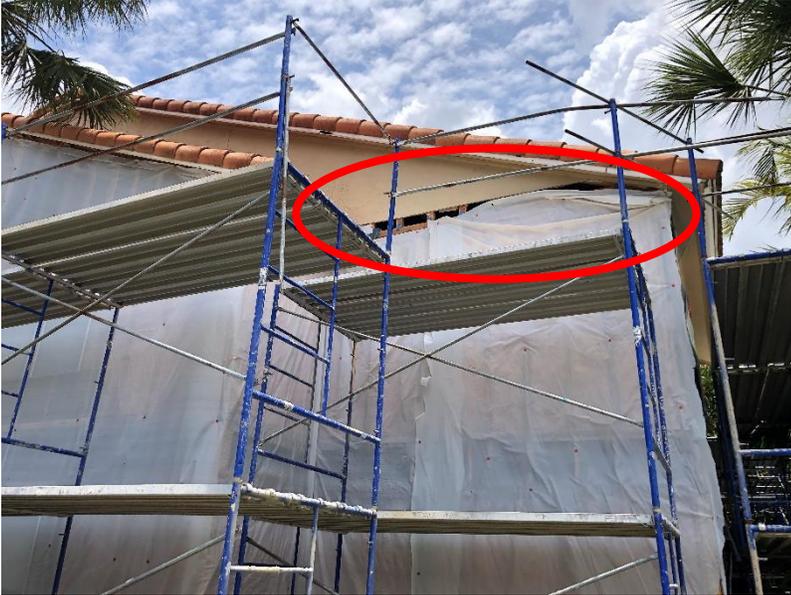
PHOTOGRAPH #15

**BUILDING 8
SECTION D**

Plastic tarps used for protection of open walls during construction, does not cover open gable end attic space.

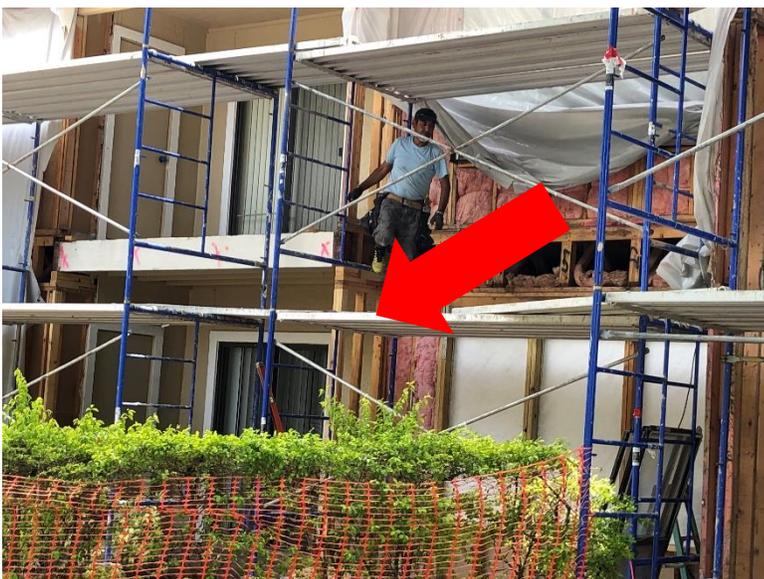
PHOTOGRAPH #16

**BUILDING 8
SECTION B**

Unit #803- Contractor has begun framing repairs at lanai wing wall supporting built up beam of upper balcony.

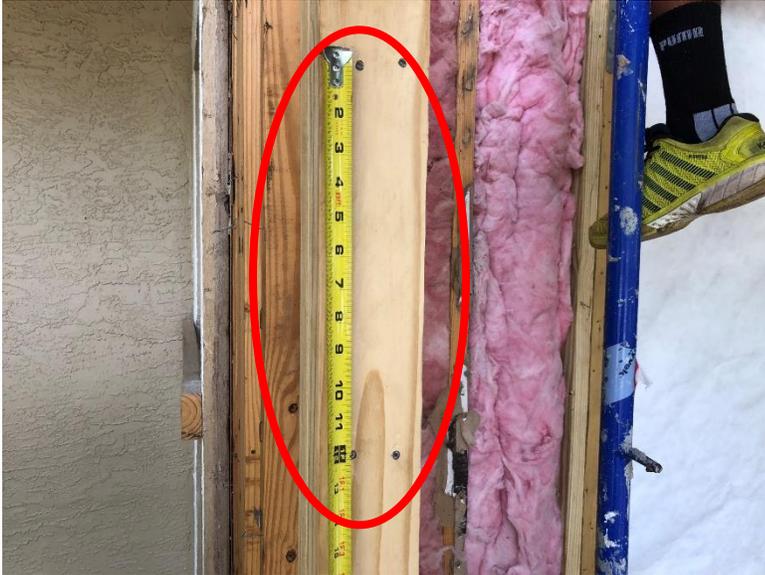
PHOTOGRAPH #17

**BUILDING 8
SECTION B**

Unit #803- New framing studs fastened at 12" O.C. with 16d nails.

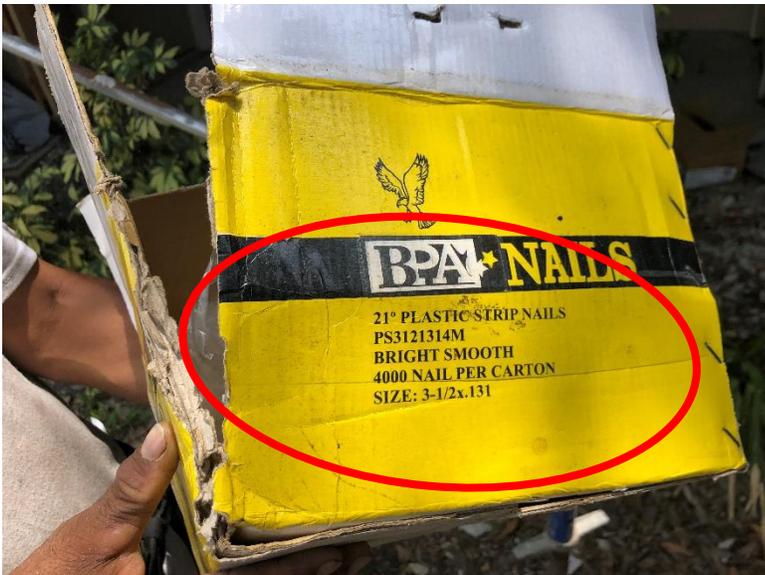
PHOTOGRAPH #18

**BUILDING 8
SECTION B**

Unit #803- New framing studs fastened at 12" O.C. with 16d nails.

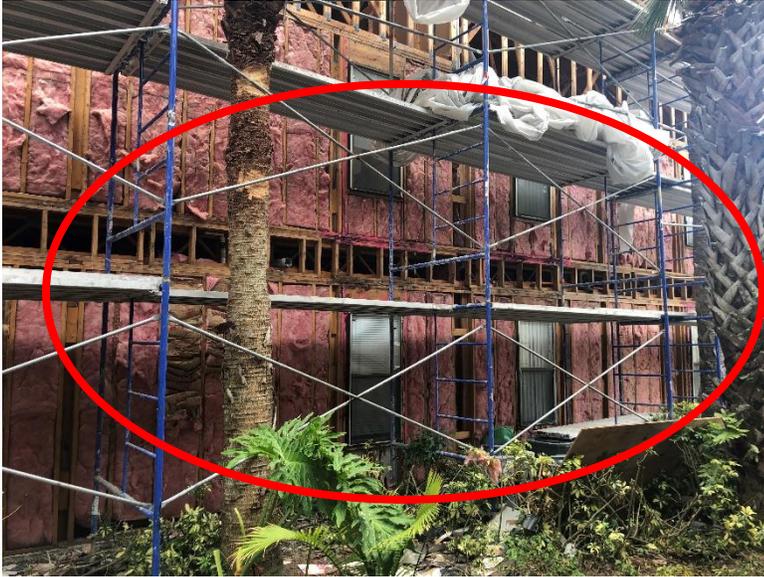
PHOTOGRAPH #19

**BUILDING 13
SECTION H**

Framing damage inspected and marked for repairs by Delta.

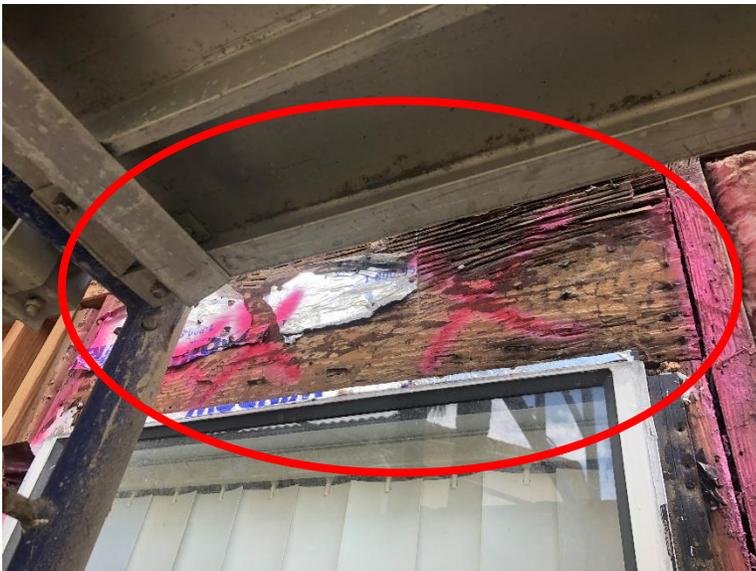
PHOTOGRAPH #20

**BUILDING 13
SECTION H**

Unit #1301- Damaged single window headers marked for removal and replacement.

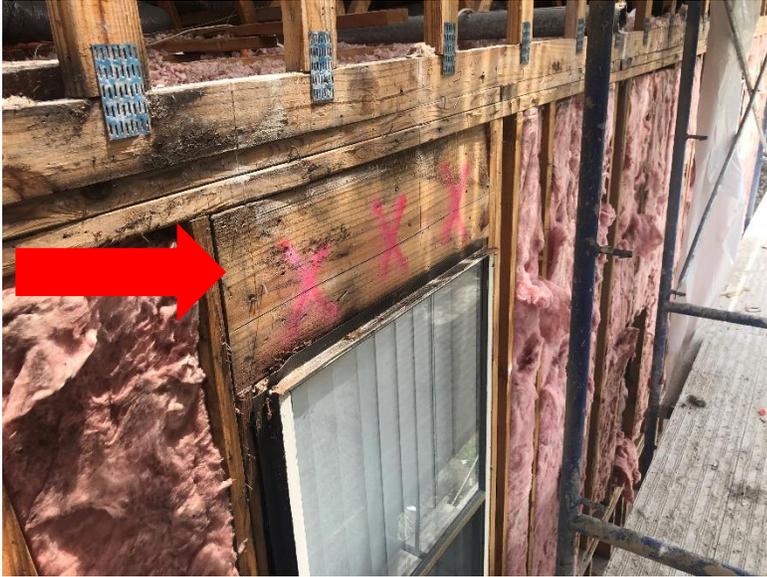
PHOTOGRAPH #21

**BUILDING 13
SECTION H**

Unit #1301- Damaged single window headers marked for removal and replacement.

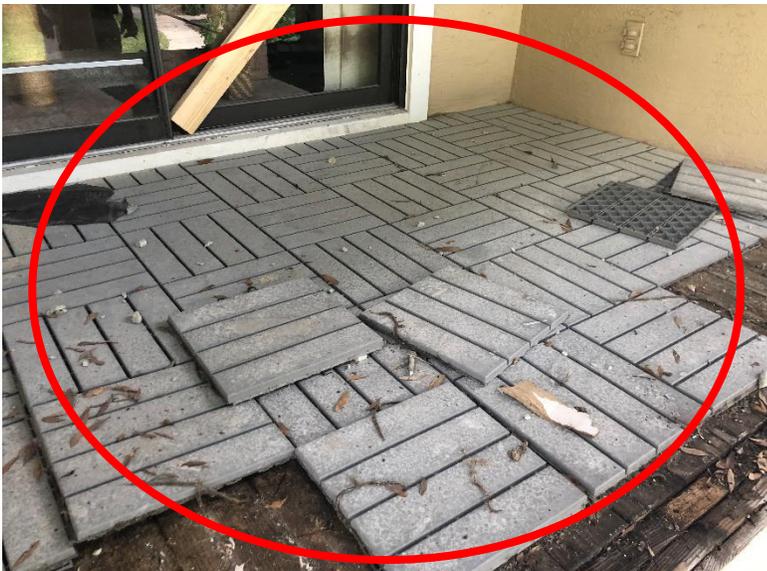
PHOTOGRAPH #22

**BUILDING 13
SECTION G**

Unit #1322- Balcony floor covering is required to be removed by owners for inspection of wood deck conditions.

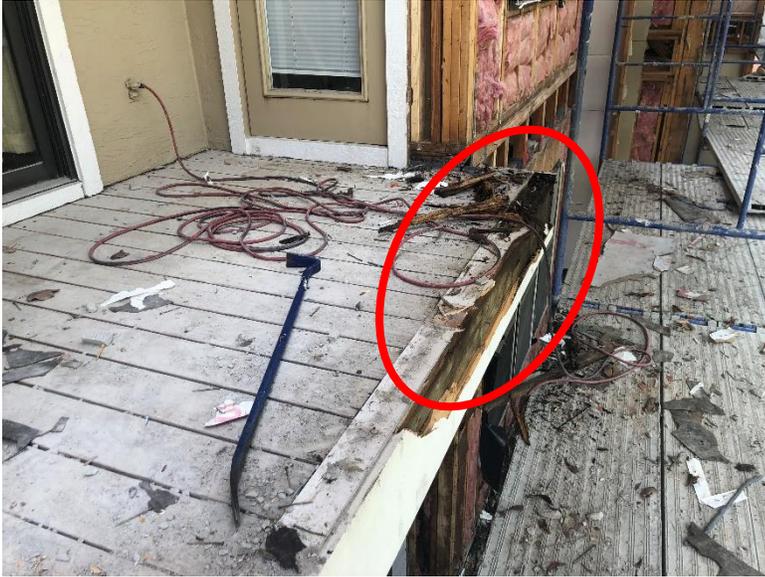
PHOTOGRAPH #23

**BUILDING 13
SECTION F**

Unit #1324- Top plate of built-up beam was not PT lumber and has deteriorated. This balcony was previously repaired by RLJ and is under warranty.

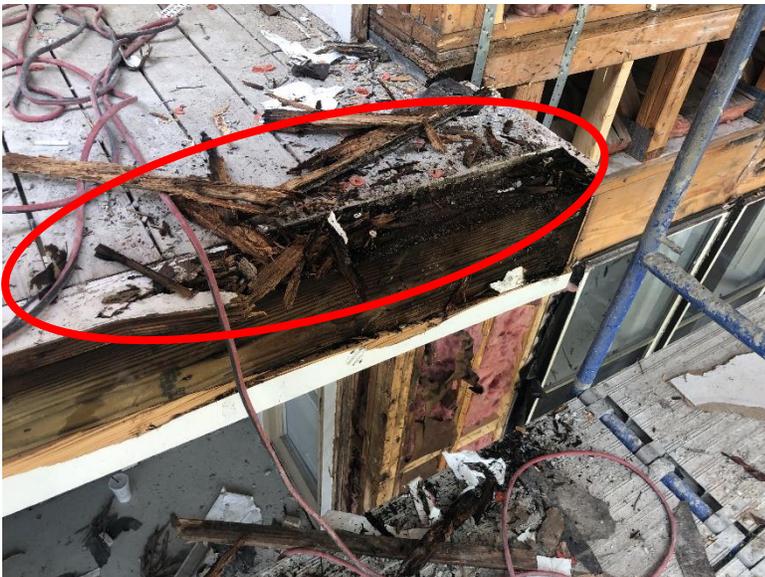
PHOTOGRAPH #24

**BUILDING 13
SECTION F**

Unit #1324- Top plate of built-up beam was not PT lumber and has deteriorated. This balcony was previously repaired by RLJ and is under warranty.

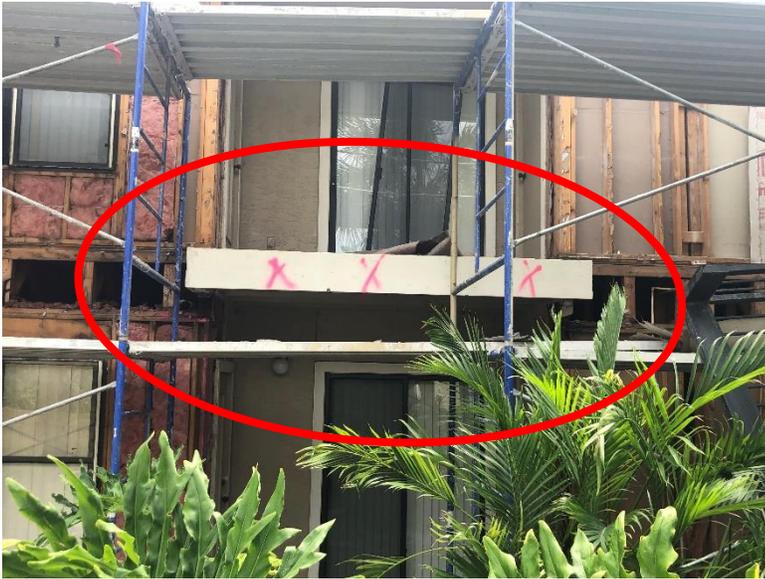
PHOTOGRAPH #25

**BUILDING 13
SECTION F**

Unit #1326- Balcony built up beam and supporting framing marked for full repairs.

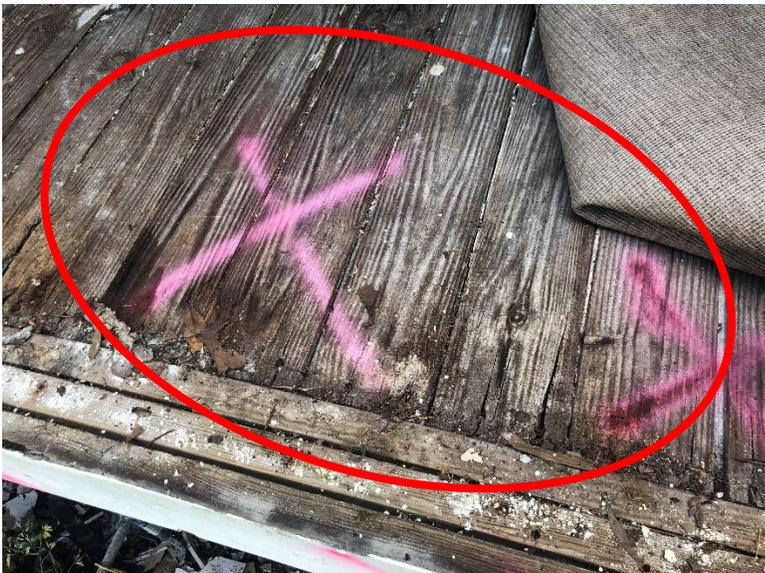
PHOTOGRAPH #26

**BUILDING 13
SECTION F**

Unit #1326- Balcony deck boards marked for removal and replacement.

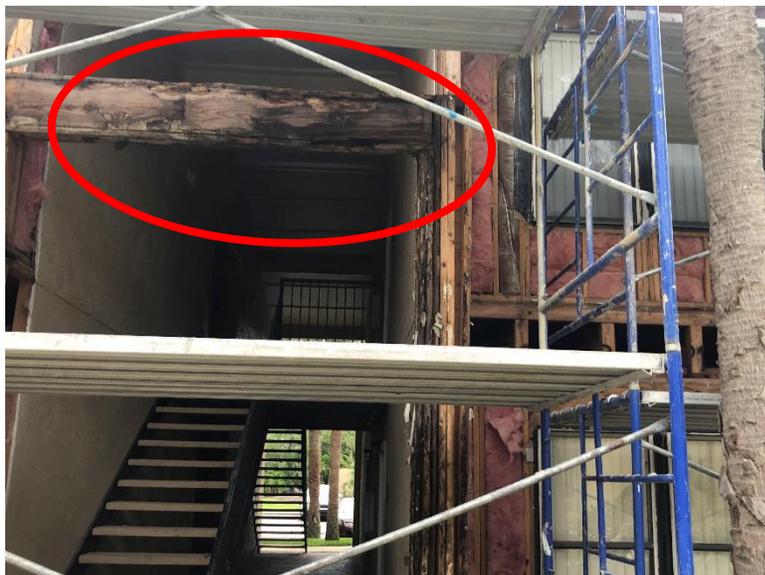
PHOTOGRAPH #27

**BUILDING 13
SECTION E- BREEZEWAY**

Damaged breezeway box beam and supporting posts marked for full replacement.

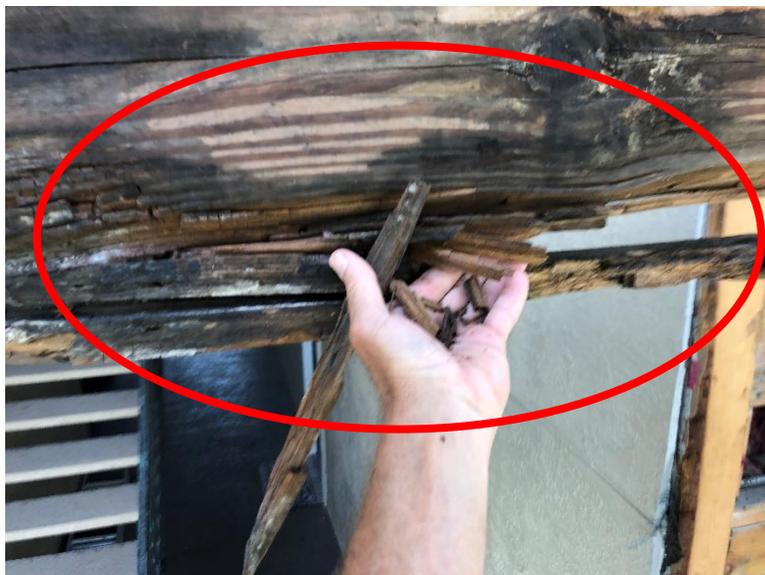
PHOTOGRAPH #28

**BUILDING 13
SECTION E- BREEZEWAY**

Damaged breezeway box beam and supporting posts marked for full replacement.

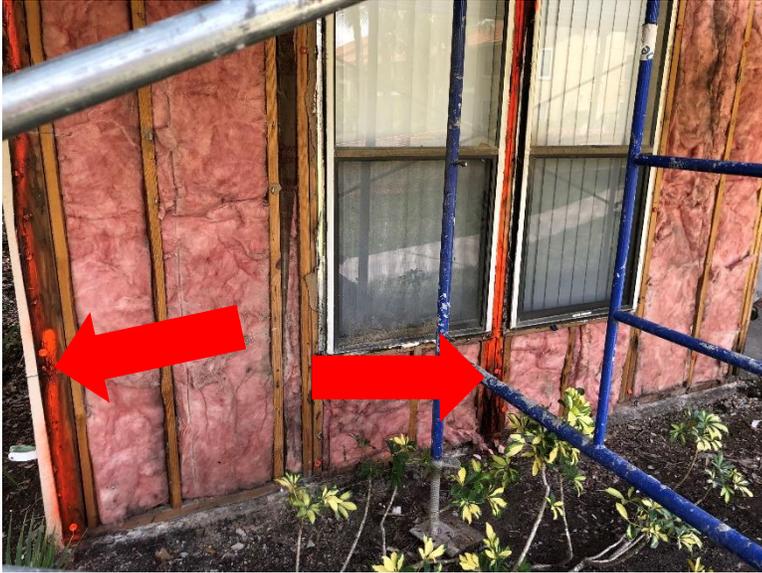
PHOTOGRAPH #29

**BUILDING 13
SECTION E**

Unit #1308- Damaged window framing studs and corner post studs marked for replacement.
