PHOTOGRAPHS

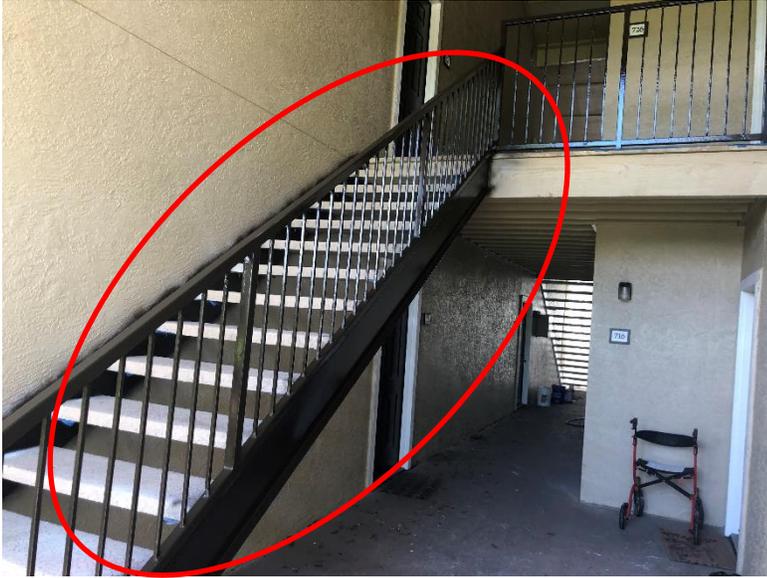
PHOTOGRAPH #1

**BUILDING 7
SECTION A- BREEZEWAY**

Contractor has spray painted steel stairway railing with Florida Paints Sundeavor Urethane Enamel.

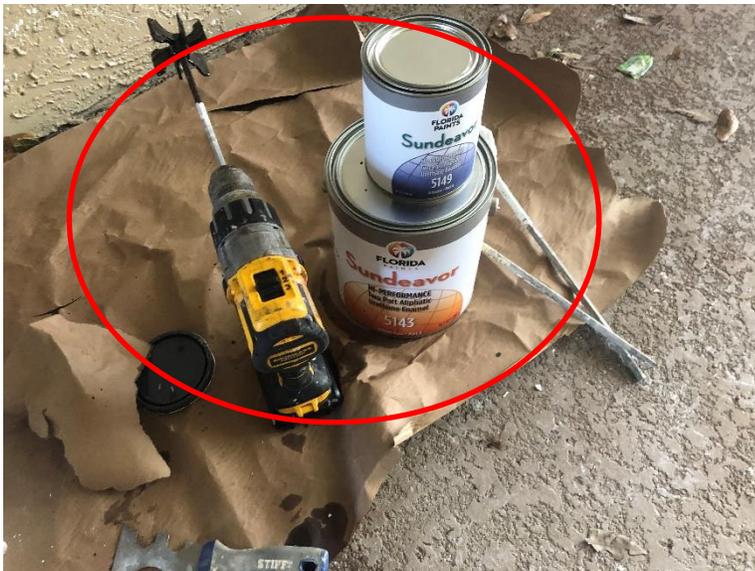
PHOTOGRAPH #2

**BUILDING 7
SECTION A- BREEZEWAY**

Contractor has spray painted steel stairway railing with Florida Paints Sundeavor Urethane Enamel.

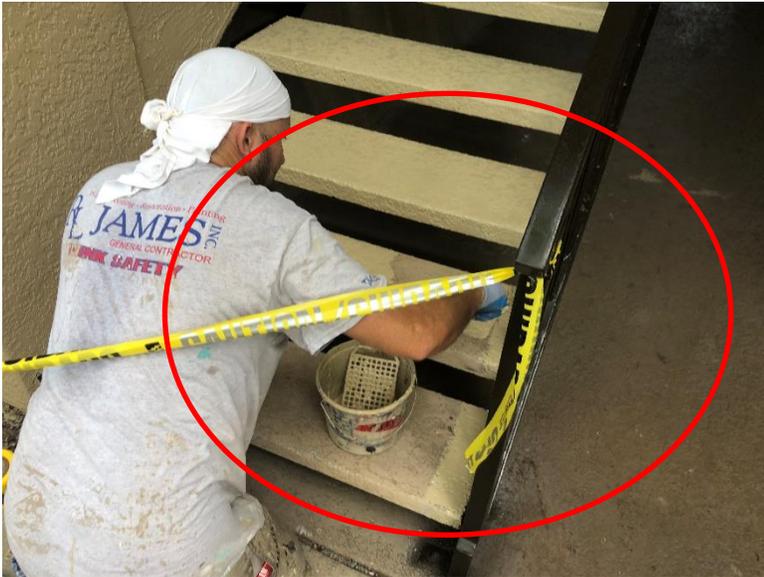
PHOTOGRAPH #3

**BUILDING 7
SECTION A**

Contractor painting concrete stair pads at breezeway stairways with Florida Paints TropiCrete Concrete Sealer.

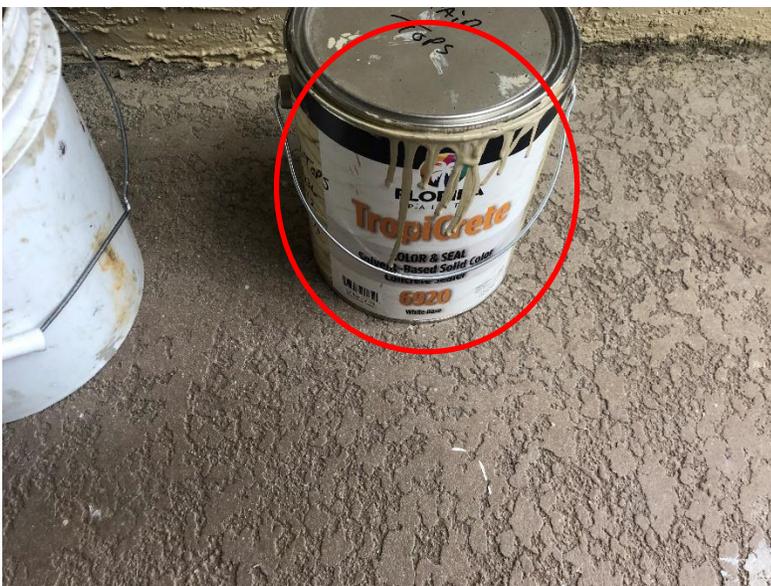
PHOTOGRAPH #4

**BUILDING 7
SECTION A**

Contractor painting concrete stair pads at breezeway stairways with Florida Paints TropiCrete Concrete Sealer.

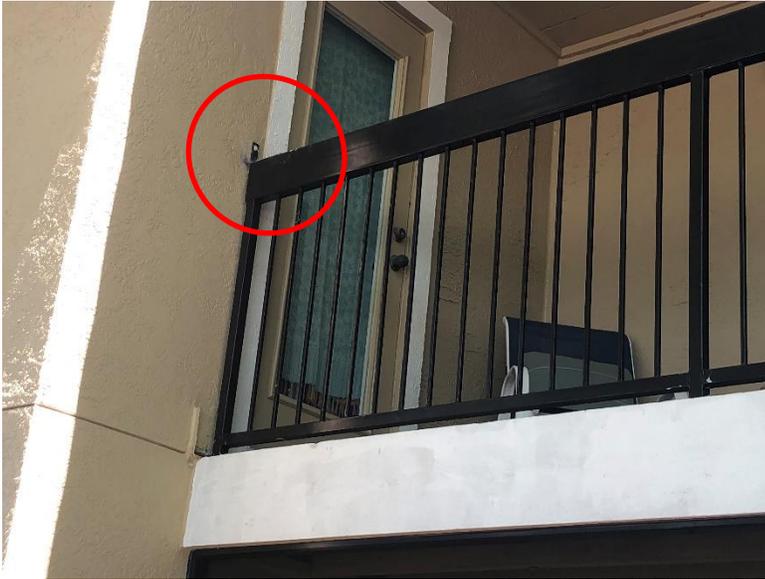
PHOTOGRAPH #5

**BUILDING 7
SECTION A- BREEZEWAY**

Steel railings at balconies have been attached at top railing through stucco into framing at welded brackets with anchor bolts.

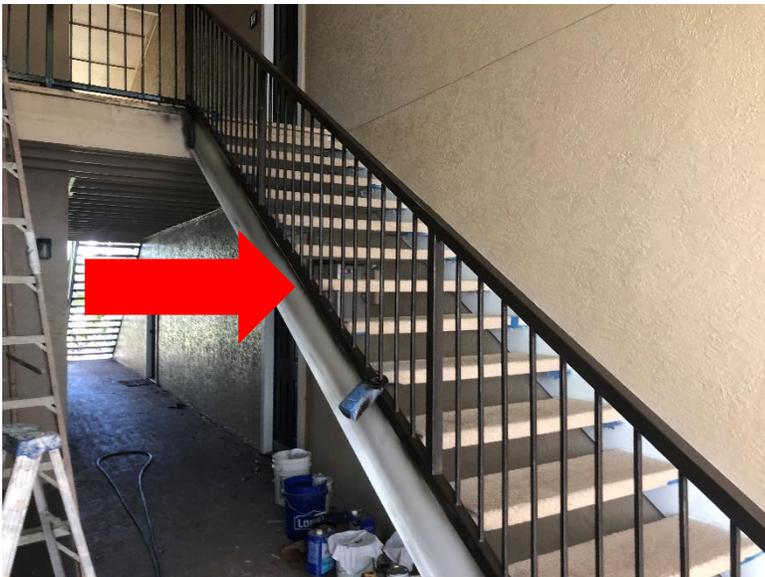
PHOTOGRAPH #6

**BUILDING 7
SECTION C**

Contractor has spray painted steel stairway railing with Florida Paints Sundeavor Urethane Enamel.

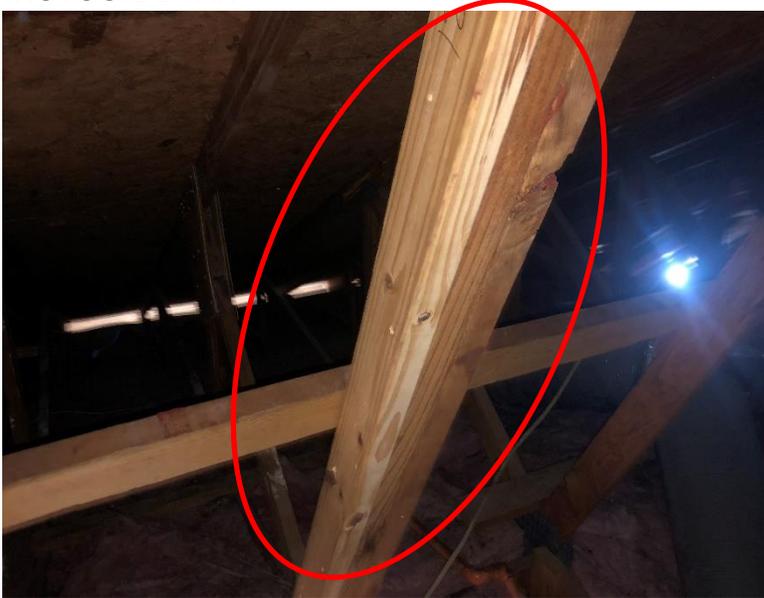
PHOTOGRAPH #7

**BUILDING 7
SECTION F**

Unit #724- Truss scab repairs performed in attic space as per drawings.

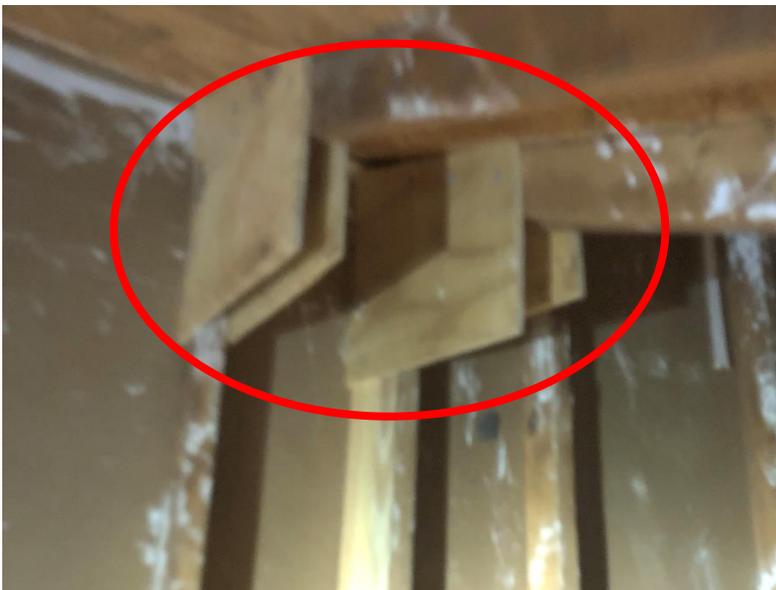
PHOTOGRAPH #8

**BUILDING 7
SECTION F**

Unit #724- Gusset plate repair details performed in attic space as per drawings.

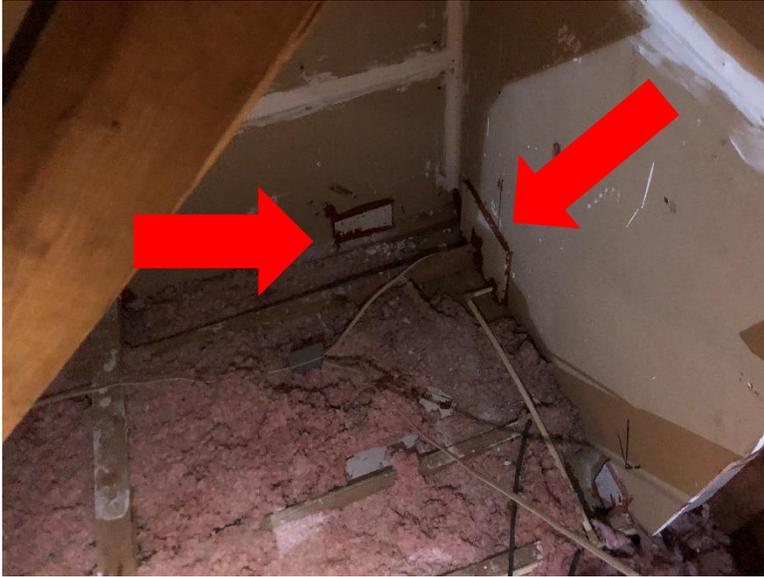
PHOTOGRAPH #9

**BUILDING 7
SECTION F**

Unit # 724- Fire board repairs and fire caulk repairs performed in attic space.

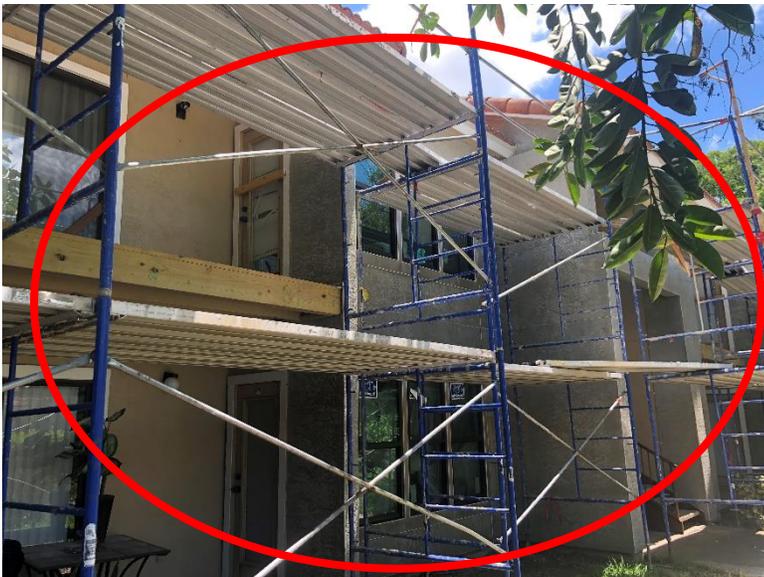
PHOTOGRAPH #10

**BUILDING 8
SECTION F**

Sub-Contractor has applied three coat 7/8" stucco system as per specifications and ASTM standards.

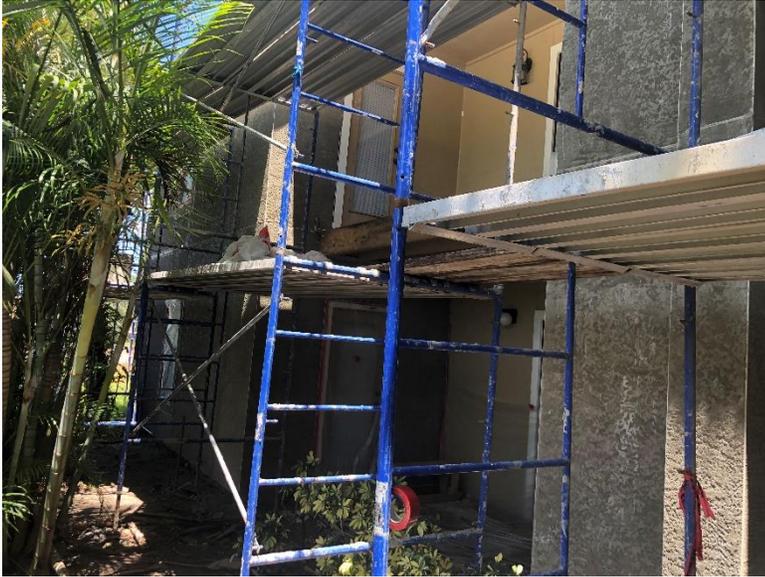
PHOTOGRAPH #11

**BUILDING 8
SECTION E**

Sub-Contractor has applied three coat 7/8" stucco system as per specifications and ASTM standards.

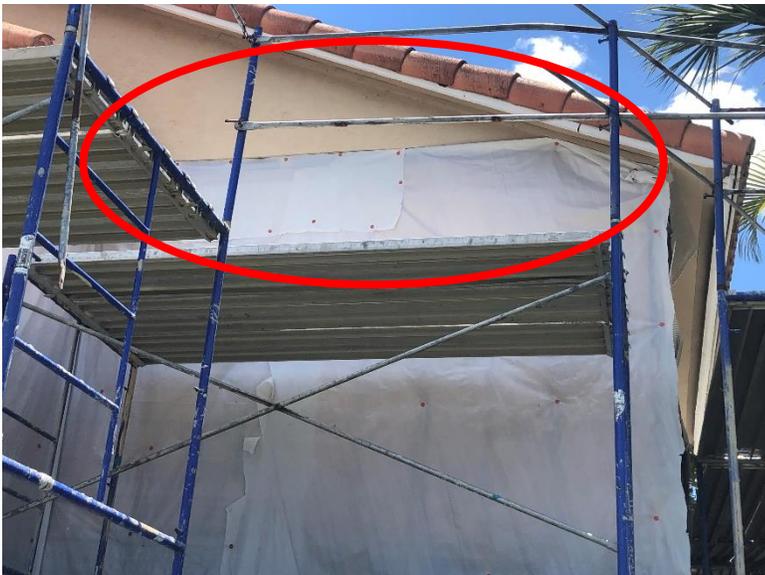
PHOTOGRAPH #12

**BUILDING 8
SECTION D**

Gable end wall plastic tarp protection has been secured over open space at attic.

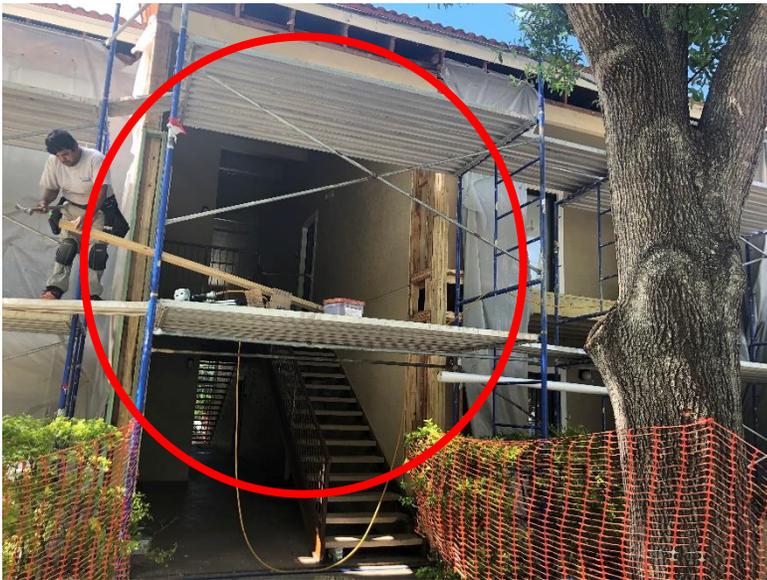
PHOTOGRAPH #13

**BUILDING 8
SECTION C**

Contractor replacing damaged breezeway framing as marked for repairs.

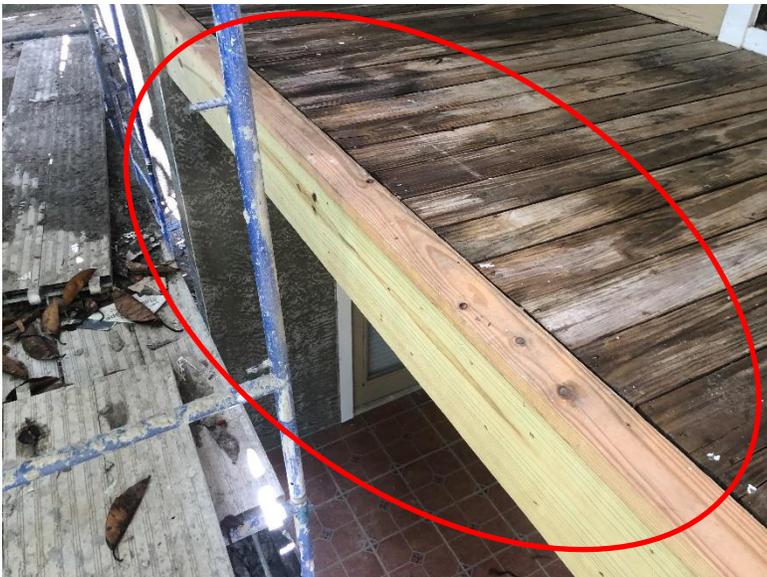
PHOTOGRAPH #14

**BUILDING 8
SECTION B**

Unit #825- contractor has replaced built up beam at balcony as per drawings.

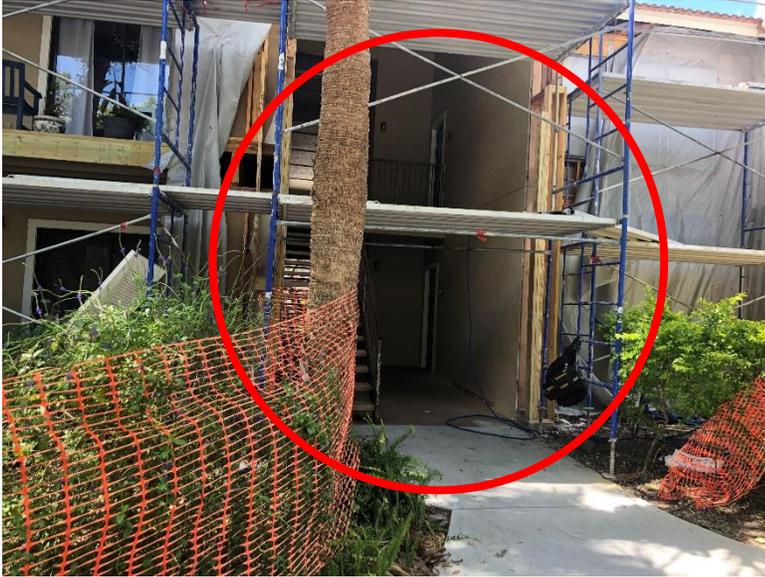
PHOTOGRAPH #15

**BUILDING 8
SECTION A**

Contractor replacing damaged breezeway framing as marked for repairs.

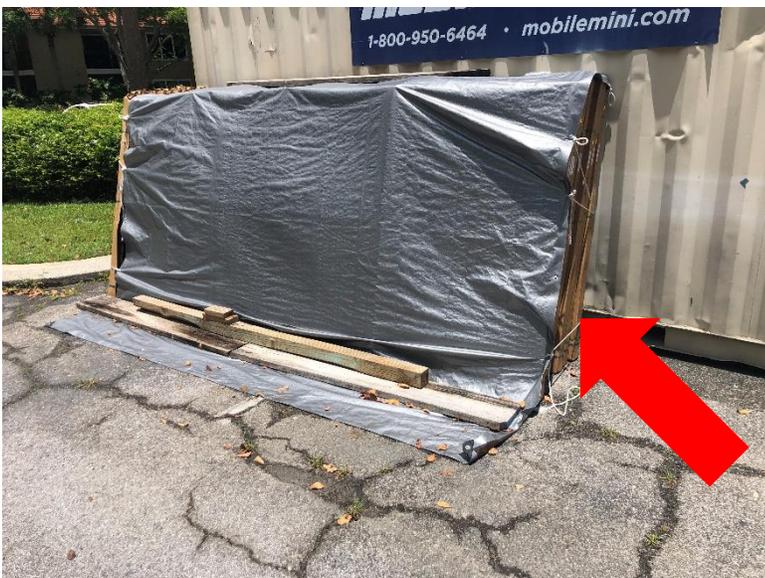
PHOTOGRAPH #16

**BUILDING 8
GROUNDS**

New PGT windows delivered to site have been left outside of storage trailer.

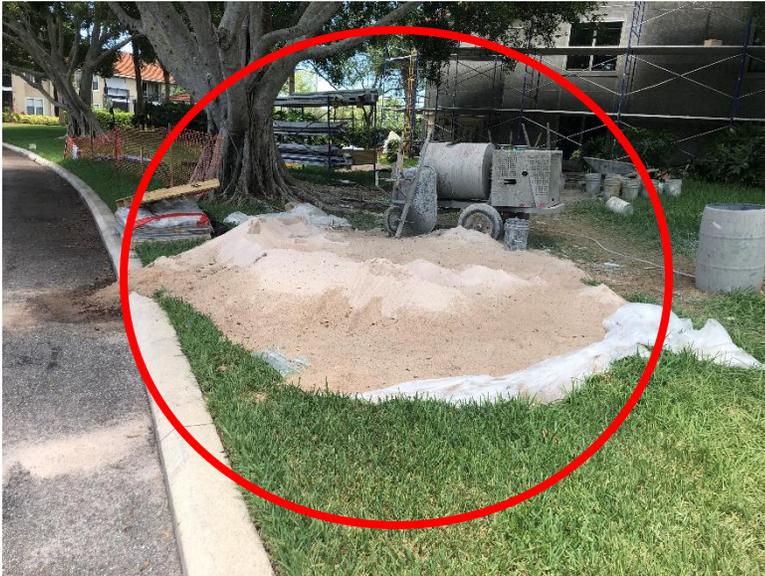
PHOTOGRAPH #17

**BUILDING 8
GROUNDS**

Stucco staging area is outside of construction fencing and sand is not covered.

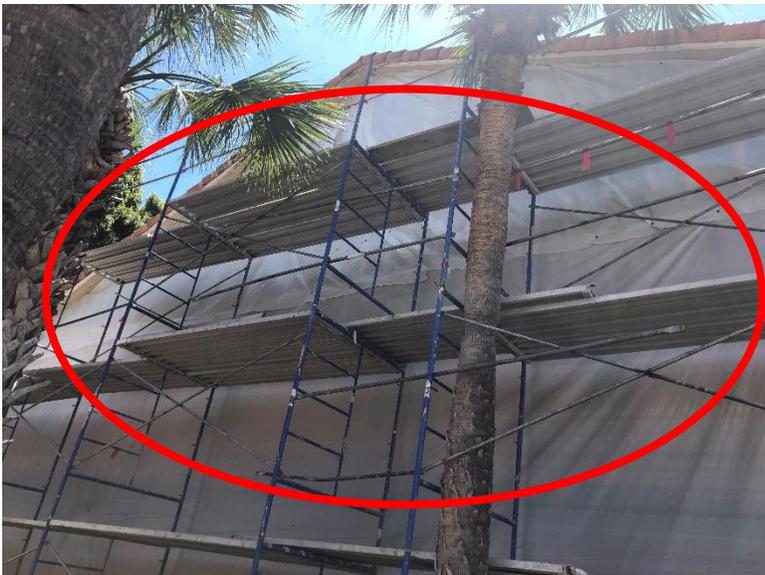
PHOTOGRAPH #18

**BUILDING 13
SECTION H**

Open walls have been covered with heavy duty plastic protection.

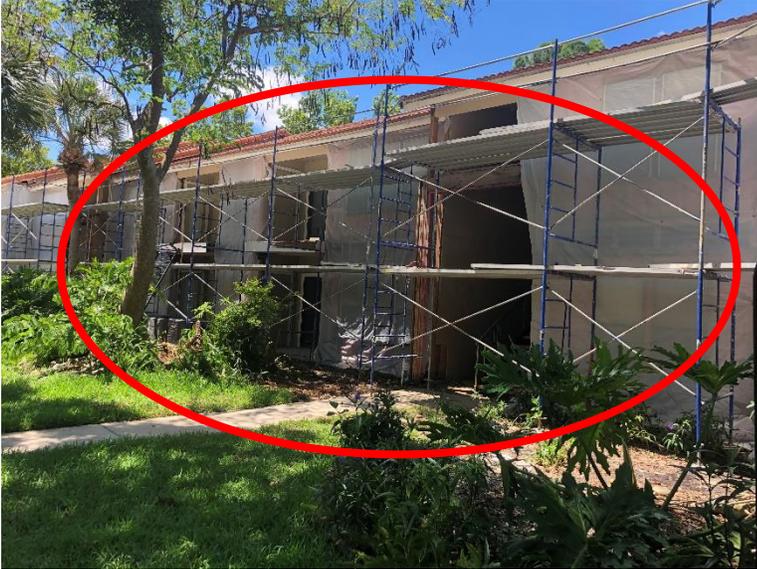
PHOTOGRAPH #19

**BUILDING 13
SECTION F**

Open walls have been covered with heavy duty plastic protection.

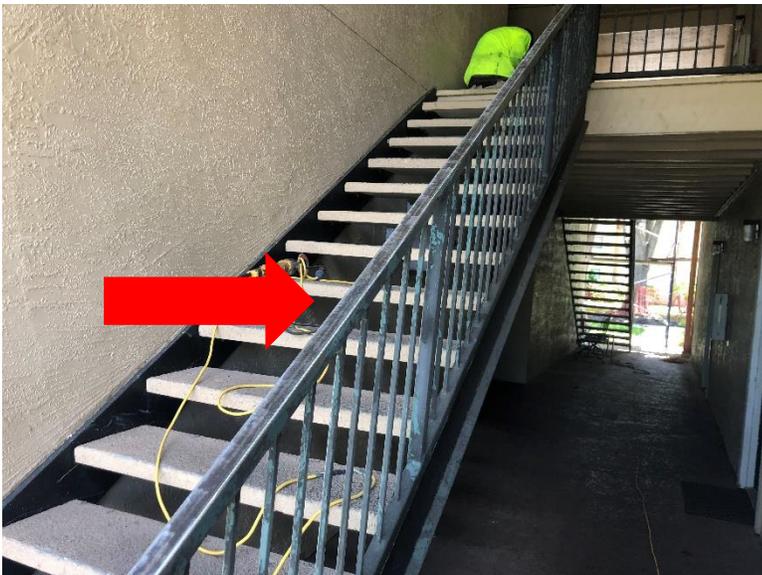
PHOTOGRAPH #20

**BUILDING 13
SECTION A**

Breezeway stairway railings are in process of preparation by grinding away loose paint and rust.
