PHOTOGRAPHS

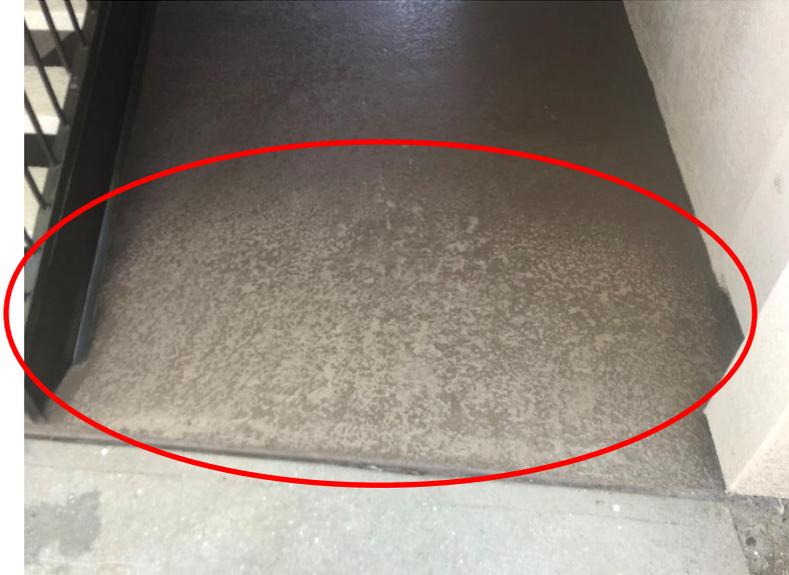
PHOTOGRAPH #1

**BUILDING 7
SECTION A- BREEZEWAY**

Floor paint appears to have been damaged by rain prior to drying.

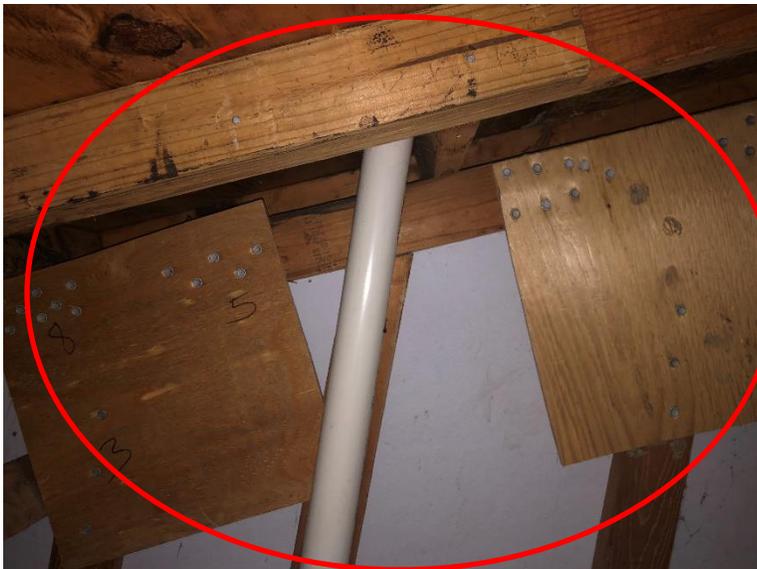
PHOTOGRAPH #2

**BUILDING 7
SECTION A- ATTIC**

Unit #721- Contractor has performed gusset repairs at trusses as per drawings in attic.

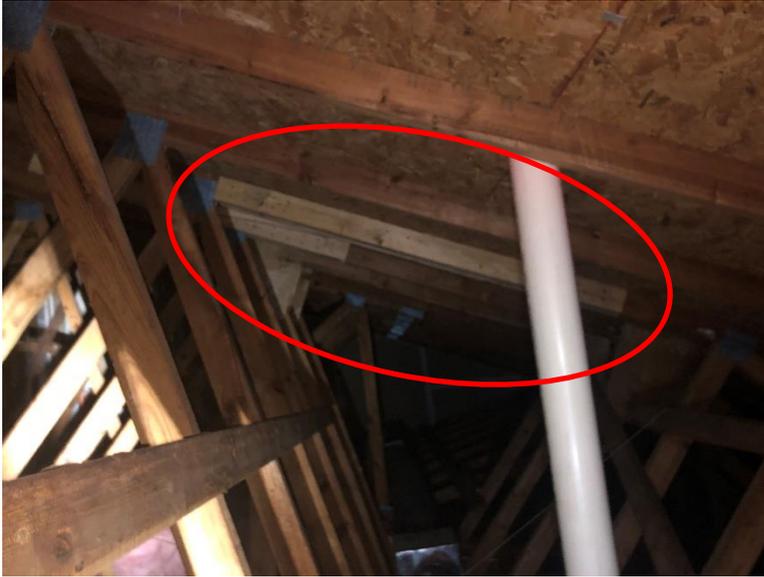
PHOTOGRAPH #3

**BUILDING 7
SECTION A-ATTIC**

Unit #721- Contractor has performed scab repairs at trusses as per drawings in attic.

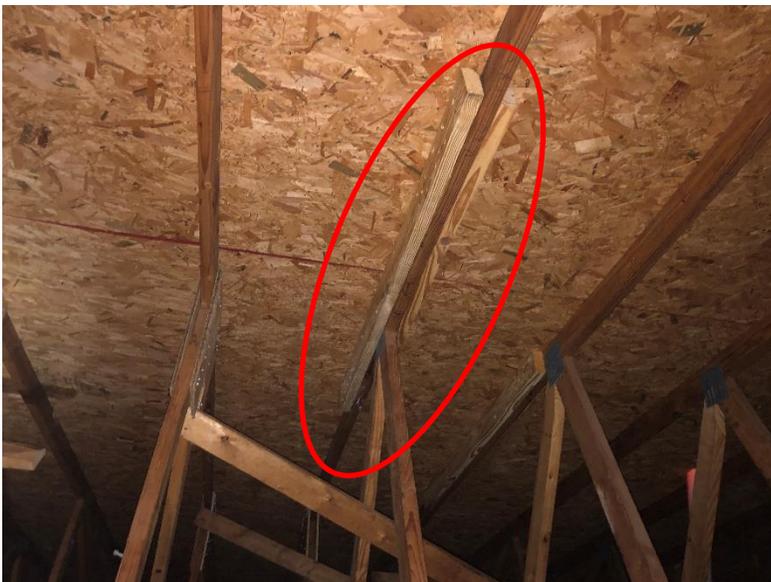
PHOTOGRAPH #4

**BUILDING 7
SECTION A-ATTIC**

Unit # 721- Contractor has performed scab repairs at trusses as per drawings in attic.

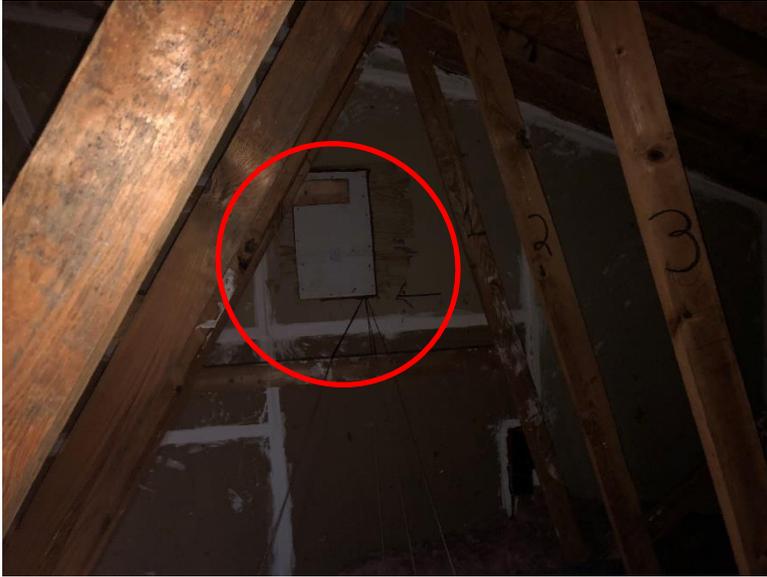
PHOTOGRAPH #5

**BUILDING 7
SECTION A- ATTIC**

Unit # 721- Contractor has performed fire wall repairs at separation wall as per drawings in attic.

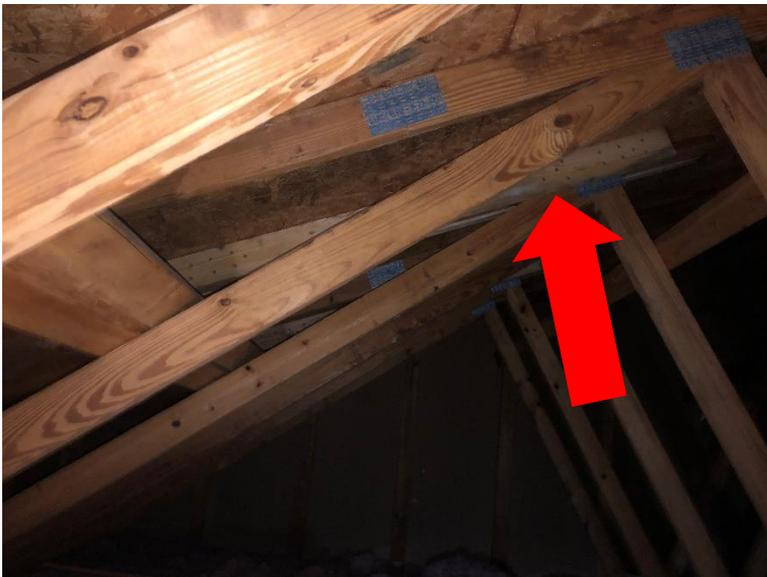
PHOTOGRAPH #6

**BUILDING 7
SECTION B- ATTICS**

Unit #725- Contractor has performed scab repairs at trusses as per drawings in attic.

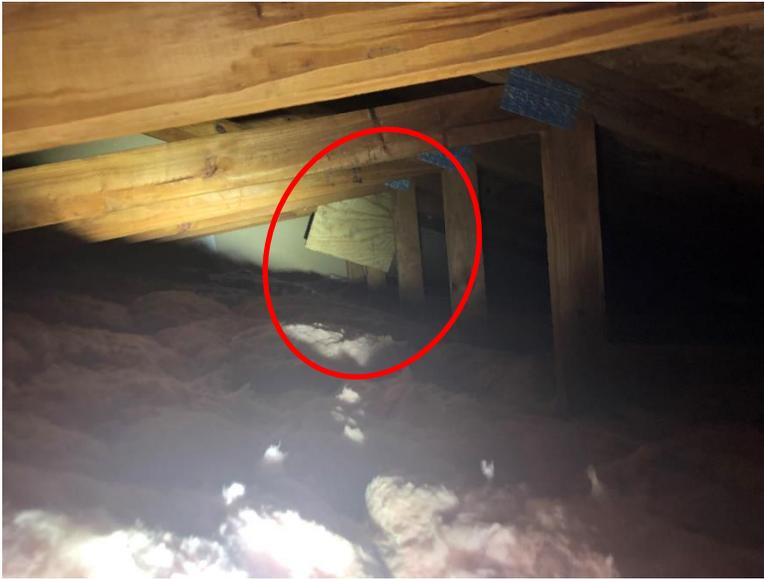
PHOTOGRAPH #7

**BUILDING 7
SECTION B- ATTICS**

Unit #725- Contractor has performed gusset repairs at trusses as per drawings in attic.

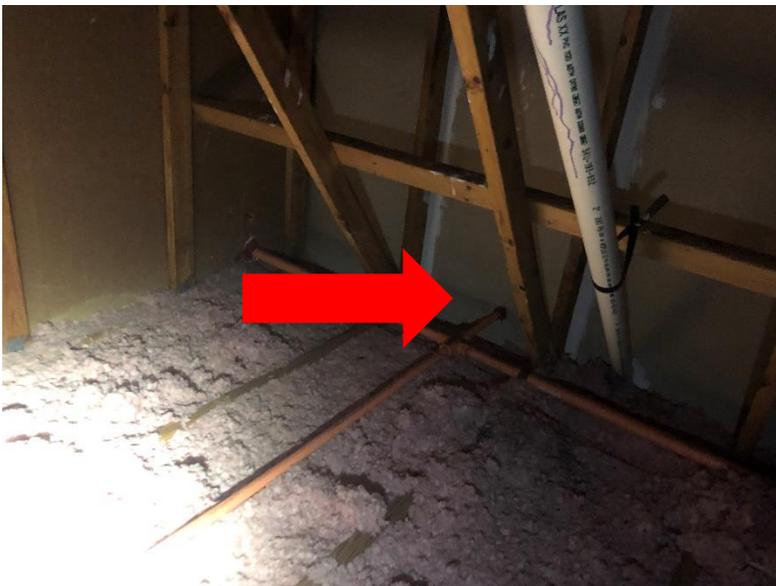
PHOTOGRAPH #8

**BUILDING 7
SECTION B- ATTICS**

Unit #725- Fire caulk repairs performed in attic space at penetrations and holes.

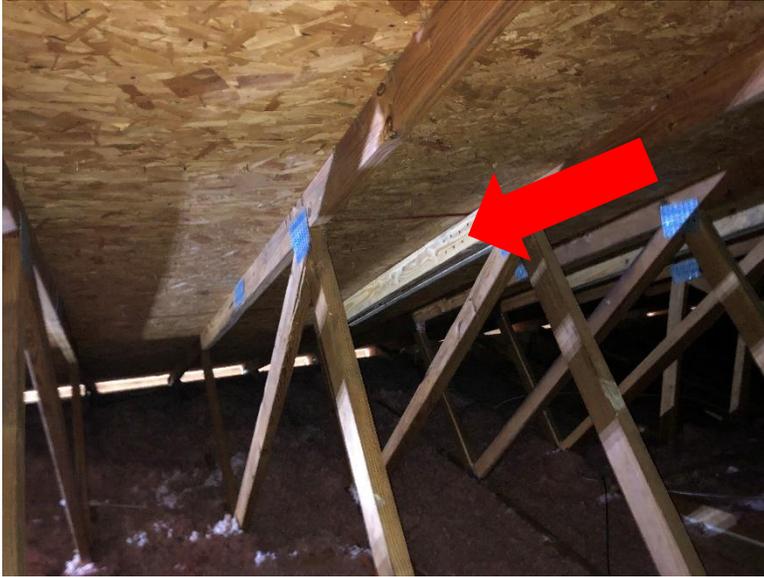
PHOTOGRAPH #9

**BUILDING 7
SECTION C- ATTICS**

Unit # 727- Contractor has performed scab repairs at trusses as per drawings in attic.

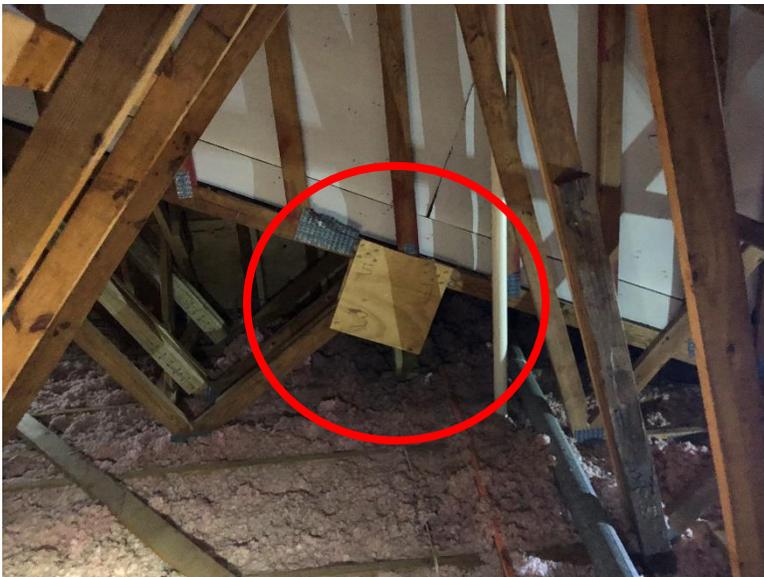
PHOTOGRAPH #10

**BUILDING 7
SECTION C- ATTICS**

Unit # 727- Contractor has performed gusset repairs at trusses as per drawings in attic.

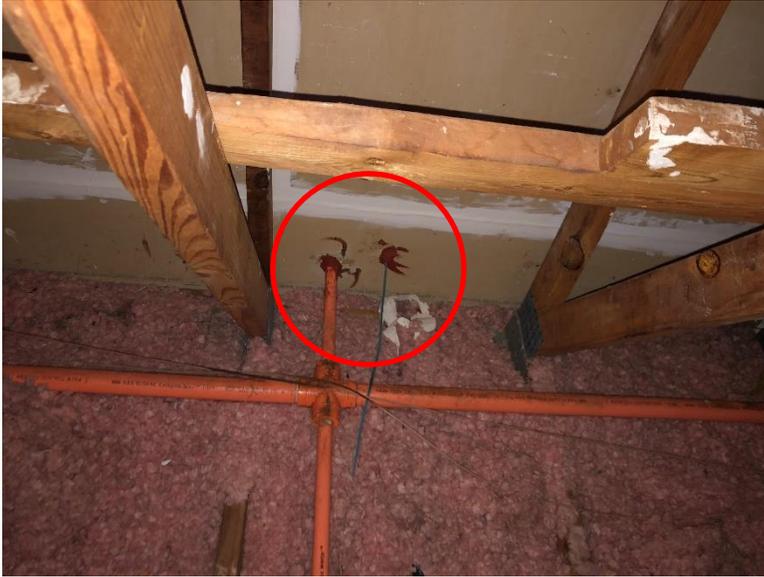
PHOTOGRAPH #11

**BUILDING 7
SECTION C- ATTICS**

Unit # 727- Fire caulk repairs performed in attic space at penetrations and holes.

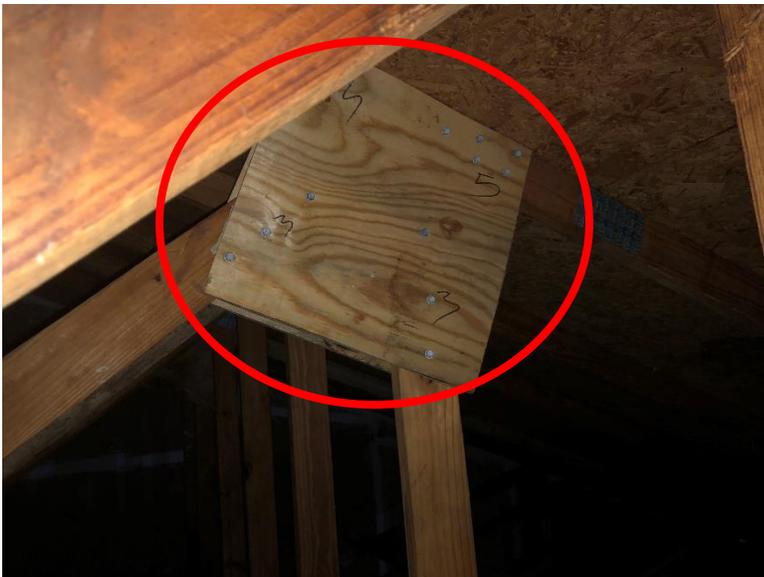
PHOTOGRAPH #12

**BUILDING 7
SECTION E-ATTICS**

Unit #728- Contractor has performed gusset repairs at trusses as per drawings in attic.

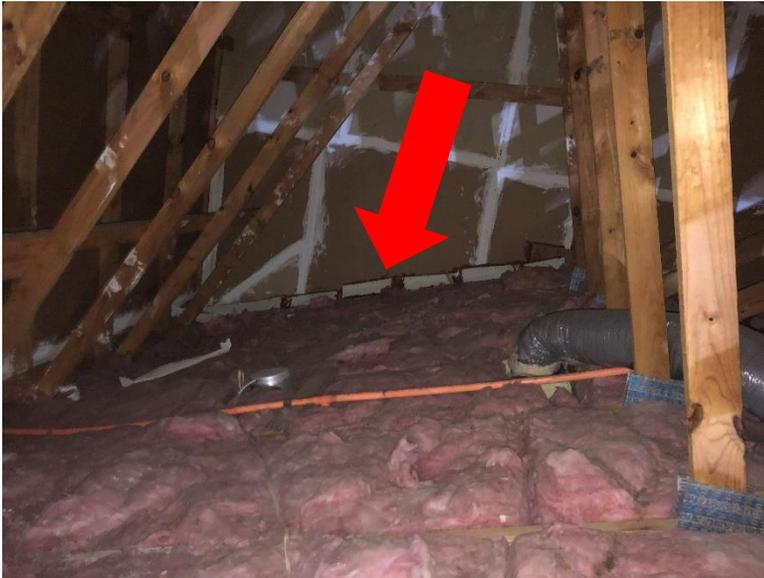
PHOTOGRAPH #13

**BUILDING 7
SECTION E-ATTICS**

Unit #728- Contractor has performed fire wall repairs at separation wall as per drawings in attic.

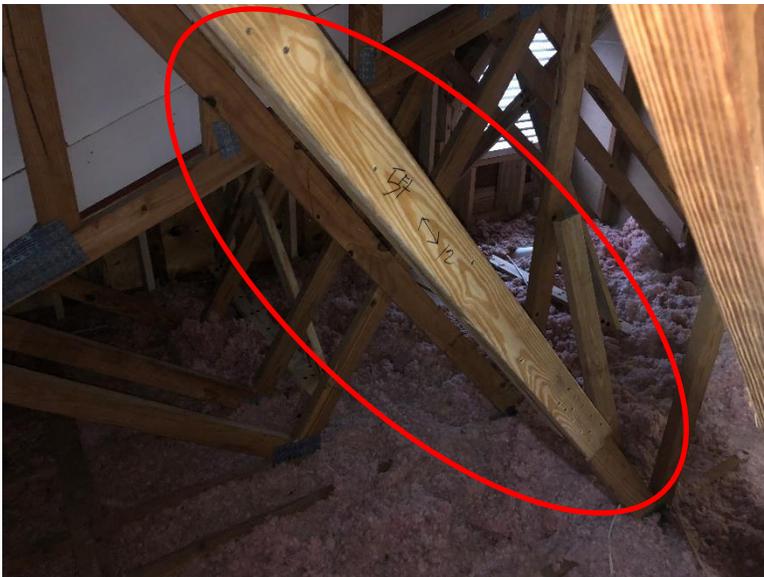
PHOTOGRAPH #14

**BUILDING 7
SECTION E-ATTICS**

Unit #728- Contractor has performed scab repairs at trusses as per drawings in attic.

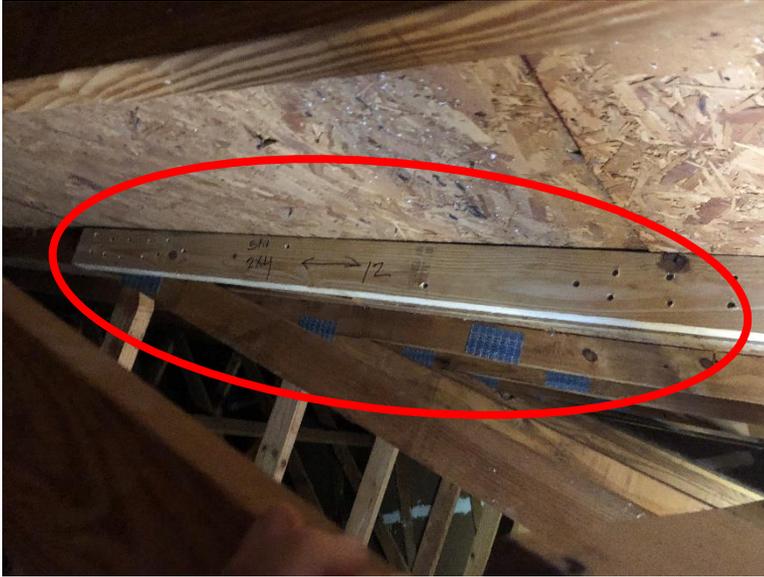
PHOTOGRAPH #15

**BUILDING 7
SECTION F-ATTICS**

Unit #726- Contractor has performed scab repairs at trusses as per drawings in attic.

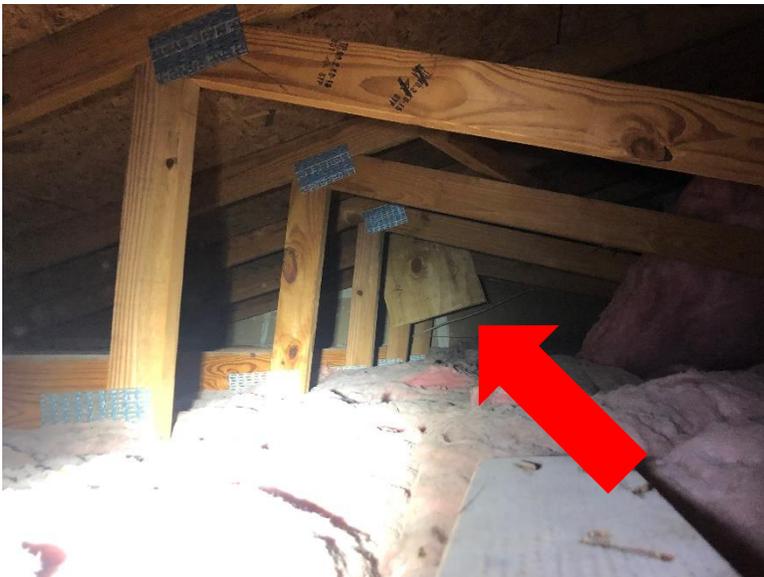
PHOTOGRAPH #16

**BUILDING 7
SECTION F-ATTICS**

Unit #726- Contractor has performed gusset repairs at trusses as per drawings in attic.

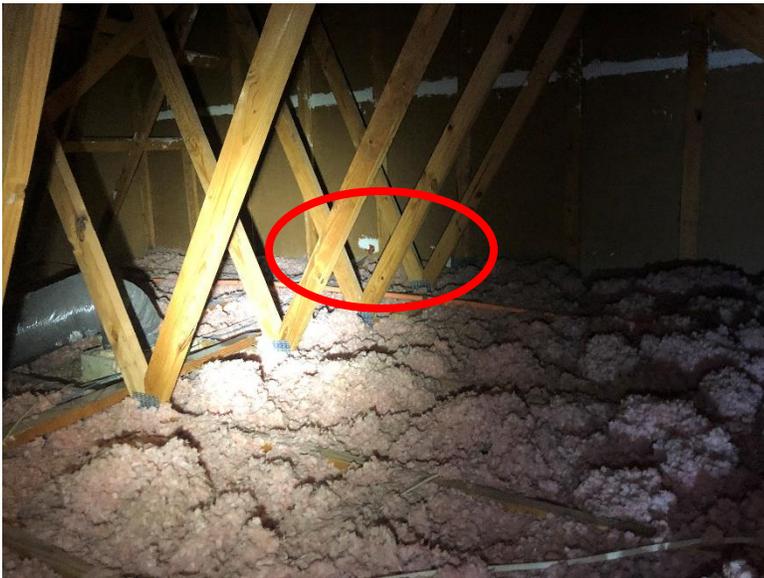
PHOTOGRAPH #17

**BUILDING 7
SECTION F-ATTICS**

Unit #726- Contractor has performed fire wall repairs at separation wall as per drawings in attic.

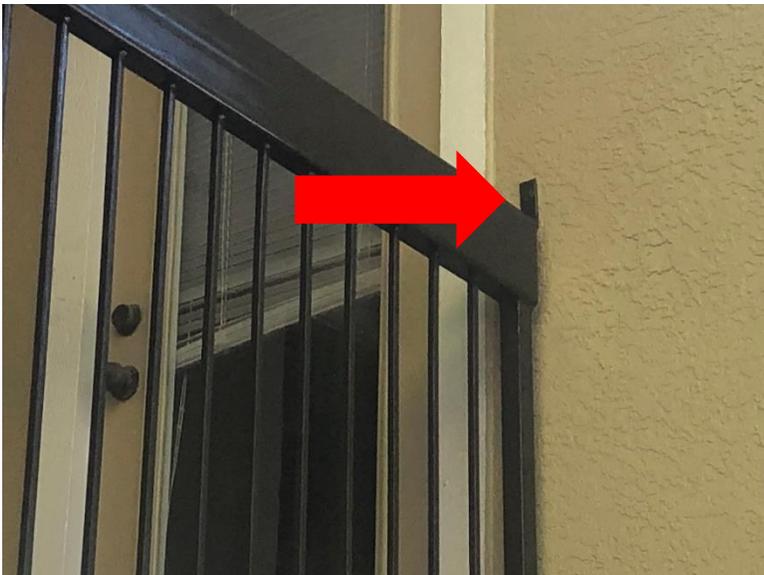
PHOTOGRAPH #18

**BUILDING 8
SECTION F**

Handrailing brackets at top railing have been painted.

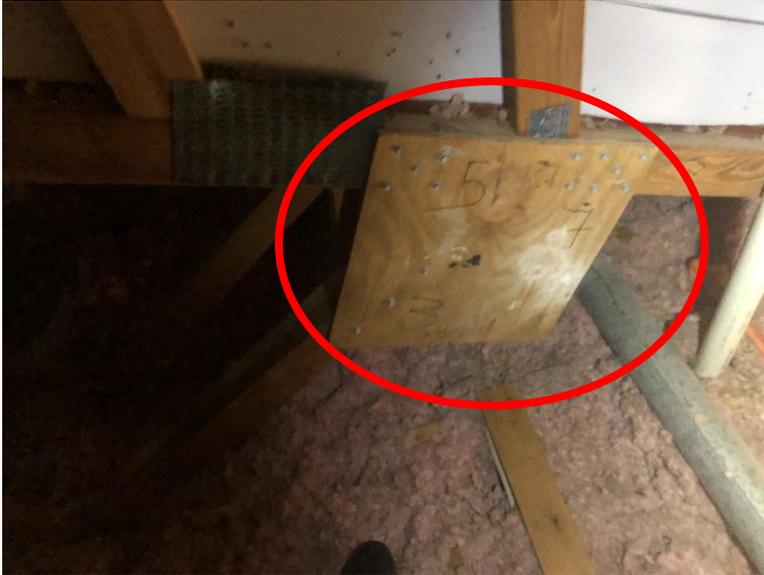
PHOTOGRAPH #19

**BUILDING 7
SECTION H-ATTICS**

Unit #722- Contractor has performed gusset repairs at trusses as per drawings in attic.

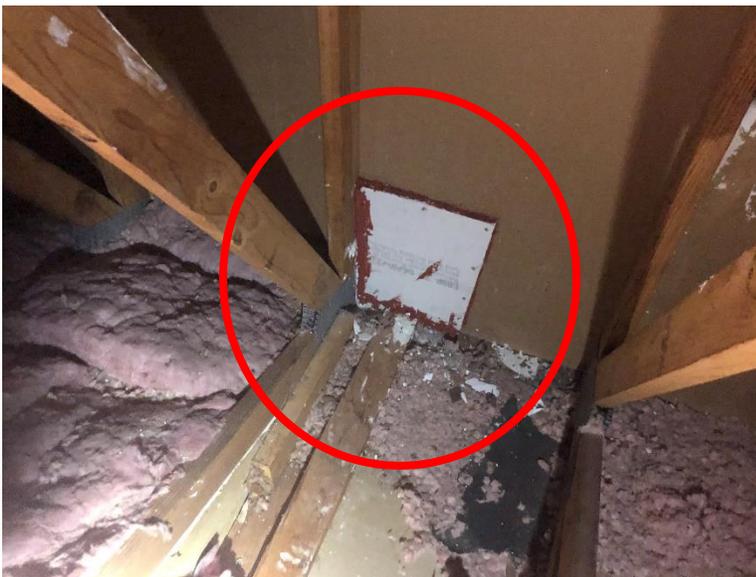
PHOTOGRAPH #20

**BUILDING 7
SECTION H-ATTICS**

Unit #722- Contractor has performed fire wall repairs at separation wall as per drawings in attic.

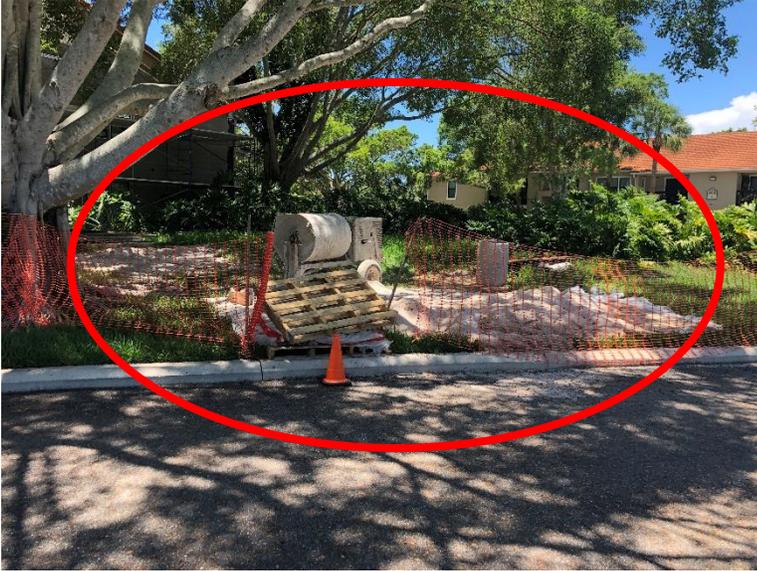
PHOTOGRAPH #21

**BUILDING 8
SECTION -GROUNDS AREA**

Construction fencing has been secured around stucco staging area.

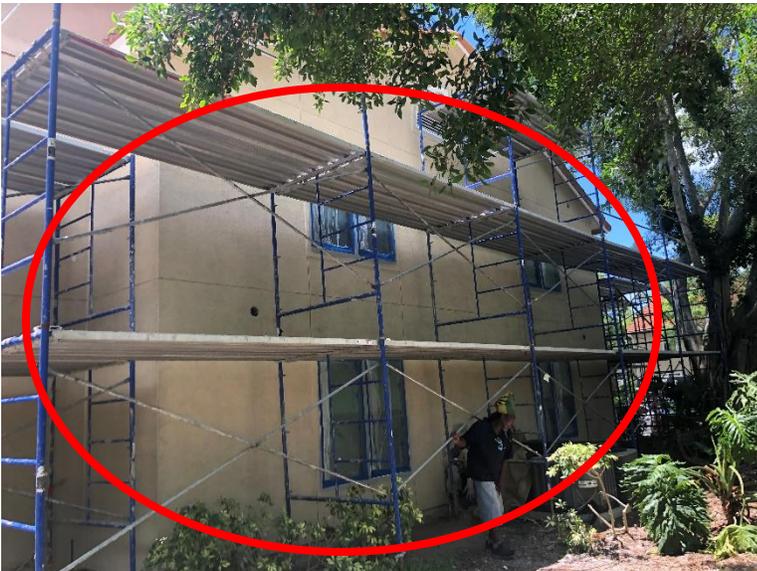
PHOTOGRAPH #22

**BUILDING 8
SECTION H**

Contractor has protected new windows and applied Florida Paint acrylic masonry primer to new stucco.

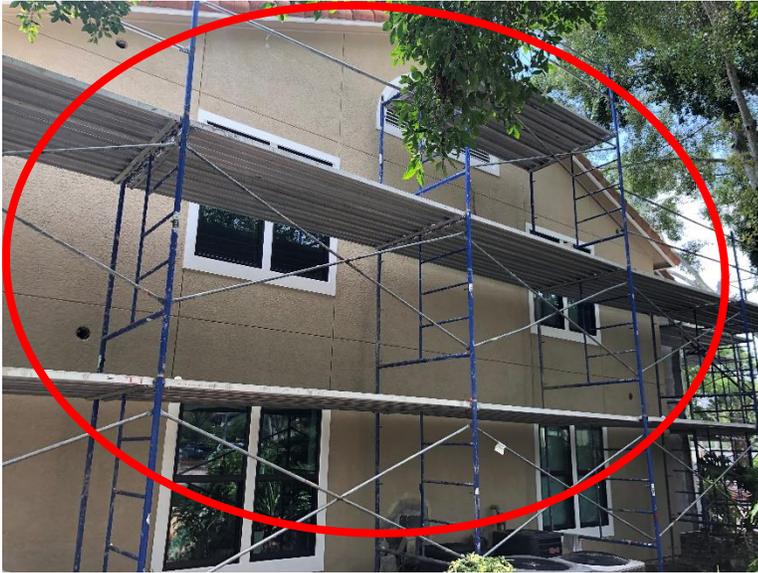
PHOTOGRAPH #23

**BUILDING 8
SECTION H**

Contractor has applied Florida Paint Ultra Exterior SuperCoat over acrylic masonry primer at new stucco.

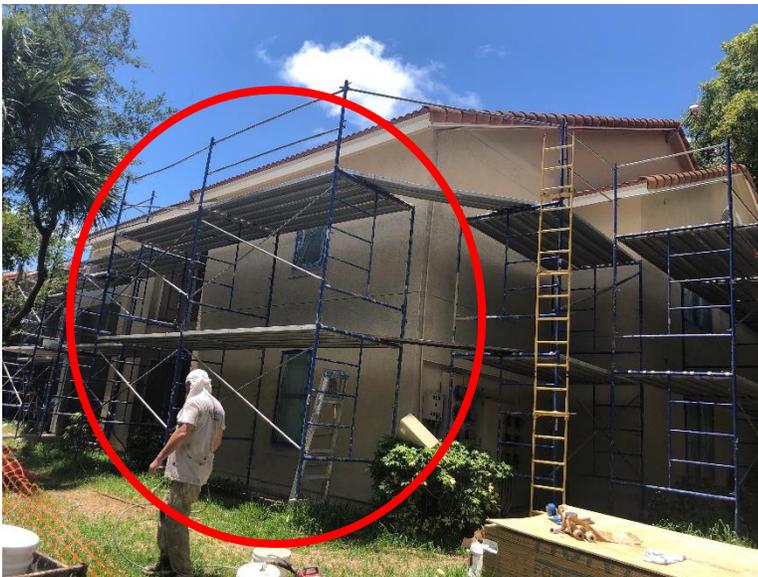
PHOTOGRAPH #24

**BUILDING 8
SECTION G**

Contractor has protected new windows and applied Florida Paint acrylic masonry primer to new stucco.

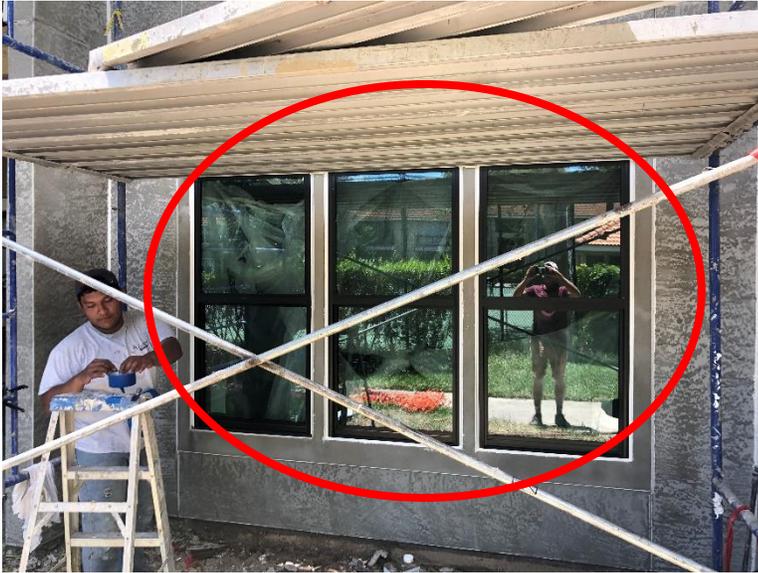
PHOTOGRAPH #25

**BUILDING 8
SECTION F**

Contractor masking metal frames and installing MasterSeal NP 150 sealant at new window perimeters.

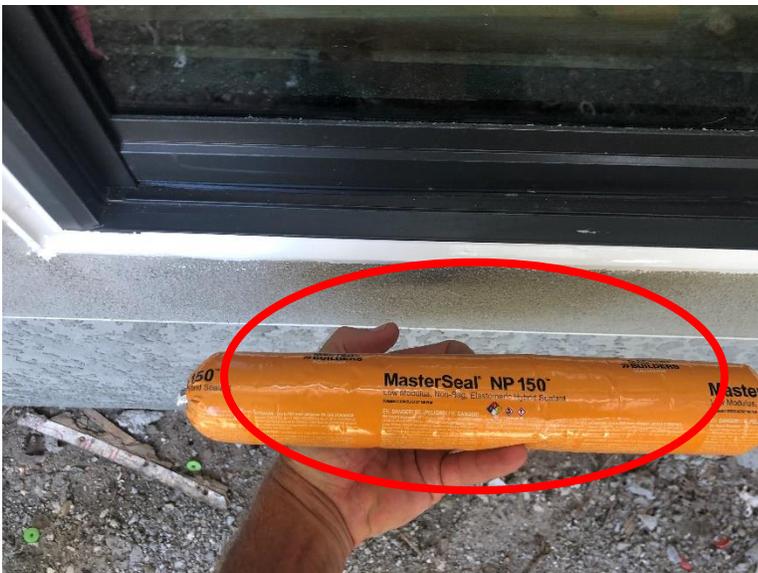
PHOTOGRAPH #26

**BUILDING 8
SECTION F**

Contractor masking metal frames and installing MasterSeal NP 150 sealant at new window perimeters.

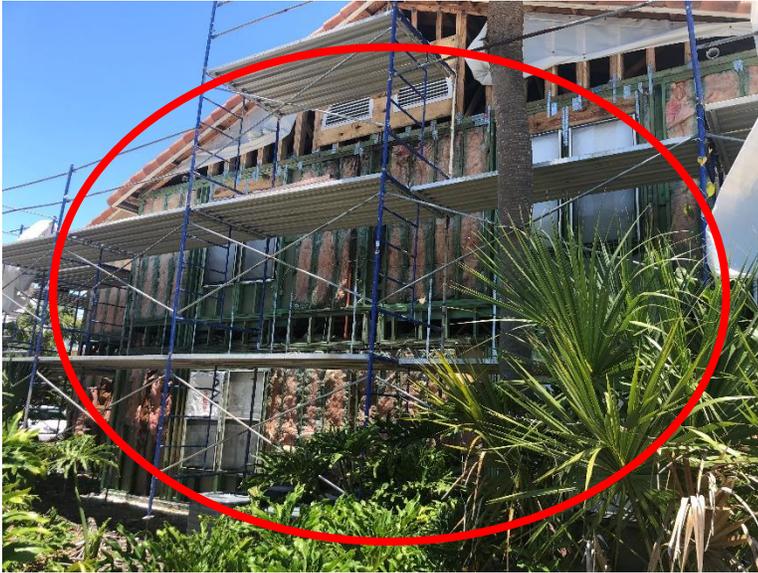
PHOTOGRAPH #27

**BUILDING 8
SECTION D**

Bora-Care Termite treatment applied to framing and New Simpson Strong-Tie connectors installed as per drawings.

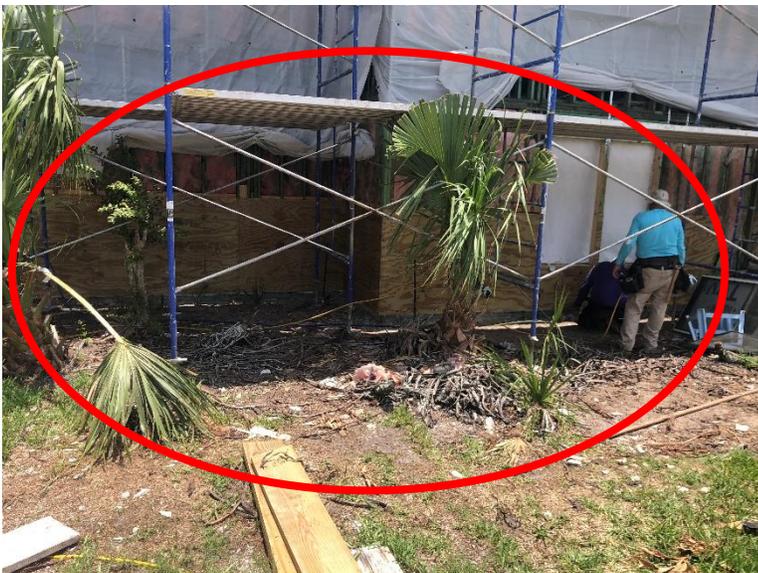
PHOTOGRAPH #28

**BUILDING 8
SECTION D**

Contractor has begun placing new pressure treated plywood sheathing at bottom row as per specifications.

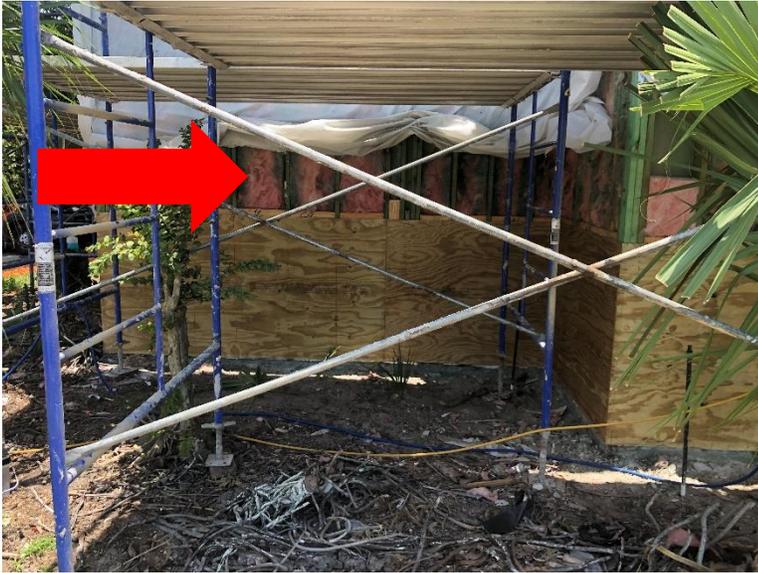
PHOTOGRAPH #29

**BUILDING 8
SECTION H**

New R-19 insulation installed where damaged or missing.

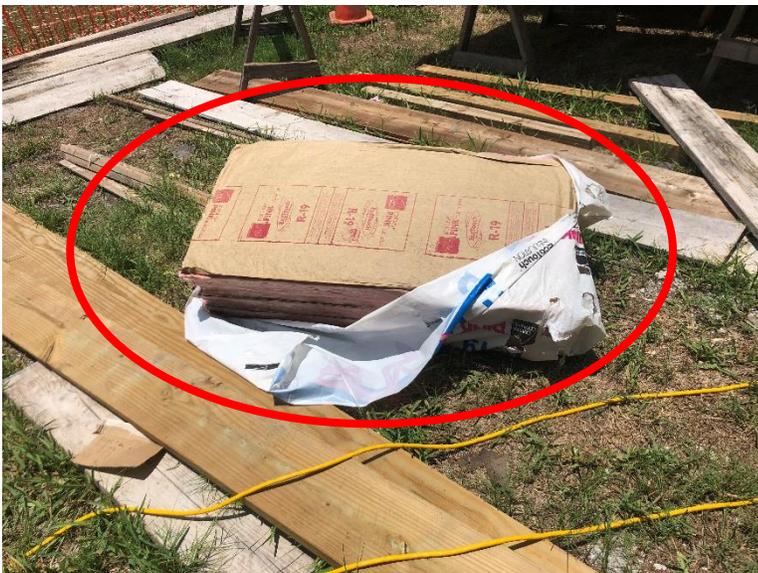
PHOTOGRAPH #30

**BUILDING 8
SECTION H**

New Owens Corning R-19 insulation installed where damaged or missing.

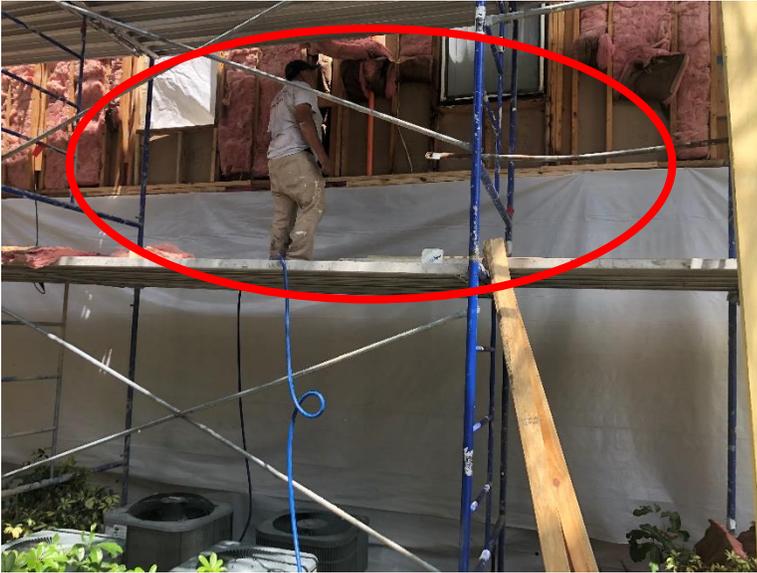
PHOTOGRAPH #31

**BUILDING 13
SECTION H**

Contractor has begun framing repairs at top plate and windows of gable end wall.
