PHOTOGRAPHS

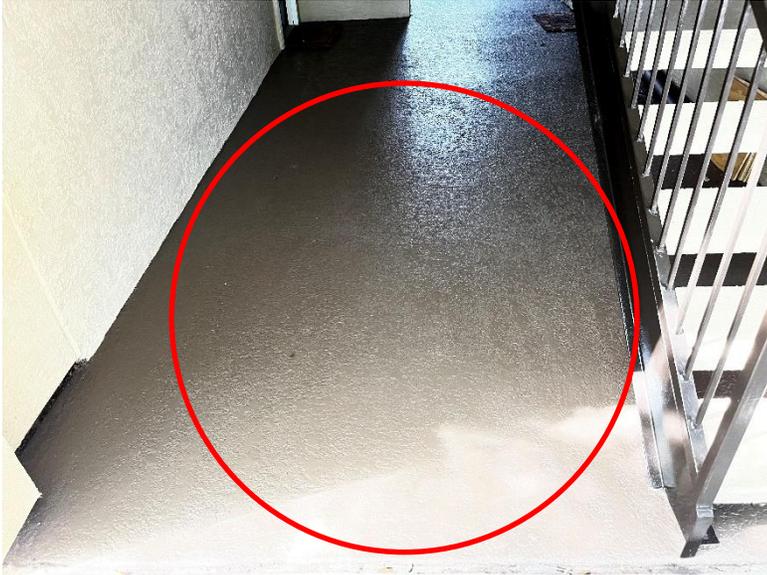
PHOTOGRAPH #1

**BUILDING 7
SECTION A- BREEZEWAY**

Floor paint has been repainted where damaged by rain.

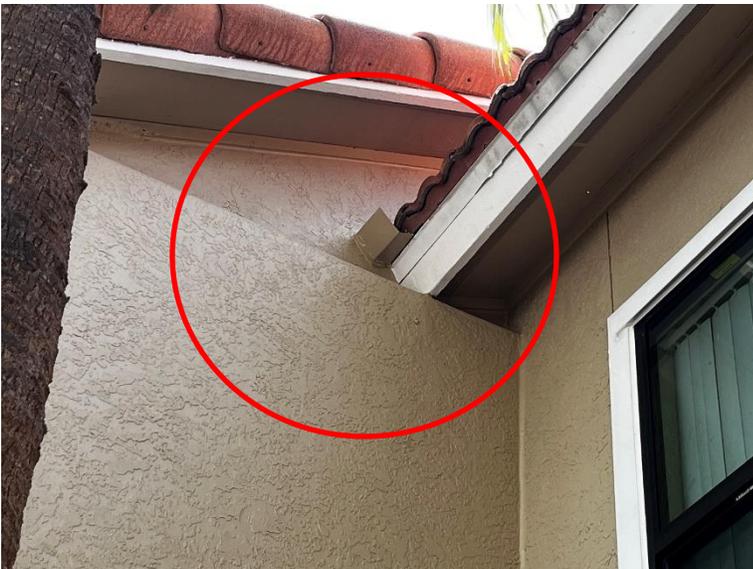
PHOTOGRAPH #2

**BUILDING 7
SECTION B**

Roof to wall kick out flashings have been repaired as per drawings and specifications.

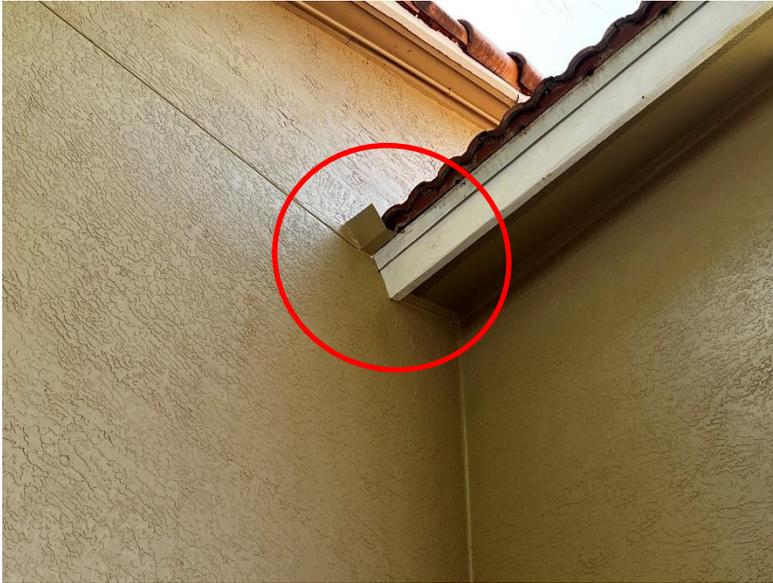
PHOTOGRAPH #3

**BUILDING 7
SECTION D**

Roof to wall kick out flashings have been repaired as per drawings and specifications.

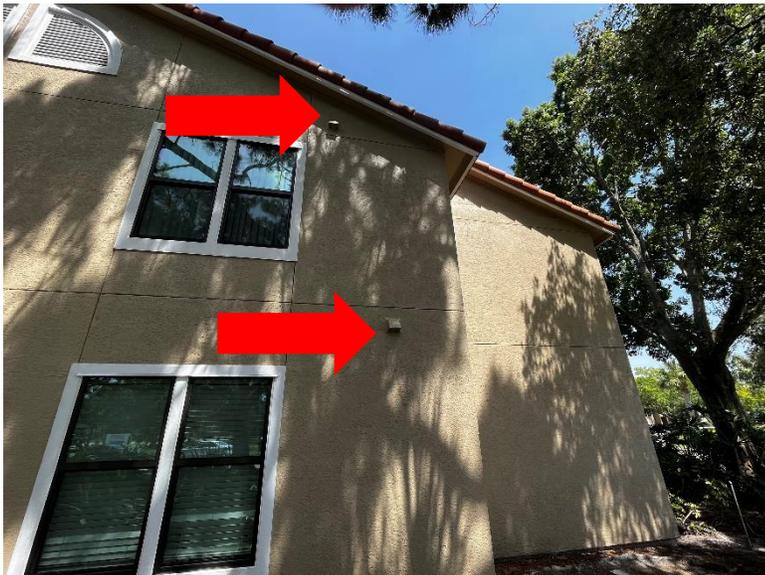
PHOTOGRAPH #4

**BUILDING 7
SECTION H**

Missing dryer vents have been installed.

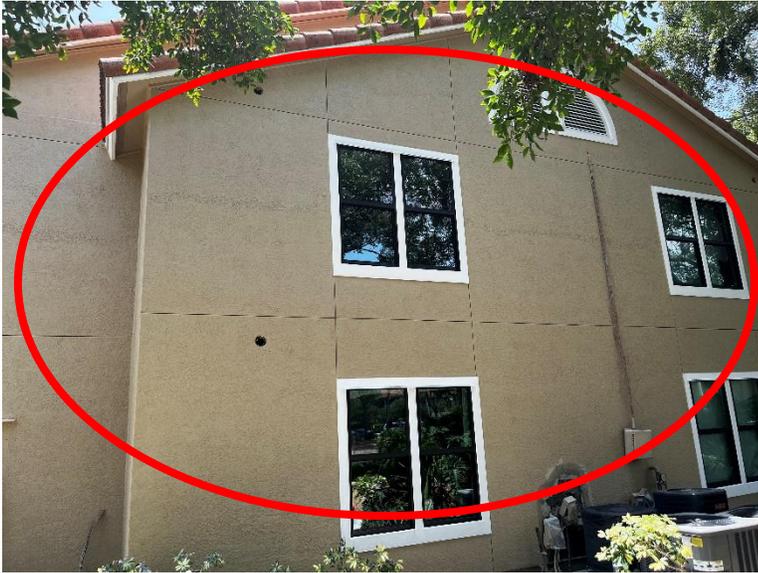
PHOTOGRAPH #5

**BUILDING 8
SECTION H**

Contractor has substantially completed painting and removed access scaffolding.

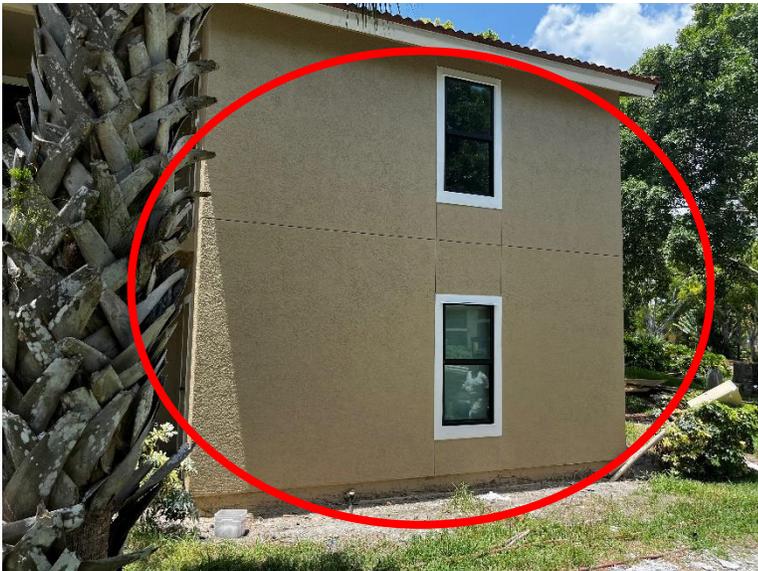
PHOTOGRAPH #6

**BUILDING 8
SECTION G**

Contractor has substantially completed painting and removed access scaffolding.

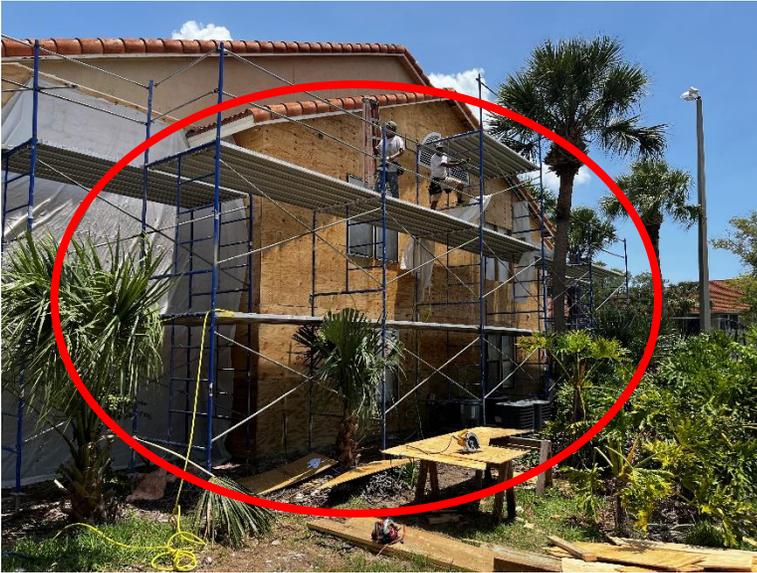
PHOTOGRAPH #7

**BUILDING 8
SECTION D**

Contractor in process of installing 15/32" plywood sheathing at gable end wall.

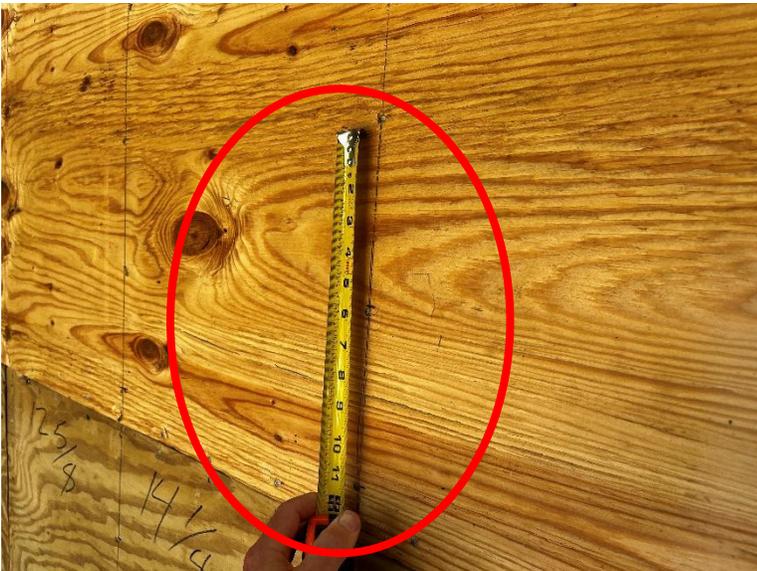
PHOTOGRAPH #8

**BUILDING 8
SECTION D**

Sheathing fastened to framing with 8d nailed spaced at 6" O.C. along interior studs as per drawings.

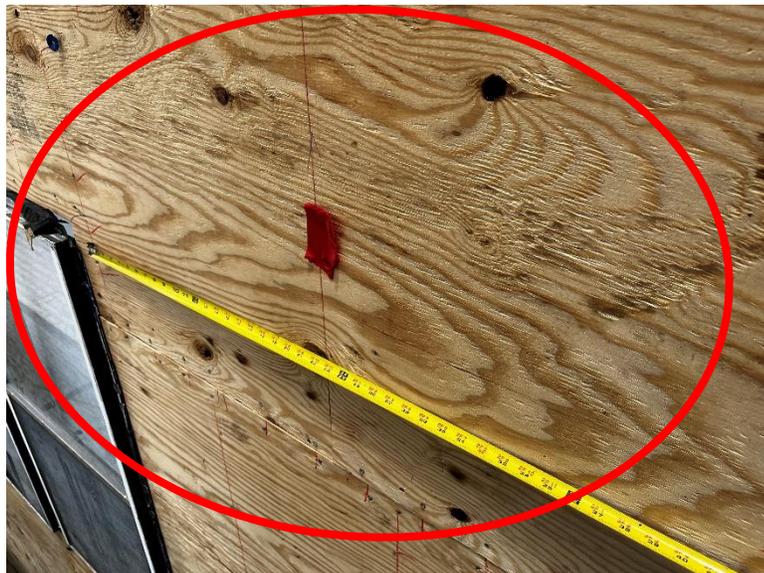
PHOTOGRAPH #9

**BUILDING 8
SECTION D**

Nailing of sheathing missed and not attached to framing, marked for corrections.

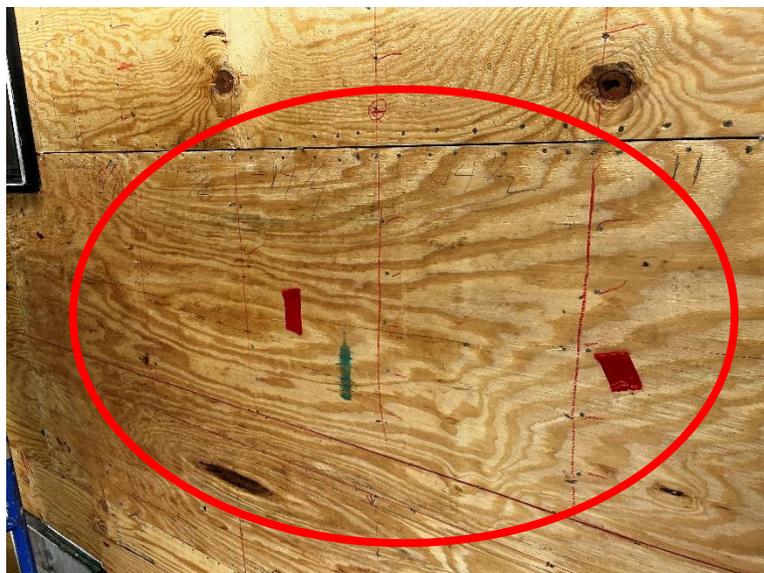
PHOTOGRAPH #10

**BUILDING 8
SECTION D**

Contractor has made corrections by nailing new plywood at each stud 16" O.C. as per drawings.

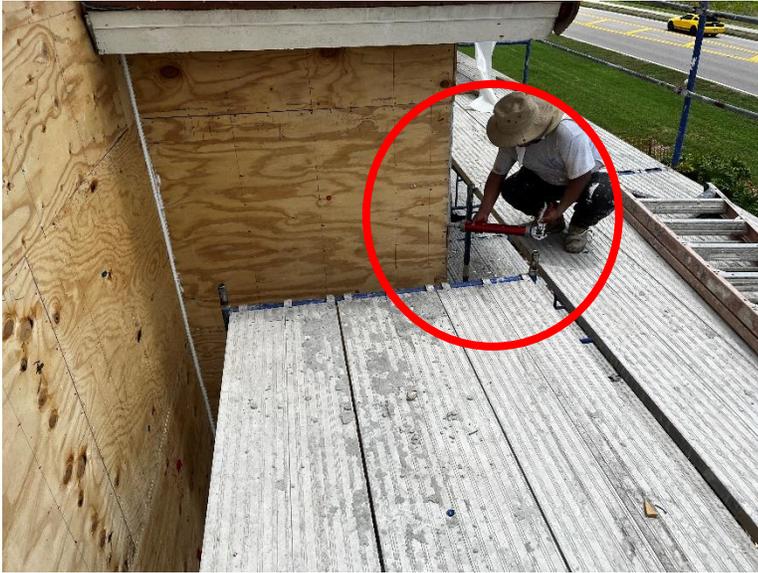
PHOTOGRAPH #11

**BUILDING 8
SECTION D**

Contractor applying MasterSeal NP 150 sealant at gaps between plywood larger than 1/4".

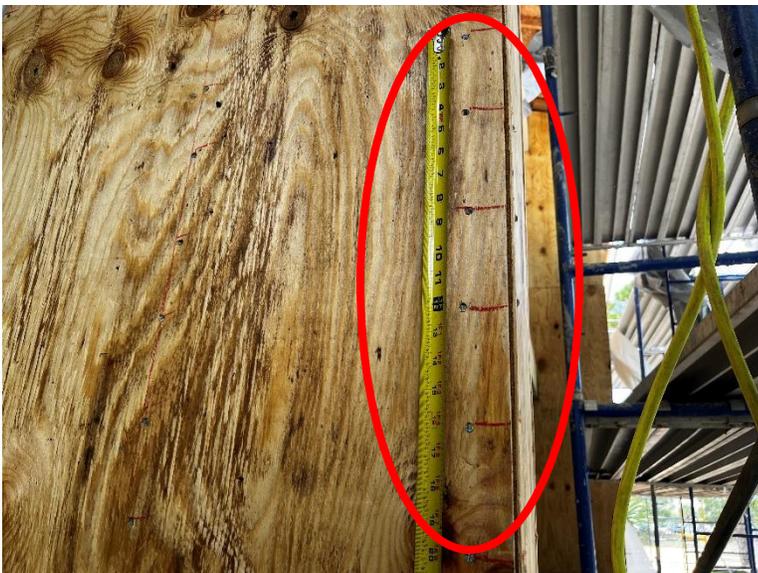
PHOTOGRAPH #12

**BUILDING 8
SECTION C**

Sheathing fastened to framing at perimeter with 8d nailed spaced at 4" O.C. along interior studs as per drawings.

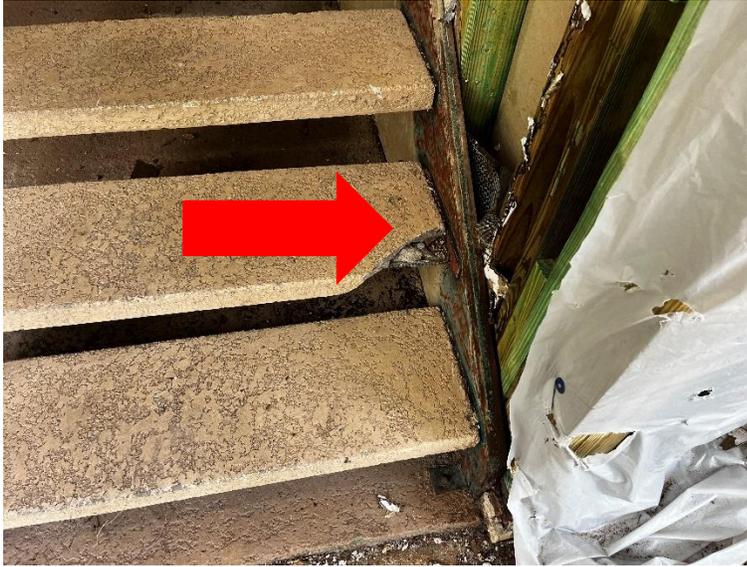
PHOTOGRAPH #13

**BUILDING 8
SECTION C**

Breezeway stairway concrete stair pad broken and will require repairs.

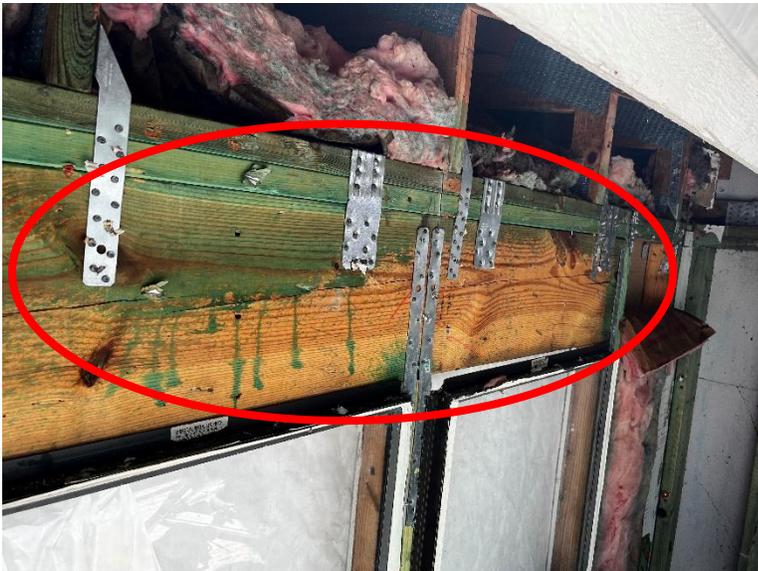
PHOTOGRAPH #14

**BUILDING 8
SECTION B**

Unit #825 -BoraCare termite product not fully applied to window header as required.

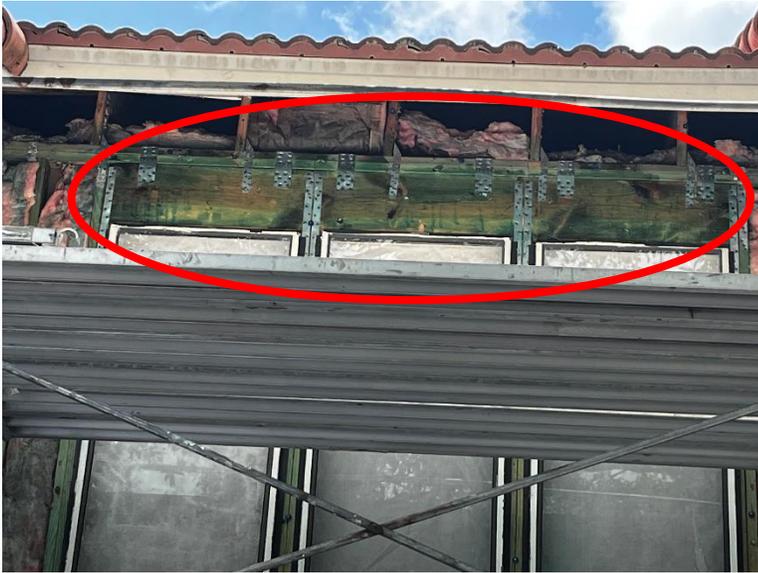
PHOTOGRAPH #15

**BUILDING 8
SECTION B**

Unit #825 - Contractor has returned and hand applied BoraCare termite product where missed.

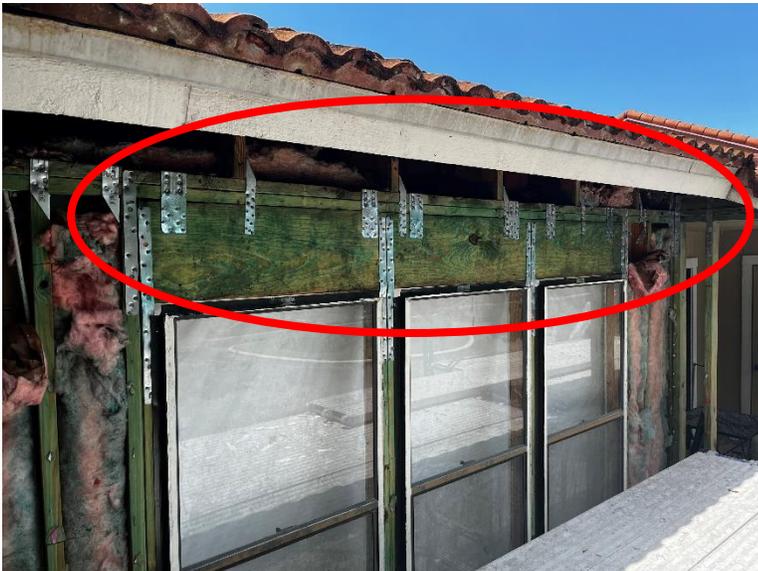
PHOTOGRAPH #16

**BUILDING 8
SECTION B**

Simpson Strong-Tie connectors and screws in place at studs, headers, top plates, and truss connections as per drawings.

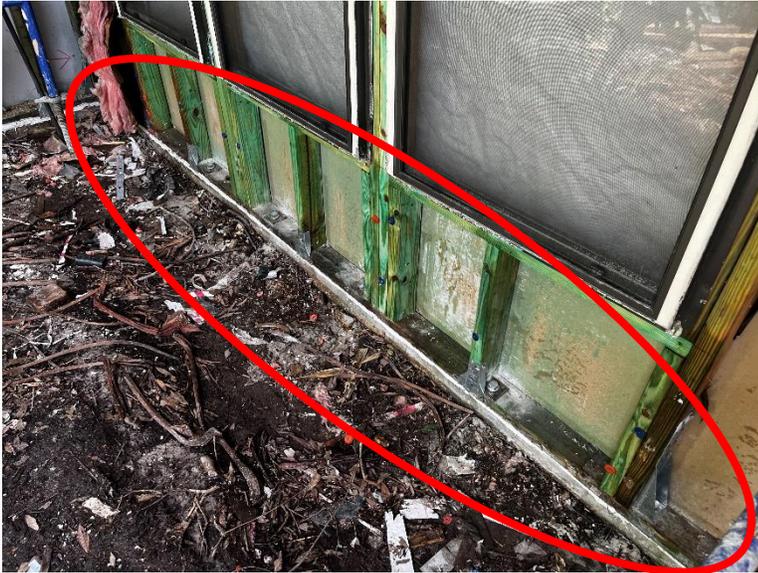
PHOTOGRAPH #17

**BUILDING 8
SECTION B**

Simpson Strong-Tie connectors and anchors in place at framing studs, cripple studs, and bottom plates as per drawings.

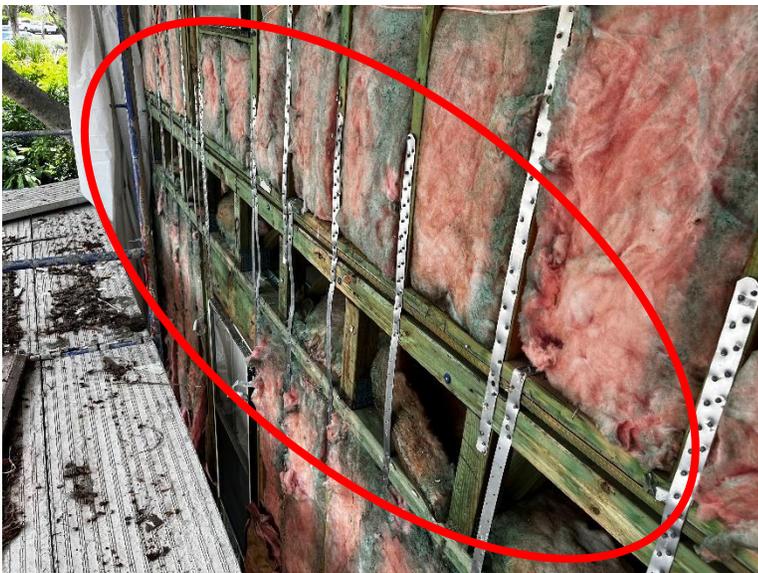
PHOTOGRAPH #18

**BUILDING 8
SECTION A**

Simpson Strong-Tie strap connectors in place at each framing studs as per drawings between floors.

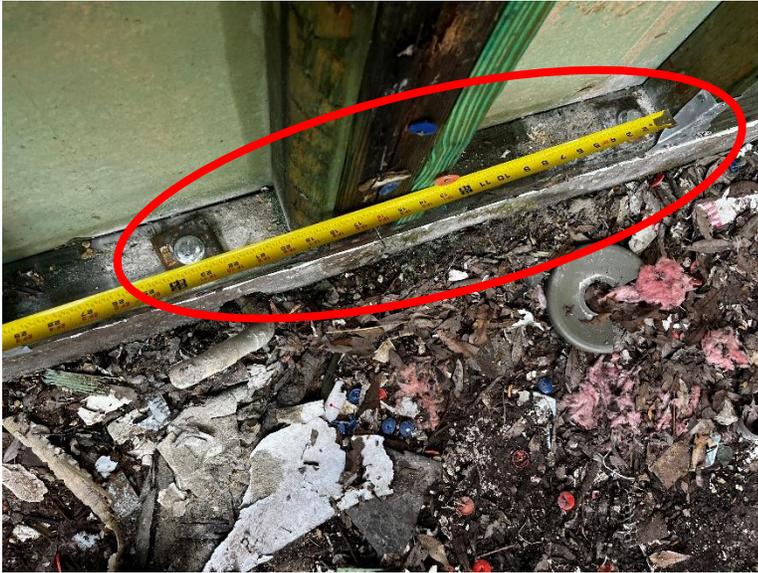
PHOTOGRAPH #19

**BUILDING 8
SECTION A**

Simpson Strong-Tie Titen HD anchors installed at 24" O.C. max. as per drawings.

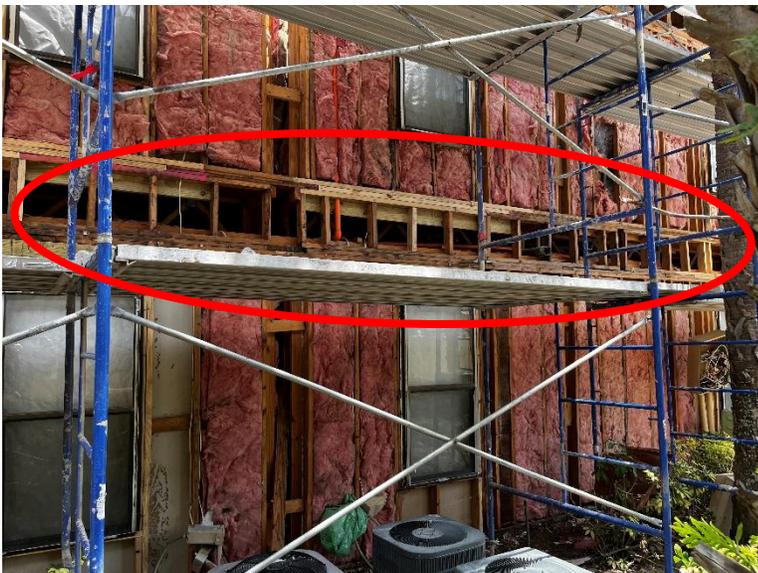
PHOTOGRAPH #20

**BUILDING 13
SECTION H**

Second floor bottom plate framing and Sub floor repairs reviewed and quantified.

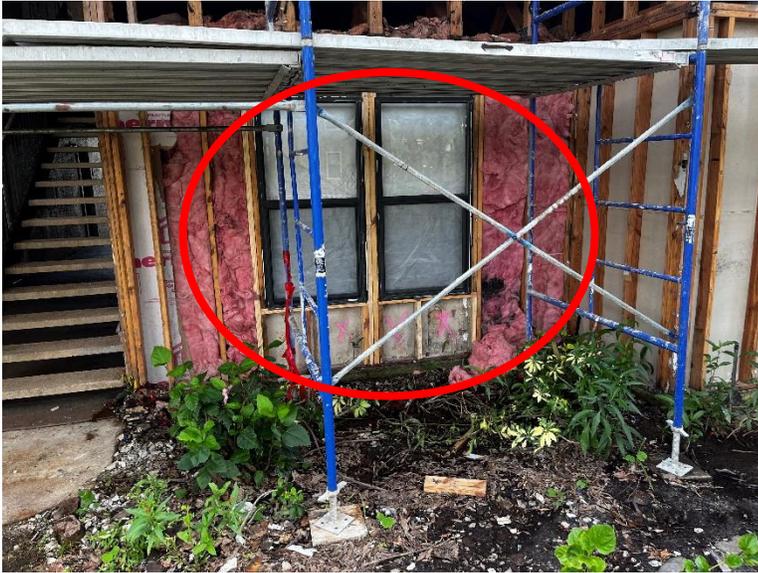
PHOTOGRAPH #21

**BUILDING 13
SECTION G**

Unit #1312- Window framing repairs performed by contractor and quantified.

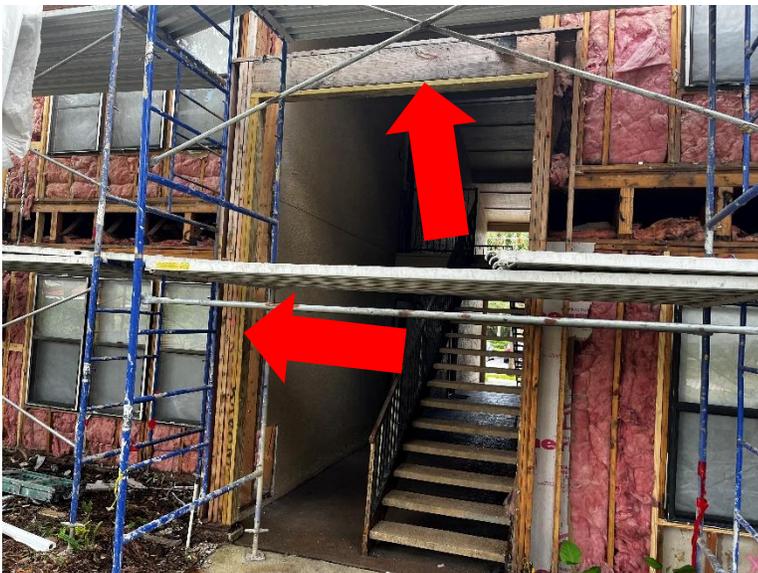
PHOTOGRAPH #22

**BUILDING 13
SECTION G**

Damaged post and box beam framing replaced at breezeway.

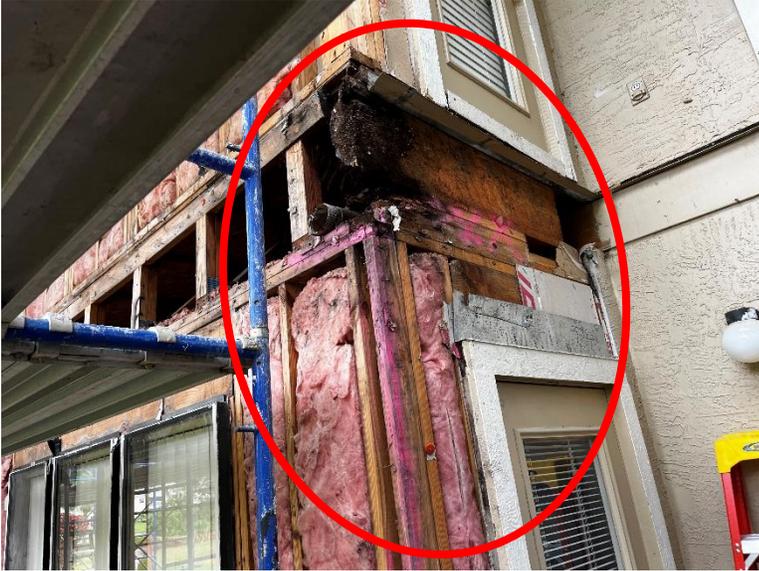
PHOTOGRAPH #23

**BUILDING 13
SECTION F**

Unit #1326- Contractor has begun repairs at damaged balcony framing support.

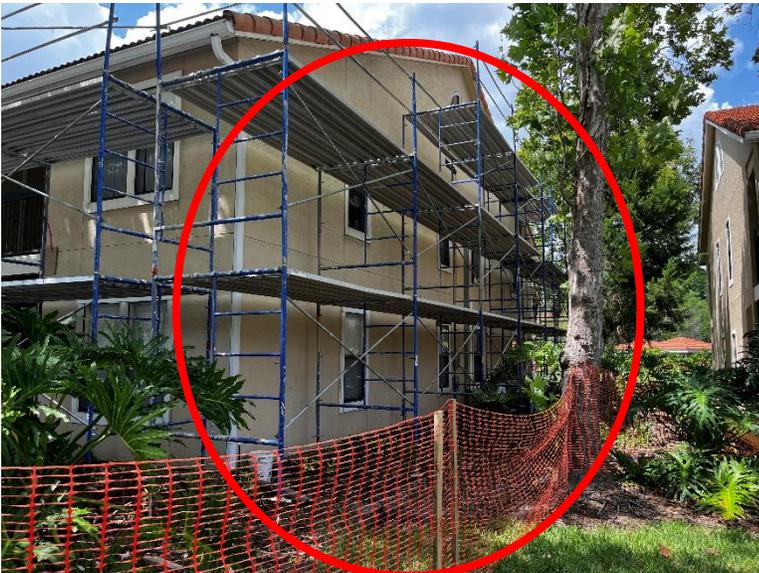
PHOTOGRAPH #24

**BUILDING 13
SECTION D**

Contractor has built access scaffolding and secured work areas with construction fencing.

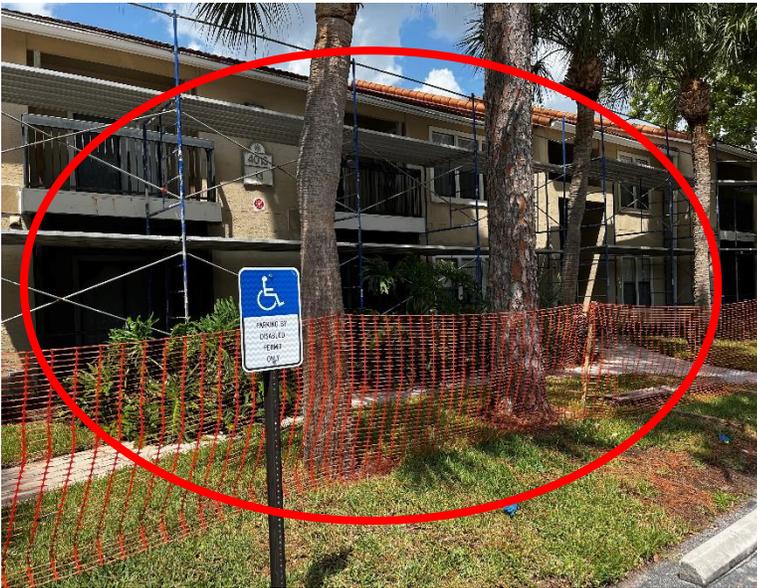
PHOTOGRAPH #25

**BUILDING 13
SECTION B**

Contractor has built access scaffolding and secured work areas with construction fencing.

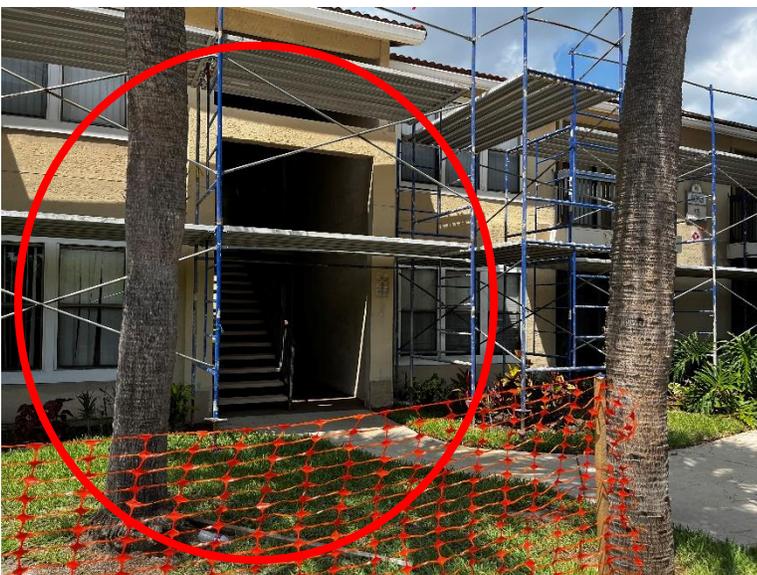
PHOTOGRAPH #26

**BUILDING 13
SECTION A**

Contractor has built access scaffolding and secured work areas with construction fencing.
