PHOTOGRAPHS

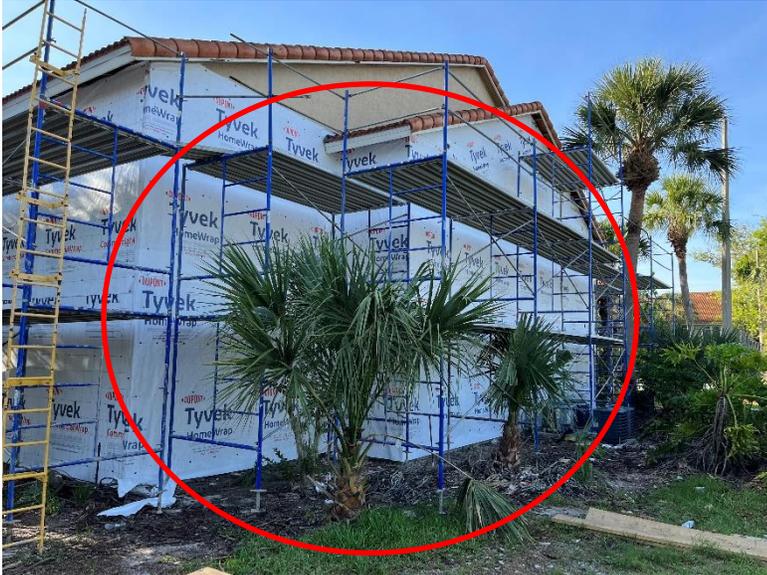
PHOTOGRAPH #1

**BUILDING 8  
SECTION D**

New plywood sheathing covered with Dupont Tyvek HomeWrap as first layer of water-resistant barrier.

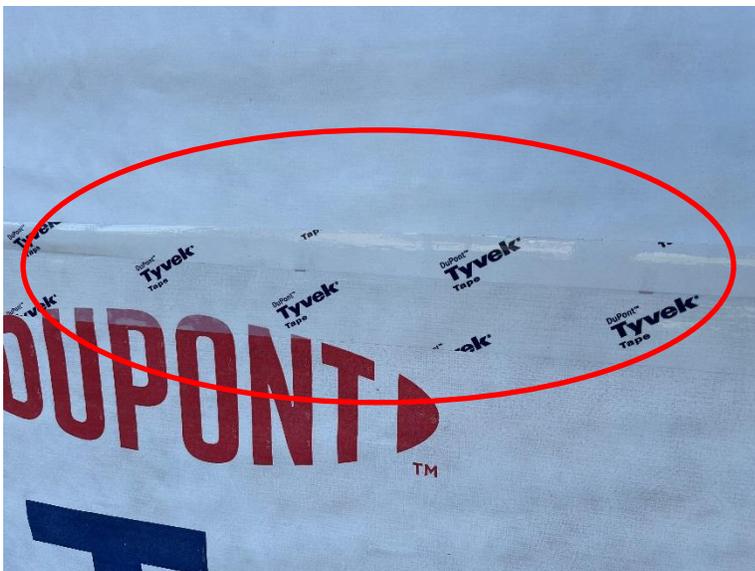
PHOTOGRAPH #2

**BUILDING 8  
SECTION D**

3" Tyvek seam tape applied at all seams as per manufacturers requirements.

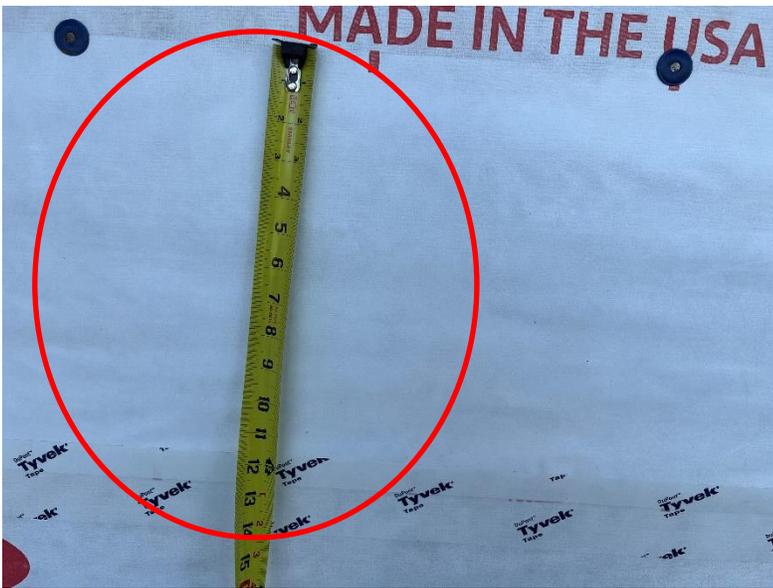
**PHOTOGRAPH #3**

**BUILDING 8  
SECTION D**

Contractor has overlapped Dupont Tyvek HomeWrap WRB sheets 12”.

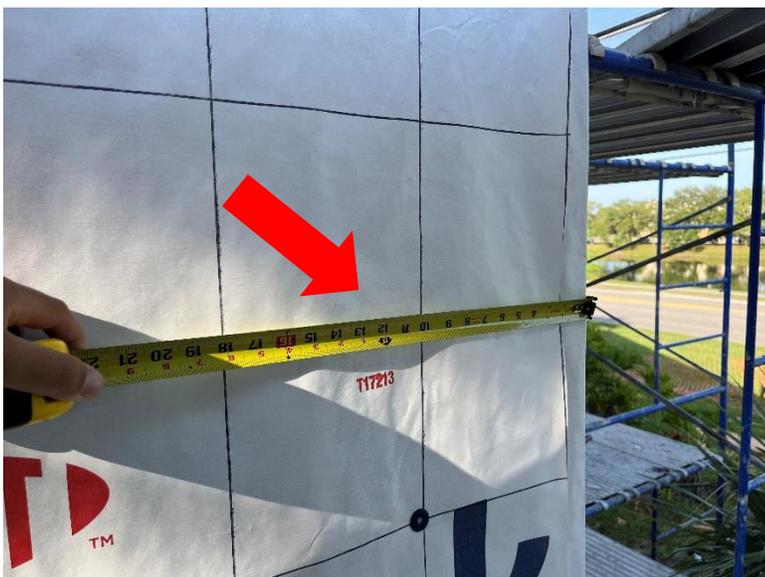
**PHOTOGRAPH #4**

**BUILDING 8  
SECTION D**

Contractor has overlapped Dupont Tyvek HomeWrap WRB sheets 12”.

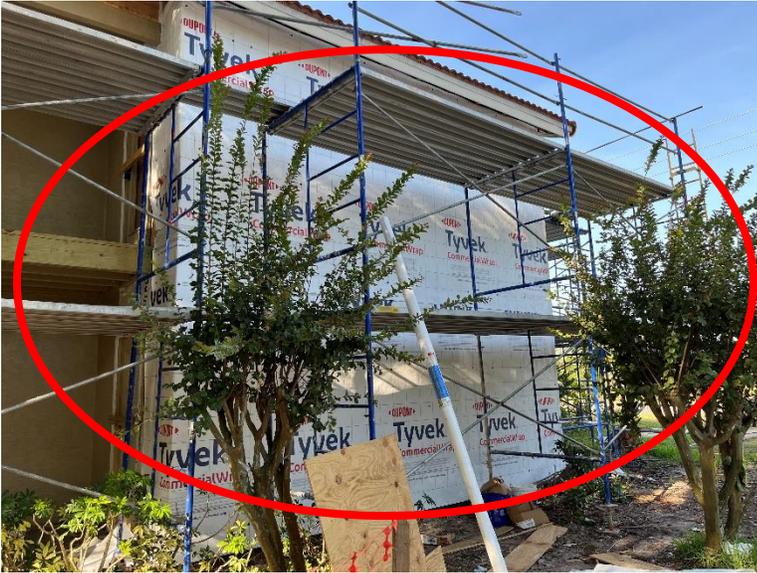
**PHOTOGRAPH #5**

**BUILDING 8  
SECTION C**

New plywood sheathing covered with Dupont Tyvek CommercialWrap as first layer of water-resistant barrier.

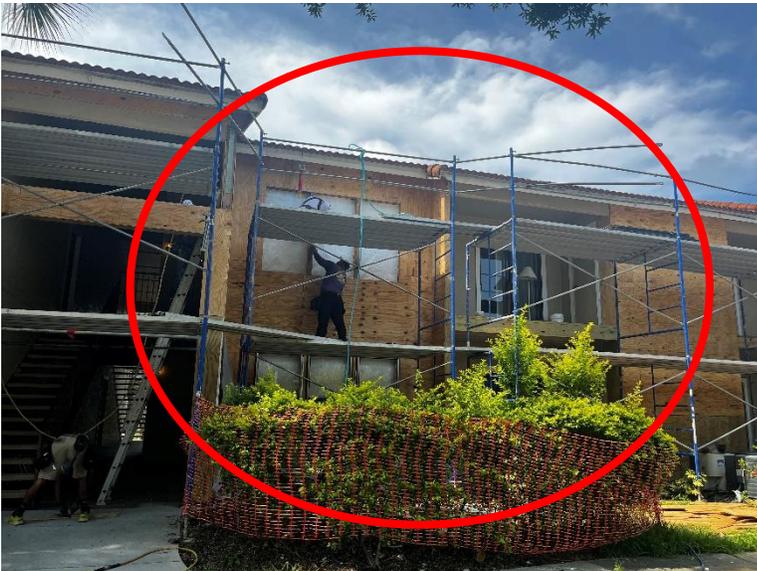
**PHOTOGRAPH #6**

**BUILDING 8  
SECTION B**

Contractor fastening new plywood to framing with 8d common nails.

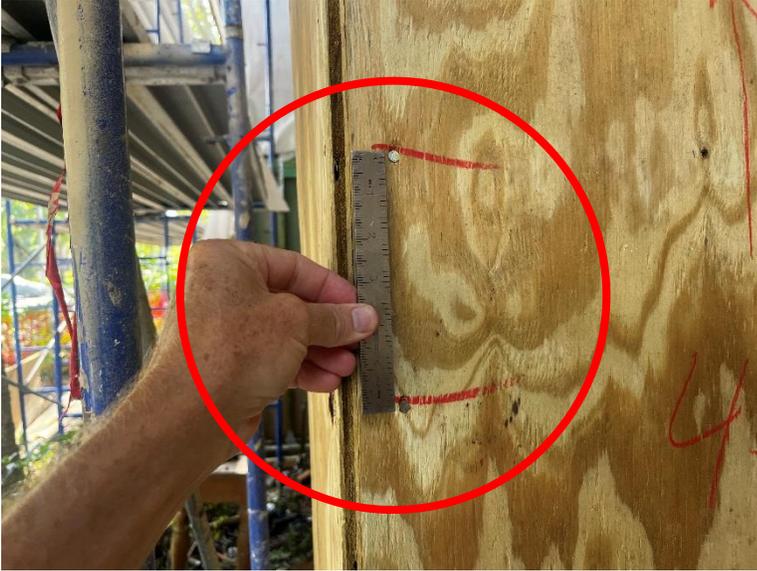
**PHOTOGRAPH #7**

**BUILDING 8  
SECTION B**

Contractor improperly fastened plywood perimeter at 6" O.C. where required to be at 4" O.C.

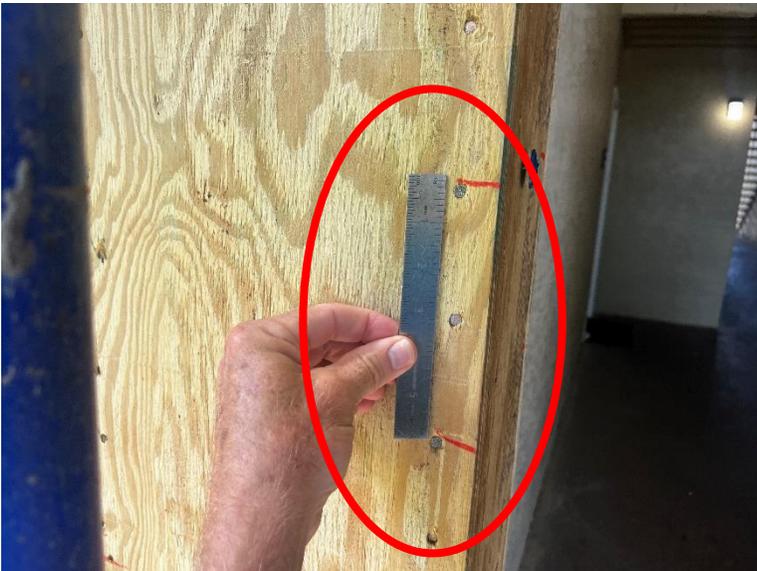
**PHOTOGRAPH #8**

**BUILDING 8  
SECTION B**

Contractor has made corrections by adding more fasteners where improperly fastening plywood perimeter at 6" O.C.

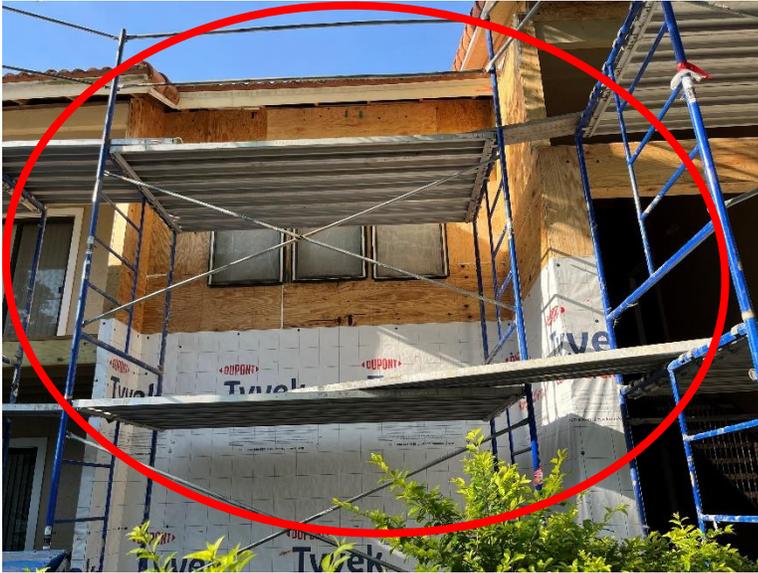
**PHOTOGRAPH #9**

**BUILDING 8  
SECTION B**

Contractor has begun application of Dupont Tyvek CommercialWrap as first layer of water-resistant barrier.

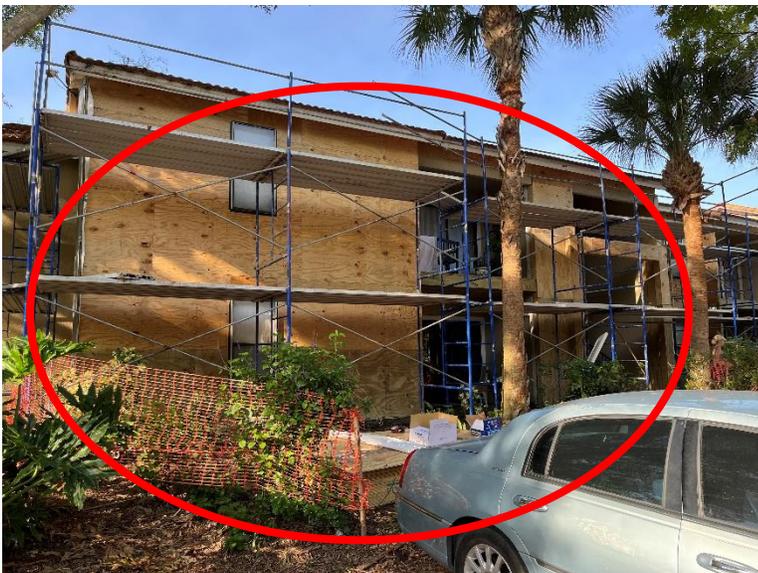
**PHOTOGRAPH #10**

**BUILDING 8  
SECTION A**

Sheathing fastened to framing studs at with 8d nails spaced at 4" O.C. min. at perimeters of sheets and 6" O.C. min. in field as per drawings.

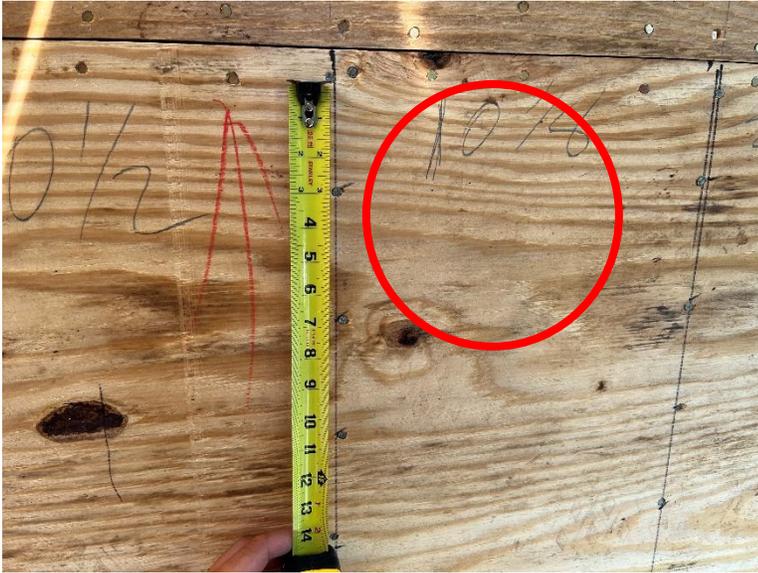
**PHOTOGRAPH #11**

**BUILDING 8  
SECTION A**

Sheathing fastened to framing studs at with 8d nails spaced at 4" O.C. min. at perimeters of sheets and 6" O.C. min. in field as per drawings.

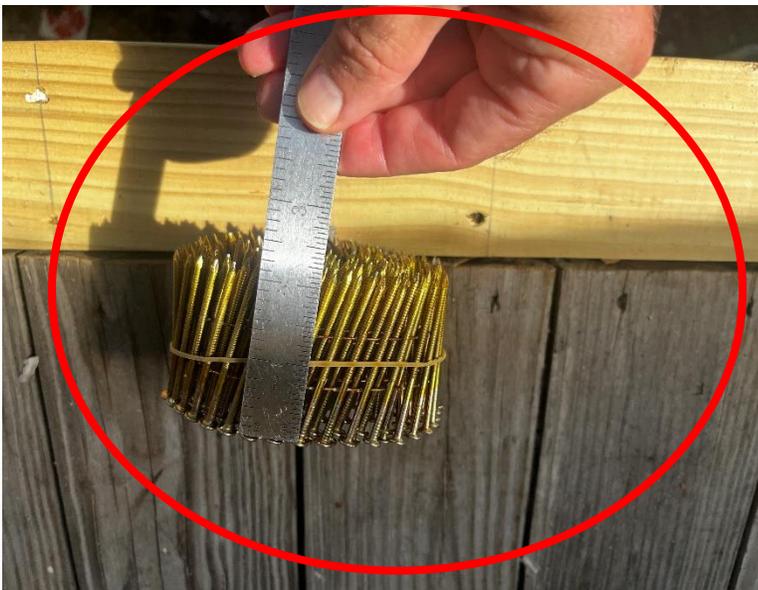
**PHOTOGRAPH #12**

**BUILDING 8  
SECTION A**

8d common nails attaching new sheathing to framing as per drawings.

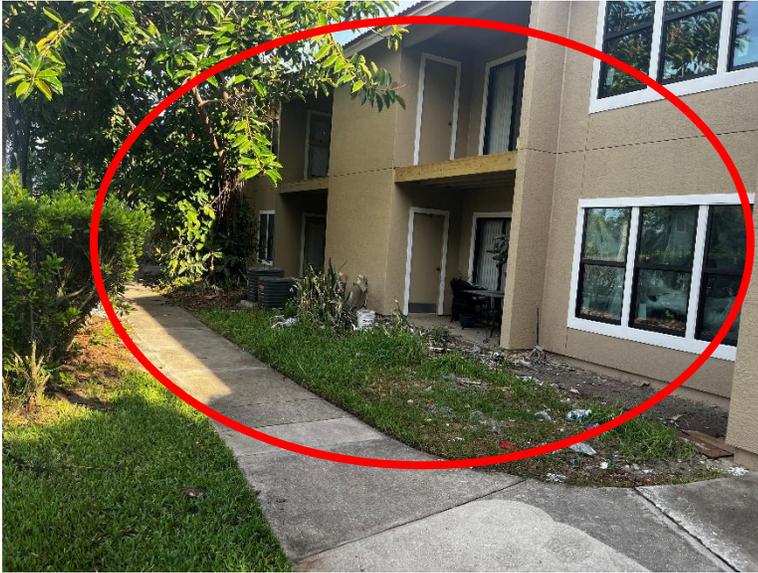
**PHOTOGRAPH #13**

**BUILDING 8  
SECTION F**

Contractor has removed access scaffolding and in process of cleaning site.

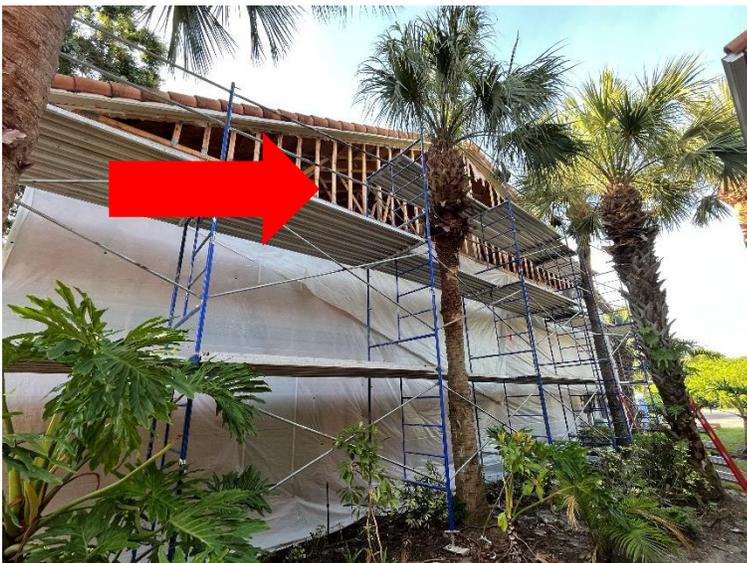
**PHOTOGRAPH #14**

**BUILDING 13  
SECTION H**

Contractor preparing to start gable end reinforcement at trusses.

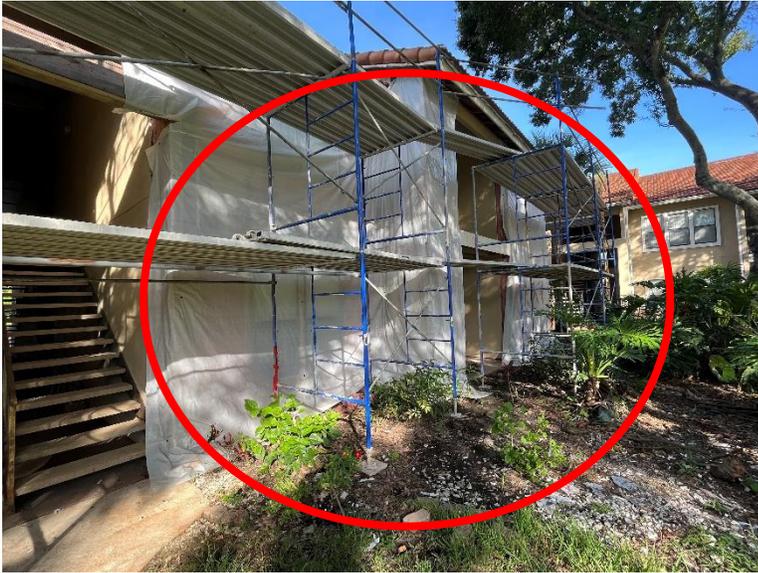
**PHOTOGRAPH #15**

**BUILDING 13  
SECTION G**

Open walls have been protected with heavy plastic sheathing.

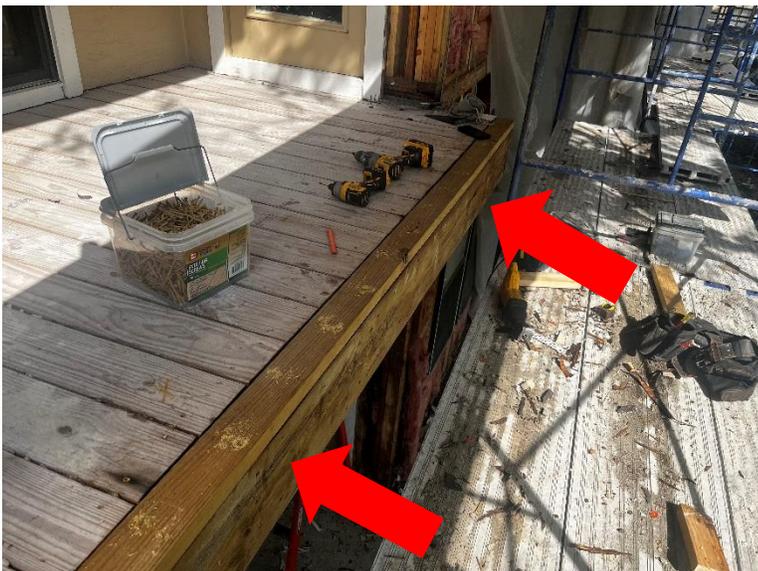
**PHOTOGRAPH #16**

**BUILDING 13  
SECTION F**

**Unit #1324-** Warranty work at built up beam is in progress using pressure treated lumber as per specifications.

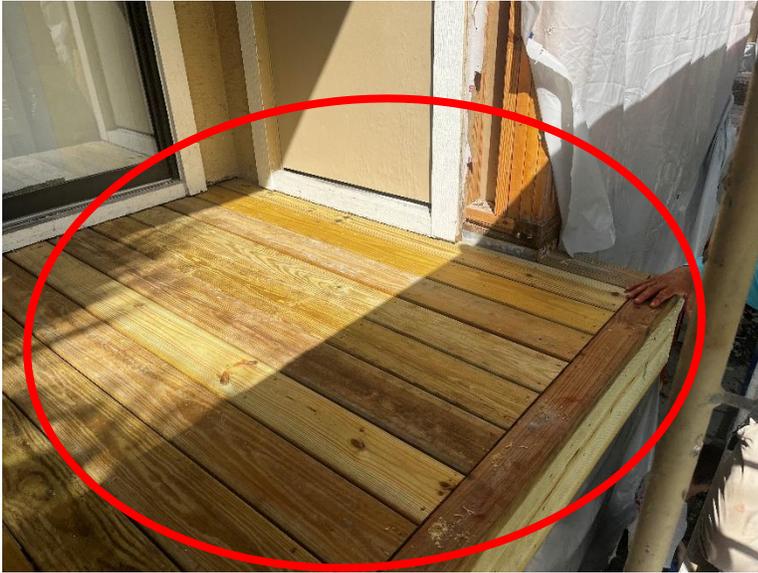
**PHOTOGRAPH #17**

**BUILDING 13  
SECTION F**

**Unit #1326-** Contractor has replaced deck boards and replaced damaged built-up beam.

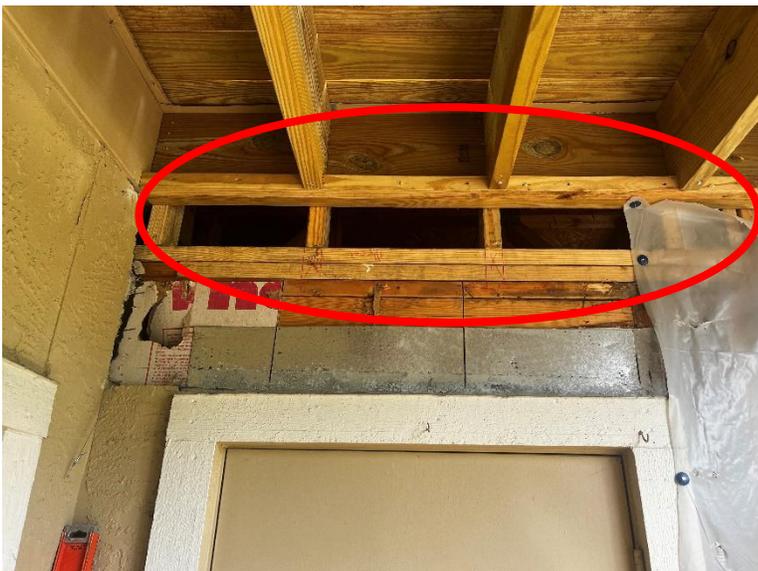
**PHOTOGRAPH #18**

**BUILDING 13  
SECTION F**

**Unit #1326-** Contractor has replaced original damaged cedar framing with new 16" O.C. framing studs and top plates.

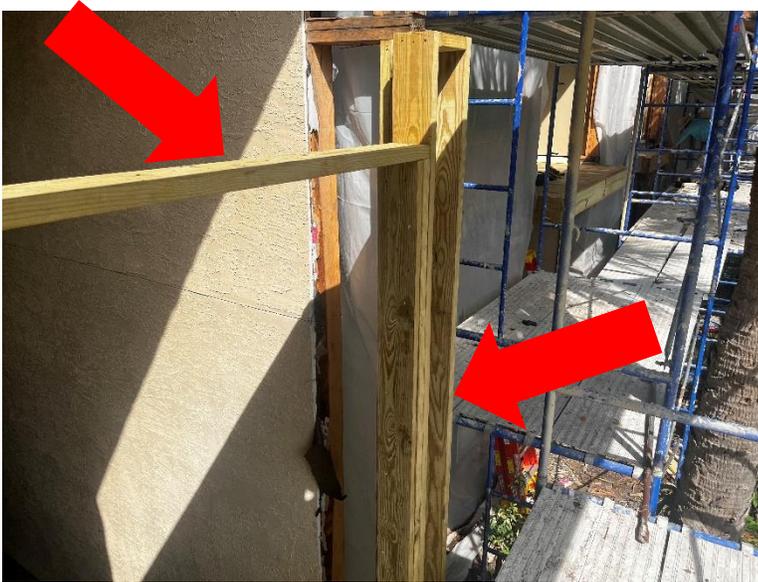
**PHOTOGRAPH #19**

**BUILDING 13  
SECTION E**

Contractor replacing overhead beam and support posts at breezeway.

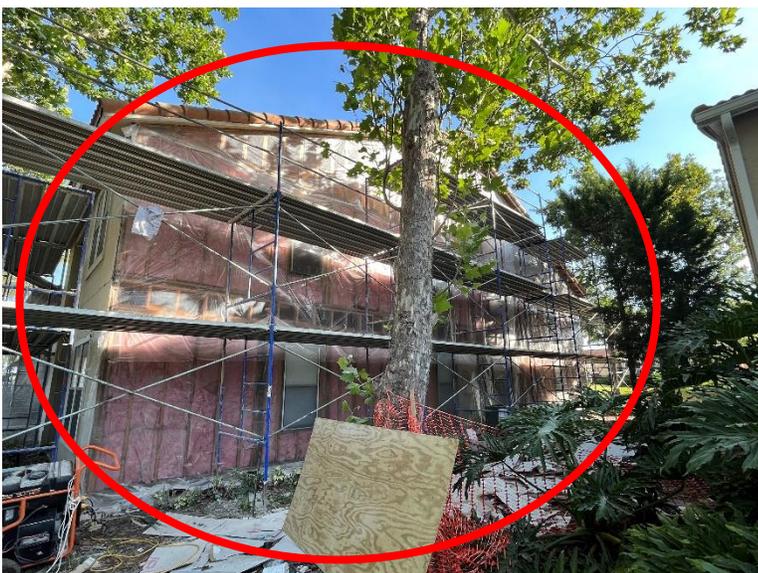
**PHOTOGRAPH #20**

**BUILDING 13  
SECTION D**

Contractor has removed existing stucco and sheathing exposing framing and insulation for damage review.

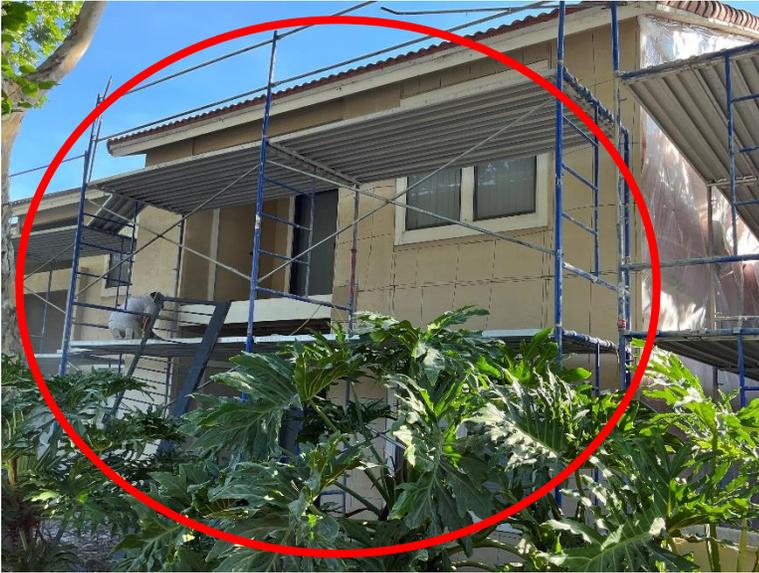
**PHOTOGRAPH #21**

**BUILDING 13  
SECTION C**

Contractor removed balcony railing and began to cut stucco for removal.

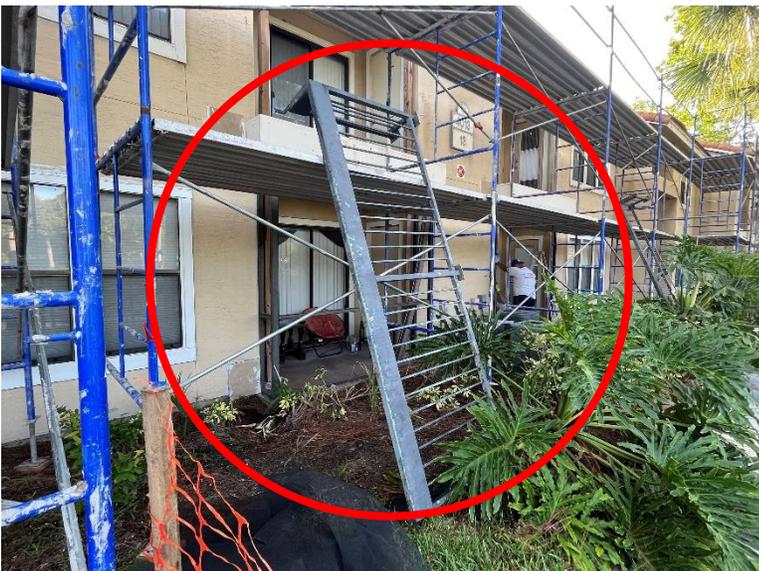
**PHOTOGRAPH #22**

**BUILDING 13  
SECTION B**

Contractor has removed balcony railings for repairs and repainting.

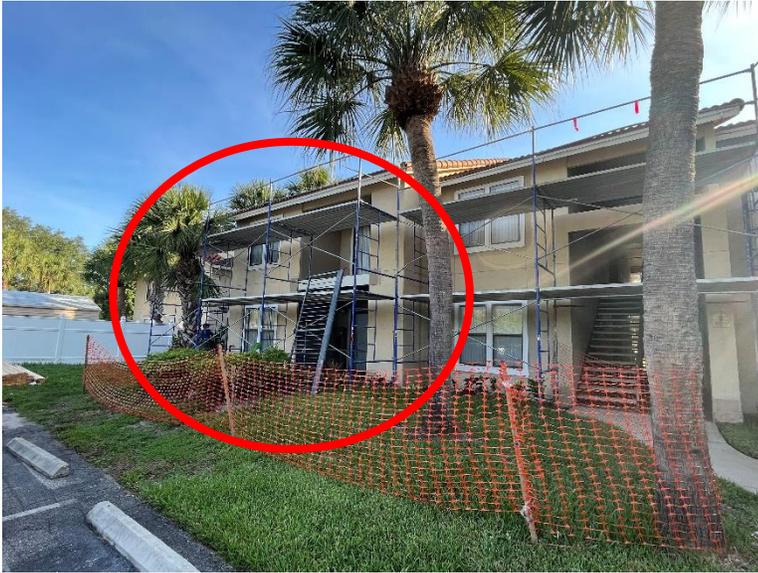
**PHOTOGRAPH #23**

**BUILDING 13  
SECTION A**

Contractor has removed balcony railings for repairs and repainting.

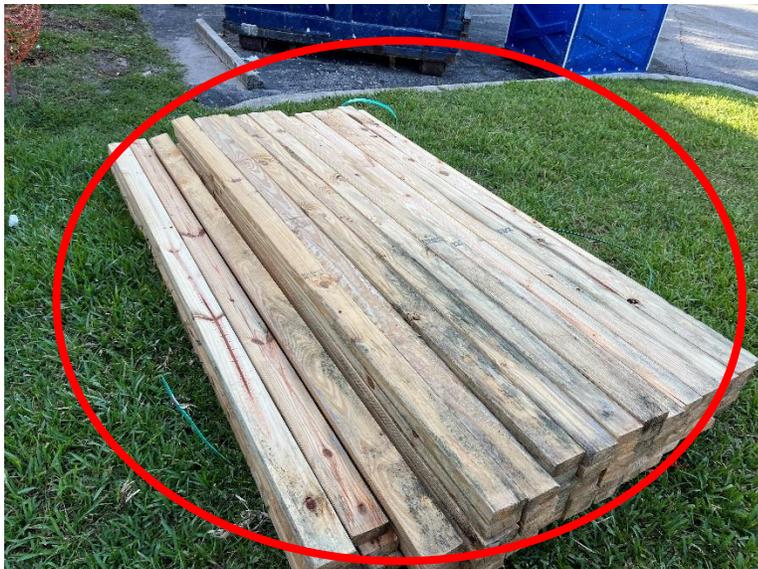
**PHOTOGRAPH #24**

**BUILDING 13  
SECTION A**

Southern Yellow Pine 2"X 4" studs delivered to site.
