PHOTOGRAPHS

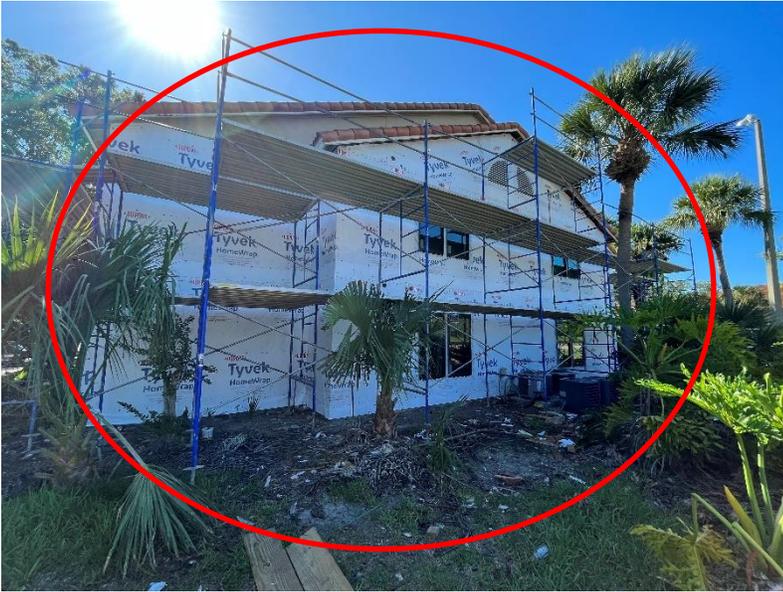
PHOTOGRAPH #1

**BUILDING 8
SECTION D**

New plywood sheathing covered with Dupont Tyvek CommercialWrap as first layer of water-resistant barrier.

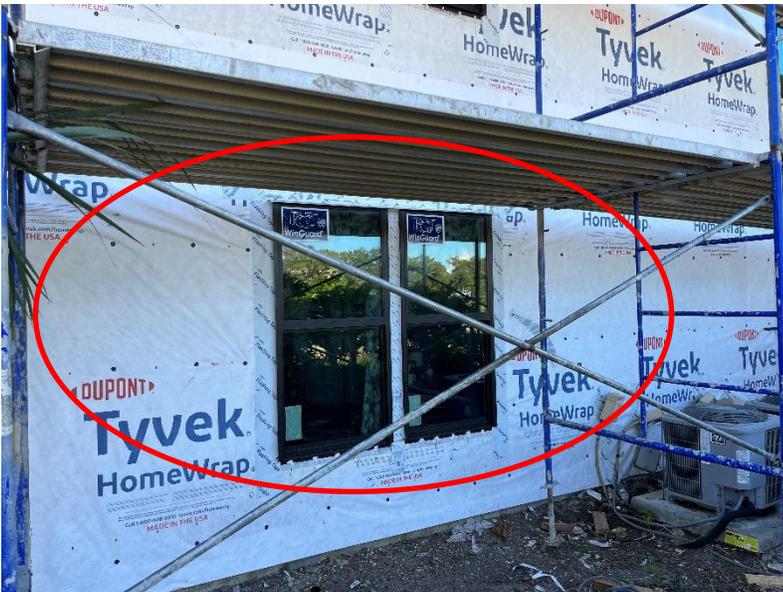
PHOTOGRAPH #2

**BUILDING 8
SECTION D**

New 770 series PGT windows installed and flashed with Dupont flashing materials as per specifications and manufacturers guidelines.

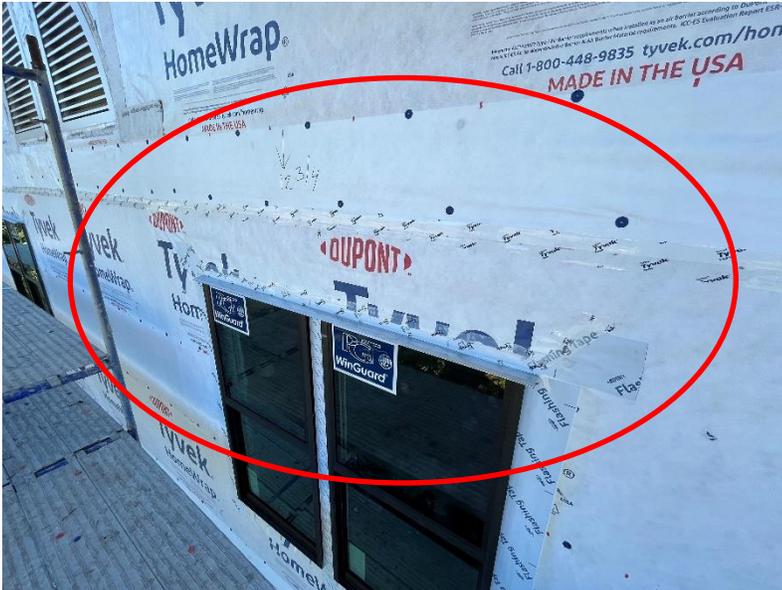
PHOTOGRAPH #3

**BUILDING 8
SECTION D**

As per specifications and manufacturers guidelines, drip edge was installed and flashed properly with Dupont flashing materials.

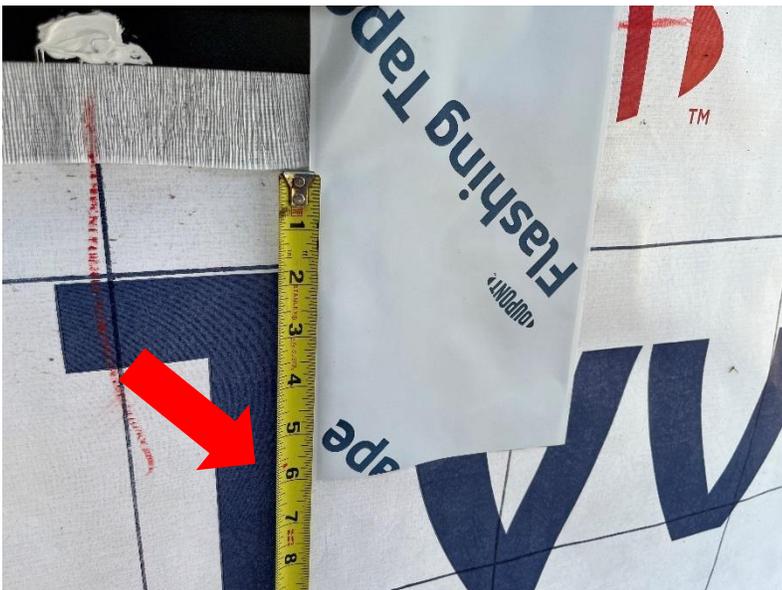
PHOTOGRAPH #4

**BUILDING 8
SECTION D**

Dupont Tyvek Flashing Tape was installed over window flanges and extends past window framing over FlexWrap flashing 6" as specified.

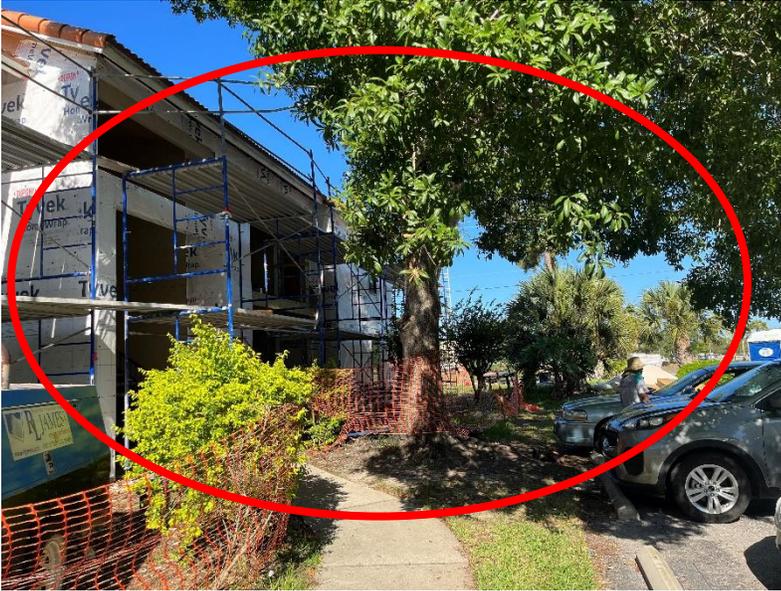
PHOTOGRAPH #5

**BUILDING 8
SECTION C**

New plywood sheathing covered with Dupont Tyvek CommercialWrap as first layer of water-resistant barrier.

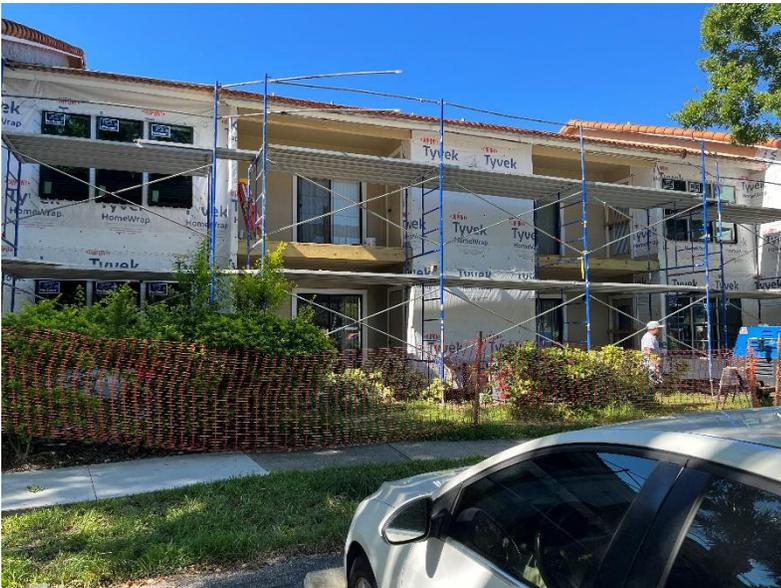
PHOTOGRAPH #6

**BUILDING 8
SECTION B**

New plywood sheathing covered with Dupont Tyvek CommercialWrap as first layer of water-resistant barrier.

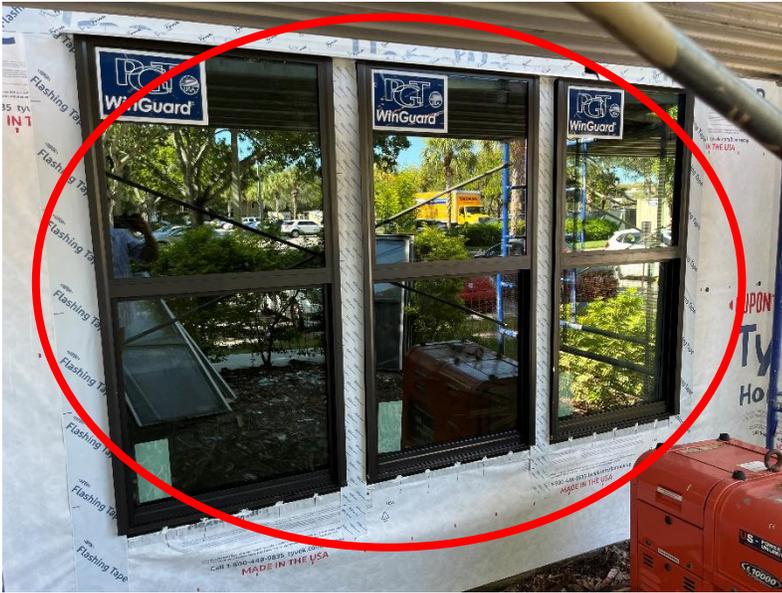
PHOTOGRAPH #7

**BUILDING 8
SECTION B**

New 770 series PGT windows installed and flashed with Dupont flashing materials as per specifications and manufacturers guidelines.

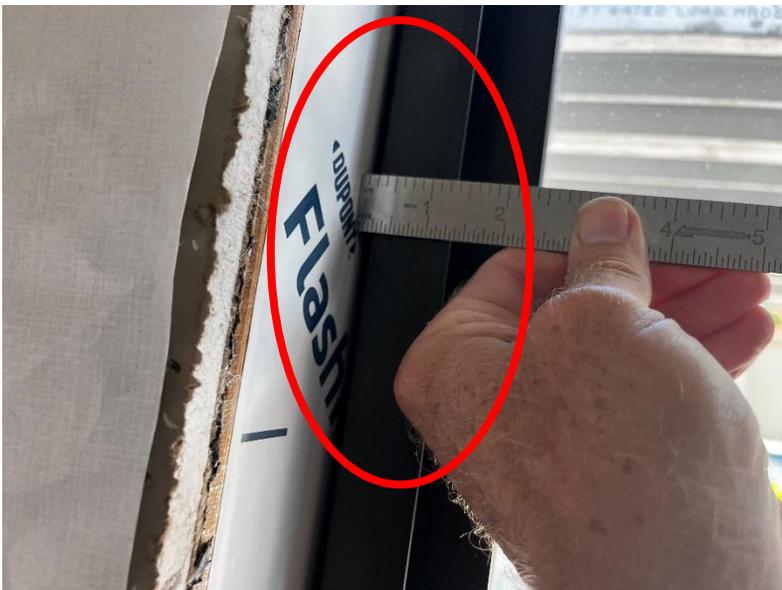
PHOTOGRAPH #8

**BUILDING 8
SECTION B (UNIT 815)**

Gaps from edge of window frame to window jams do not exceed maximum allowed 5/16" as per manufacturers NOA.

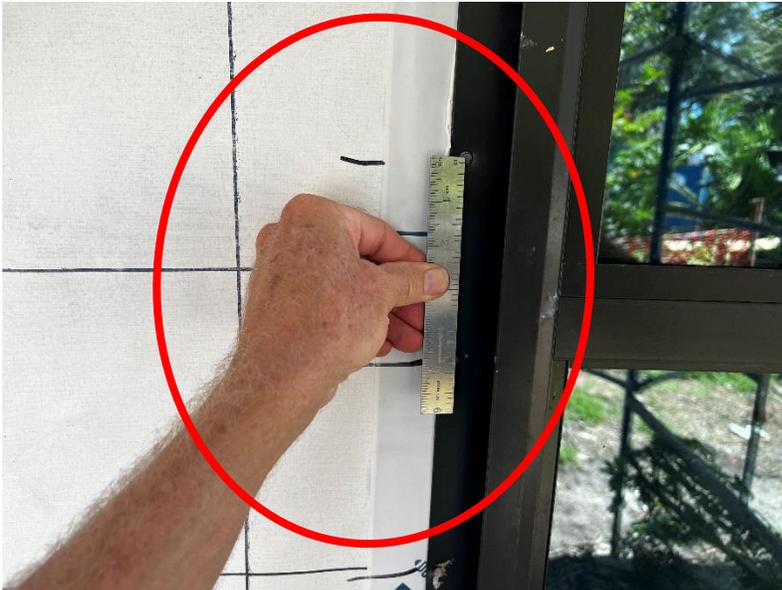
PHOTOGRAPH #9

**BUILDING 8
SECTION B**

Fastening of new window nailed at 5" O.C.
as per Manufactures NOA and
specifications.

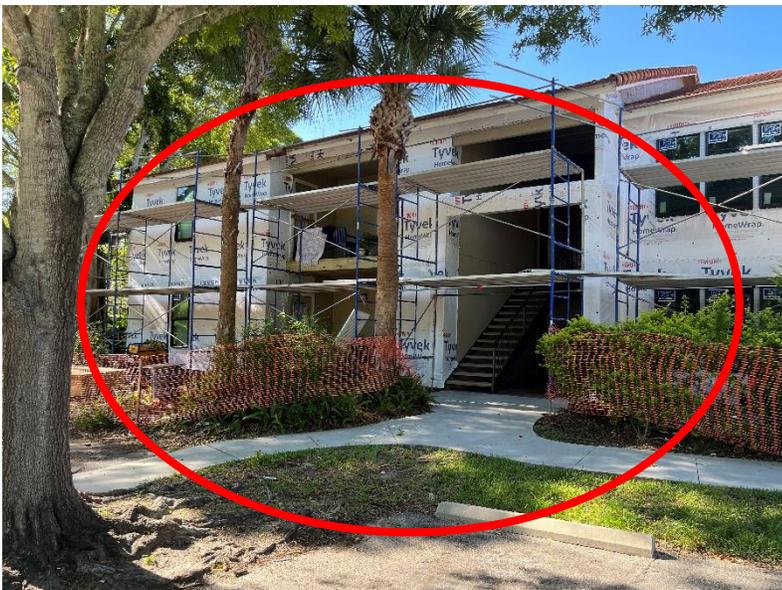
PHOTOGRAPH #10

**BUILDING 8
SECTION A**

New plywood sheathing covered with
Dupont Tyvek CommercialWrap as first
layer of water-resistant barrier.

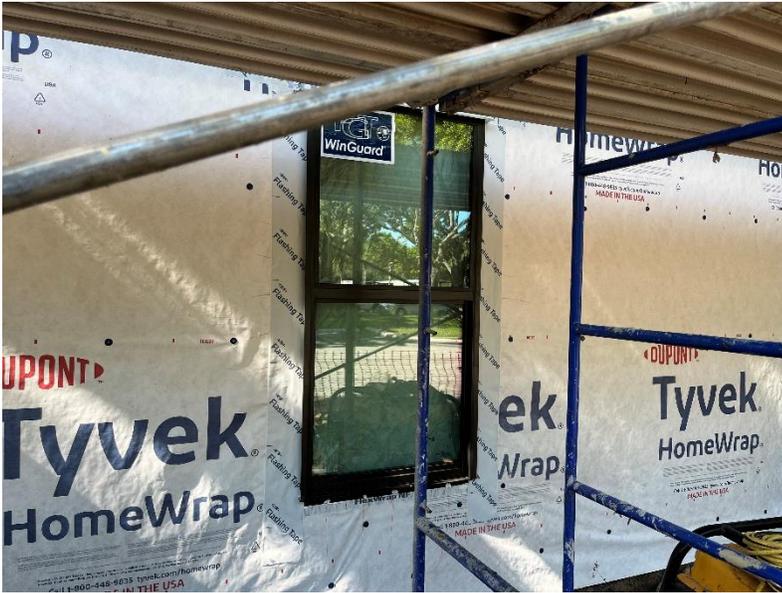
PHOTOGRAPH #11

**BUILDING 8
SECTION A**

New 770 series PGT windows installed and flashed with Dupont flashing materials as per specifications and manufacturers guidelines.

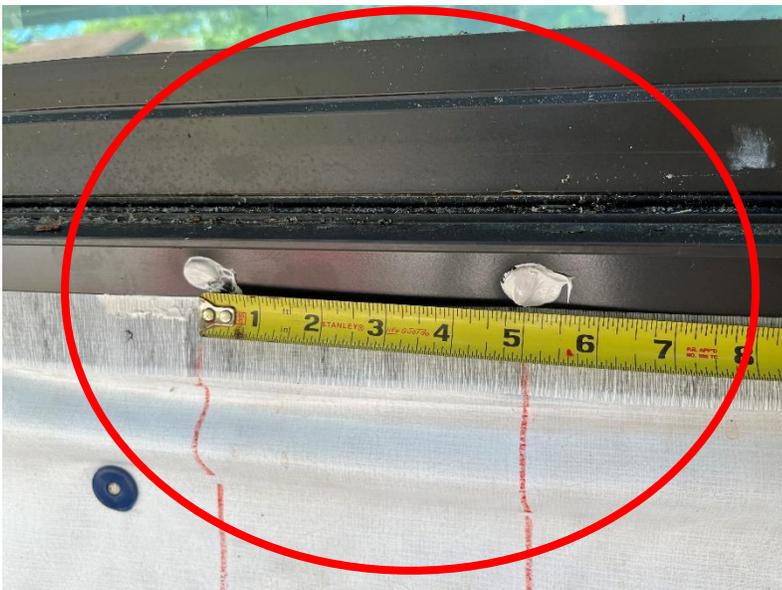
PHOTOGRAPH #12

**BUILDING 8
SECTION A**

Fastening of new window nailed at 5" O.C. as per Manufactures NOA and specifications. All nails were then sealed with Masterseal NP150 as per project specifications.

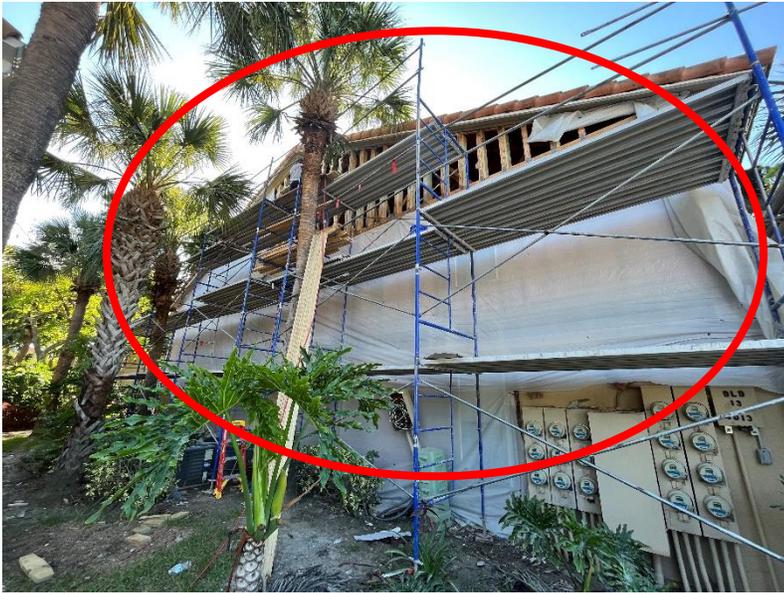
PHOTOGRAPH #13

**BUILDING 13
SECTION H**

Contractor has started to perform gable end reinforcement at trusses.

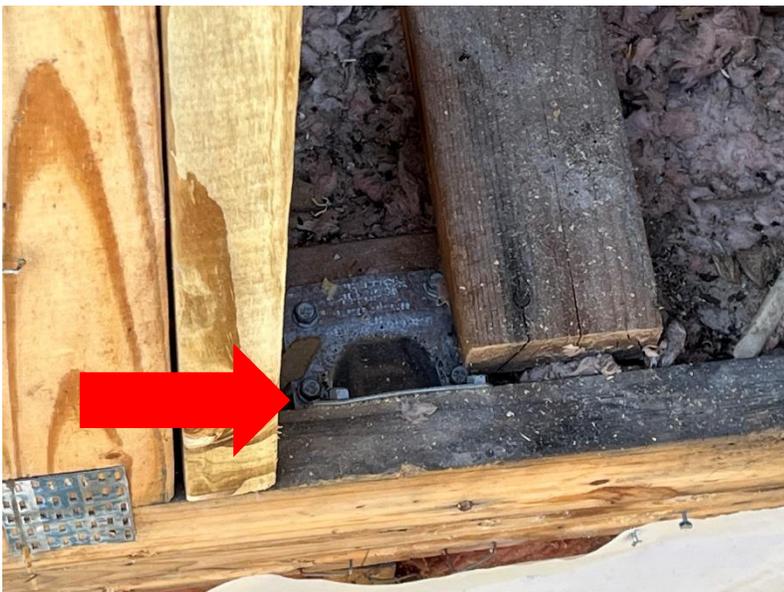
PHOTOGRAPH #14

**BUILDING 13
SECTION H**

Simpson Strong-Tie HGA 10 clips were installed 4' OC as per project specifications.

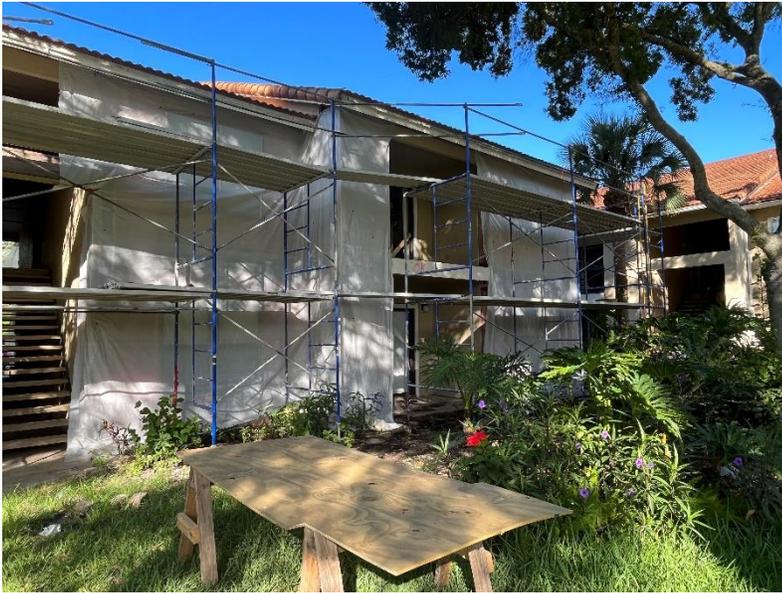
PHOTOGRAPH #15

**BUILDING 13
SECTION G**

Contractor has removed existing stucco and sheathing exposing framing and insulation for damage review. Open walls have been protected and made watertight with heavy plastic.

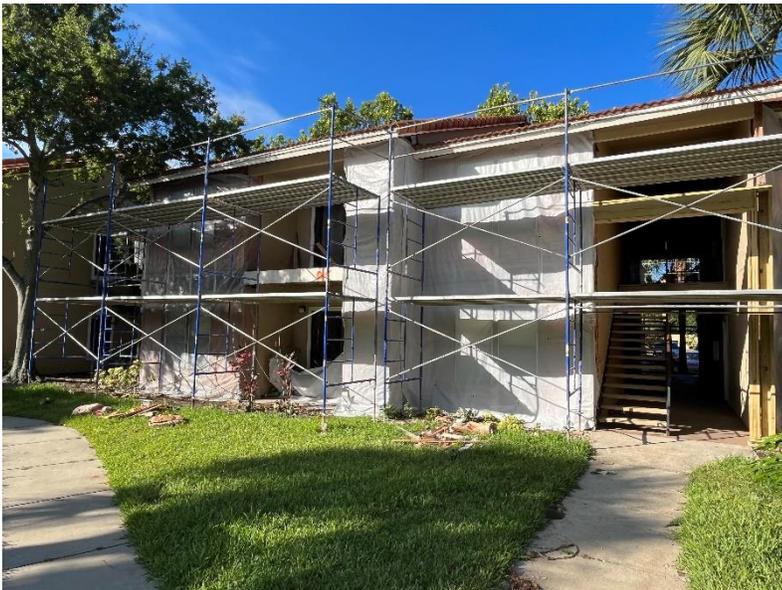
PHOTOGRAPH #16

**BUILDING 13
SECTION F**

Contractor has removed existing stucco and sheathing exposing framing and insulation for damage review. Open walls have been protected and made watertight with heavy plastic.

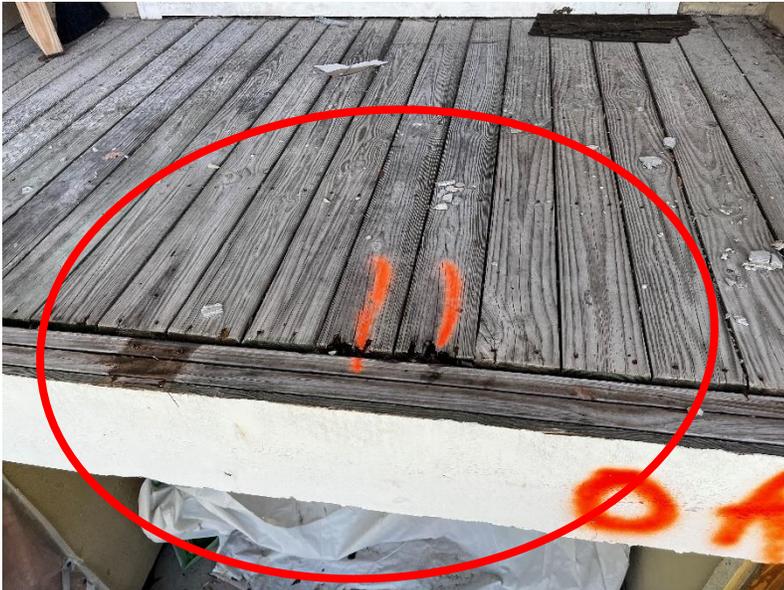
PHOTOGRAPH #17

**BUILDING 13
SECTION F**

Damaged deck boards marked for replacement.

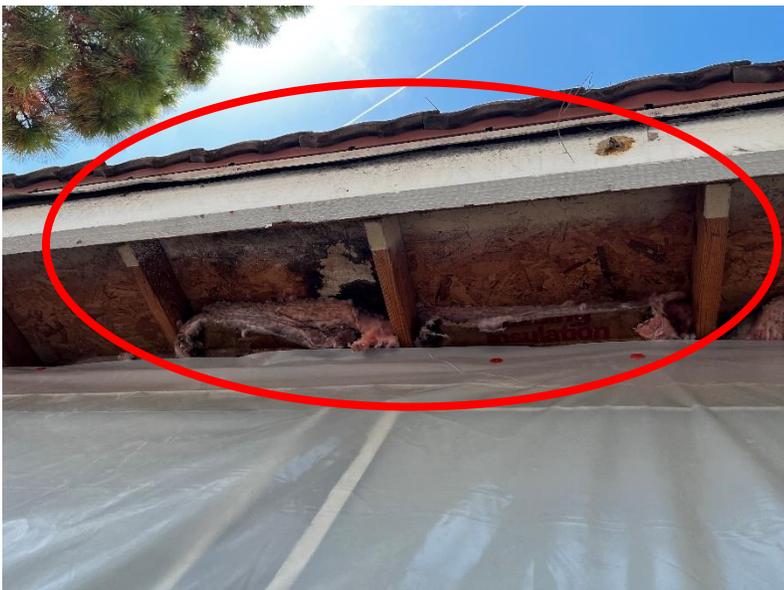
PHOTOGRAPH #18

**BUILDING 13
SECTION F**

Damaged Roof Sheathing to be repaired by Owners Roofers.

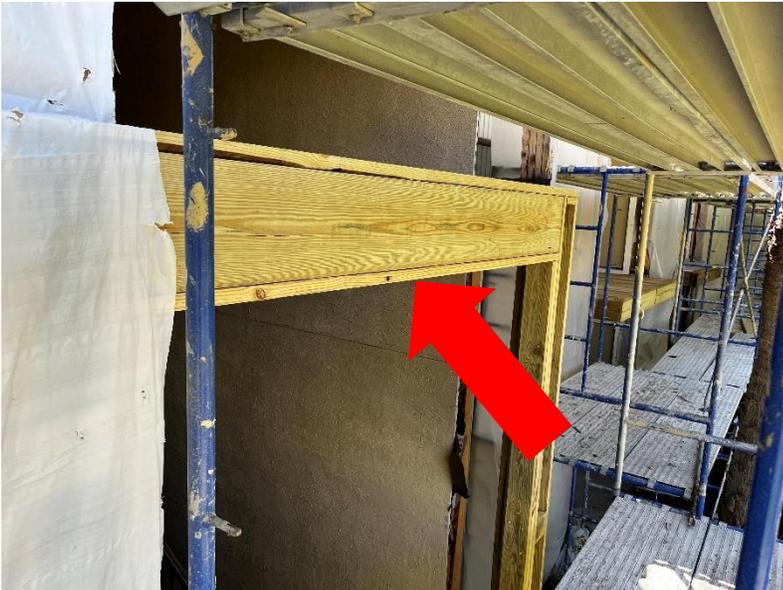
PHOTOGRAPH #19

**BUILDING 13
SECTION E**

Contractor in process of replacing overhead beam and support posts at breezeway.

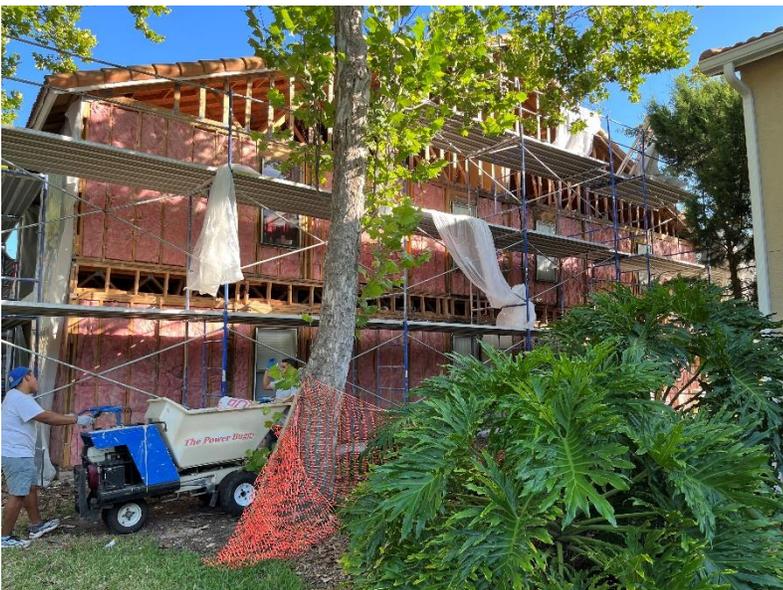
PHOTOGRAPH #20

**BUILDING 13
SECTION D**

Contractor has removed existing stucco and sheathing exposing framing and insulation for damage inspection.

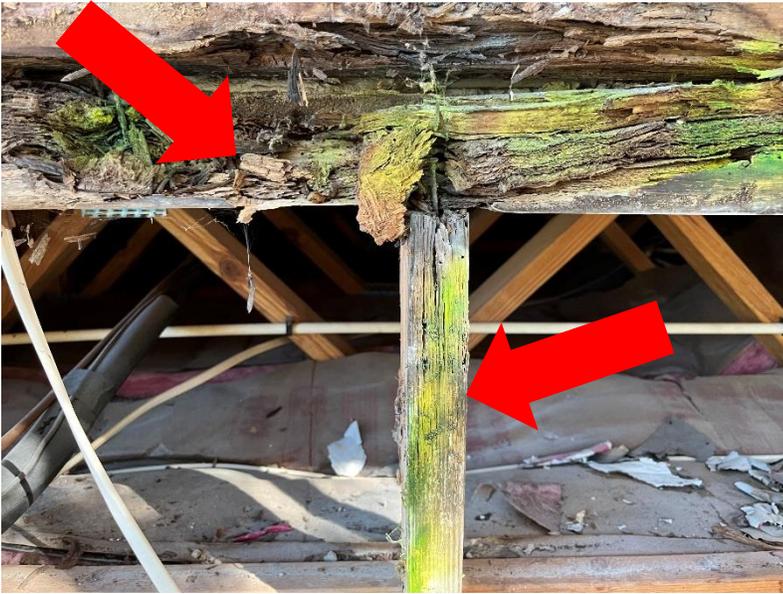
PHOTOGRAPH #21

**BUILDING 13
SECTION D**

Damaged wood framing marked for repairs and replacement.

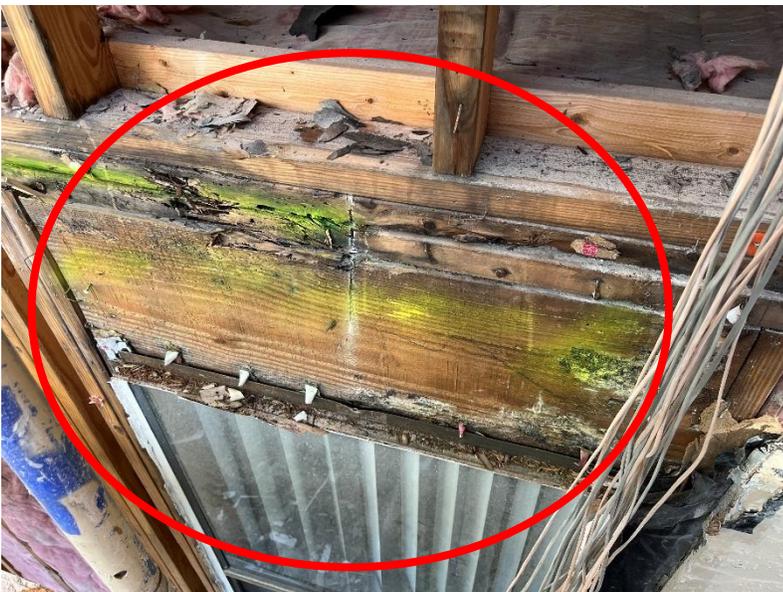
PHOTOGRAPH #22

**BUILDING 13
SECTION D**

Damaged wood framing at Window Header marked for repairs and replacement.

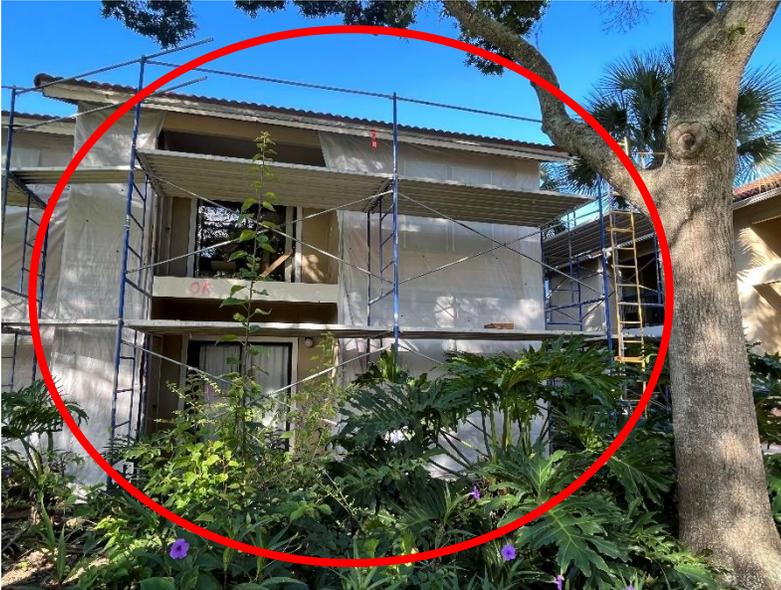
PHOTOGRAPH #23

**BUILDING 13
SECTION C**

Contractor has removed existing stucco and sheathing exposing framing and insulation for damage review. Open walls have been protected and made watertight with heavy plastic.

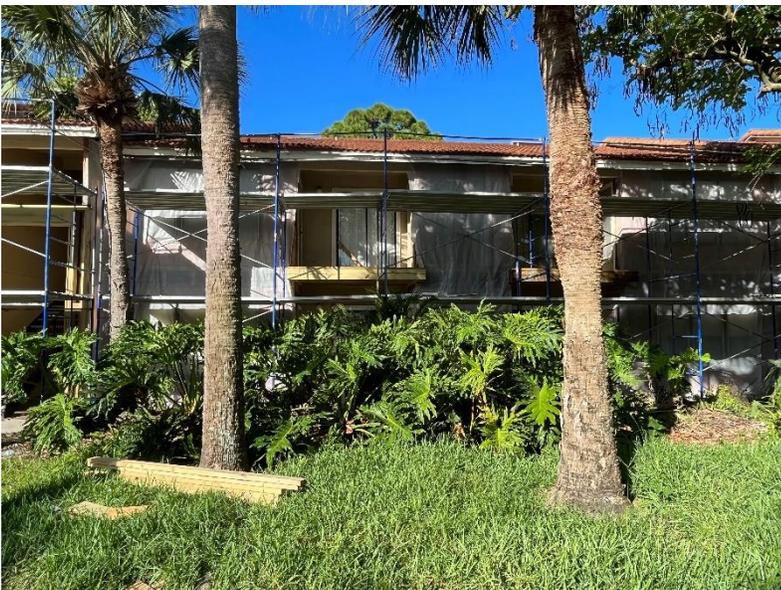
PHOTOGRAPH #24

**BUILDING 13
SECTION B**

Contractor has removed existing stucco and sheathing exposing framing and insulation for damage review. Open walls have been protected and made watertight with heavy plastic.

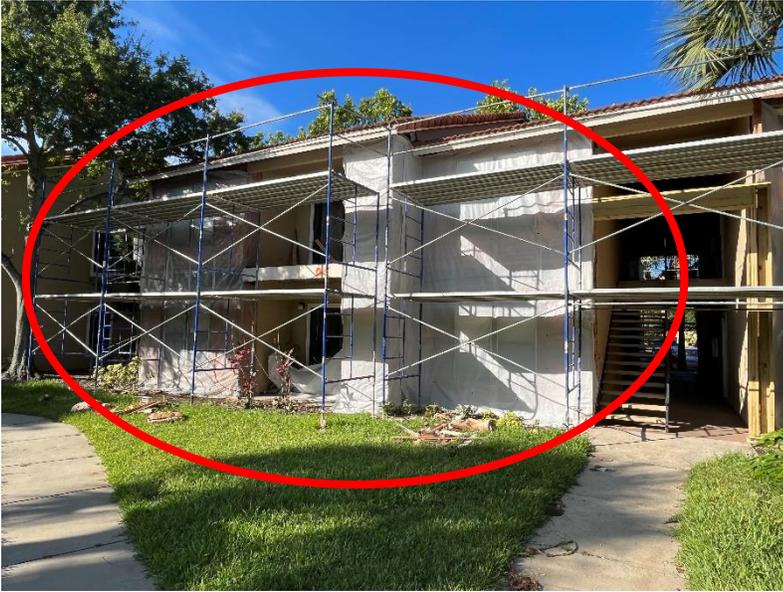
PHOTOGRAPH #25

**BUILDING 13
SECTION A**

Contractor is in the process of removing stucco and sheathing. Open walls have been protected and made watertight with heavy plastic.

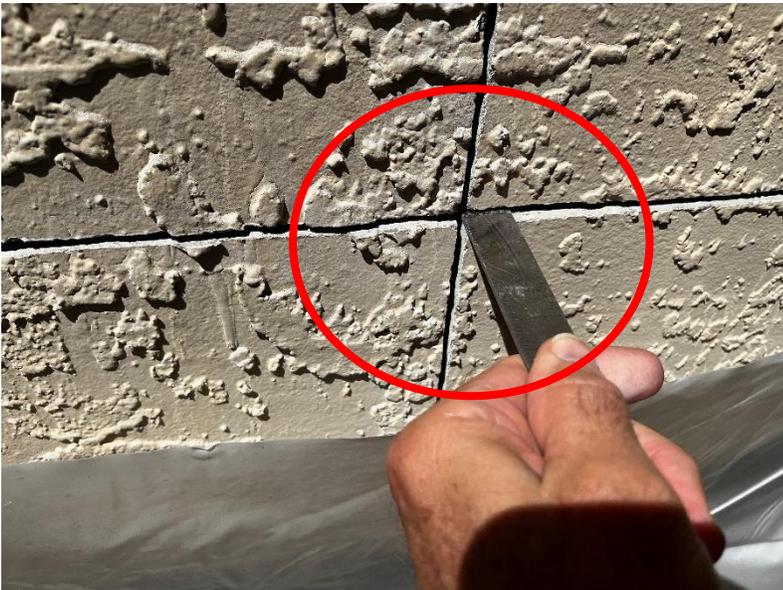
PHOTOGRAPH #26

**BUILDING 13
SECTION A**

Contractor demo crew has cut existing stucco at 1" depth into squares for removal and handling.
