PHOTOGRAPHS

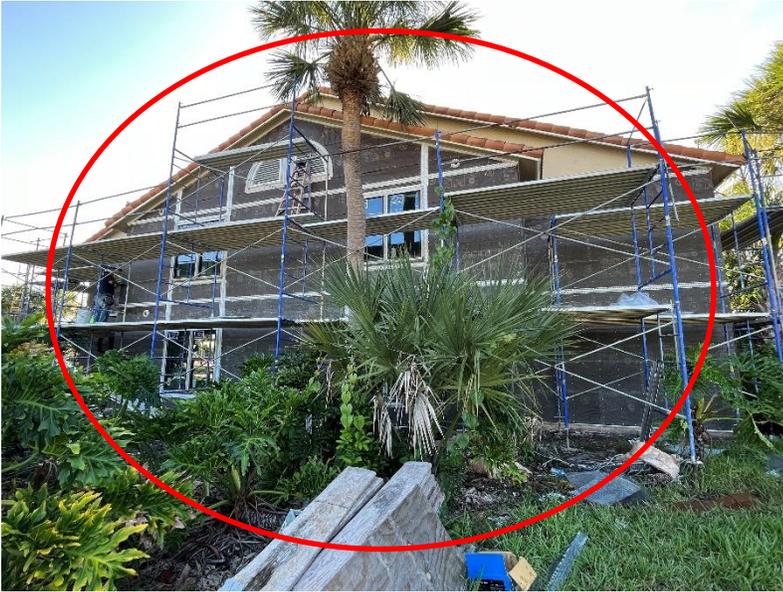
PHOTOGRAPH #1

**BUILDING 8  
SECTION D**

Stucco Sub-Contractor has completed installation of stucco accessories and metal lathing for application of specified new Stucco.

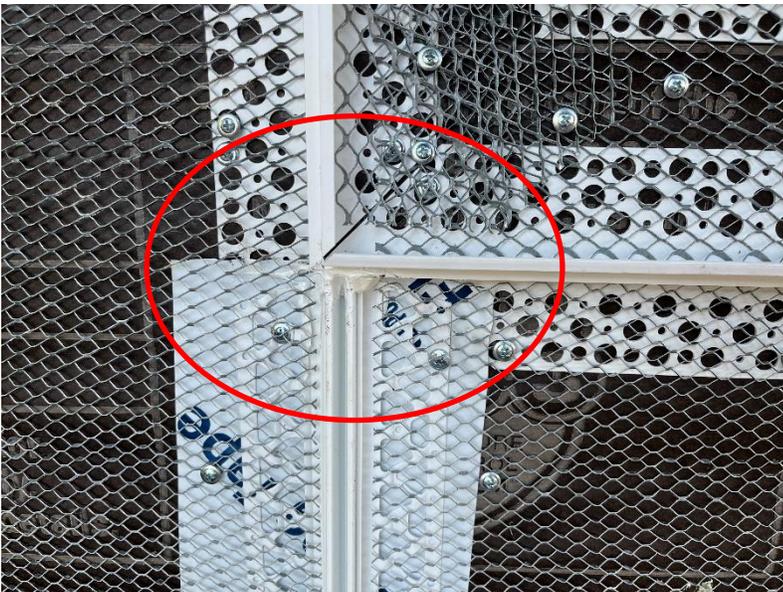
PHOTOGRAPH #2

**BUILDING 8  
SECTION D**

New urethane sealant installed at all stucco accessory corner and butt joint transitions.

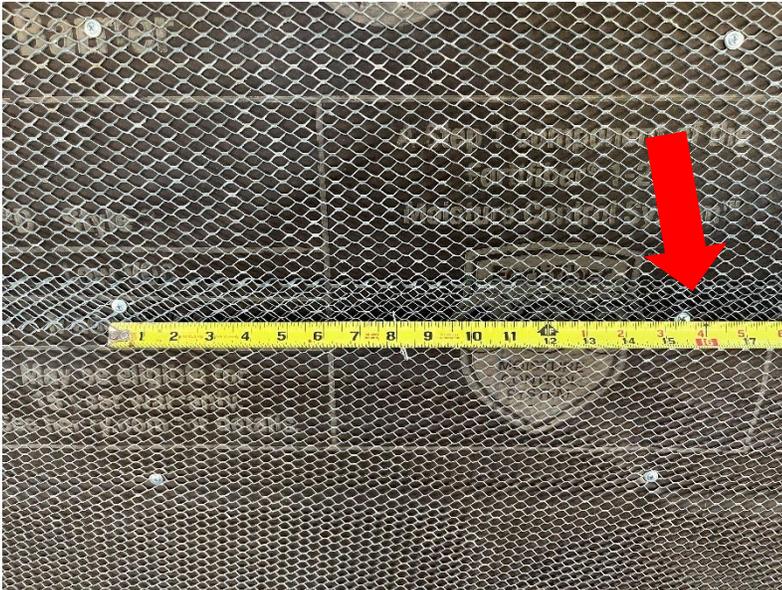
**PHOTOGRAPH #3**

**BUILDING 8  
SECTION D**

Self-Furring Galvanized metal lathing attached to framing at 16" O.C. as per drawings and specifications.

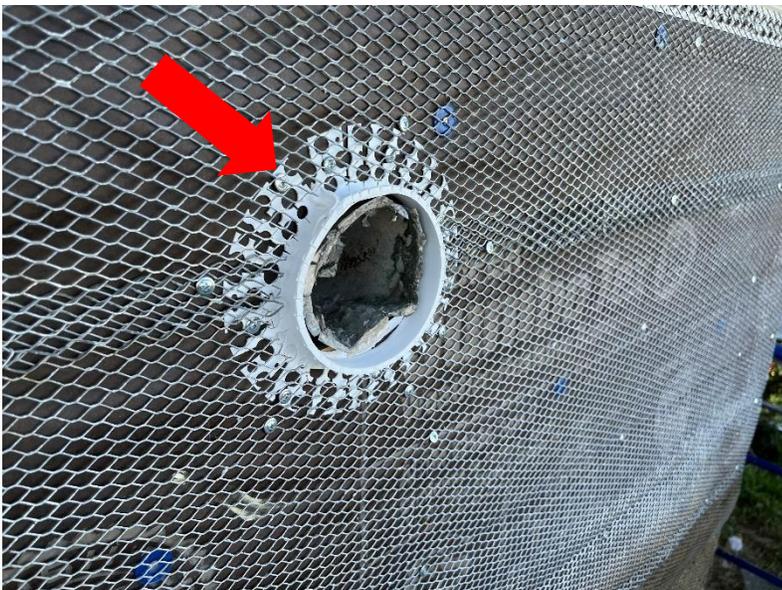
**PHOTOGRAPH #4**

**BUILDING 8  
SECTION D**

Stucco subcontractor has installed vinyl vent stucco accessories over secondary water-resistant barrier and installed galvanized metal lathing as per drawings and specifications.

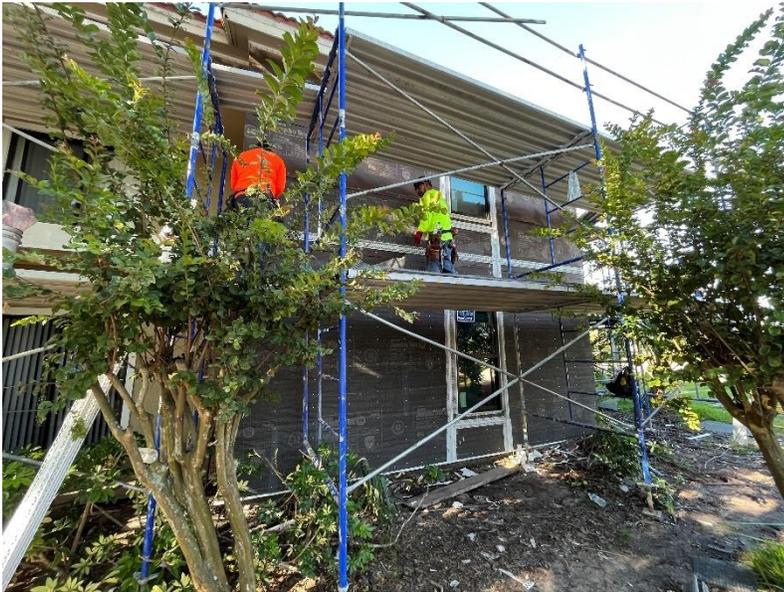
**PHOTOGRAPH #5**

**BUILDING 8  
SECTION C**

Stucco Sub-Contractor has completed installation of stucco accessories and metal lathing for application of specified new Stucco.

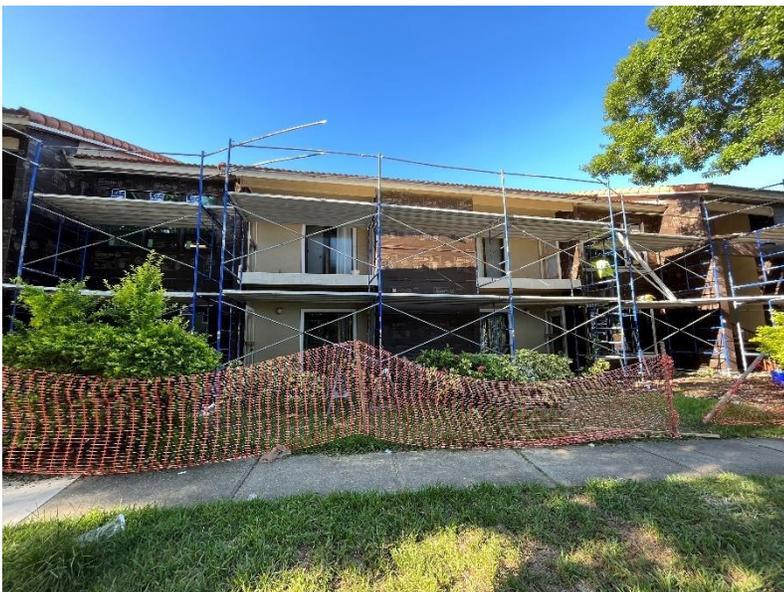
**PHOTOGRAPH #6**

**BUILDING 8  
SECTION B**

Stucco Subcontractor has applied second water vapor barrier with Super JumboTex 60.

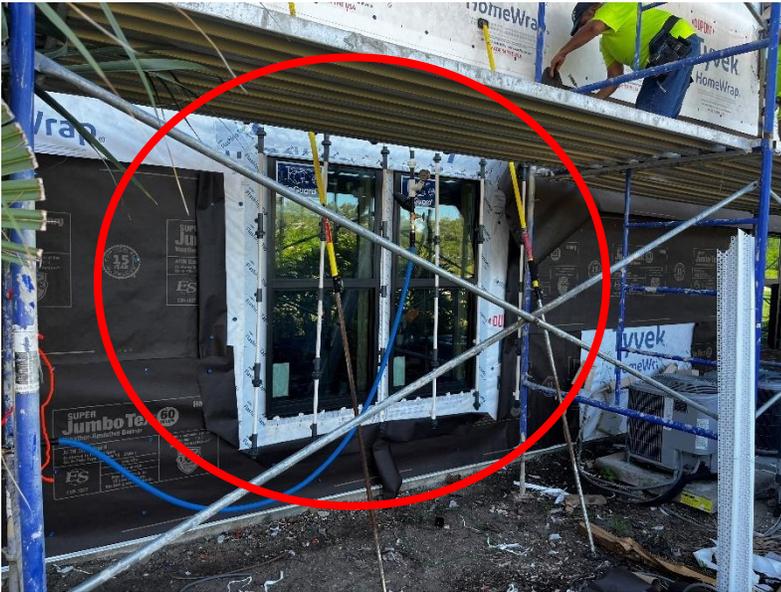
**PHOTOGRAPH #7**

**BUILDING 8  
SECTION B**

**Unit #817** – Independent testing agency performed AAMA 502 water testing at double window with no leaks or failures.

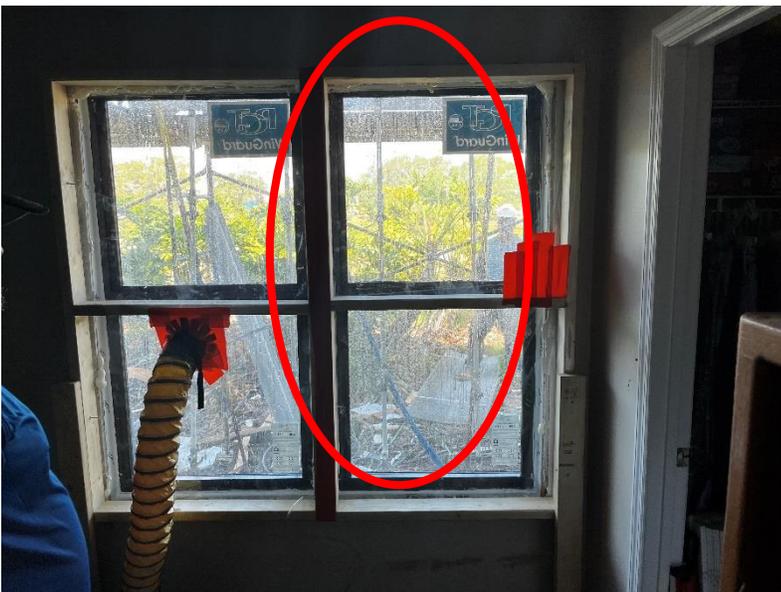
**PHOTOGRAPH #8**

**BUILDING 8  
SECTION B**

**Unit #817** – Independent testing agency performed AAMA 502 water testing at double window with no leaks or failures.

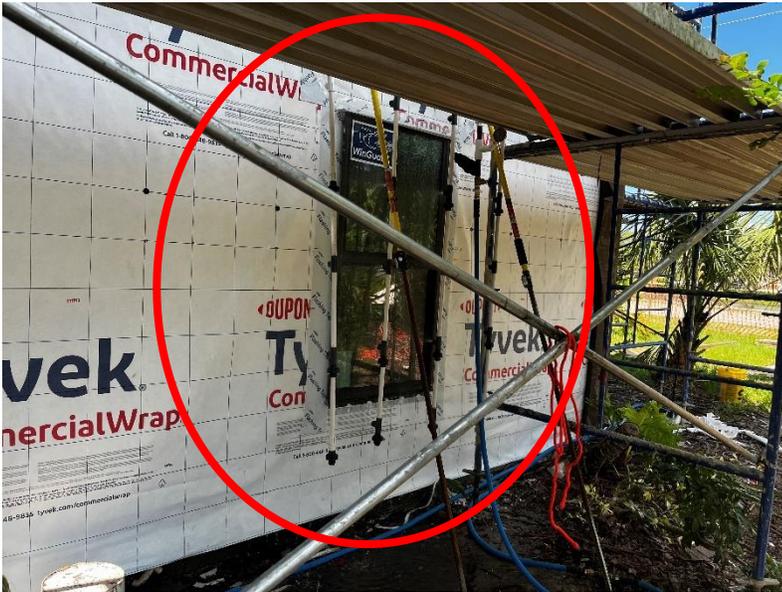
**PHOTOGRAPH #9**

**BUILDING 8  
SECTION B**

**Unit #817** – Independent testing agency performed AAMA 502 water testing at single window with no leaks or failures.

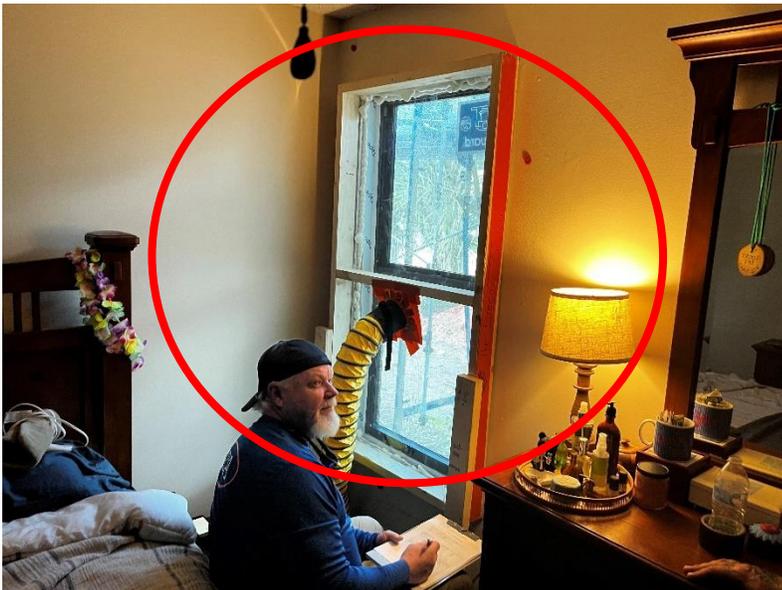
**PHOTOGRAPH #10**

**BUILDING 8  
SECTION B**

**Unit #817** – Independent testing agency performed AAMA 502 water testing at single window with no leaks or failures.

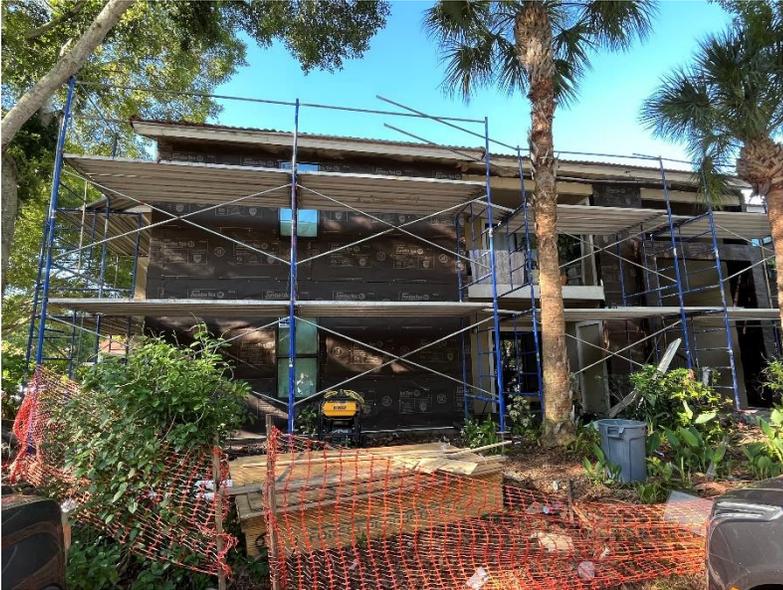
**PHOTOGRAPH #11**

**BUILDING 8  
SECTION A**

Stucco Subcontractor has applied second water vapor barrier with Super JumboTex 60.

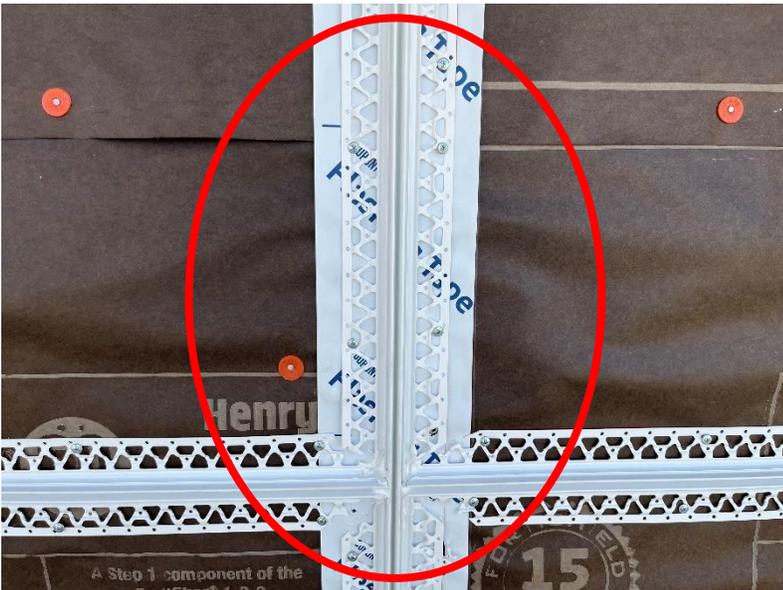
**PHOTOGRAPH #12**

**BUILDING 8  
SECTION A**

Continuous vertical self-adhering Dupont straight flash applied over WRB prior to installation of new control joint accessories as per project drawings.

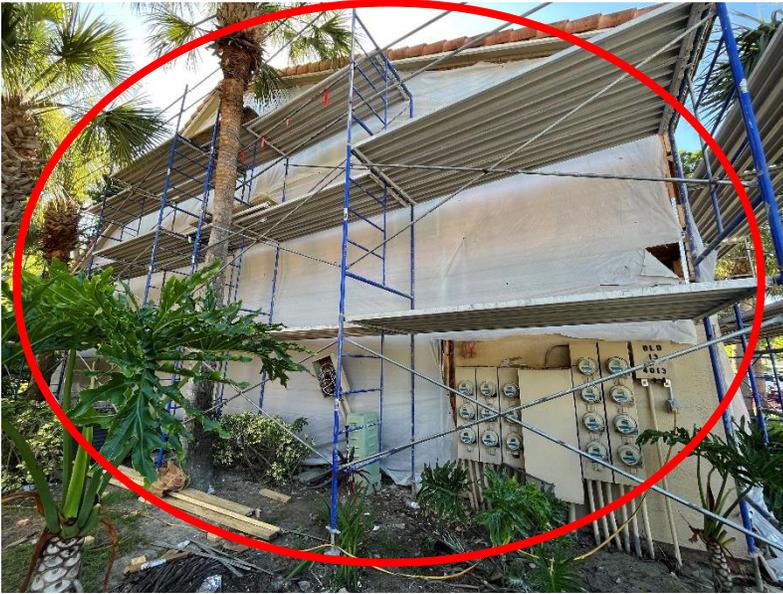
**PHOTOGRAPH #13**

**BUILDING 13  
SECTION H**

Contractor has removed existing stucco and sheathing exposing framing and begun performing repairs to damaged framing areas as directed by Delta in the Field.

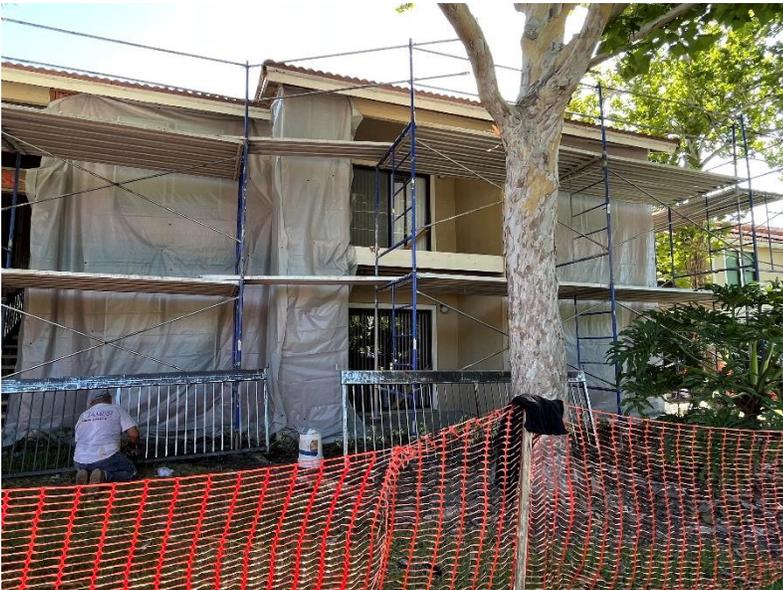
**PHOTOGRAPH #14**

**BUILDING 13  
SECTION G**

Contractor has removed existing stucco and sheathing exposing framing and insulation for damage review. Contractor is now installing Simpson Strong Tie hardware fasteners as per drawings and specifications.

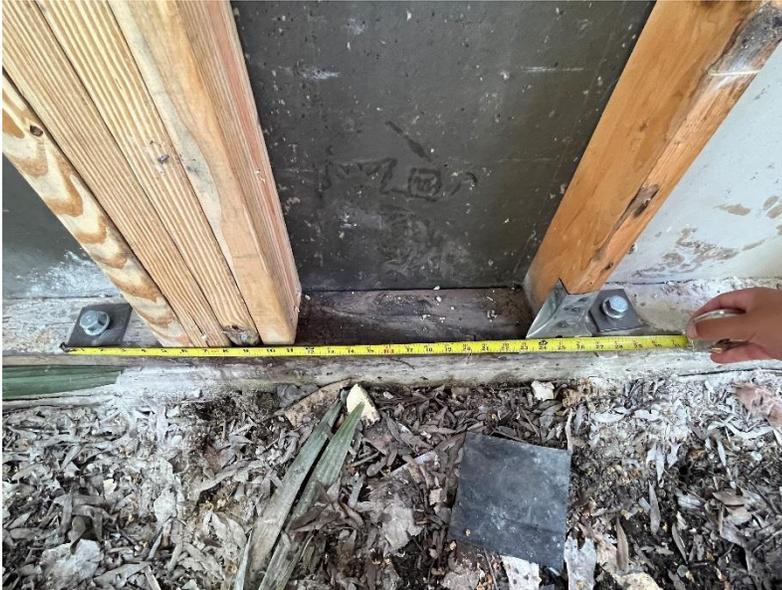
**PHOTOGRAPH #15**

**BUILDING 13  
SECTION G**

Contractor has installed new 5/8" Simpson Strong – Tie HD fasteners at base plate as per drawings and specifications.

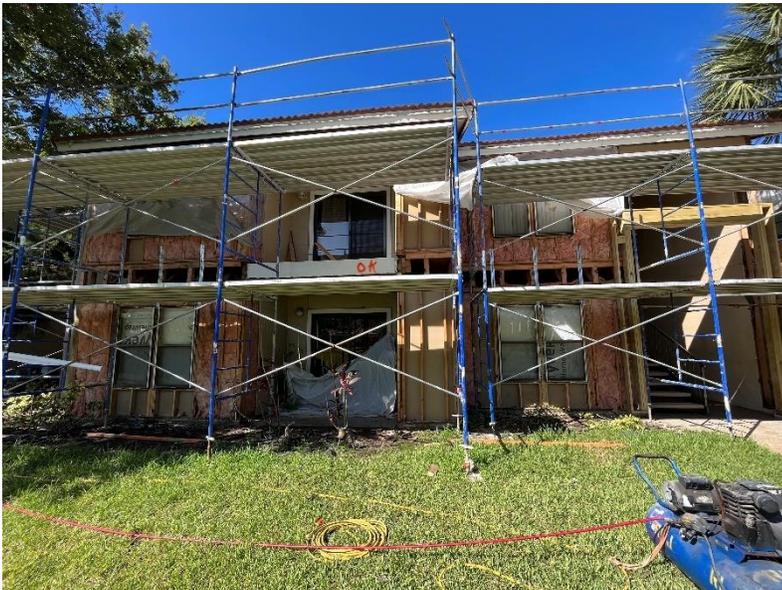
**PHOTOGRAPH #16**

**BUILDING 13  
SECTION F**

Contractor has removed existing stucco and sheathing exposing framing and insulation for damage review. Contractor is now installing Simpson Strong Tie hardware fasteners as per drawings and specifications.

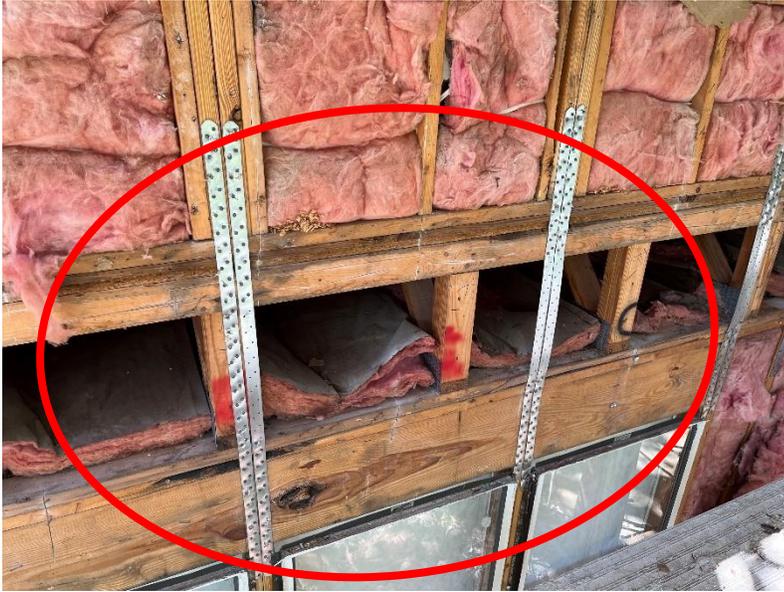
**PHOTOGRAPH #17**

**BUILDING 13  
SECTION F**

Contractor has installed new Simpson Strong – Tie #LSTA-15 Strap at stud to truss connections 48” O.C. per drawings.

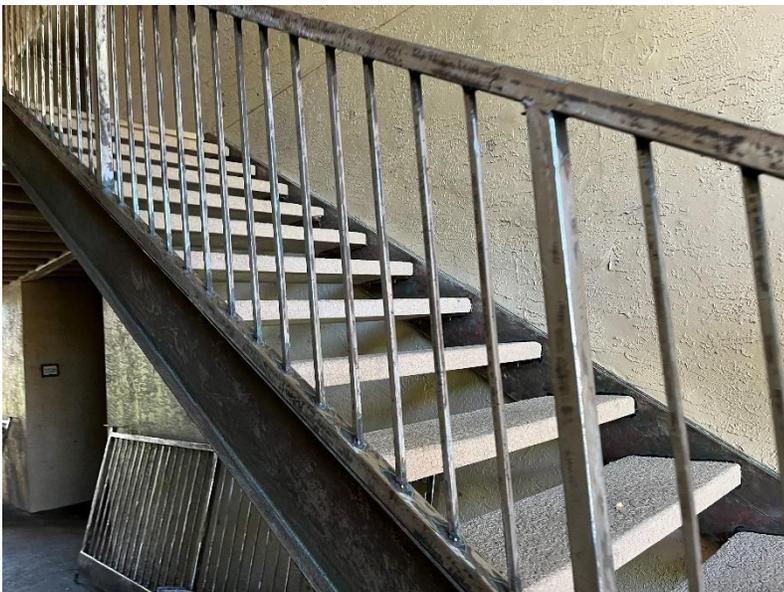
**PHOTOGRAPH #18**

**BUILDING 13  
SECTION F**

Breezeway railings in process of surface preparation (removing loose paint and rust) with hand grinders.

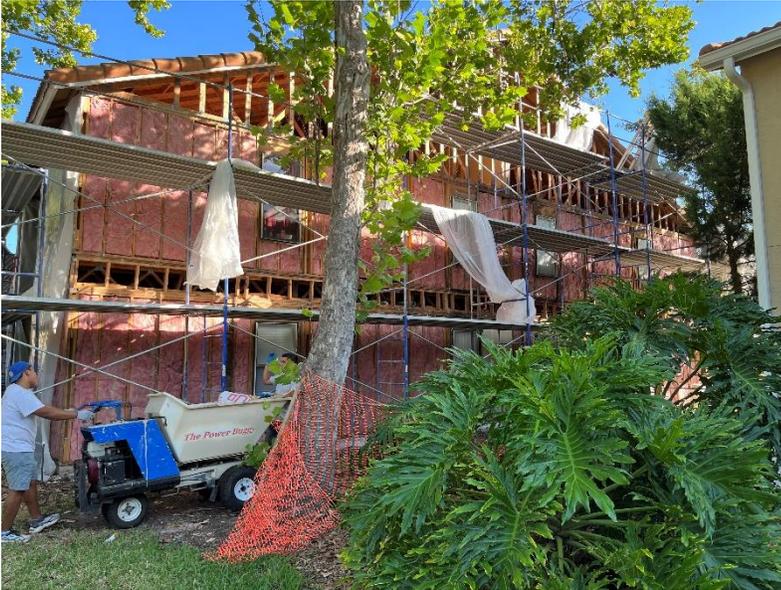
**PHOTOGRAPH #19**

**BUILDING 13  
SECTION D**

Contractor has removed existing stucco and sheathing exposing framing and begun performing repairs to damaged framing areas as directed by Delta in the Field.

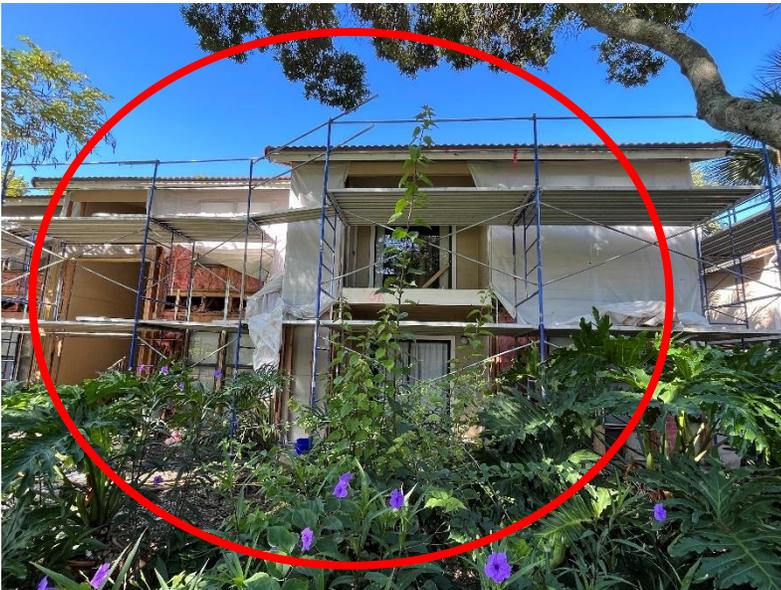
**PHOTOGRAPH #20**

**BUILDING 13  
SECTION C**

Contractor has removed existing stucco and sheathing exposing framing and insulation for damage review. Contractor is now installing Simpson Strong Tie hardware fasteners as per drawings and specifications.

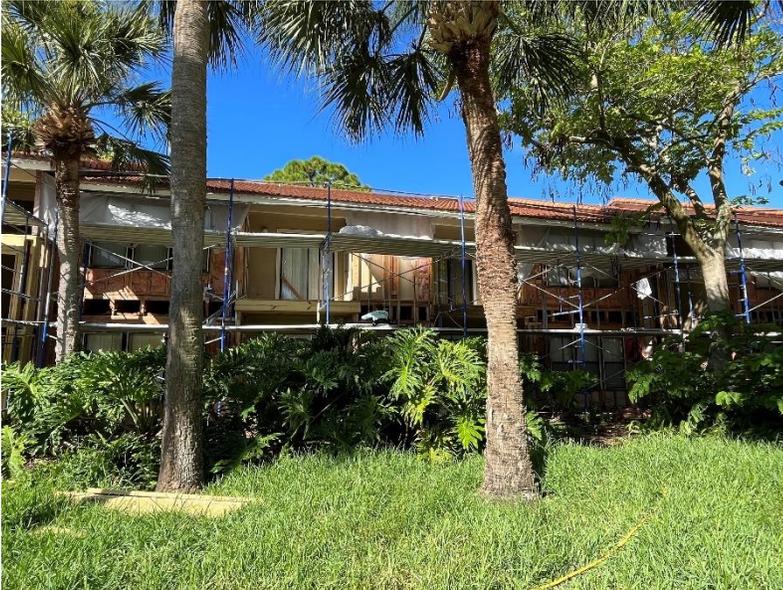
**PHOTOGRAPH #21**

**BUILDING 13  
SECTION B**

Contractor has removed existing stucco and sheathing exposing framing and insulation for damage review. Contractor is now installing Simpson Strong Tie hardware fasteners as per drawings and specifications.

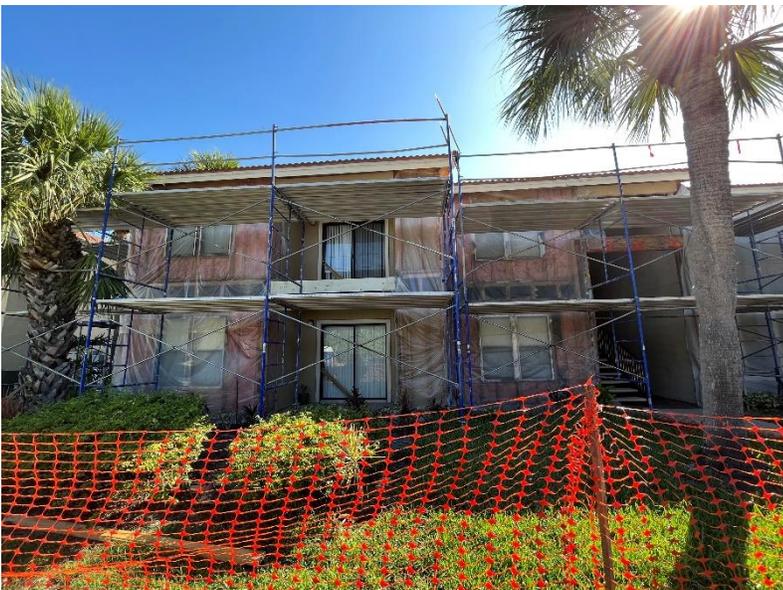
**PHOTOGRAPH #22**

**BUILDING 13  
SECTION A**

Contractor has removed existing stucco and sheathing exposing framing and insulation for damage review. Contractor is now installing Simpson Strong Tie hardware fasteners as per drawings and specifications.

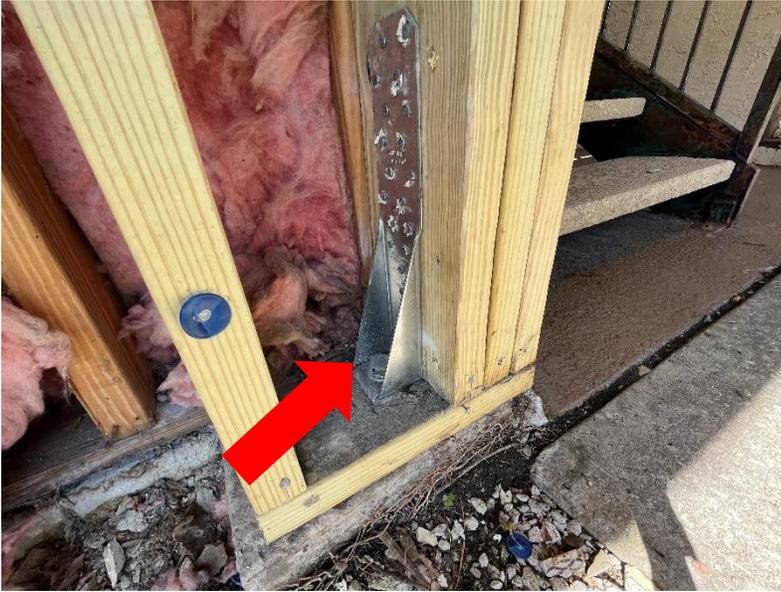
**PHOTOGRAPH #23**

**BUILDING 13  
SECTION E**

Simpson Connector (HTT4) installed with Simpson Connector (Simpson Strong-Tie 5/8"x 8" Titen HD Anchors), at 24" O.C. as per drawings and specifications.
