PHOTOGRAPHS

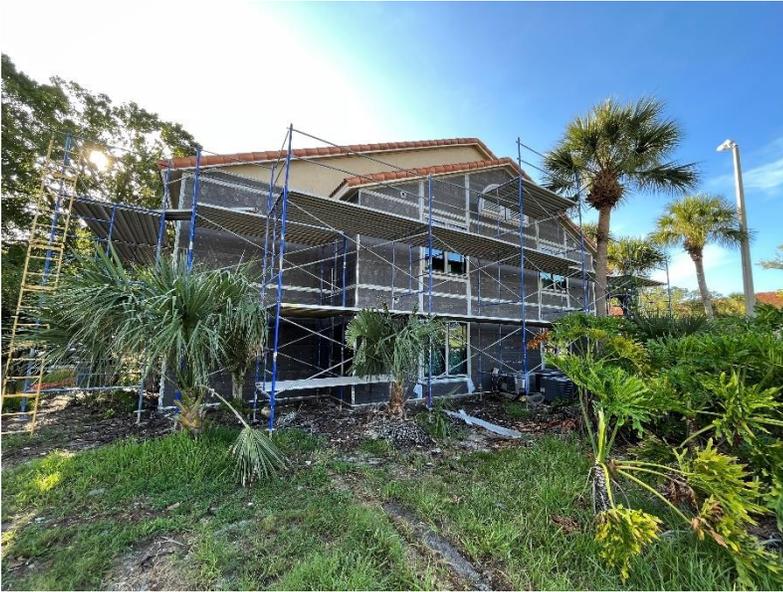
PHOTOGRAPH #1

**BUILDING 8  
SECTION D**

Stucco Subcontractor has installed vinyl stucco accessories over secondary water-resistant barrier and installed galvanized metal lathing as per drawings and specifications.

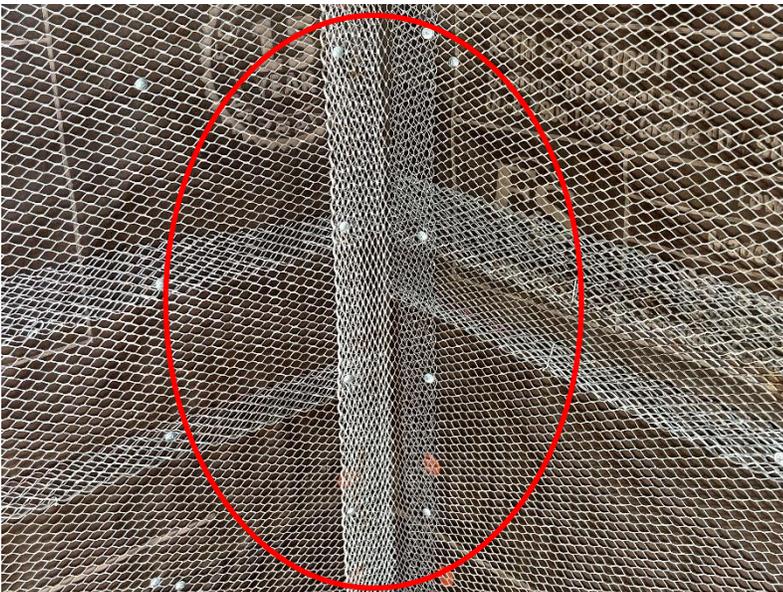
PHOTOGRAPH #2

**BUILDING 8  
SECTION D**

"L" shaped four galvanized self-furring lath strips used at inside corner for best application of new stucco.

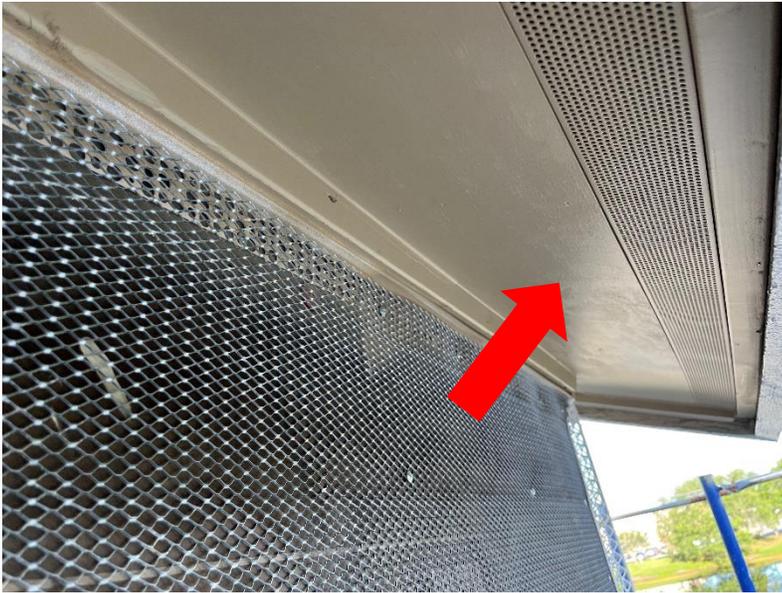
**PHOTOGRAPH #3**

**BUILDING 8  
SECTION D**

Contractor has installed new wood soffit and vinyl venting as per drawings and specifications. They have also applied primer and finished paint as required.

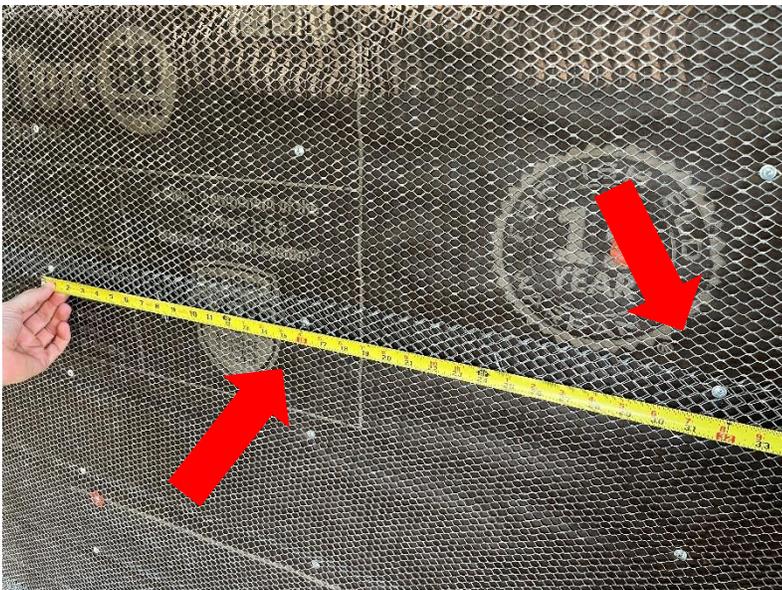
**PHOTOGRAPH #4**

**BUILDING 8  
SECTION D**

Self-Furring Galvanized metal lathing attached to framing at 16" O.C. as per drawings and specifications.

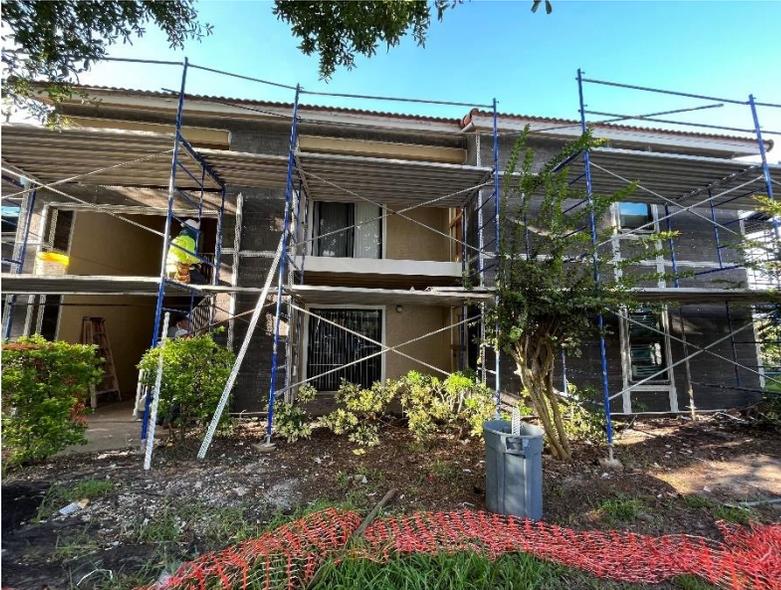
**PHOTOGRAPH #5**

**BUILDING 8  
SECTION C**

Stucco Subcontractor has installed vinyl stucco accessories over secondary water-resistant barrier and installed galvanized metal lathing as per drawings and specifications.

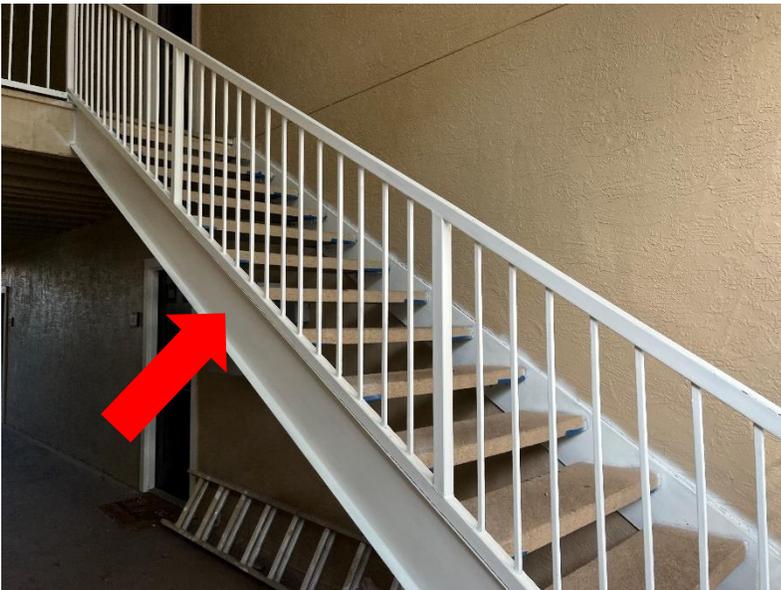
**PHOTOGRAPH #6**

**BUILDING 8  
SECTION C**

Breezeway railings were cleaned (Removing loose paint and rust) with grinders. Contractor has now primed and prepared railings to receive coat of paint finish.

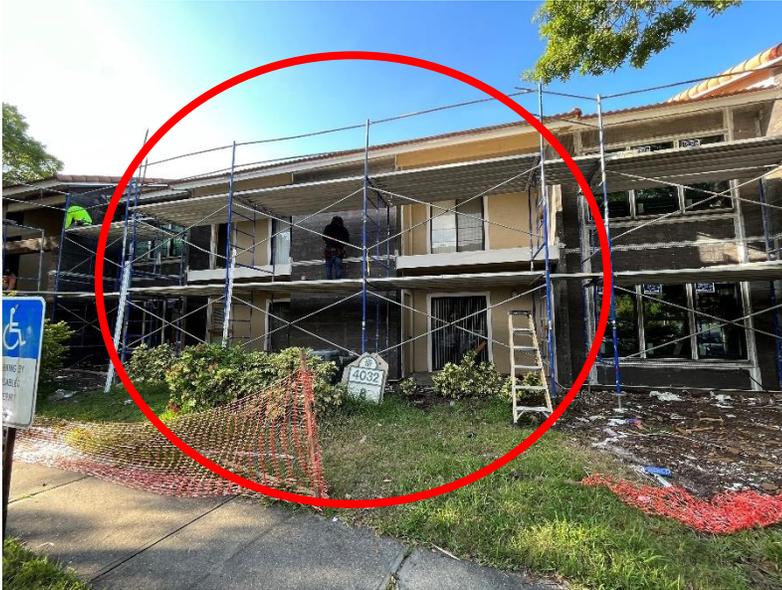
**PHOTOGRAPH #7**

**BUILDING 8  
SECTION B**

Stucco Subcontractor has installed vinyl stucco accessories over secondary water-resistant barrier and installed galvanized metal lathing as per drawings and specifications.

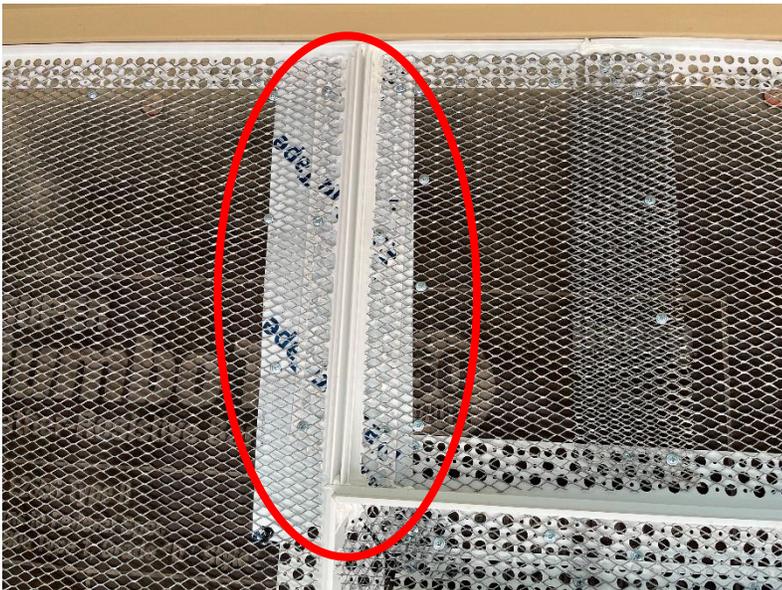
**PHOTOGRAPH #8**

**BUILDING 8  
SECTION B**

Continuous vertical self-adhering Dupont Straight flash applied over WRB prior to installation of new control joint accessories as per project drawings.

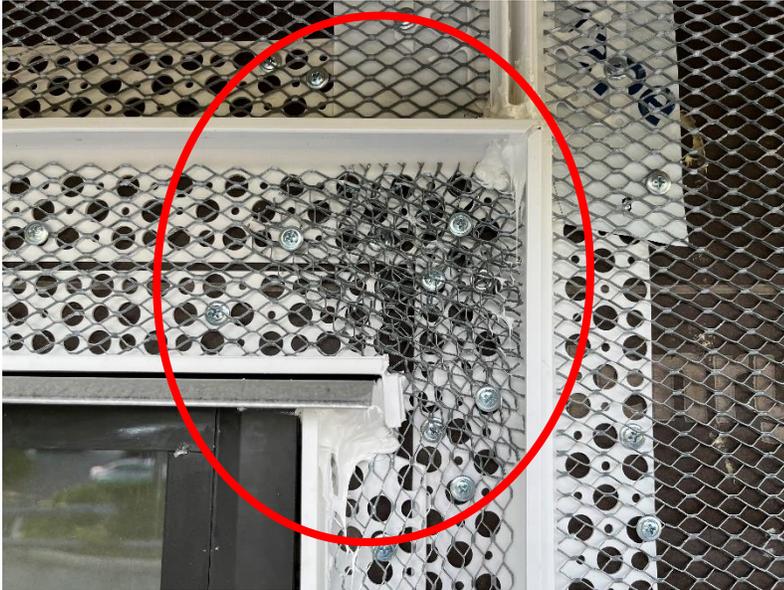
**PHOTOGRAPH #9**

**BUILDING 8  
SECTION B**

As required, Contractor has installed Metal lath butterfly to self-furring lath at each corner of window frame.

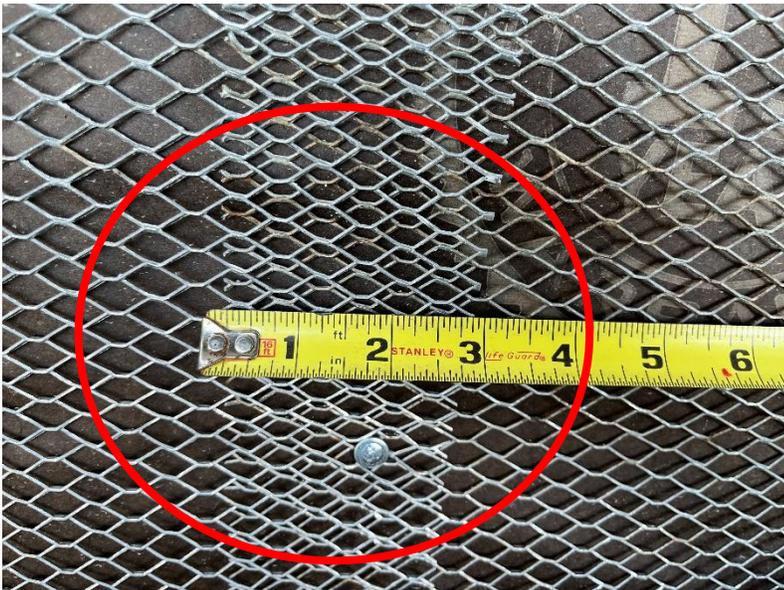
**PHOTOGRAPH #10**

**BUILDING 8  
SECTION B**

It was observed that the metal lath lap ends were 3" which met the minimum of 1" as required in the project specification.

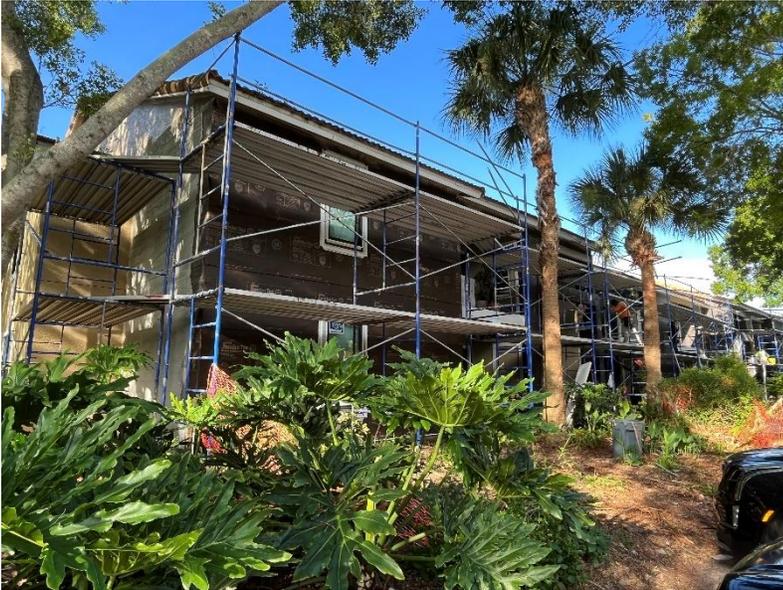
**PHOTOGRAPH #11**

**BUILDING 8  
SECTION A**

Stucco Subcontractor has applied second water vapor barrier with Super JumboTex 60.

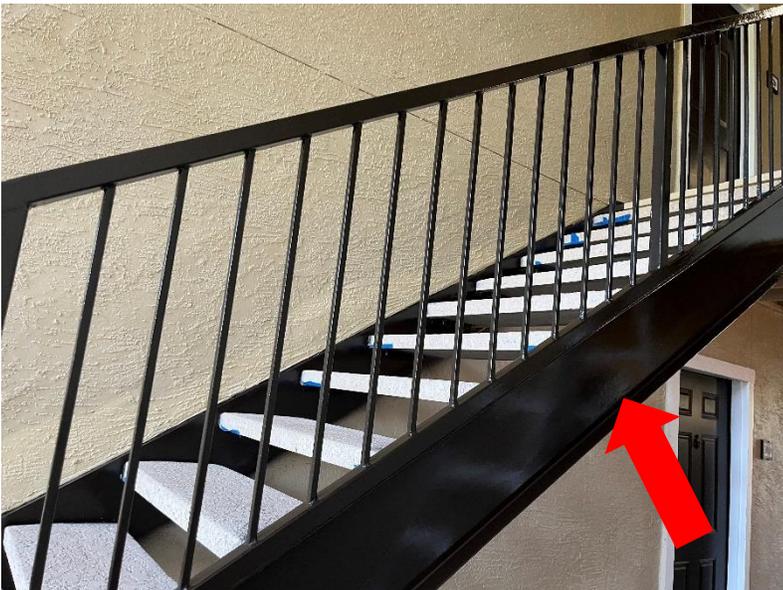
**PHOTOGRAPH #12**

**BUILDING 8  
SECTION A**

Breezeway railings were cleaned (Removing loose paint and rust) with grinders. Contractor has now primed and successfully painted the railings with a finish coat.

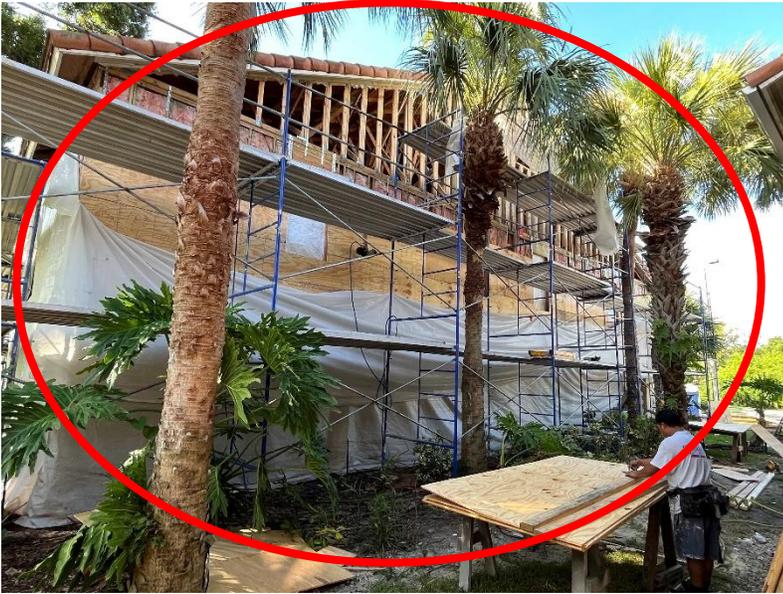
**PHOTOGRAPH #13**

**BUILDING 13  
SECTION H**

Contractor has begun to install specified 15/32" plywood sheathing fastened to framing members as per drawings and specifications.

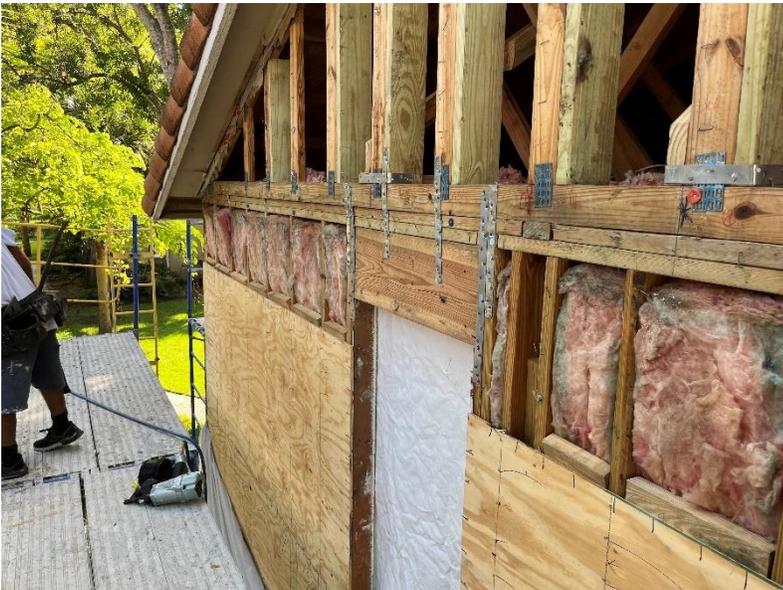
**PHOTOGRAPH #14**

**BUILDING 13  
SECTION H**

New 15/32" plywood sheathing fastened to framing members as per drawings and specifications.

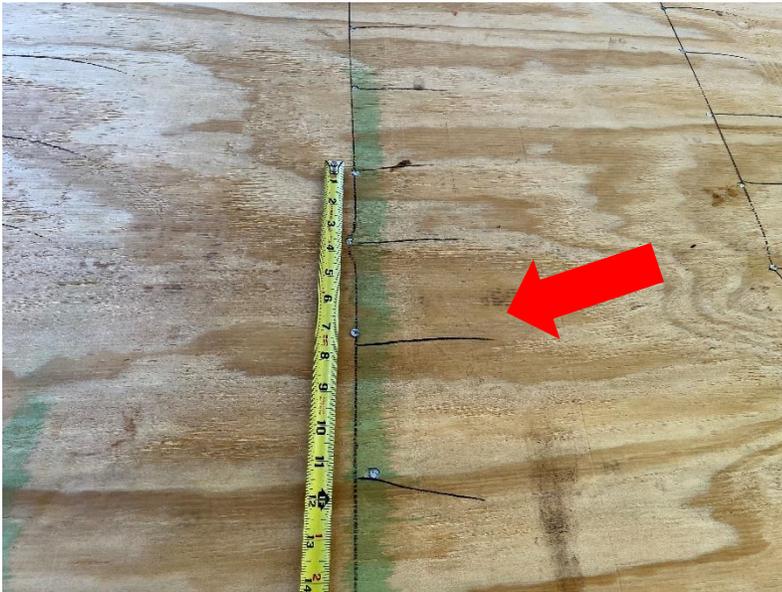
**PHOTOGRAPH #15**

**BUILDING 13  
SECTION H**

Plywood marked by contractor for consistent attachment to framing at 4" O.C.

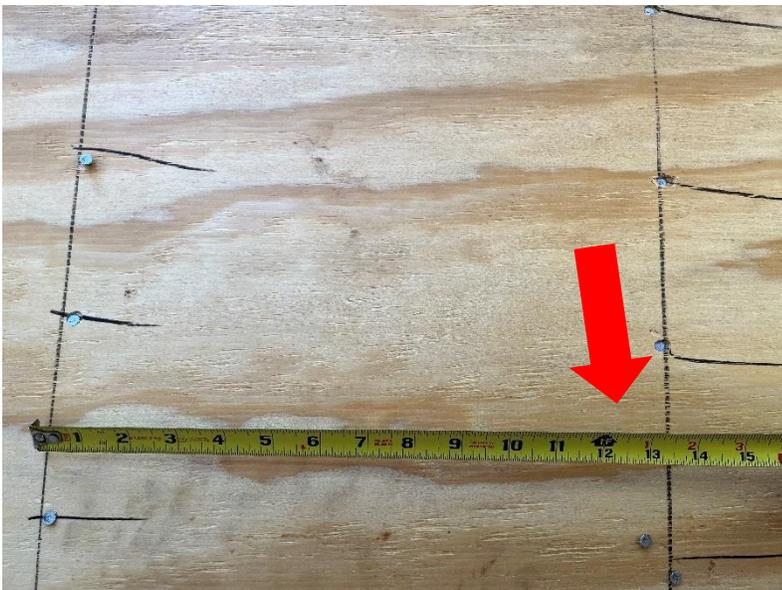
**PHOTOGRAPH #16**

**BUILDING 13  
SECTION H**

New 15/32" plywood sheathing fastened to framing members at 16" spacing as per drawings and specifications.

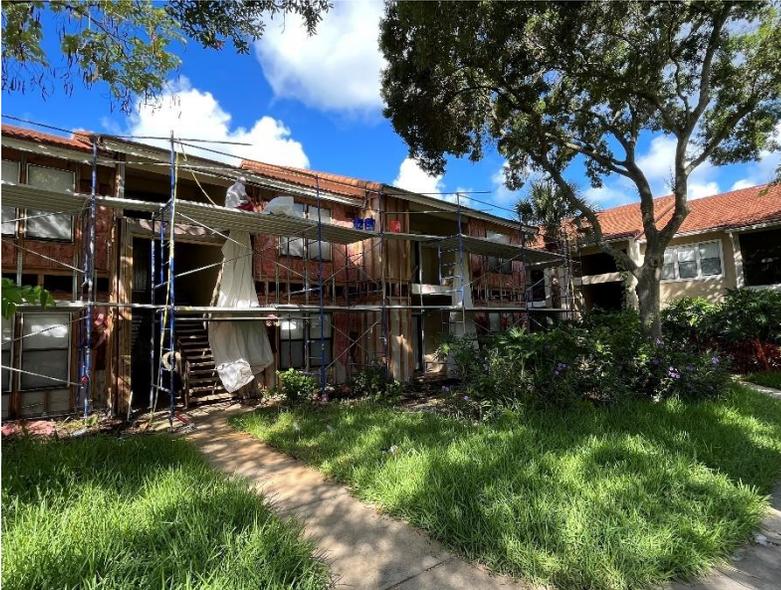
**PHOTOGRAPH #17**

**BUILDING 13  
SECTION G**

Contractor has removed existing stucco and sheathing exposing framing and insulation for damage review. Contractor has now installed Simpson Strong Tie hardware fasteners as per drawings and specifications.

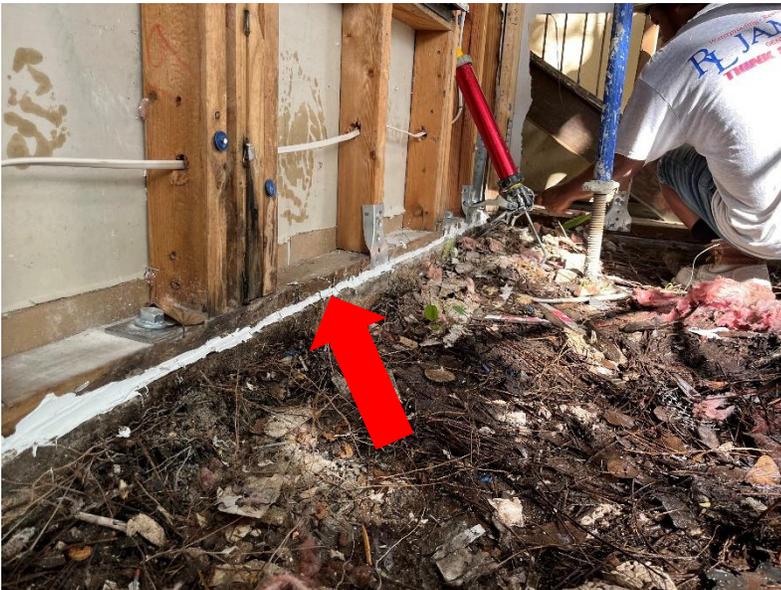
**PHOTOGRAPH #18**

**BUILDING 13  
SECTION G**

Contractor has installed sealant along base plate joint as required by project specifications.

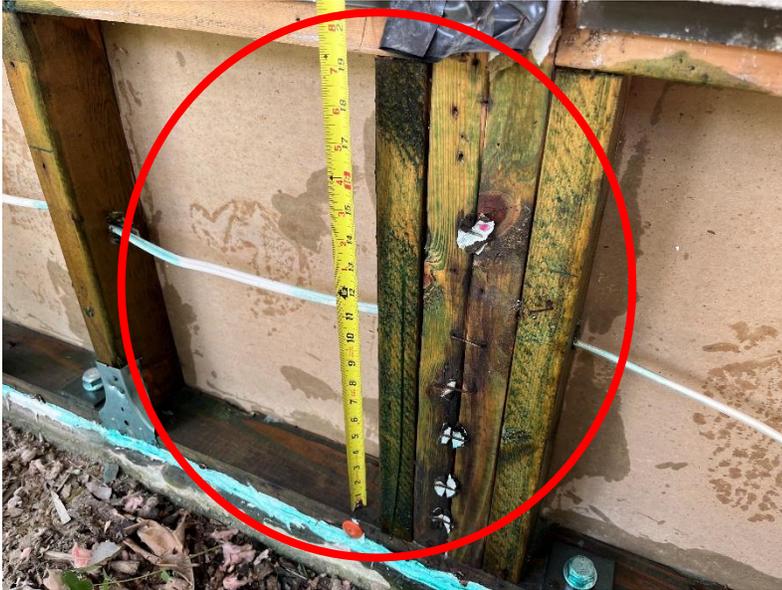
**PHOTOGRAPH #19**

**BUILDING 13  
SECTION G**

Contractor has treated wood framing at top of base plate with Wood Preservative as required by the project documents.

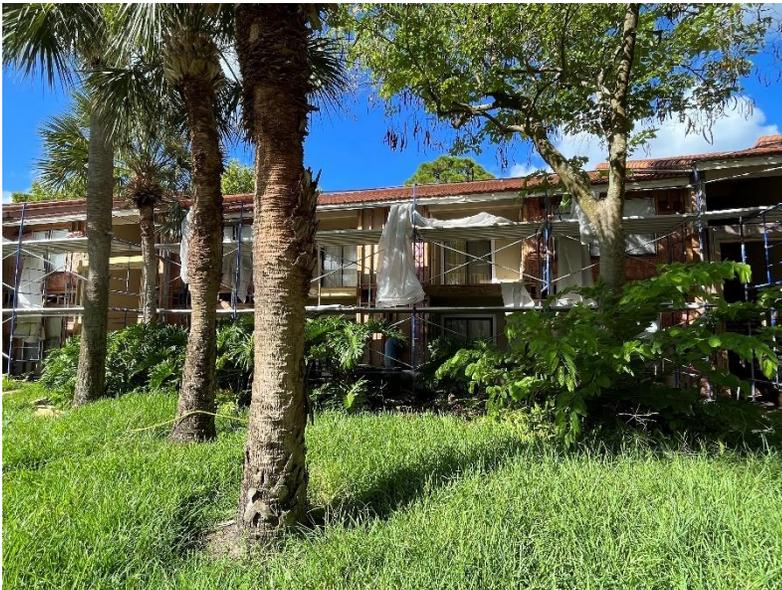
**PHOTOGRAPH #20**

**BUILDING 13  
SECTION F**

Contractor has removed existing stucco and sheathing exposing framing and insulation for damage review. Contractor has now installed Simpson Strong Tie hardware fasteners as per drawings and specifications.

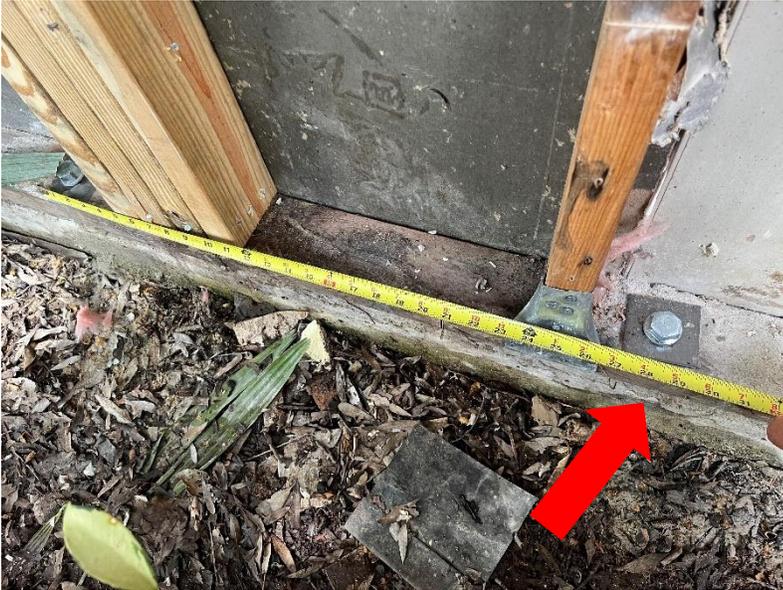
**PHOTOGRAPH #21**

**BUILDING 13  
SECTION F**

Contractor has installed new 5/8" Simpson Strong – Tie HD Fasteners at base plate as per drawings and specifications.

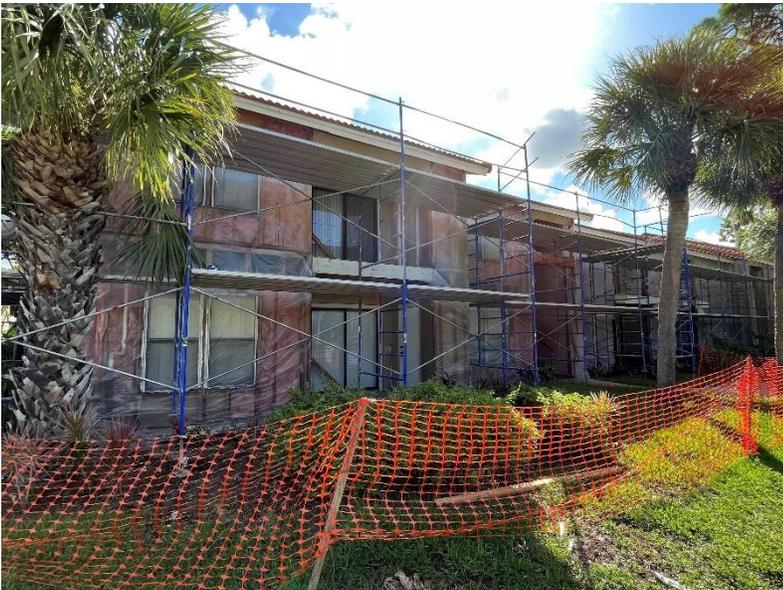
**PHOTOGRAPH #22**

**BUILDING 13  
SECTION A**

Contractor has removed existing stucco and sheathing exposing framing and insulation for damage review.

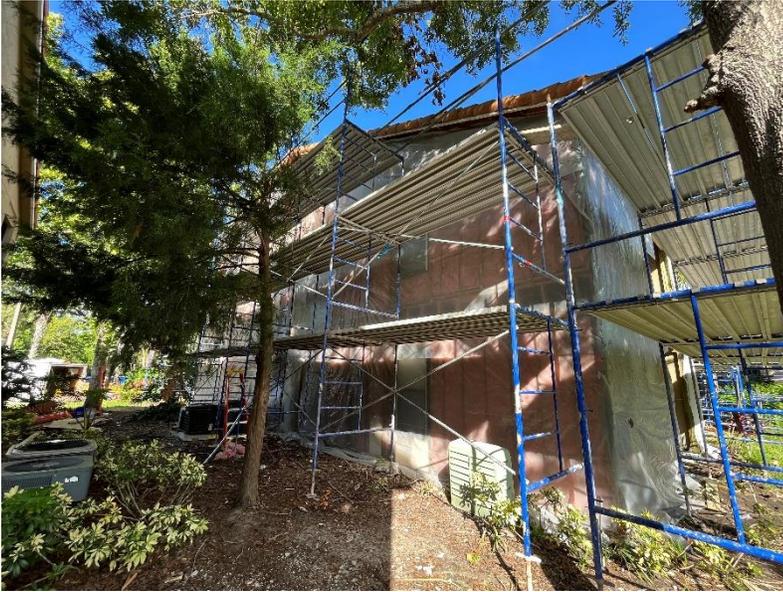
**PHOTOGRAPH #23**

**BUILDING 13  
SECTION D**

Contractor has removed existing stucco and sheathing exposing framing and insulation for damage review. Contractor is now installing Simpson Strong Tie hardware fasteners as per drawings and specifications.

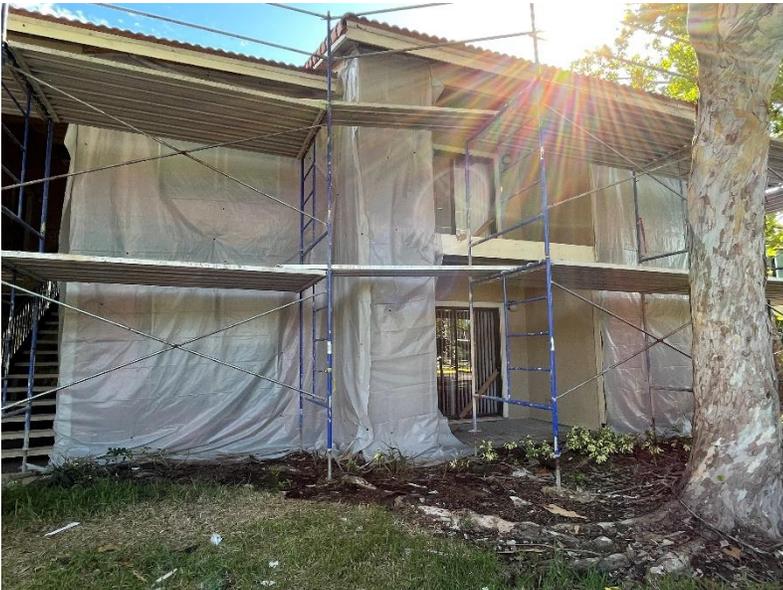
**PHOTOGRAPH #24**

**BUILDING 13  
SECTION C**

Contractor has removed existing stucco and sheathing exposing framing and insulation for damage review.

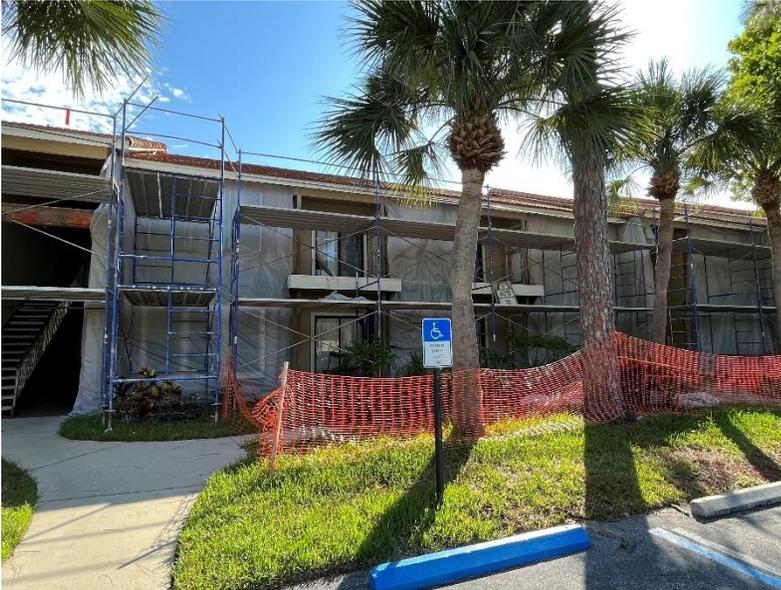
**PHOTOGRAPH #25**

**BUILDING 13  
SECTION B**

Contractor has removed existing stucco and sheathing exposing framing and insulation for damage review.

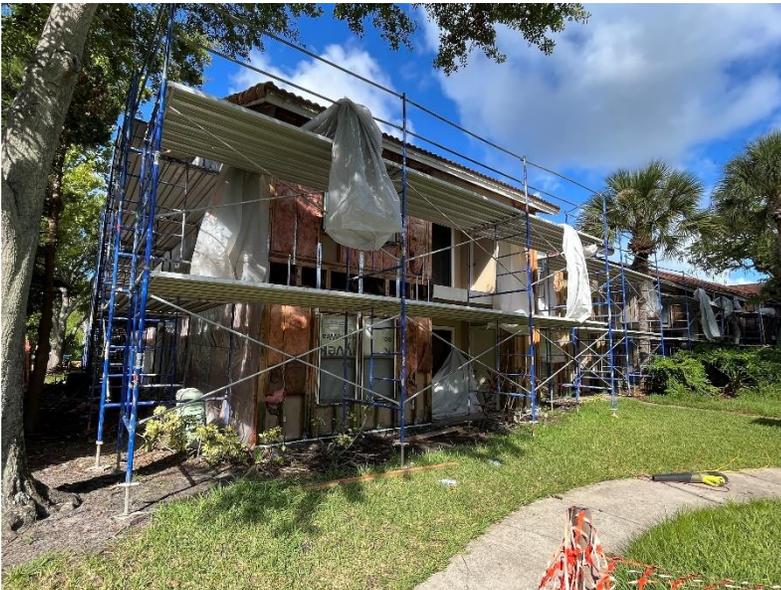
**PHOTOGRAPH #26**

**BUILDING 13  
SECTION E**

Contractor has removed existing stucco and sheathing exposing framing and insulation for damage review. Contractor is now installing Simpson Strong Tie hardware fasteners as per drawings and specifications.
