PHOTOGRAPHS

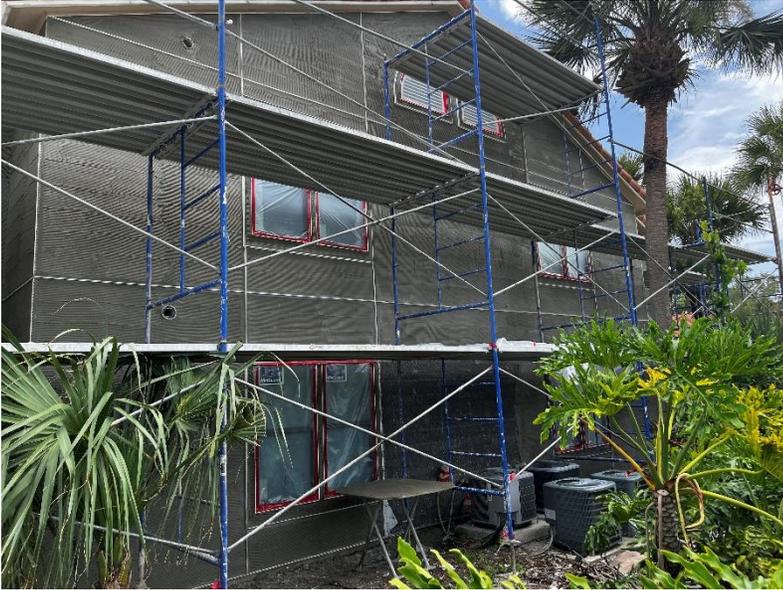
PHOTOGRAPH #1

**BUILDING 8
SECTION D**

Stucco Subcontractor has protected windows and applied scratch coat of three coat 7/8" stucco system.

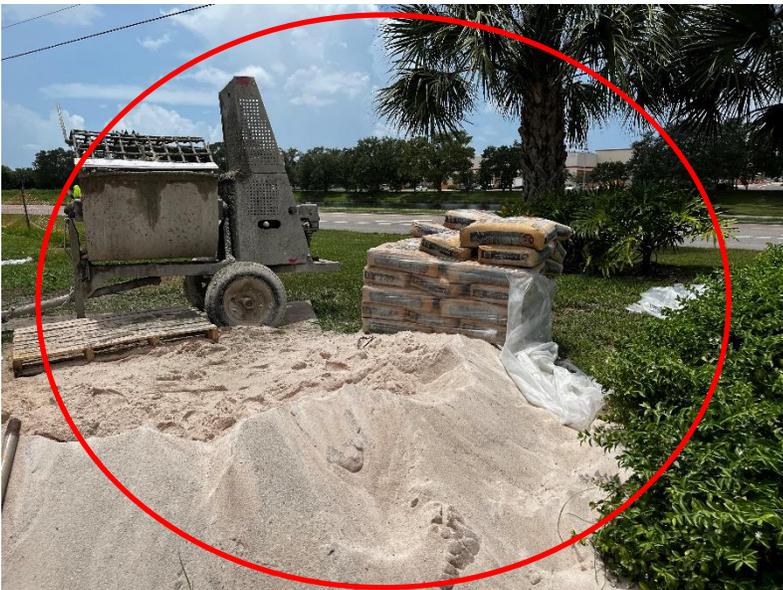
PHOTOGRAPH #2

**BUILDING 8
SECTION D**

Stucco mixing lay down area with mixer sand and bagged stucco mix.

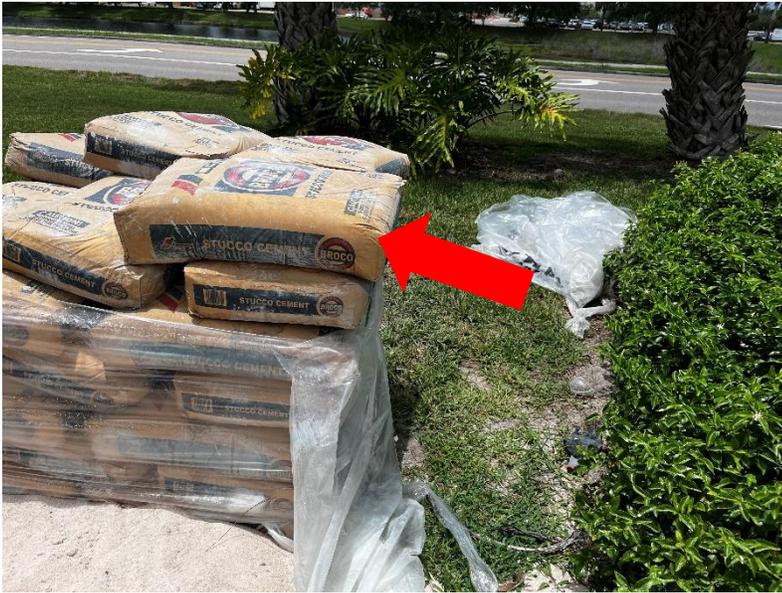
PHOTOGRAPH #3

**BUILDING 8
SECTION D**

Bagged Broco Stucco Cement mixed with sand at site used for stucco applications.

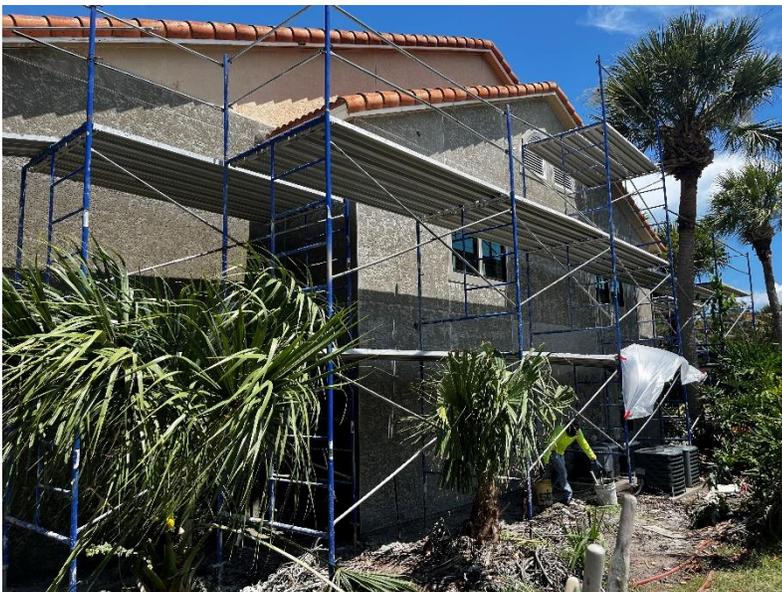
PHOTOGRAPH #4

**BUILDING 8
SECTION D**

Stucco Sub contractor has complete finish texture coat of three coat 7/8" stucco system.

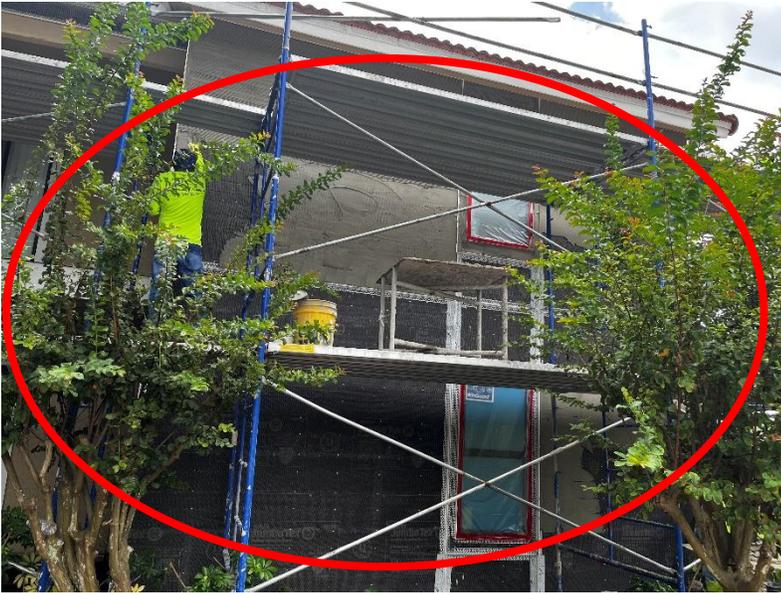
PHOTOGRAPH #5

**BUILDING 8
SECTION C**

Stucco Subcontractor has protected windows and begun to apply scratch coat of three coat 7/8" stucco system.

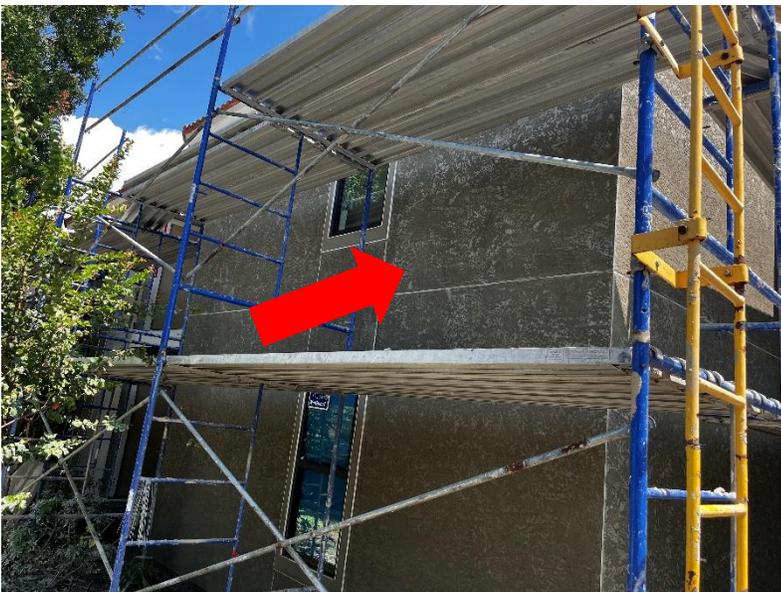
PHOTOGRAPH #6

**BUILDING 8
SECTION C**

Stucco Sub contractor has complete finish texture coat of three coat 7/8" stucco system.

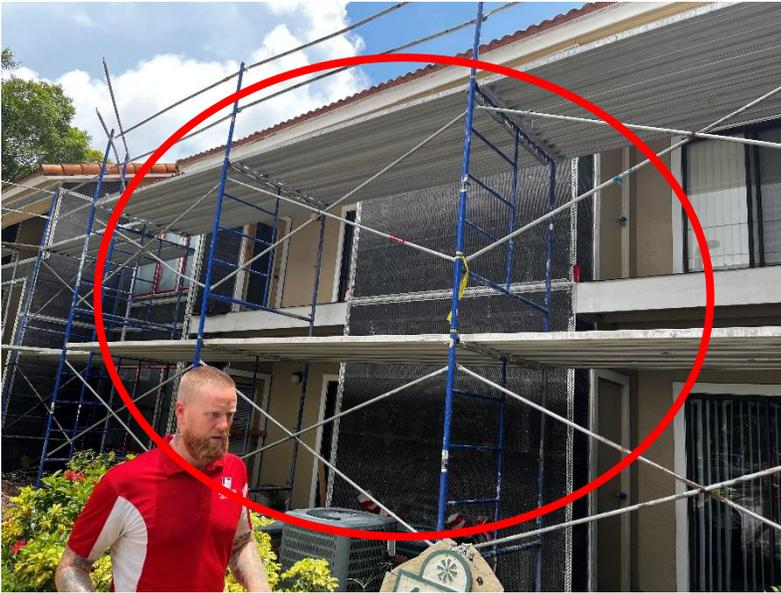
PHOTOGRAPH #7

**BUILDING 8
SECTION B**

Stucco Sub Contractor has completed application of vinyl stucco accessories and self-furring metal lath as per specifications and drawings.

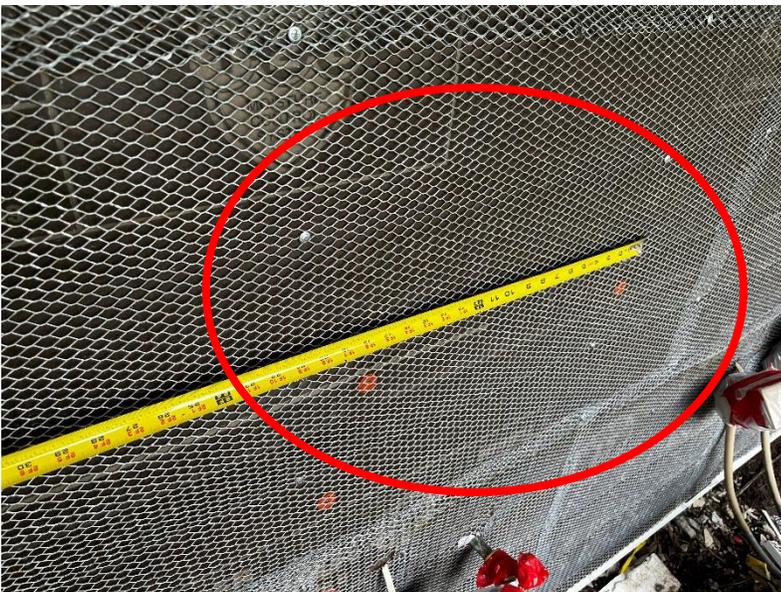
PHOTOGRAPH #8

**BUILDING 8
SECTION B**

New galvanized metal lathing attached at framing members 16" O.C. as per drawings.

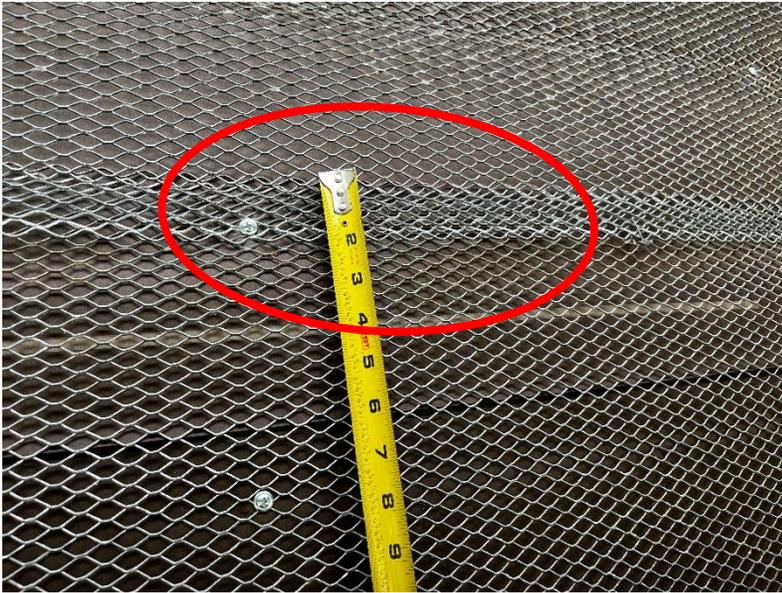
PHOTOGRAPH #9

**BUILDING 8
SECTION B**

New galvanized self-furring metal lathing over lapped 2" meets minimum requirement as per drawings and ASTM C1063.

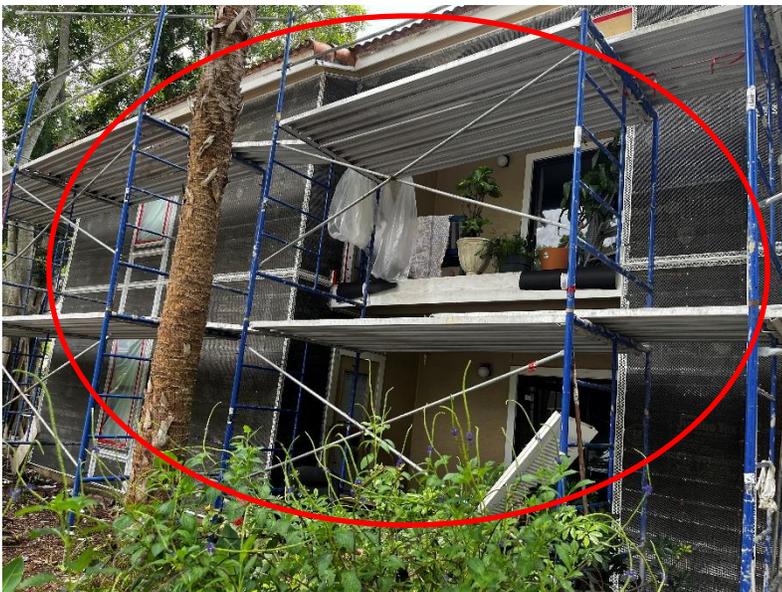
PHOTOGRAPH #10

**BUILDING 8
SECTION A**

Stucco Sub Contractor has completed application of vinyl stucco accessories and self-furring metal lath as per specifications and drawings.

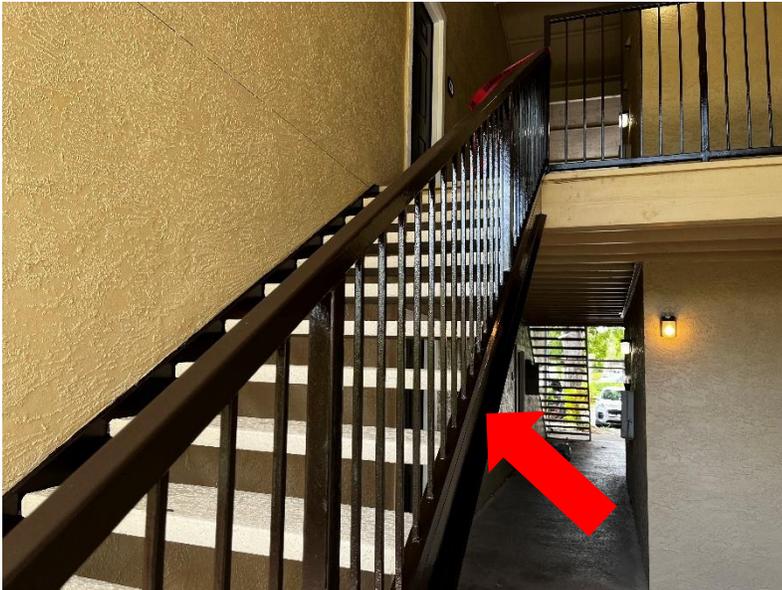
PHOTOGRAPH #11

**BUILDING 8
SECTION G**

Breezeway railings were cleaned (Removing loose paint and rust) with grinders. Contractor has now primed and successfully painted the railings with a finish coat.

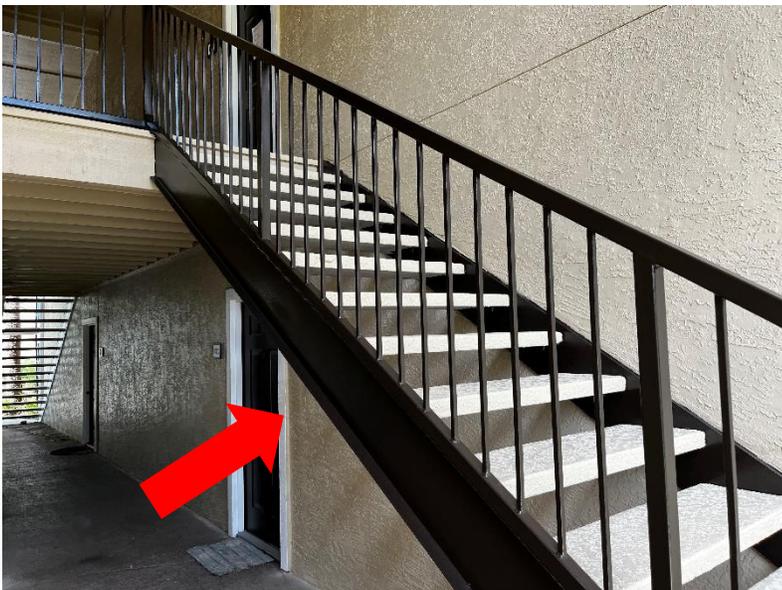
PHOTOGRAPH #12

**BUILDING 8
SECTION E**

Breezeway railings were cleaned (Removing loose paint and rust) with grinders. Contractor has now primed and successfully painted the railings with a finish coat.

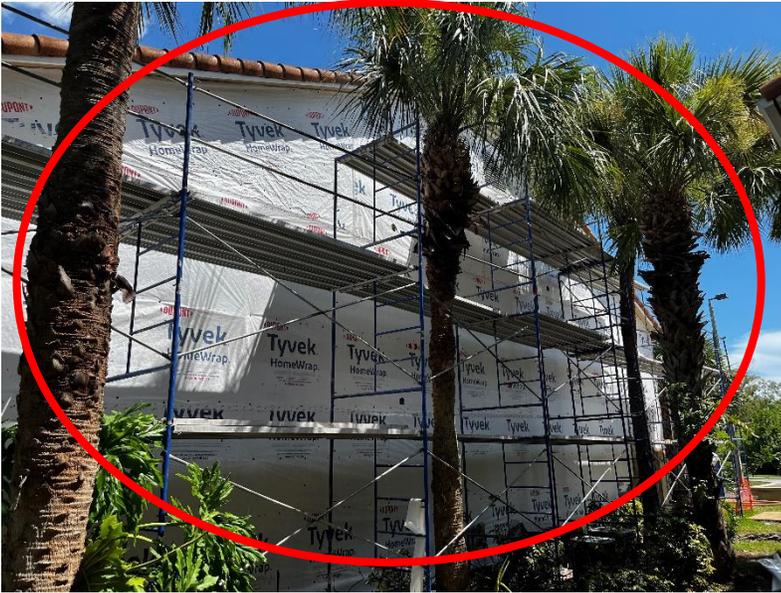
PHOTOGRAPH #13

**BUILDING 13
SECTION H**

Contractor has installed Dupont Tyvek HomeWrap water resistant barrier temporarily covering the window openings.

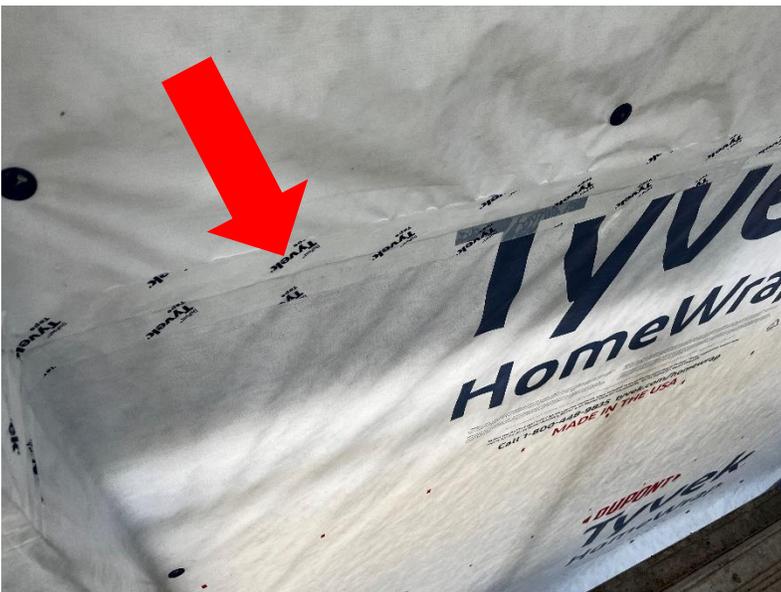
PHOTOGRAPH #14

**BUILDING 13
SECTION H**

Dupont Tyvek 3" seam tape applied at all Tyvek HomeWrap sheet over laps.

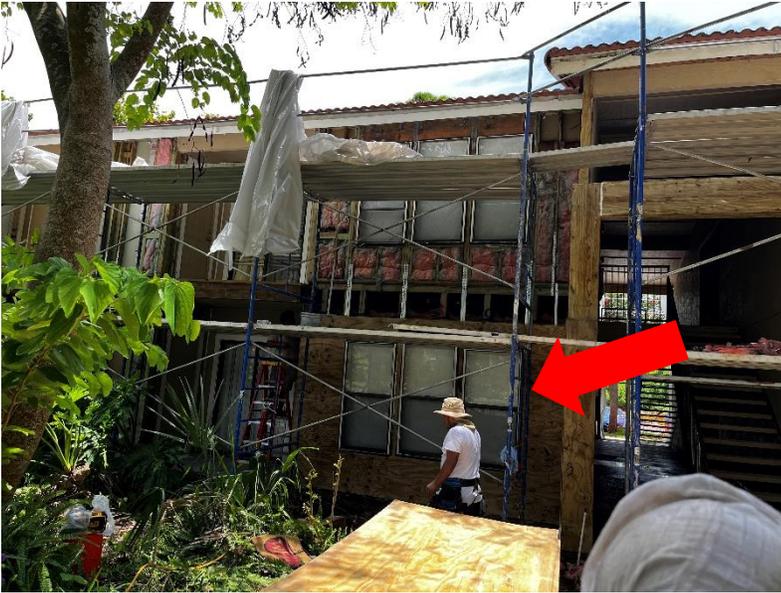
PHOTOGRAPH #15

**BUILDING 13
SECTION F**

Contractor has begun to install specified 15/32" plywood sheathing fastened to framing members as per drawings and specifications.

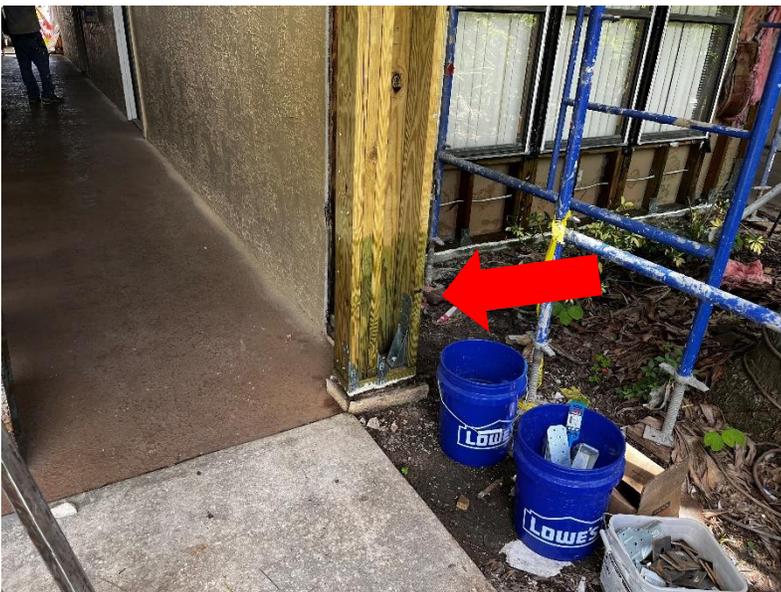
PHOTOGRAPH #16

**BUILDING 13
SECTION E**

Copper Green wood preservative applied to new wood framing at breezeway locations.

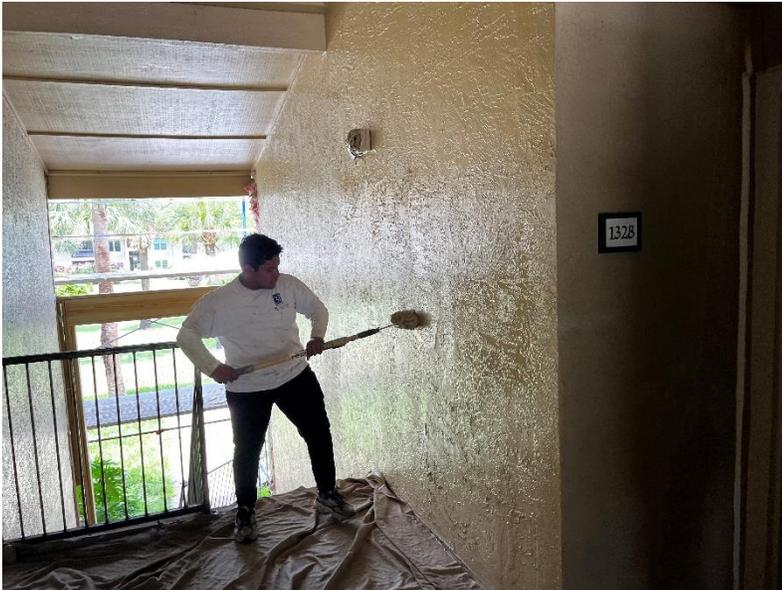
PHOTOGRAPH #17

**BUILDING 13
SECTION E**

Contractor applying Florida Paints Ultra Supercoat finish paint by backtrolling sprayed materials at breezeways walls.

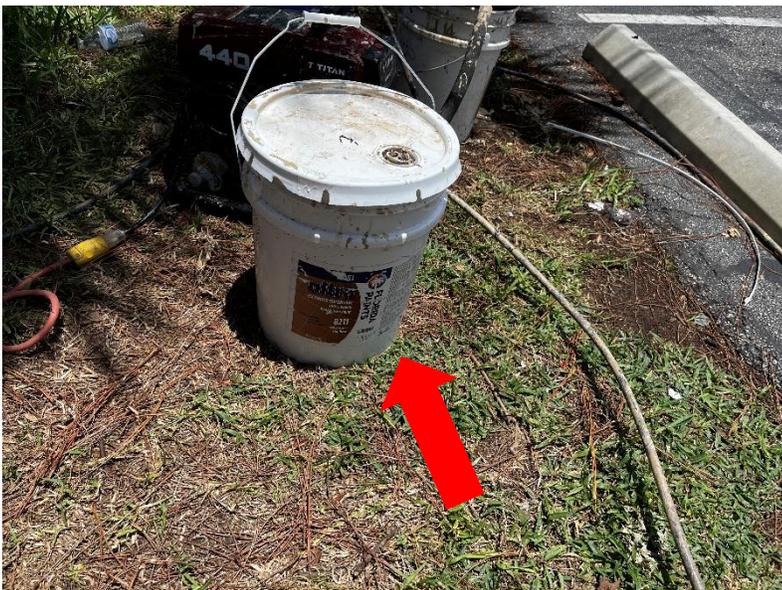
PHOTOGRAPH #18

**BUILDING 13
SECTION E**

Contractor applying Florida Paints Ultra Supercoat finish paint by backtrolling sprayed materials at breezeways walls.

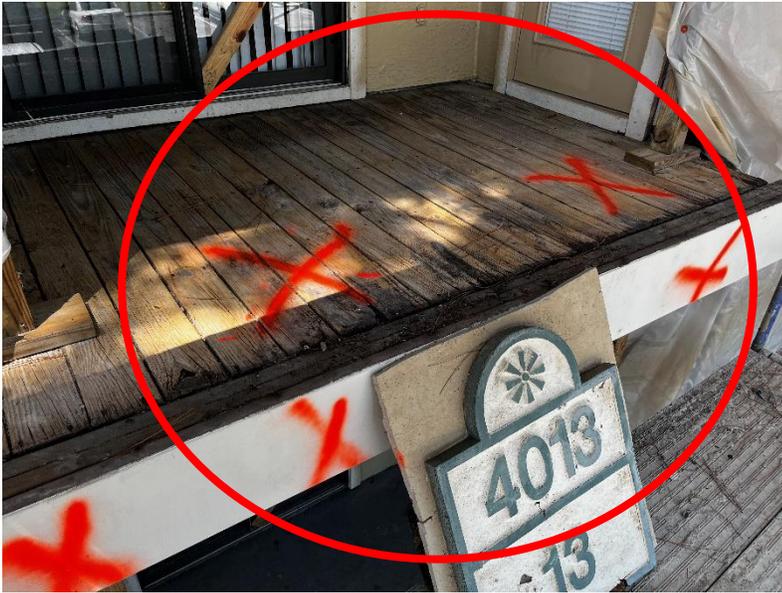
PHOTOGRAPH #19

**BUILDING 13
SECTION B**

Balcony framing and decking damage reviewed and marked for repairs by Delta.

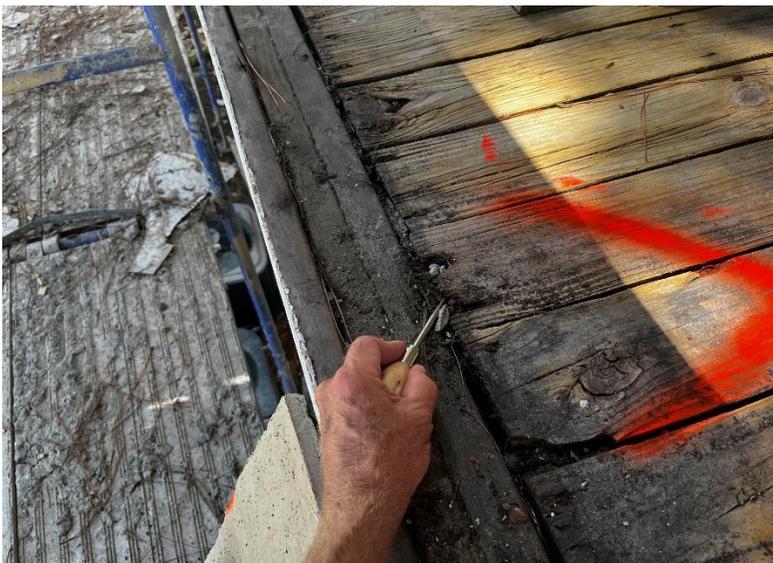
PHOTOGRAPH #20

**BUILDING 13
SECTION B**

Balcony framing and decking damage reviewed and marked for repairs by Delta.

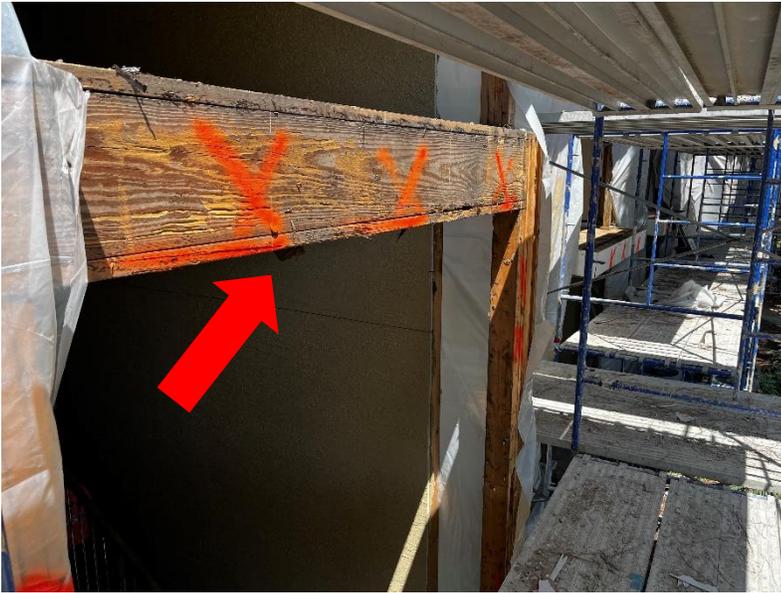
PHOTOGRAPH #21

**BUILDING 13
SECTION A**

Breezeway framing damage reviewed and marked for repairs by Delta.
