PHOTOGRAPHS

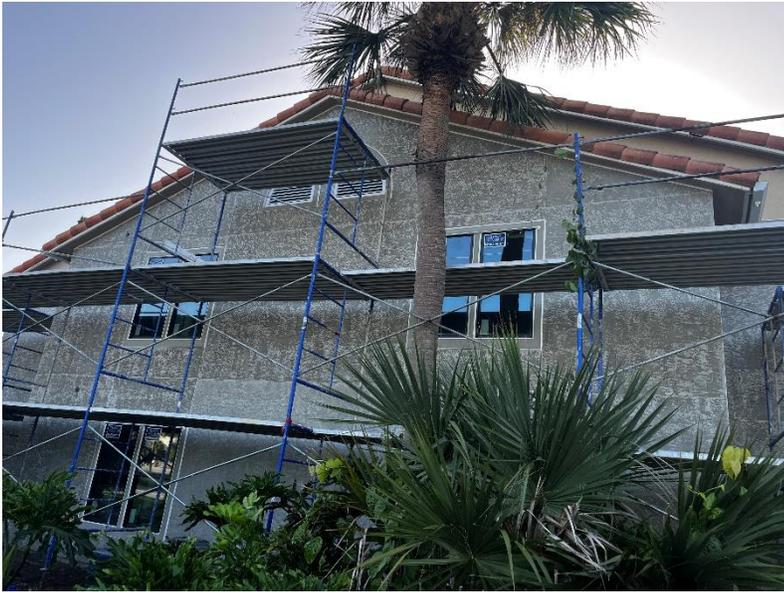
PHOTOGRAPH #1

**BUILDING 8
SECTION D**

Contractor is applying BASF MasterSeal 150 sealant at windows perimeters and transitions.

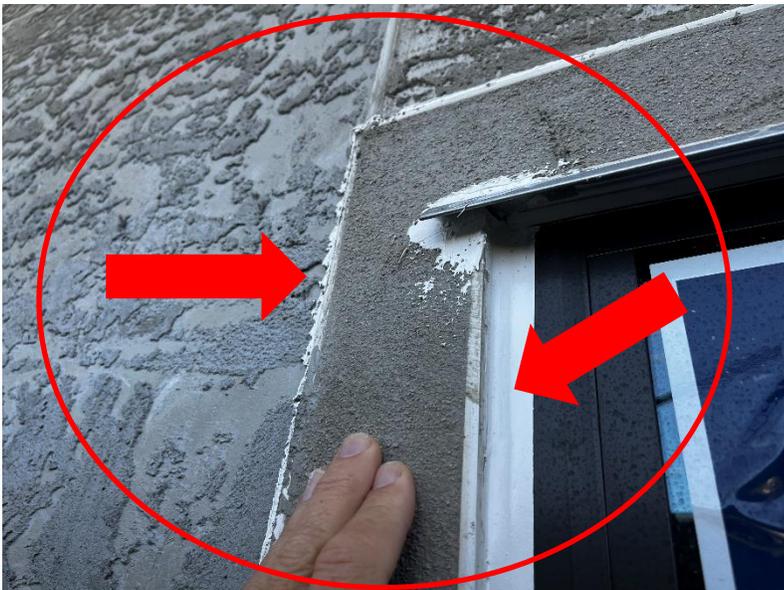
PHOTOGRAPH #2

**BUILDING 8
SECTION D**

Contractor is applying BASF MasterSeal 150 sealant at windows perimeters and transitions.

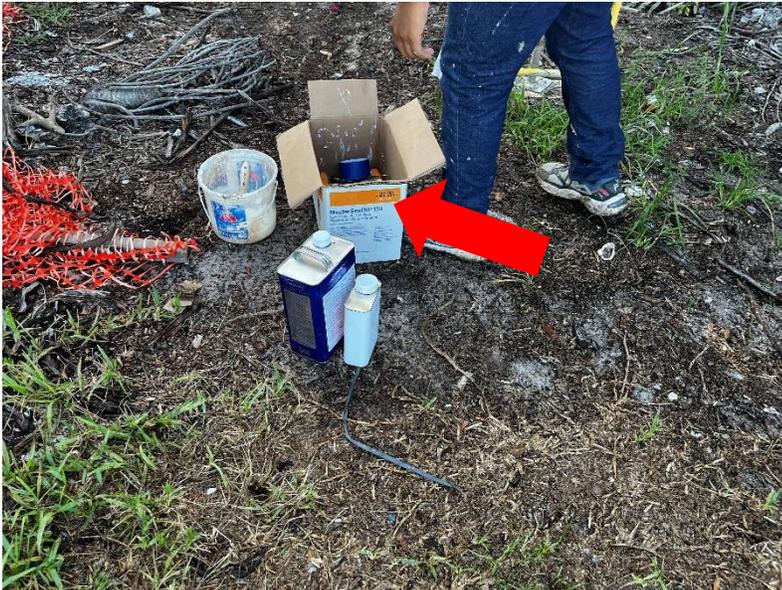
PHOTOGRAPH #3

**BUILDING 8
SECTION D**

Contractor is applying BASF MasterSeal 150 sealant at windows perimeters and transitions.

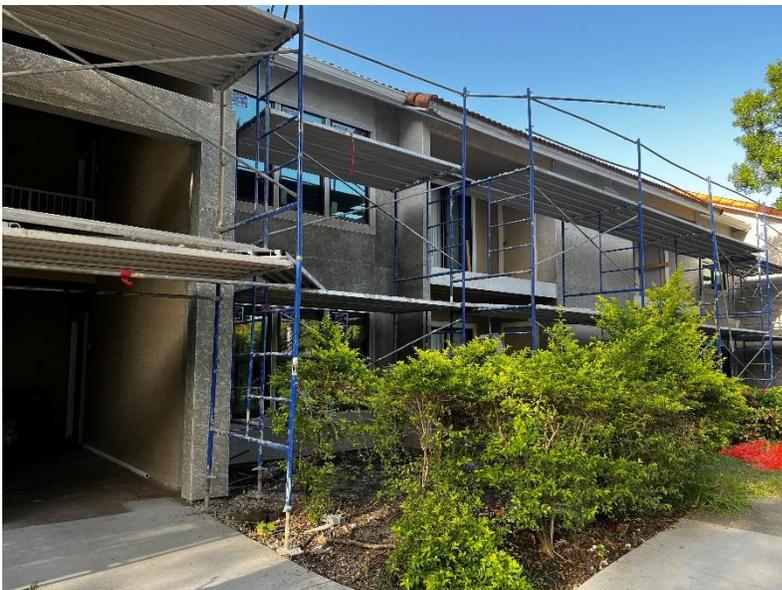
PHOTOGRAPH #4

**BUILDING 8
SECTION B**

Stucco Sub contractor has complete finish texture coat of three coat 7/8" stucco system.

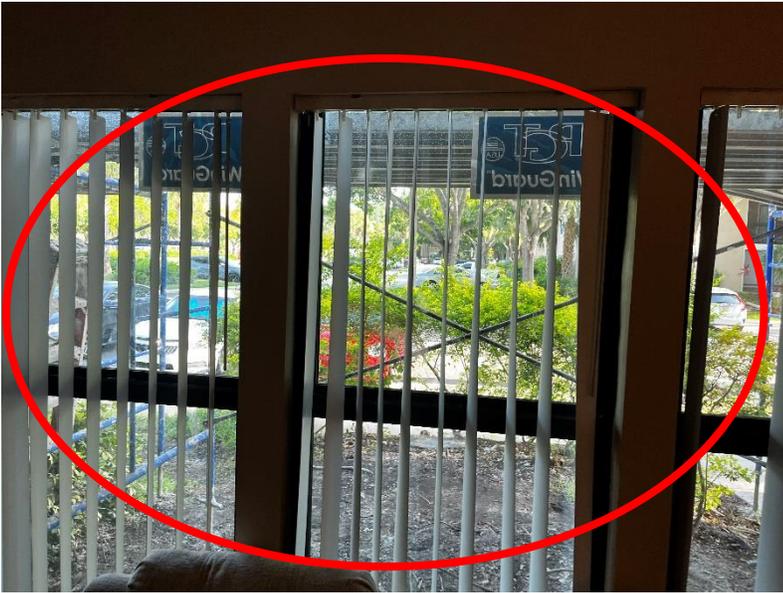
PHOTOGRAPH #5

**BUILDING 8
SECTION B- UNIT 813**

Interior new window installation and drywall repairs completed.

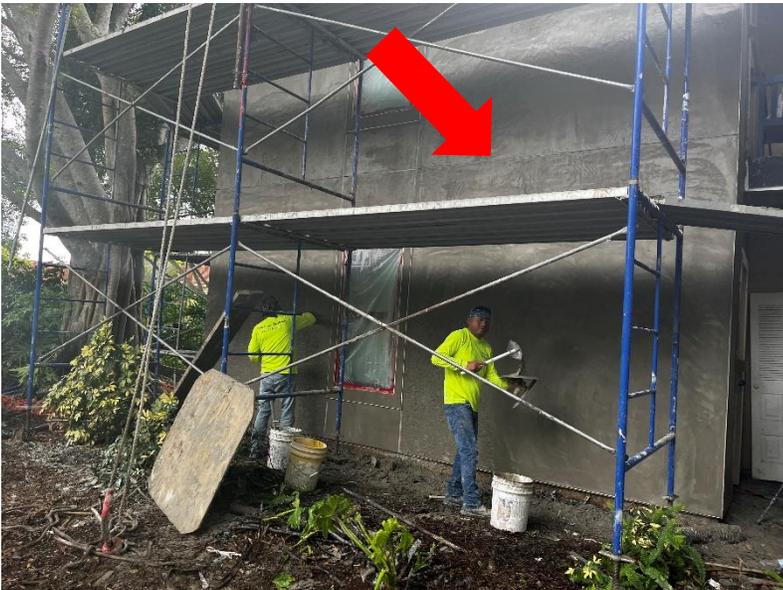
PHOTOGRAPH #6

**BUILDING 8
SECTION A**

Stucco Sub contractor applying brown coat of three coat 7/8" stucco system.

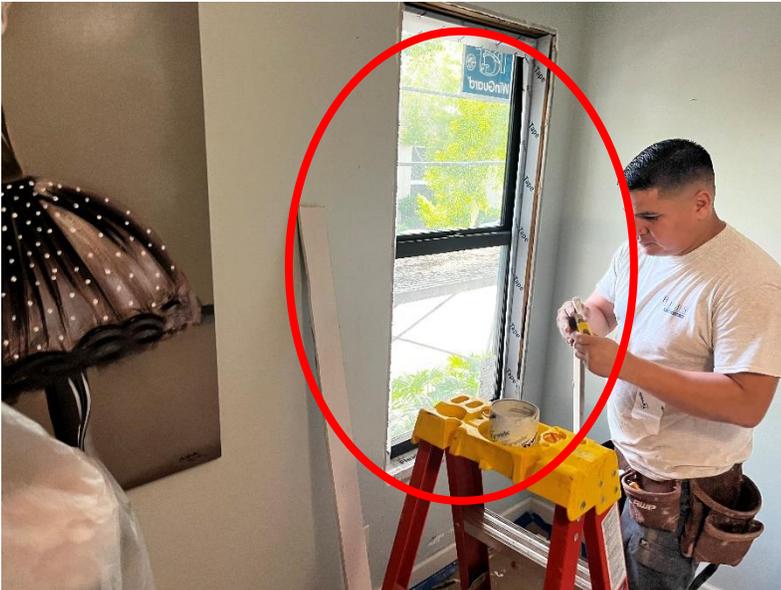
PHOTOGRAPH #7

**BUILDING 8
SECTION A-UNIT 821**

Contractor performing interior window details and restoring drywall and windowsills removed for installation of new PGT windows.

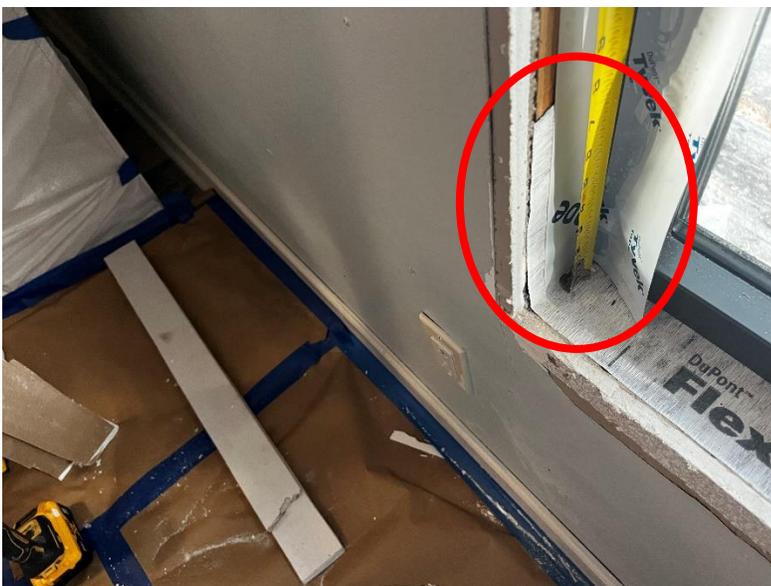
PHOTOGRAPH #8

**BUILDING 8
SECTION A-UNIT 821**

DuPont StraightFlash at window jamb laps over Dupont FlexWrap at sill minimum of 6" as per drawings and manufactures recommendation.

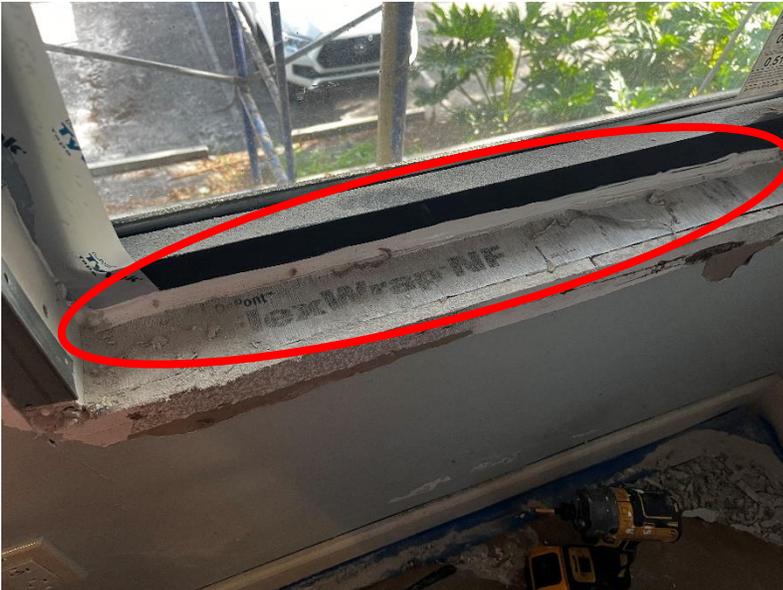
PHOTOGRAPH #9

**BUILDING 8
SECTION A- UNIT 821**

New PGT window sealed at interior perimeter to Dupont FlexWrap with BASF 150 sealant.

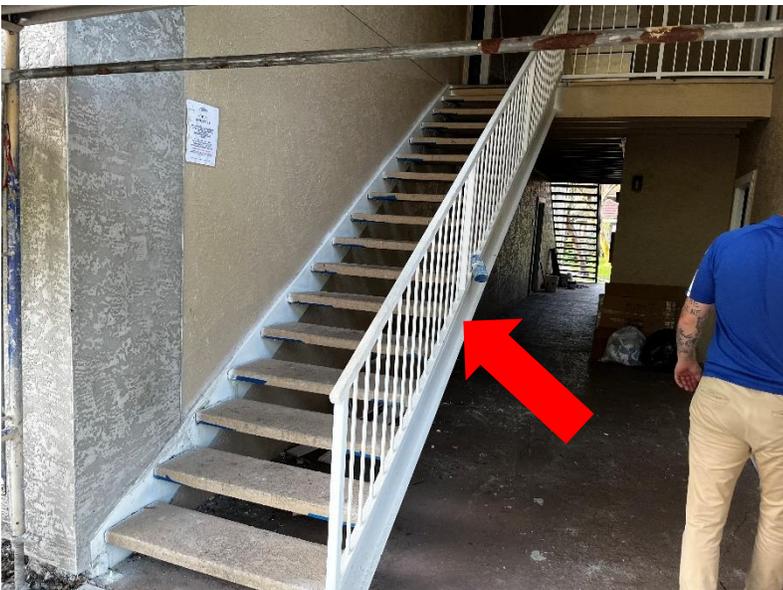
PHOTOGRAPH #10

**BUILDING 8
SECTION A**

Florida Paints Epoxy mastic primer applied to stairway railings is soft and sticky, not properly curing.

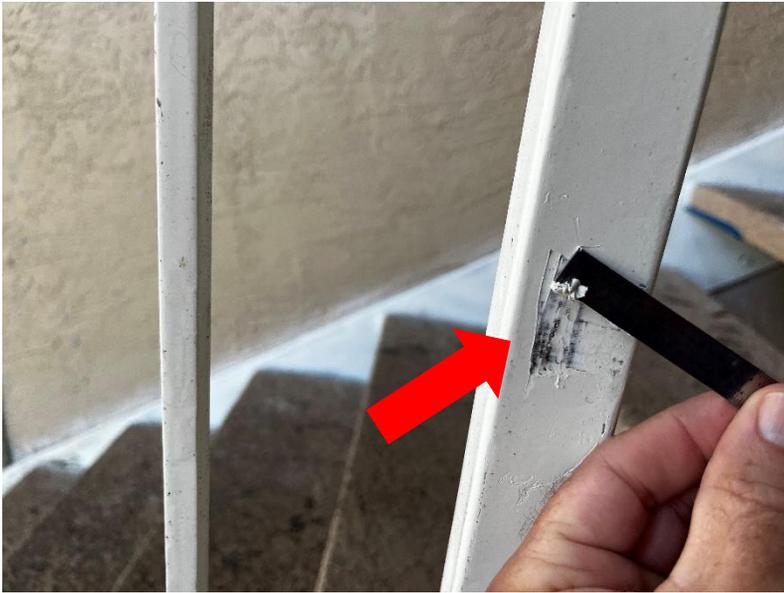
PHOTOGRAPH #11

**BUILDING 8
SECTION A**

Florida Paints Epoxy mastic primer applied to stairway railings is soft and sticky, not properly curing.

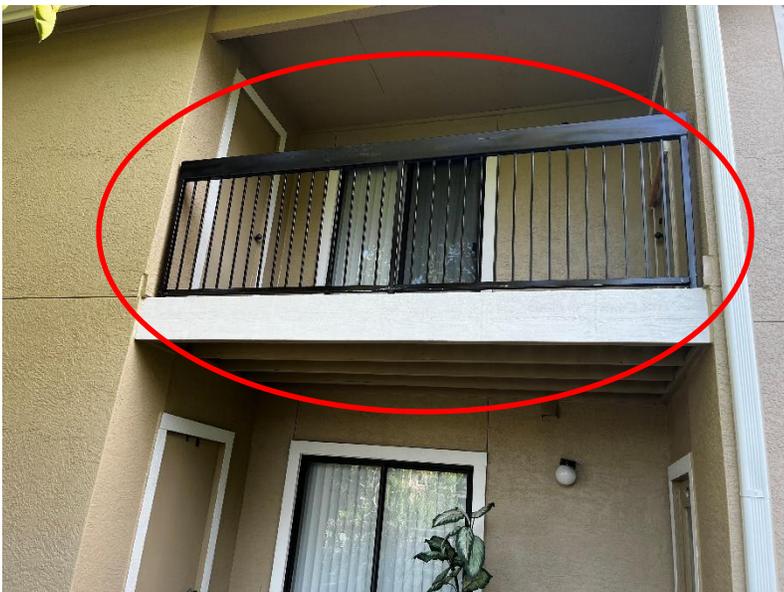
PHOTOGRAPH #12

**BUILDING 8
SECTION F- UNIT 826**

Repainted steel railing has been reinstalled at balcony by railing post attachments to the built-up beam framing.

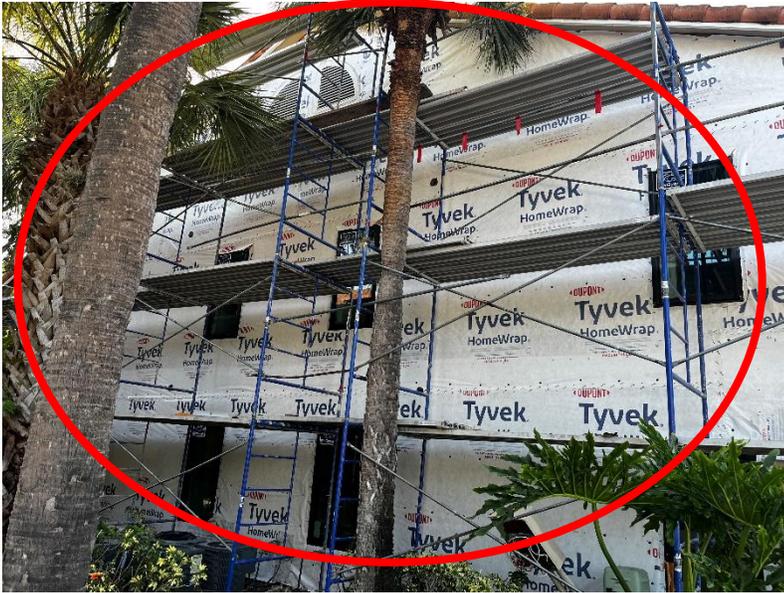
PHOTOGRAPH #13

**BUILDING 13
SECTION H**

Contractor in process of installing new PGT 770 series windows as per drawings and specifications.

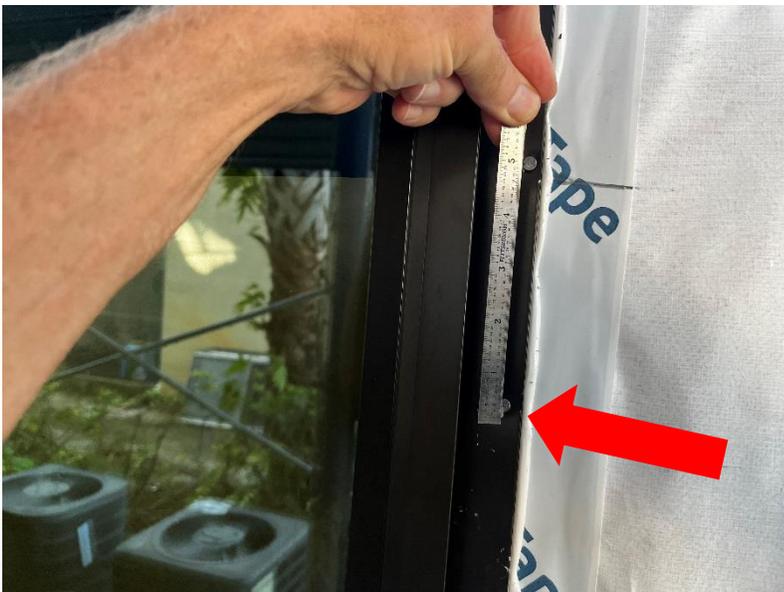
PHOTOGRAPH #14

**BUILDING 13
SECTION H-UNIT 1311**

Window fin attachments nailed at 5" O.C with 10d nails as per manufacturers NOA.

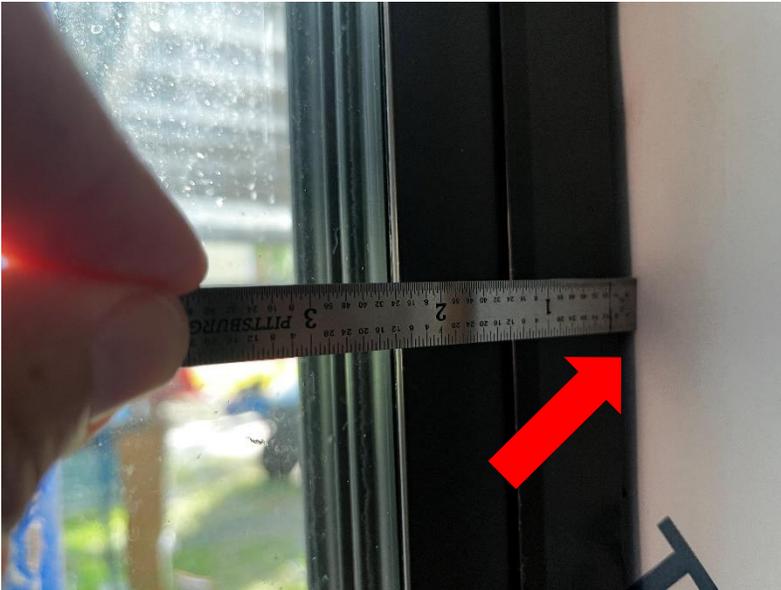
PHOTOGRAPH #15

**BUILDING 13
SECTION H-UNIT 1312**

Window installation measured for maximum 5/16" gap between 2X wood stud and window jamb framing.

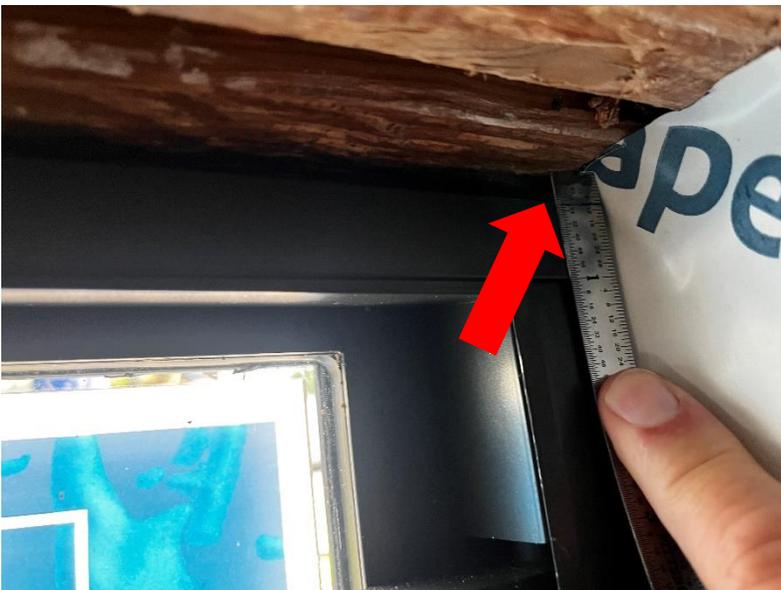
PHOTOGRAPH #16

**BUILDING 13
SECTION H-1312**

Window installation measured for maximum 5/16" gap between 2X wood stud and window head framing.

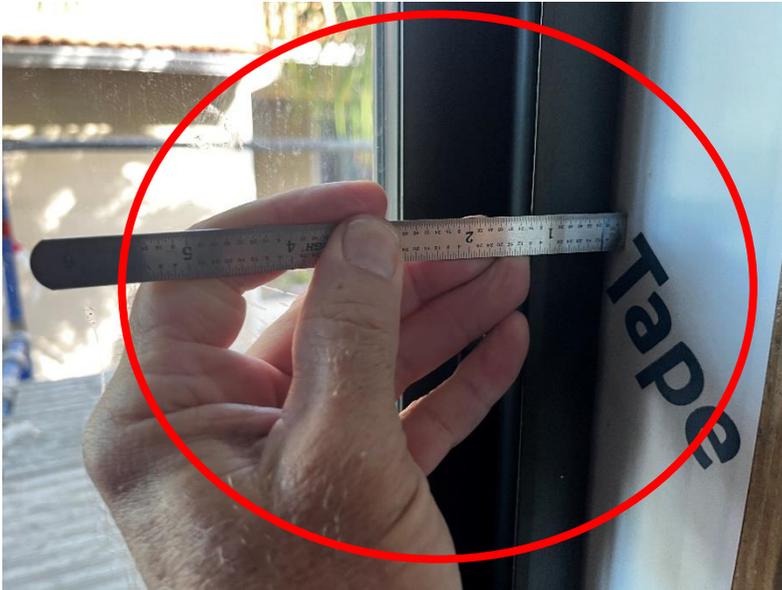
PHOTOGRAPH #17

**BUILDING 13
SECTION H-UNIT 1322**

Window installation measured for maximum 5/16" gap between 2X wood stud and window jamb framing.

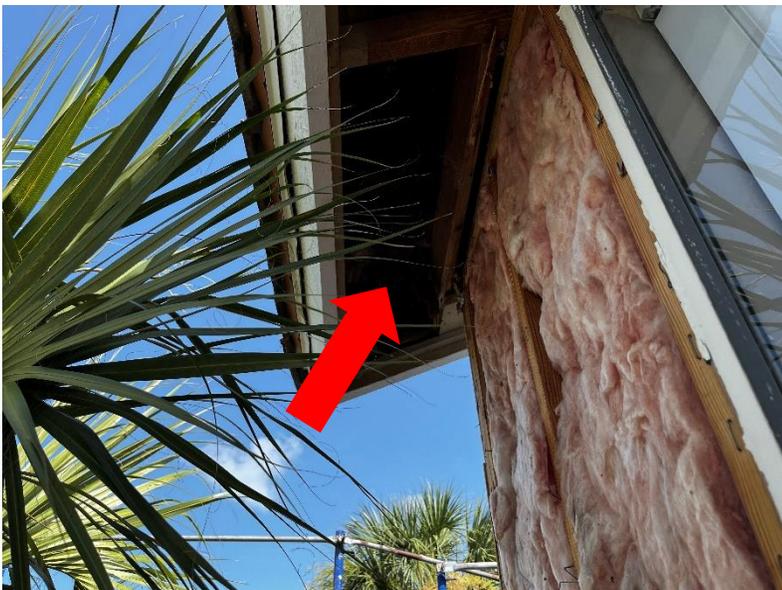
PHOTOGRAPH #18

**BUILDING 13
SECTION G**

Removal of soffit has exposed roofing sheathing that has failed and deteriorated from roof leaks.

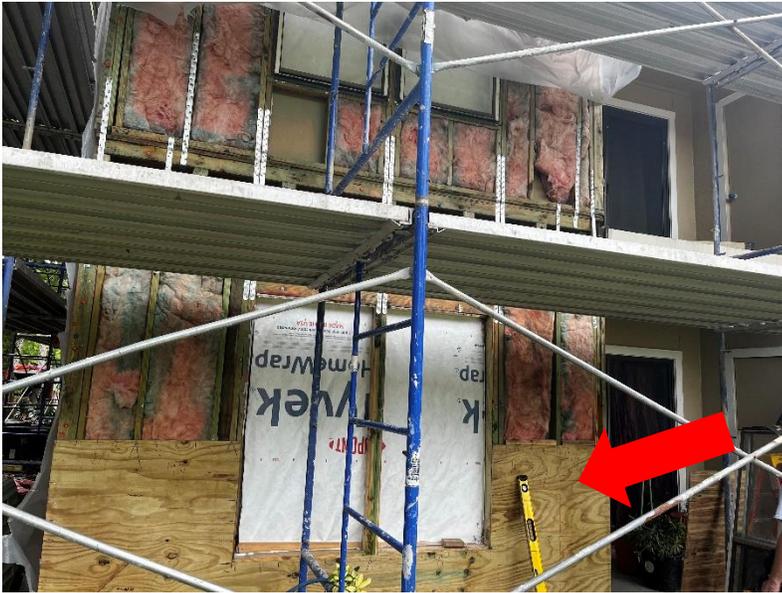
PHOTOGRAPH #19

**BUILDING 13
SECTION F**

New 5/16" 4' x 8' sheet of pressure treated plywood sheathing applied at base of wall as per specifications.

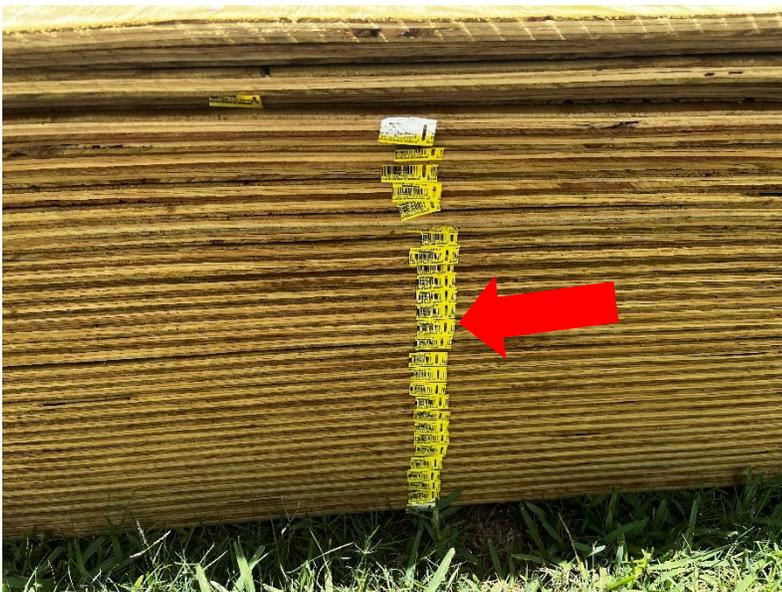
PHOTOGRAPH #20

**BUILDING 13
SECTION F**

New 5/16" 4' x 8' sheet of pressure treated plywood sheathing applied at base of wall as per specifications.

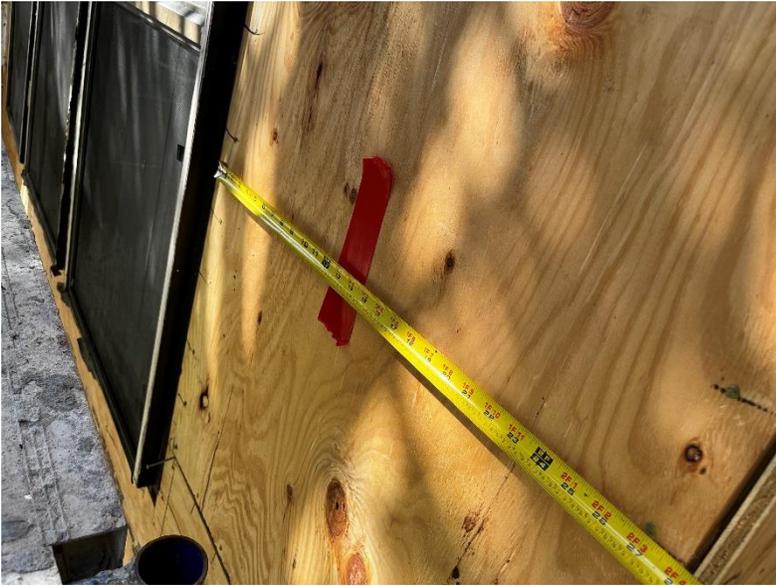
PHOTOGRAPH #21

**BUILDING 13
SECTION F**

Contractor has missed fastening new sheathing to framing at 16" O.C..

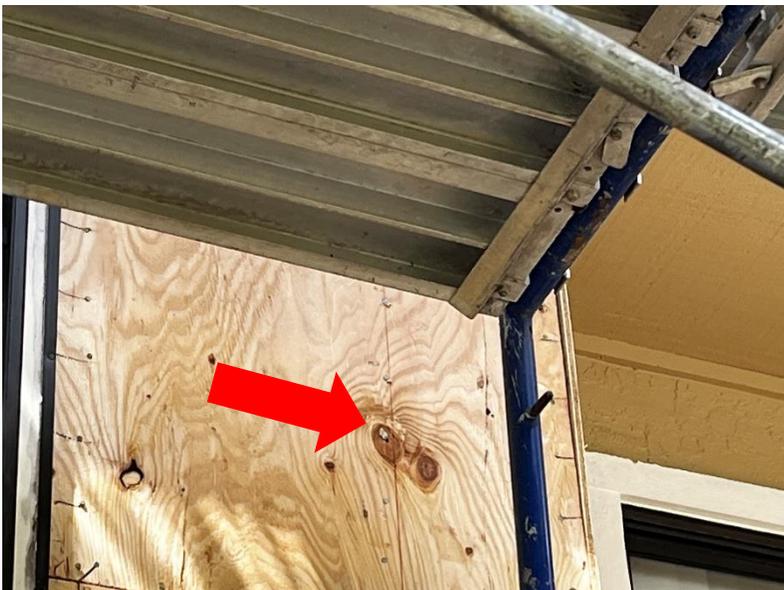
PHOTOGRAPH #22

**BUILDING 13
SECTION F**

Contractor has made corrections where missing fasteners to framing. .

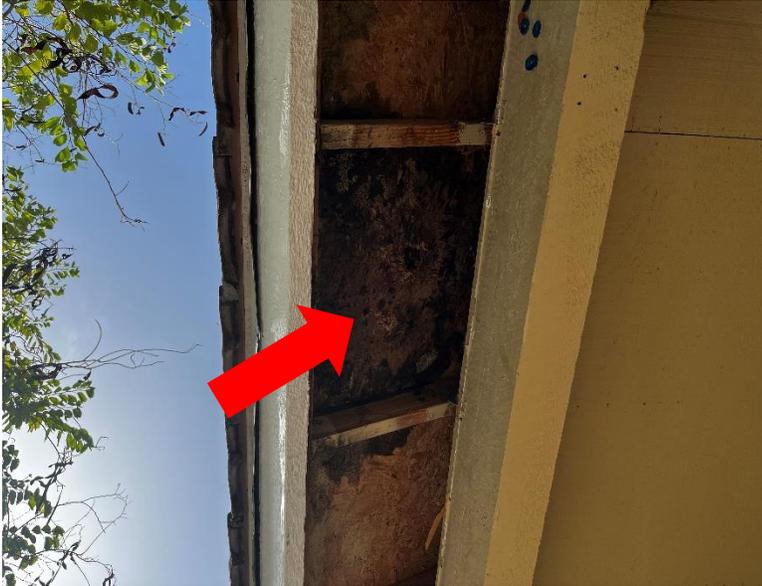
PHOTOGRAPH #23

**BUILDING 13
SECTION F**

Removal of soffit has exposed roofing sheathing that has failed and deteriorated from roof leaks.

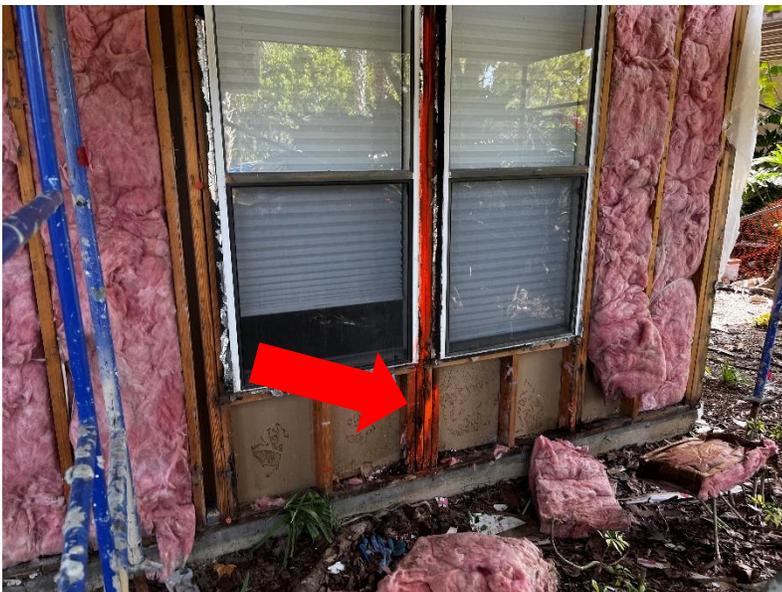
PHOTOGRAPH #24

**BUILDING 13
SECTION C**

Additional damaged window framing marked for repairs.

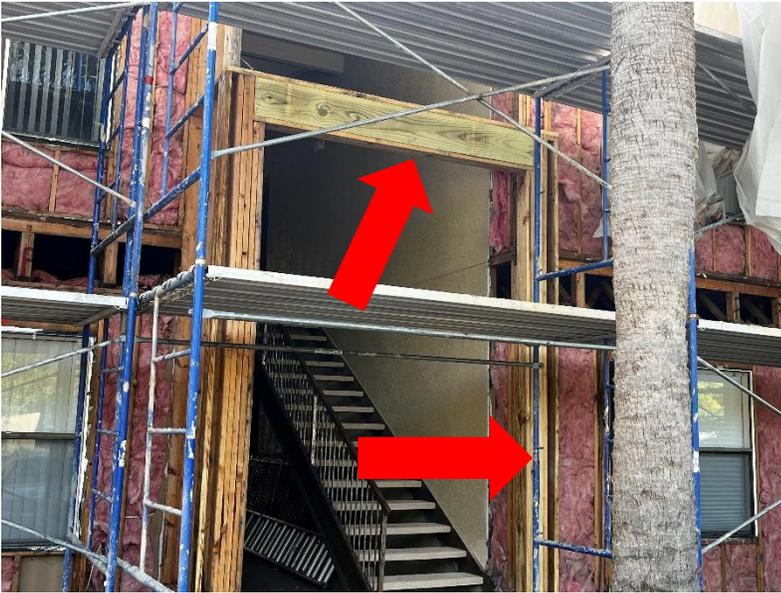
PHOTOGRAPH #25

**BUILDING 13
SECTION C**

Contractor has rebuilt damaged breezeway header and 2"X6" studs marked for repairs at post.

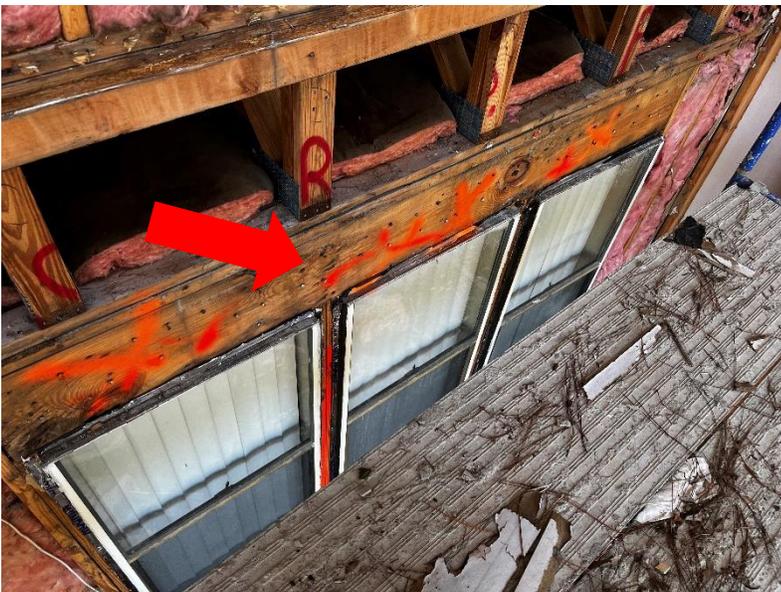
PHOTOGRAPH #26

**BUILDING 13
SECTION B**

Additional damaged window header and framing marked for repairs.

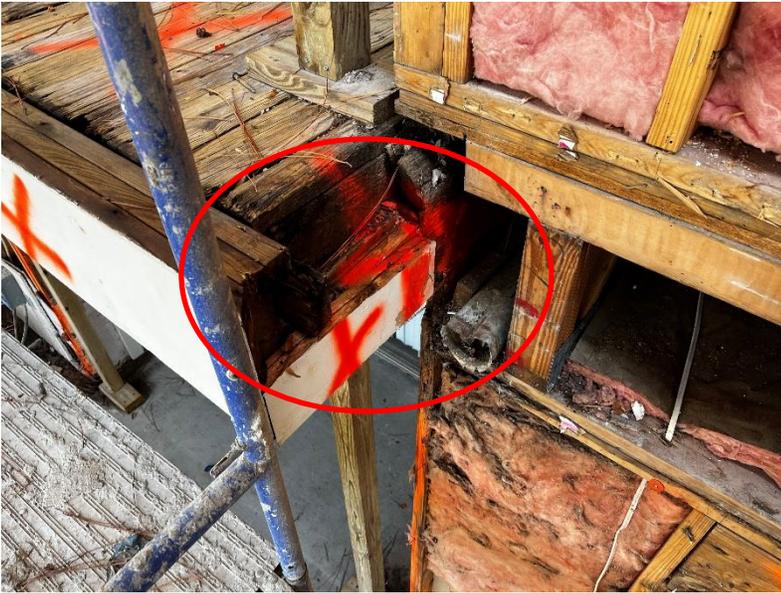
PHOTOGRAPH #27

**BUILDING 13
SECTION B- UNIT 1325**

Balcony built up beam framing and ledgers marked from replacement.
