PHOTOGRAPHS

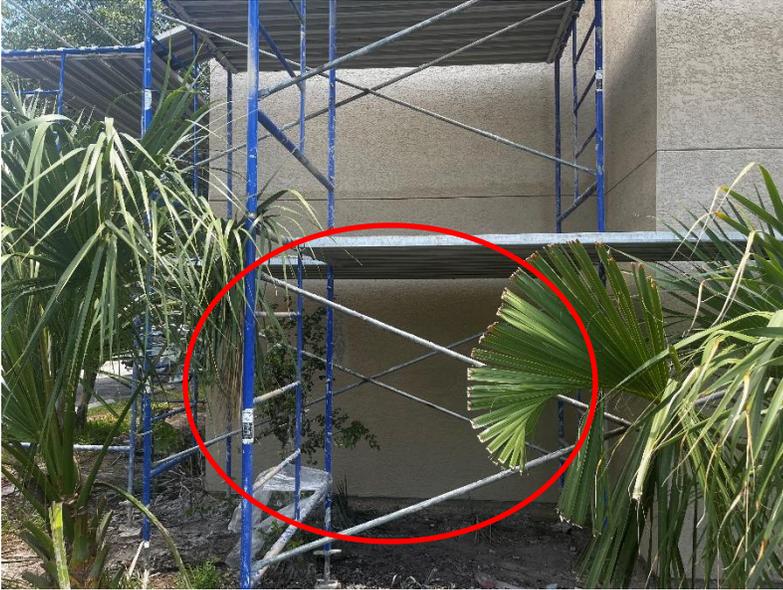
PHOTOGRAPH #1

**BUILDING 8  
SECTION D**

Contractor has applied Florida Paints Glades Exterior 100% Acrylic Wall and Trim Paint for substitution mockup approval.

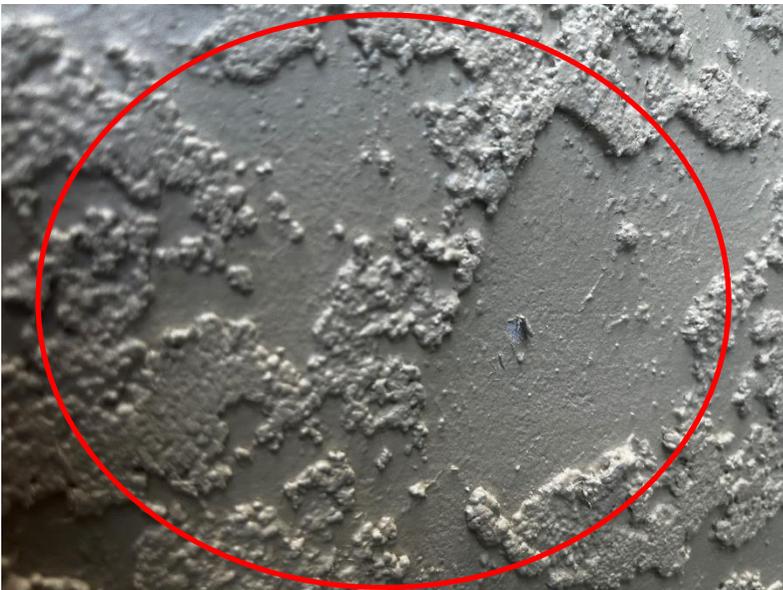
PHOTOGRAPH #2

**BUILDING 8  
SECTION D**

Contractor has applied Florida Paints Glades Exterior 100% Acrylic Wall and Trim Paint for substitution mockup approval.

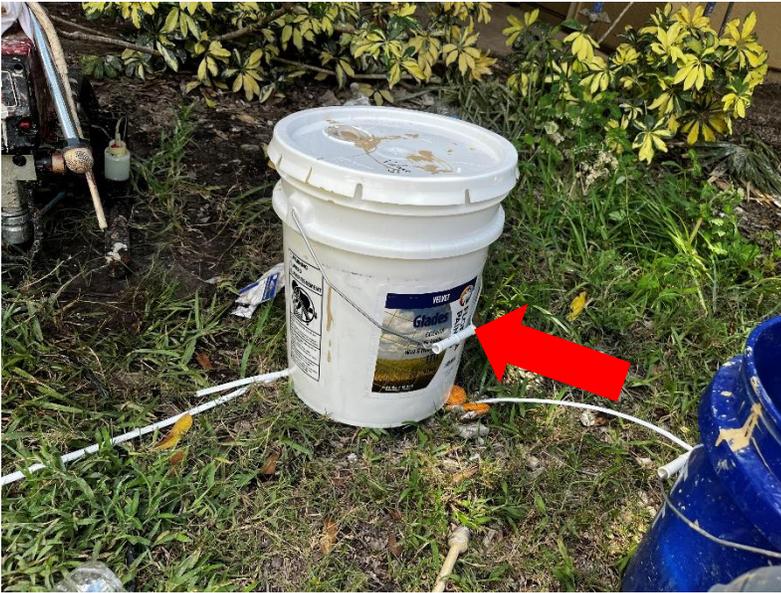
**PHOTOGRAPH #3**

**BUILDING 8  
SECTION D**

Contractor has applied Florida Paints Glades Exterior 100% Acrylic Wall and Trim Paint for substitution mockup approval.

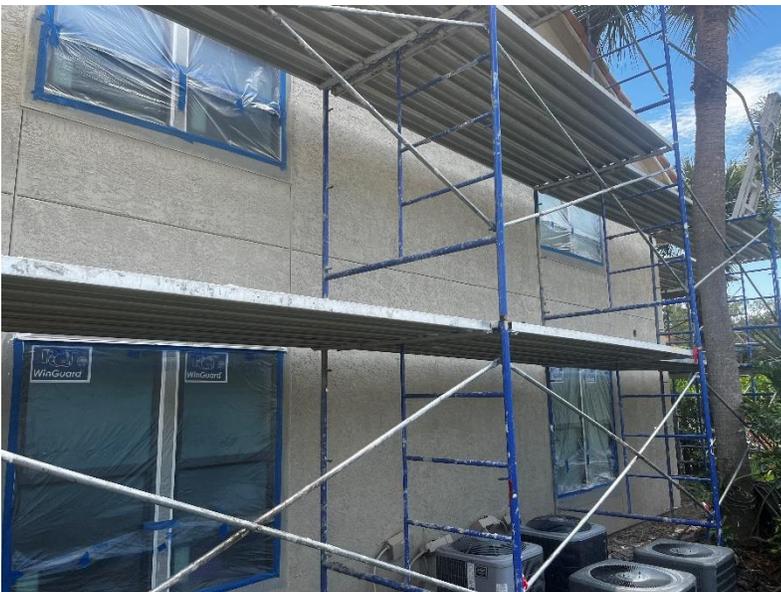
**PHOTOGRAPH #4**

**BUILDING 8  
SECTION D**

Contractor has protected new PGT windows and applied Florida Paints SunFlex exterior masonry and concrete primer.

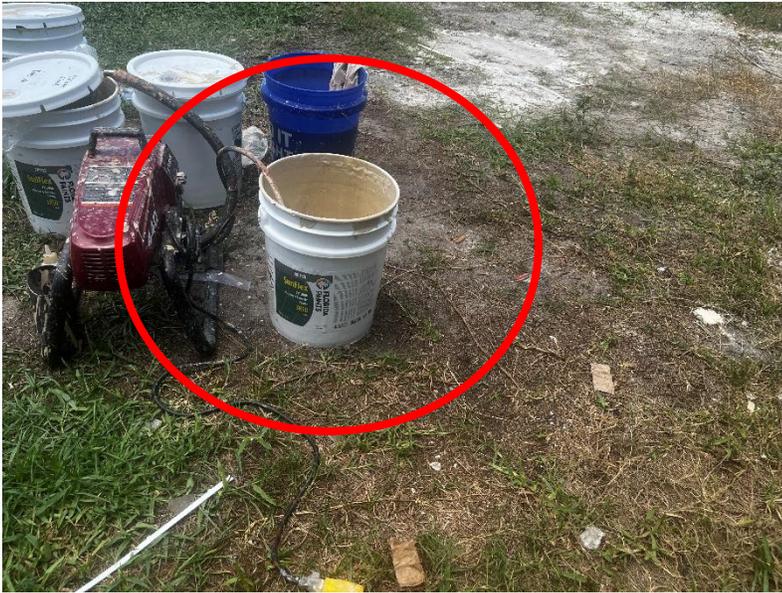
**PHOTOGRAPH #5**

**BUILDING 8  
SECTION D**

Contractor has protected new PGT windows and applied Florida Paints SunFlex exterior masonry and concrete primer.

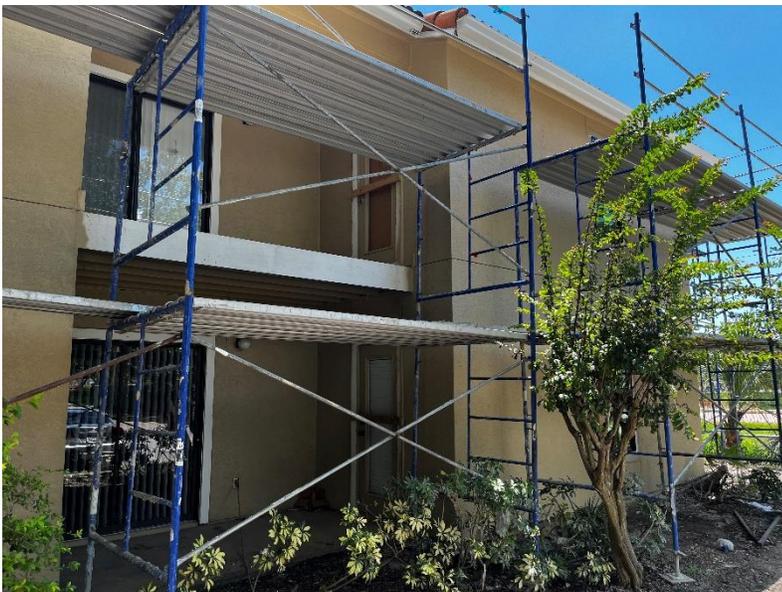
**PHOTOGRAPH #6**

**BUILDING 8  
SECTION C**

Contractor has protected new PGT windows and applied Florida Paints SunFlex exterior masonry and concrete primer.

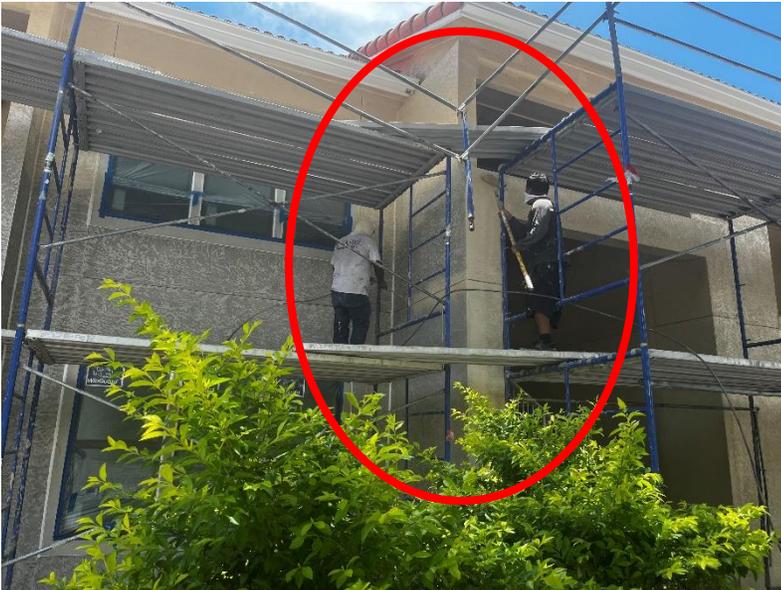
**PHOTOGRAPH #7**

**BUILDING 8  
SECTION B**

Contractor in process of applying Florida Paints SunFlex exterior masonry and concrete primer by spray and back rolling new stucco.

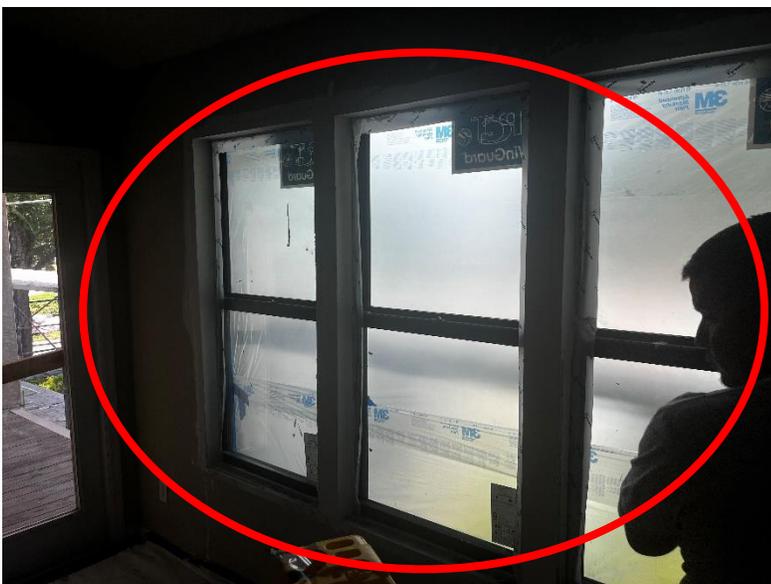
**PHOTOGRAPH #8**

**BUILDING 8  
SECTION B-UNIT 823**

Contractor has performed interior drywall repairs and replaced windowsill as per specification.

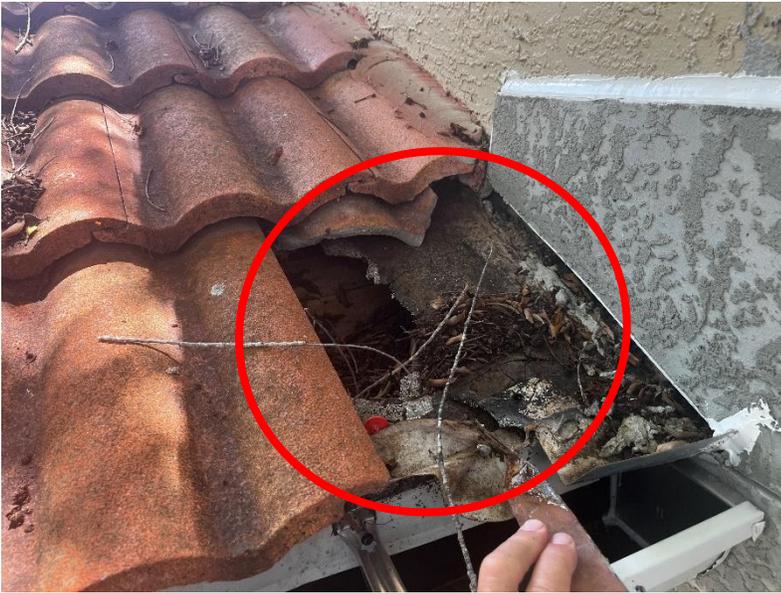
**PHOTOGRAPH #9**

**BUILDING 8  
SECTION A- UNIT 821**

Roof damage observed where tile removed for installation of new kick out flashing.

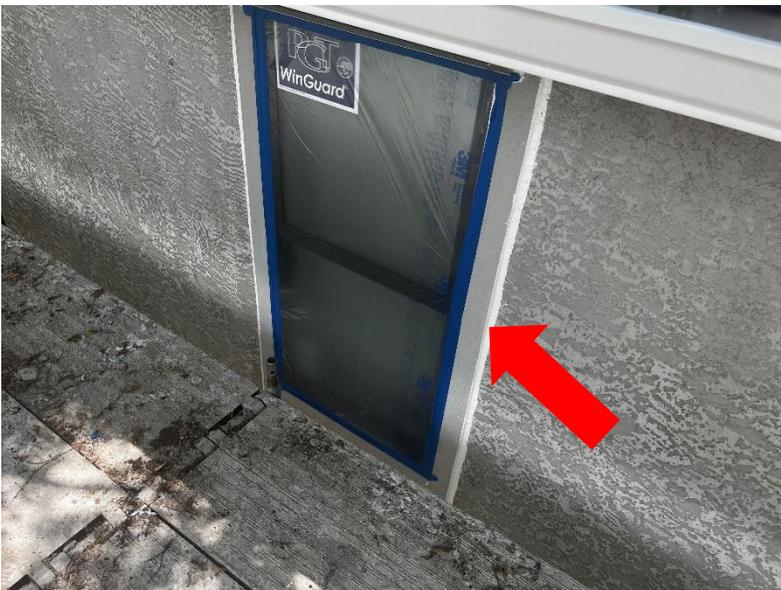
**PHOTOGRAPH #10**

**BUILDING 8  
SECTION A- UNIT 821**

New BASF sealants applied at window band stucco to stucco transition and window covered for protection.

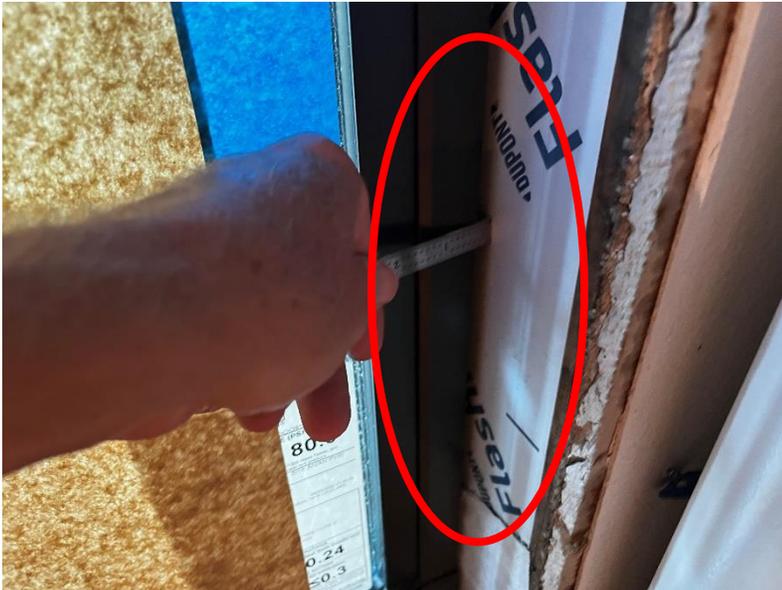
**PHOTOGRAPH #11**

**BUILDING 13  
SECTION H- UNIT 1311**

Window installation measured for maximum 5/16" gap between 2X wood stud and window jamb framing.

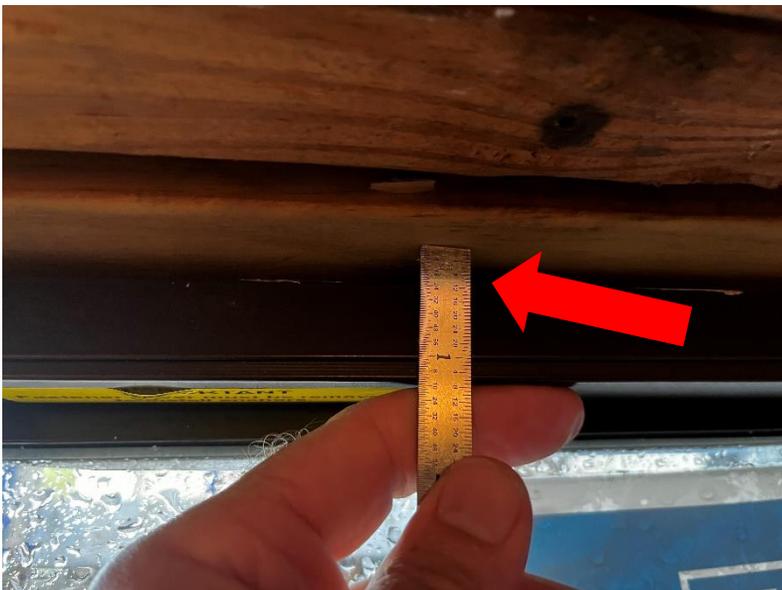
**PHOTOGRAPH #12**

**BUILDING 13  
SECTION H-UNIT 1311**

Window installation measured for maximum 5/16" gap between 2X wood stud and window head framing.

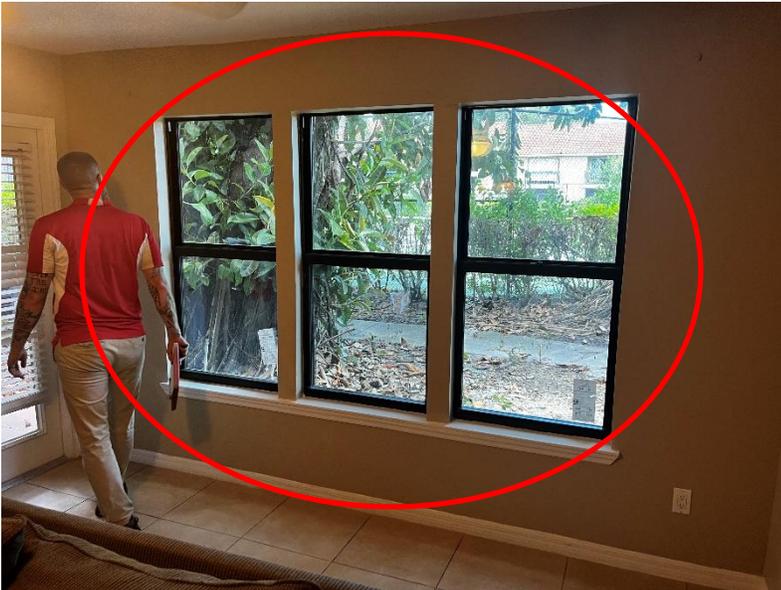
**PHOTOGRAPH #13**

**BUILDING 8  
SECTION F -UNIT 816**

Contractor has performed interior drywall repairs and replaced windowsill as per specifications.

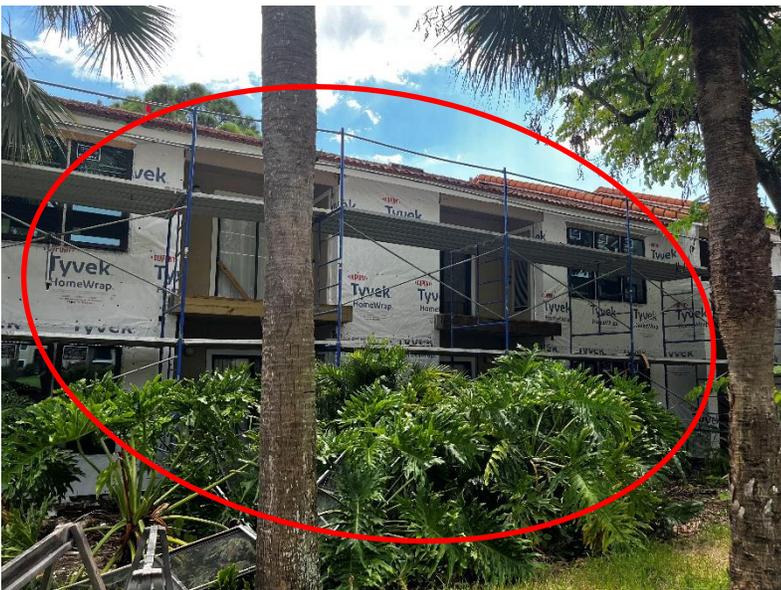
**PHOTOGRAPH #14**

**BUILDING 13  
SECTION F**

New PGT 770 series windows installed as per drawings and manufacture's NOAs.

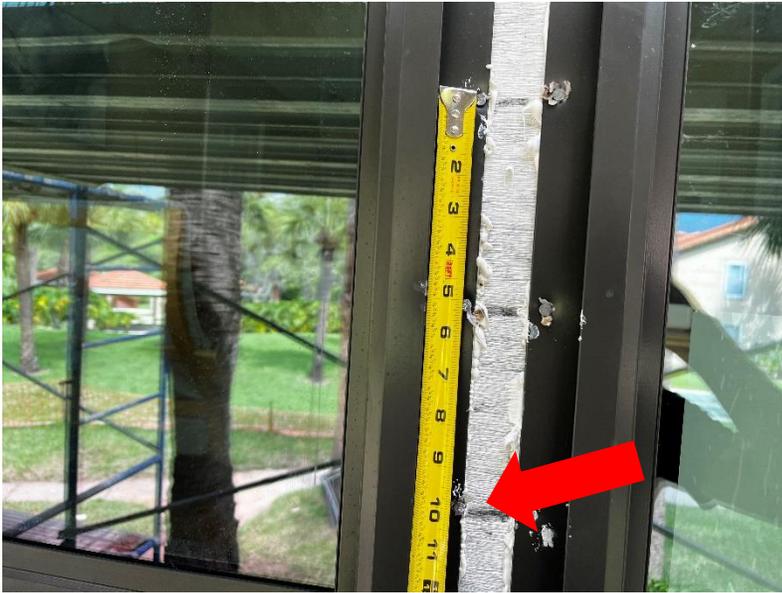
**PHOTOGRAPH #15**

**BUILDING 13  
SECTION F-UNIT 1316**

Window fin fasteners installed to wood framing at 5" O.C. as per drawings and manufacturer's NOA

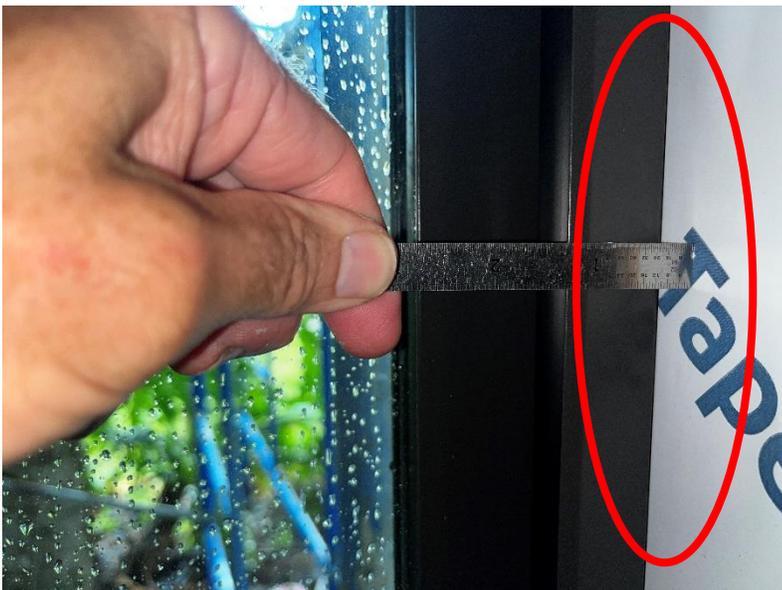
**PHOTOGRAPH #16**

**BUILDING 13  
SECTION F-UNIT 1316**

Window installation measured for maximum 5/16" gap between 2X wood stud and window jamb framing.

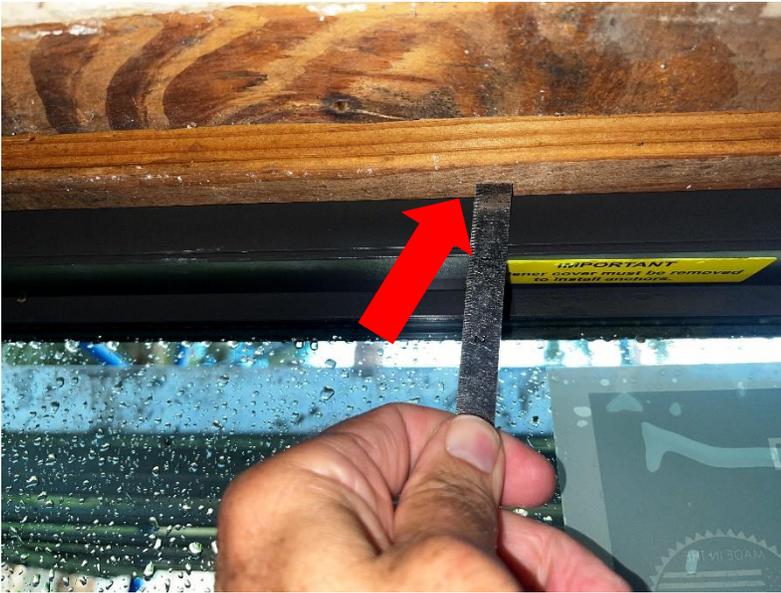
**PHOTOGRAPH #17**

**BUILDING 13  
SECTION F-UNIT 1316**

Window installation measured for maximum 5/16" gap between 2X wood stud and window head framing.

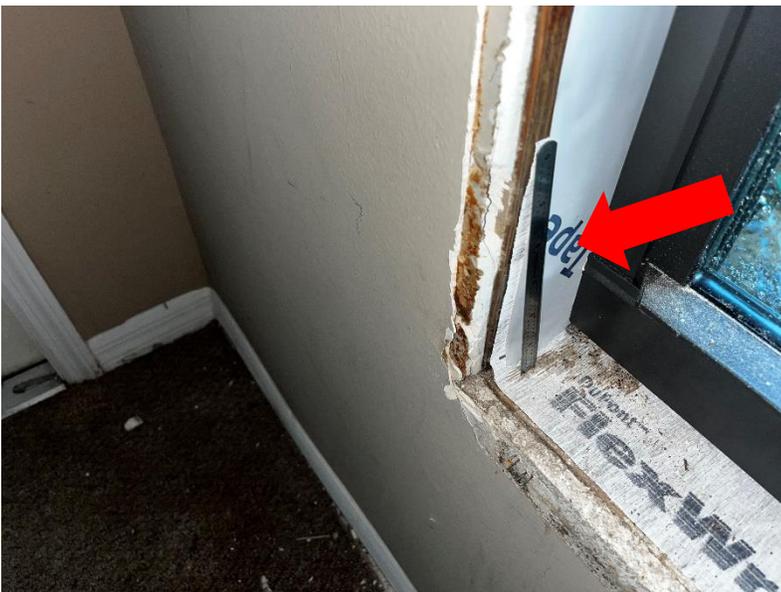
**PHOTOGRAPH #18**

**BUILDING 13  
SECTION F-UNIT 1316**

DuPont flashing overlapped at jamb 6" as per drawings and manufacture's recommendations.

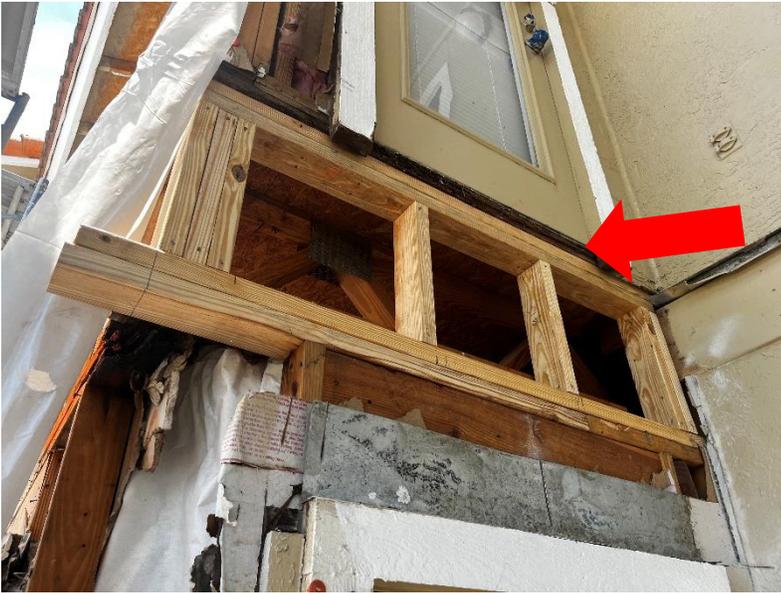
**PHOTOGRAPH #19**

**BUILDING 13  
SECTION B- UNIT 1323**

Contractor has removed damaged cedar framing and rebuilt framing per ESI #1 drawing SK-1 dated 10/18/19.

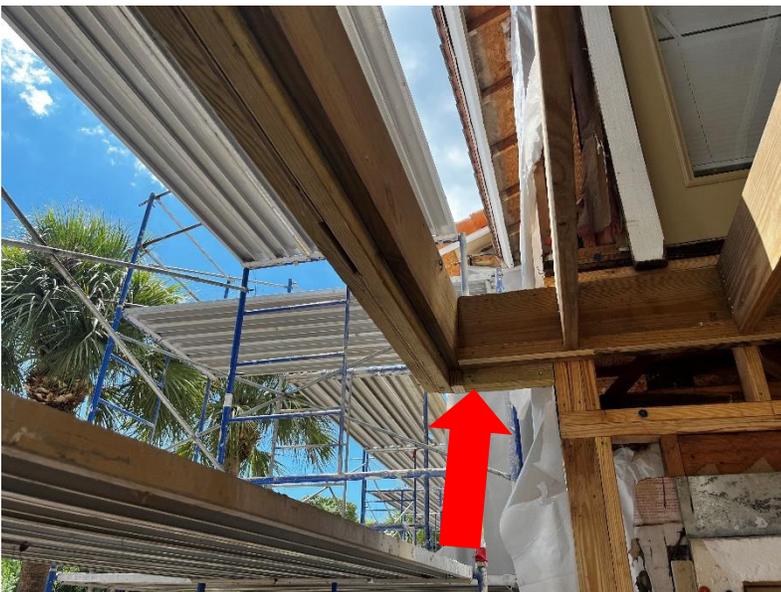
**PHOTOGRAPH #20**

**BUILDING 13  
SECTION B-UNIT 1323**

Contractor has not followed Balcony Edge / Rail Beam Detail S-7.4 positioning new built-up beam to low. .

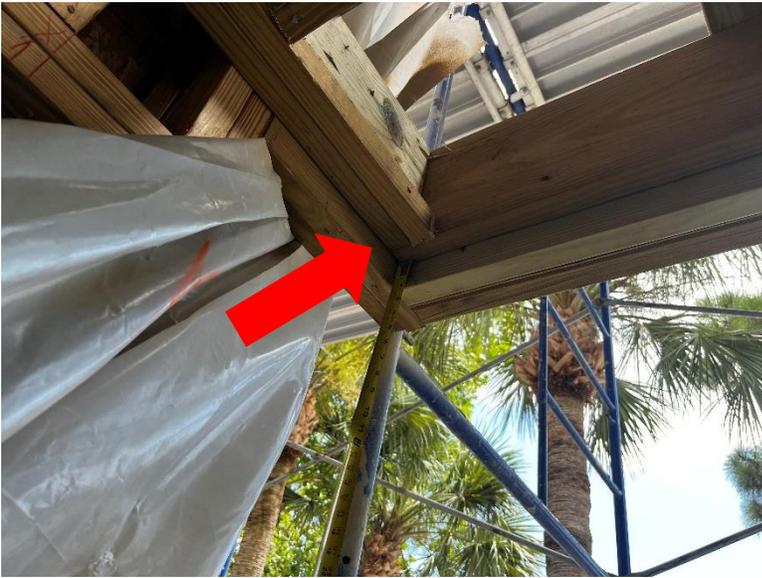
**PHOTOGRAPH #21**

**BUILDING 13  
SECTION B-UNIT 1323**

Contractor has not followed Balcony Edge / Rail Beam Detail S-7.4 positioning new built-up beam to low

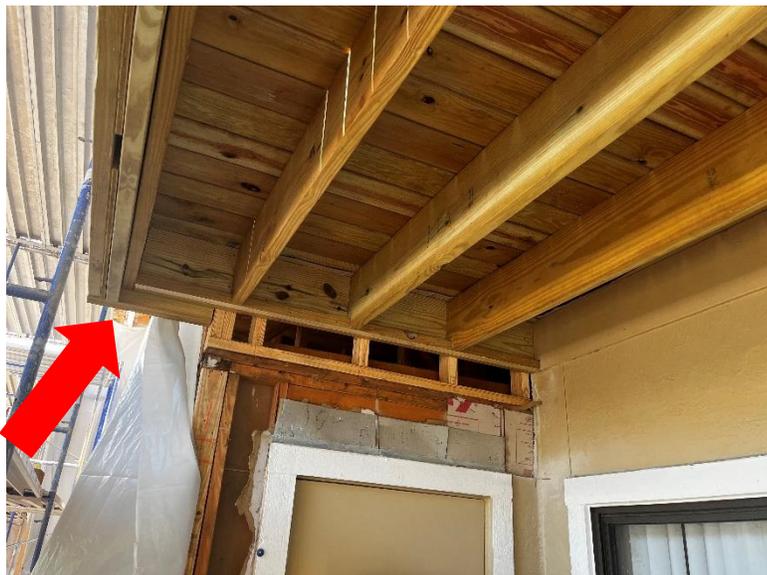
**PHOTOGRAPH #22**

**BUILDING 13  
SECTION B-UNIT 1325**

Contractor has not followed Balcony Edge / Rail Beam Detail S-7.4 positioning new built-up beam to low

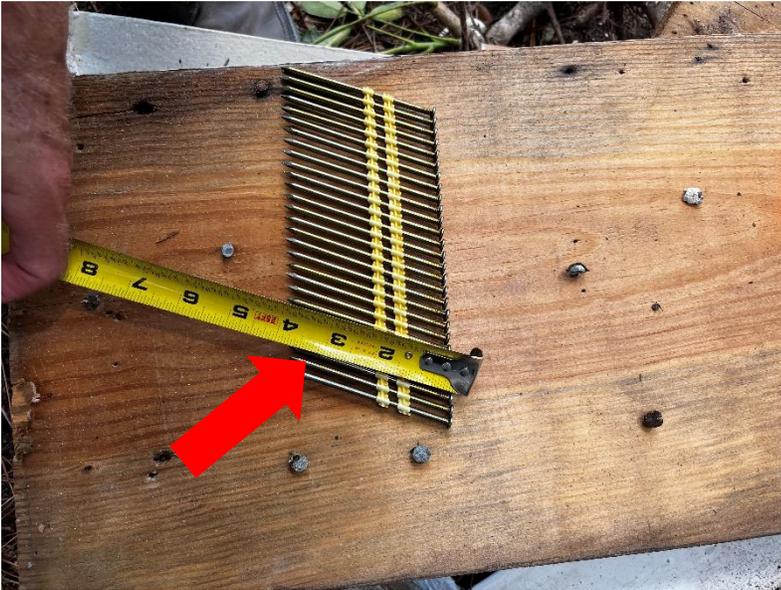
**PHOTOGRAPH #23**

**BUILDING 13  
SECTION B**

Contractor using 16d 3.5" nails for faming repairs as per drawings and specifications. .
