PHOTOGRAPHS

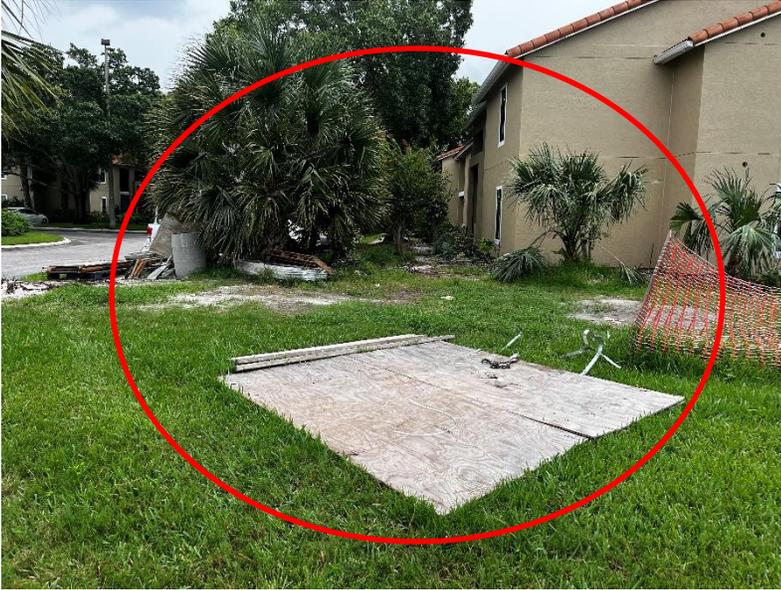
PHOTOGRAPH #1

**BUILDING 8  
SECTION D**

Contractor has removed scaffolding and begun material and site cleanup.

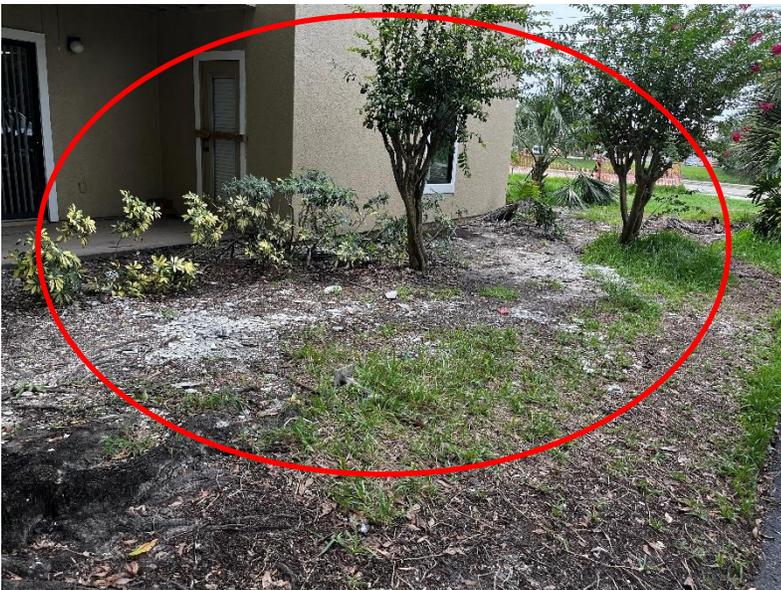
PHOTOGRAPH #2

**BUILDING 8  
SECTION C**

Contractor has removed scaffolding and begun material and site cleanup.

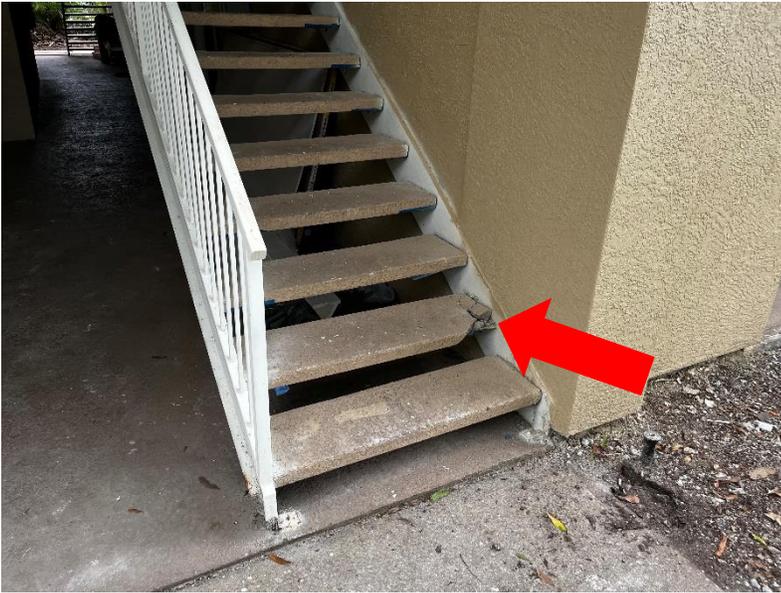
**PHOTOGRAPH #3**

**BUILDING 8  
SECTION C**

Second stair from bottom is damaged and will require replacement with new angle welding details.

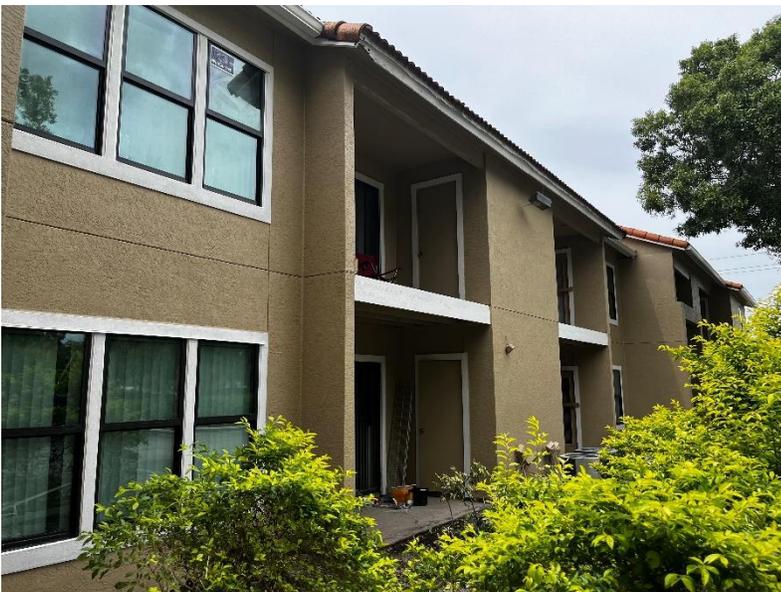
**PHOTOGRAPH #4**

**BUILDING 8  
SECTION B**

Contractor completed stucco finish painting with Florida Paint Glades Acrylic Paint.

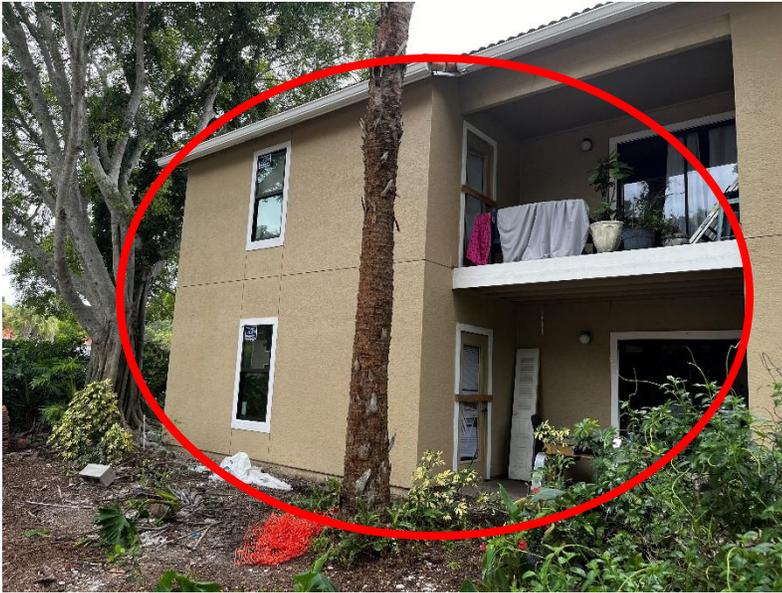
**PHOTOGRAPH #5**

**BUILDING 8  
SECTION A**

Contractor completed stucco finish painting with Florida Paint Glades Acrylic Paint.

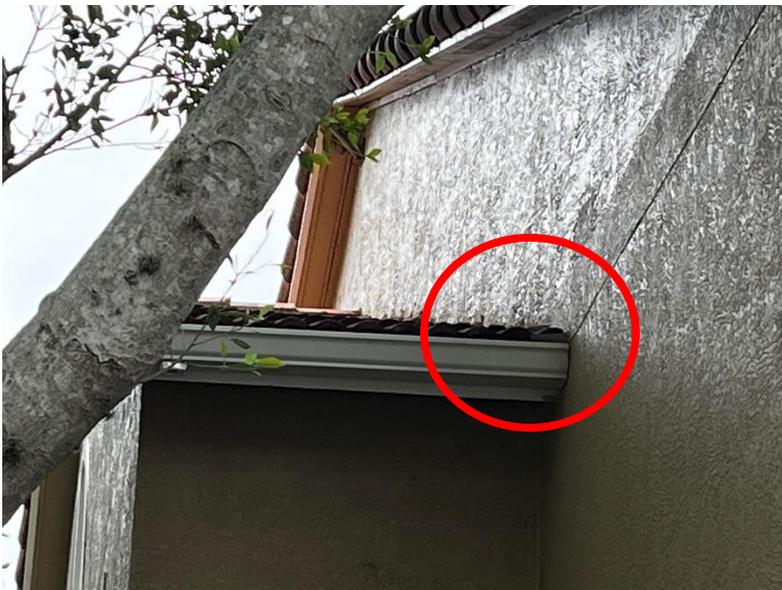
**PHOTOGRAPH #6**

**BUILDING 8  
SECTION A- UNIT 821**

Roof damage where tile removed for installation of new kick out flashing has been repaired by owner's roofer.

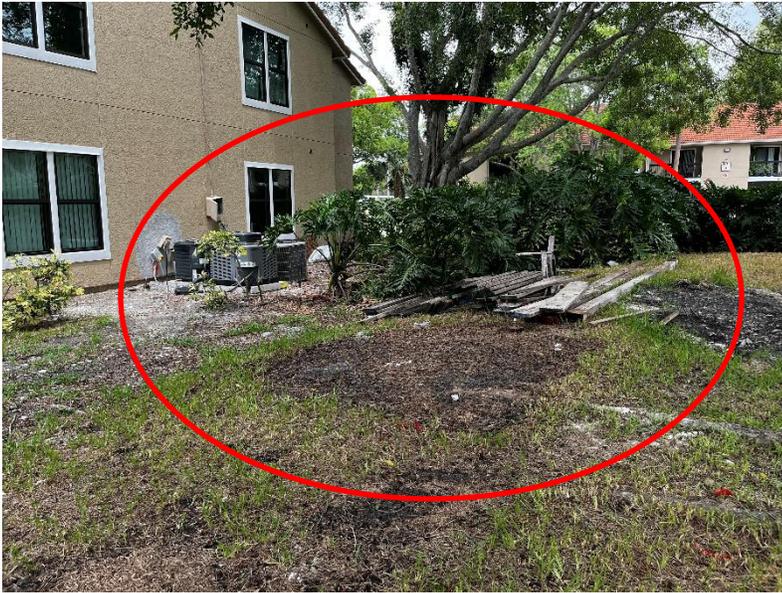
**PHOTOGRAPH #7**

**BUILDING 8  
SECTION H**

Contractor has removed scaffolding and begun material and site cleanup

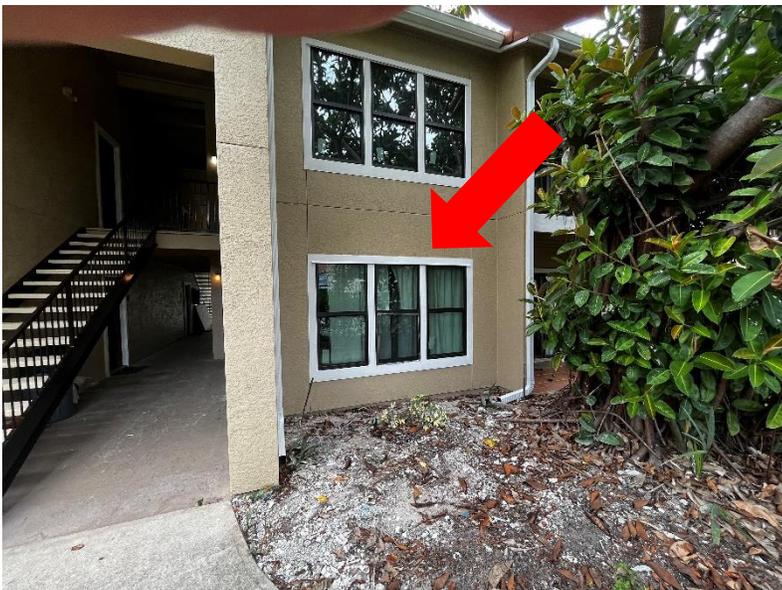
**PHOTOGRAPH #8**

**BUILDING 8  
SECTION F- UNIT 816**

Window header flashing has been caulked shut not allowing weep as designed.

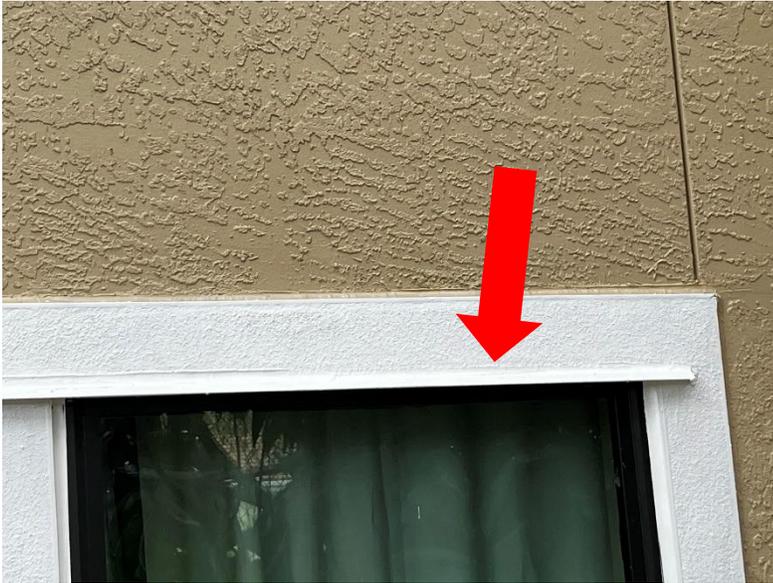
**PHOTOGRAPH #9**

**BUILDING 8  
SECTION F- UNIT 816**

Window header flashing has been caulked shut not allowing weep as designed.

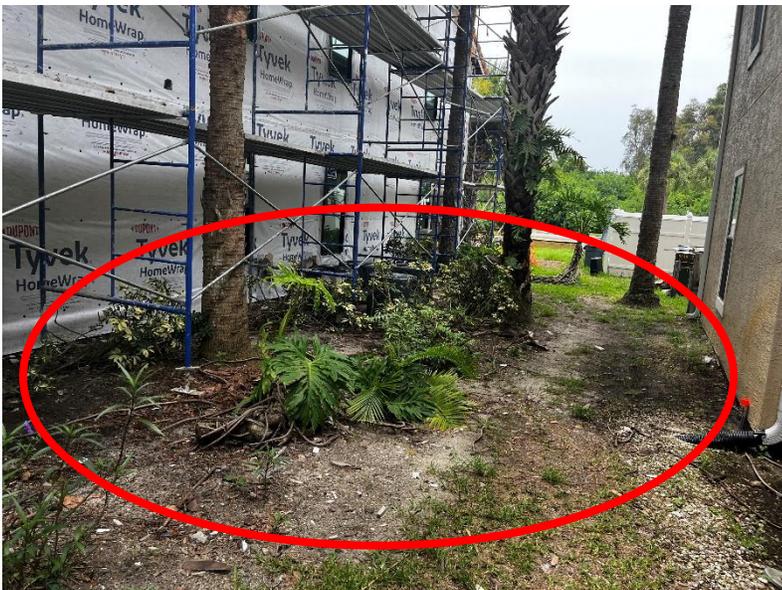
**PHOTOGRAPH #10**

**BUILDING 13  
SECTION H**

Contractor has cleaned up site by removing rubbish and construction debris.

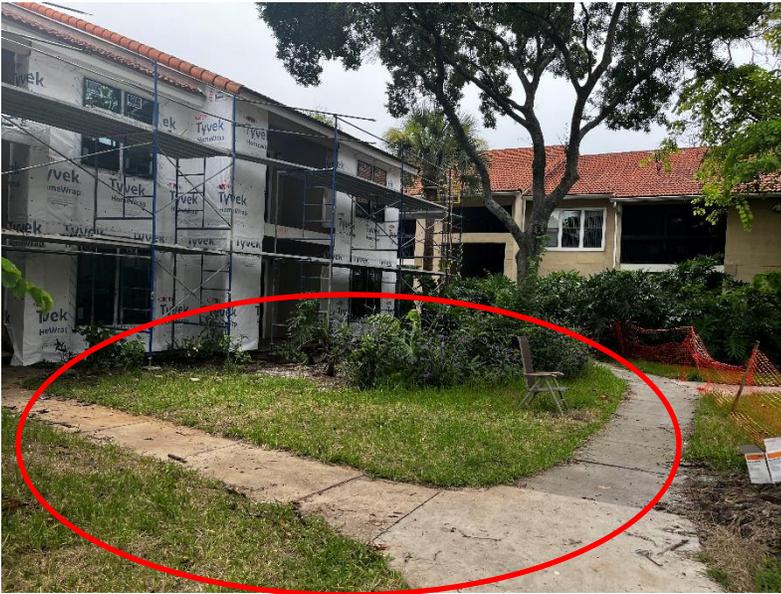
**PHOTOGRAPH #11**

**BUILDING 13  
SECTION F**

Contractor has cleaned up site by removing rubbish and construction debris.

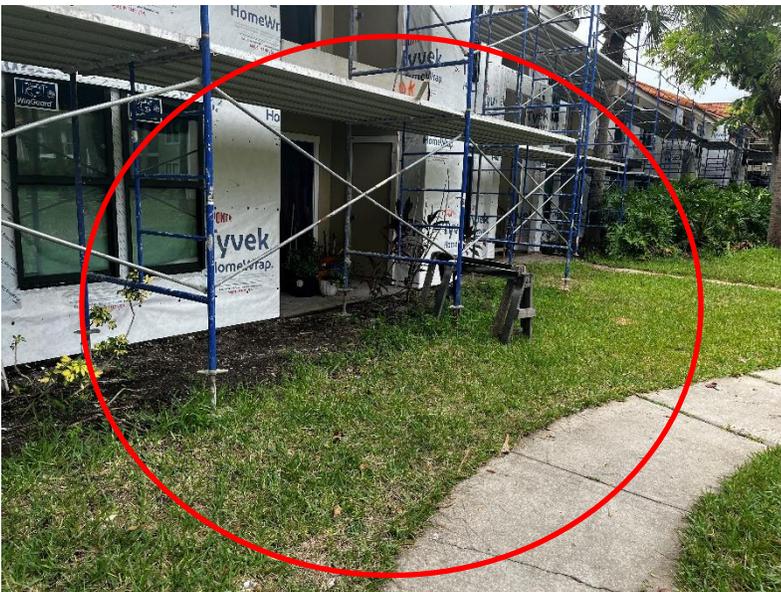
**PHOTOGRAPH #12**

**BUILDING 8  
SECTION E**

Contractor has cleaned up site by removing rubbish and construction debris.

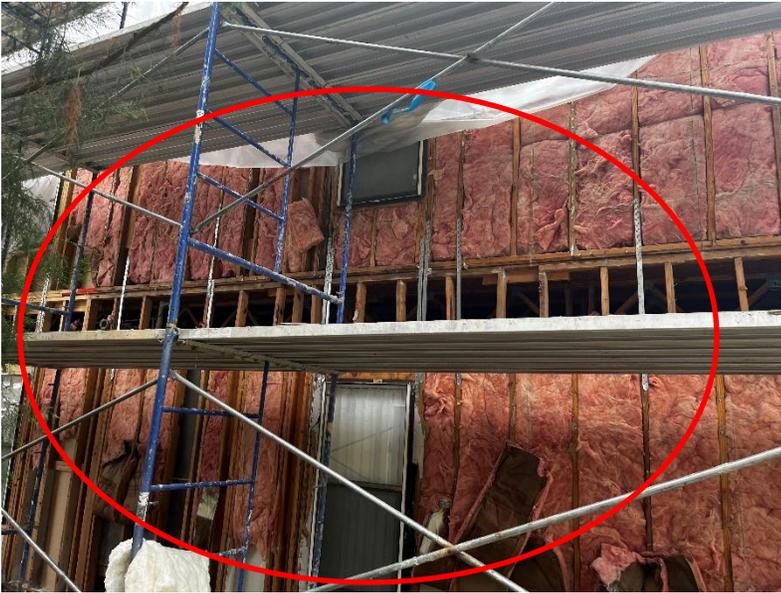
**PHOTOGRAPH #13**

**BUILDING 13  
SECTION D**

RLJames has completed framing repairs and begun application of Simpson Strong-Tie connectors.

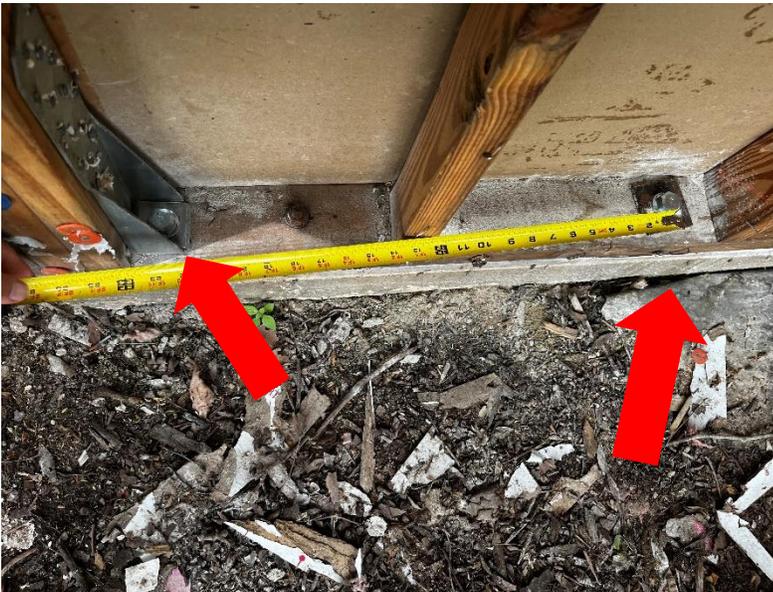
**PHOTOGRAPH #14**

**BUILDING 13  
SECTION D**

5/8" Simpson Strong-Tie Titen HD anchors at sill plate to existing footing installed at 24" O.C. Max. spacing.

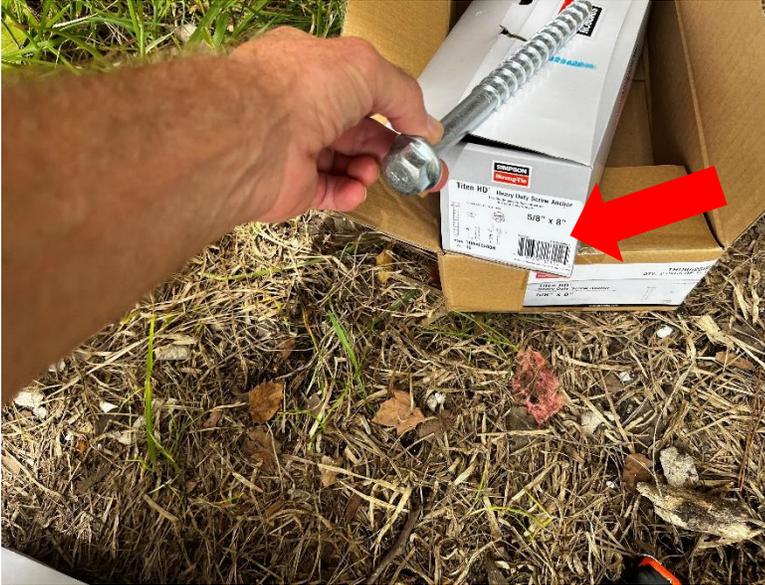
**PHOTOGRAPH #15**

**BUILDING 13  
SECTION D**

5/8" Simpson Strong-Tie Titen HD anchors at sill plate to existing footing installed at 24" O.C. Max. spacing.

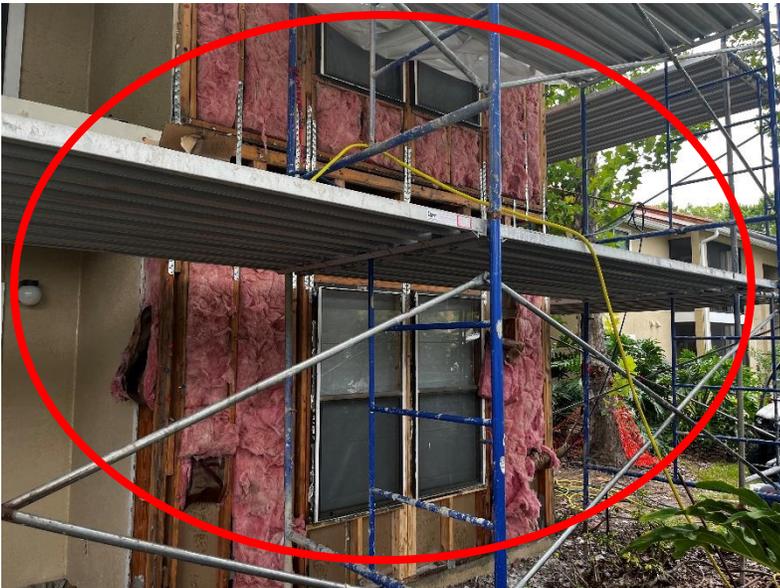
**PHOTOGRAPH #16**

**BUILDING 13  
SECTION C**

RLJ has completed framing repairs and begun application of Simpson Strong-Tie connectors

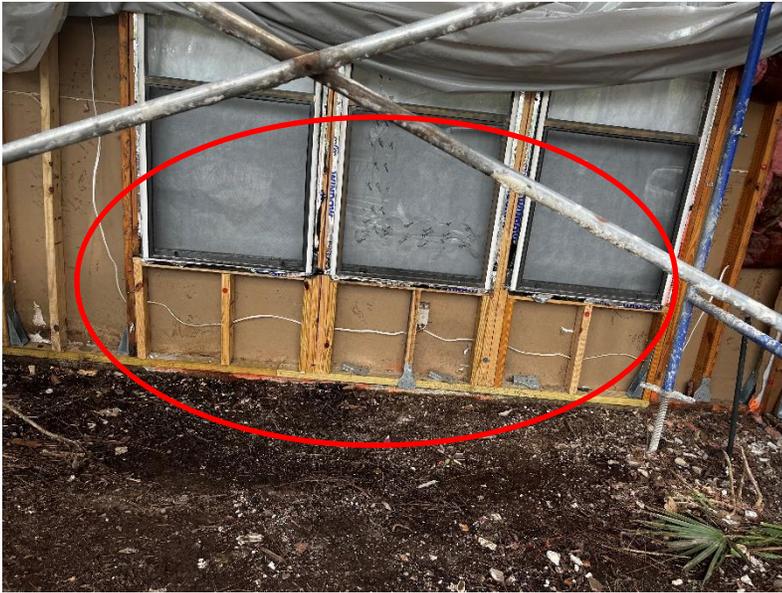
**PHOTOGRAPH #17**

**BUILDING 13  
SECTION B**

Damaged window framing, studs and sill plate replaced where marked for repairs.

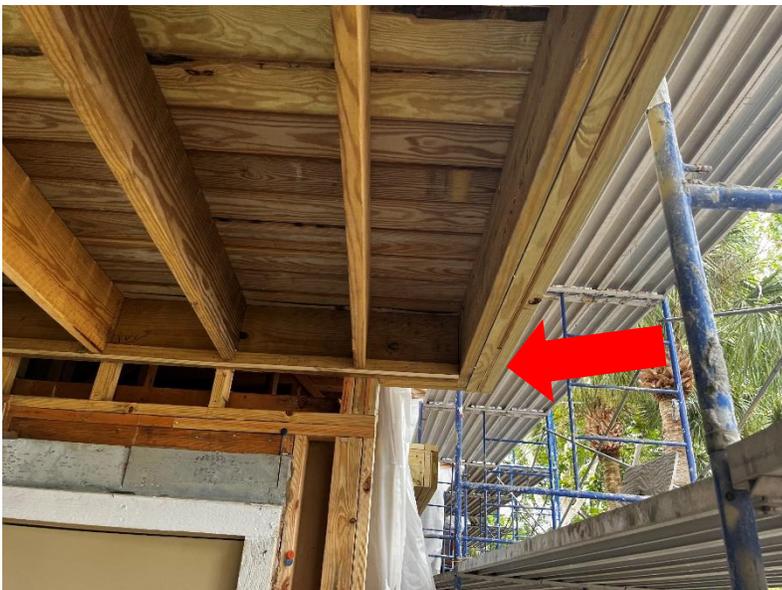
**PHOTOGRAPH #18**

**BUILDING 13  
SECTION B- UNIT 1323**

RLJ has removed and corrected repairs at Balcony Edge / Rail Beam per Detail S-7.4..

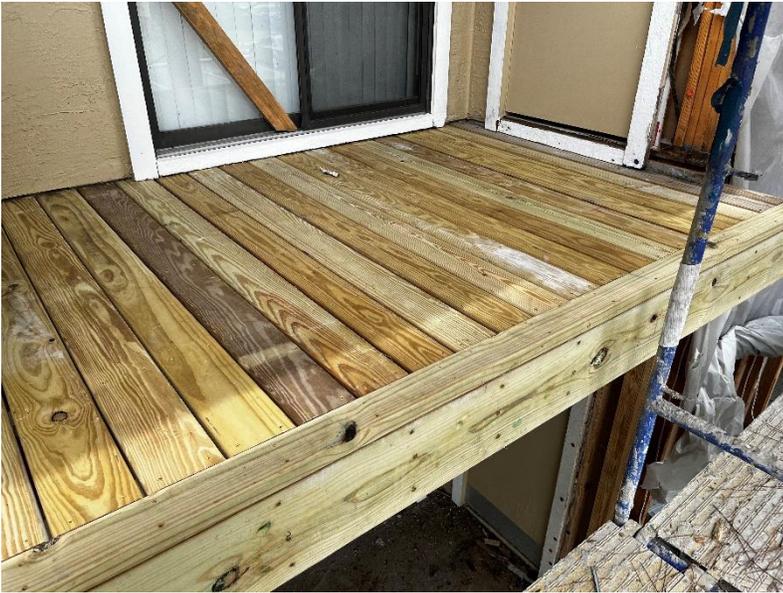
**PHOTOGRAPH #19**

**BUILDING 13  
SECTION B-UNIT 1323**

RLJ has removed and corrected repairs at Balcony Edge / Rail Beam per Detail S-7.4.

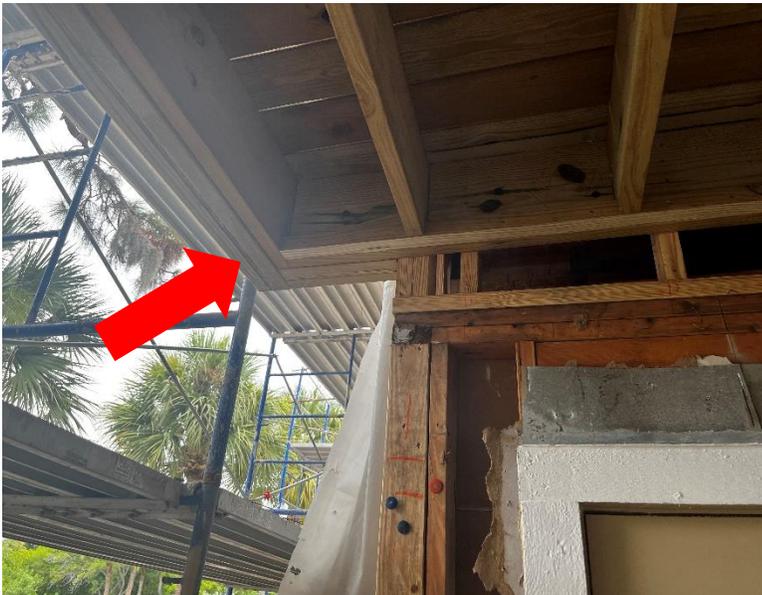
**PHOTOGRAPH #20**

**BUILDING 13  
SECTION B-UNIT 1325**

RLJ has removed and corrected repairs at Balcony Edge / Rail Beam per Detail S-7.4.

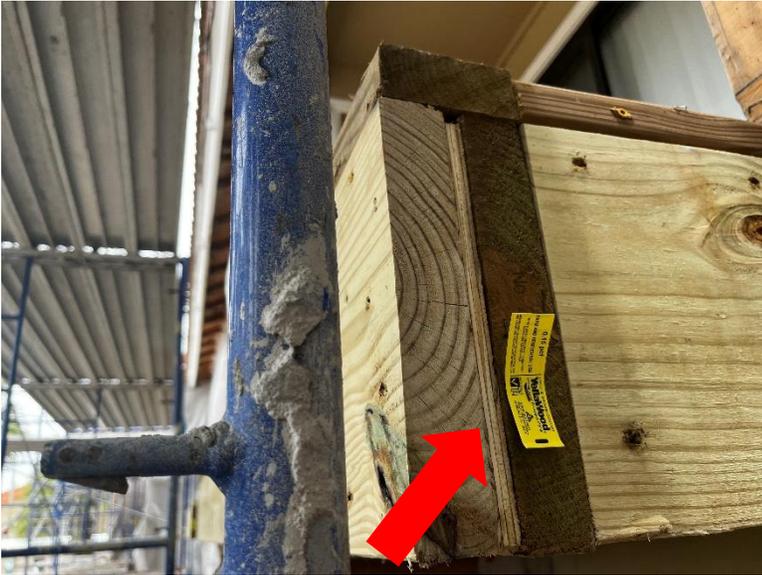
**PHOTOGRAPH #21**

**BUILDING 13  
SECTION B-UNIT 1325**

RLJ using PT 2x lumber as specified for  
Balcony Edge / Rail Beam Detail S-7.4.

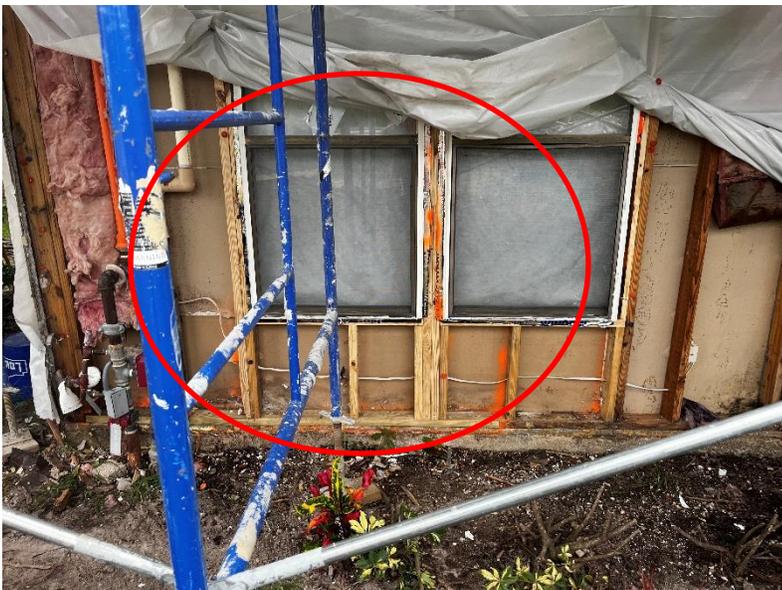
**PHOTOGRAPH #22**

**BUILDING 13  
SECTION A-UNIT 1311**

Damaged window framing, studs and sill  
plate replaced where marked for repairs.

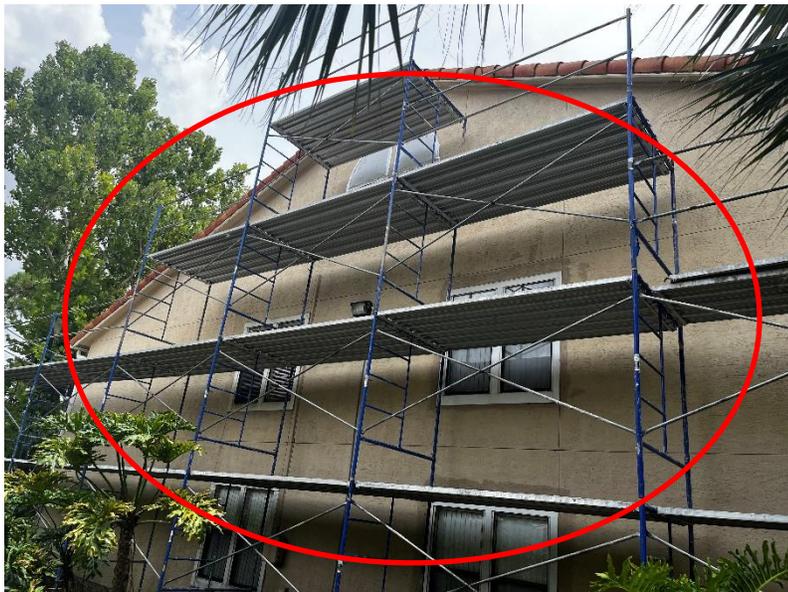
**PHOTOGRAPH #23**

**BUILDING 18  
SECTION H**

RLJ has mobilized and built access scaffolding for repairs.

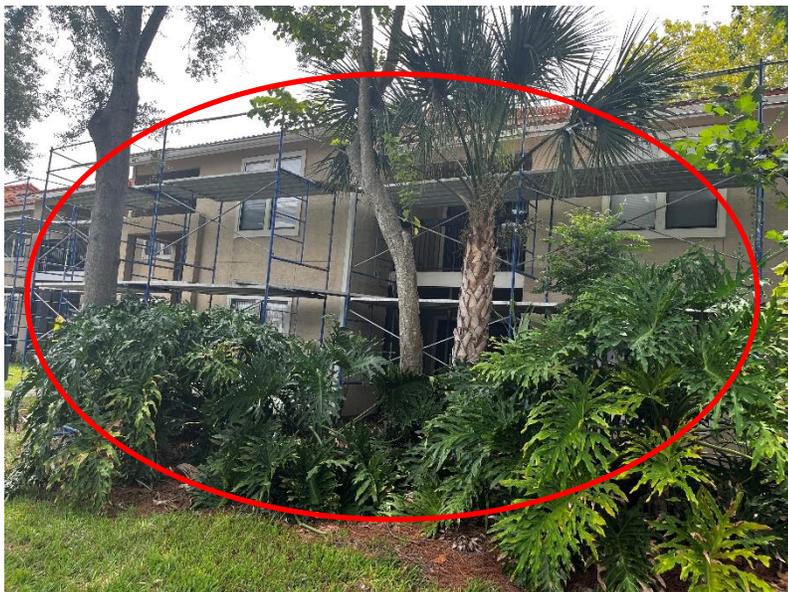
**PHOTOGRAPH #24**

**BUILDING 18  
SECTION F**

RLJ has mobilized and built access scaffolding for repairs.

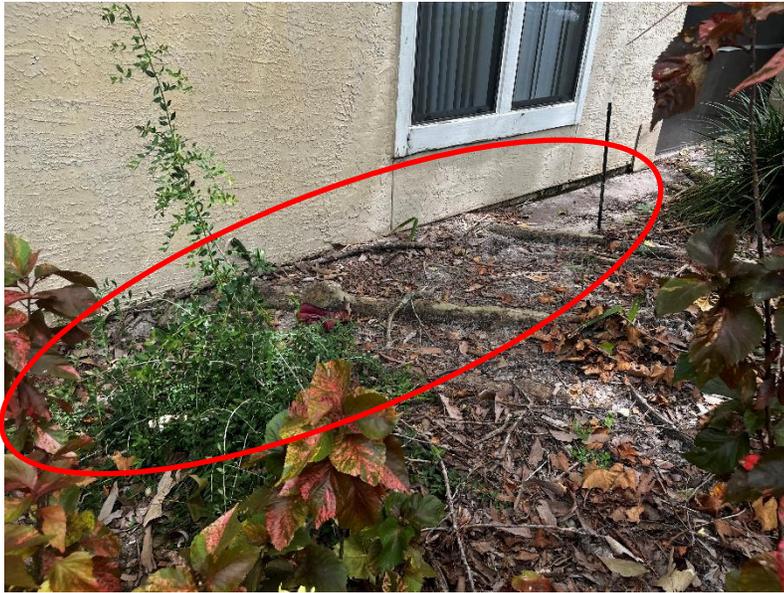
**PHOTOGRAPH #25**

**BUILDING 18  
SECTION A**

Existing conditions do not support required sloped grade away from building 6" below wall termination as per drawings.
