PHOTOGRAPHS

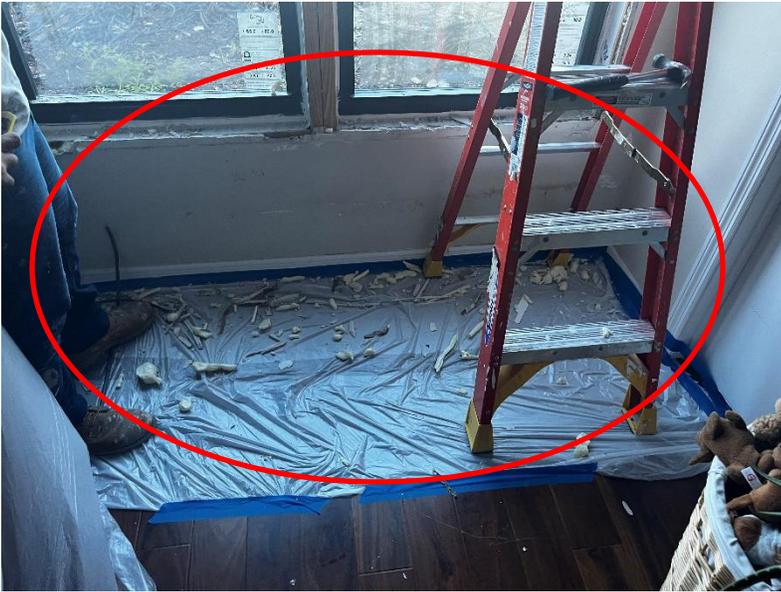
PHOTOGRAPH #1

**BUILDING 8
SECTION D- UNIT #817**

RL James performing drywall repairs around new window installations has covered owners flooring.

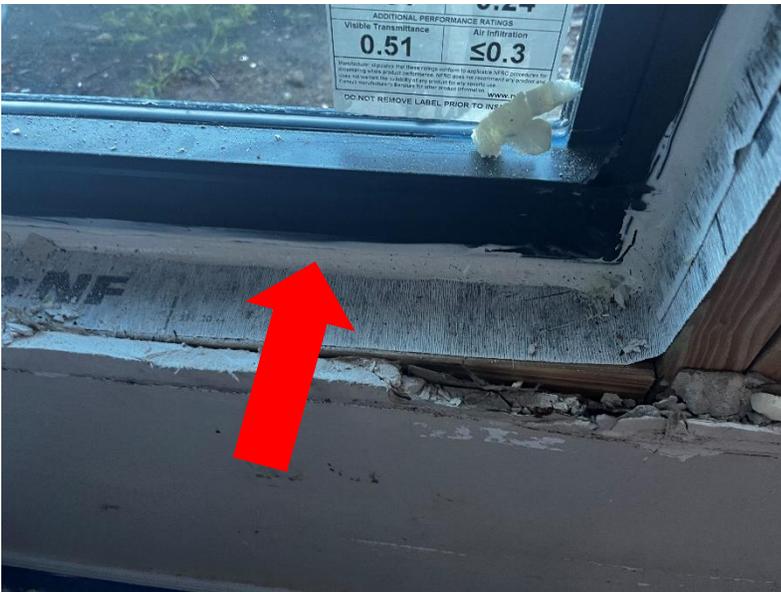
PHOTOGRAPH #2

**BUILDING 8
SECTION D- UNIT #817**

RLJ has installed new BASF sealant at interior side of Dupont Flashing to PGT window framing as per drawings and specifications.

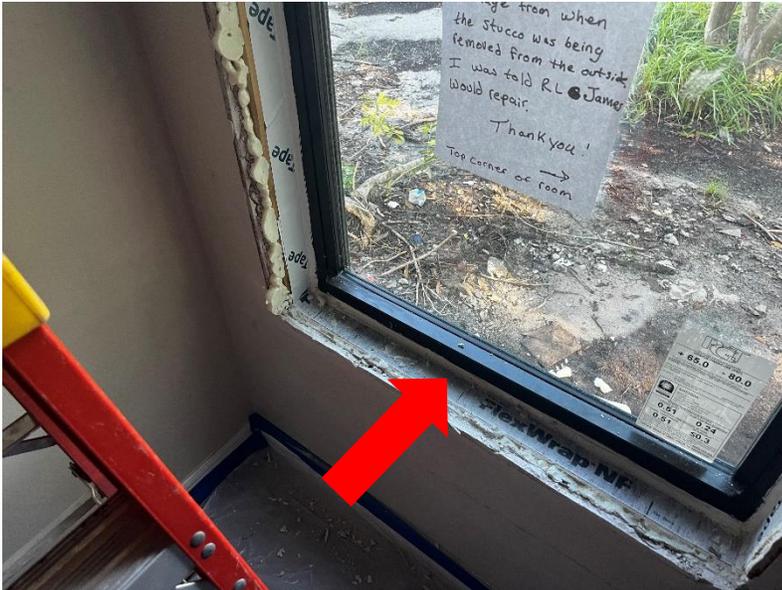
PHOTOGRAPH #3

**BUILDING 8
SECTION C- UNIT #817**

RLJ has installed new BASF sealant at interior side of Dupont Flashing to PGT window framing as per drawings and specifications.

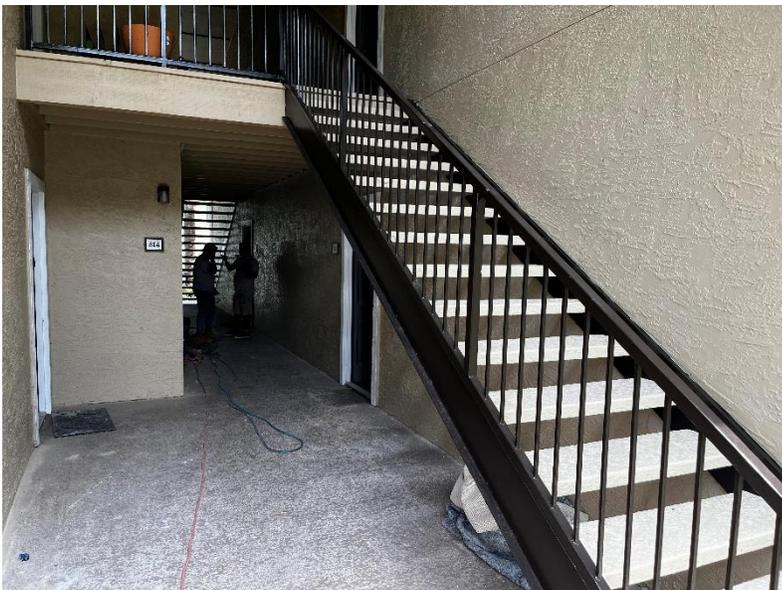
PHOTOGRAPH #4

**BUILDING 8
SECTION C**

RLJ has finished stairway railing with Florida Paint Sundeavor Hi- Performance Urethane Enamel.

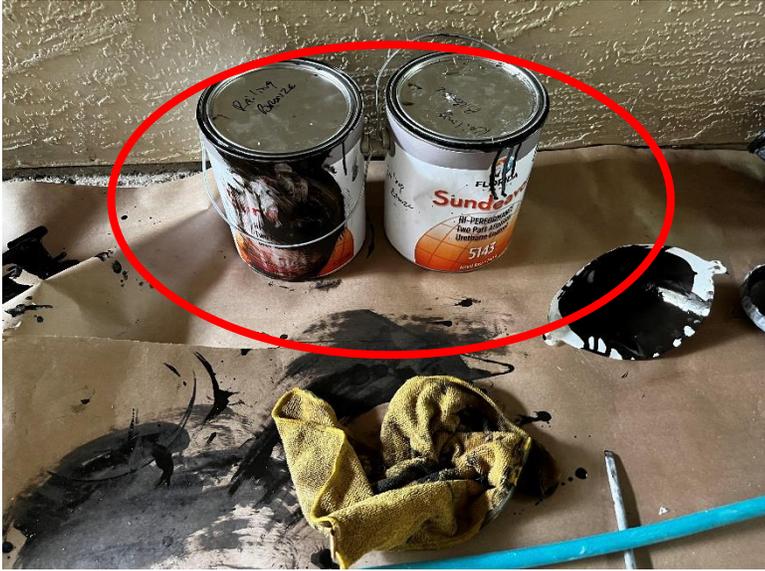
PHOTOGRAPH #5

**BUILDING 8
SECTION C**

RLJ has finished stairway railing with Florida Paint Sundeavor Hi- Performance Urethane Enamel.

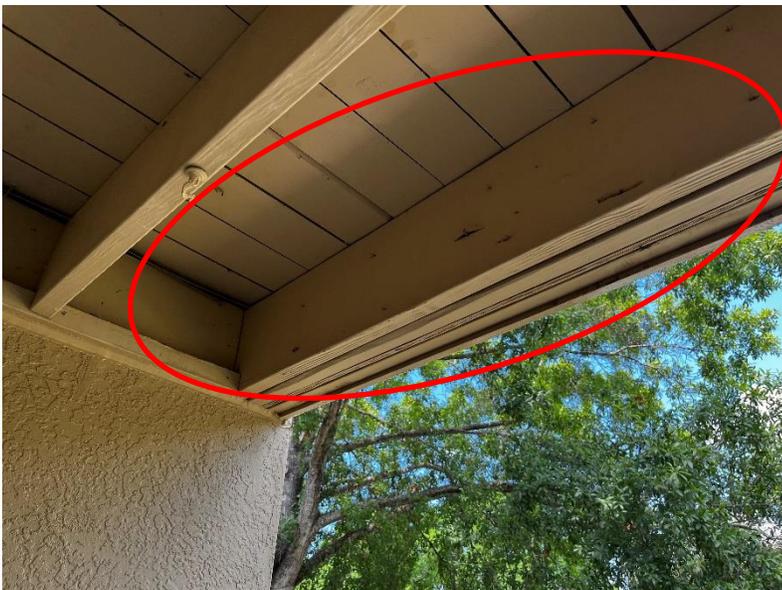
PHOTOGRAPH #6

**BUILDING 8
SECTION B**

Simpson Strong- Tie clips and screws have not been installed at balconies Built up beams as per drawings.

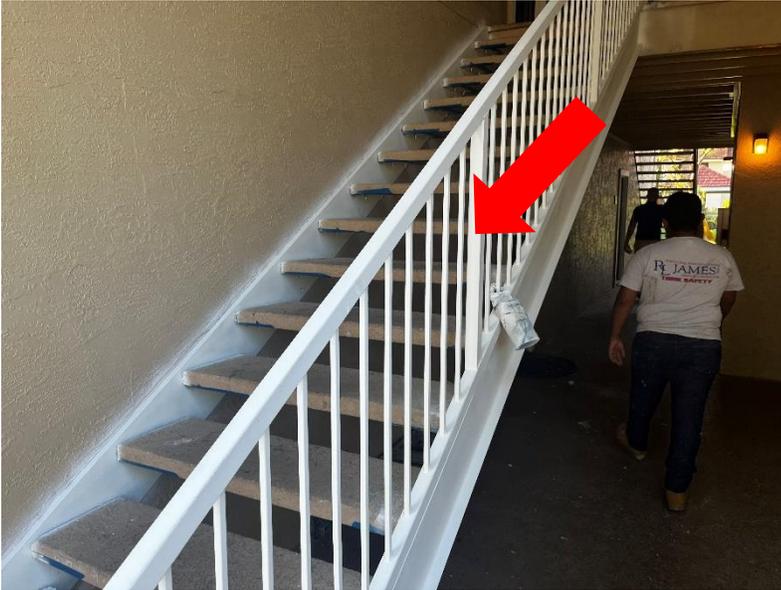
PHOTOGRAPH #7

**BUILDING 8
SECTION A**

RLJ has recoated stairway handrails with Florida Paints epoxy mastic that appears to have cured properly.

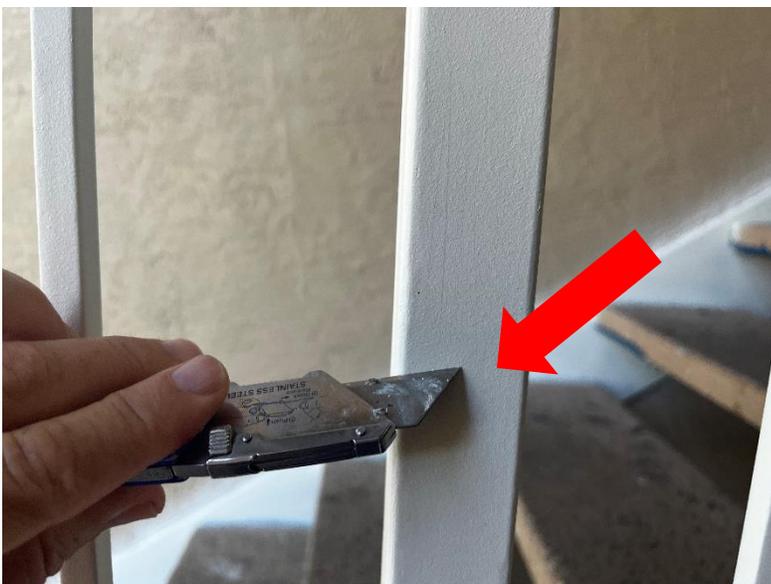
PHOTOGRAPH #8

**BUILDING 8
SECTION A**

RLJ has recoated stairway handrails with Florida Paints epoxy mastic that appears to have cured properly.

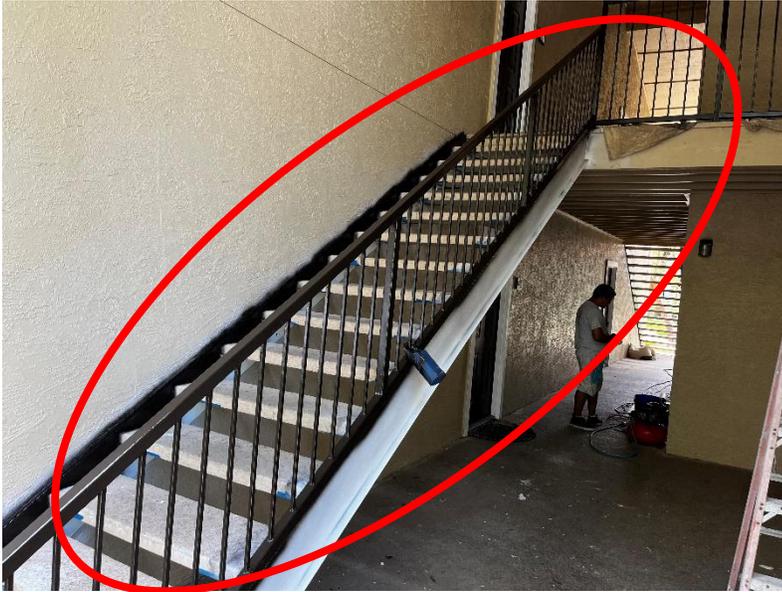
PHOTOGRAPH #9

**BUILDING 13
SECTION A**

RLJ has finished stairway railing with Florida Paint Sundeavor Hi- Performance Urethane Enamel.

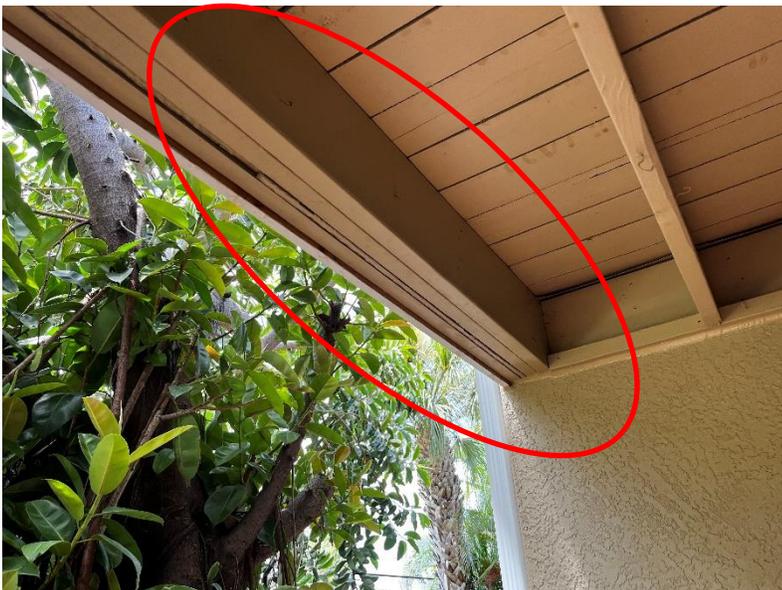
PHOTOGRAPH #10

**BUILDING 8
SECTION F**

Simpson Strong- Tie clips and screws have not been installed at balconies Built up beams as per drawings.

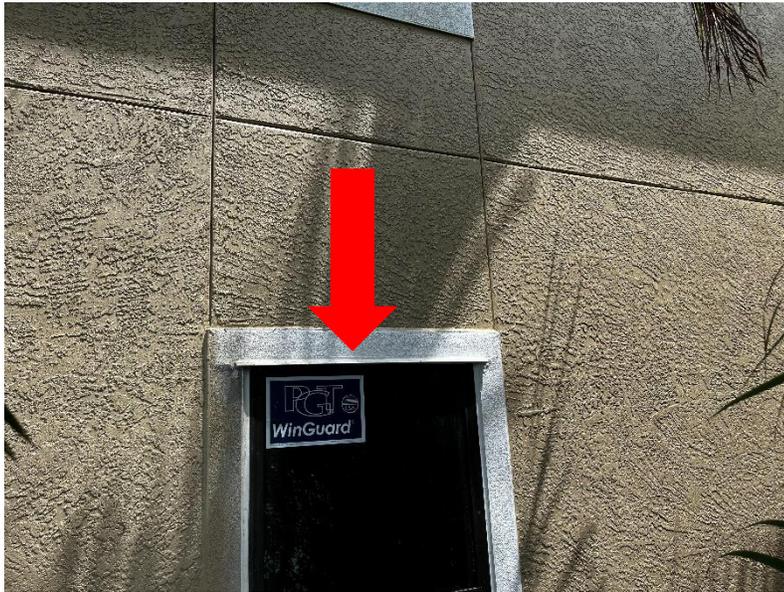
PHOTOGRAPH #11

**BUILDING 8
SECTION G – UNIT #818**

Window header flashing has been caulked shut not allowing weep as designed and will require correction.

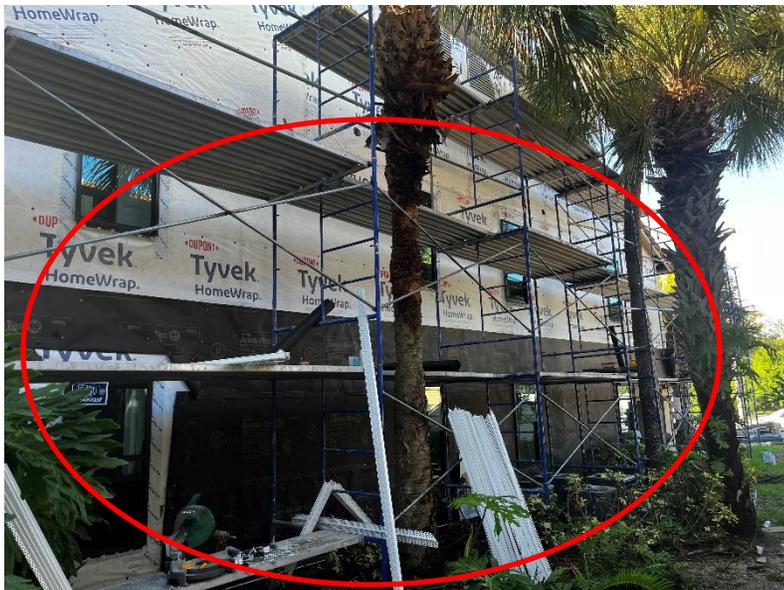
PHOTOGRAPH #12

**BUILDING 13
SECTION H**

Stucco sub-contractor has begun to apply Super Jumbo Tex WRB over Dupont Tyvek.

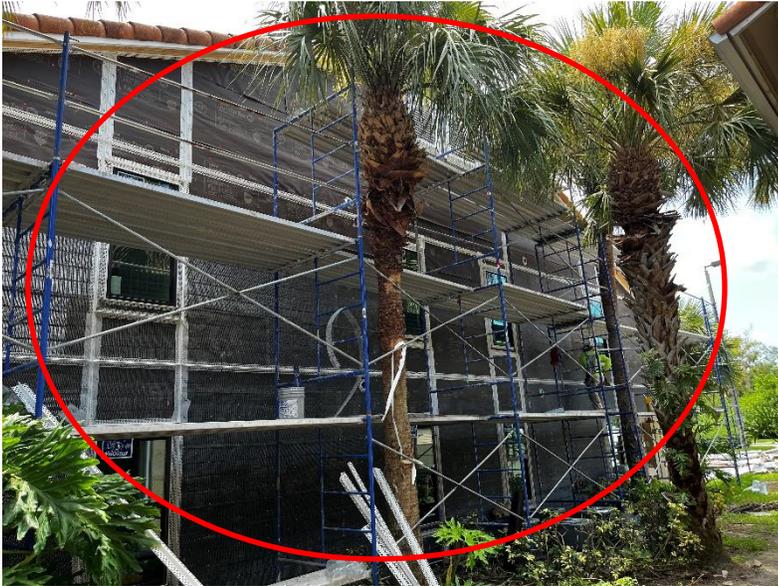
PHOTOGRAPH #13

**BUILDING 13
SECTION H**

Sub-Contractor applying new vinyl control joints and stucco accessories over Jumbo Tex WRB.

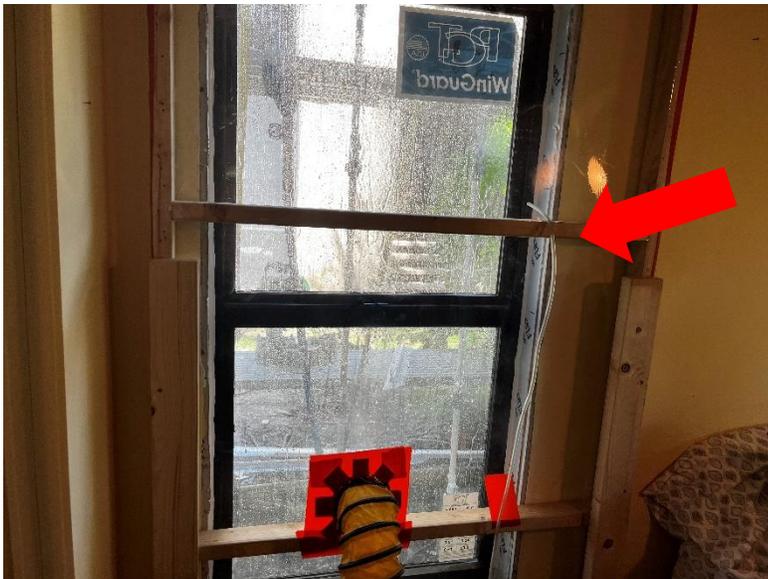
PHOTOGRAPH #14

**BUILDING 13
SECTION H- UNIT #1312**

Independent Testing Agency performed water testing at single PGT SH7700A window as per AMMA 502 with no failures or water penetration.

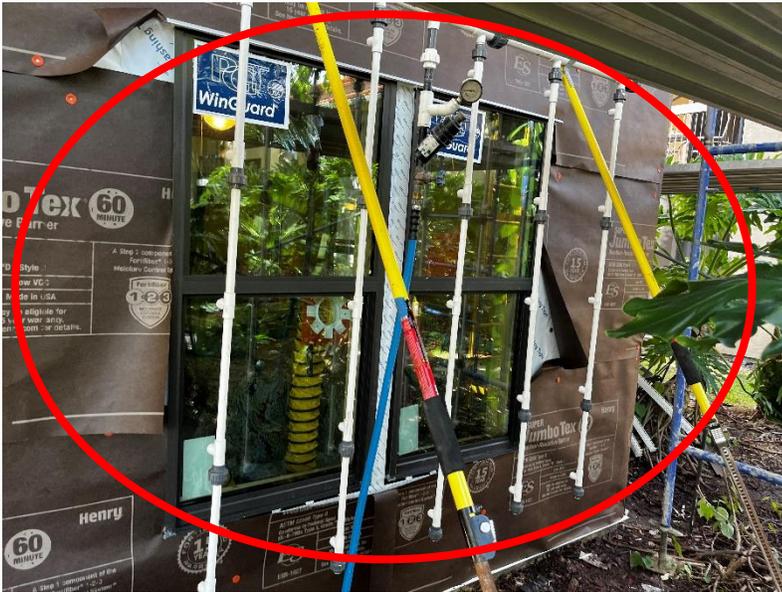
PHOTOGRAPH #15

**BUILDING 13
SECTION G – UNIT #1312**

Independent Testing Agency performed water testing at double PGT SH7700A window as per AMMA 502 with no failures or water penetration.

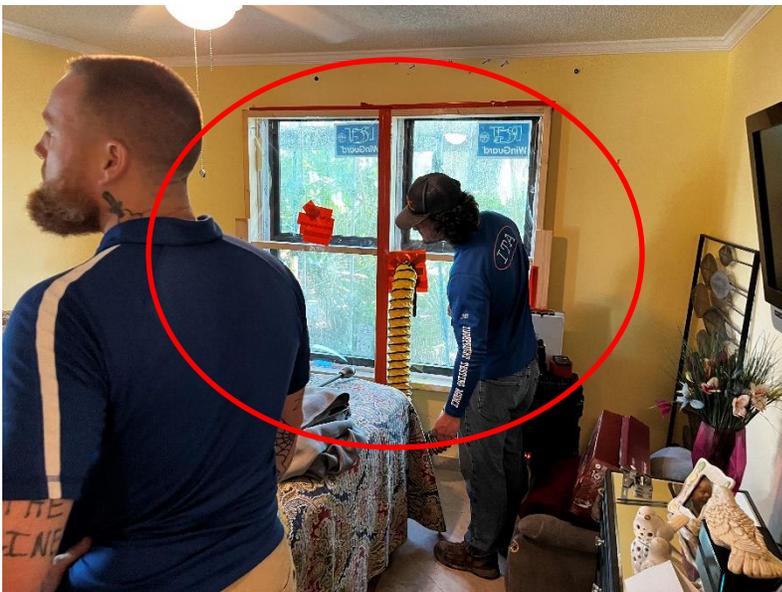
PHOTOGRAPH #16

**BUILDING 13
SECTION G- UNIT #1312**

Independent Testing Agency performed water testing at double PGT SH7700A window as per AMMA 502 with no failures or water penetration.

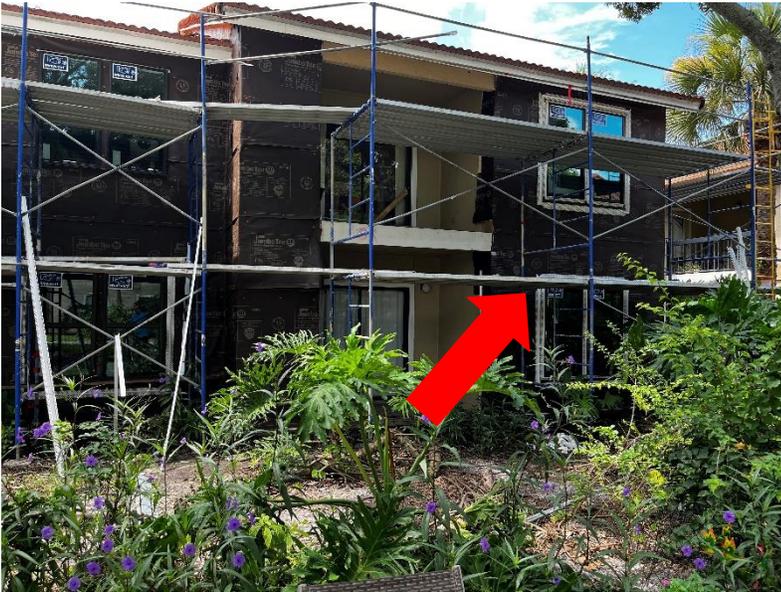
PHOTOGRAPH #17

**BUILDING 13
SECTION G**

Stucco sub-contractor has begun to apply Super Jumbo Tex WRB over Dupont Tyvek.

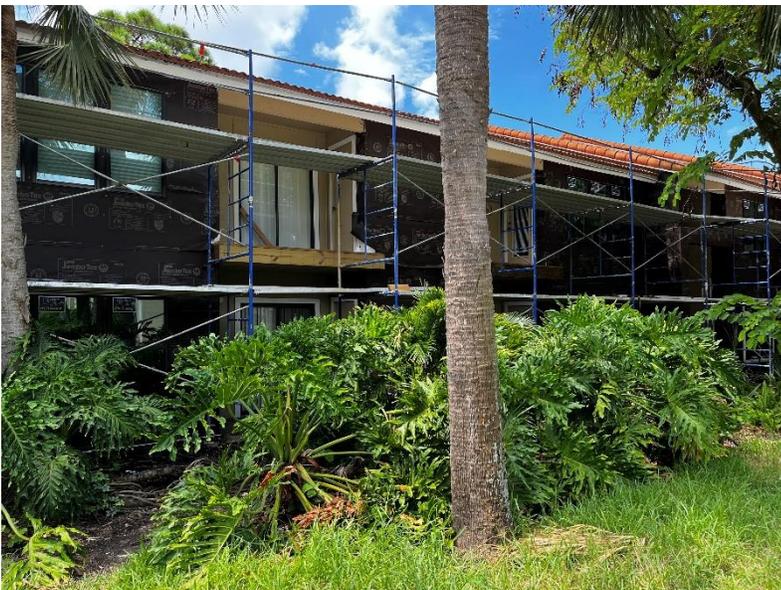
PHOTOGRAPH #18

**BUILDING 13
SECTION F**

Stucco sub-contractor has begun to apply Super Jumbo Tex WRB over Dupont Tyvek

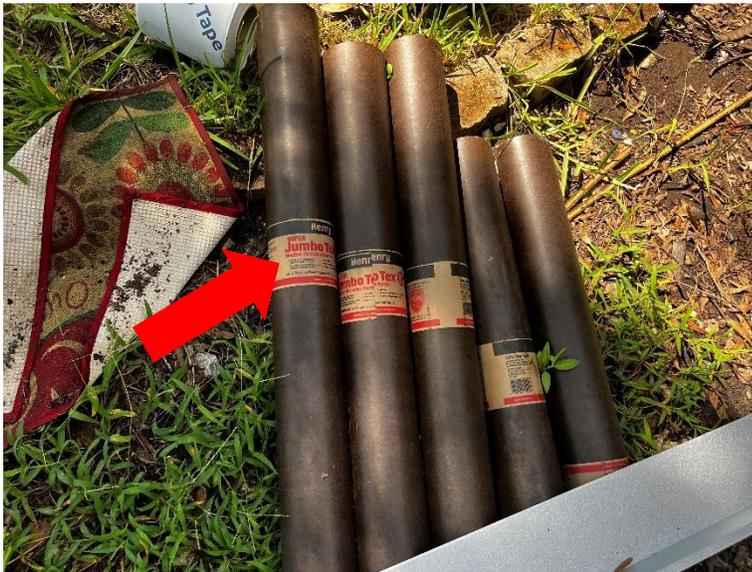
PHOTOGRAPH #19

**BUILDING 13
SECTION F**

Stucco sub-contractor has begun to apply Super Jumbo Tex WRB over Dupont Tyvek.

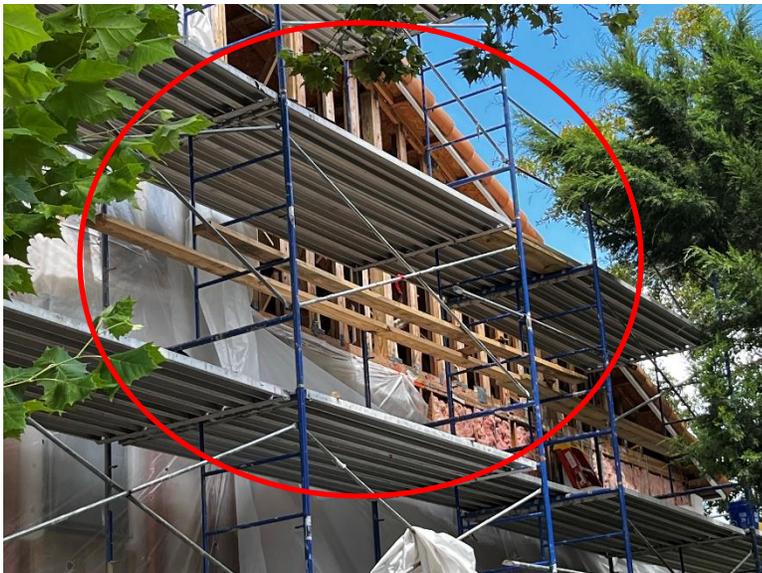
PHOTOGRAPH #20

**BUILDING 13
SECTION D**

RLJ in process of gable end reinforcement repairs as per drawings.

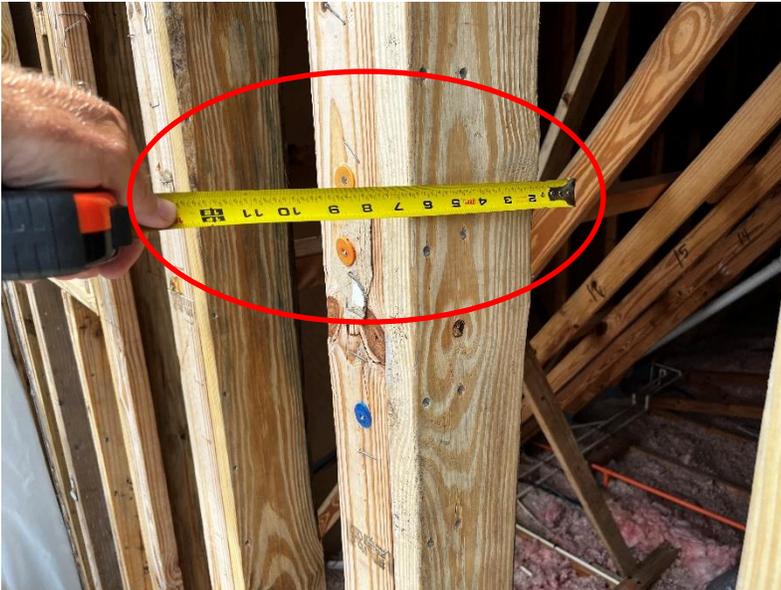
PHOTOGRAPH #21

**BUILDING 13
SECTION D**

Southern Yellow Pine 2X6 L-scabs attached to existing 2x4 gable end stud for reinforcement as per drawings.

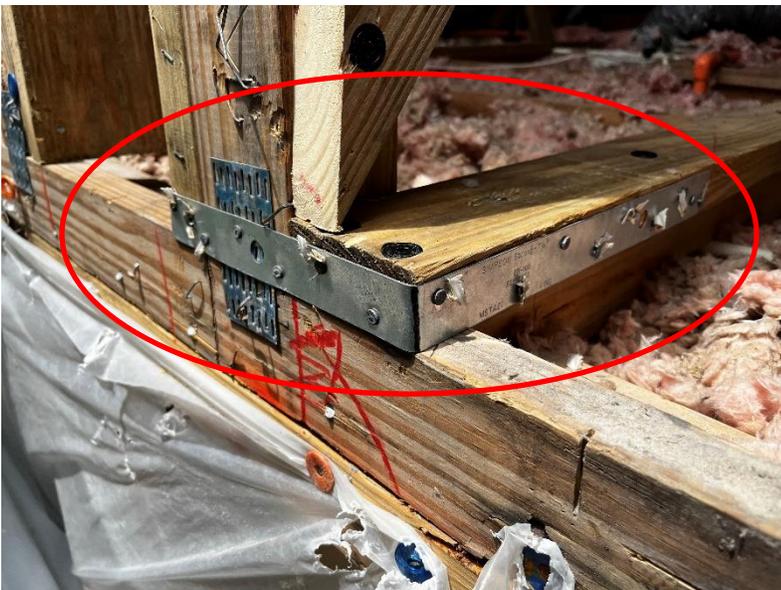
PHOTOGRAPH #22

**BUILDING 13
SECTION D**

Simpson Strong – Tie LSTA -21 strap attached at end of lateral braces to retrofit studs.

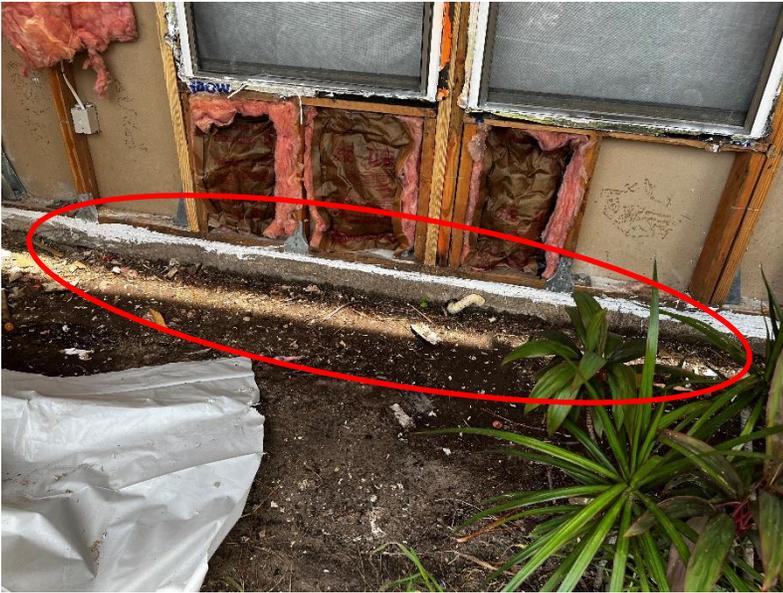
PHOTOGRAPH #23

**BUILDING 13
SECTION C**

RLJ has sealed base plate to slab with BASF urethane sealant as per drawing S-6.4. A

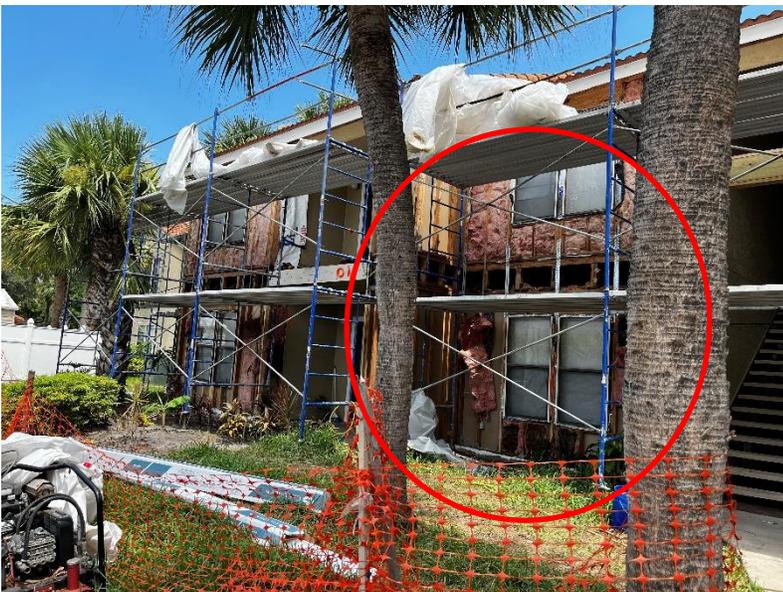
PHOTOGRAPH #24

**BUILDING 13
SECTION B**

RLJ has begun installing Simpson Strong tie connector straps and hardware.

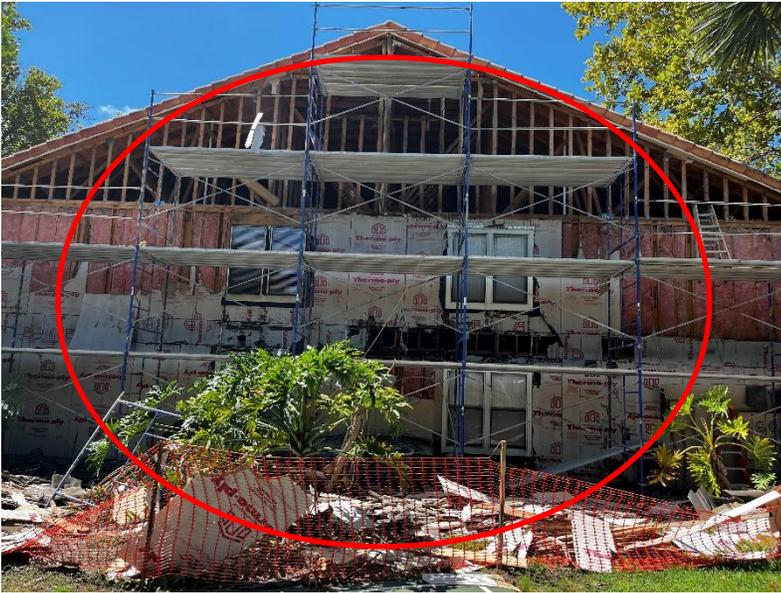
PHOTOGRAPH #25

**BUILDING 18
SECTION H**

RLJ has removed existing stucco and begun removal of existing sheathing board.

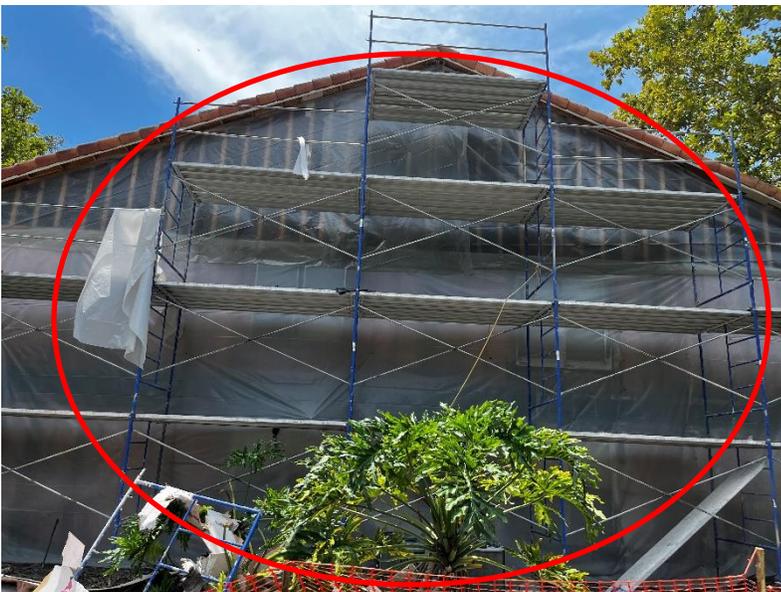
PHOTOGRAPH #26

**BUILDING 18
SECTION H**

Gable end wall covered with heavy duty plastic sheathing for protection from weather during repairs.

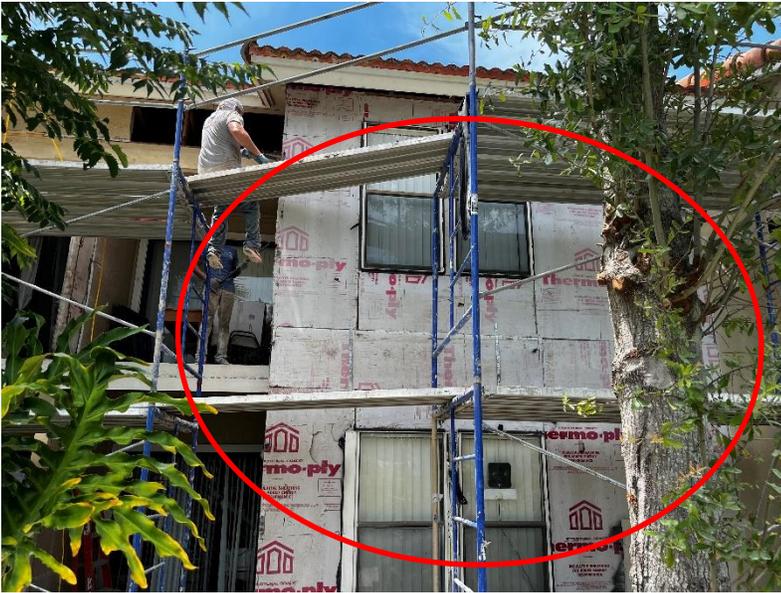
PHOTOGRAPH #27

**BUILDING 18
SECTION G**

RLJ has removed existing stucco and begun removal of existing sheathing board.

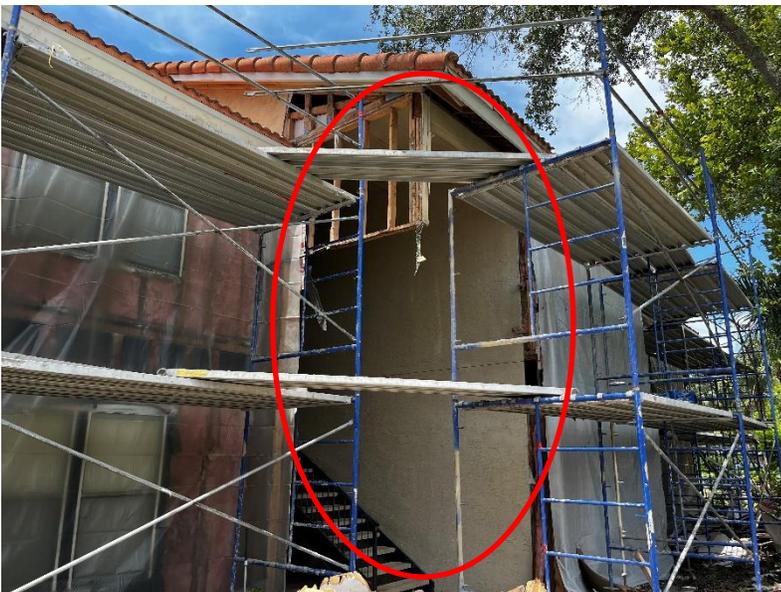
PHOTOGRAPH #28

**BUILDING 18
SECTION G**

During stucco demo damaged framing and built-up post at corner has collapsed.
