PHOTOGRAPHS

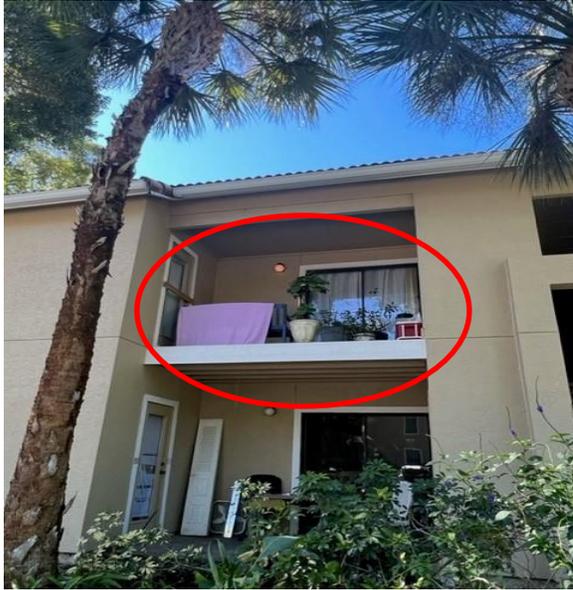
PHOTOGRAPH #1

**BUILDING 8
SECTION A- UNIT 821**

Unit owners have removed restraints place by RLJ during railing removal and accessed closed balcony.

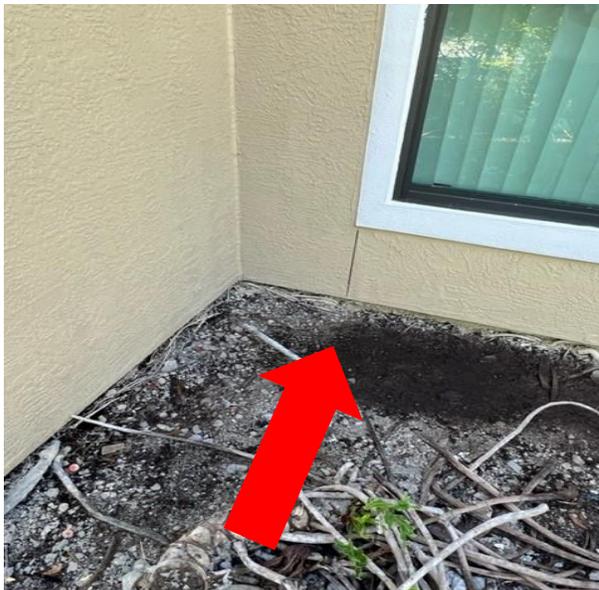
PHOTOGRAPH #2

**BUILDING 8
SECTION B**

Separation from ground to new stucco does not meet drawings requirements.

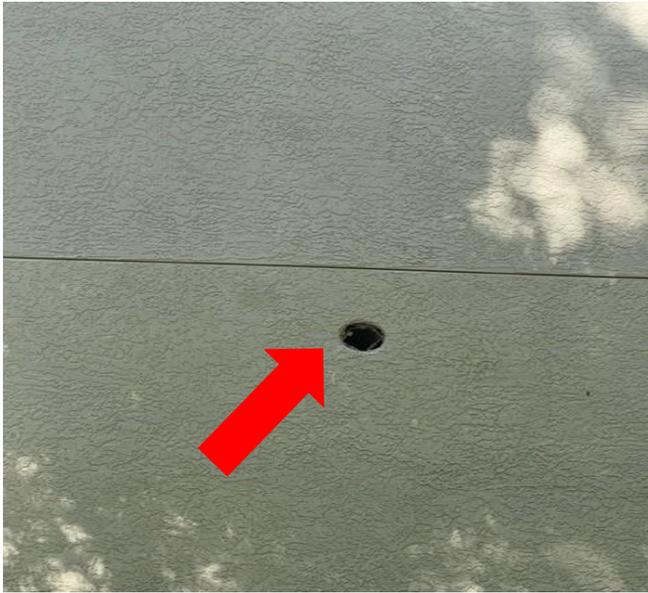
PHOTOGRAPH #3

**BUILDING 8
SECTION D**

Dryer vents have not been replaced with new as per contract documents.

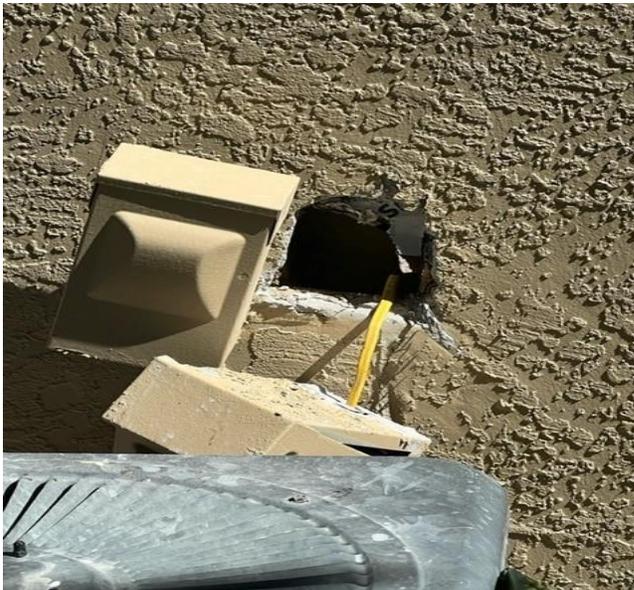
PHOTOGRAPH #4

**BUILDING 8
SECTION F**

Stucco has been removed at electrical boxes before boxes have been re attached to new stucco.

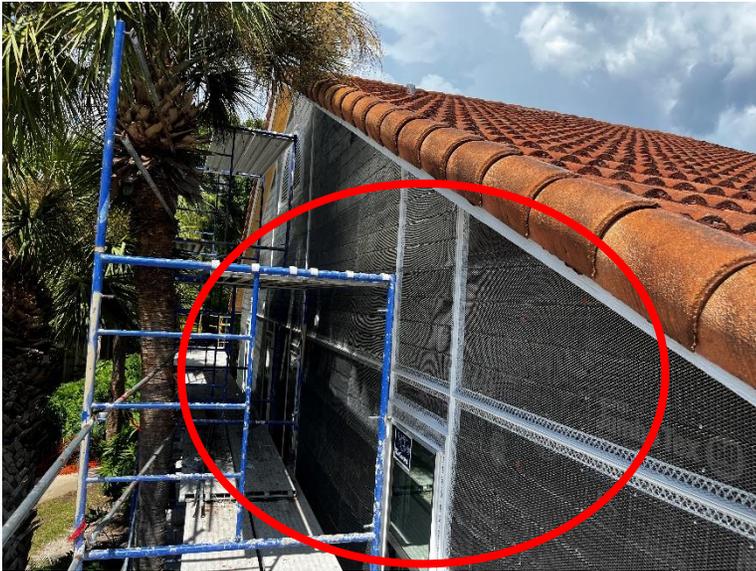
PHOTOGRAPH #5

**BUILDING 13
SECTION H**

Stucco sub-contractor installing new self-furring galvanized metal lath and vinyl stucco accessories.

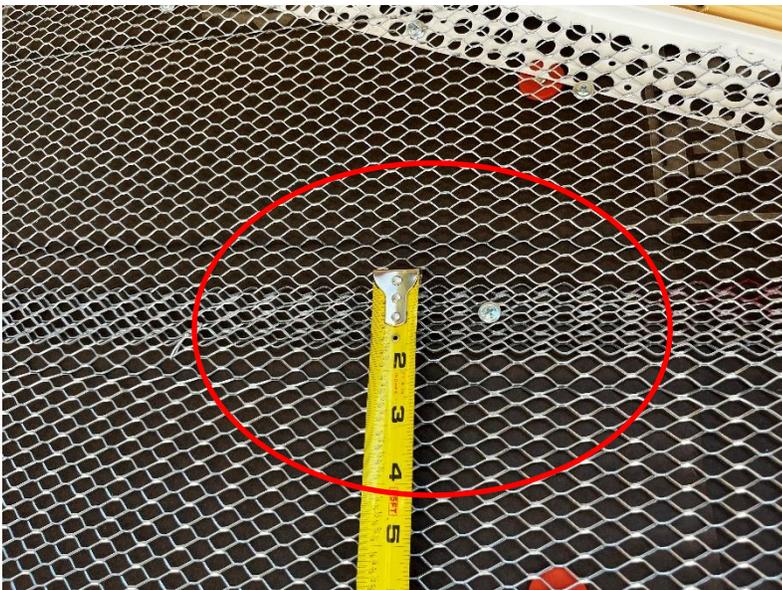
PHOTOGRAPH #6

**BUILDING 13
SECTION H**

Galvanized metal Lath overlapping at 2" meets ASTM C1063 standards.

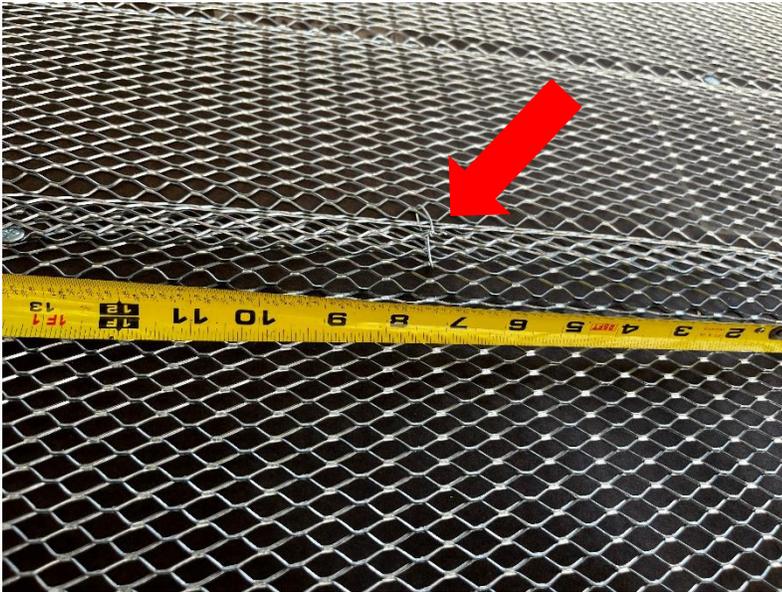
PHOTOGRAPH #7

**BUILDING 13
SECTION H**

Side laps of metal plaster bases tied between supports with wire at no more than 9" O.C. .

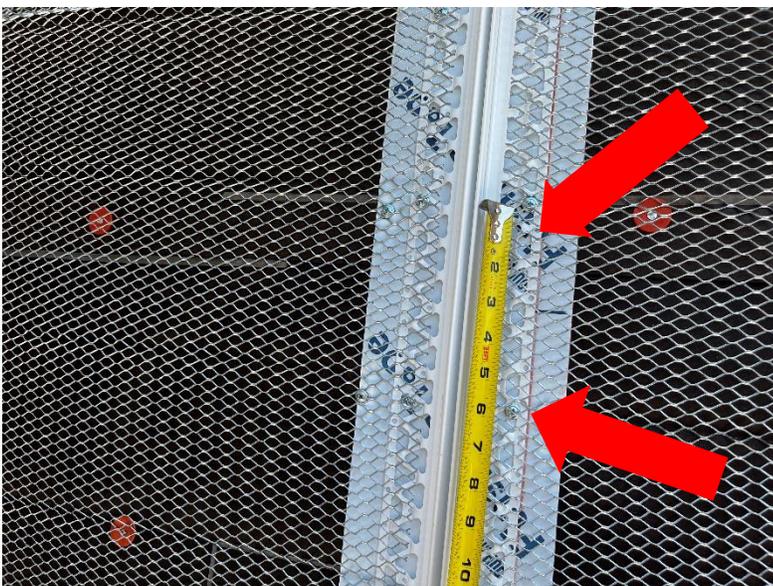
PHOTOGRAPH #8

**BUILDING 13
SECTION H**

Control joint flanges secured at no more than 7" intervals as per ASTM 1063. .

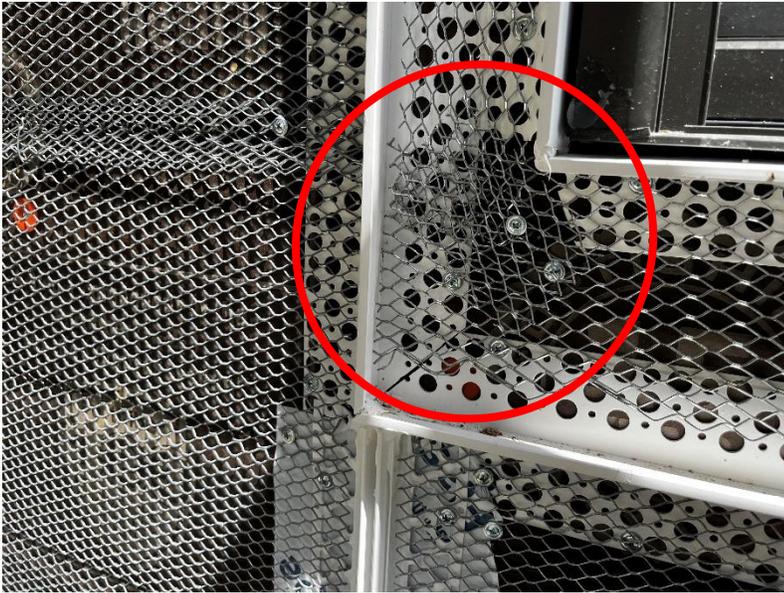
PHOTOGRAPH #9

**BUILDING 13
SECTION H**

Metal lath butterfly tied to self-furring lath at each window corner.

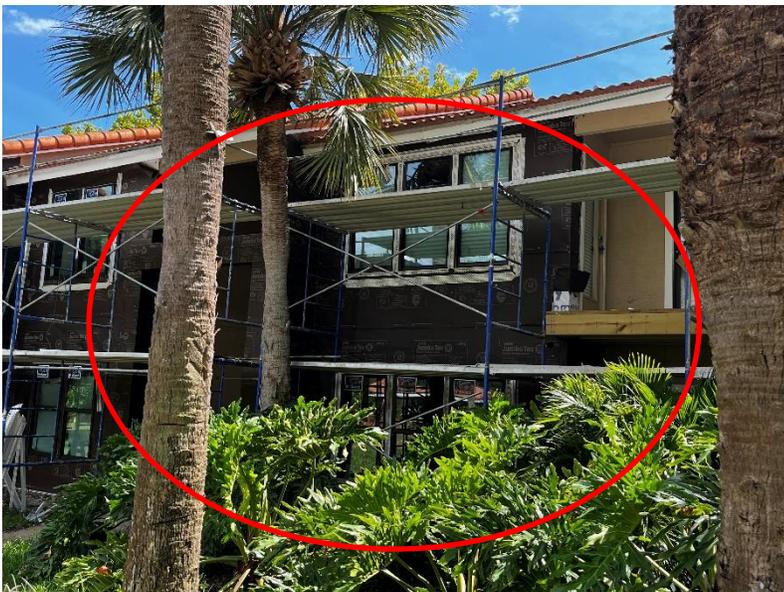
PHOTOGRAPH #10

**BUILDING 13
SECTION F**

Stucco sub-contractor has applied Jumbo Tex water resistant barrier and begun application of stucco accessories.

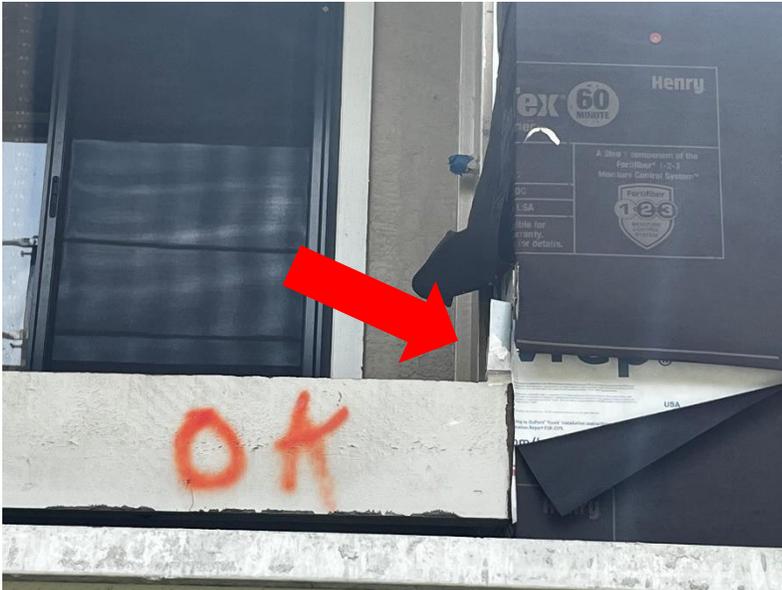
PHOTOGRAPH #11

**BUILDING 13
SECTION E**

New galvanized kick out flashing details installed at balcony transitions as per drawings.

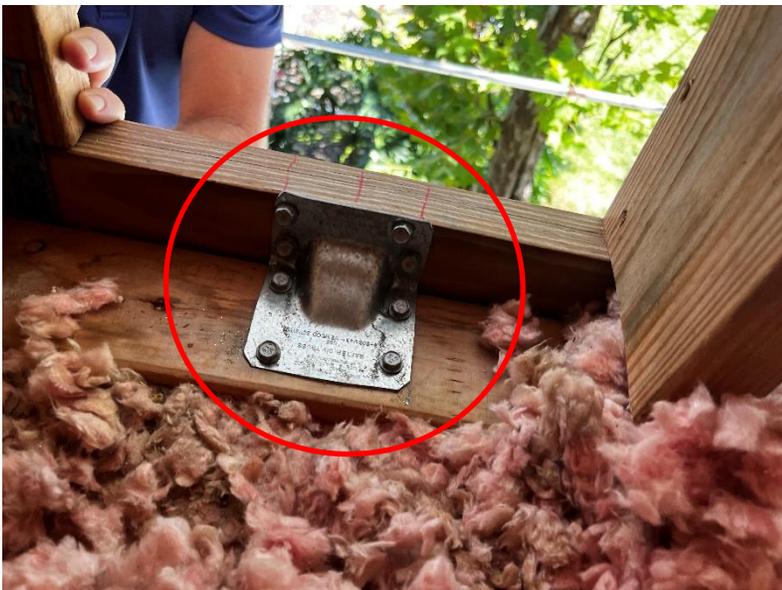
PHOTOGRAPH #12

**BUILDING 13
SECTION D**

Gable truss to plate attached with Simpson Strong-Tie #HGA 10 clips as per drawings.

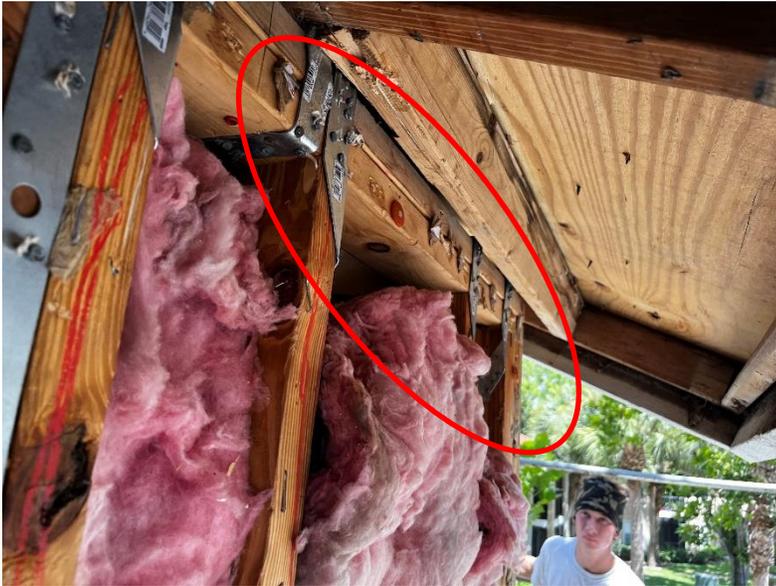
PHOTOGRAPH #13

**BUILDING 13
SECTION C**

Simpson Strong -Tie connectors and screws attaching studs to top plate, and top plate to trusses installed as per drawings.

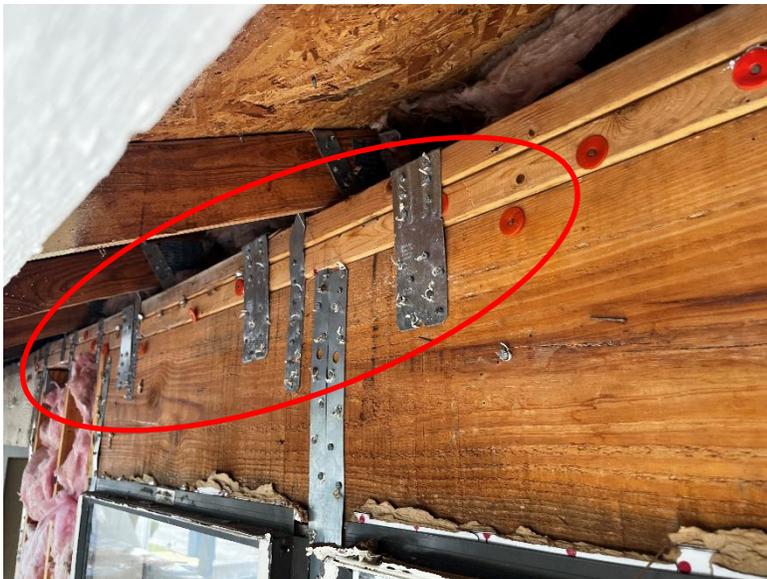
PHOTOGRAPH #14

**BUILDING 13
SECTION B**

Simpson Strong -Tie connectors and screws attaching window headers to top plate, and top plate to trusses installed as per drawings.

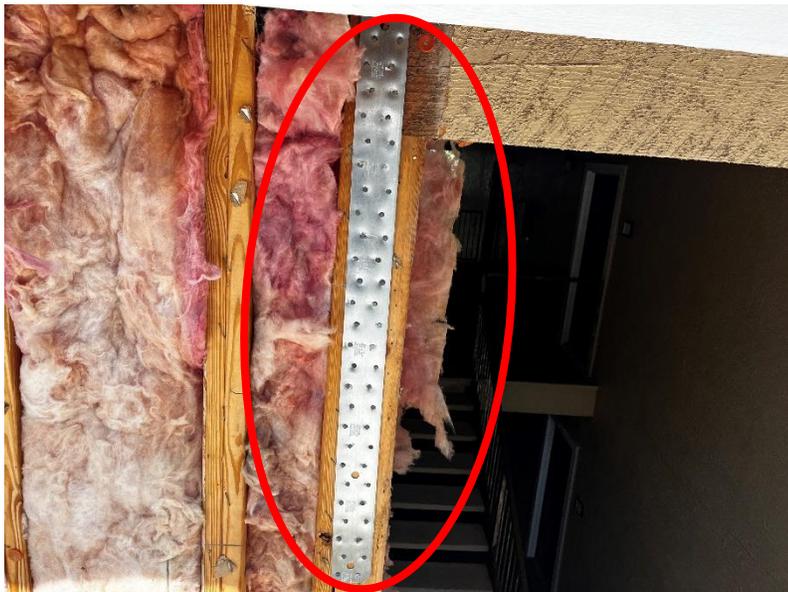
PHOTOGRAPH #15

**BUILDING 13
SECTION A**

Simpson Strong -Tie connector
MSTC48B3 attaching breezeway studs
pack to cedar beam installed as per
drawings.

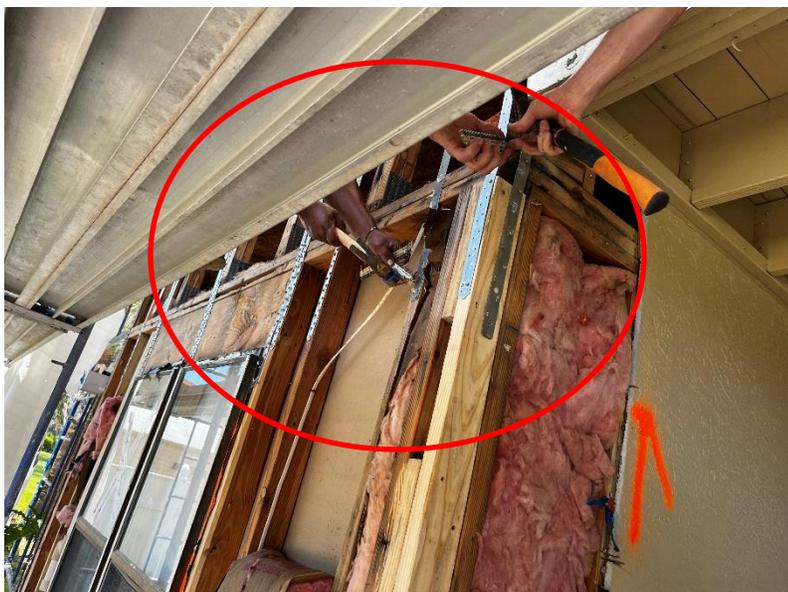
PHOTOGRAPH #16

**BUILDING 13
SECTION A**

RLJ installing missing nails observed at
connector straps.

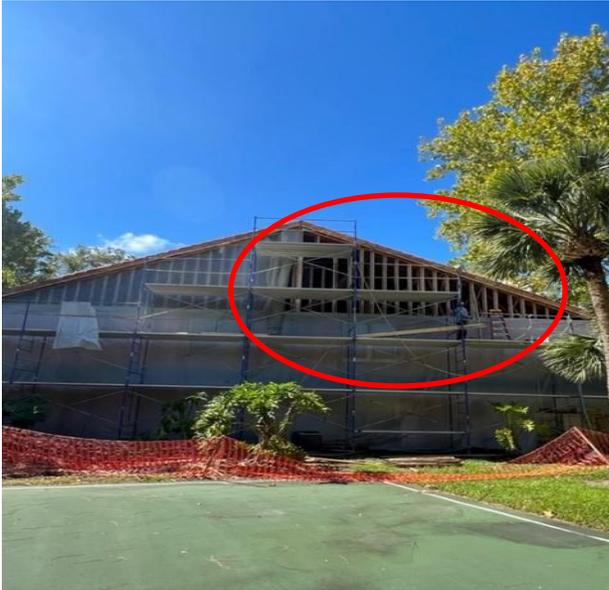
PHOTOGRAPH #17

**BUILDING 18
SECTION H**

RLJ installing cross bracing reinforcement at gable ends as per drawings and specifications

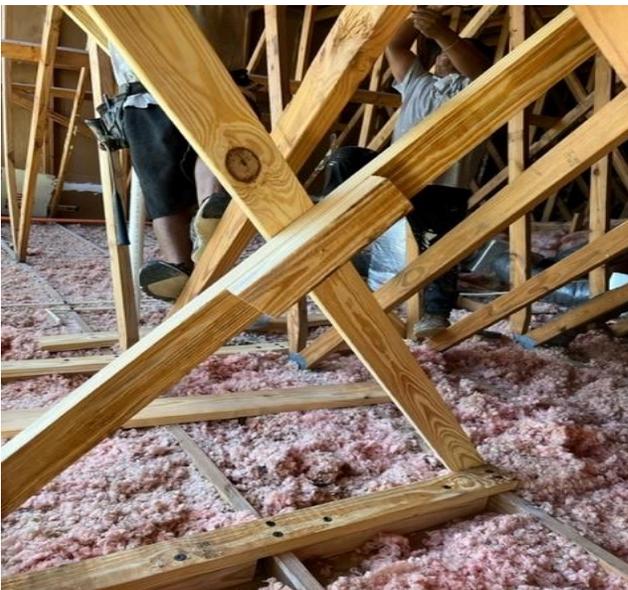
PHOTOGRAPH #18

**BUILDING 18
SECTION H**

RLJ installing cross bracing reinforcement at gable ends as per drawings and specifications.

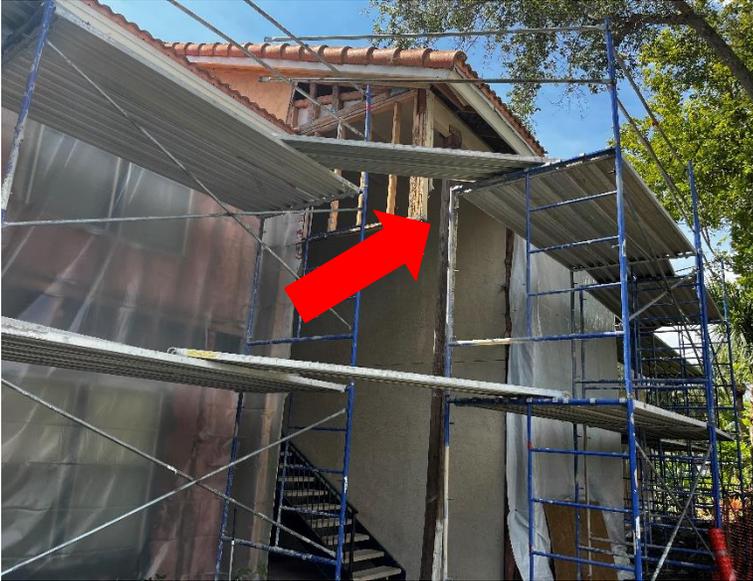
PHOTOGRAPH #19

**BUILDING 13
SECTION G**

RLJ has erected shoring post at breezeway beam where post had collapsed.
