PHOTOGRAPHS

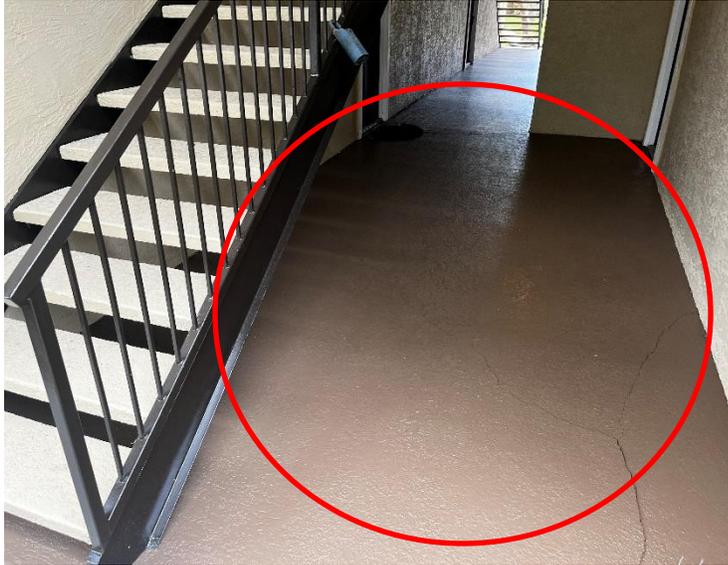
PHOTOGRAPH #1

**BUILDING 8
SECTION A- BREZEWAY**

Flooring coated with Florida Paints TropiCrete Exterior Concrete Sealer .

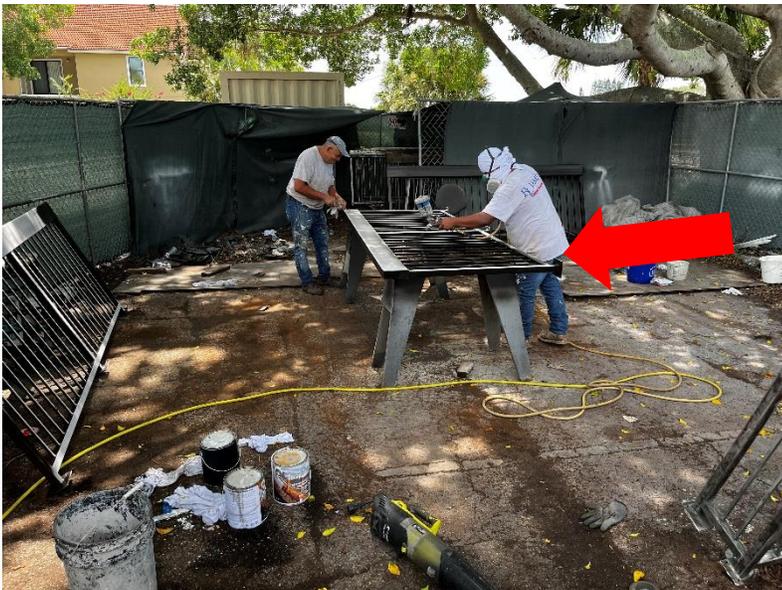
PHOTOGRAPH #2

**BUILDING 8
SECTION A**

Steel balcony railings finish coated with Florida Paints Urethane Aliphatic gloss enamel.

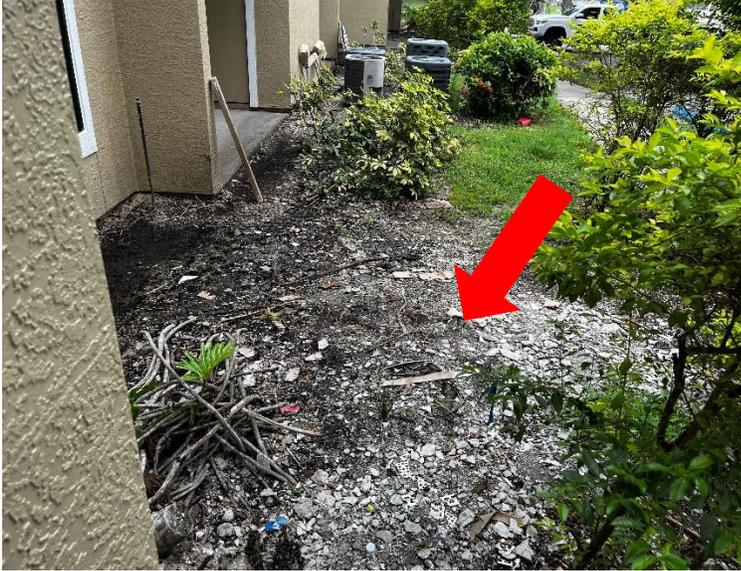
PHOTOGRAPH #3

**BUILDING 8
SECTION B**

Final cleanup of stucco and construction debris is not complete.

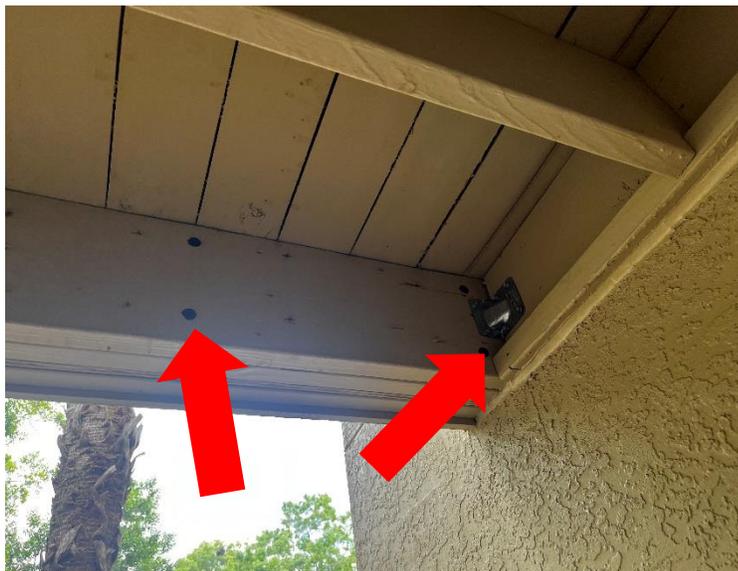
PHOTOGRAPH #4

**BUILDING 8
SECTION B**

Simpson Strong-Tie #SDW22458 Screws and shear clips installed at balcony built up beams.

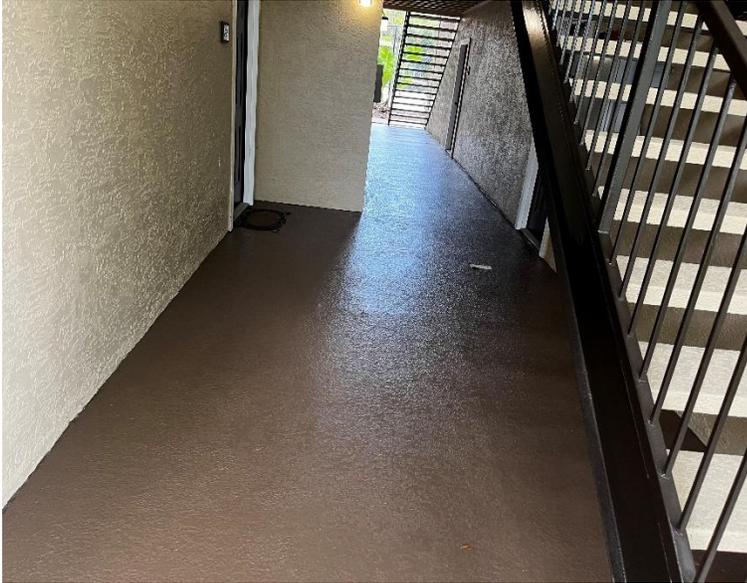
PHOTOGRAPH #5

**BUILDING 8
SECTION B**

Flooring coated with Florida Paints
TropiCrete Exterior Concrete Sealer.

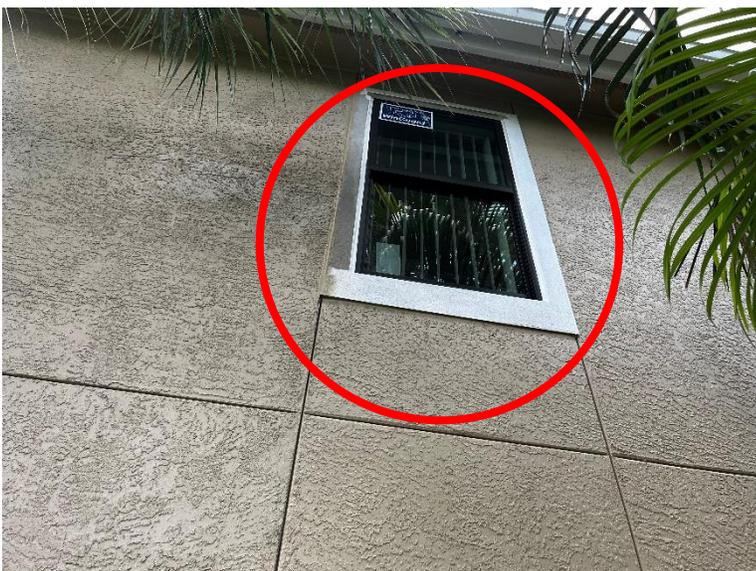
PHOTOGRAPH #6

**BUILDING 8
SECTION E- UNIT #828**

Trim Painting at single window band is not
complete

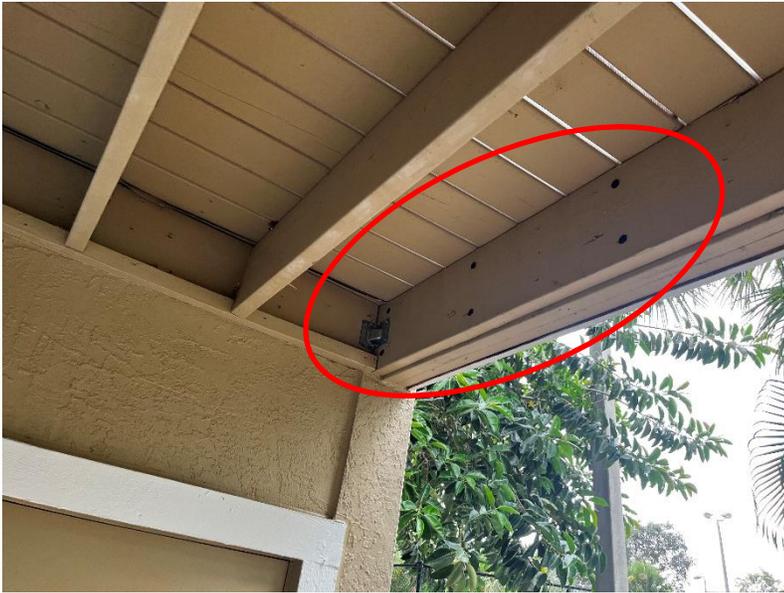
PHOTOGRAPH #7

**BUILDING 8
SECTION F**

Simpson Strong-Tie #SDW22458 Screws and shear clips installed at balcony built up beams.

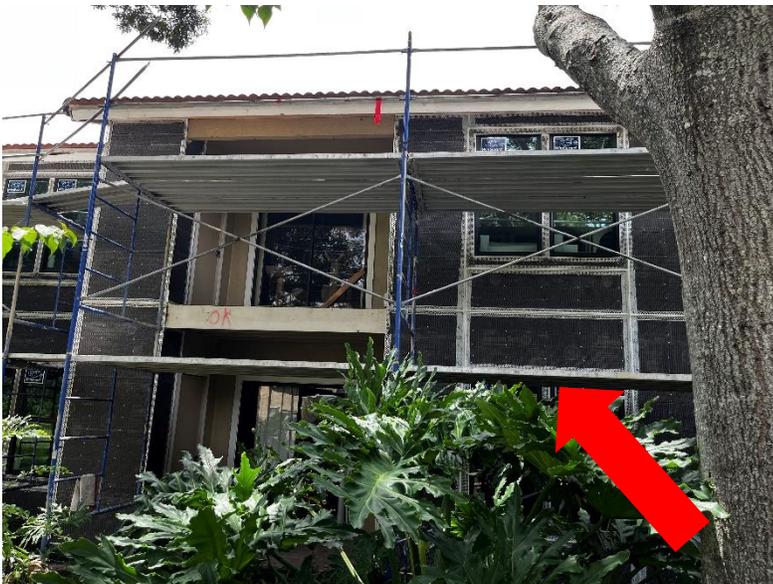
PHOTOGRAPH #8

**BUILDING 13
SECTION G**

Stucco sub-contractor has applied stucco accessories and galvanized metal self-furring lathing as per drawings.

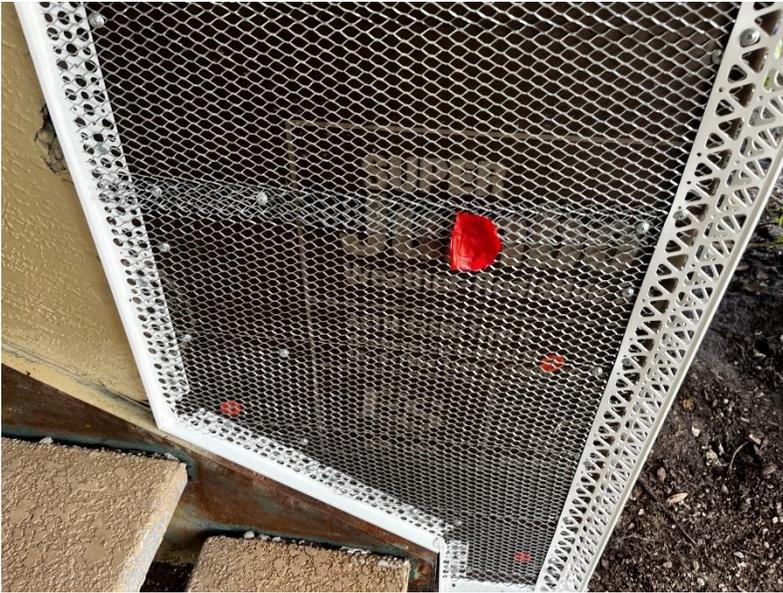
PHOTOGRAPH #9

**BUILDING 13
SECTION G**

Metal lath overlap has not been tied between framing supports with tie wire at this location.

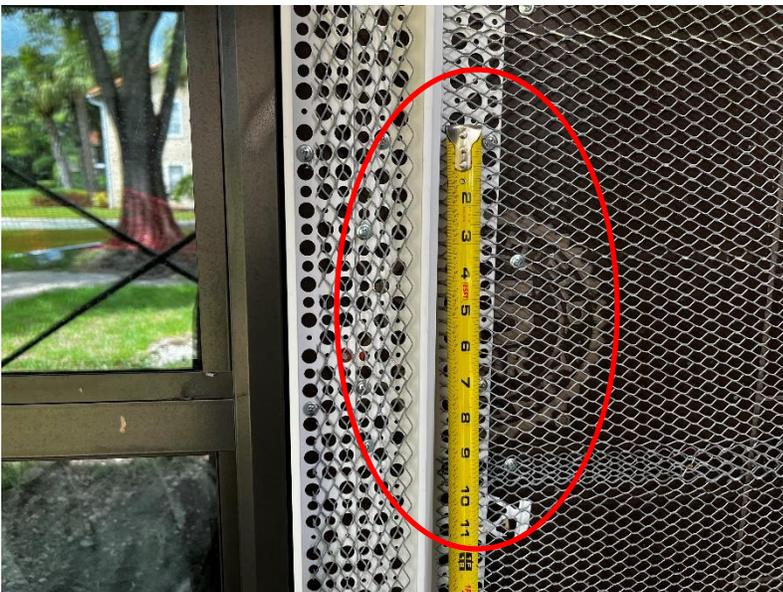
PHOTOGRAPH #10

**BUILDING 13
SECTION F**

Stucco sub-contractor has fastened stucco joints and stop accessories a 7" O.C. as per ASTM C1063.

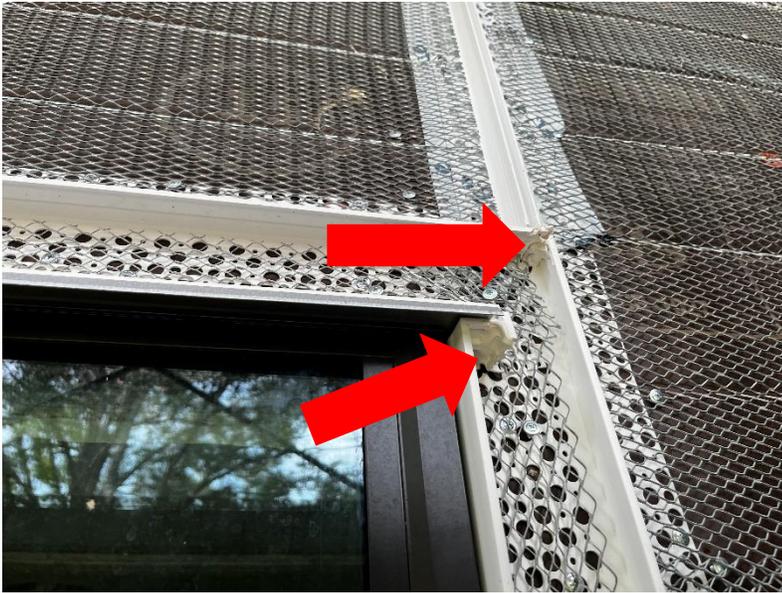
PHOTOGRAPH #11

**BUILDING 13
SECTION F**

New urethane sealants applied at stucco accessory transitions and butt joints as per drawings.

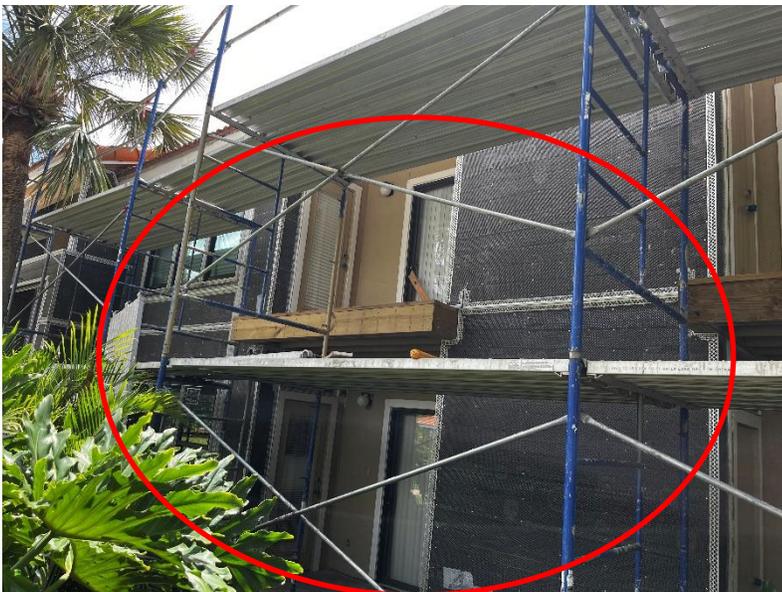
PHOTOGRAPH #12

**BUILDING 13
SECTION E**

Stucco sub-contractor has applied stucco accessories and galvanized metal self-furring lathing as per drawings.

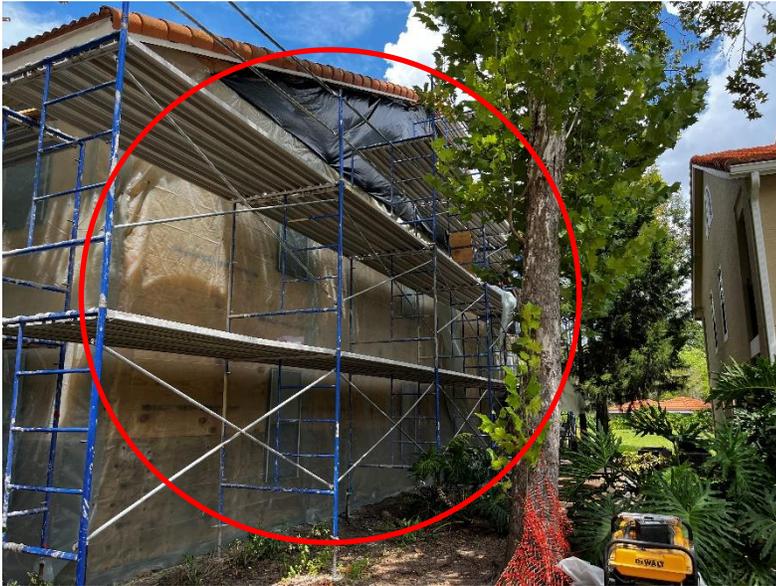
PHOTOGRAPH #13

**BUILDING 13
SECTION D**

RLJ has installed 15/32" plywood sheathing and covered with plastic protection.

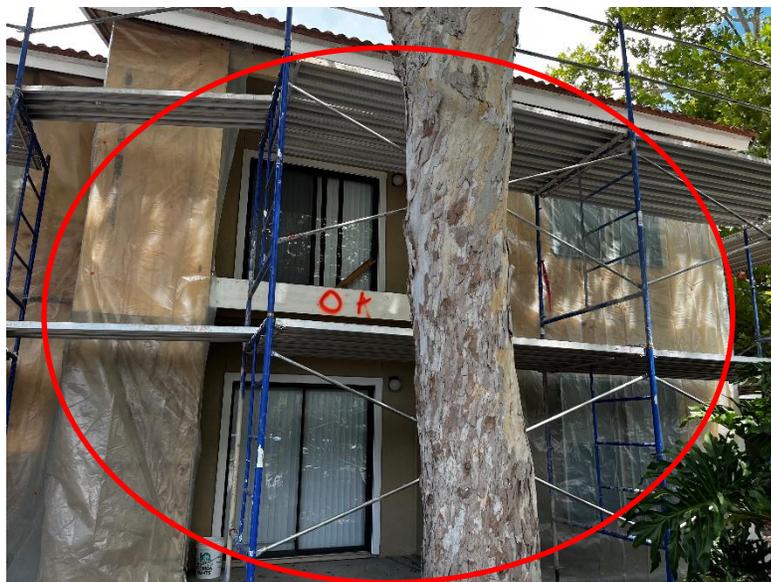
PHOTOGRAPH #14

**BUILDING 13
SECTION C**

RLJ has installed 15/32" plywood sheathing and covered with plastic protection.

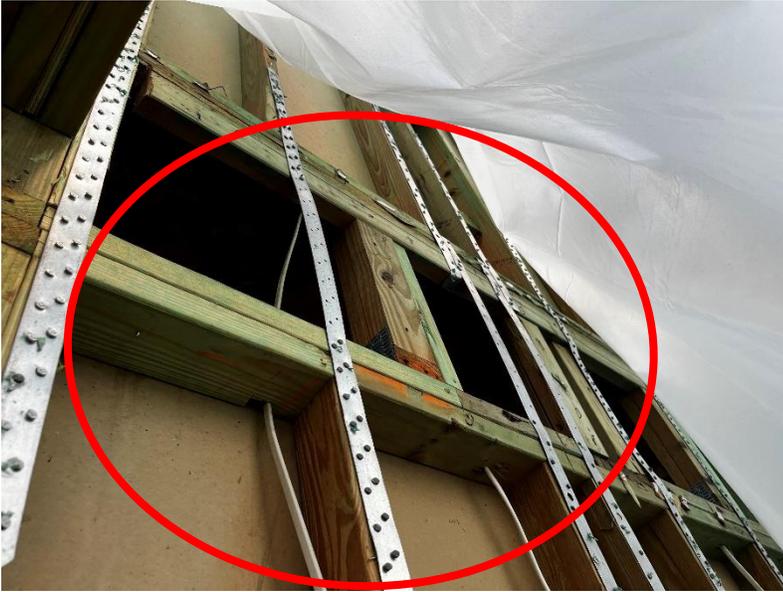
PHOTOGRAPH #15

**BUILDING 13
SECTION B**

Pest control contractor has applied Bora-Care termite treatment to framing as per specifications.

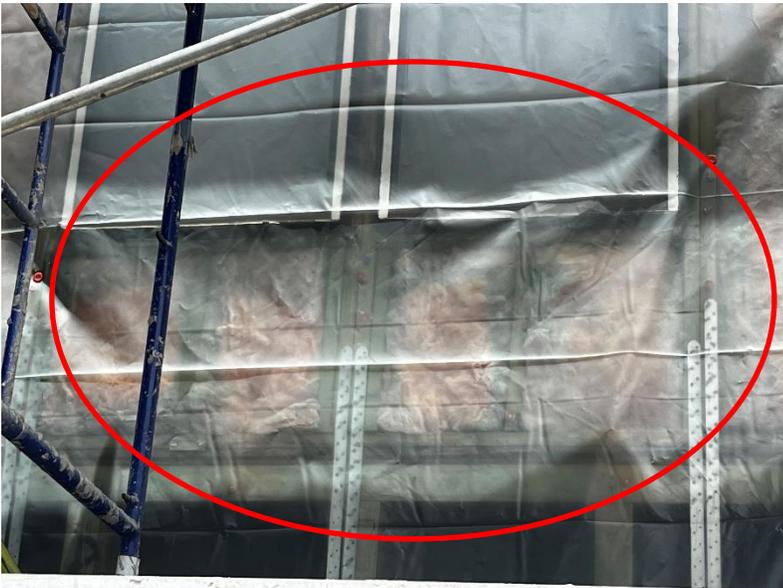
PHOTOGRAPH #16

**BUILDING 13
SECTION B**

Pest control contractor has applied Bora-Care termite treatment to framing as per specifications.

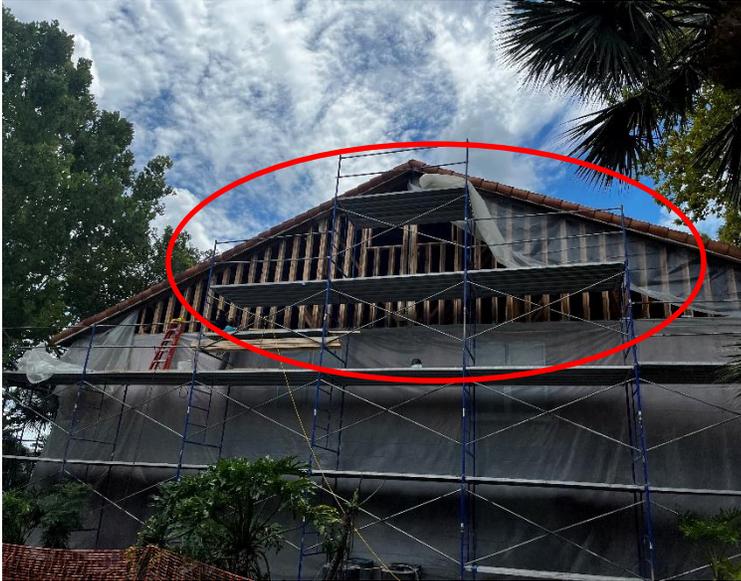
PHOTOGRAPH #17

**BUILDING 18
SECTION H**

RLJ continuing cross bracing reinforcement repairs at gable ends as per drawings and specifications

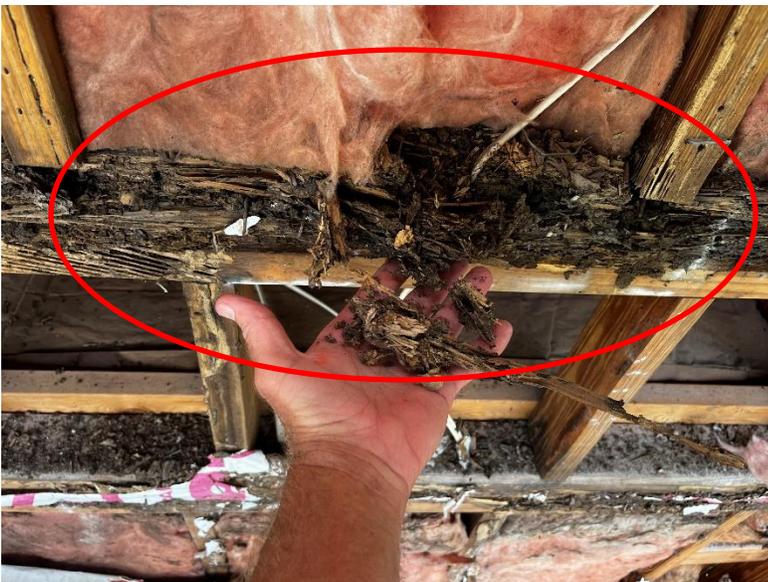
PHOTOGRAPH #18

**BUILDING 13
SECTION H**

Second floor plate and flooring truss framing damage inspected and marked for repairs.

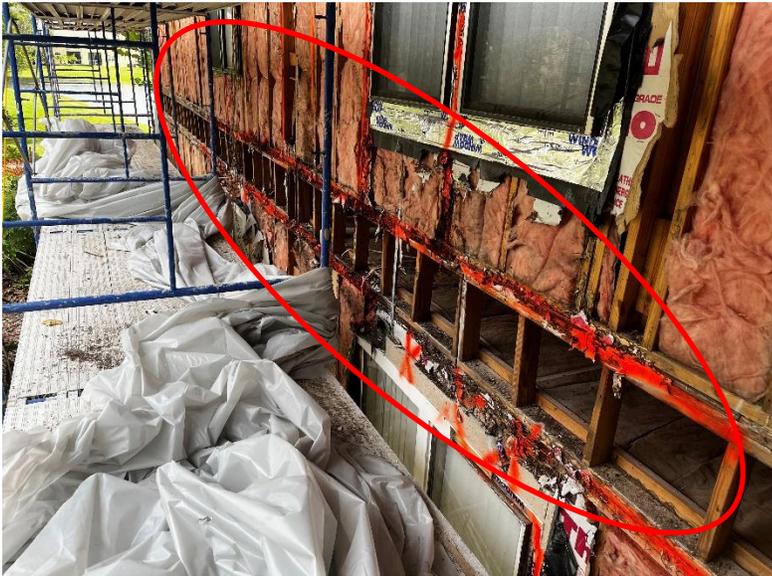
PHOTOGRAPH #19

**BUILDING 18
SECTION H**

Damaged framing at subfloor, studs, plates and window headers marked for repairs.

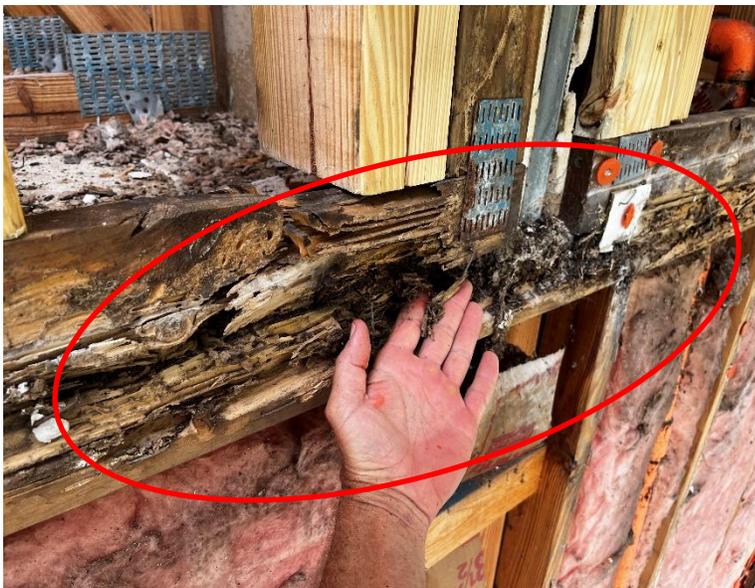
PHOTOGRAPH #20

**BUILDING 13
SECTION H**

Damaged gable end truss and second floor top plate framing marked for repairs.

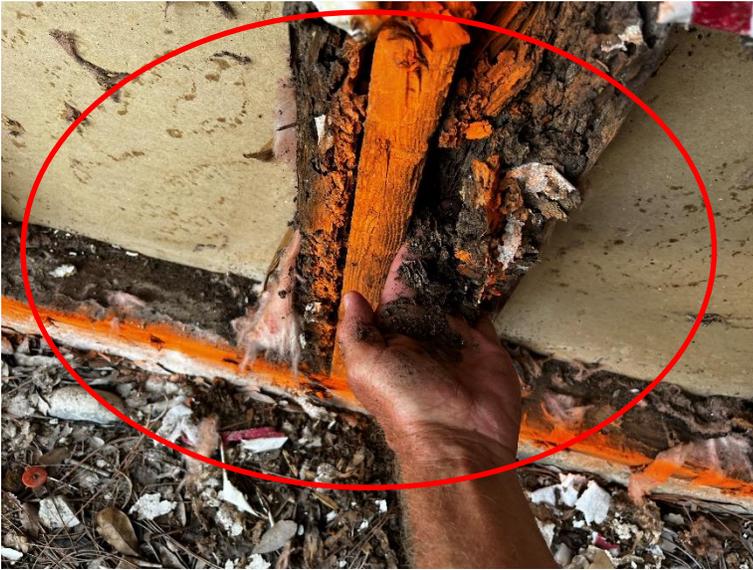
PHOTOGRAPH #21

**BUILDING 13
SECTION G**

Damaged bottom plate and window stud framing marked for repairs.

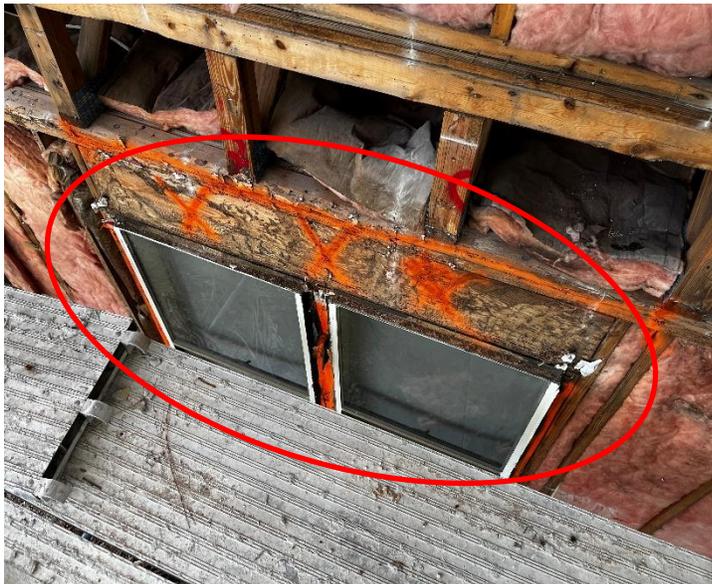
PHOTOGRAPH #22

**BUILDING 13
SECTION G**

Damaged window headers and framing marked for repairs.
