PHOTOGRAPHS

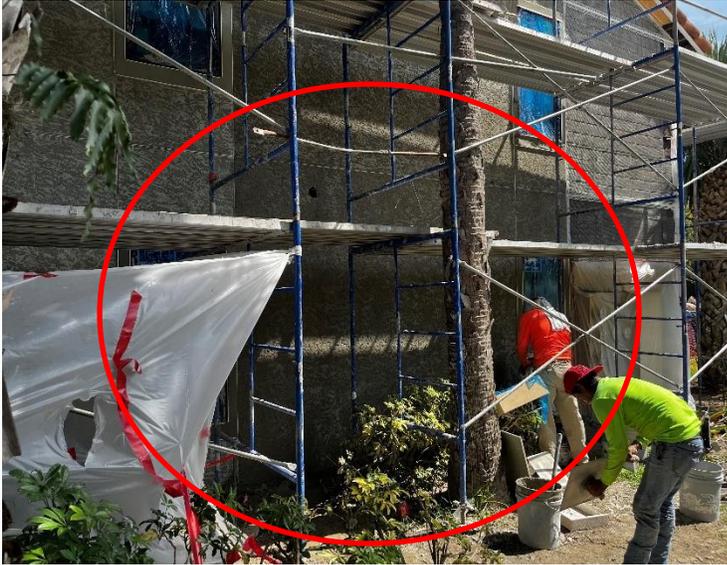
PHOTOGRAPH #1

**BUILDING 13  
SECTION H**

Stucco sub-contractor applying finish coat of three coat 7/8" stucco as per drawings and specification .

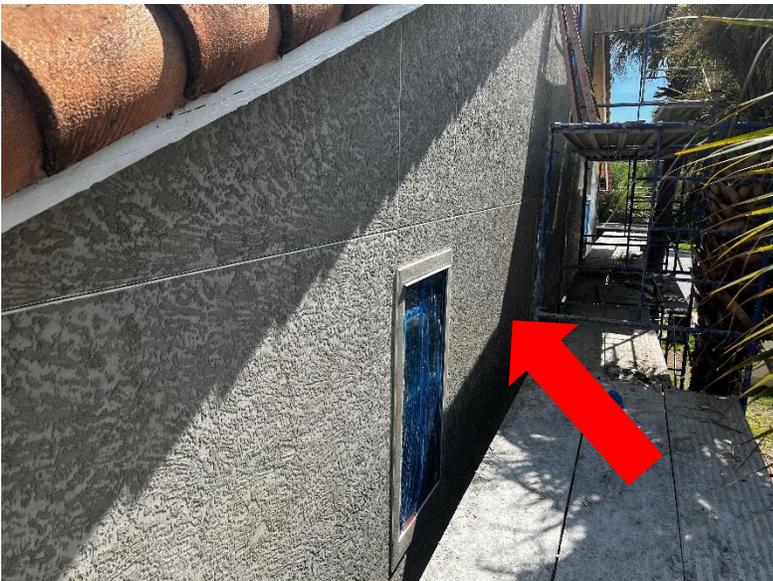
PHOTOGRAPH #2

**BUILDING 13  
SECTION H**

Stucco sub-contractor applying finish coat of three coat 7/8" stucco as per drawings and specification.

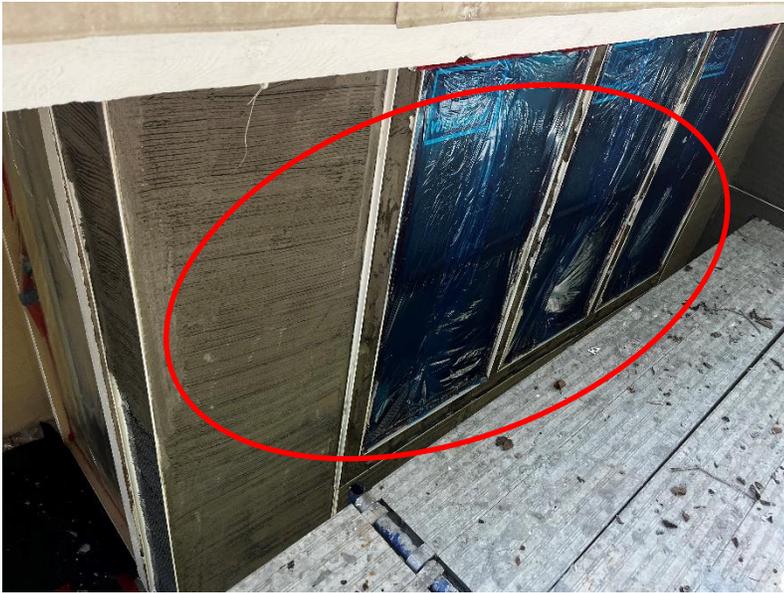
**PHOTOGRAPH #3**

**BUILDING 13  
SECTION G**

Stucco sub-contractor applying scratch coat of three coat 7/8" stucco as per drawings and specification.

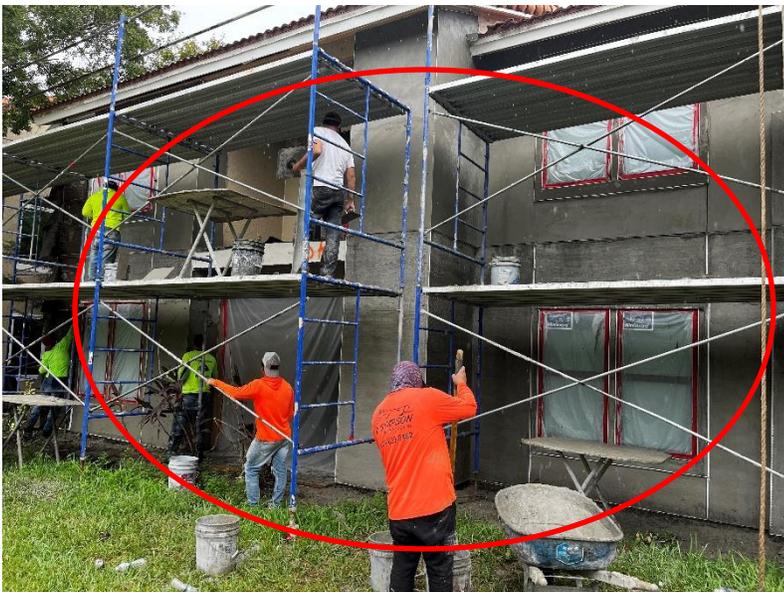
**PHOTOGRAPH #4**

**BUILDING 13  
SECTION F**

Stucco sub-contractor applying scratch coat of three coat 7/8" stucco as per drawings and specification.

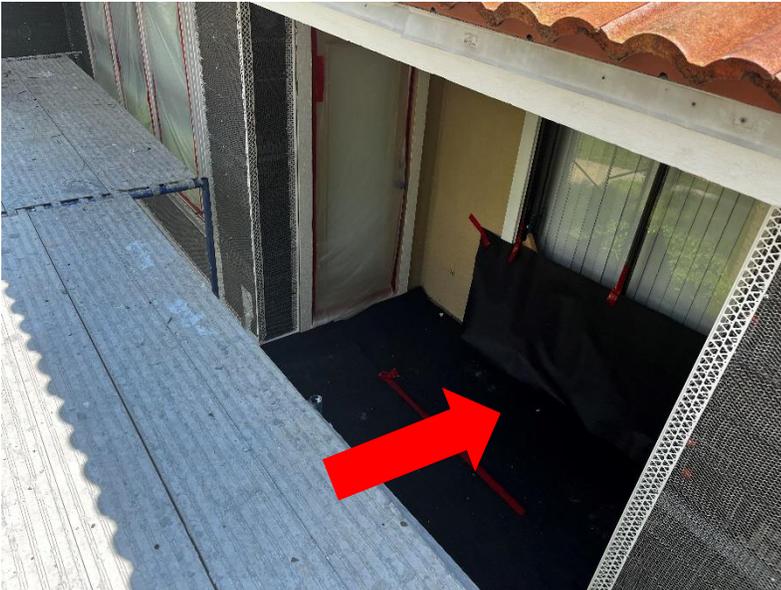
**PHOTOGRAPH #5**

**BUILDING 13  
SECTION F**

Stucco sub-contractor has protected adjacent surfaces at balcony with protection sheet.

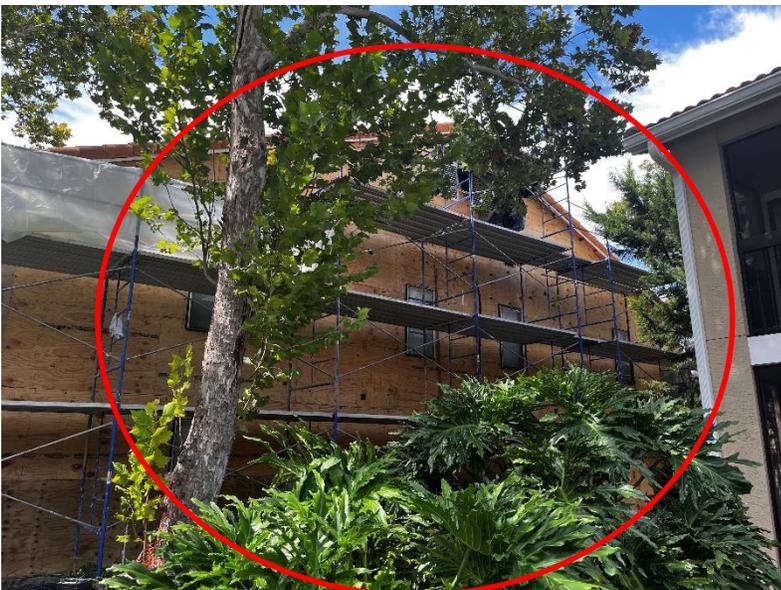
**PHOTOGRAPH #6**

**BUILDING 13  
SECTION D**

RLJ has installed new 15/32" plywood sheathing per drawing and specifications.

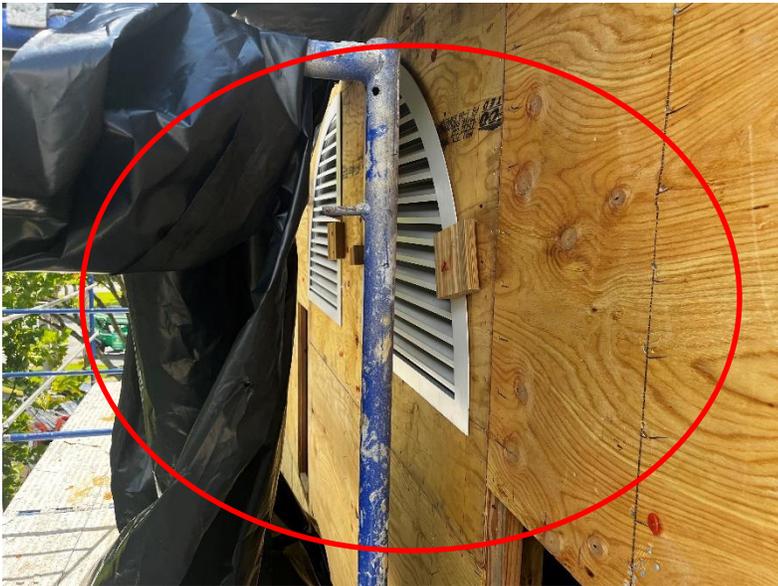
**PHOTOGRAPH #7**

**BUILDING 13  
SECTION D**

New Green Heck louvers installation in progress at gable end attic space as per specifications.

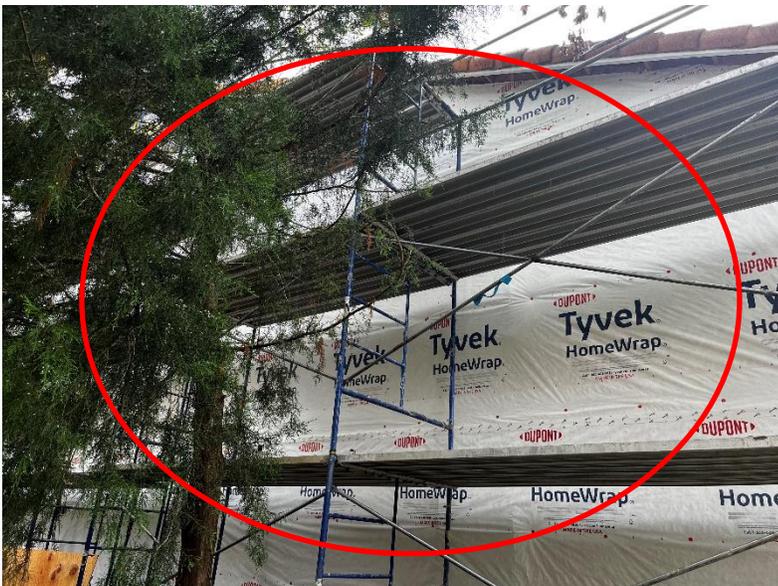
**PHOTOGRAPH #8**

**BUILDING 13  
SECTION D**

RLJ has installed Tyvek Home wrap water resistant barrier at gable end wall.

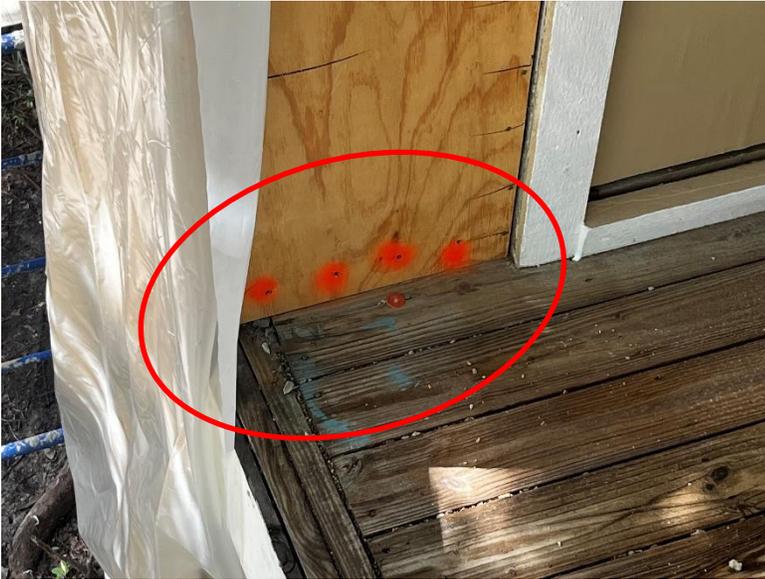
**PHOTOGRAPH #9**

**BUILDING 13  
SECTION C**

RLJ has fastened new plywood sheathing to framing member were missed and marked by Delta for correction.

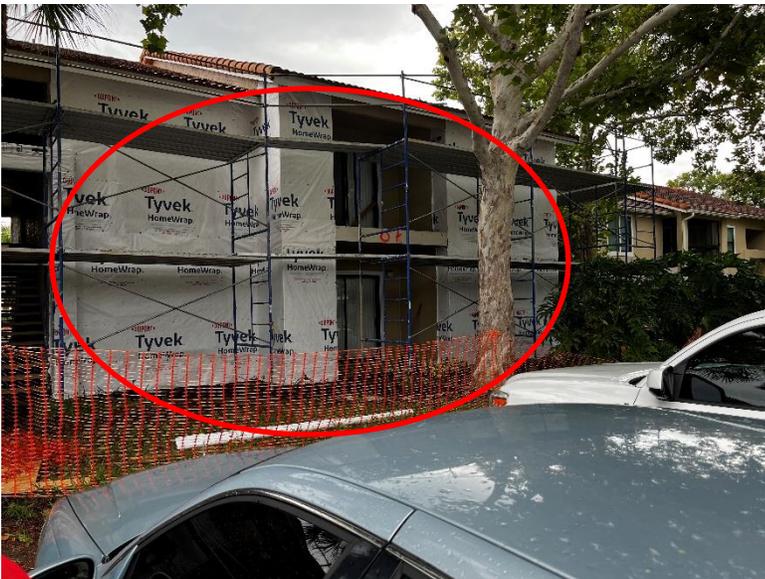
**PHOTOGRAPH #10**

**BUILDING 13  
SECTION C**

RLJ has installed Tyvek Home wrap water resistant barrier at framed bearing walls.

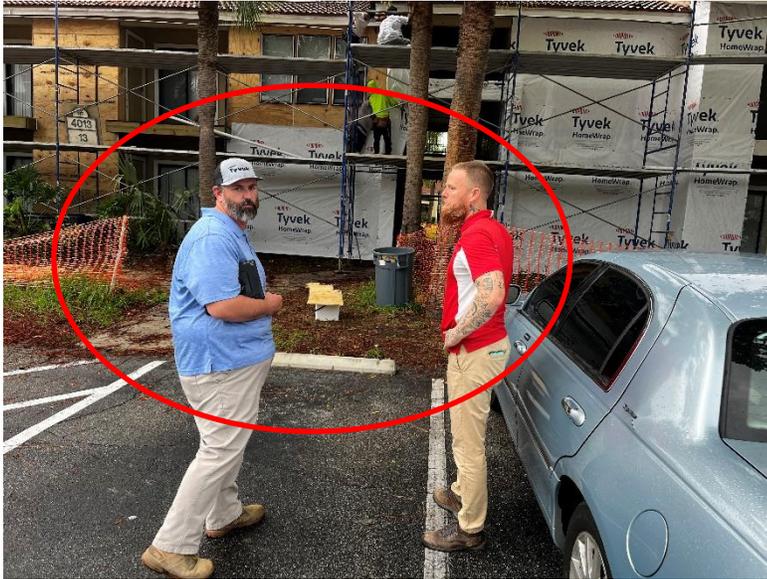
**PHOTOGRAPH #11**

**BUILDING 13  
SECTION C**

DuPont Tyvek manufacturer's representative on site, inspecting Tyvek installation.

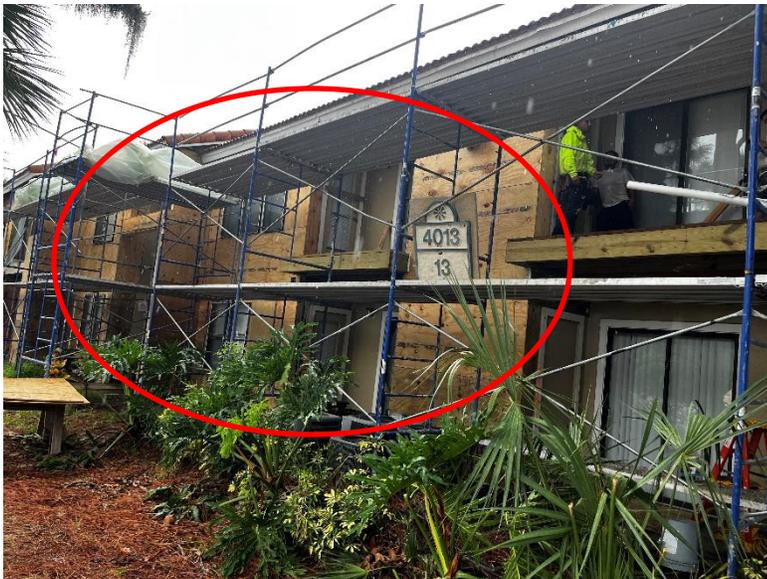
**PHOTOGRAPH #12**

**BUILDING 13  
SECTION B**

RLJ in process of installing 15/32" plywood sheathing.

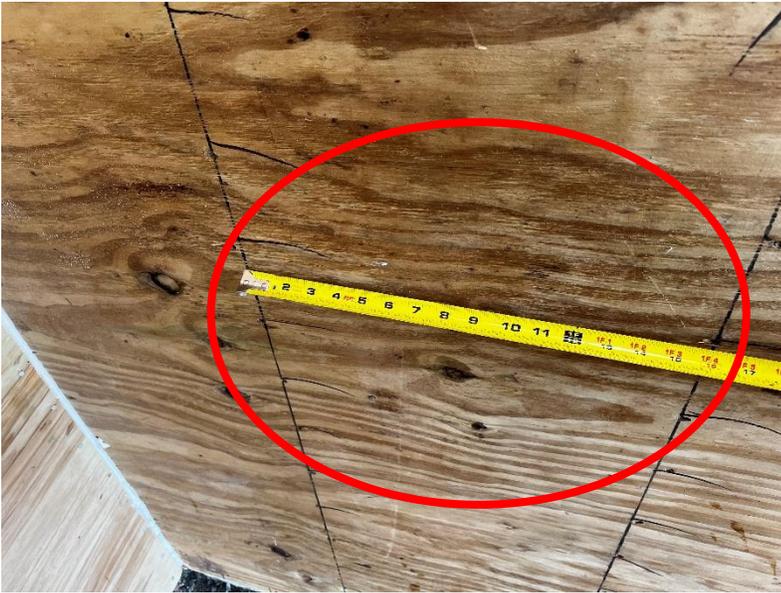
**PHOTOGRAPH #13**

**BUILDING 13  
SECTION B**

New plywood sheathing attached to framing members at 16" spacing as per drawings and specifications.

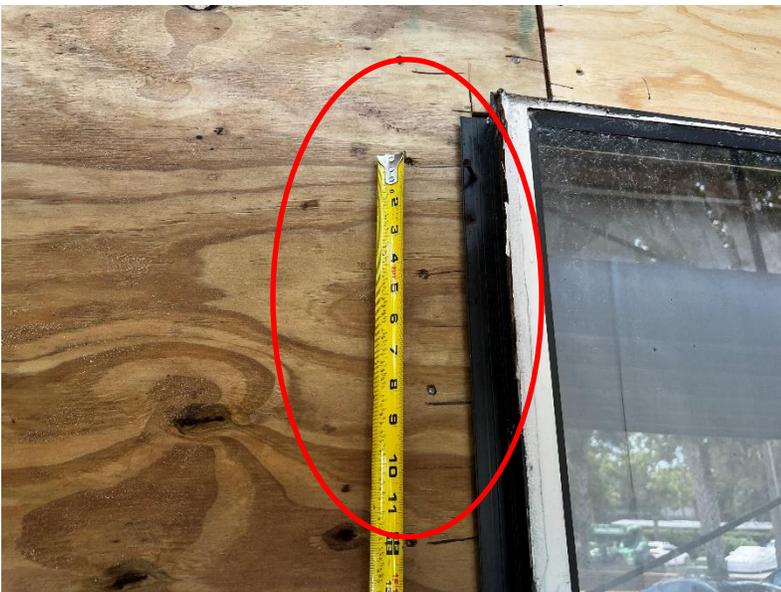
**PHOTOGRAPH #14**

**BUILDING 13  
SECTION B**

New plywood sheathing attached to framing members with 10d nails at 4" O.C.

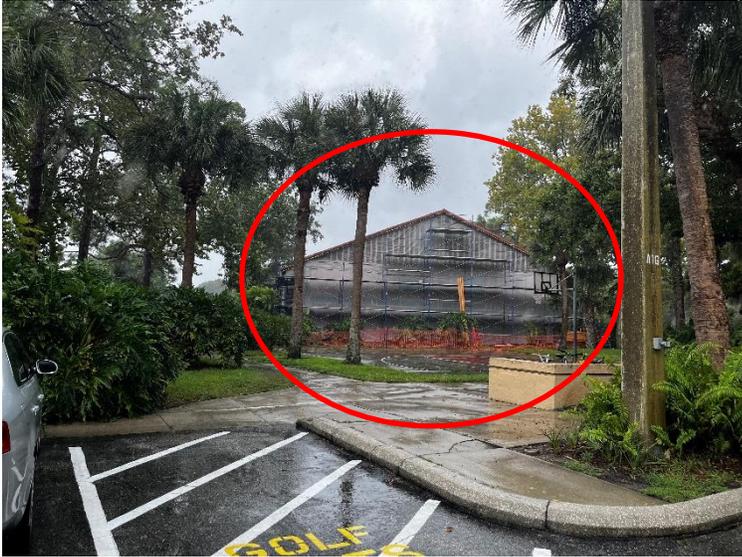
**PHOTOGRAPH #15**

**BUILDING 18  
SECTION H**

RLJ has protected open walls with heavy duty plastic while repairs are in progress.

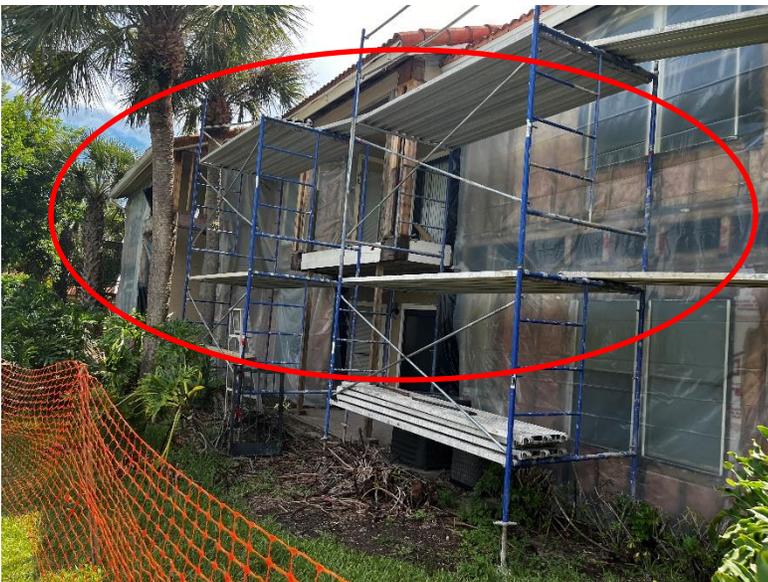
**PHOTOGRAPH #16**

**BUILDING 13  
SECTION F**

RLJ has protected open walls with heavy duty plastic while repairs are in progress.

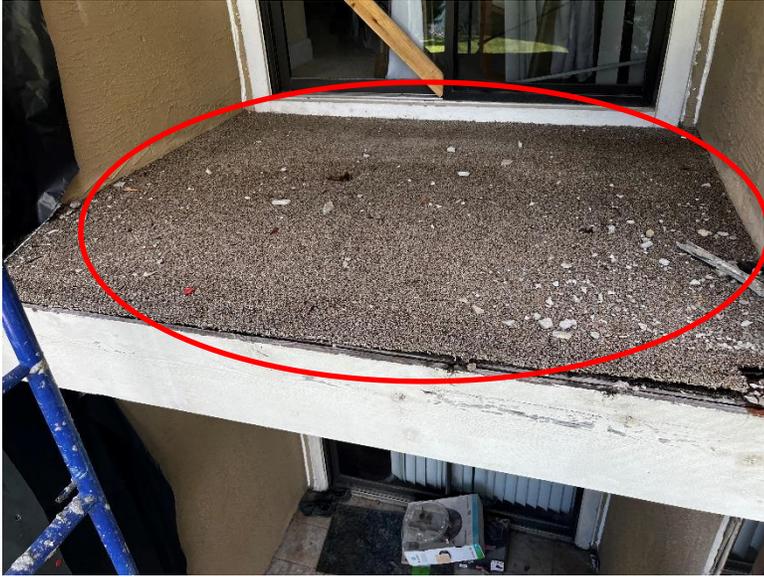
**PHOTOGRAPH #17**

**BUILDING 18  
SECTION F**

Upper balconies covered with carpet by owners will require removal for inspection of deck condition.
