PHOTOGRAPHS

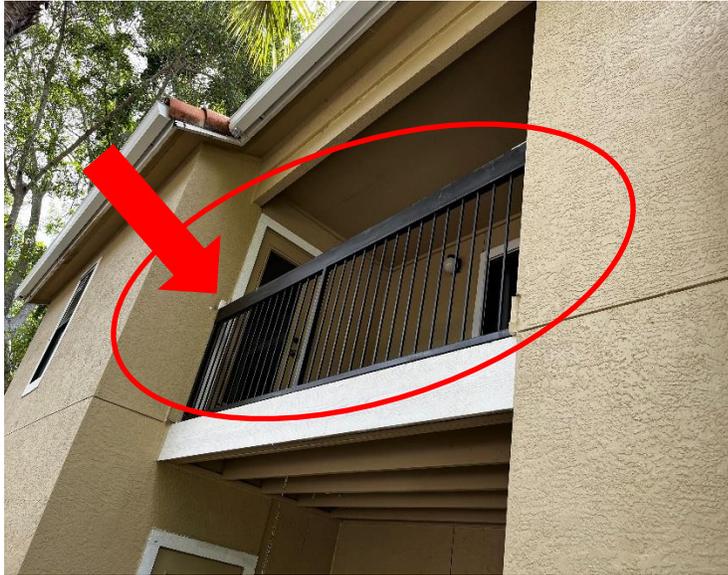
PHOTOGRAPH #1

**BUILDING 8
SECTION A**

New steel railing attached at walls with welded steel angles.

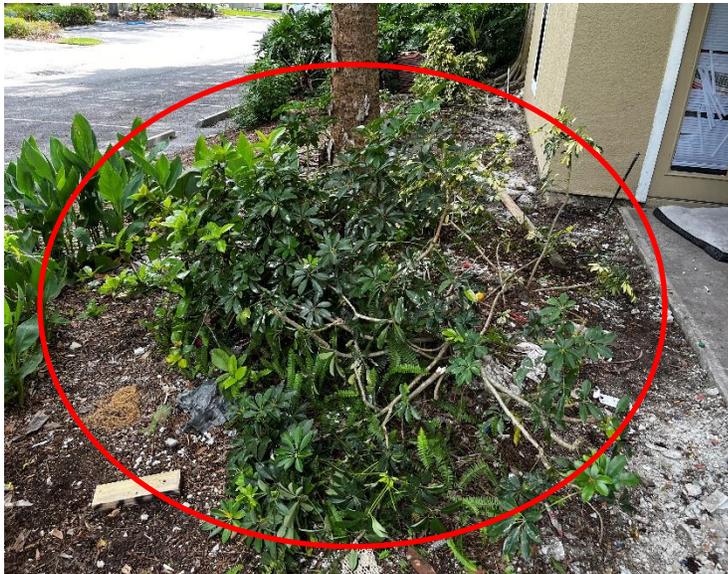
PHOTOGRAPH #2

**BUILDING 8
SECTION A**

Un sightly rubbish and construction debris remain around building grounds and landscaping.

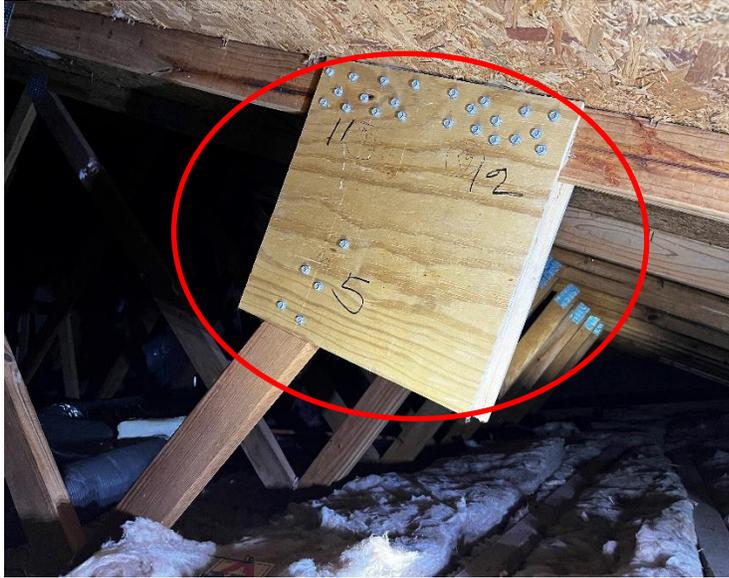
PHOTOGRAPH #3

**BUILDING 8
SECTION H- UNIT 821**

RLJ has performed truss gusset repairs as per drawings and specifications.

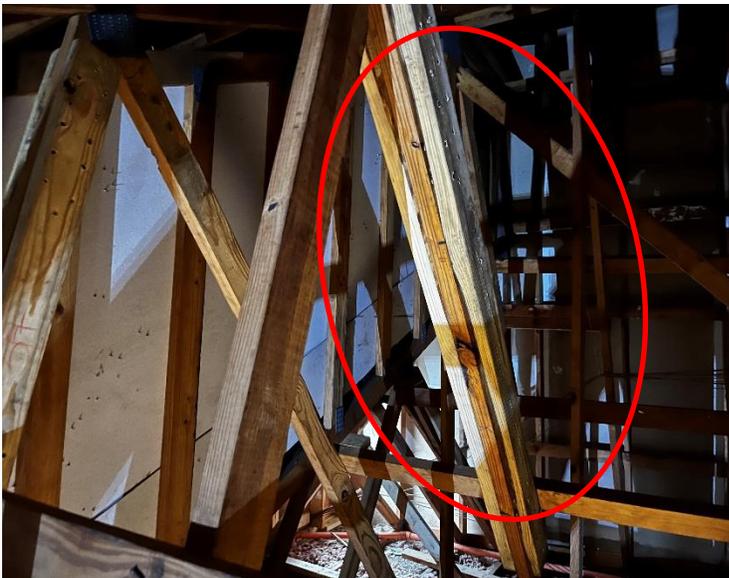
PHOTOGRAPH #4

**BUILDING 8
SECTION H- UNIT 821**

RLJ has performed truss scab repairs as per drawings and specifications.

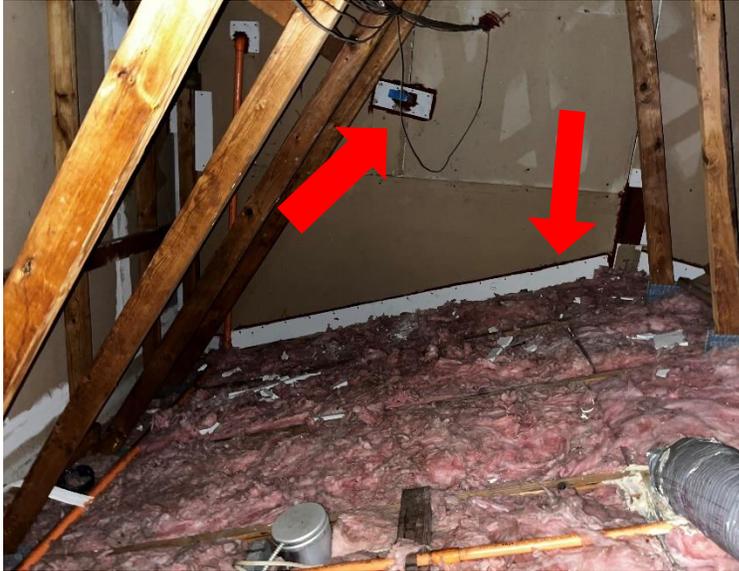
PHOTOGRAPH #5

**BUILDING 8
SECTION H- UNIT 821**

RLJ has performed fire board and fire caulking repairs as per drawings and specifications.

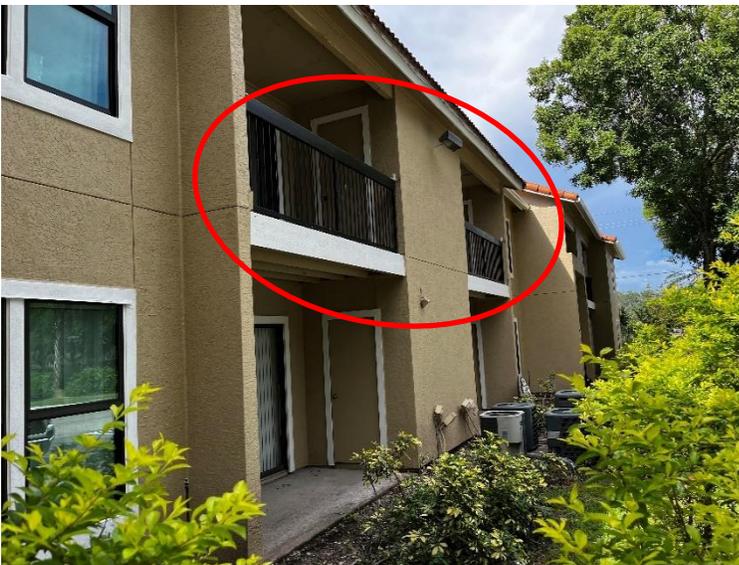
PHOTOGRAPH #6

**BUILDING 8
SECTION B**

New steel railing attached at walls with welded steel angles.

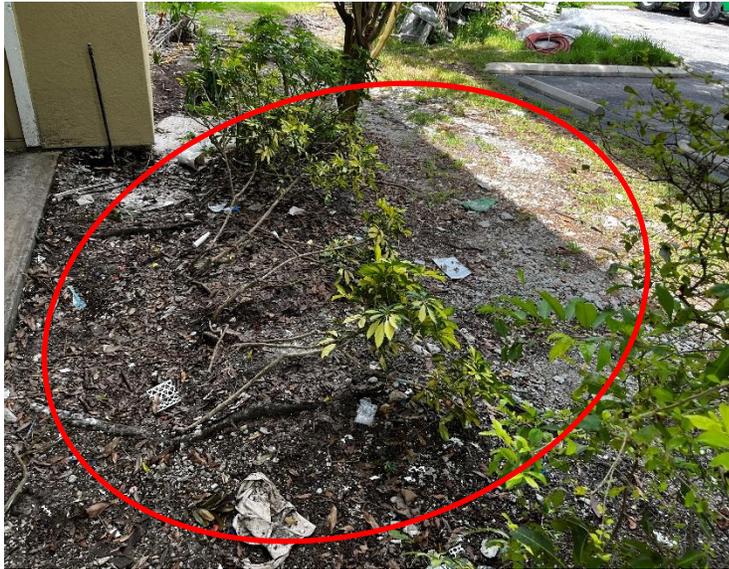
PHOTOGRAPH #7

**BUILDING 8
SECTION B**

Un sightly rubbish and construction debris remain around building grounds and landscaping.

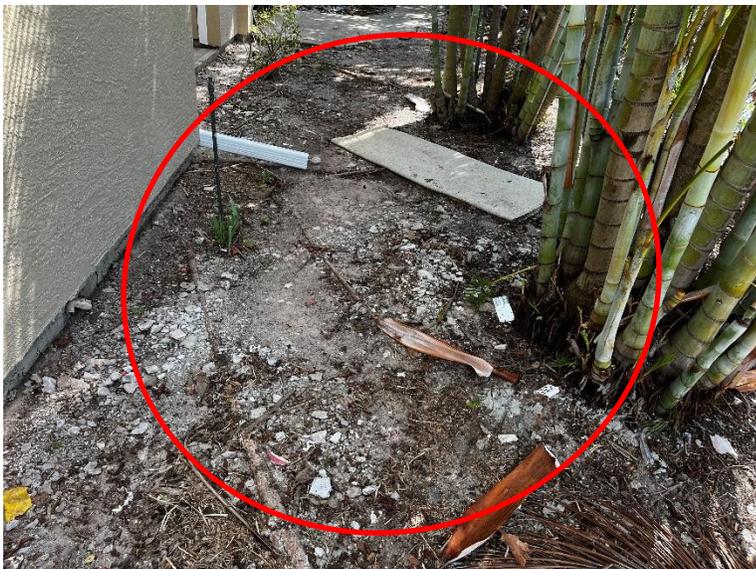
PHOTOGRAPH #8

**BUILDING 8
SECTION E**

Un sightly rubbish and construction debris remain around building grounds and landscaping.

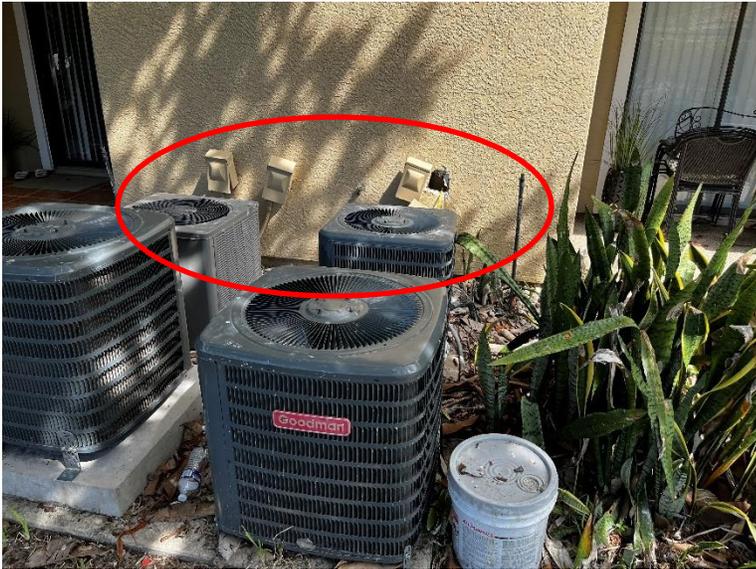
PHOTOGRAPH #9

**BUILDING 8
SECTION F**

Stucco repairs and re attachment of electrical boxes incomplete at A/C unit locations .

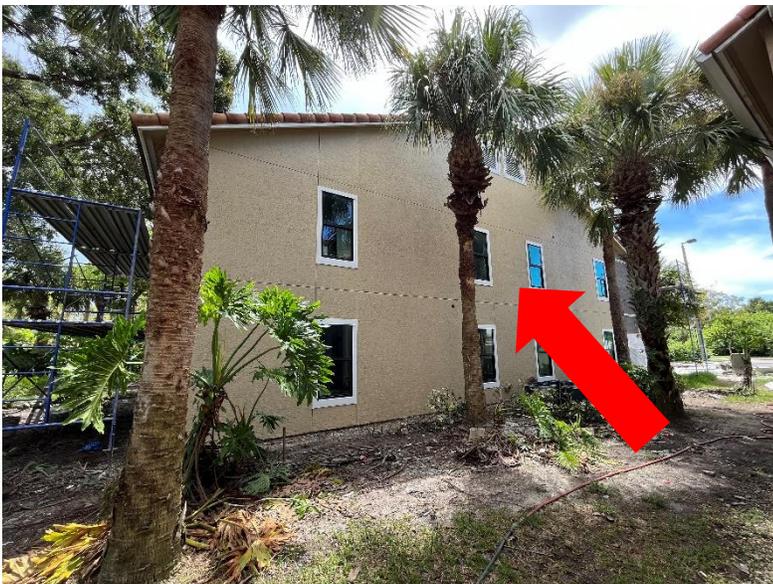
PHOTOGRAPH #10

**BUILDING 13
SECTION H**

RLJ has begun painting new stucco with Florida Paints .

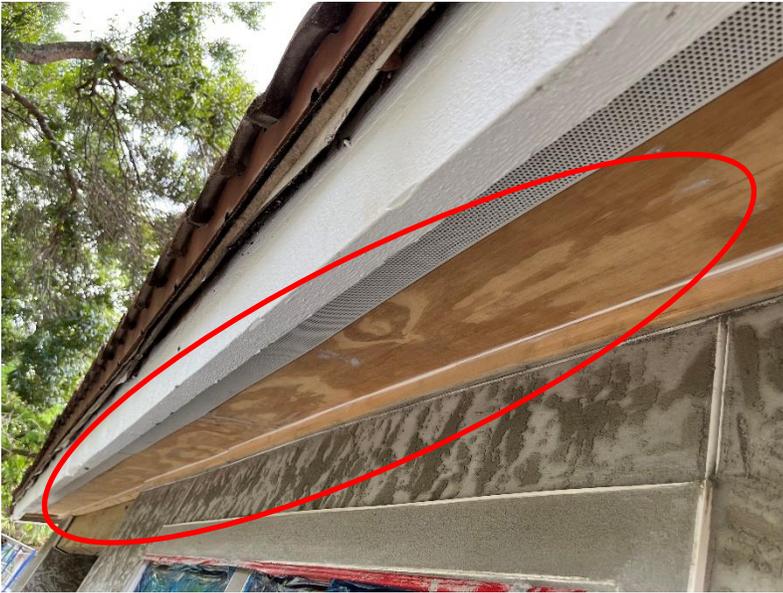
PHOTOGRAPH #11

**BUILDING 13
SECTION G**

RLJ has installed new plywood soffit and vinyl vent as per drawings and PM.

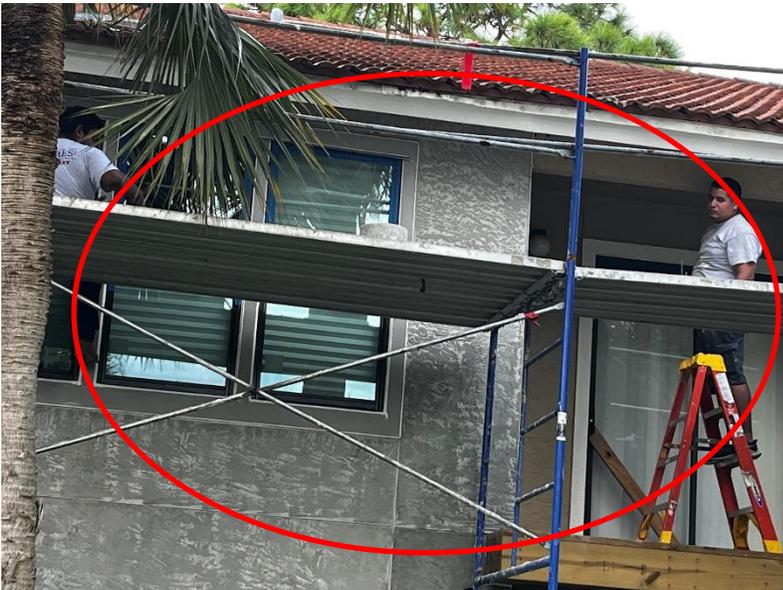
PHOTOGRAPH #12

**BUILDING 13
SECTION F**

RLJ installing BASF NP 150 sealant at window perimeters and stucco transitions.

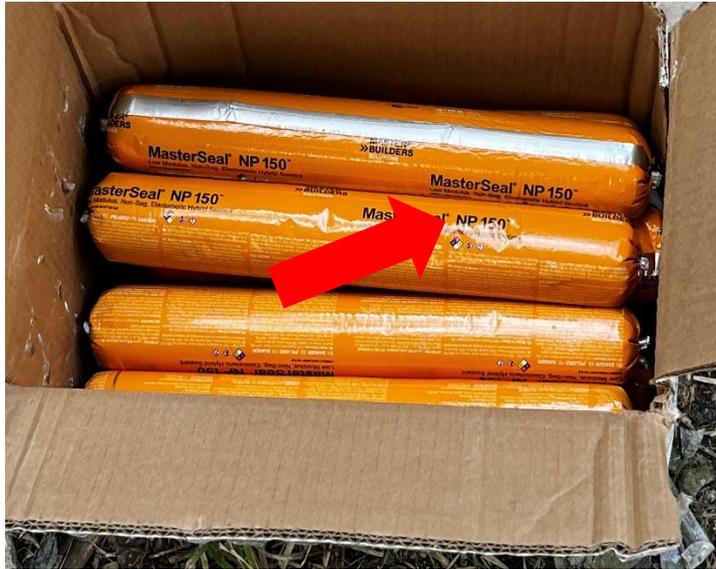
PHOTOGRAPH #13

**BUILDING 13
SECTION F**

RLJ installing BASF NP 150 sealant at window perimeters and stucco transitions.

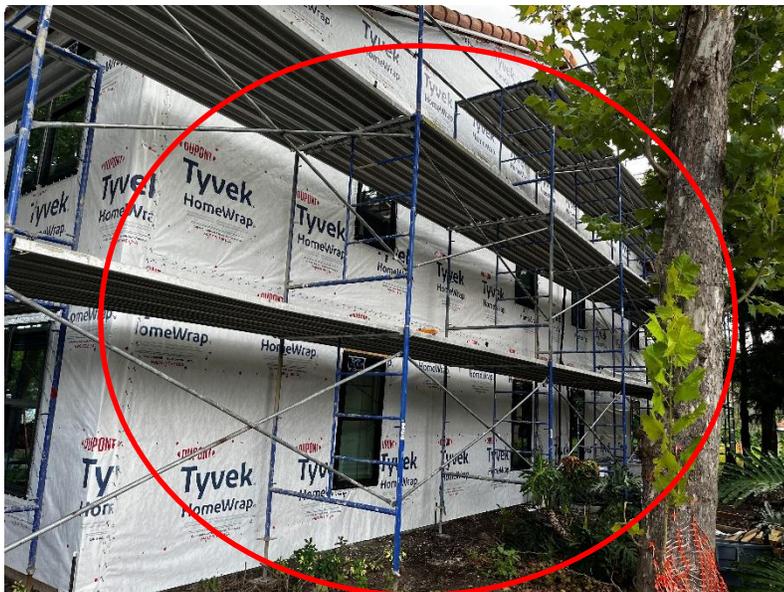
PHOTOGRAPH #14

**BUILDING 13
SECTION D**

New PGT windows installed with Dupont Tyvek flashing details as per drawings and manufacturer's specifications.

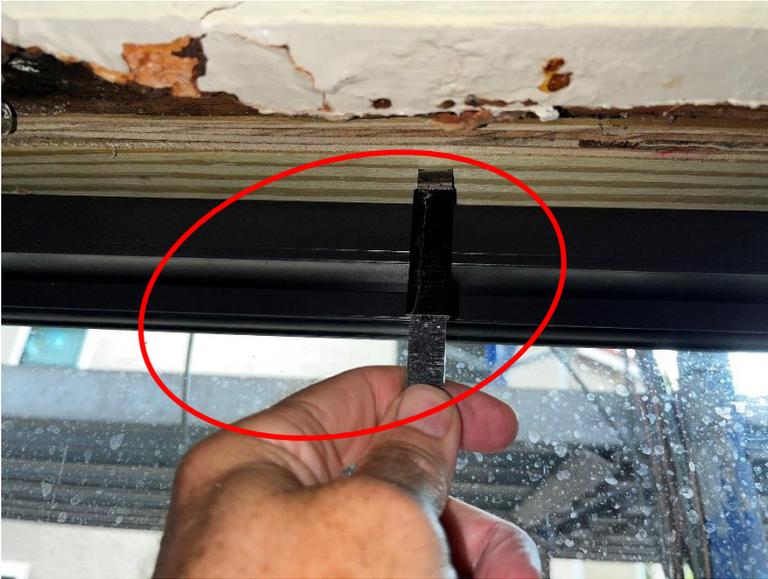
PHOTOGRAPH #15

**BUILDING 13
SECTION C- UNIT 1317**

Gap from new window to head framing greater than max. 5/16" allowed by PGT NOA.

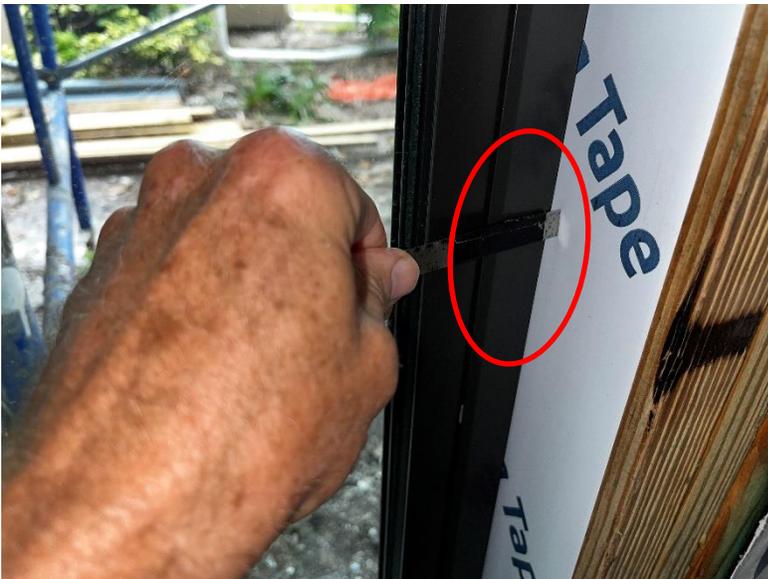
PHOTOGRAPH #16

**BUILDING 13
SECTION C- UNIT 1317**

Gap from new window to 2x jamb framing in compliance with max. 5/16" allowed by PGT NOA.

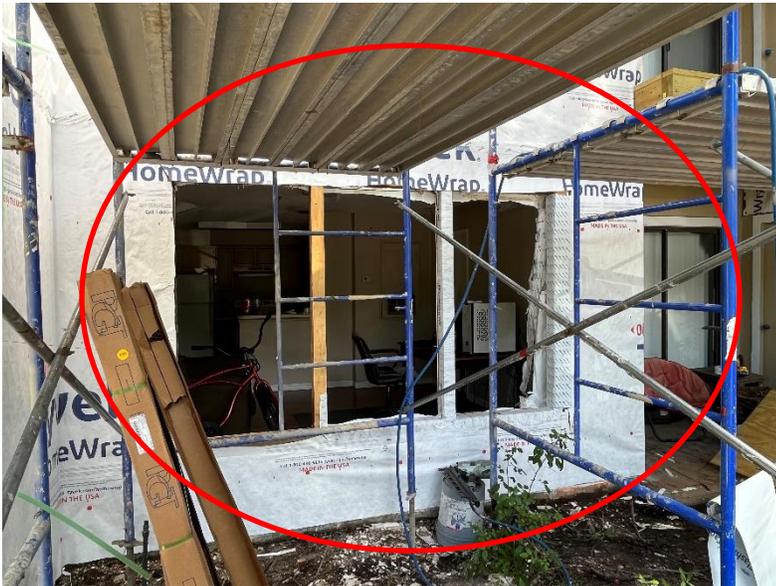
PHOTOGRAPH #17

**BUILDING 13
SECTION B- UNIT 1315**

RLJ in process of installing new PGT windows has begun flashing with Dupont FlexWrap and StraightFlash as per drawings and specifications.

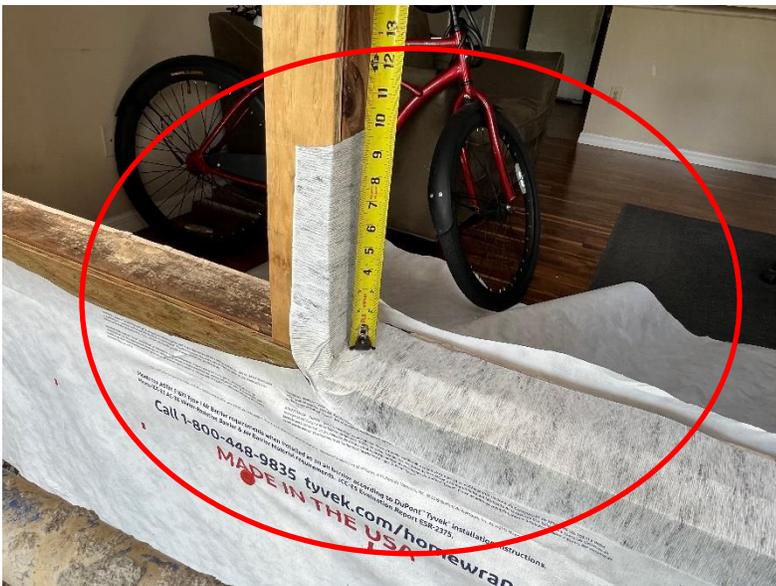
PHOTOGRAPH #18

**BUILDING 13
SECTION B- UNIT 1315**

DuPont FlexWrap installed over Tyvek HomeWrap into window opening at sill and up jambs 6".

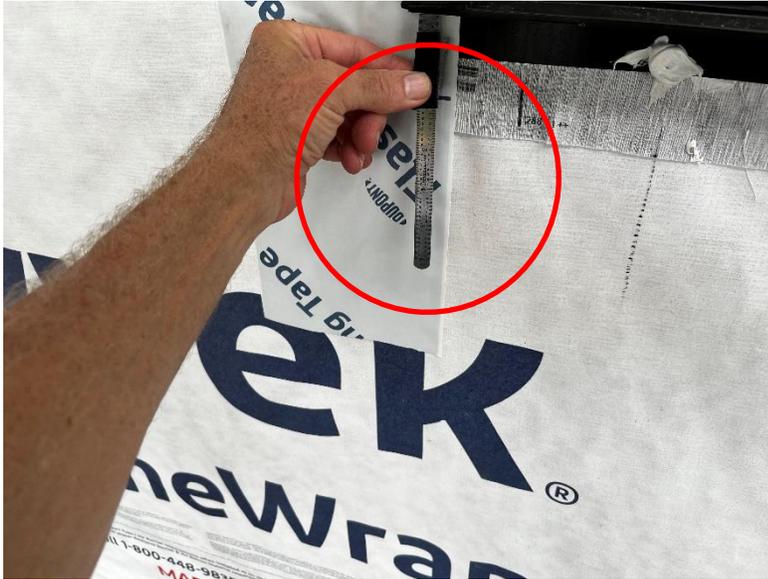
PHOTOGRAPH #19

**BUILDING 13
SECTION B- UNIT 1313**

DuPont StraightFlash covering window fin extended past bottom of window flashing 6" as per drawings and specifications.

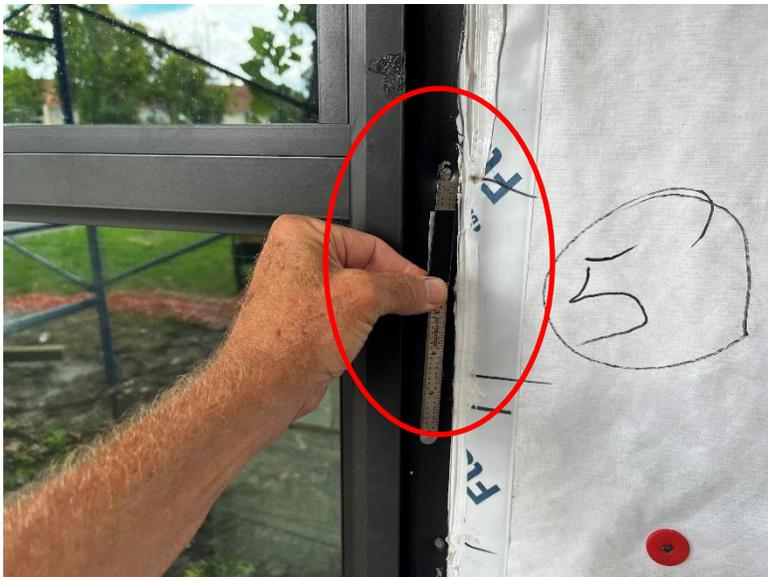
PHOTOGRAPH #20

**BUILDING 13
SECTION B- UNIT 1313**

Window fin fasteners spaced at 5" O.C. as per PGT NOA.

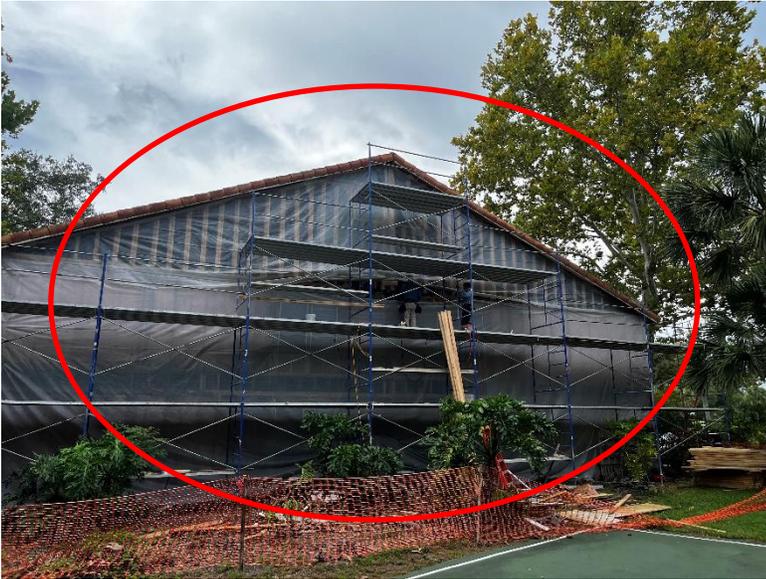
PHOTOGRAPH #21

**BUILDING 13
SECTION H**

RLJ continuing framing repairs at upper floor top plate and gable end truss.

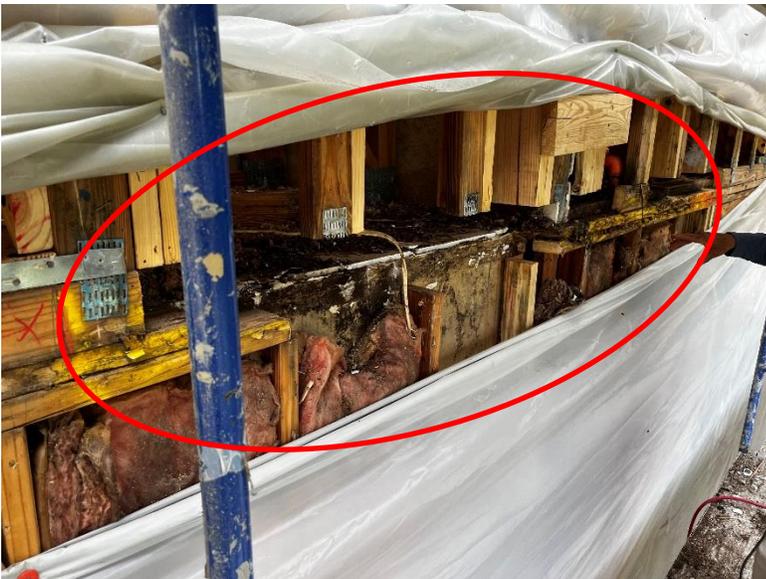
PHOTOGRAPH #22

**BUILDING 18
SECTION H**

RLJ continuing framing repairs at upper floor top plate and gable end truss.

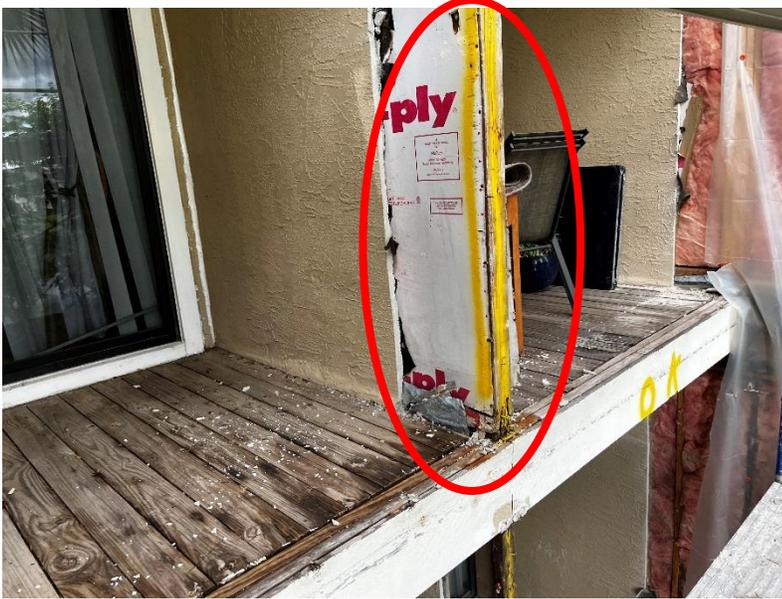
PHOTOGRAPH #23

**BUILDING 18
SECTION F- UNIT 1824**

Additional damaged framing marked for repairs.

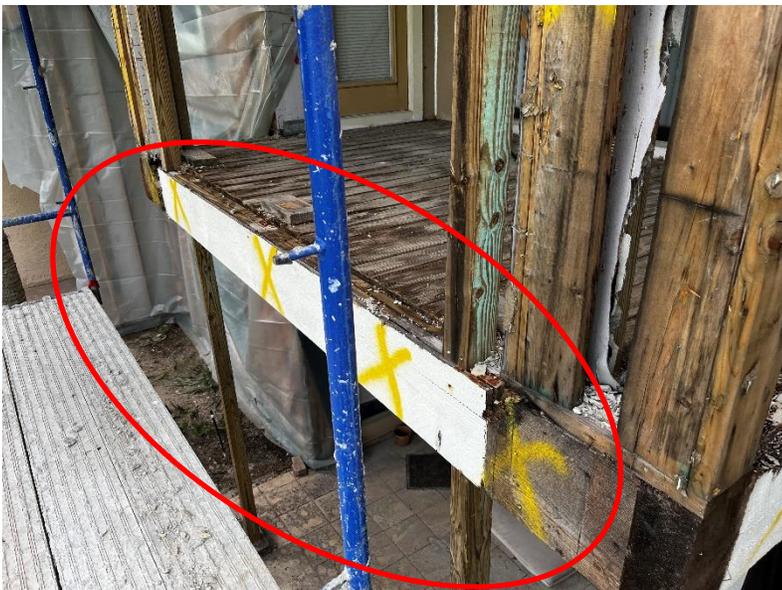
PHOTOGRAPH #24

**BUILDING 18
SECTION F- UNIT 1826**

Balcony damage marked for full built-up beam and column replacement.
