PHOTOGRAPHS

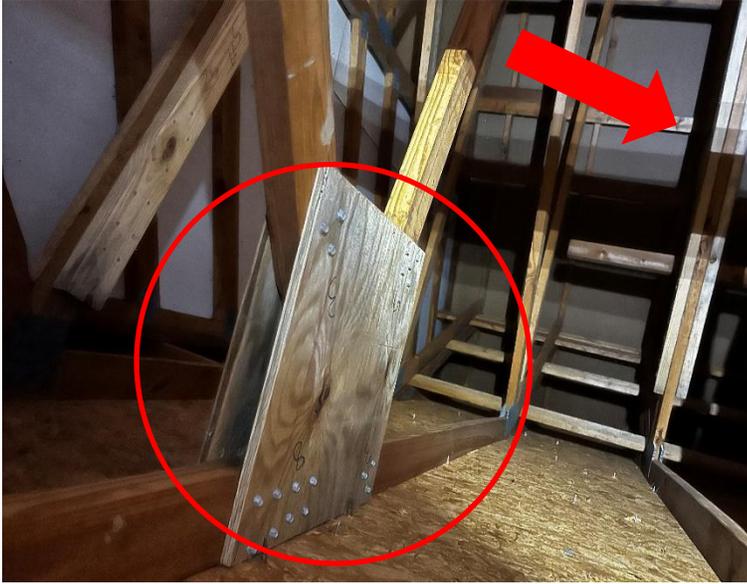
PHOTOGRAPH #1

**BUILDING 8
UNIT #822 ATTIC**

Contractor has performed gusset repairs and scab repairs at trusses as per drawings.

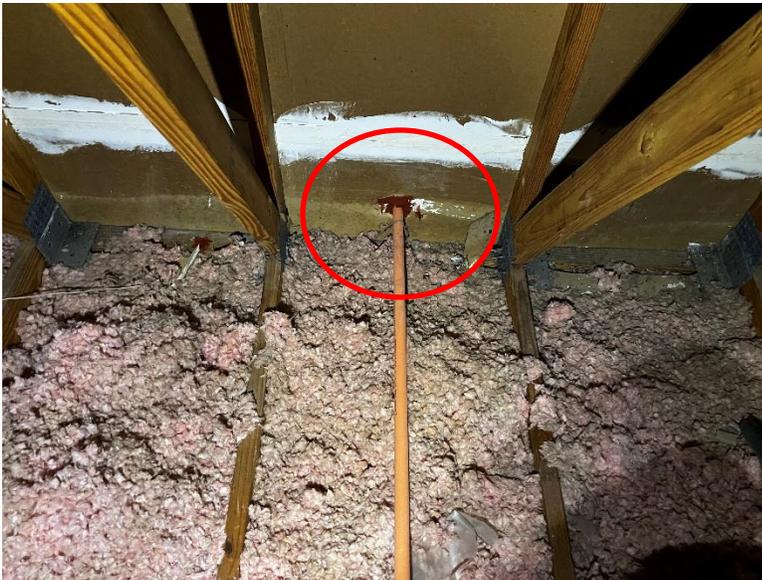
PHOTOGRAPH #2

**BUILDING 8
UNIT #822 ATTIC**

Fire caulk applied at open penetrations with 3M fire barrier sealant.

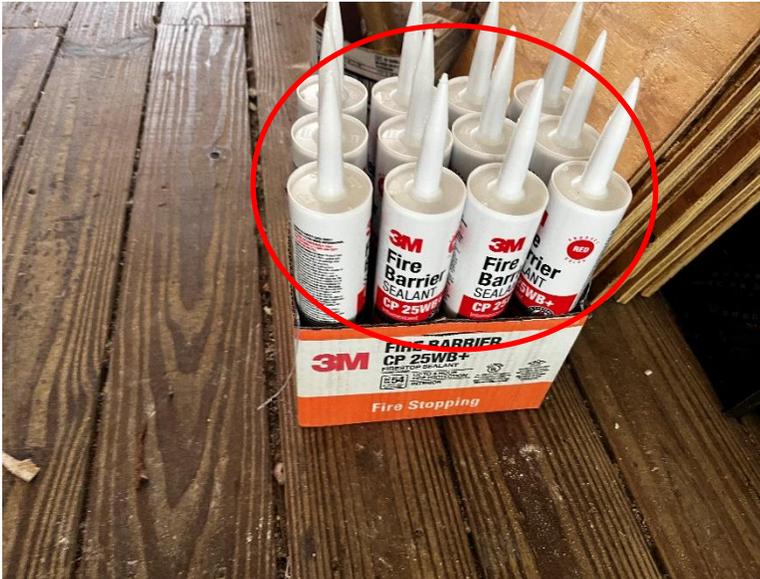
PHOTOGRAPH #3

**BUILDING 8
UNIT #822 ATTIC**

Fire caulk applied at open penetrations with 3M fire barrier sealant.

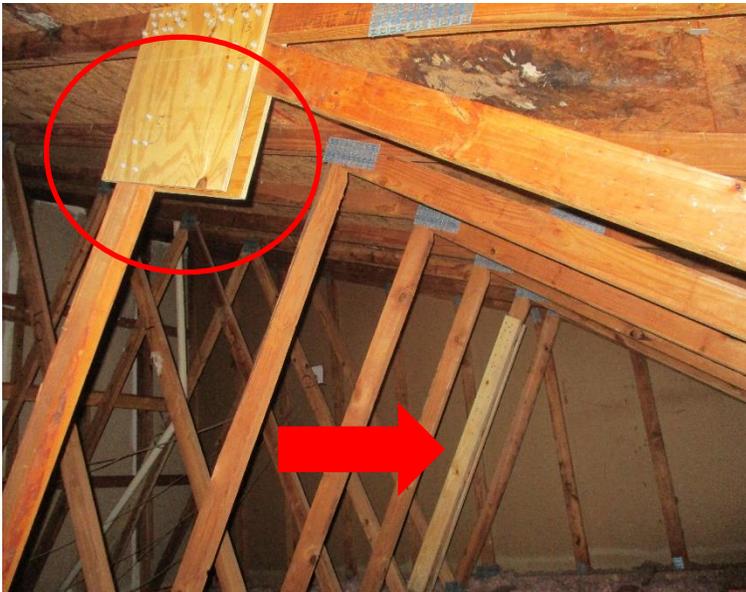
PHOTOGRAPH #4

**BUILDING 8
UNIT #823 ATTIC**

Contractor has performed gusset repairs and scab repairs at trusses as per drawings.

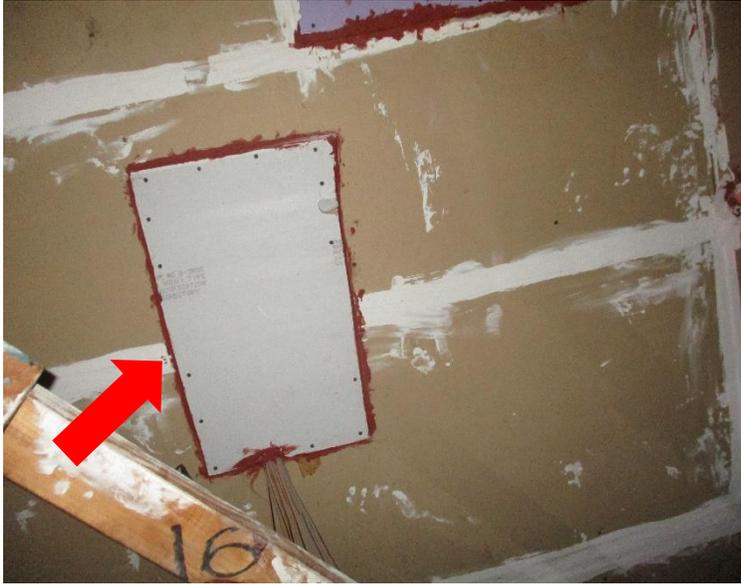
PHOTOGRAPH #5

**BUILDING 8
UNIT #823 ATTIC**

Fire rated gypsum board installed at holes in existing fire walls.

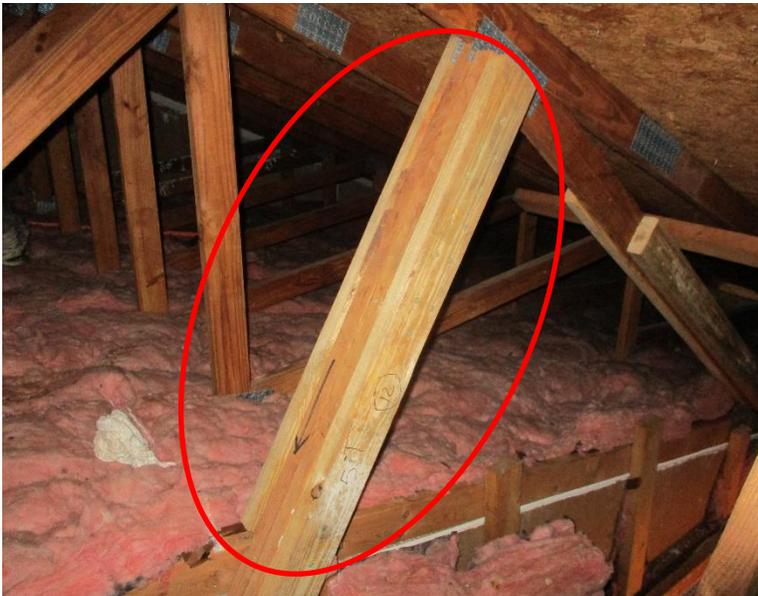
PHOTOGRAPH #6

**BUILDING 8
UNIT #825 ATTIC**

Damaged trusses repaired with 2x4 scabs as per drawings and details.

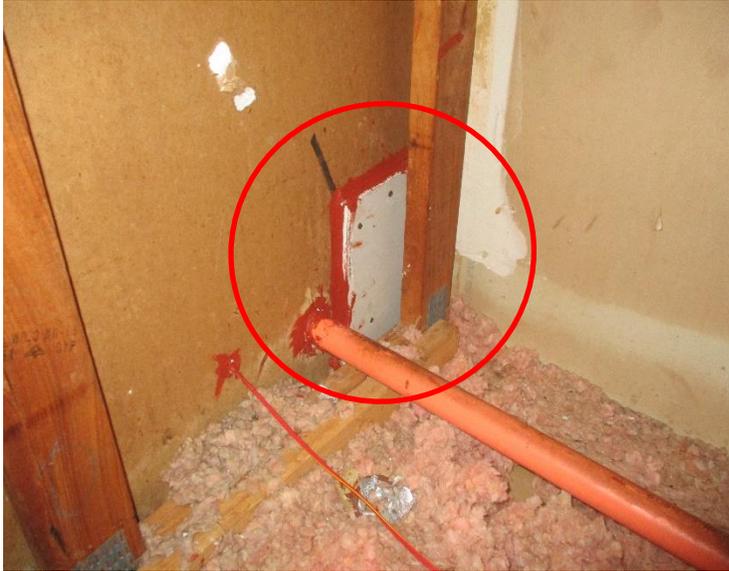
PHOTOGRAPH #7

**BUILDING 8
UNIT #825 ATTIC**

Fire rated gypsum board and fire caulk installed at holes and penetrations in existing fire walls.

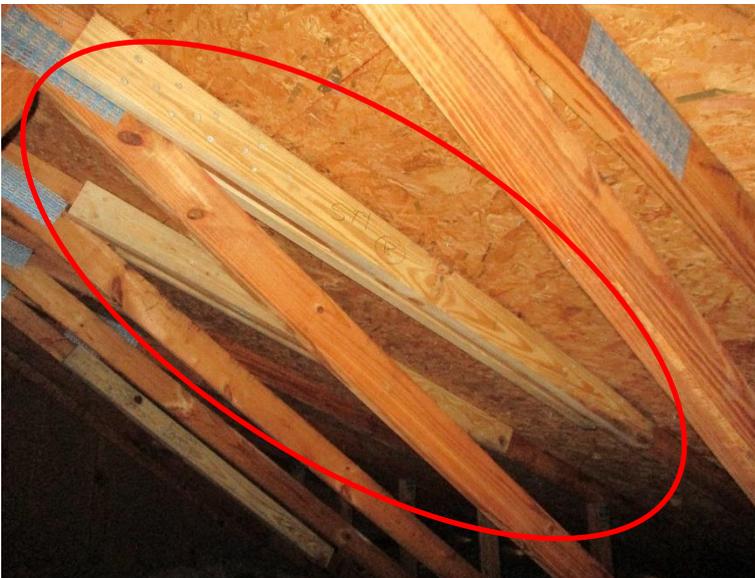
PHOTOGRAPH #8

**BUILDING 8
UNIT #826 ATTIC**

Damaged trusses repaired with 2x4 scabs as per drawings and details.

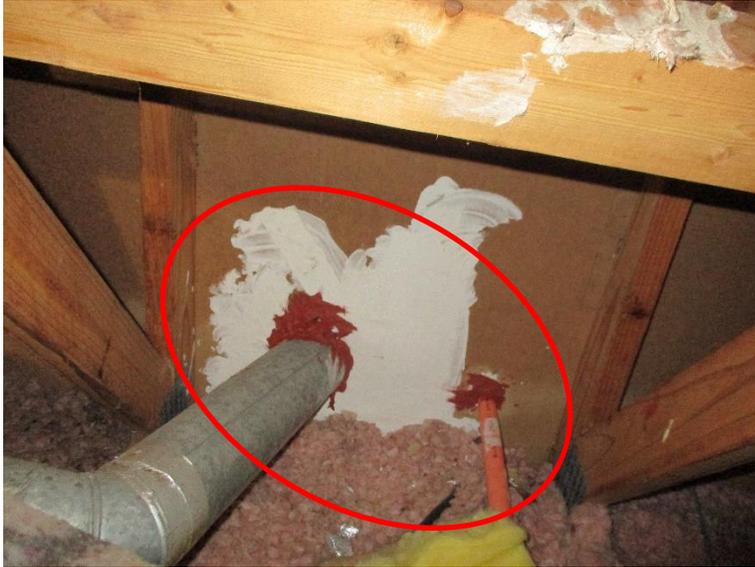
PHOTOGRAPH #9

**BUILDING 8
UNIT #826 ATTIC**

Fire caulk applied at open penetrations with 3M fire barrier sealant.

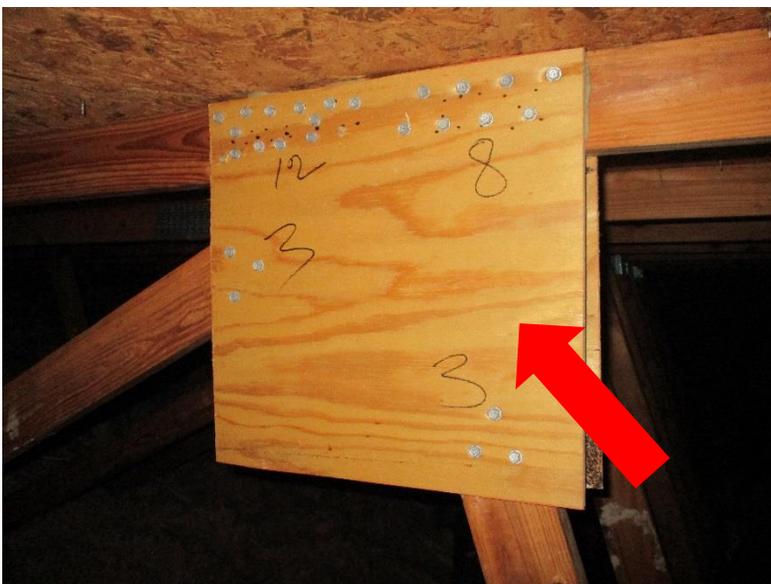
PHOTOGRAPH #10

**BUILDING 8
UNIT #827 ATTIC**

Gusset repairs performed at truss damage and truss connectors as per drawings.

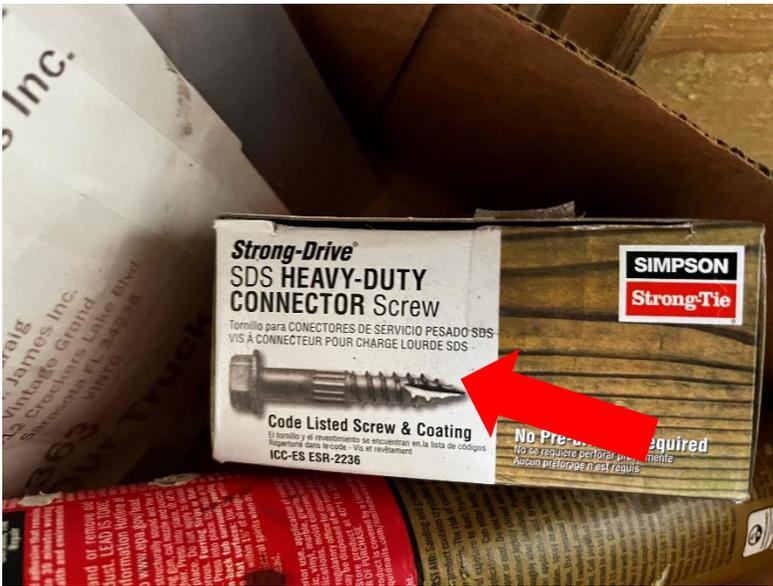
PHOTOGRAPH #11

**BUILDING 8
UNIT #827 ATTIC**

Gusset fasteners 1 1/2" Simpson SD connector screws.

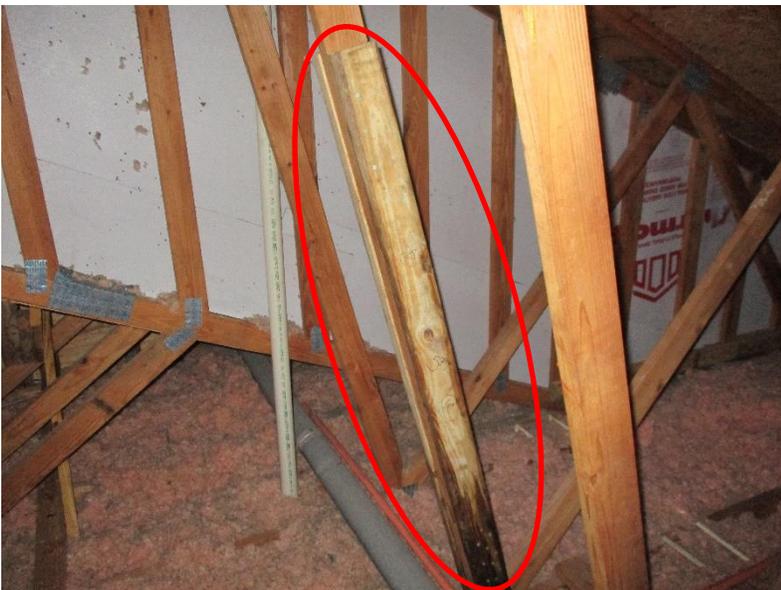
PHOTOGRAPH #12

**BUILDING 8
UNIT #827 ATTIC**

Damaged trusses repaired with 2x4 scabs as per drawings and details.

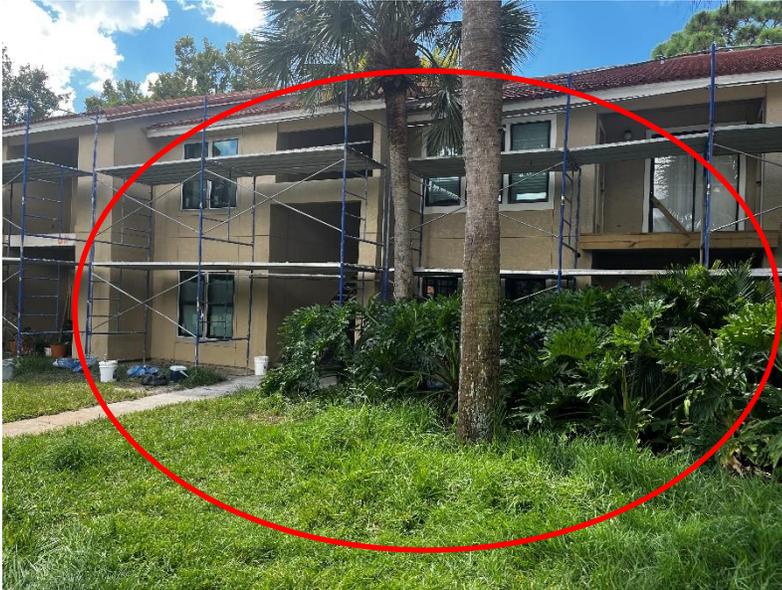
PHOTOGRAPH #13

**BUILDING 13
SECTION F**

RLJ priming and finish coating new stucco with Florida Paints Glades Exterior 100% Acrylic Paint.

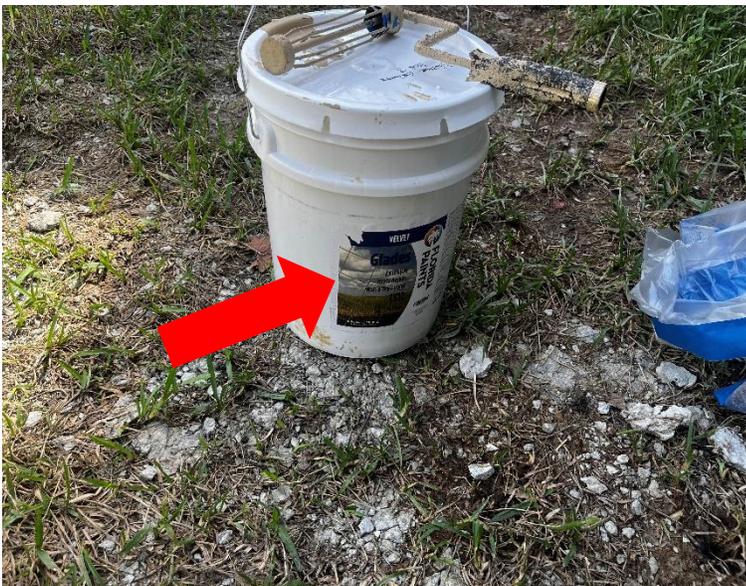
PHOTOGRAPH #14

**BUILDING 13
SECTION F**

RLJ priming and finish coating new stucco with Florida Paints Glades Exterior 100% Acrylic Paint.

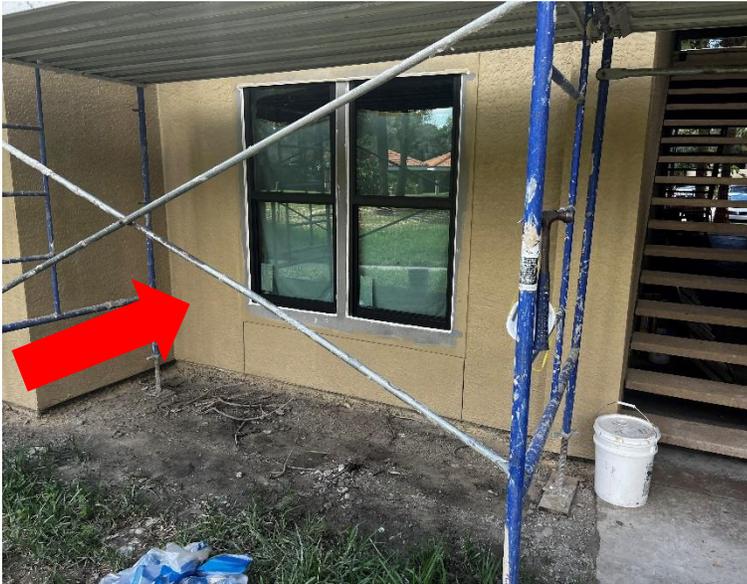
PHOTOGRAPH #15

**BUILDING 13
SECTION E**

RLJ priming and finish coating new stucco with Florida Paints Glades Exterior 100% Acrylic Paint.

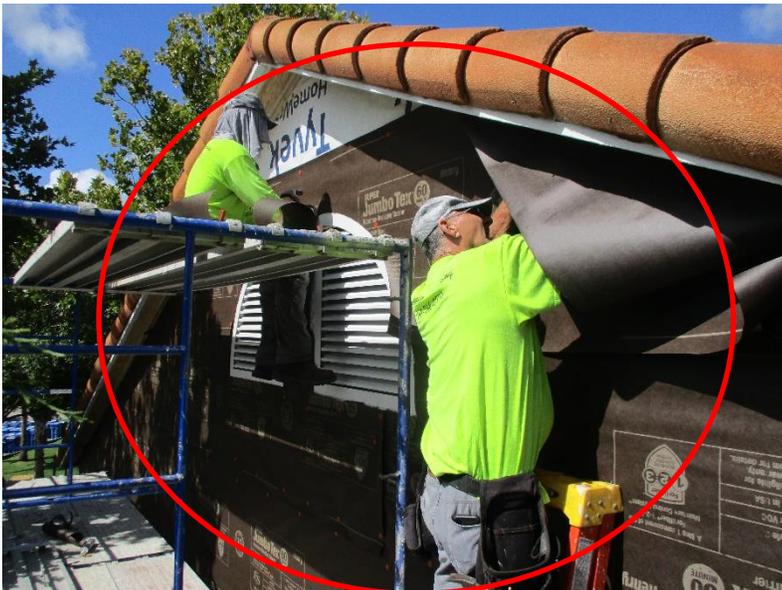
PHOTOGRAPH #16

**BUILDING 13
SECTION D**

Stucco Contractor applying new Jumbo Tex water resistant barrier over Tyvek HomeWrap WRB.

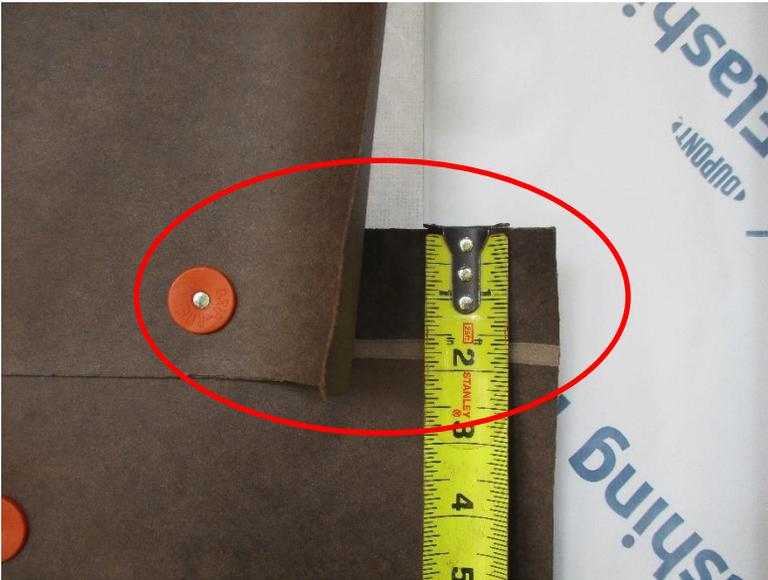
PHOTOGRAPH #17

**BUILDING 13
SECTION D**

Jumbo Tex WRB overlapped 2" as per specifications and manufacturers recommendations.

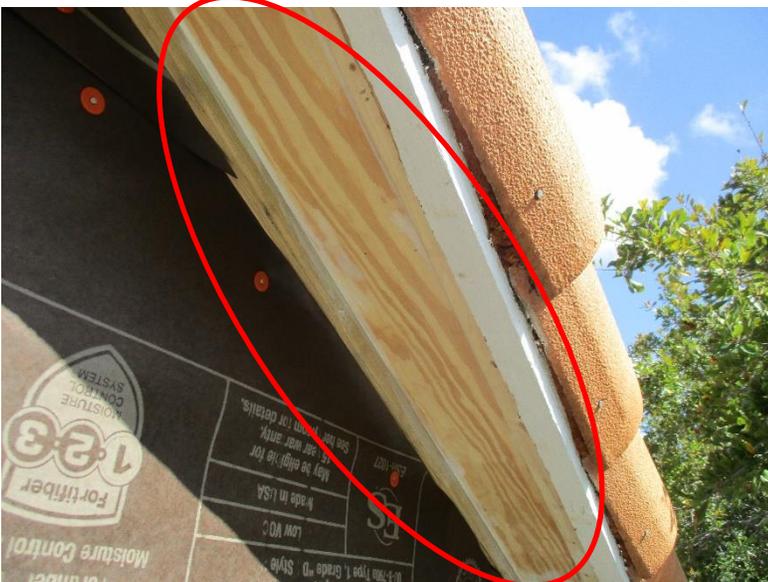
PHOTOGRAPH #18

**BUILDING 13
SECTION D**

New plywood soffit installed and prepared for priming and painting.

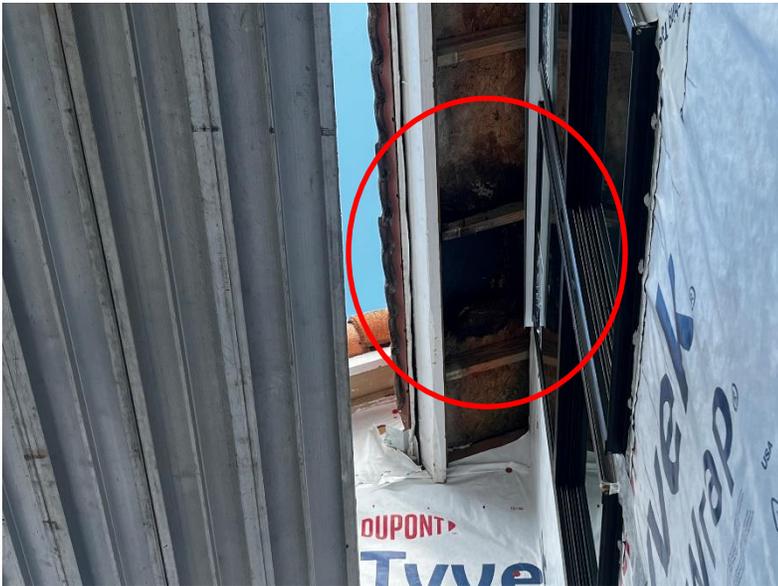
PHOTOGRAPH #19

**BUILDING 13
SECTION B**

Preexisting water damaged roof sheathing. Owners' roofers to do repairs.

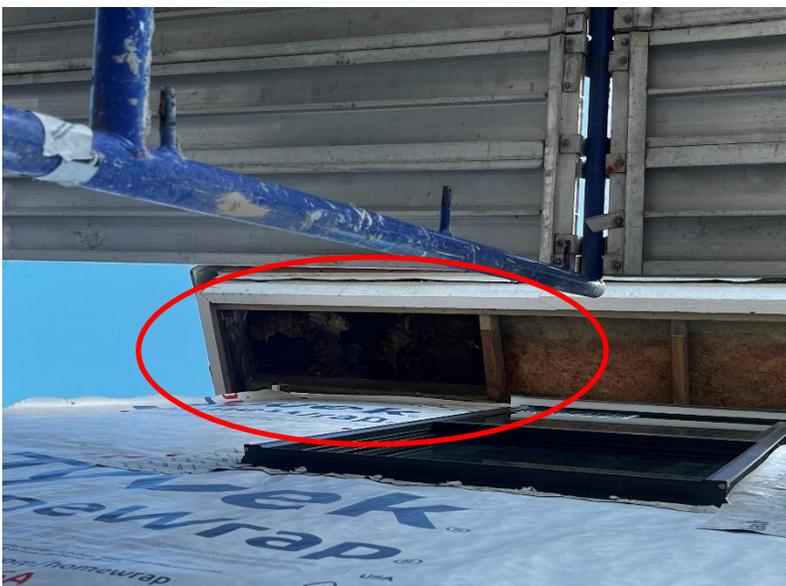
PHOTOGRAPH #20

**BUILDING 13
SECTION A**

Preexisting water damaged roof sheathing. Owners' roofers to do repairs.

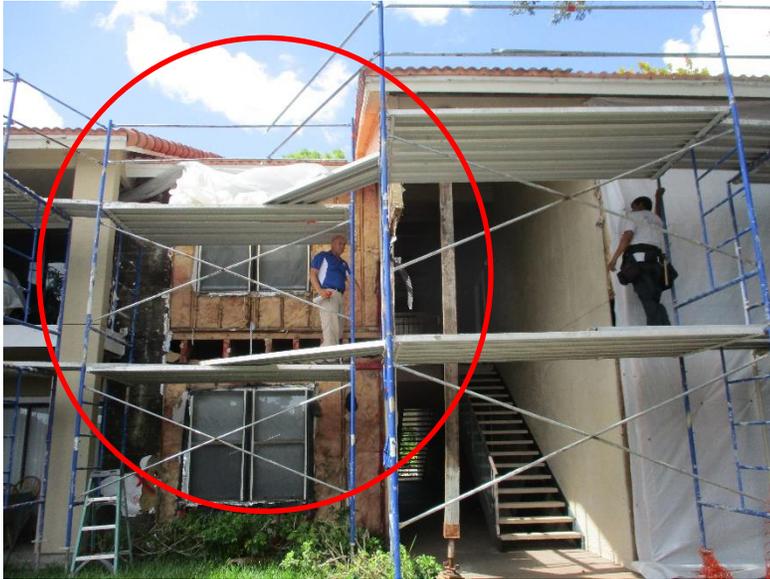
PHOTOGRAPH #21

**BUILDING 18
SECTION F**

Delta marking existing wood damage for contractor to do repairs.

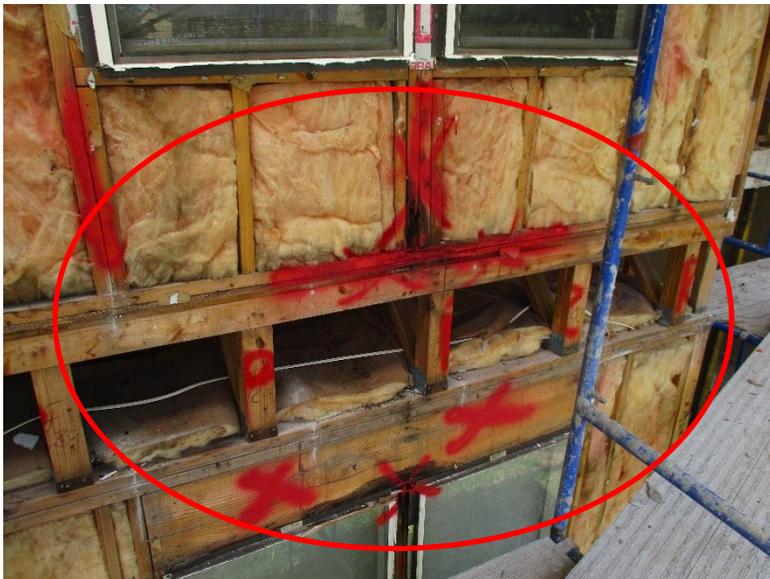
PHOTOGRAPH #22

**BUILDING 13
SECTION F**

Damaged window header floor truss, bottom plate and framing studs marked for repairs.

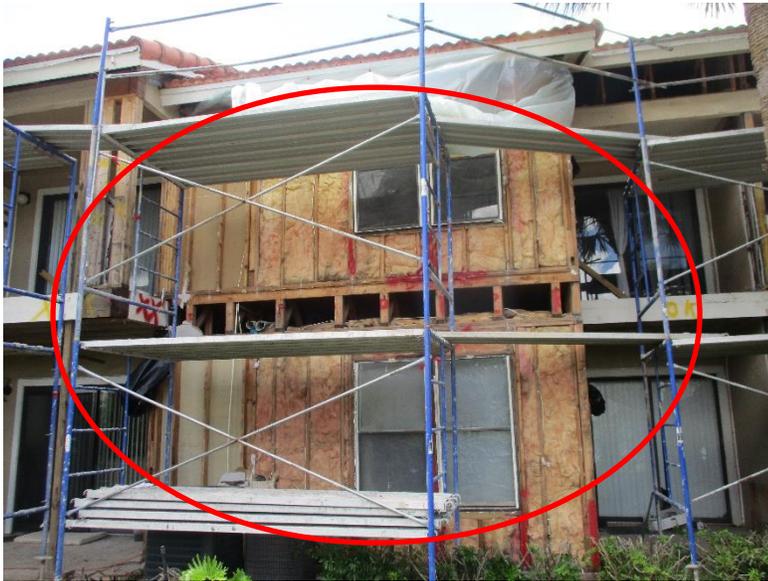
PHOTOGRAPH #23

**BUILDING 13
SECTION F**

Damaged window header floor truss, bottom plate and framing studs marked for repairs.

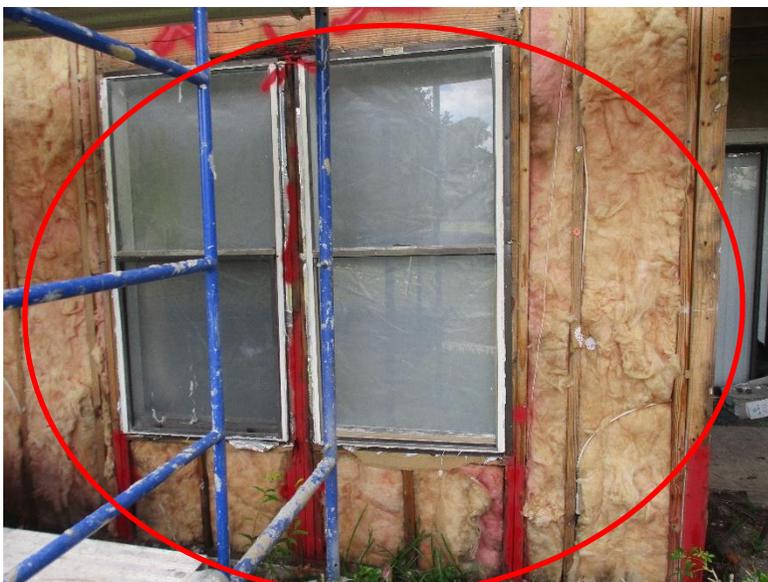
PHOTOGRAPH #24

**BUILDING 18
SECTION F**

Damaged window header and framing studs marked for repairs.
