PHOTOGRAPHS

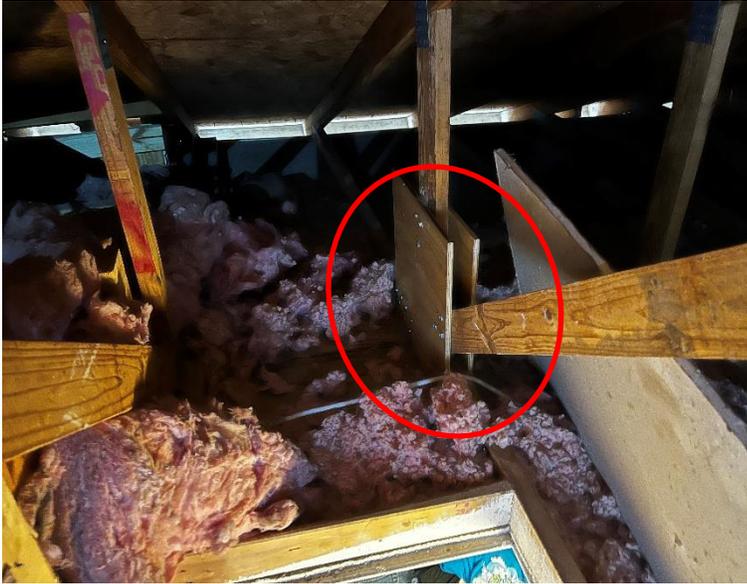
**BUILDING 8
UNIT #824 ATTIC**

Contractor has performed gusset repairs at trusses as per drawings.

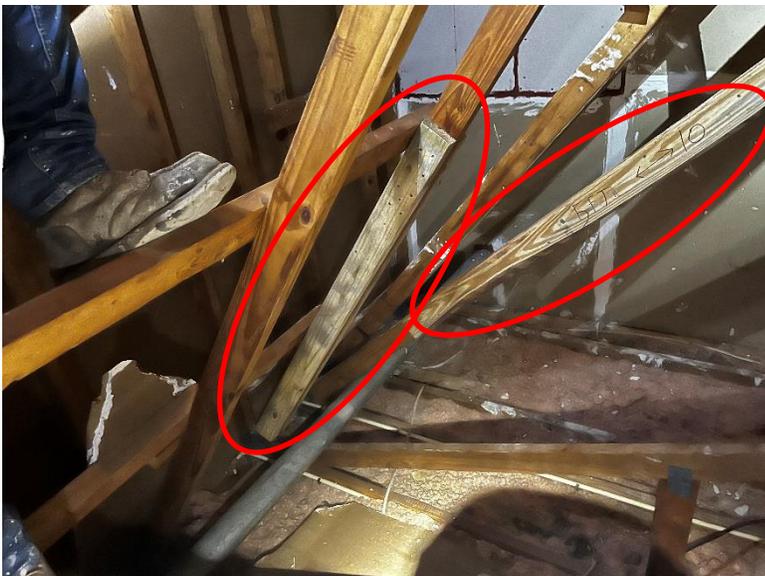
**BUILDING 8
UNIT #824 ATTIC**

Damaged trusses repaired with 2x4 scabs as per drawings and details.

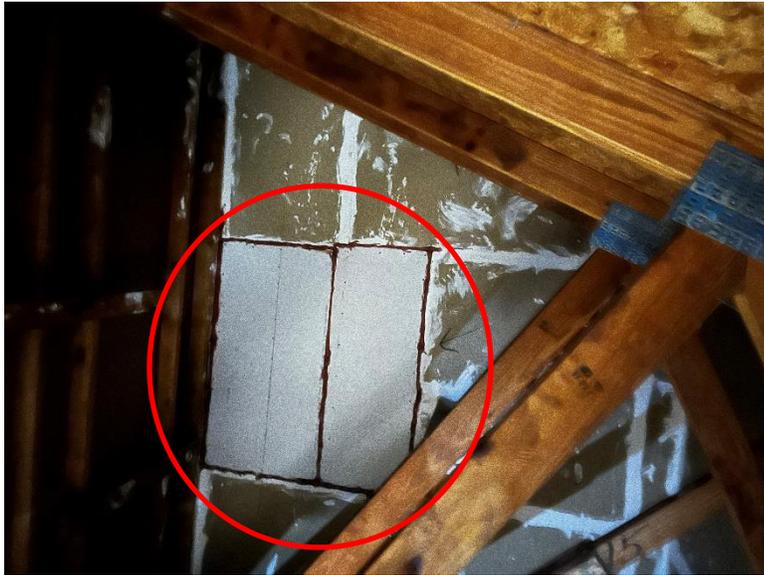
**BUILDING 8
UNIT #824 ATTIC**

Fire rated gypsum board installed at holes in existing fire walls and fire caulk applied at perimeters .

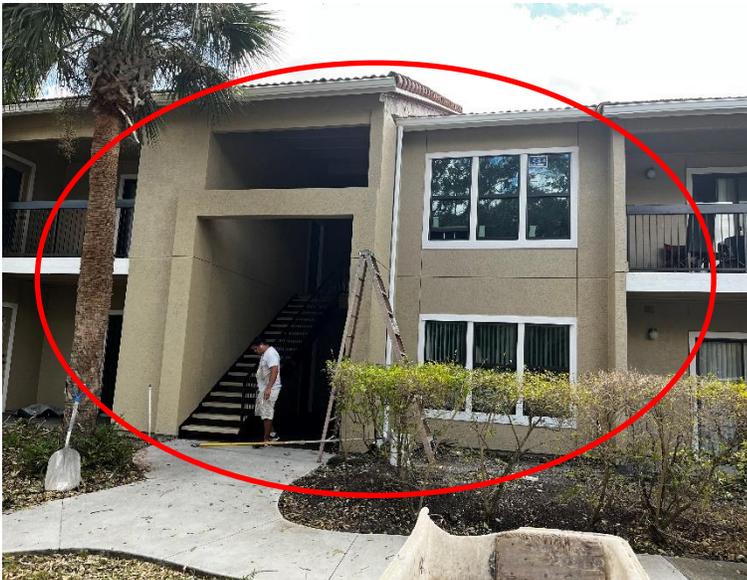
**BUILDING 8
SECTION A**

Contractor in process of touching up finish paint in preparation for final walk through.

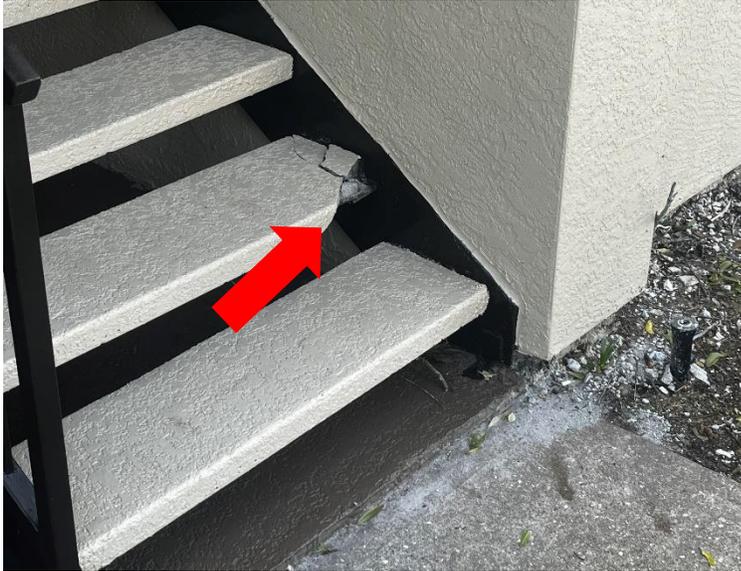
**BUILDING 8
SECTION C BREEWAY**

Broken stair will require replacement and welding of angle.

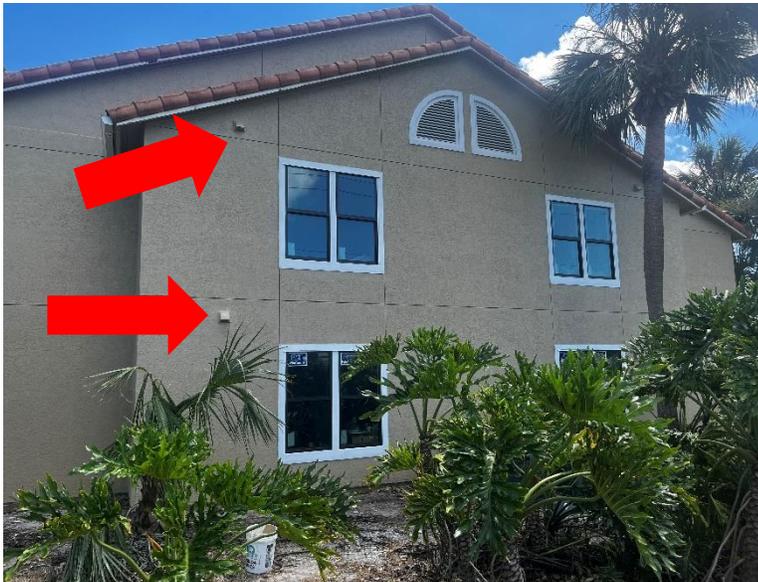
**BUILDING 8
SECTION D**

Dryer vent hoods have been replaced at gable ends .

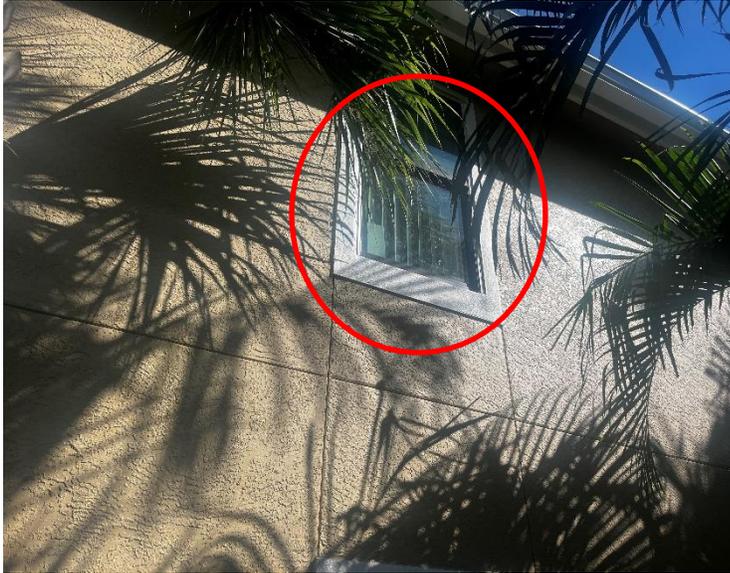
**BUILDING 8
UNIT #828**

Window band painting has been completed.

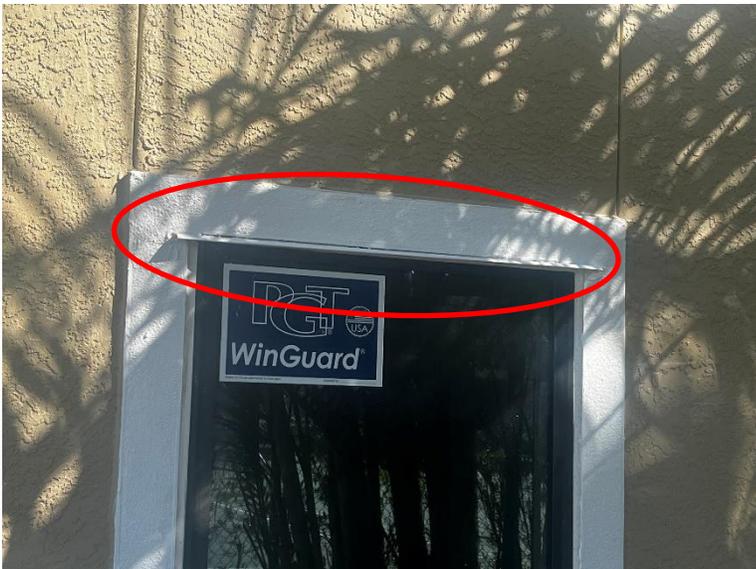
**BUILDING 8
UNIT #818**

Sealants have been removed at head flashing above window.

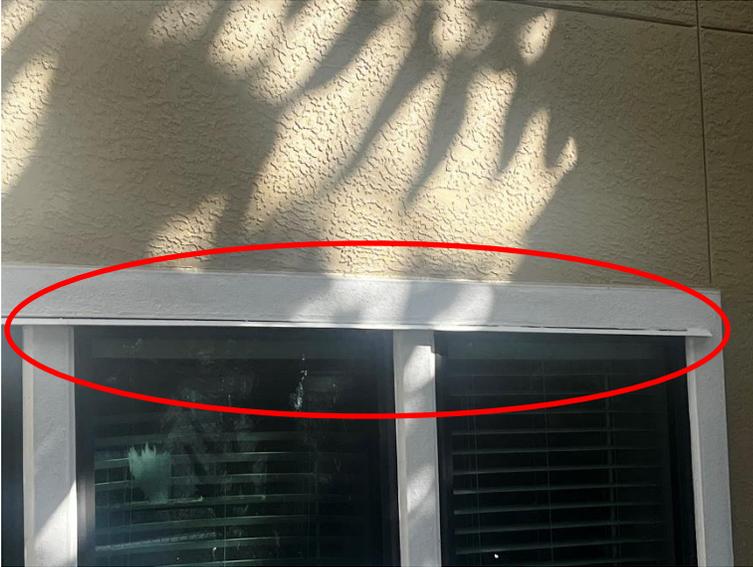
**BUILDING 8
UNIT #816**

Sealants have been removed at head flashing above window.

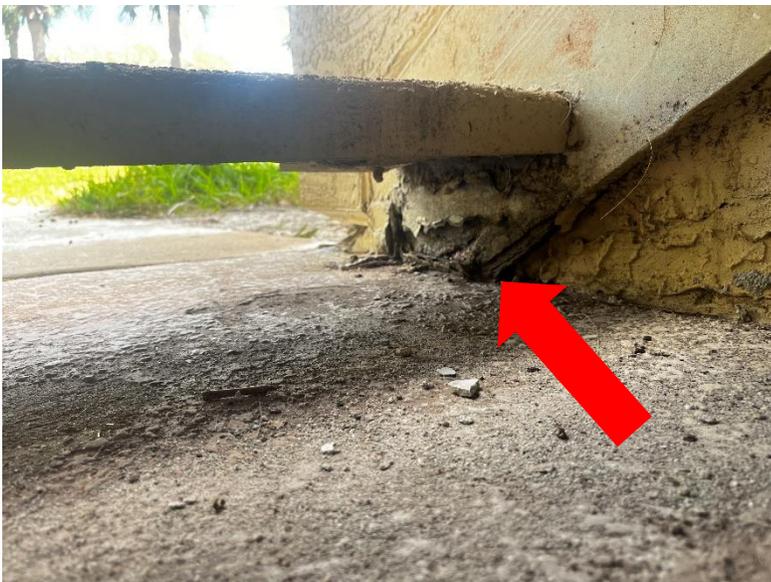
**BUILDING 13
SECTION G BREEZEWAY**

Stairway stringer and stair step angles are deteriorated and will require welding repairs.

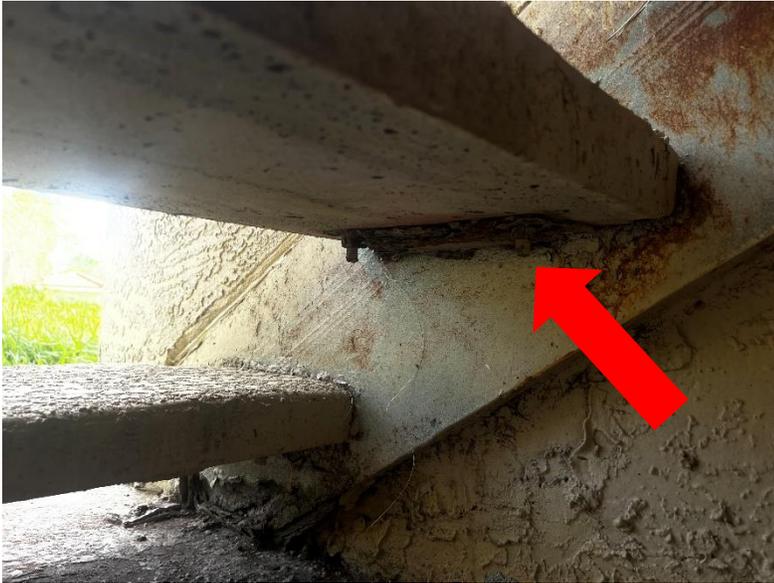
**BUILDING 13
SECTION G BREEZEWAY**

Stairway stringer and stair step angles are deteriorated and will require welding repairs.

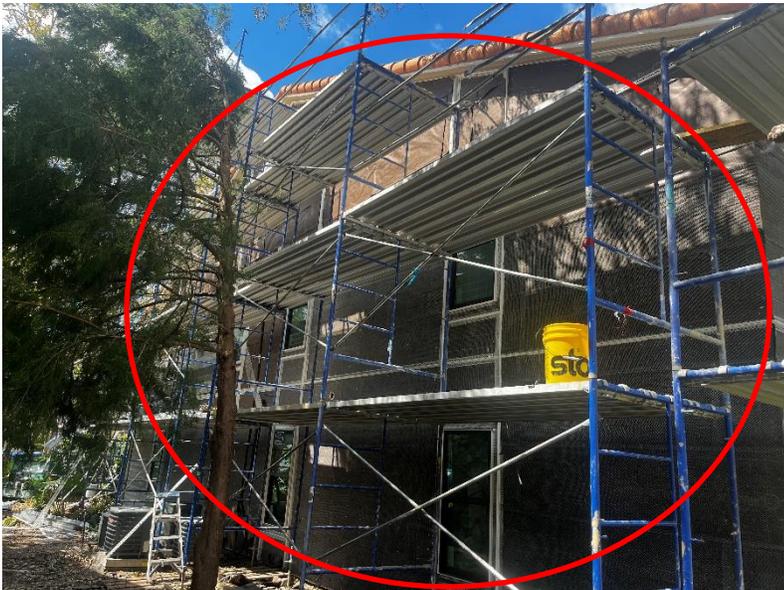
**BUILDING 13
SECTION D**

Stucco subcontractor applying self-furring galvanized metal lath as per specification and drawings.

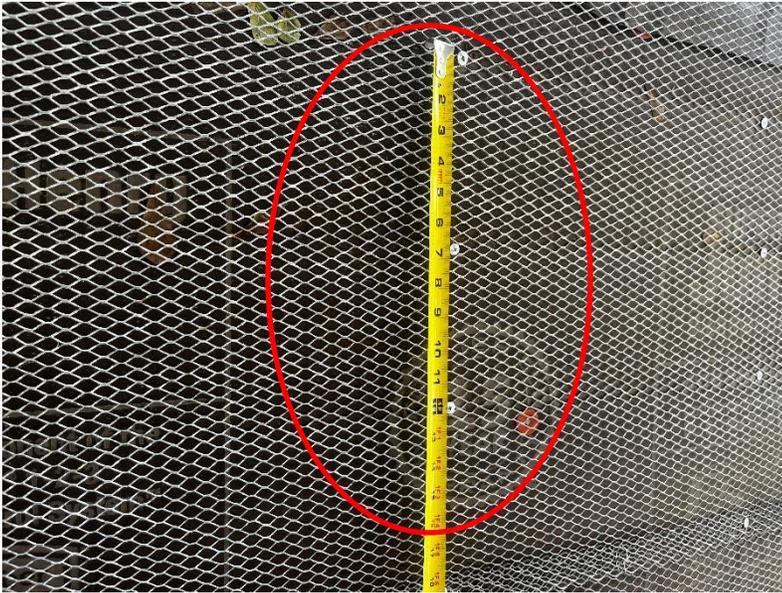
**BUILDING 13
SECTION D**

Metal lathing attached to framing at 6" with waffle head zinc coated self-tapping screw.

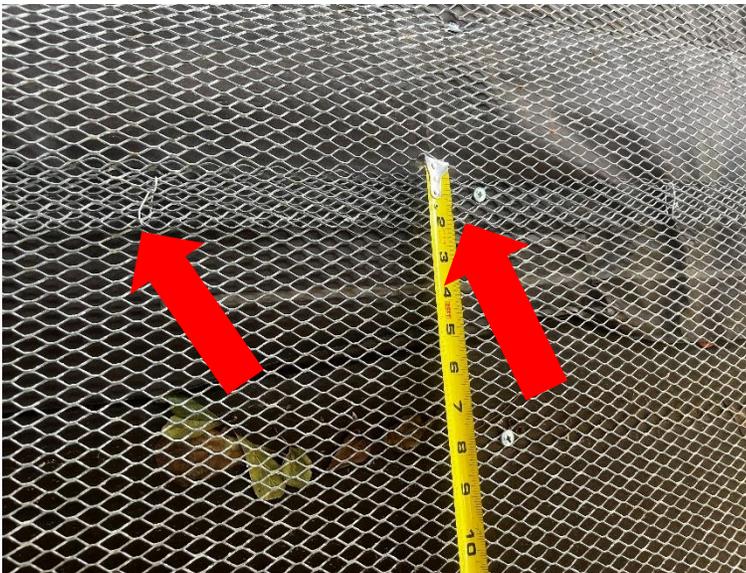
**BUILDING 13
SECTION D**

Metal lathing overlapped 2" and wire tied in between fasteners to meet ASTM C1063 specification and drawing requirements.

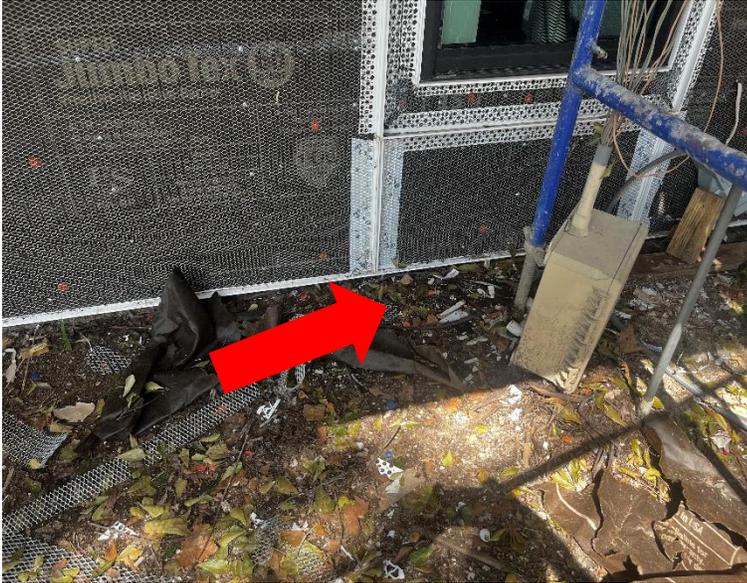
**BUILDING 13
SECTION D**

Soil has not been re-graded by others to provide 6" minimum separation from grade to new stucco accessories as per drawings.

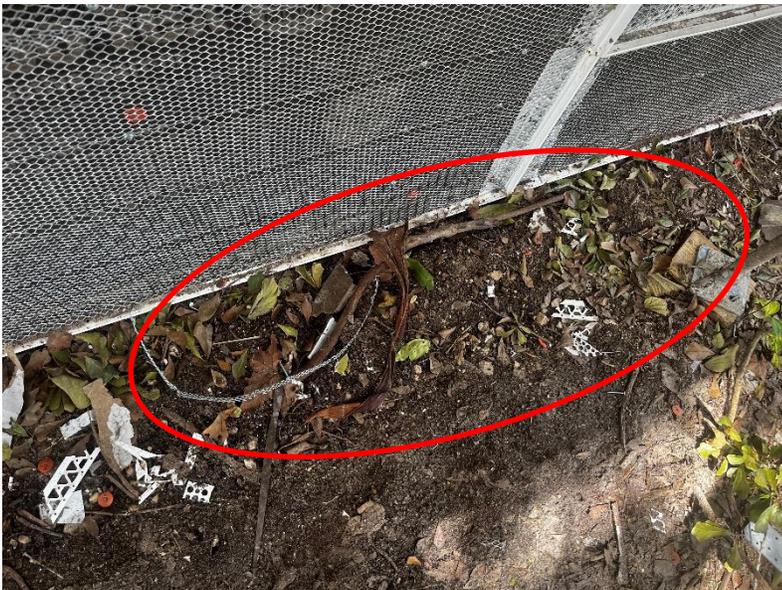
**BUILDING 13
SECTION D**

Soil has not been re-graded by others to provide 6" minimum separation from grade to new stucco accessories as per drawings

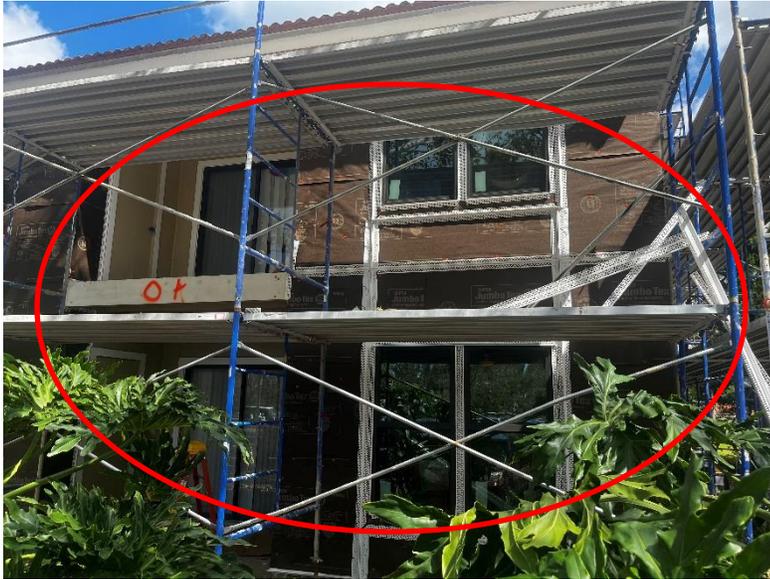
**BUILDING 13
SECTION C**

Stucco Subcontractor in process of installing new vinyl control joints and window accessories.

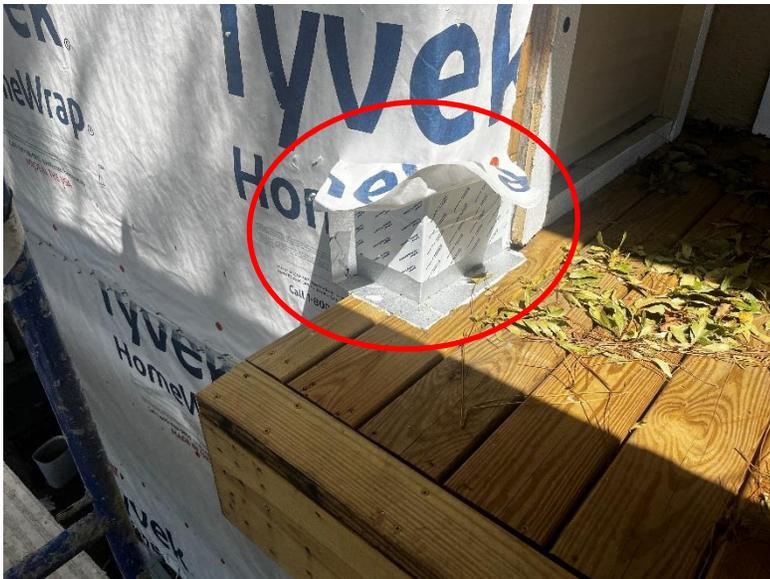
**BUILDING 13
SECTION B**

Kick out flashing installed at balconies sealed to deck and flashing into sheathing with Dupont Tyvek straight flash.

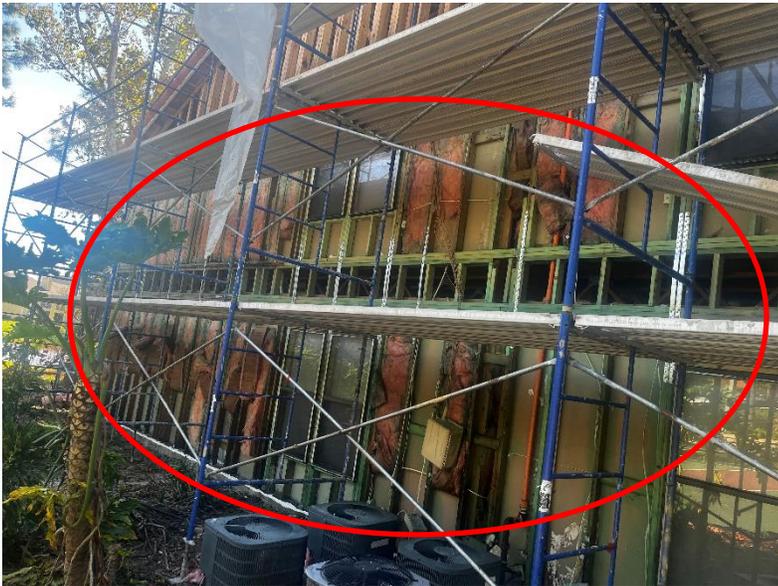
**BUILDING 18
SECTION H**

Simpson Strong-Tie straps and connectors installed, and Bora Care termite treatment applied.

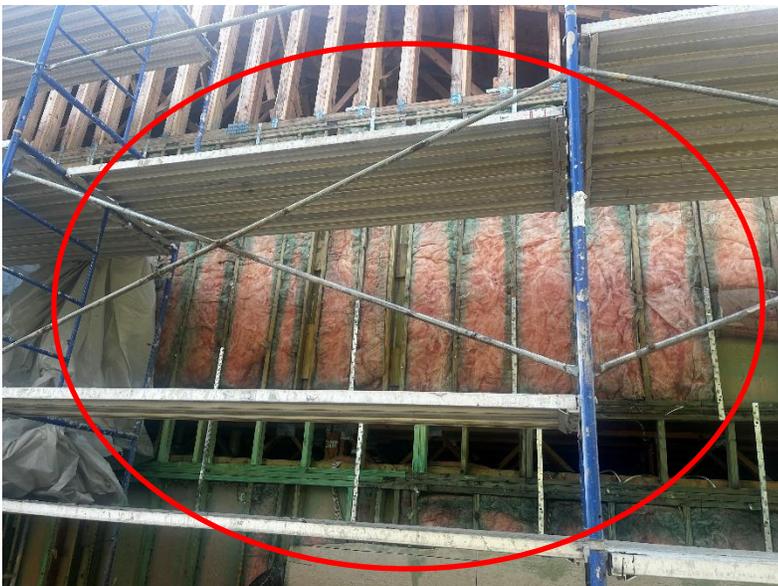
**BUILDING 18
SECTION H**

Simpson Strong-Tie straps and connectors installed, and Bora Care termite treatment applied.

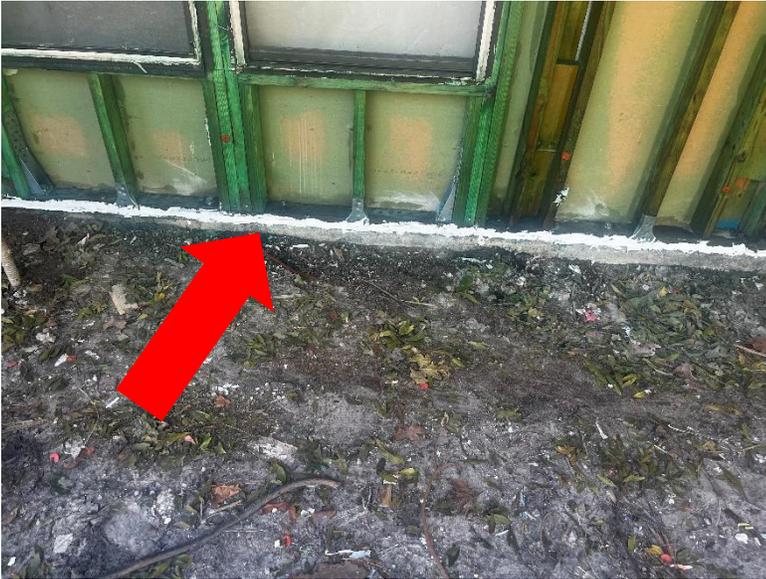
**BUILDING 18
SECTION H**

New BASF sealant applied at base plate to existing concrete slab as per stucco at base flashing detail drawings.

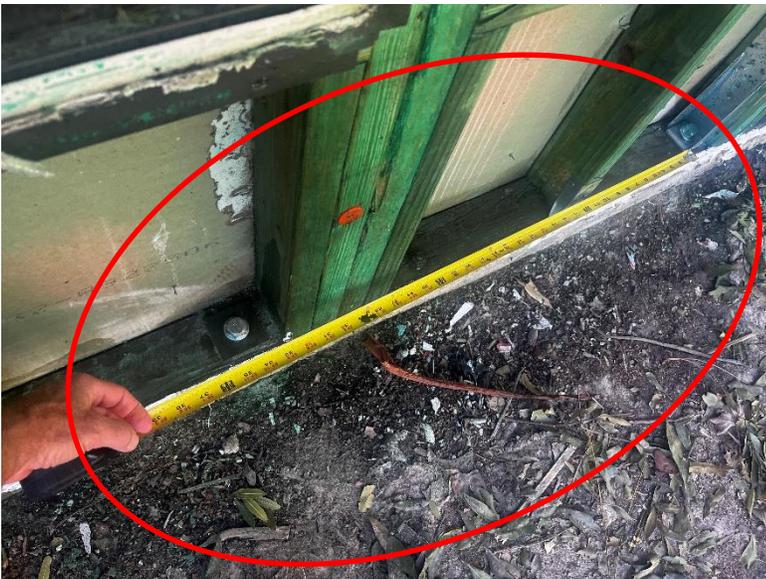
**BUILDING 18
SECTION H**

Base Plate fastened with Simpson Strong Titen HD fasteners at 24" O.C Max.as per drawings.

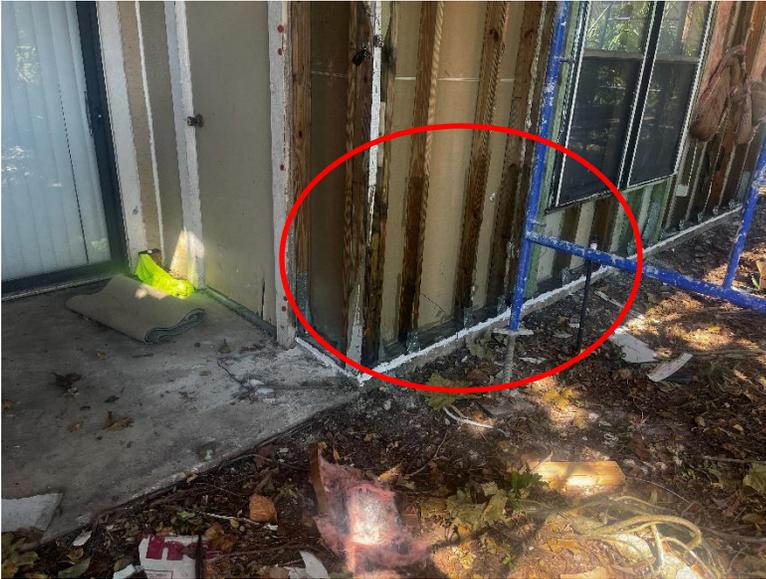
**BUILDING 18
SECTION G**

Copper Green wood preservative applied at base plate and lower 2' of framing as per specifications.

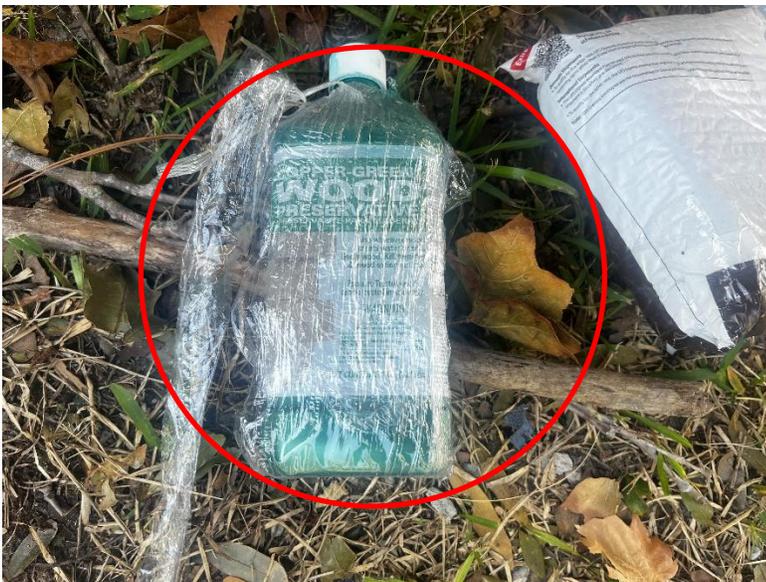
**BUILDING 18
SECTION G**

Copper Green wood preservative applied at base plate and lower 2' of framing as per specifications.

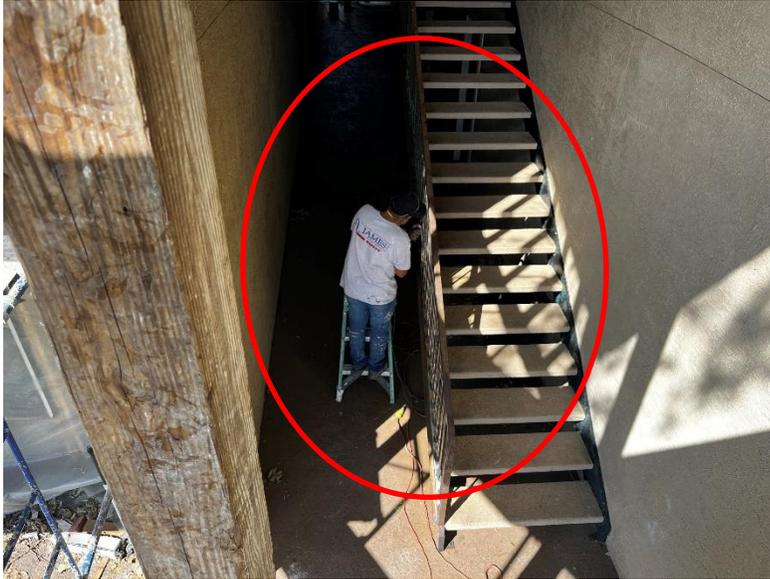
**BUILDING 18
SECTION G**

RLJ removing peeling coatings and rust at breezeway stairs in preparation for painting.

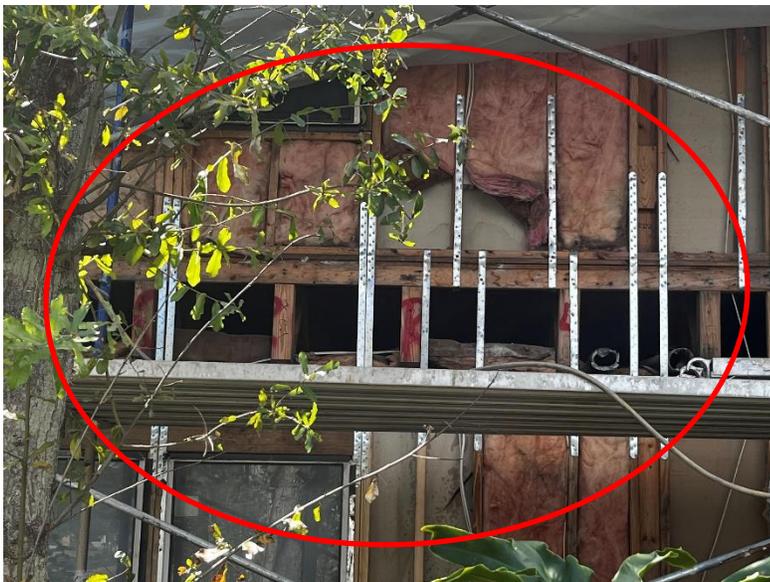
**BUILDING 18
SECTION G**

Simpson Strong-Tie MSTA connector straps installed at window headers and framing studs as per drawings.

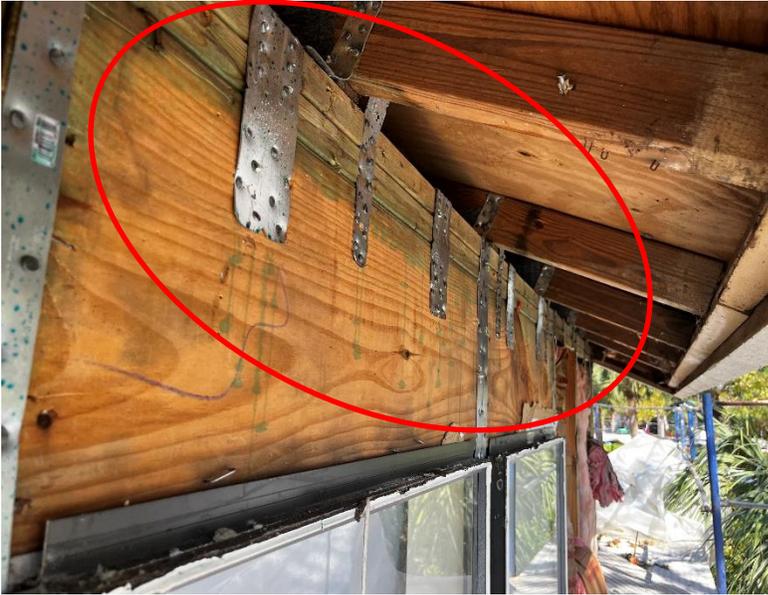
**BUILDING 18
SECTION G**

Simpson Strong-Tie connector hardware installed at window headers and framing to top plates and roof trusses as per drawings.

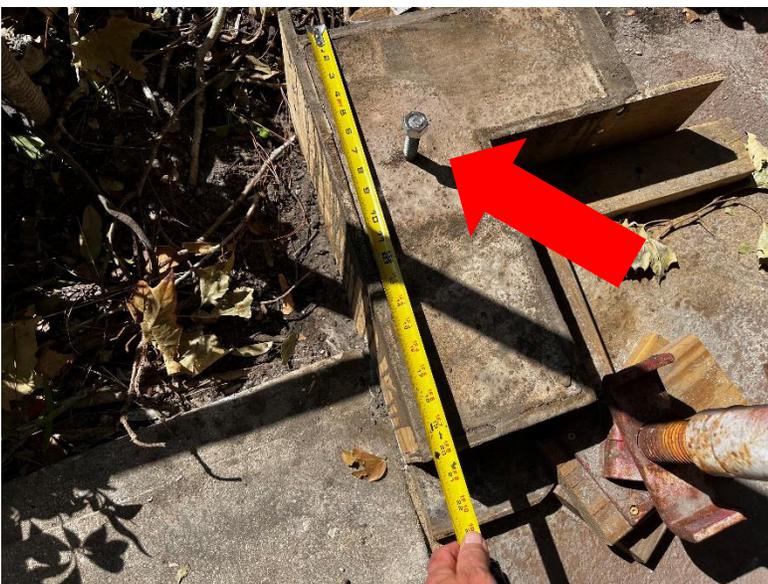
**BUILDING 18
SECTION G**

RLJ has not followed drawings details and installed only one threaded rod for fastening base plate at new breezeway elevation pedestal.

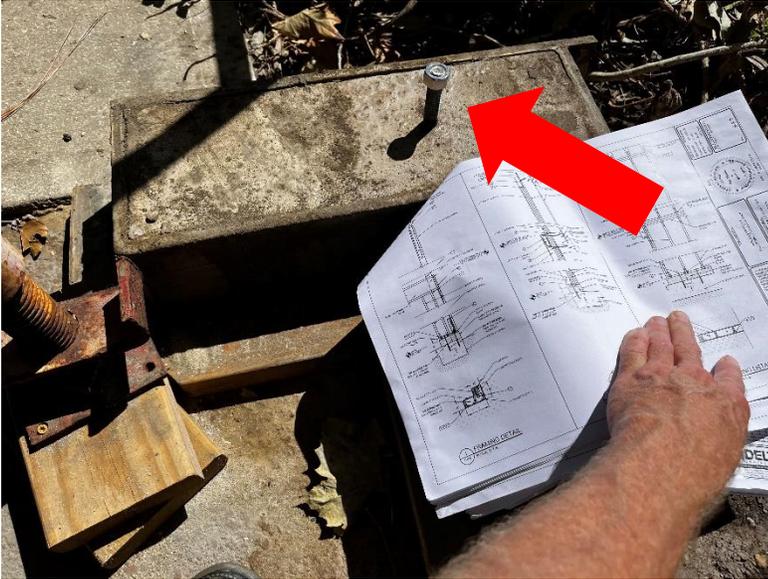
**BUILDING 18
SECTION F**

RLJ has not followed drawings details and installed only one threaded rod for fastening base plate at new balcony elevation pedestal.
