PHOTOGRAPHS

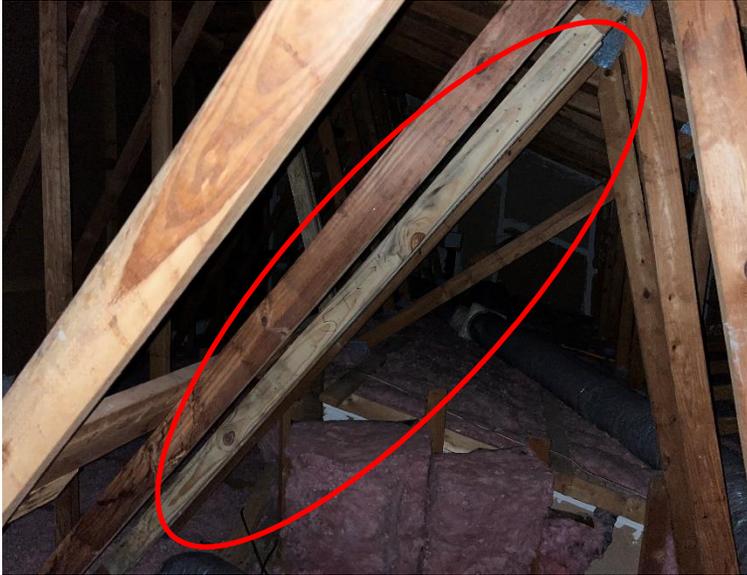
PHOTOGRAPH #1

**BUILDING 8
UNIT #828 ATTIC**

Contractor has performed scab repairs at trusses as per drawings.

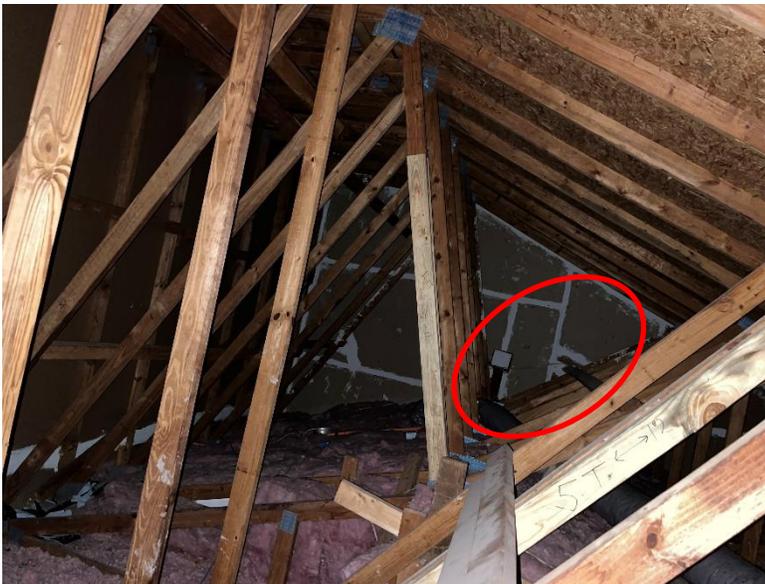
PHOTOGRAPH #2

**BUILDING 8
UNIT #828 ATTIC**

Fire rated gypsum board installed at holes in existing fire walls and fire caulk applied at perimeters.

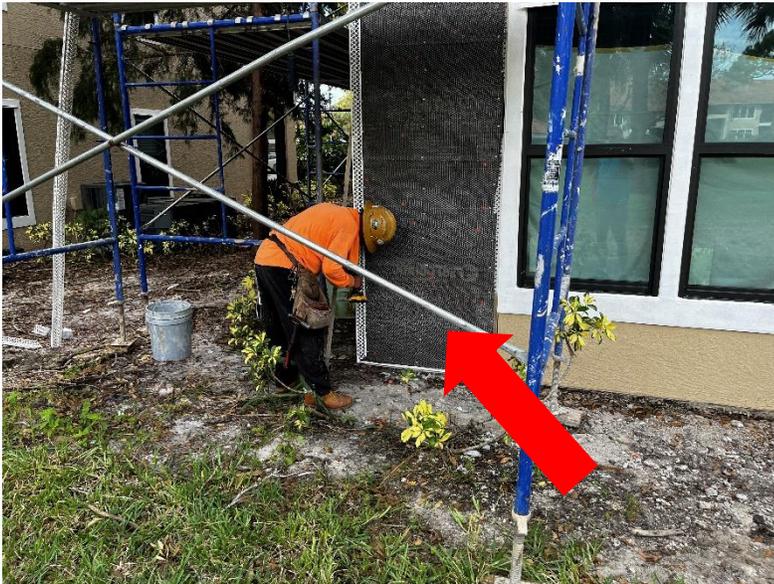
PHOTOGRAPH #3

**BUILDING 13
SECTION E BREEZEWAY**

Stucco sub-contractor attaching vinyl corner beading to framing at 7" O.C. max per ASTM C1063 and drawings.

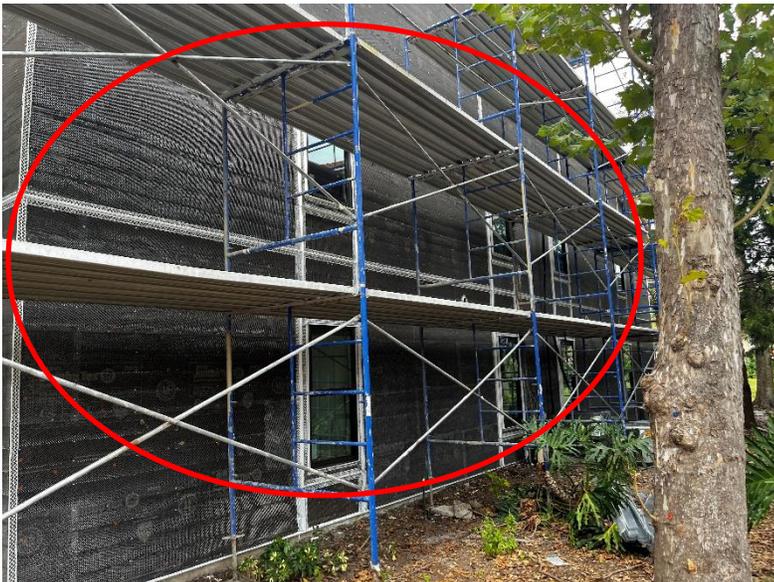
PHOTOGRAPH #4

**BUILDING 13
SECTION D**

Lathing inspection completed and elevating approved for stucco application.

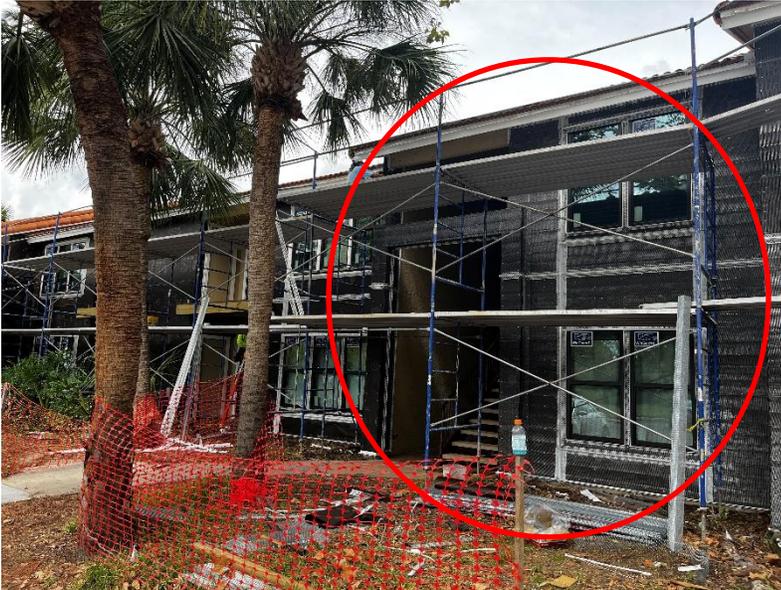
PHOTOGRAPH #5

**BUILDING 13
SECTION C**

Stucco subcontractor applying self-furring galvanized metal lath as per specification and drawings.

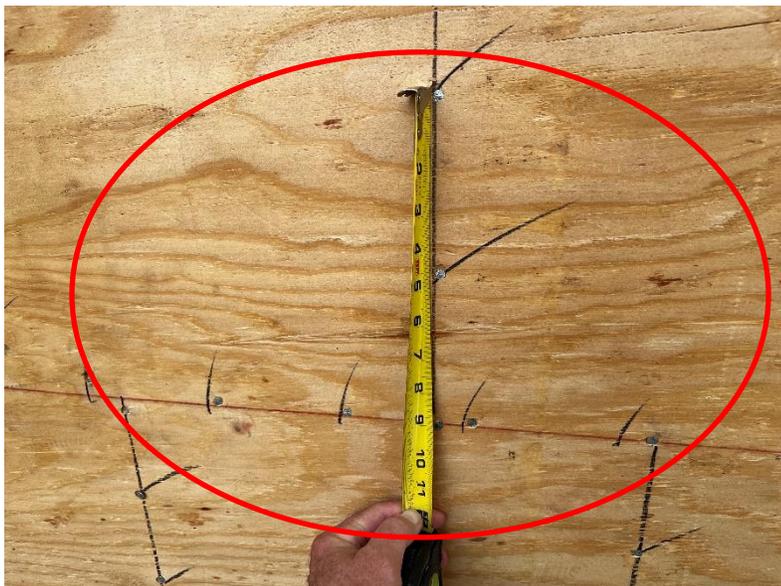
PHOTOGRAPH #6

**BUILDING 18
SECTION H**

Plywood sheathing attached to framing in field members at less than 6" O.C. with 8d common nails as per drawings.

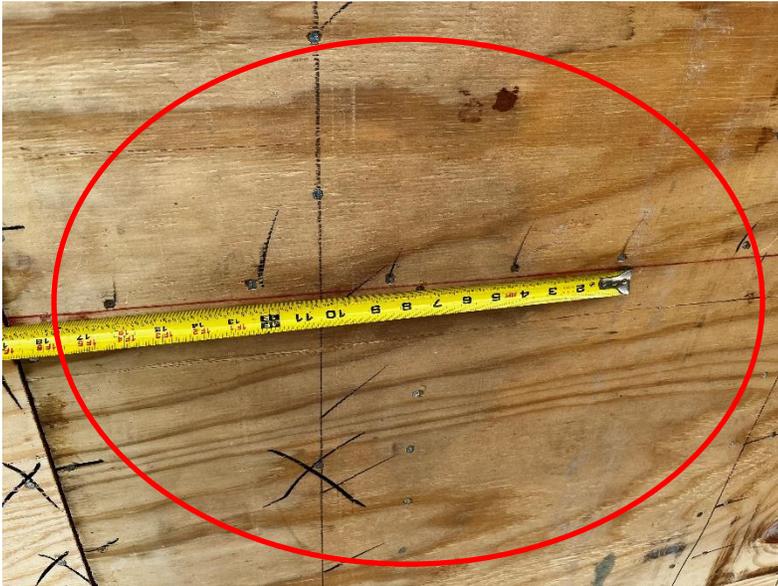
PHOTOGRAPH #7

**BUILDING 18
SECTION H**

Plywood sheathing attached along perimeter to framing at 4" O.C. with 8d common nails as per drawings.

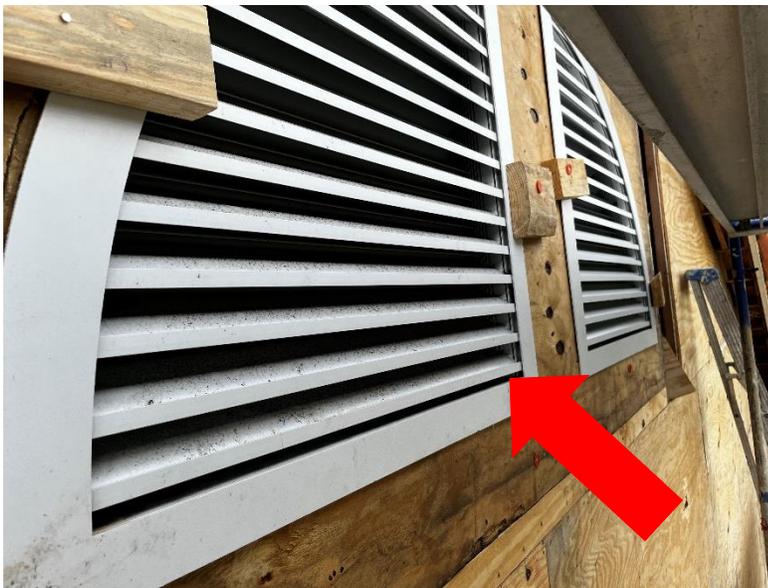
PHOTOGRAPH #8

**BUILDING 18
SECTION H**

New Green Heck louvers temporarily installed at gable end.

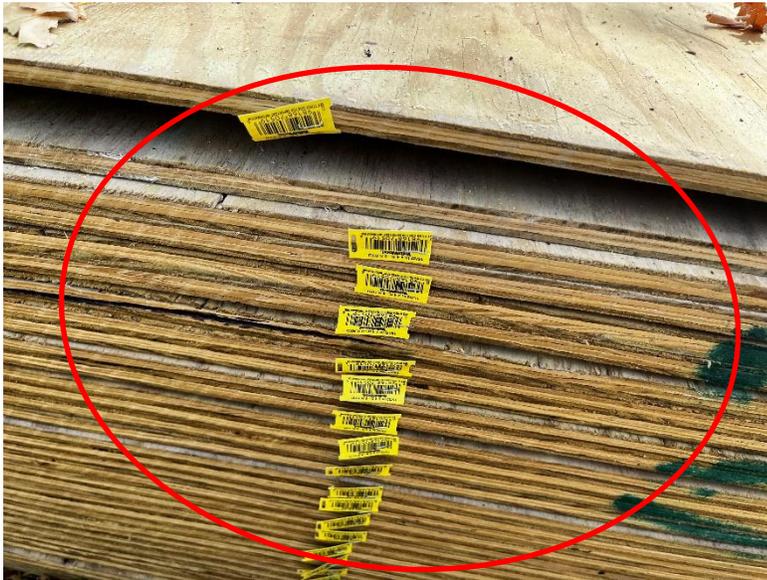
PHOTOGRAPH #9

**BUILDING 18
SECTION H**

4'x 8' - 15/32" pressure treated plywood for bottom row sheathing as per plans and drawings.

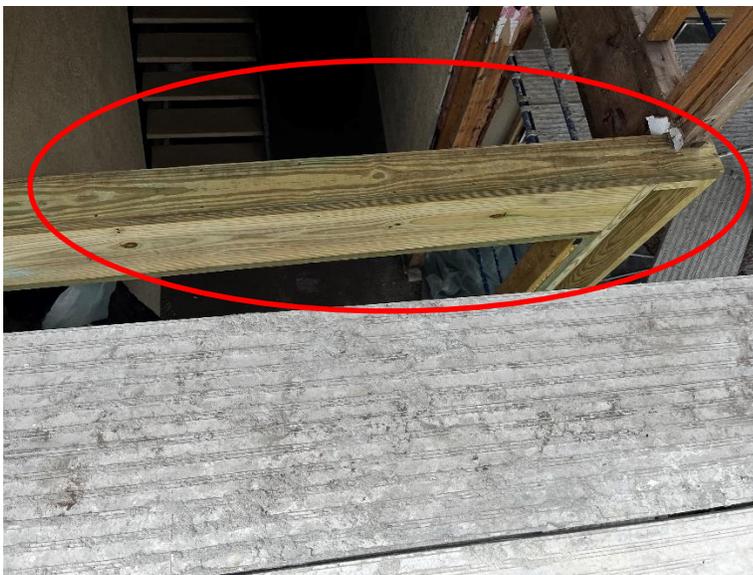
PHOTOGRAPH #10

**BUILDING 18
SECTION G BREEZEWAY**

Contractor has replaced damaged Breezeway framing box beam and studs.

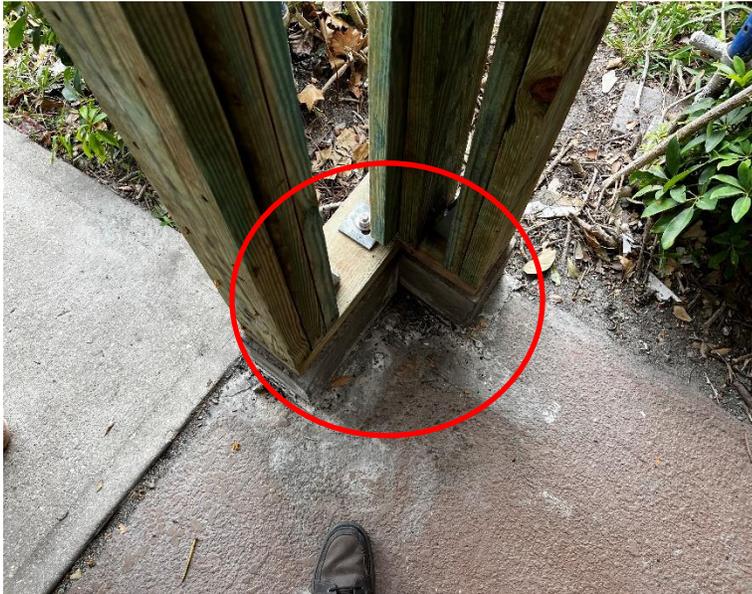
PHOTOGRAPH #11

**BUILDING 18
SECTION G BREEZEWAY**

RLJ has corrected installation of threaded rods at new breezeway pedestal detail as per drawings.

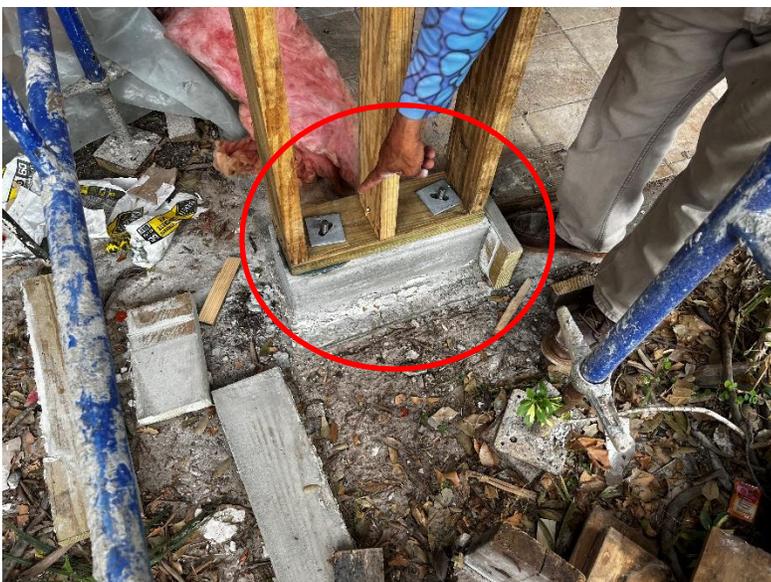
PHOTOGRAPH #12

**BUILDING 18
SECTION F**

RLJ has corrected installation of threaded rods at new balcony pedestal detail as per drawings.

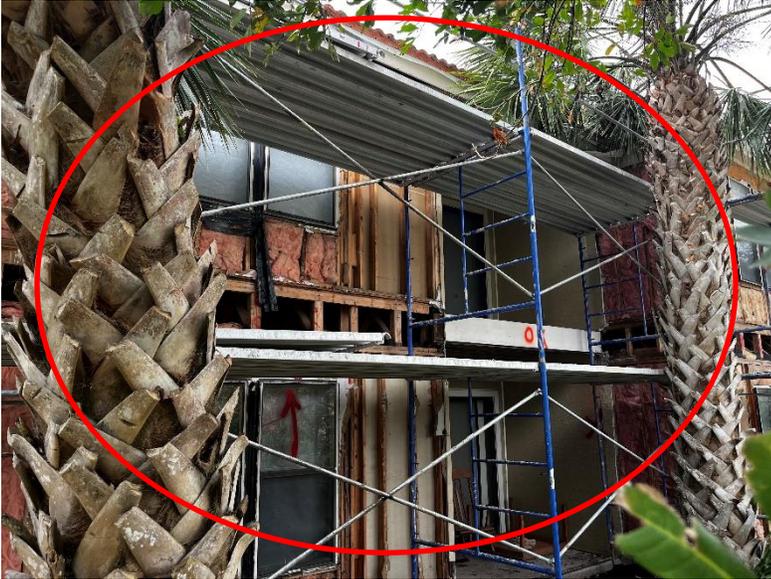
PHOTOGRAPH #13

**BUILDING 18
SECTION E**

Balconies and framing inspected and marked for repairs.

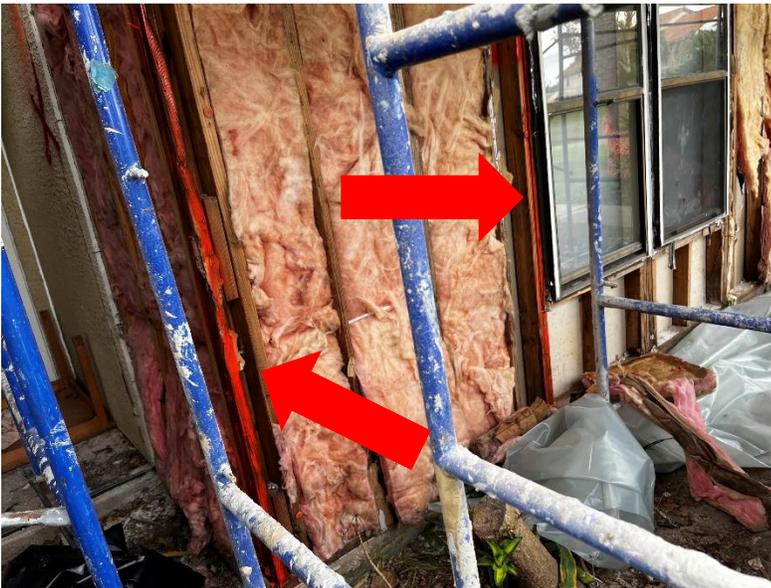
PHOTOGRAPH #14

**BUILDING 18
SECTION E**

Damaged framing studs marked for repairs.

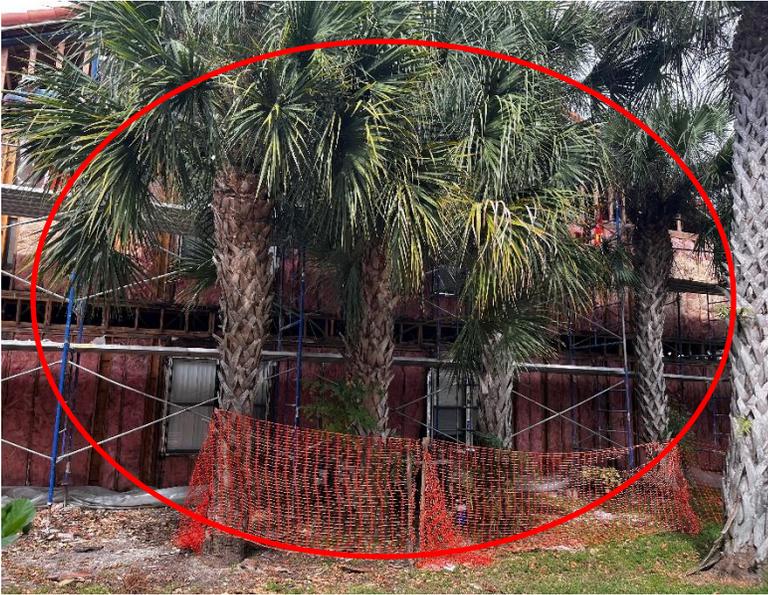
PHOTOGRAPH #15

**BUILDING 18
SECTION D**

Gable end framing inspected and marked for repairs.

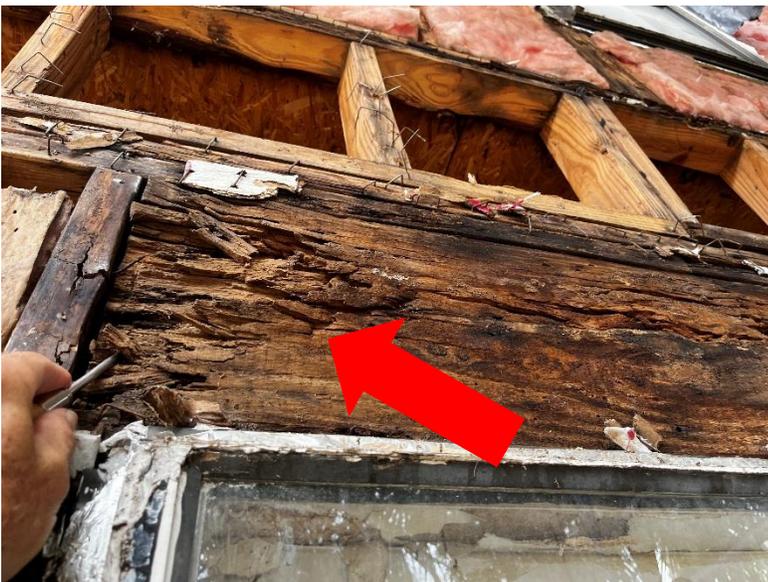
PHOTOGRAPH #16

**BUILDING 18
SECTION D**

Damaged window headers marked for repairs.

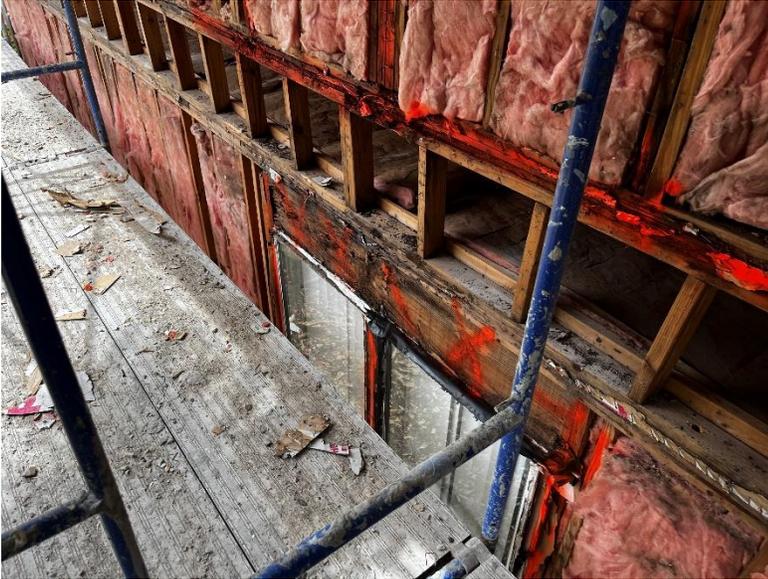
PHOTOGRAPH #17

**BUILDING 18
SECTION D**

Damaged bottom plates , floor trusses, window headers and window framing marked for repairs.

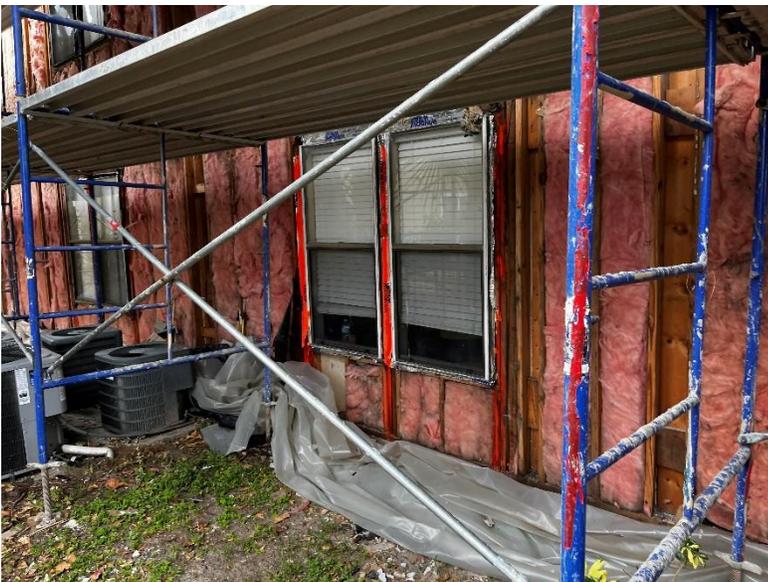
PHOTOGRAPH #18

**BUILDING 18
SECTION D**

Damaged window framing marked for repairs.

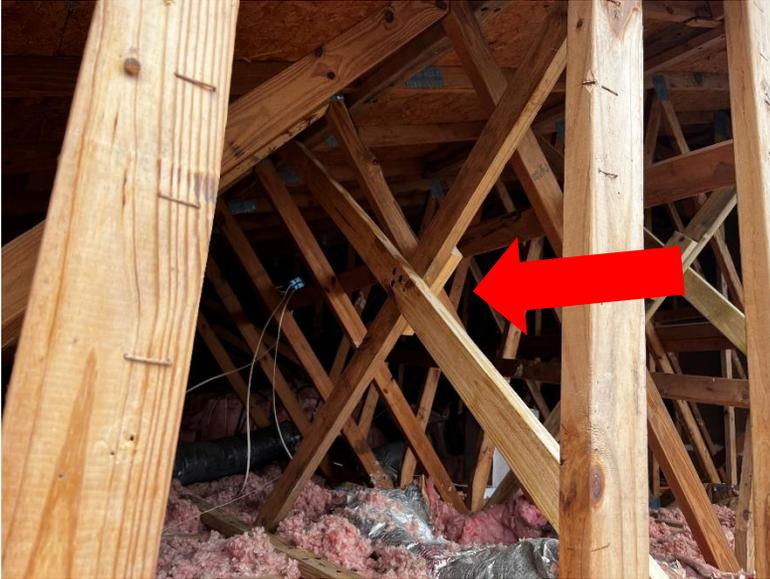
PHOTOGRAPH #19

**BUILDING 18
SECTION D**

RLJ has begun gable end bracing as per drawings and specifications.
