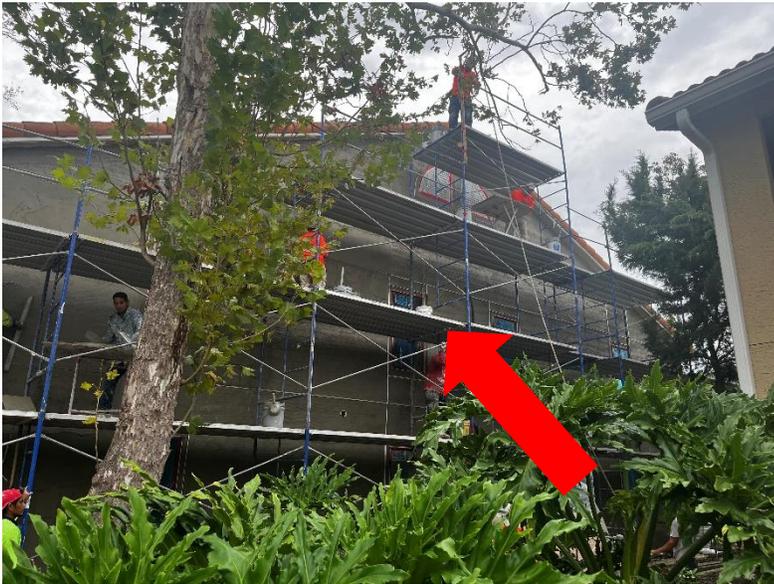
**PHOTOGRAPH #1**

**BUILDING 13  
SECTION D**

Stucco sub-contractor applying scratch and brown coats as per specification and drawings.

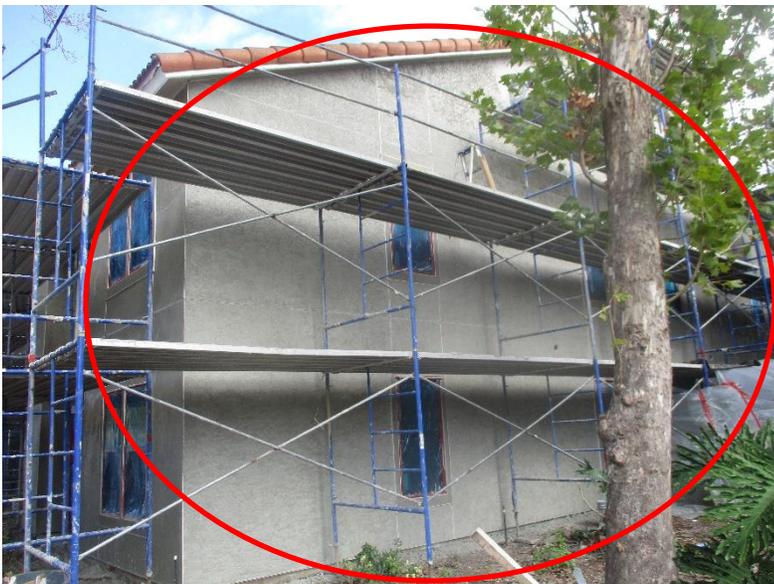
**PHOTOGRAPH #2**

**BUILDING 13  
SECTION D**

Stucco sub-contractor has applied full three coat 7/8" stucco system as per specification and drawings.

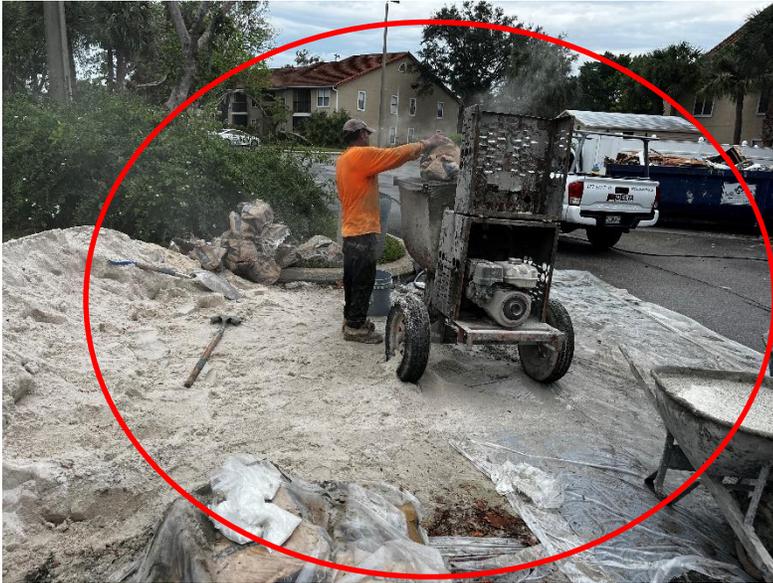
**PHOTOGRAPH #3**

**BUILDING 13  
SECTION D**

Stucco sub-contractor mixing approved Chemrex Broco stucco bag mix product and sand.

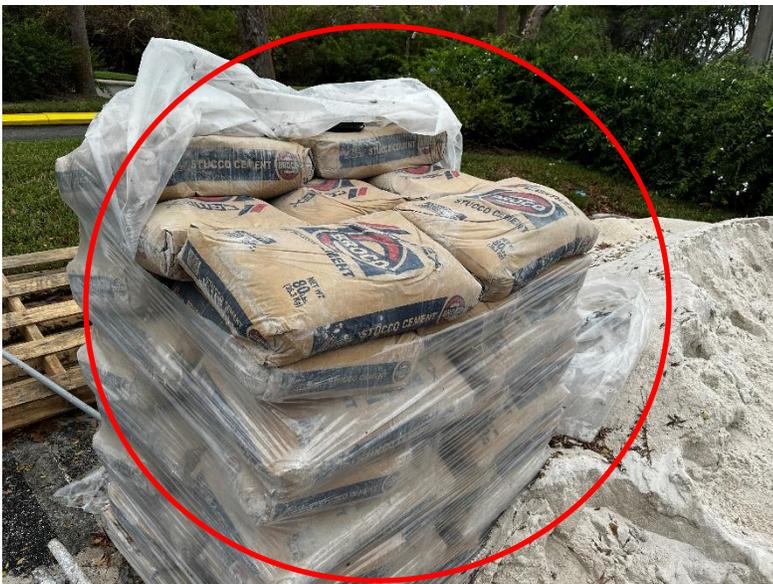
**PHOTOGRAPH #4**

**BUILDING 13  
SECTION D**

Stucco sub-contractor mixing approved Chemrex Broco stucco bag mix product and sand.

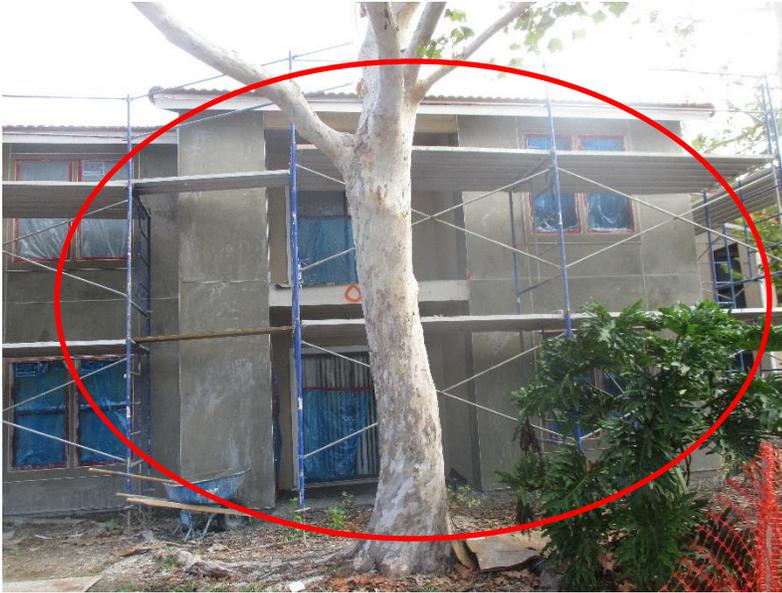
**PHOTOGRAPH #5**

**BUILDING 13  
SECTION C**

Stucco sub-contractor applying scratch and brown coats as per specification and drawings.

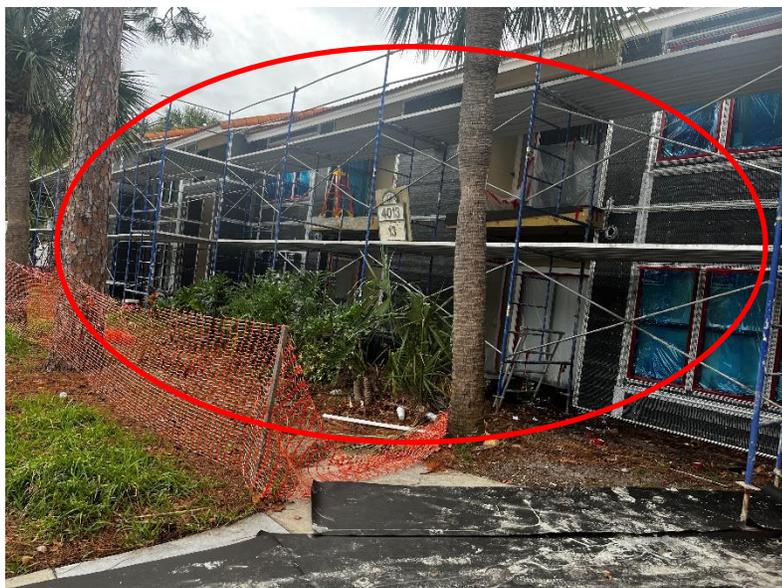
**PHOTOGRAPH #6**

**BUILDING 13  
SECTION B**

Stucco sub-contractor protecting windows and adjacent surfaces in preparation for stucco applications.

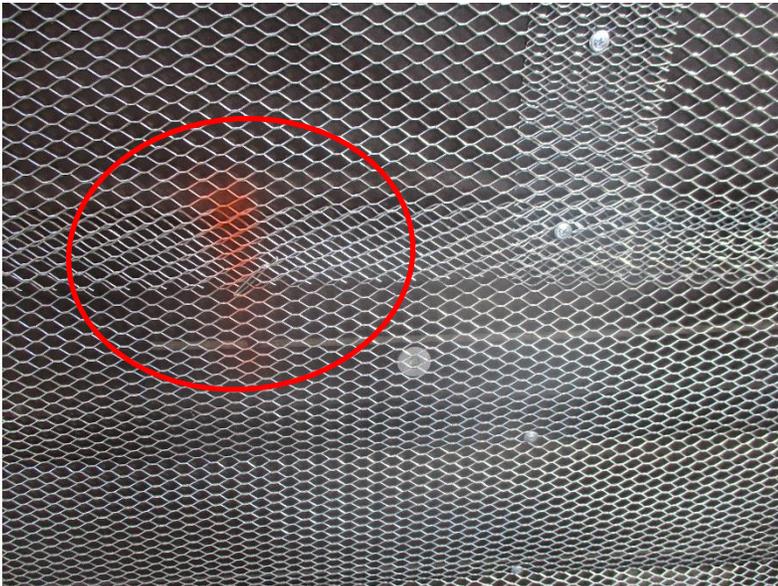
**PHOTOGRAPH #7**

**BUILDING 13  
SECTION B**

New galvanized self-furring lath tied with tie wire at overlap between framing attachments as per ASTM C1063 and drawing.

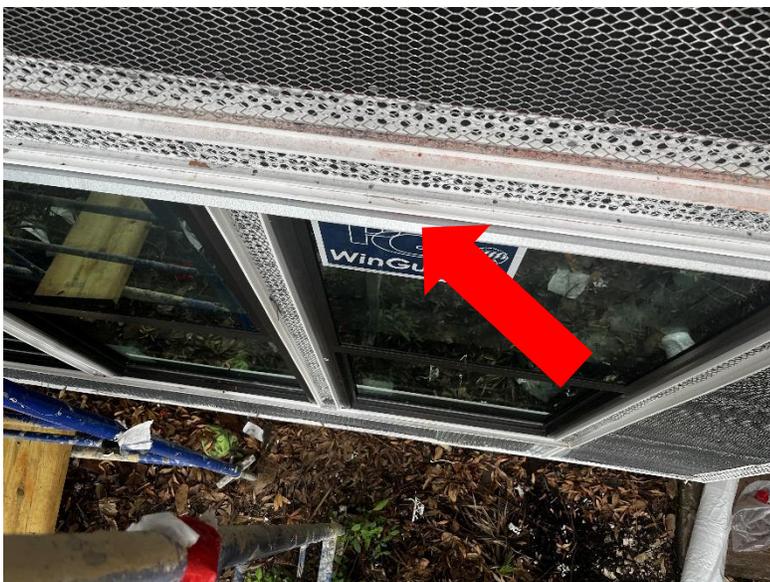
**PHOTOGRAPH #8**

**BUILDING 13  
SECTION B**

Weep holes installed at horizontal header stucco accessories as per drawings.

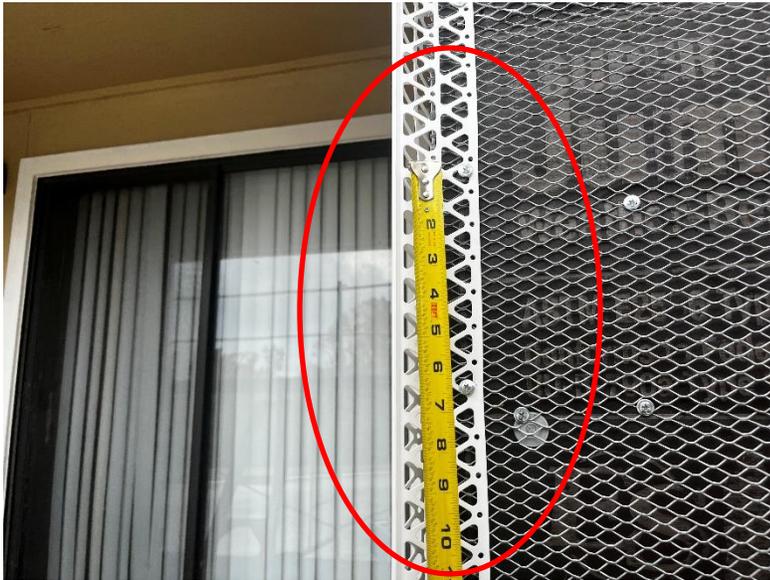
**PHOTOGRAPH #9**

**BUILDING 13  
SECTION B**

New vinyl corner stucco accessories attached to framing at 7" O.C. with waffle head self-tapping screws.

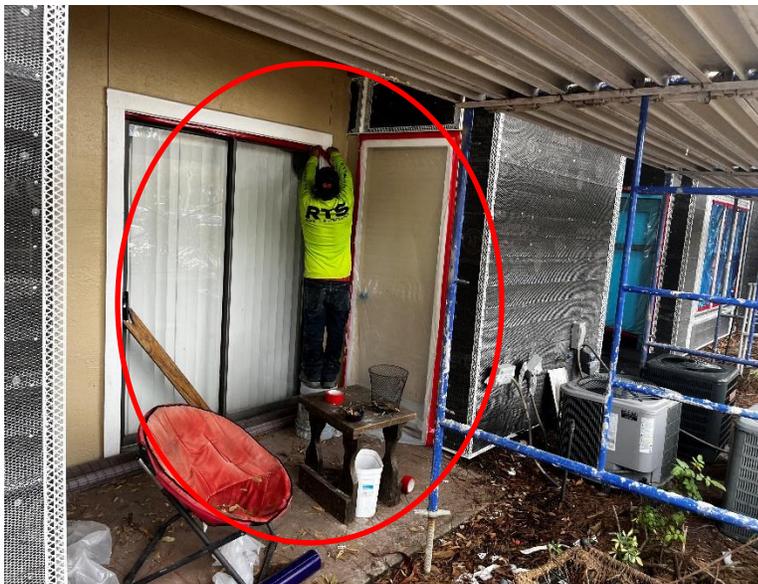
**PHOTOGRAPH #10**

**BUILDING 13  
SECTION A**

Stucco sub-contractor protecting windows and adjacent surfaces in preparation for stucco applications.

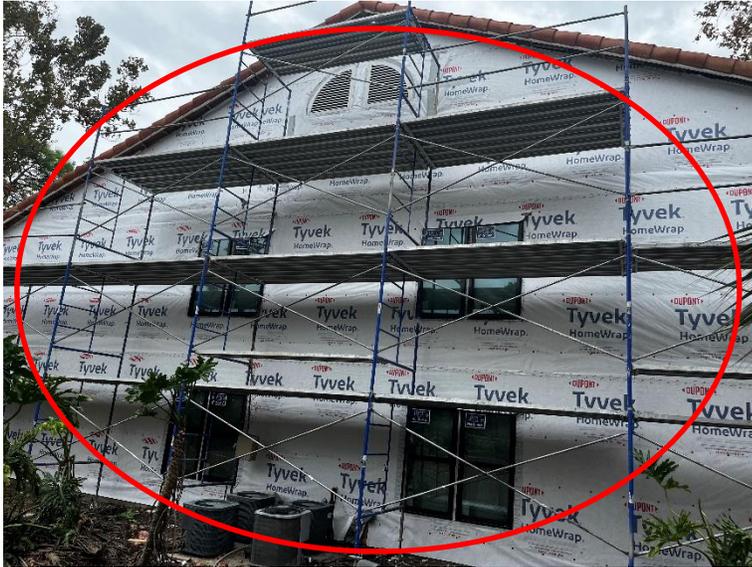
**PHOTOGRAPH #11**

**BUILDING 18  
SECTION H**

RLJ has applied Dupont Tyvek HomeWrap WRB and installed new PGT windows as per drawings and specifications.

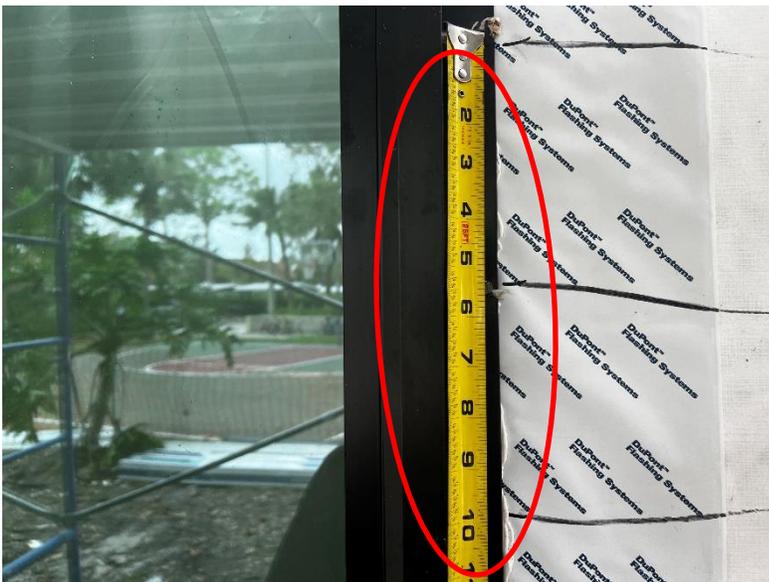
**PHOTOGRAPH #12**

**BUILDING 18  
SECTION H**

New PGT flanged windows attached at wood framing 5" O.C as per manufacturer's NOA.

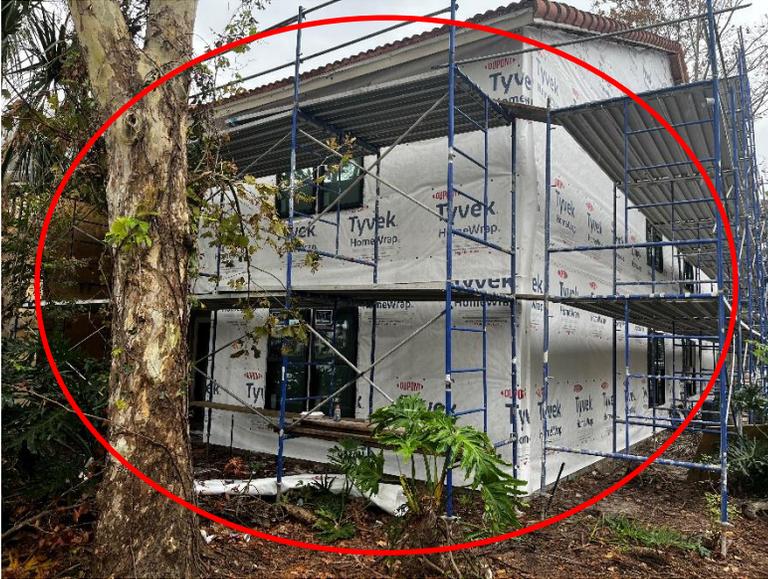
**PHOTOGRAPH #13**

**BUILDING 18  
SECTION G**

RLJ has applied Dupont Tyvek HomeWrap WRB and installed new PGT windows as per drawings and specifications.

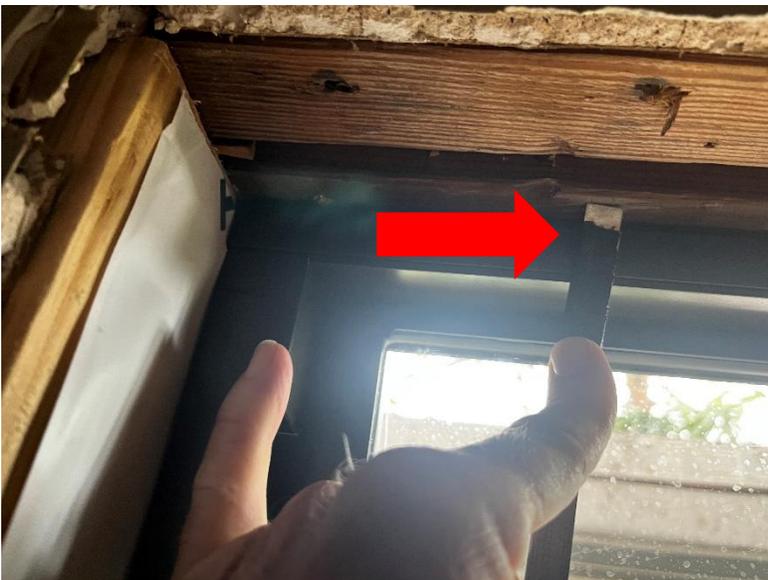
**PHOTOGRAPH #14**

**BUILDING 18  
UNIT 1812**

Gap at window head from window frame to wood header does not exceed 5/16" max allowance per drawings.

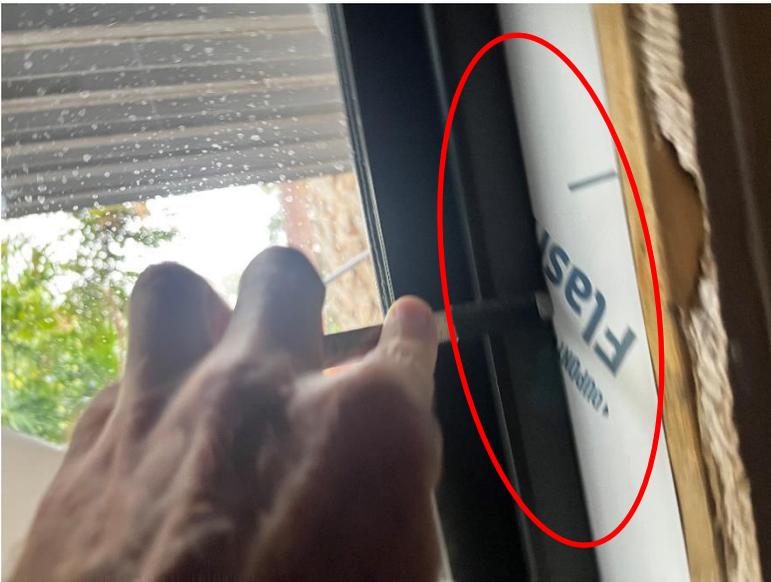
**PHOTOGRAPH #15**

**BUILDING 18  
UNIT 1812**

Gap at window jamb from window frame to wood framing does not exceed 5/16" max allowance per drawings.

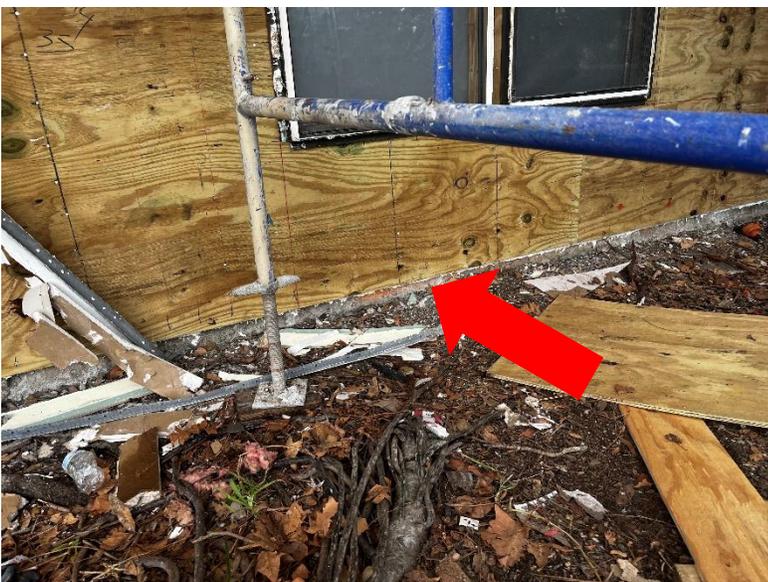
**PHOTOGRAPH #16**

**BUILDING 18  
SECTION G**

Pressure treated plywood sheathing has been sealed with BASF sealant to bottom plate as per drawings.

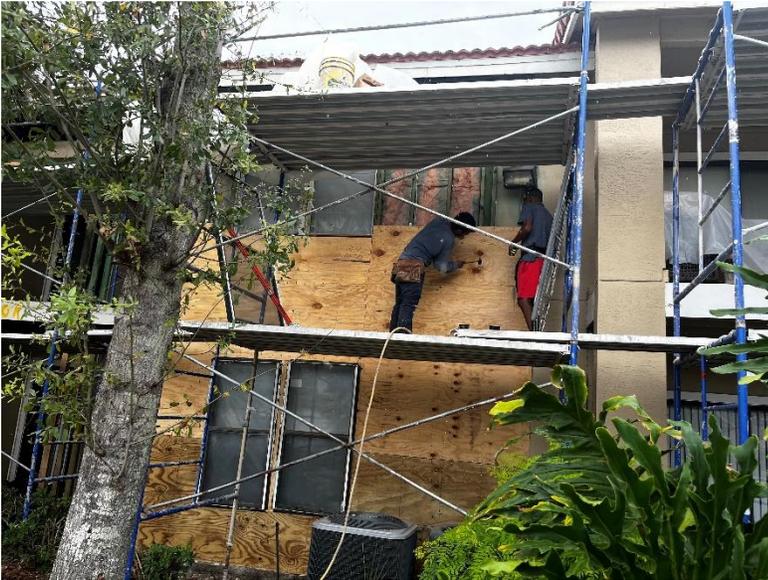
**PHOTOGRAPH #17**

**BUILDING 18  
SECTION F**

RLJ attaching new 5/16" plywood sheathing to framing with 8d common nails as per drawings.

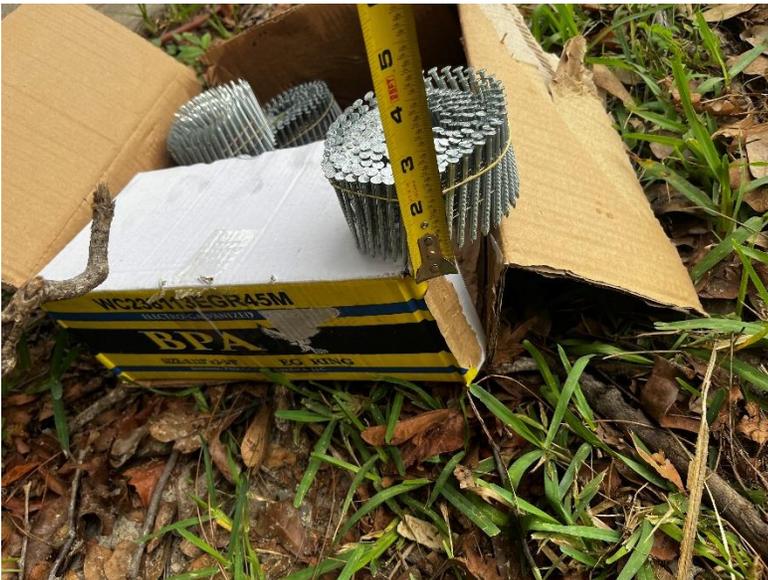
**PHOTOGRAPH #18**

**BUILDING 18  
SECTION F**

2 1/2" 8d common nails used to attached plywood sheathing.

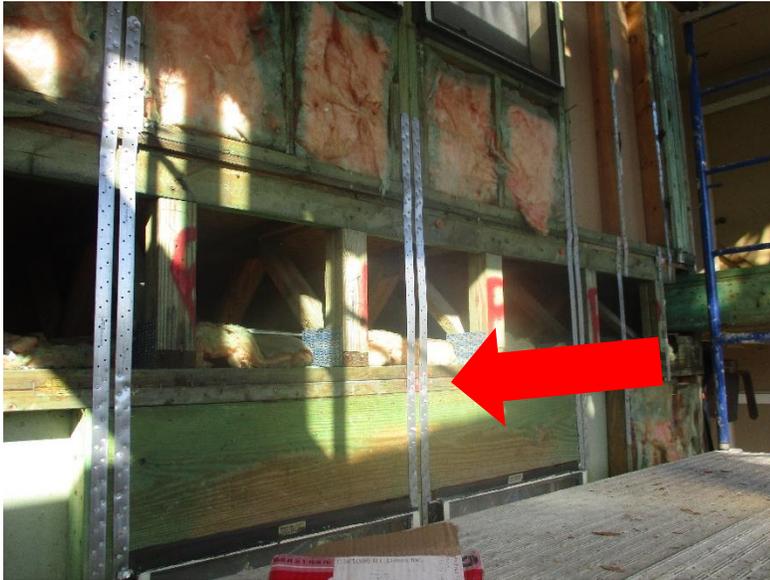
**PHOTOGRAPH #19**

**BUILDING 18  
SECTION E**

MSTA49 Simpson Strong- Tie connector straps installed as per drawings and specifications.

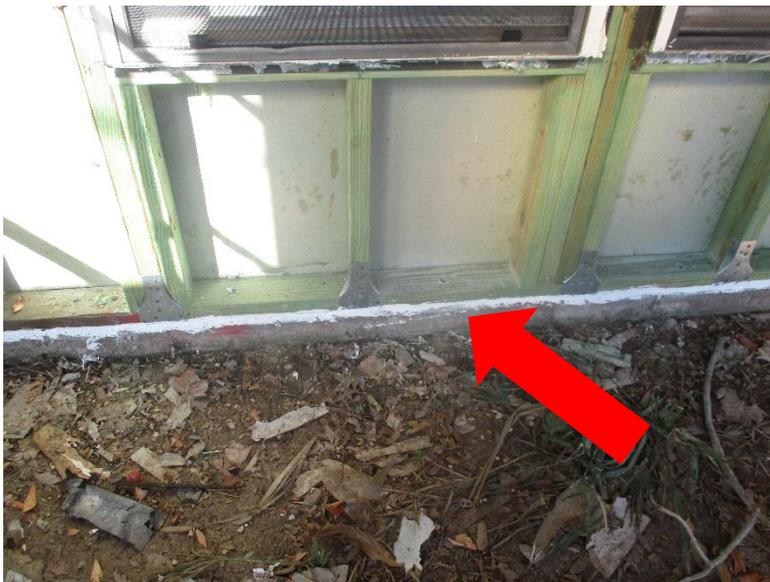
**PHOTOGRAPH #20**

**BUILDING 18  
SECTION E**

Bottom plate has been sealed with BASF sealant to concrete footing as per drawings.

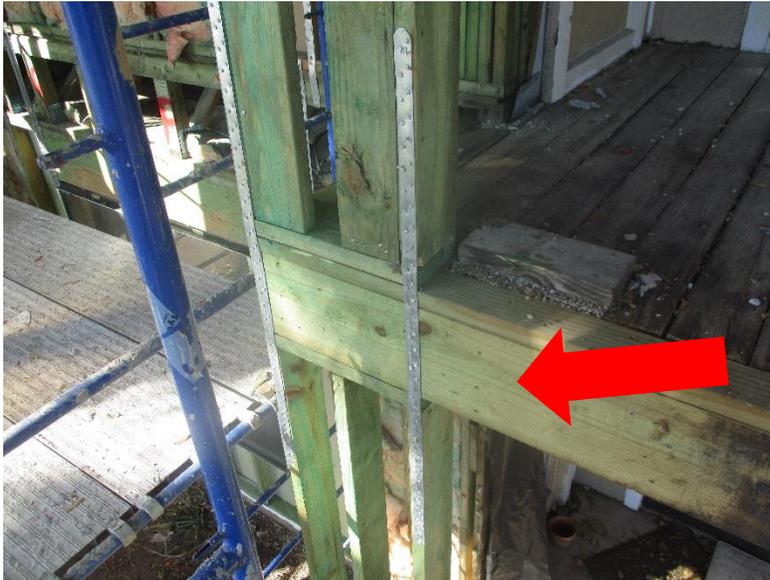
**PHOTOGRAPH #21**

**BUILDING 18  
SECTION E**

Balcony columns and beam repairs performed and Simpson Strong-Tie connector straps in place as per drawings.

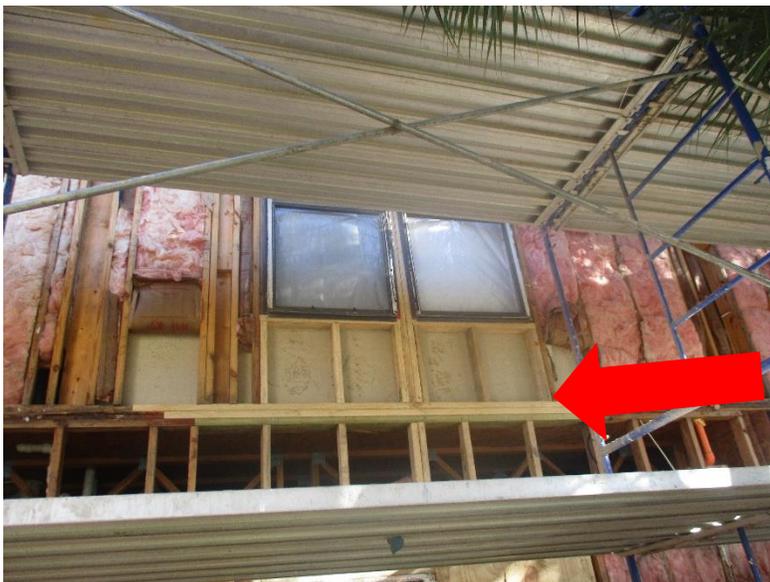
**PHOTOGRAPH #22**

**BUILDING 18  
SECTION D**

RLJ has performed framing repairs at windows, studs, bottom plates, and subflooring trusses.

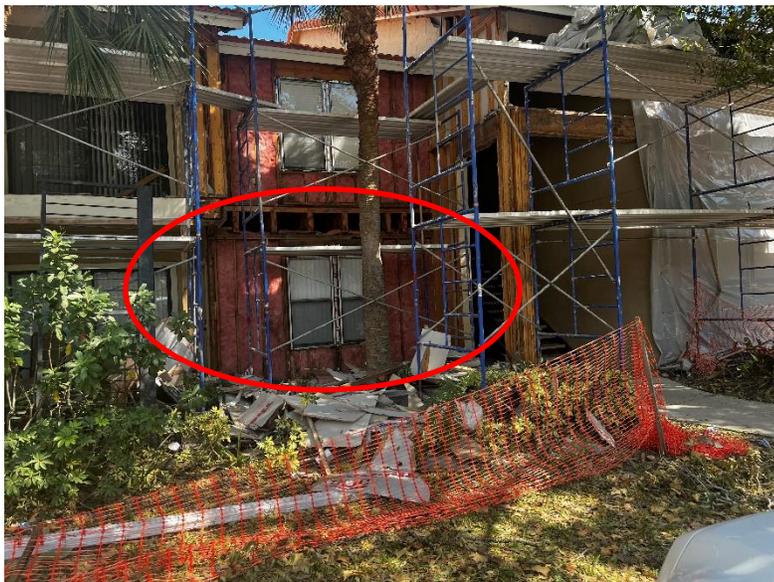
**PHOTOGRAPH #23**

**BUILDING 18  
UNIT 1805/1825**

Delta requested to observe flooring space from exterior above unit 1805 for any anomalies or damage.

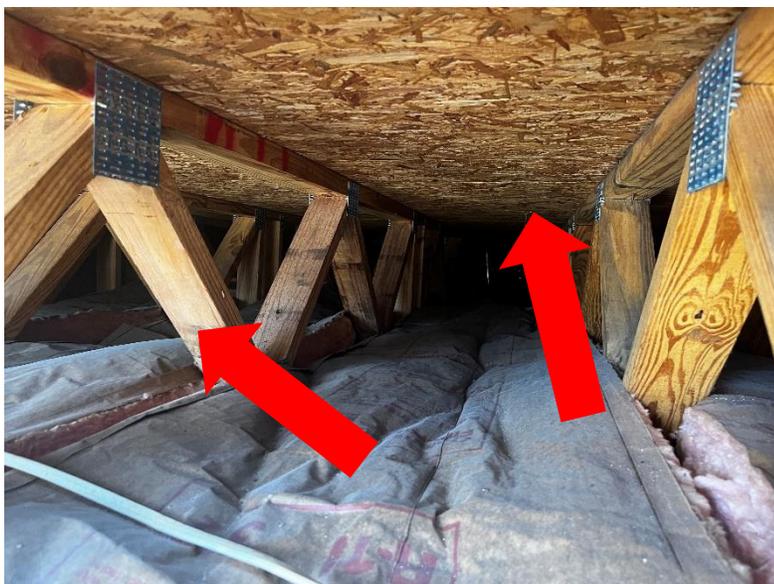
**PHOTOGRAPH #24**

**BUILDING 18  
UNIT 1805/1825**

Accessible visual observation from exterior did not find any seen damage at flooring or flooring trusses.

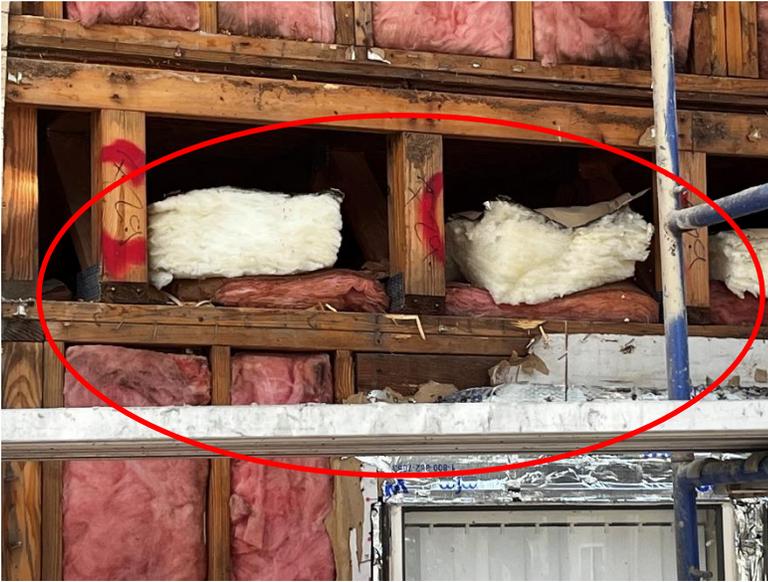
**PHOTOGRAPH #25**

**BUILDING 18  
UNIT 1805/1825**

Additional insulation has been placed in space at a few random locations.
