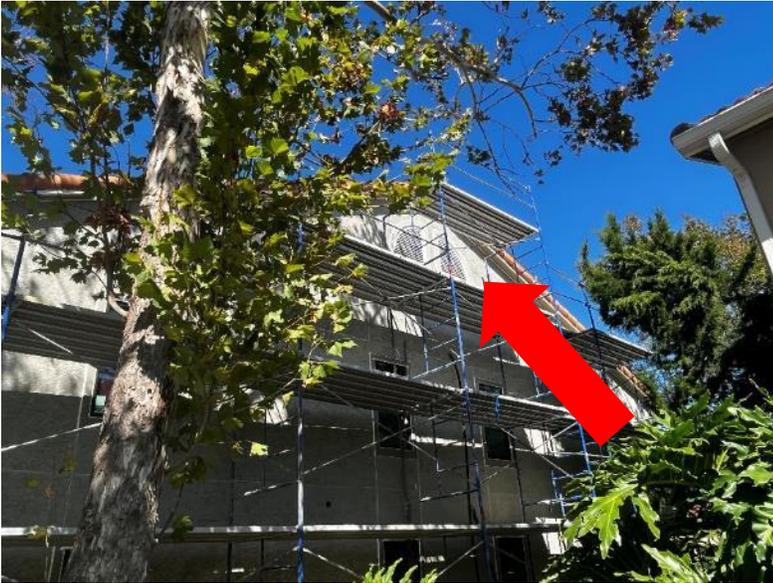
**PHOTOGRAPH #1**

**BUILDING 13  
SECTION D**

Stucco sub-contractor has completed full three coat 7/8" stucco system with new Green Heck louvers at gable end .

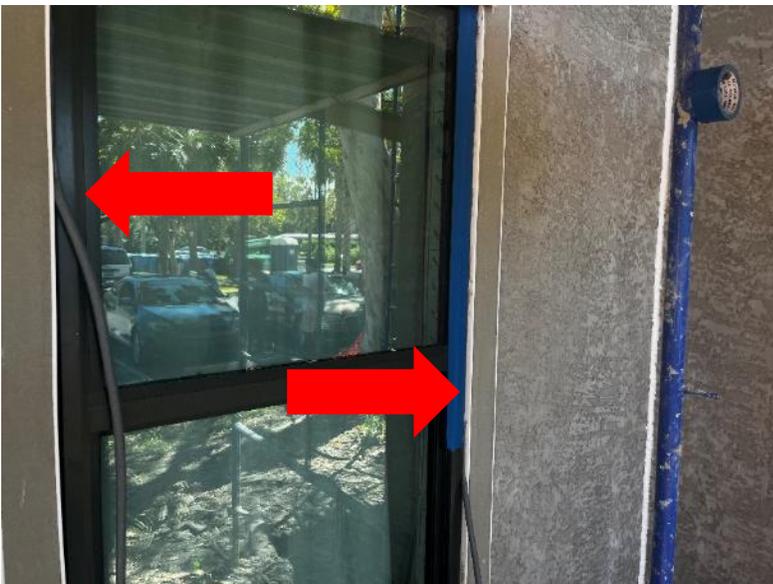
**PHOTOGRAPH #2**

**BUILDING 13  
SECTION C**

RLJ installing new soft cell backing rod, masking window frame, and installing new BASF MasterSeal 150 sealant at window perimeters .

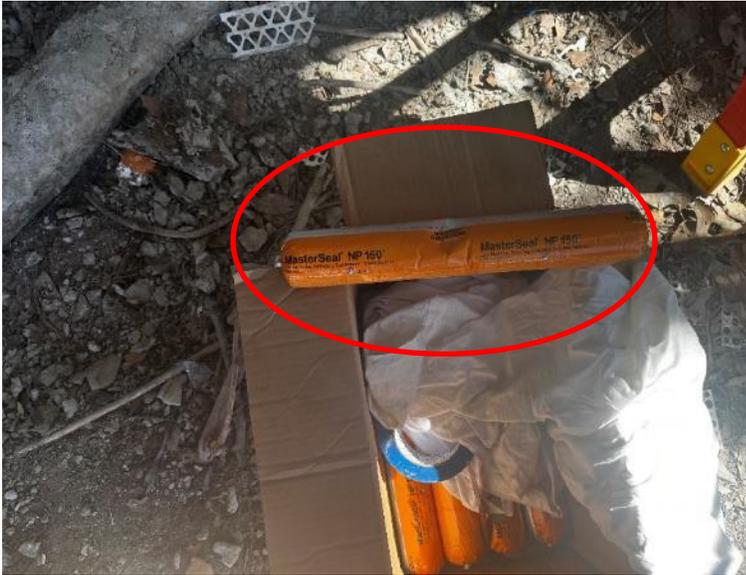
**PHOTOGRAPH #3**

**BUILDING 13  
SECTION D**

RLJ installing new soft cell backing rod, masking window frame, and installing new BASF MasterSeal 150 sealant at window perimeters.

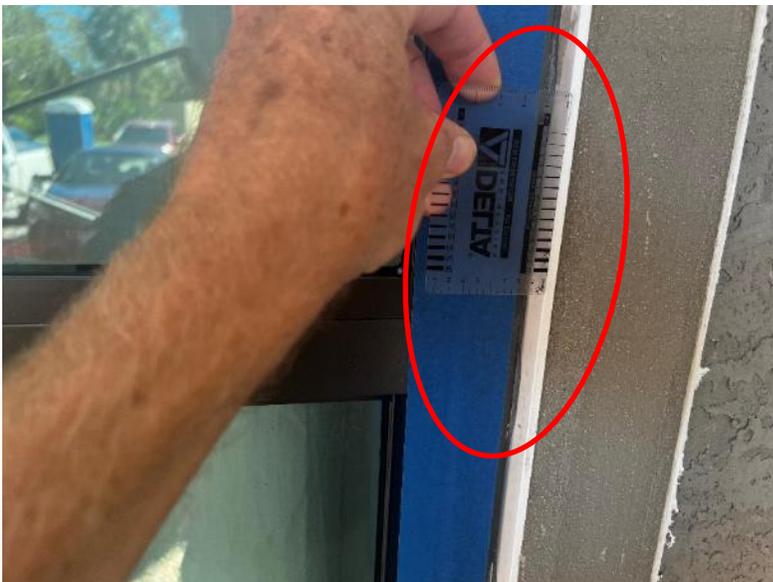
**PHOTOGRAPH #4**

**BUILDING 13  
SECTION C**

Joints from new aluminum window frame to vinyl stucco accessories varying from 1/4" Min to 1/2" Max.

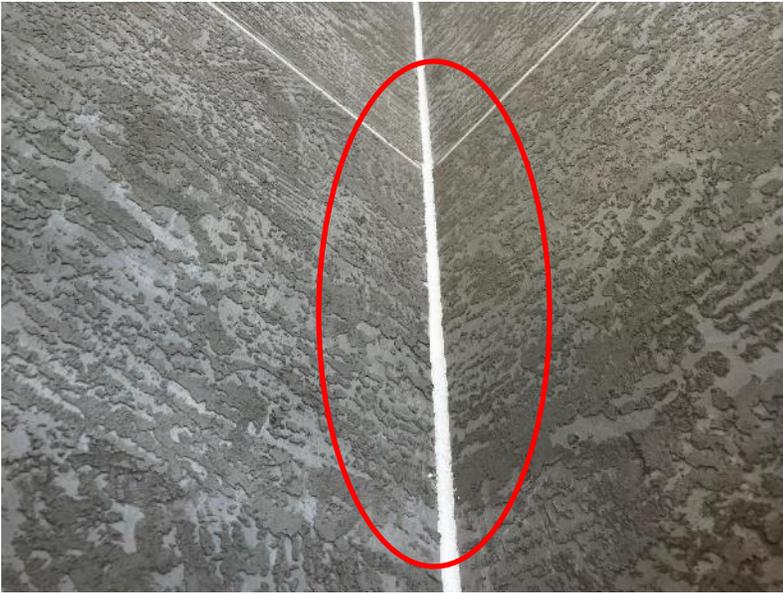
**PHOTOGRAPH #5**

**BUILDING 13  
SECTION C**

Stucco to Stucco transition joints sealed with BASF MasterSeal 150 sealant.

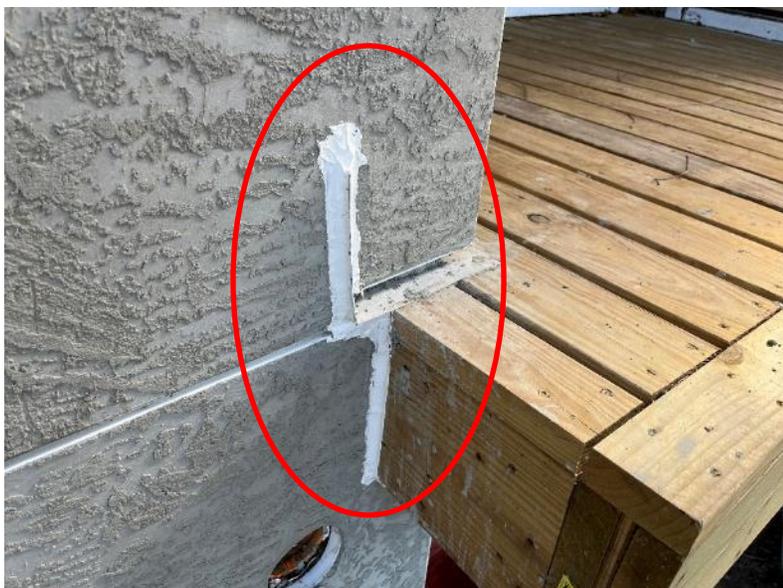
**PHOTOGRAPH #6**

**BUILDING 13  
SECTION B**

New aluminum kick out flashings at balconies sealed with BASF MasterSeal 150 sealant.

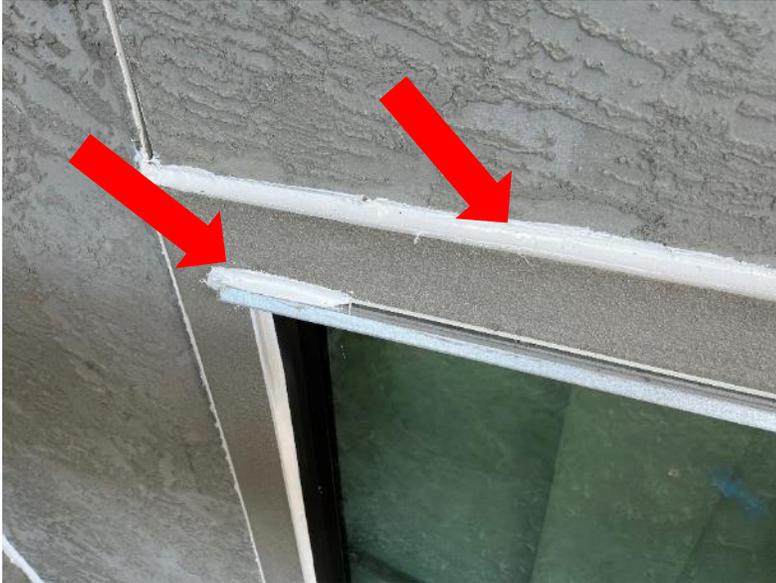
**PHOTOGRAPH #7**

**BUILDING 13  
SECTION B**

Stucco to Stucco transitions around window trim and ends of new head flashing above windows sealed with BASF MasterSeal 150 sealant.

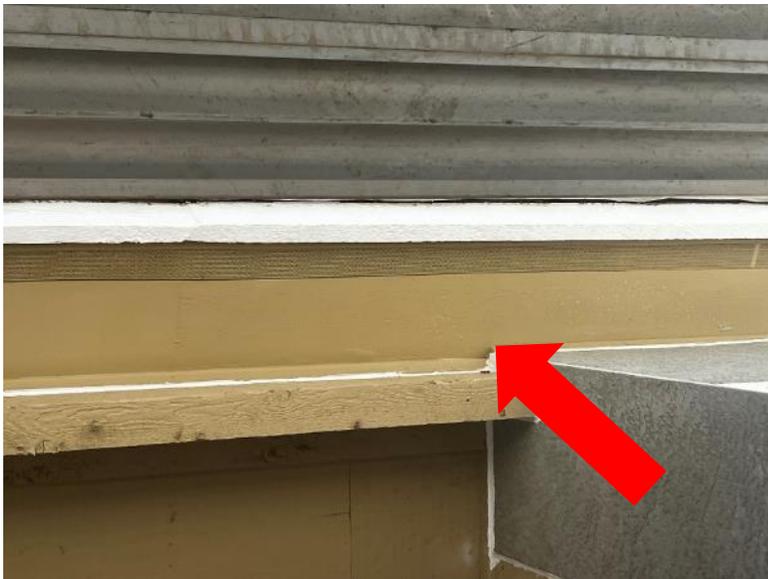
**PHOTOGRAPH #8**

**BUILDING 13  
SECTION B**

New plywood and vinyl vents installed at soffit as per drawings.

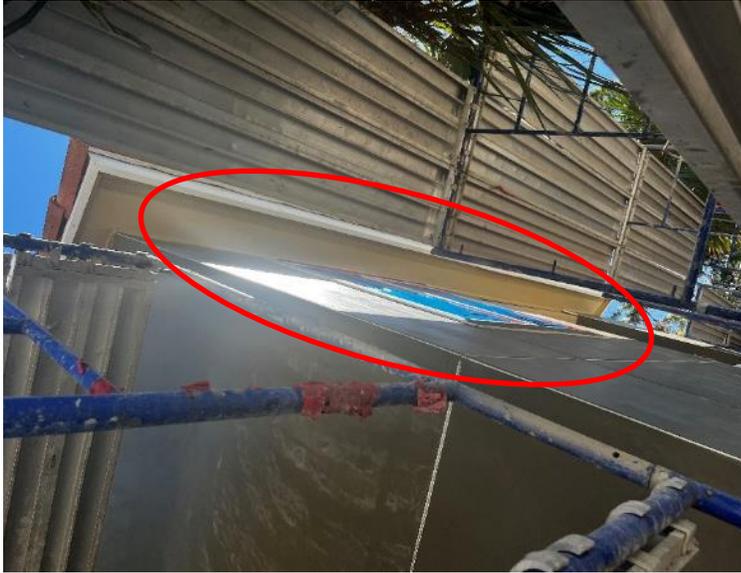
**PHOTOGRAPH #9**

**BUILDING 13  
SECTION A**

New plywood and vinyl vents installed at soffit as per drawings.

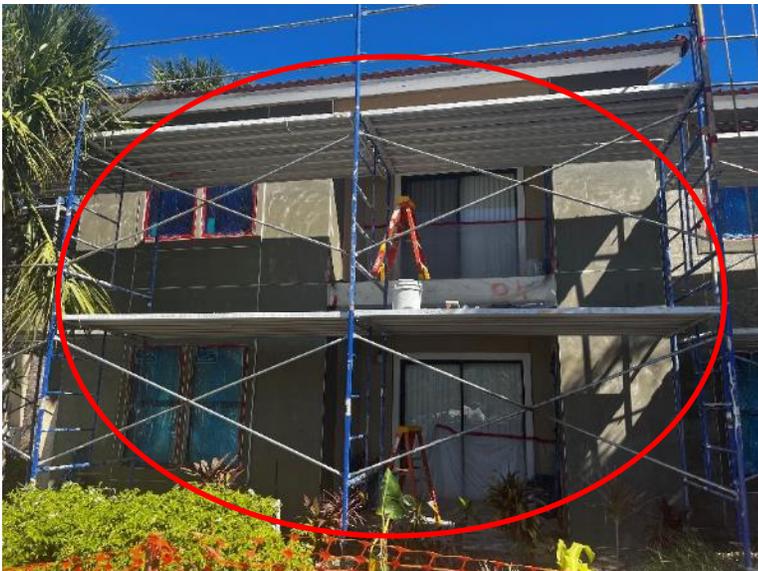
**PHOTOGRAPH #10**

**BUILDING 13  
SECTION A**

Stucco sub-contractor has applied Scratch and brown coats of new stucco system.

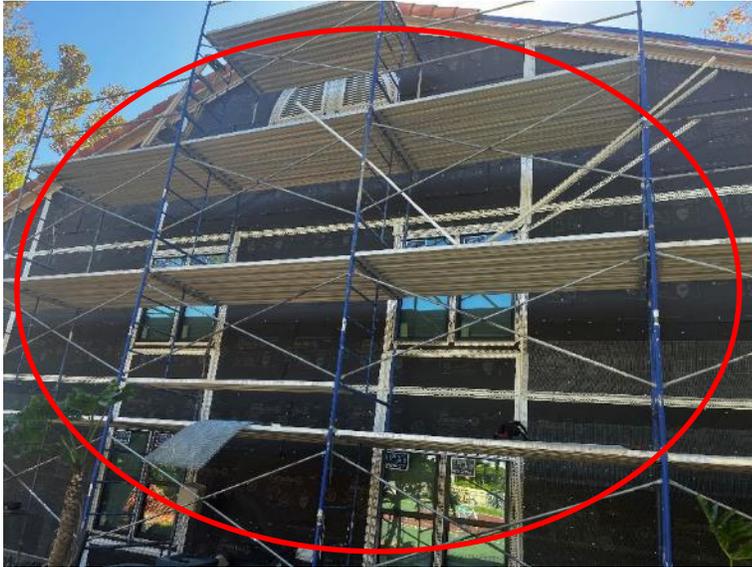
**PHOTOGRAPH #11**

**BUILDING 18  
SECTION H**

Stucco sub-contractor applying Henry Jumbo Tex 60 WRB and new vinyl stucco accessories as per drawings.

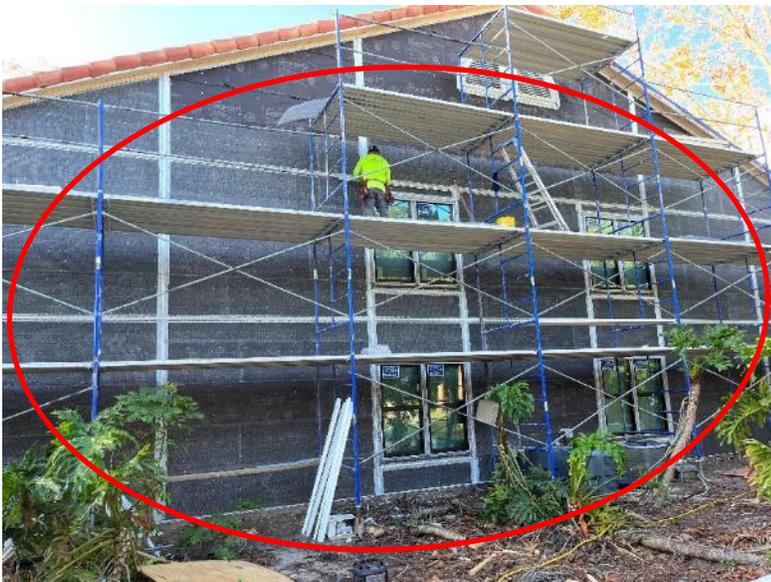
**PHOTOGRAPH #12**

**BUILDING 18  
SECTION H**

Stucco sub-contractor applying new self-furring galvanized stucco lathing as per drawings.

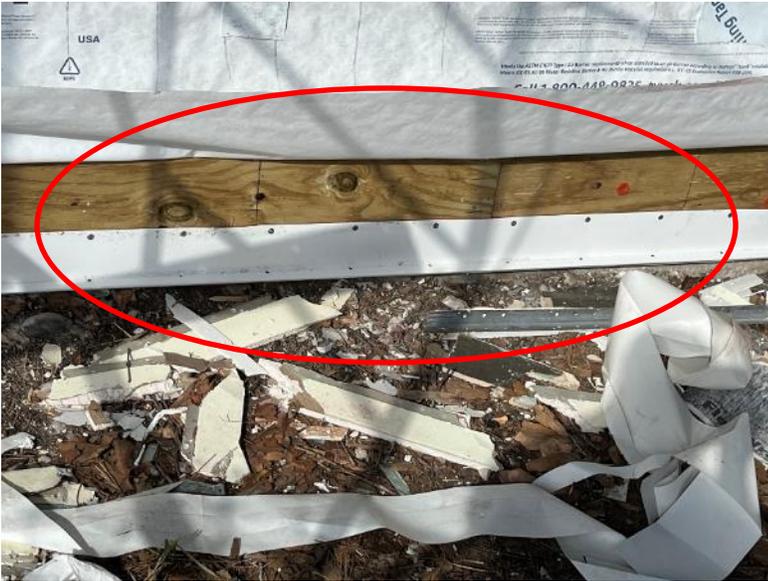
**PHOTOGRAPH #13**

**BUILDING 18  
SECTION G**

Stucco sub-contractor applying new weep screed stucco accessory at base of new pressure treated plywood sheathing as per drawings and specifications.

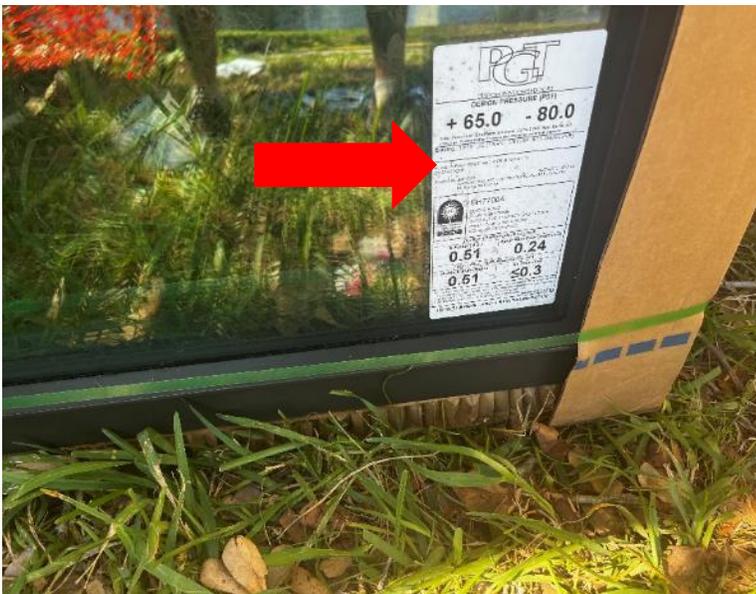
**PHOTOGRAPH #14**

**BUILDING 18  
SECTION E**

New PGT SH7700A single hung LOW E aluminum windows ready for installation.

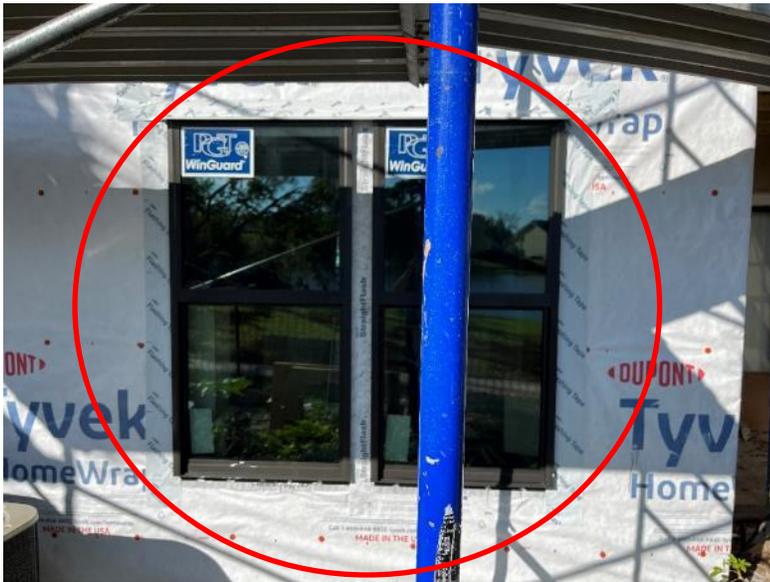
**PHOTOGRAPH #15**

**BUILDING 18  
SECTION E UINT 1808**

New PGT SH7700A single hung LOW E aluminum windows installed with Dupont Tyvek flashing system as per drawings and specifications.

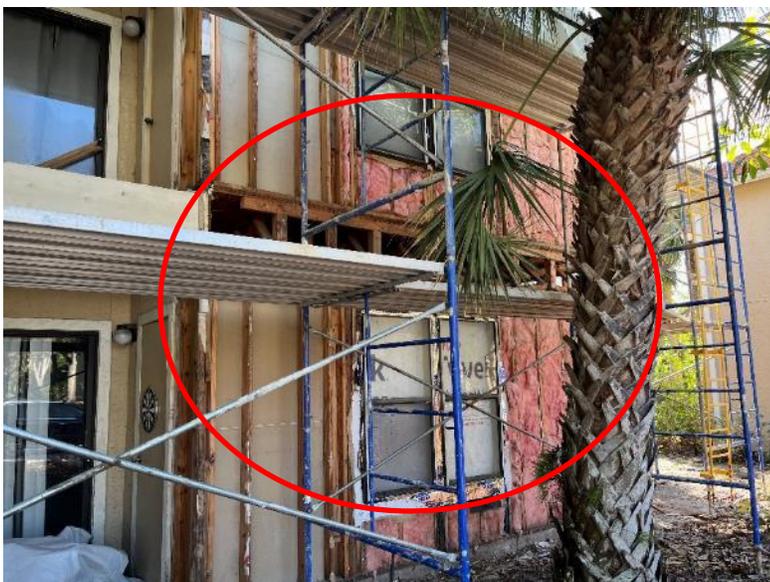
**PHOTOGRAPH #16**

**BUILDING 18  
SECTION C**

Existing wood framing inspected by Delta and marked for repairs .

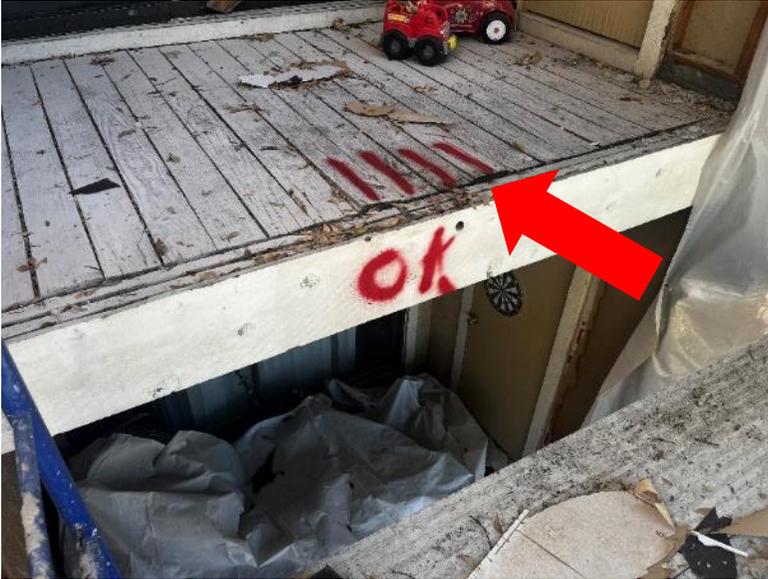
**PHOTOGRAPH #17**

**BUILDING 18  
SECTION C UNIT 1817**

Damaged deck boards marked for replacement at balcony deck.

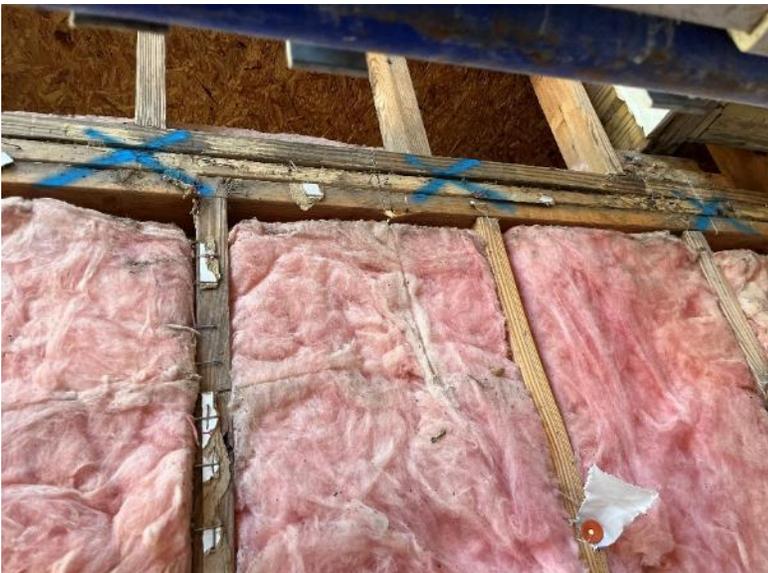
**PHOTOGRAPH #18**

**BUILDING 18  
SECTION C**

Damaged top and bottom plates marked for repairs .

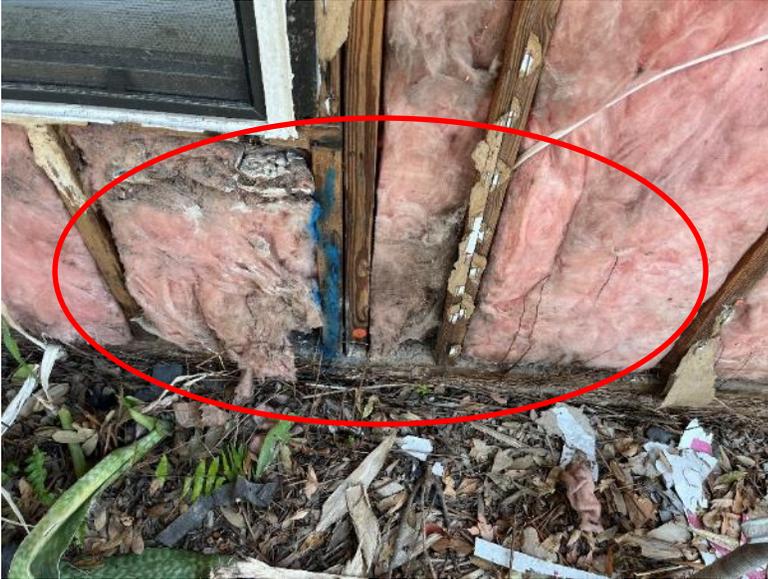
**PHOTOGRAPH #19**

**BUILDING 18  
SECTION C**

Window framing and jacks marked for repairs. Damaged insulation will require replacement.

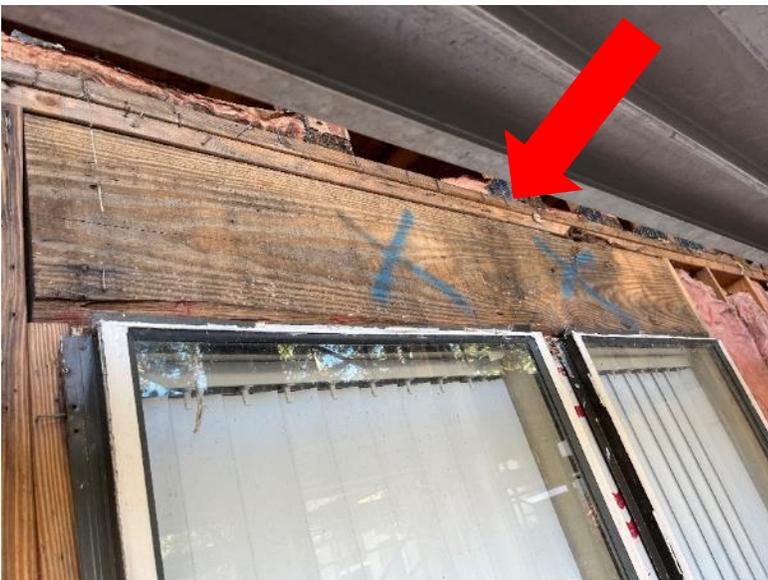
**PHOTOGRAPH #20**

**BUILDING 18  
SECTION C UNIT 1807**

Wood header at double window marked for repairs.

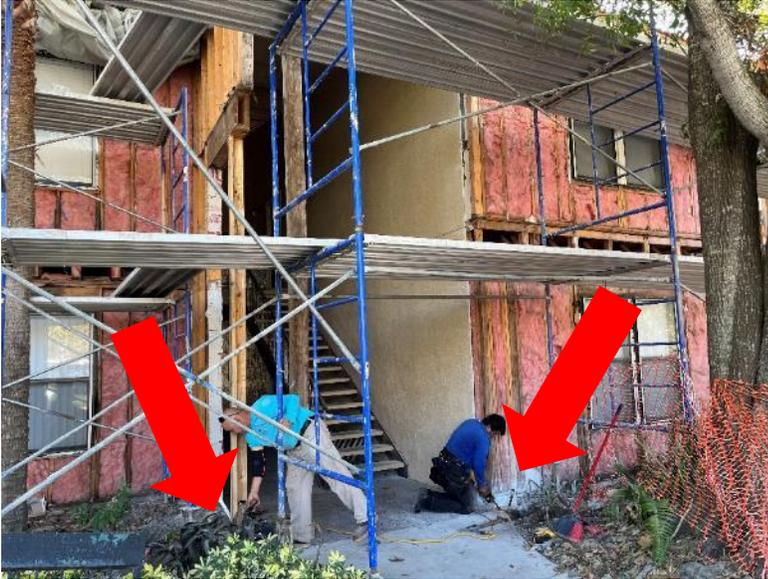
**PHOTOGRAPH #21**

**BUILDING 18  
SECTION C BREEZEWAY**

RLJ removing damaged framing and preparing areas marked for repairs.

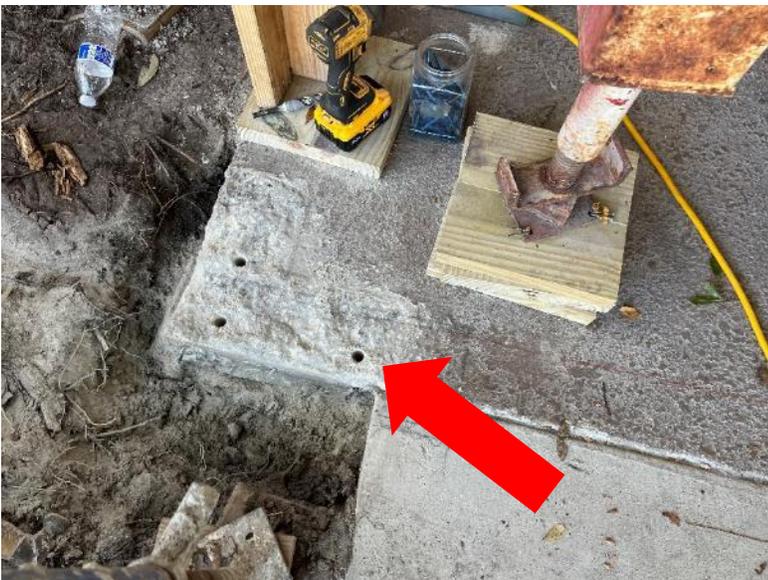
**PHOTOGRAPH #22**

**BUILDING 18  
SECTION C BREEZEWAY**

RLJ drilling holes for setting stainless steel rods at new concrete pedestal as per drawings and specifications.

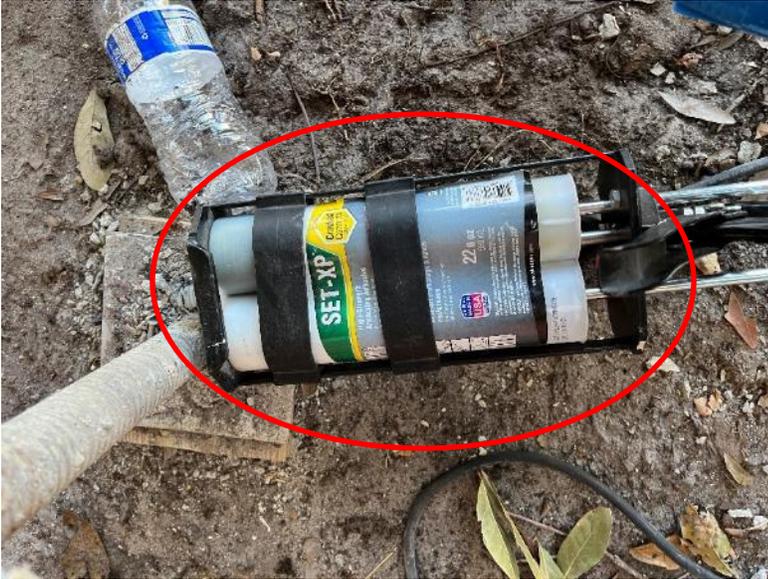
**PHOTOGRAPH #23**

**BUILDING 18  
SECTION C BREEZEWAY**

Simpson Strong-Tie Set-XP epoxy used for setting new stainless-steel rods at new concrete pedestal as per drawings.

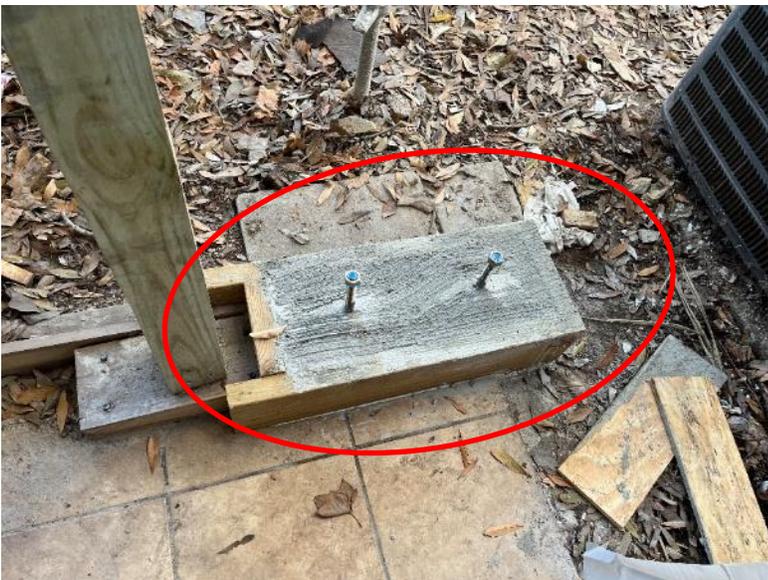
**PHOTOGRAPH #24**

**BUILDING 18  
SECTION B UNIT 1805**

RLJ has set new rods and formed and poured new concrete pedestal at patio deck.

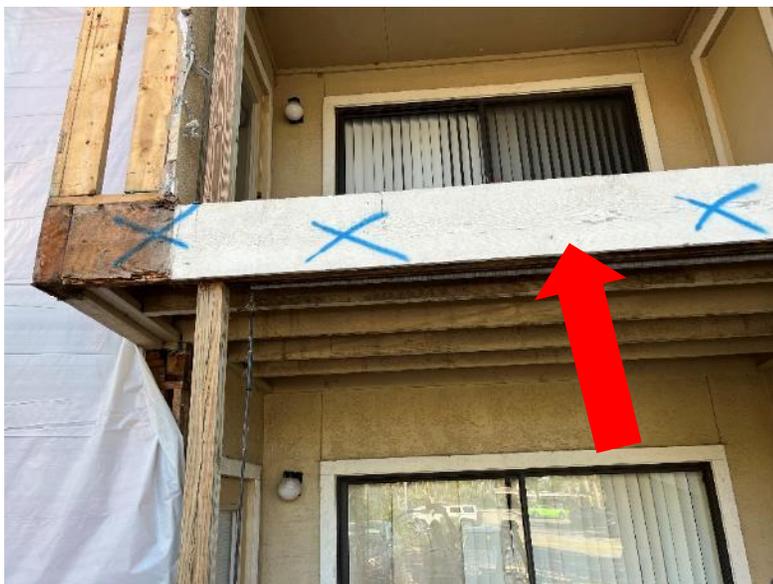
**PHOTOGRAPH #25**

**BUILDING 18  
SECTION B UNIT 1803**

Full Balcony repairs of built-up beam, columns and new concrete pedestals marked for repairs.

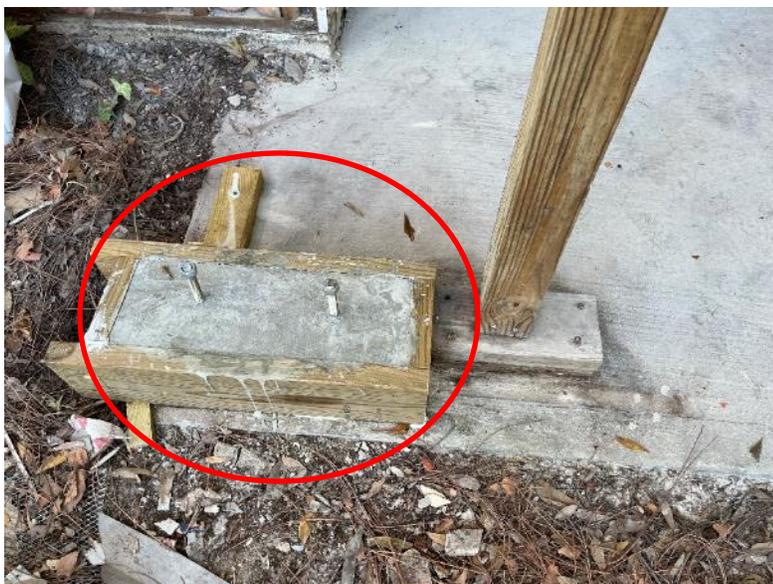
**PHOTOGRAPH #26**

**BUILDING 18  
SECTION B UNIT 1803**

RLJ has set new rods and formed and poured new concrete pedestal at patio deck.
