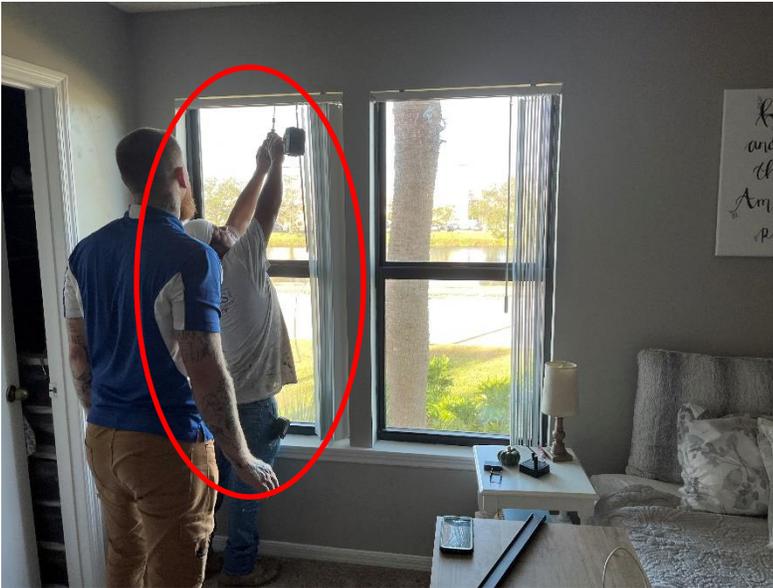
PHOTOGRAPH #1

**BUILDING 8
UNIT 828**

RLJ fastening window frame at head to wood header as corrective measure where frame to head gap is 1/2", following PGT engineering letter dated 9.17.2020.

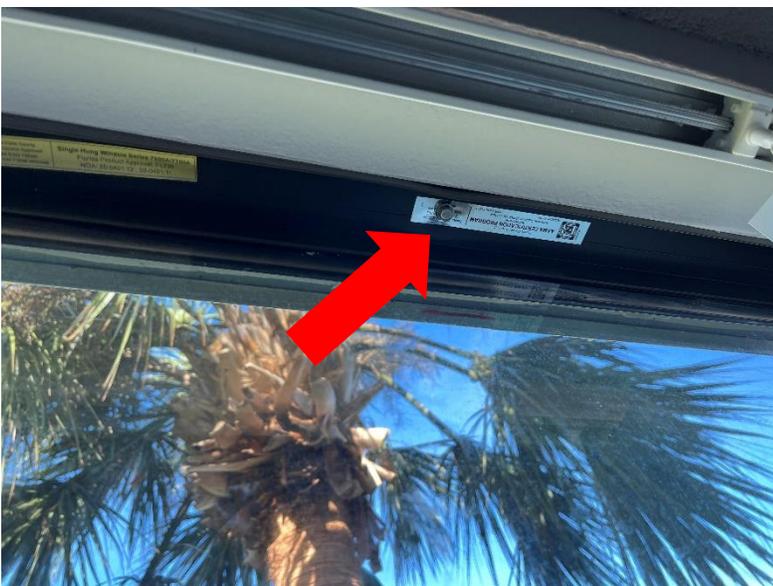
PHOTOGRAPH #2

**BUILDING 8
UNIT 828**

One #12 SMS installed at the head, thru the frame (similar to flange installation) as per PGT engineering letter and approval.

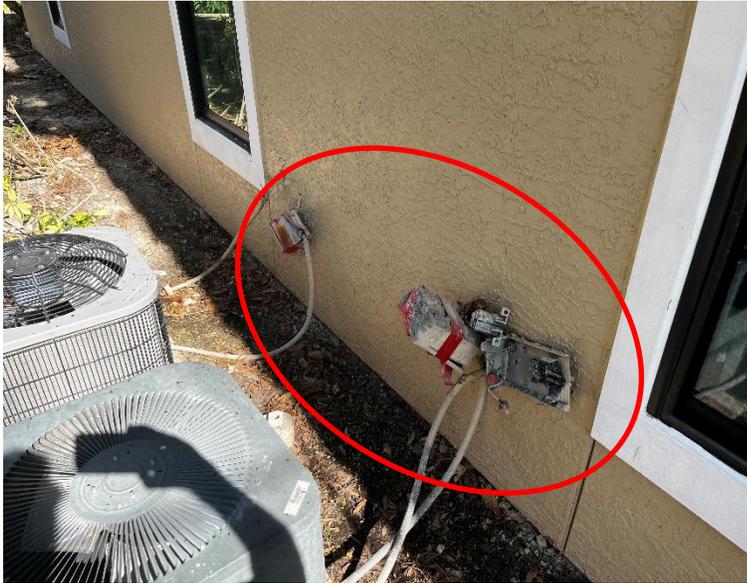
PHOTOGRAPH #3

**BUILDING 13
SECTION H**

Electrical A/C boxes have not yet been re attached and sealed to stucco wall.

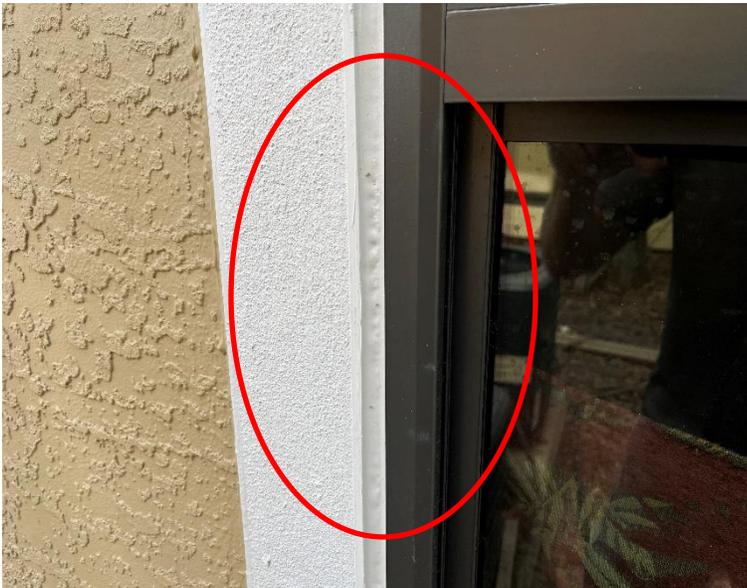
PHOTOGRAPH #4

**BUILDING 13
UNIT 1317**

New BASF urethane sealants at window perimeter appear to have bubbled and will require removal and replacement.

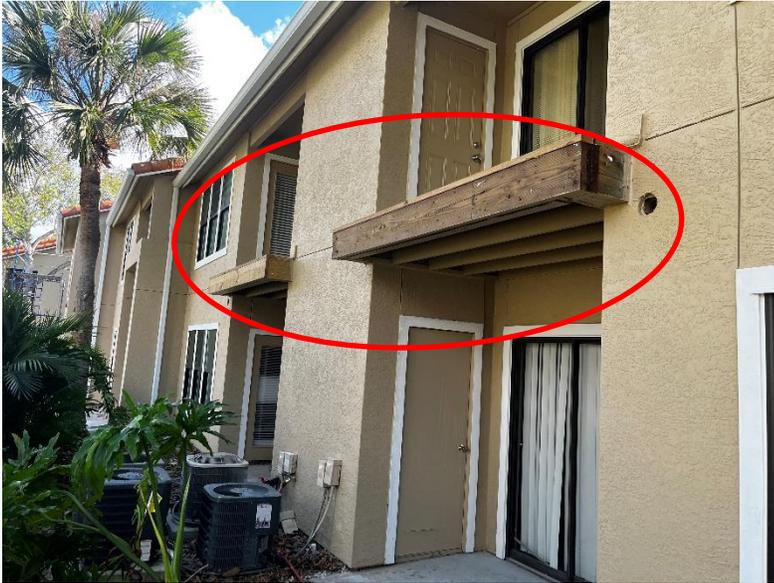
PHOTOGRAPH #5

**BUILDING 13
SECTION F**

New balcony built up beam repairs have not yet been covered with cedar fascia board as per plans and details

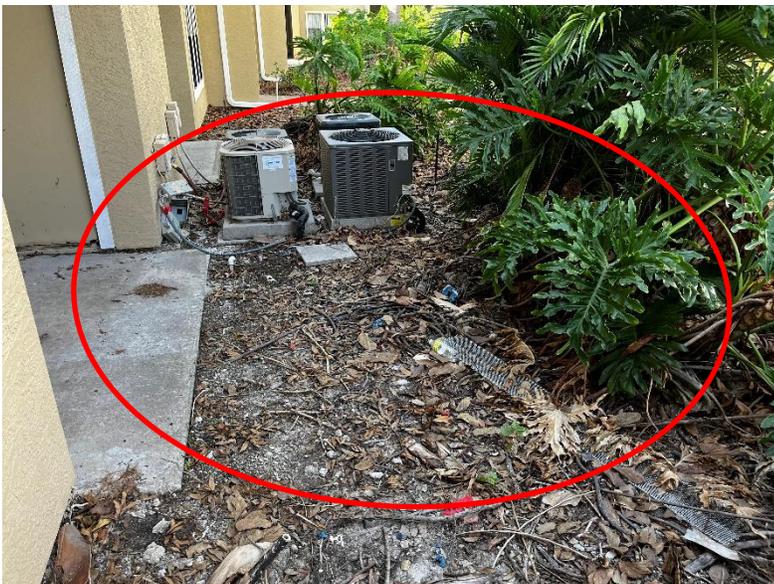
PHOTOGRAPH #6

**BUILDING 13
SECTION F**

Ground have not yet been cleaned from construction materials and rubbish.

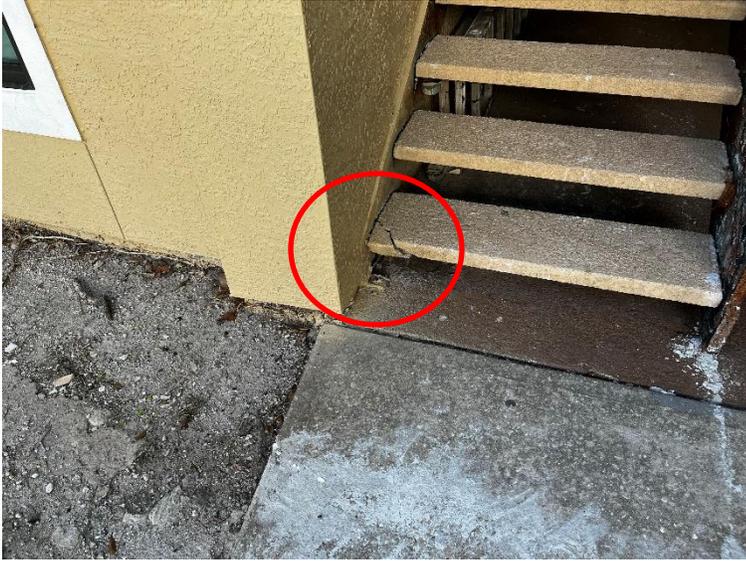
PHOTOGRAPH #7

**BUILDING 13
SECTION E BREEZEWAY**

Bottom step replacement has not yet been performed.

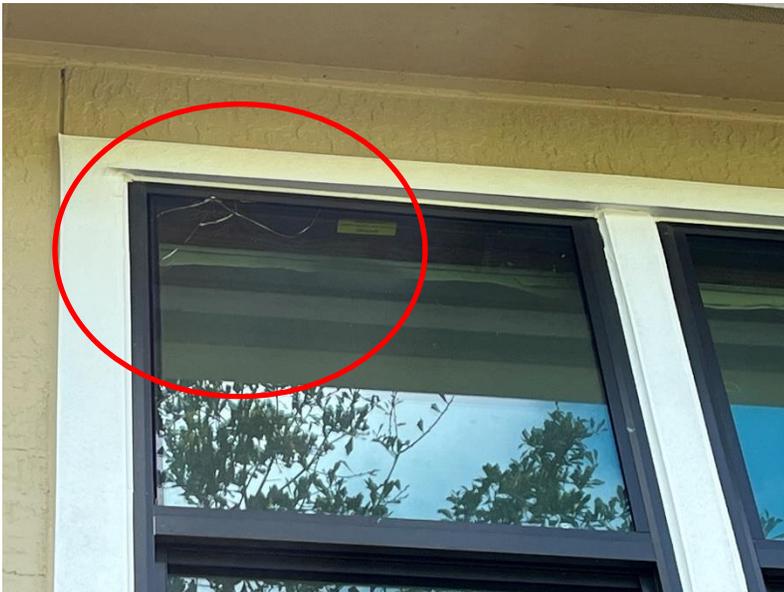
PHOTOGRAPH #8

**BUILDING 13
UNIT 1328**

New PGT window broken glass will be replaced.

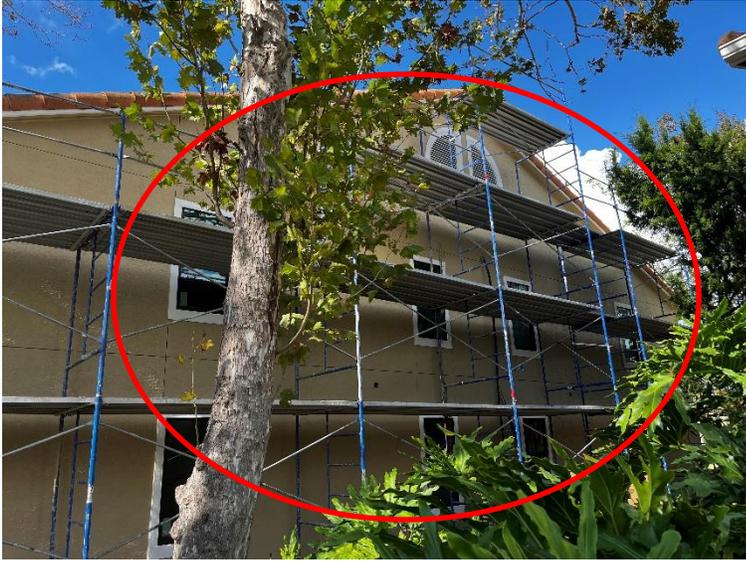
PHOTOGRAPH #9

**BUILDING 13
SECTION D**

RLJ has finish painted new stucco with Florida Paints Glades 100% acrylic wall and trim paint.

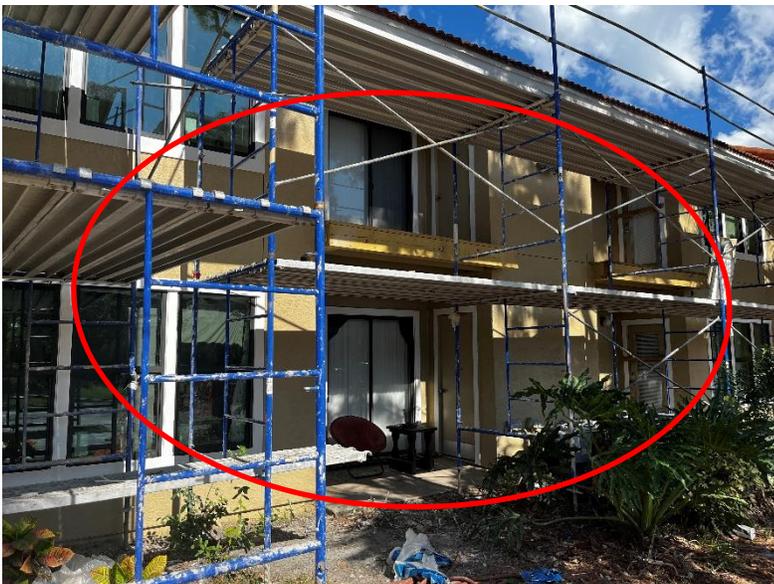
PHOTOGRAPH #10

**BUILDING 13
SECTION B**

RLJ has finish painted new stucco with Florida Paints Glades 100% acrylic wall and trim paint.

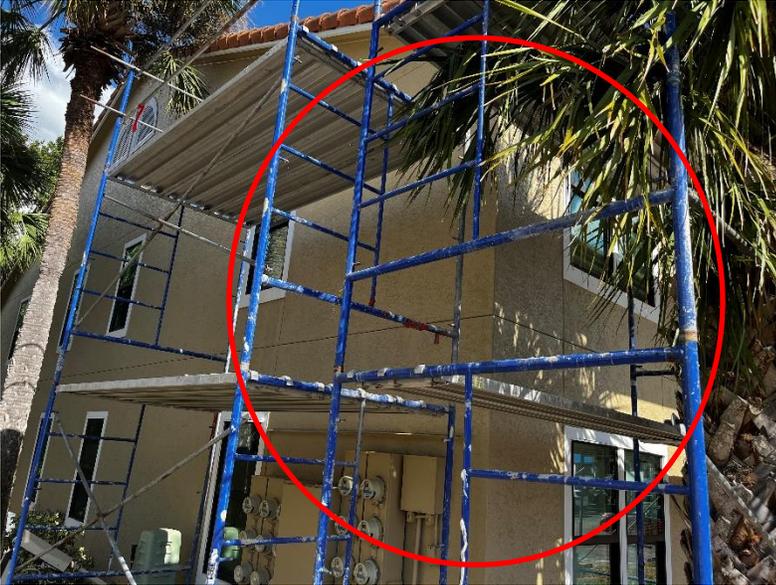
PHOTOGRAPH #11

**BUILDING 13
SECTION A**

RLJ has finish painted new stucco with Florida Paints Glades 100% acrylic wall and trim paint.

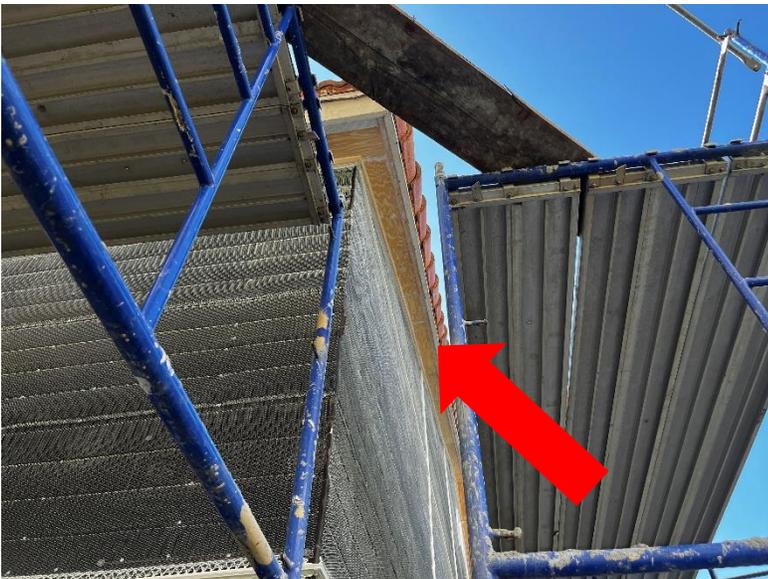
PHOTOGRAPH #12

**BUILDING 18
SECTION H**

New plywood and vinyl vents installed at soffit as per drawings.

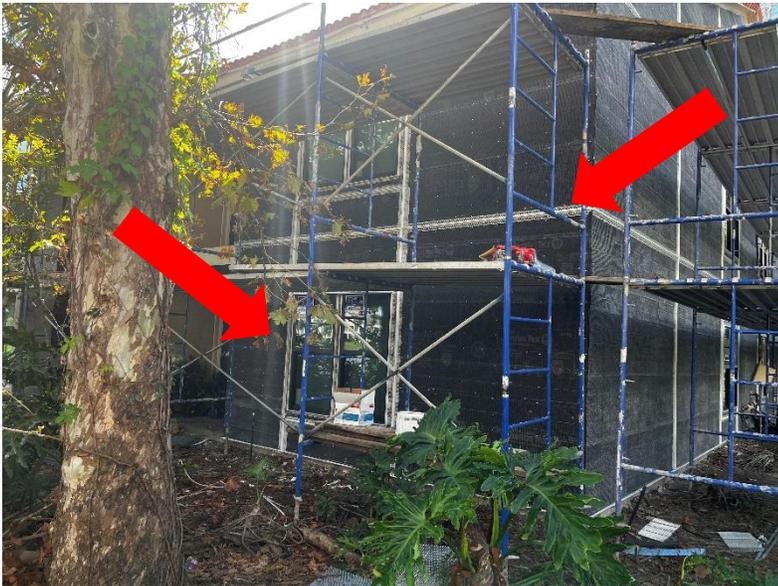
PHOTOGRAPH #13

**BUILDING 18
SECTION G**

Stucco sub-contractor has applied Henry Jumbo Tex 60 WRB and new vinyl stucco accessories as per drawings.

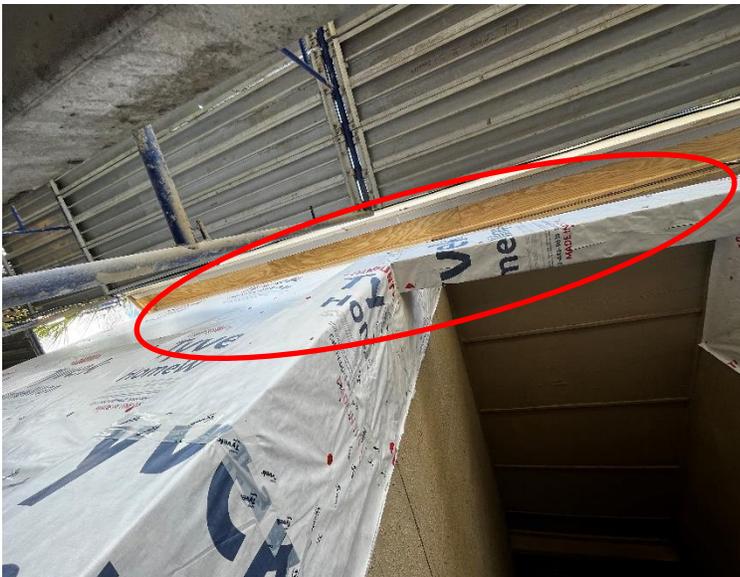
PHOTOGRAPH #14

**BUILDING 18
SECTION G**

New plywood and vinyl vents installed at soffit as per drawings.

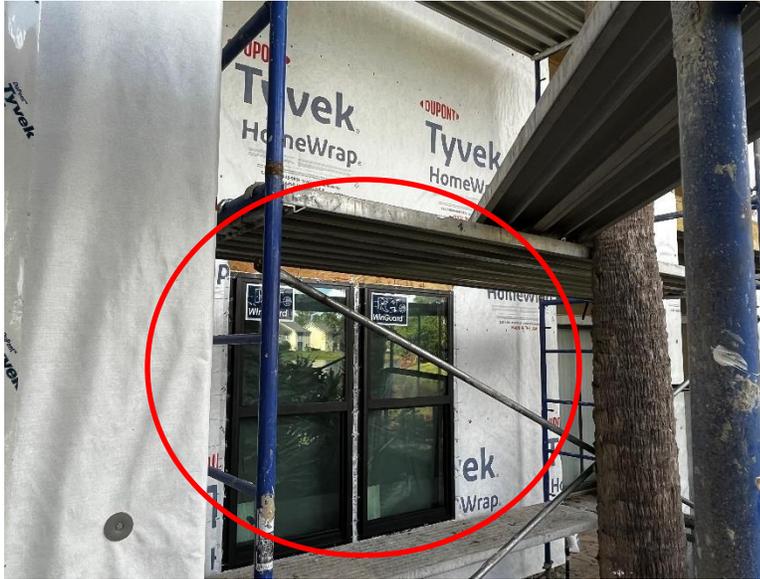
PHOTOGRAPH #15

**BUILDING 18
UNIT 1816**

New PGT SH7700A single hung LOW E aluminum windows installed with Dupont Tyvek flashing system as per drawings and specifications.

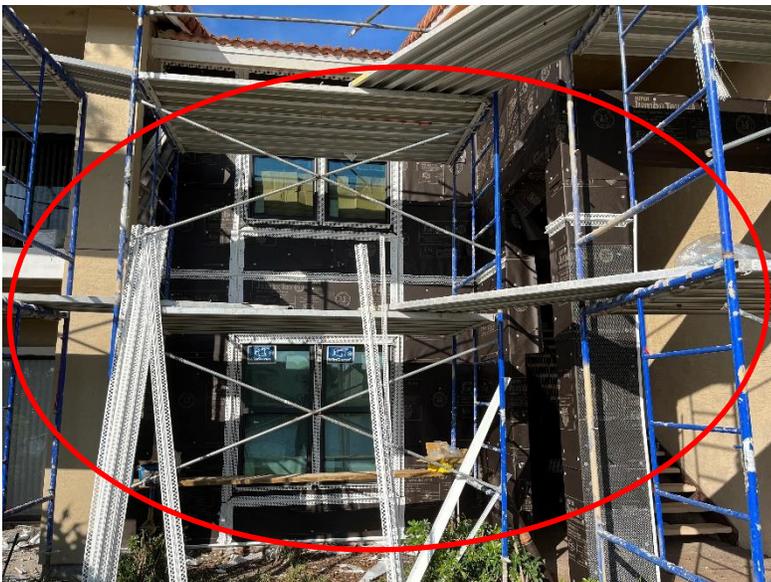
PHOTOGRAPH #16

**BUILDING 18
SECTION F**

Stucco sub-contractor applying Henry Jumbo Tex 60 WRB and new vinyl stucco accessories as per drawings.

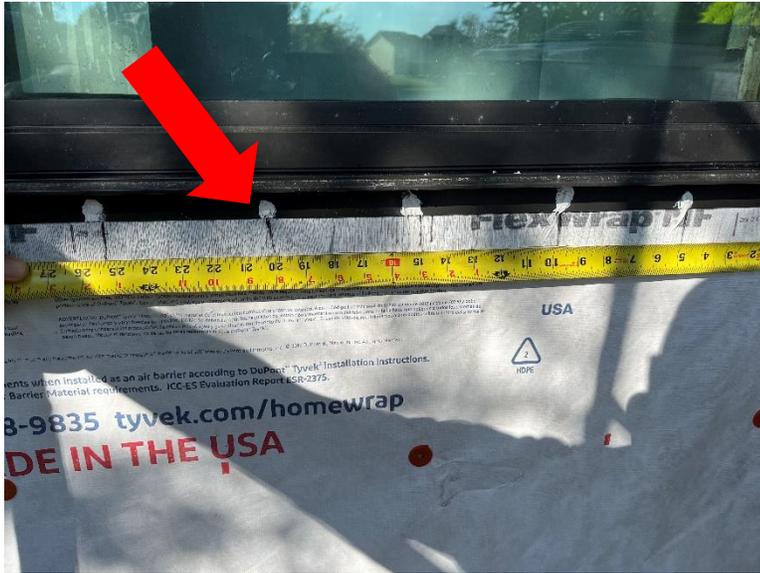
PHOTOGRAPH #17

**BUILDING 18
SECTION E**

New PGT SH7700A single hung aluminum windows attached at flange to framing with 8d common nails at 5" O.C as per Manufacturer's NOA.

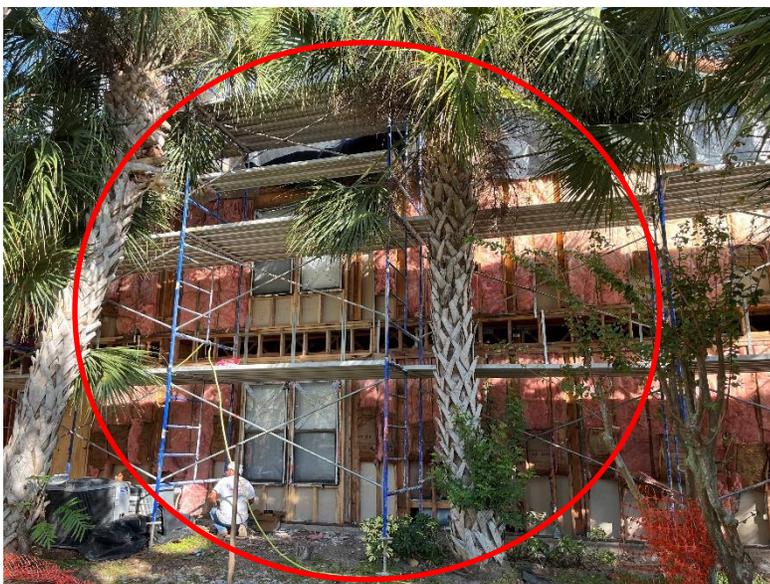
PHOTOGRAPH #18

**BUILDING 18
SECTION D**

RLJ in process of installing Simson Strong Tie connectors at gable end wall per drawings.

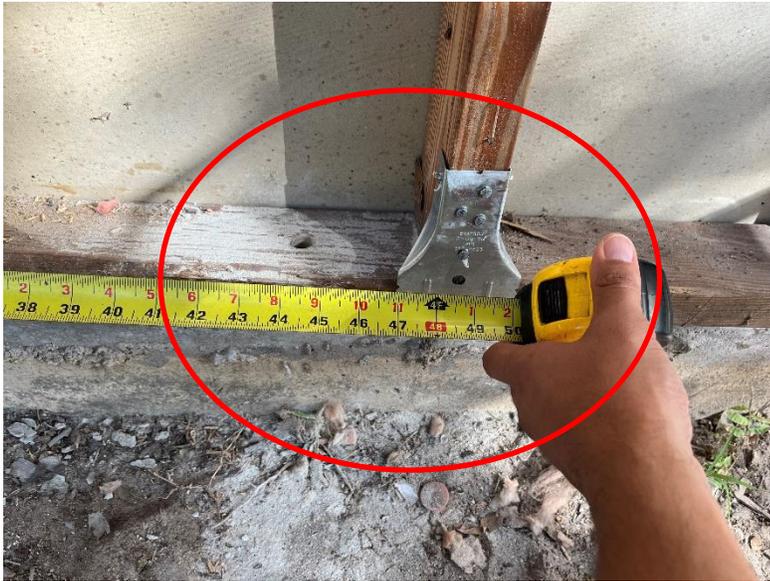
PHOTOGRAPH #19

**BUILDING 18
SECTION D**

Simpson Strong – Tie SP1 connector attaching gable end wall stud to sill plate @ 48" O.C. as per drawings.

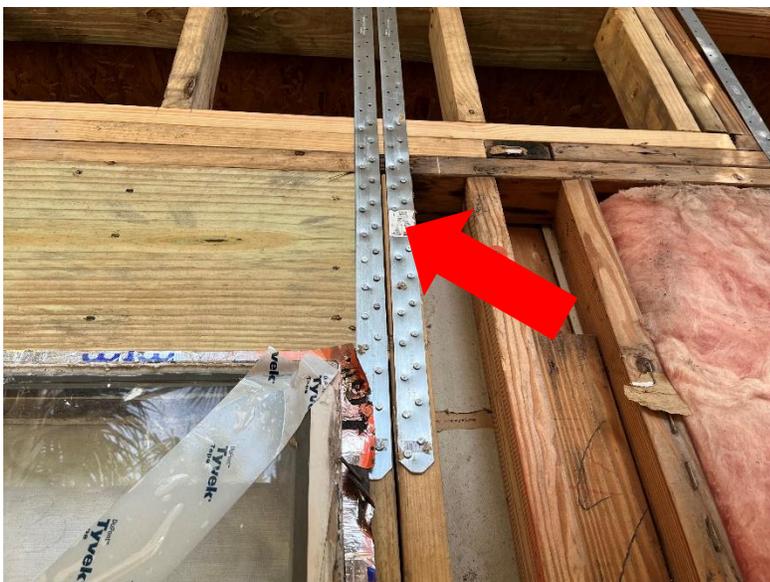
PHOTOGRAPH #20

**BUILDING 18
SECTION D**

Simpson Strong – Tie MSTA49 connector attaching studs above to stud/header below as per drawings.

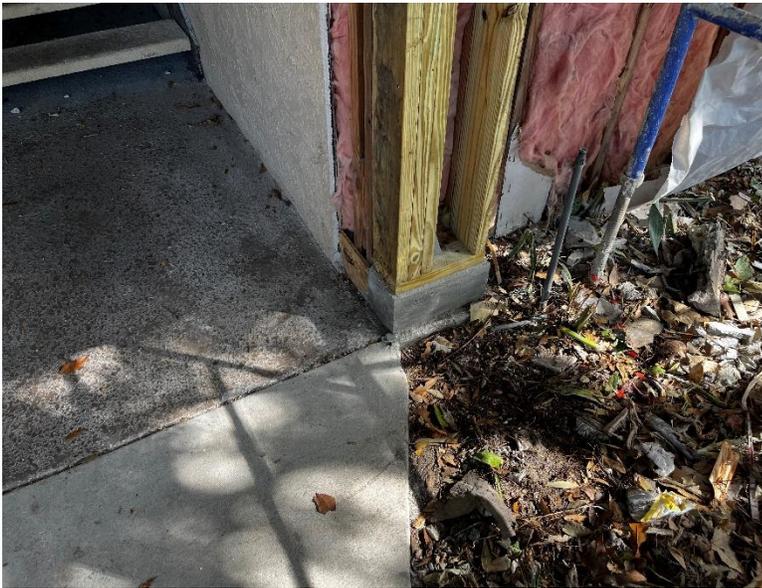
PHOTOGRAPH #21

**BUILDING 18
SECTION C BREEZWWAY**

New concrete poured pedestal installed for breezeway framing repair as per drawings.

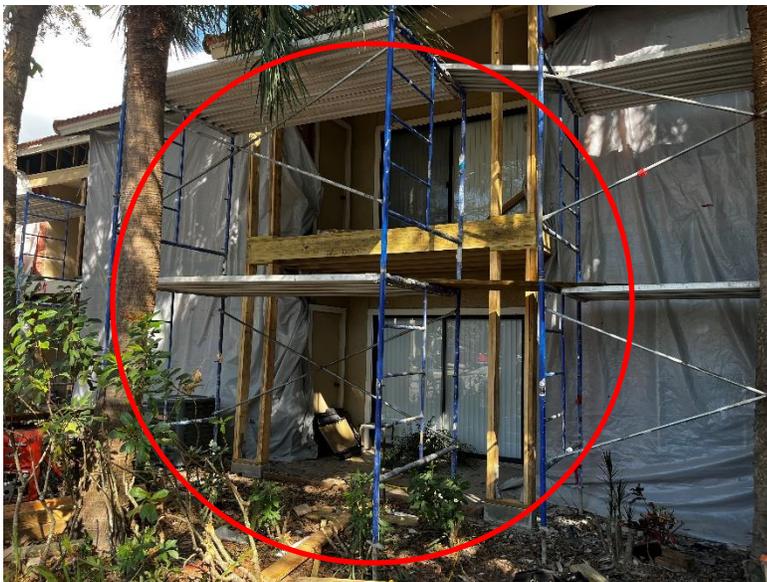
PHOTOGRAPH #22

**BUILDING 18
UNIT 1815**

Full balcony built up beams and columns repair performed as per drawings.

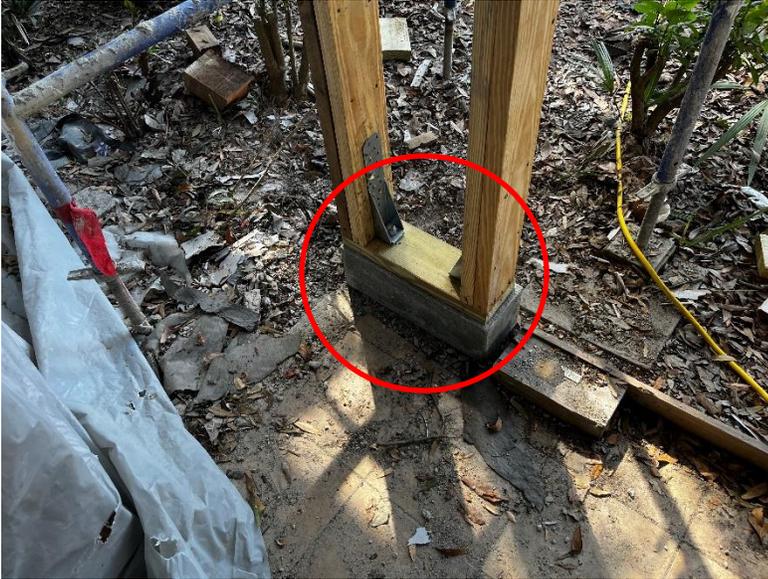
PHOTOGRAPH #23

**BUILDING 18
UNIT 1815**

New concrete poured pedestal installed for new balcony framing repair as per drawings.

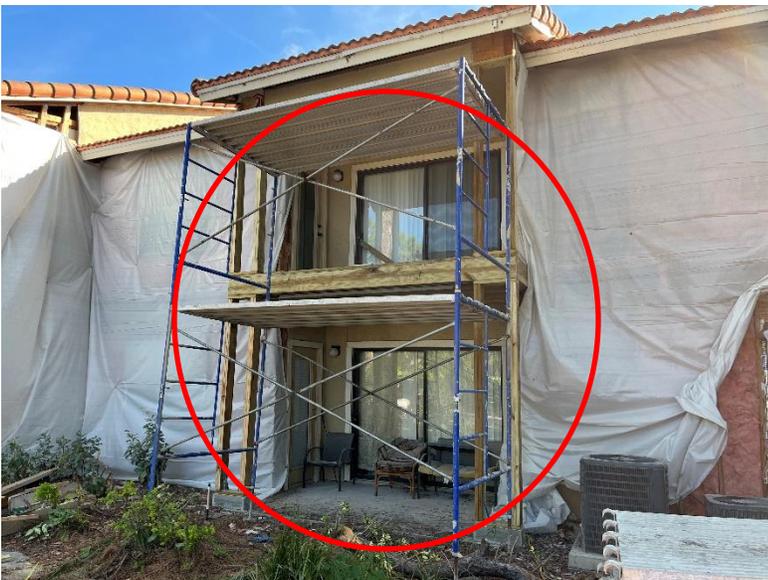
PHOTOGRAPH #24

**BUILDING 18
UNIT 1813**

Full balcony built up beams and columns repair performed as per drawings.
