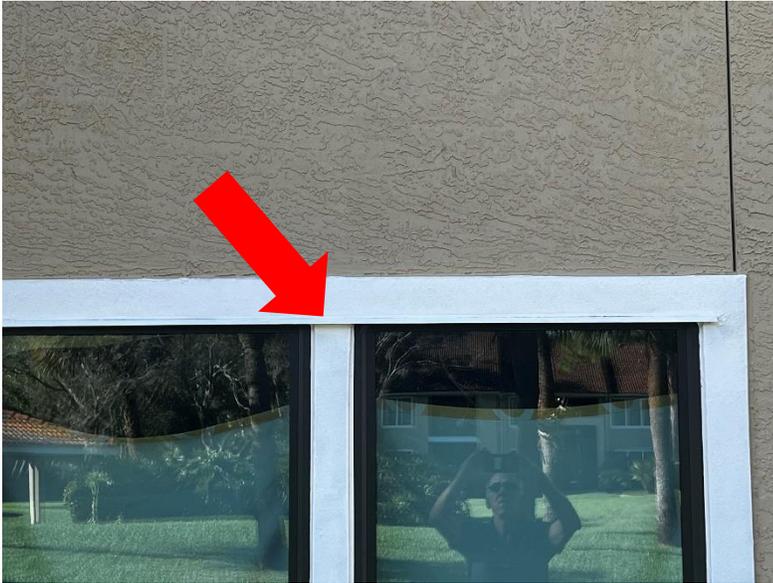
**PHOTOGRAPH #1**

**BUILDING 13  
SECTION F**

Several windows have stucco filling head flashing that needs to remain open for function of weep detail.

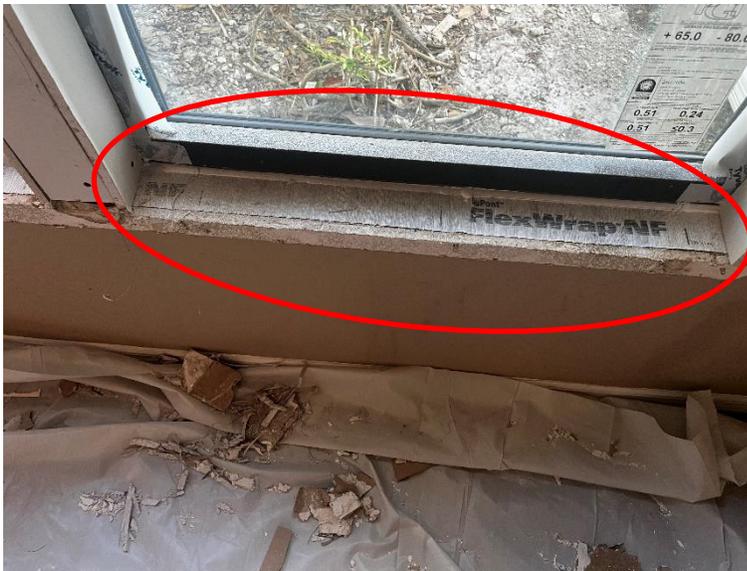
**PHOTOGRAPH #2**

**BUILDING 13  
SECTION F - UNIT 1316**

Interior bead of sealant installed from window frame to Tyvek flashings as per drawings and new drywall installation in progress.

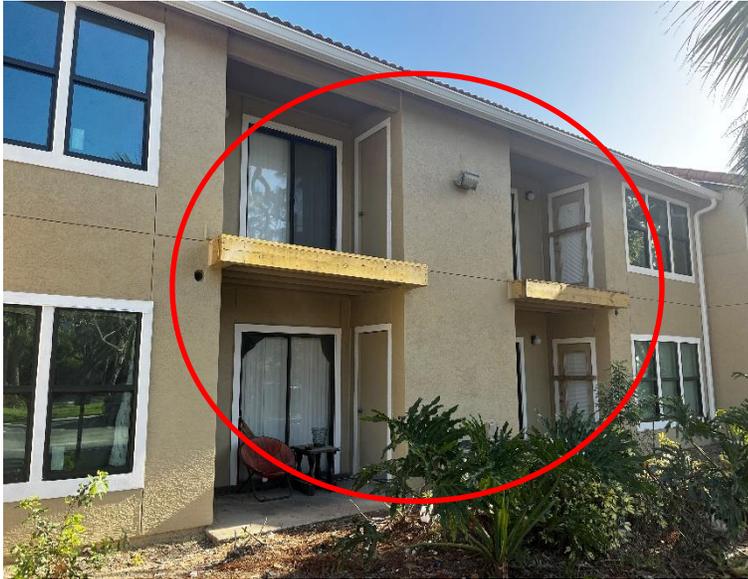
**PHOTOGRAPH #3**

**BUILDING 13  
SECTION B**

Cedar cover boards have not yet been applied to new built-up beam repairs at upper balconies.

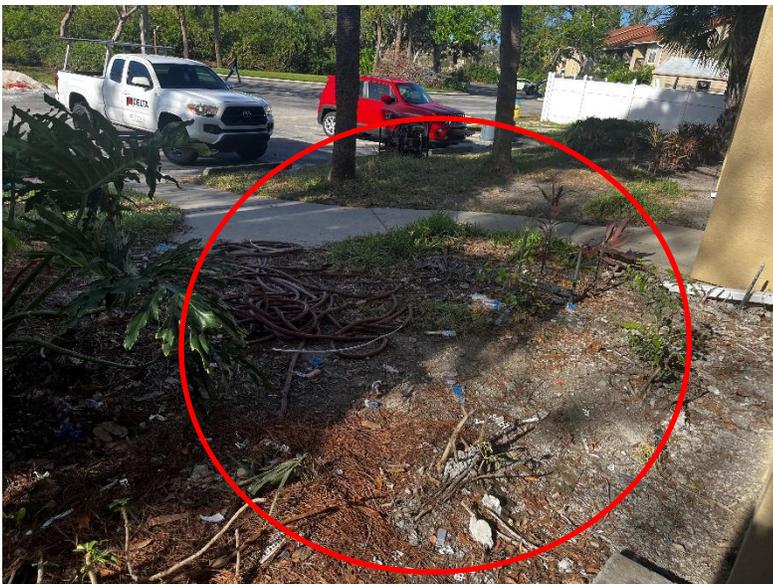
**PHOTOGRAPH #4**

**BUILDING 13  
SECTION B**

Clean up of stucco and construction debris in progress.

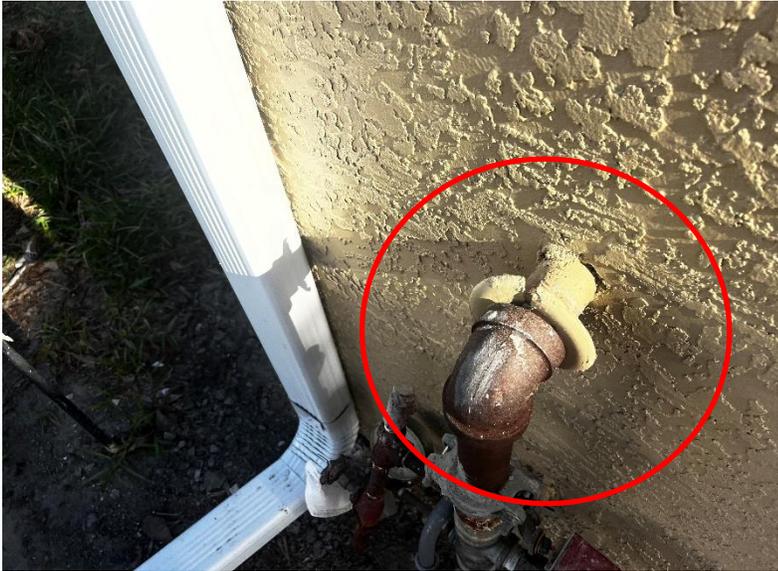
**PHOTOGRAPH #5**

**BUILDING 13  
SECTION A**

Gas pipe penetration through stucco wall has not yet been sealed as per specifications.

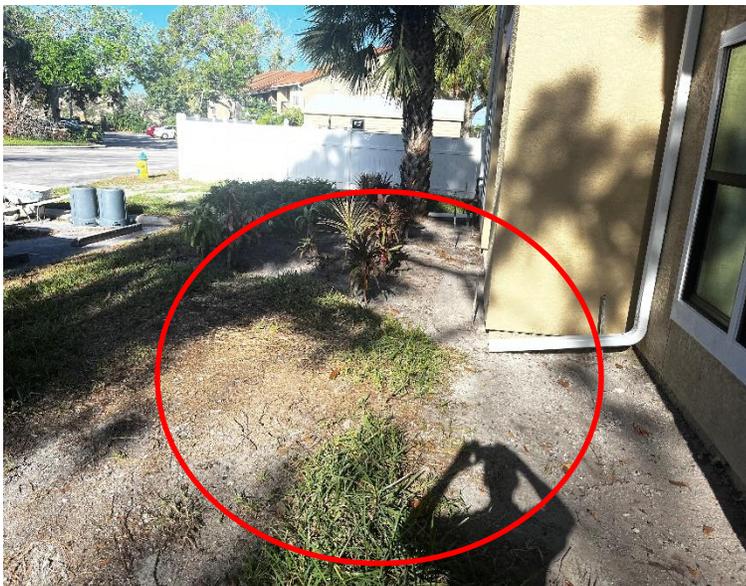
**PHOTOGRAPH #6**

**BUILDING 13  
SECTION A**

Stucco and construction debris has been cleaned up in this area.

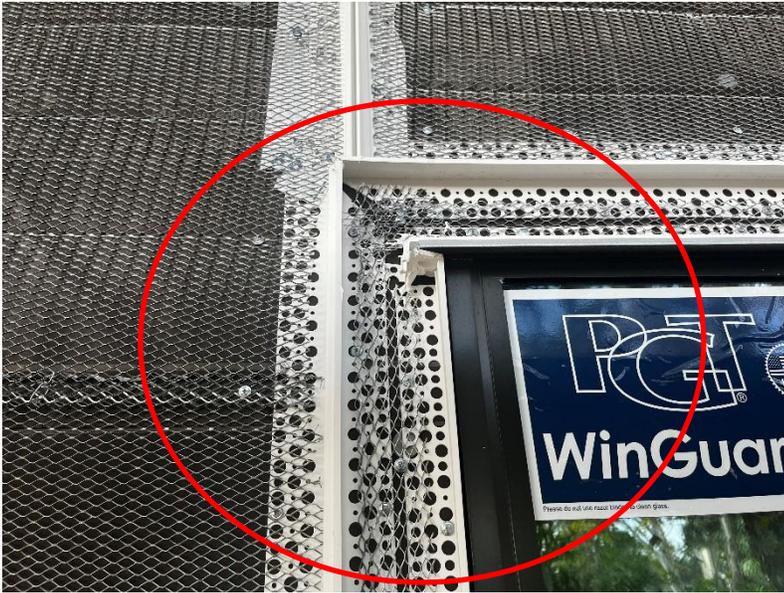
**PHOTOGRAPH #7**

**BUILDING 18  
SECTION F**

New vinyl stucco accessories and joints fastened to framing at no more than 7" intervals and new sealants installed at butts and corners.

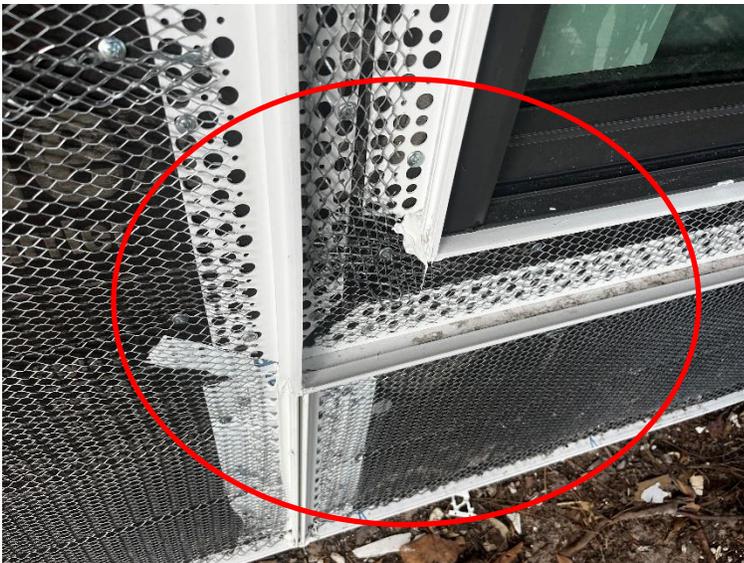
**PHOTOGRAPH #8**

**BUILDING 18  
SECTION F**

New vinyl stucco accessories and joints fastened to framing at no more than 7" intervals and new sealants installed at butts and corners.

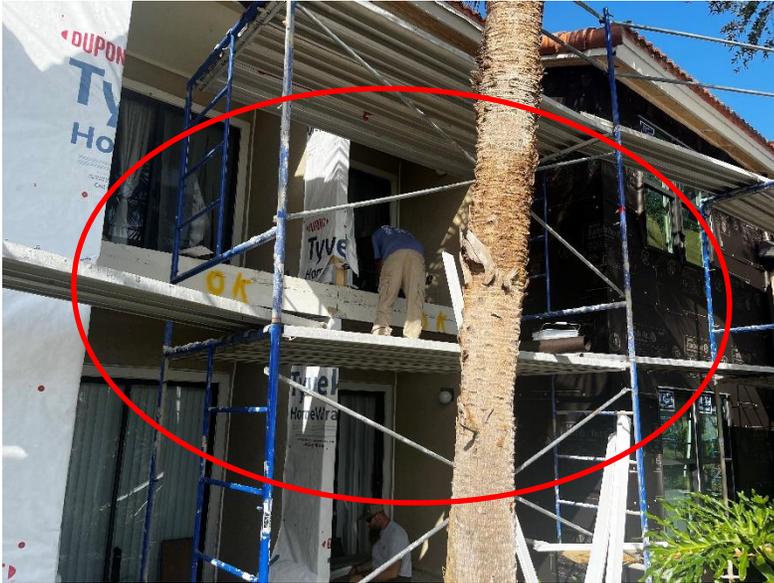
**PHOTOGRAPH #9**

**BUILDING 18  
SECTION F**

RLJ installing new kick out flashings at upper balconies as per drawings and specifications.

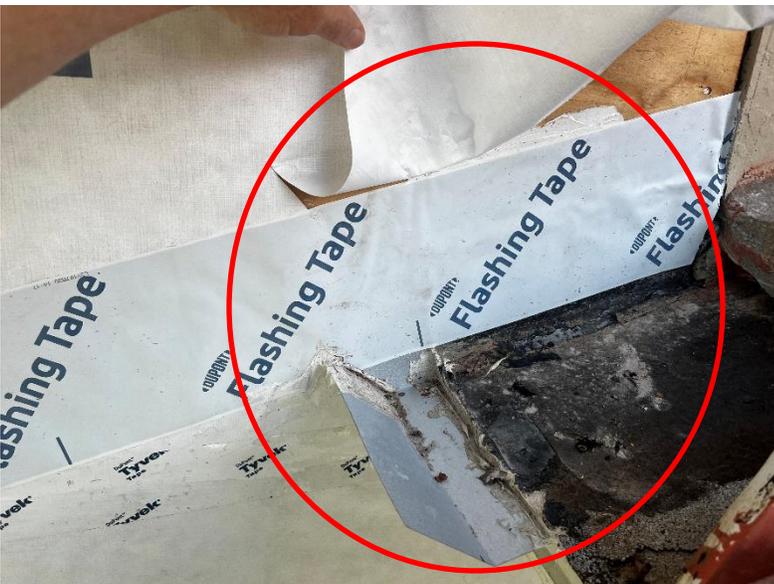
**PHOTOGRAPH #10**

**BUILDING 18  
SECTION F**

RLJ installing new kick out flashing details at roof locations per drawings and specifications before roof tile is reinstalled.

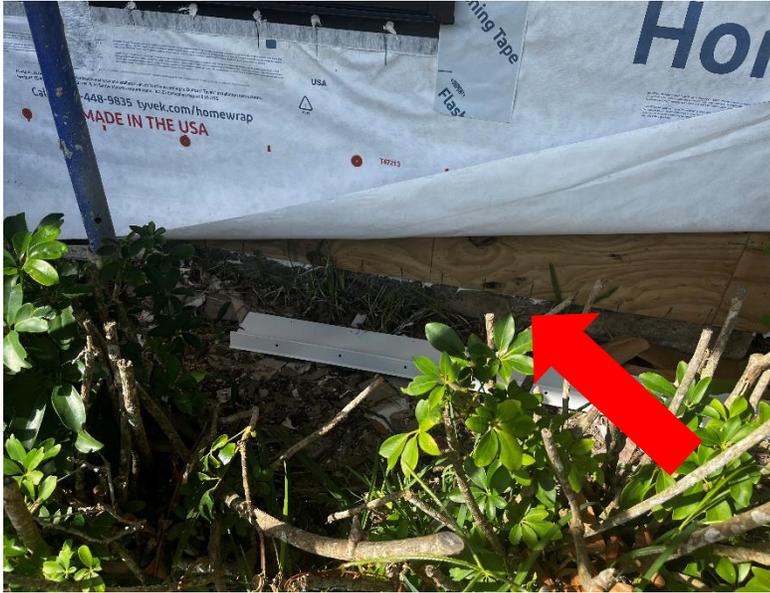
**PHOTOGRAPH #11**

**BUILDING 18  
SECTION E**

New sealants installed at base plate to foundation slab and base plate to new plywood sheathing as per drawings.

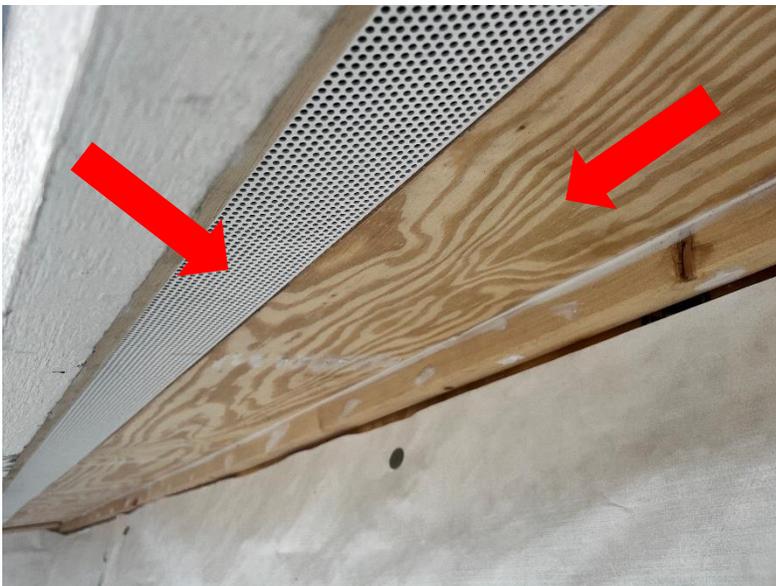
**PHOTOGRAPH #12**

**BUILDING 18  
SECTION E**

New plywood soffit and vinyl venting installed to replace existing as per drawings.

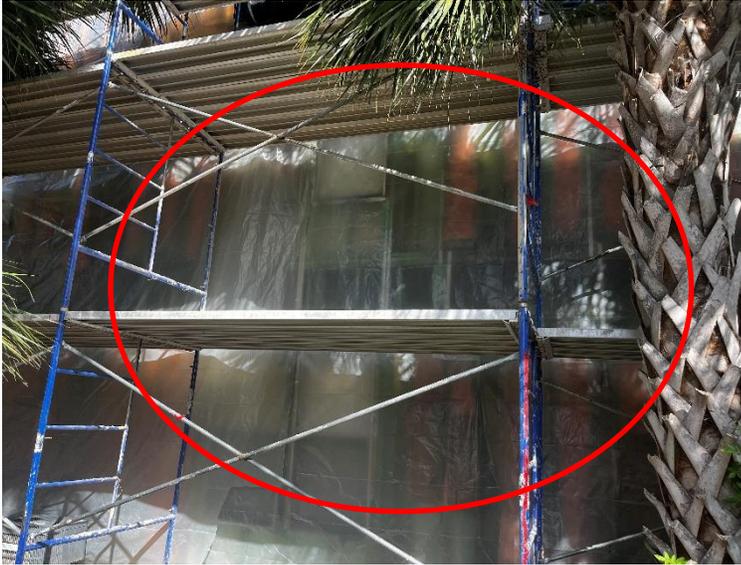
**PHOTOGRAPH #13**

**BUILDING 18  
SECTION D**

Pest contractor has applied Bora care termite treatment to gable end wall.

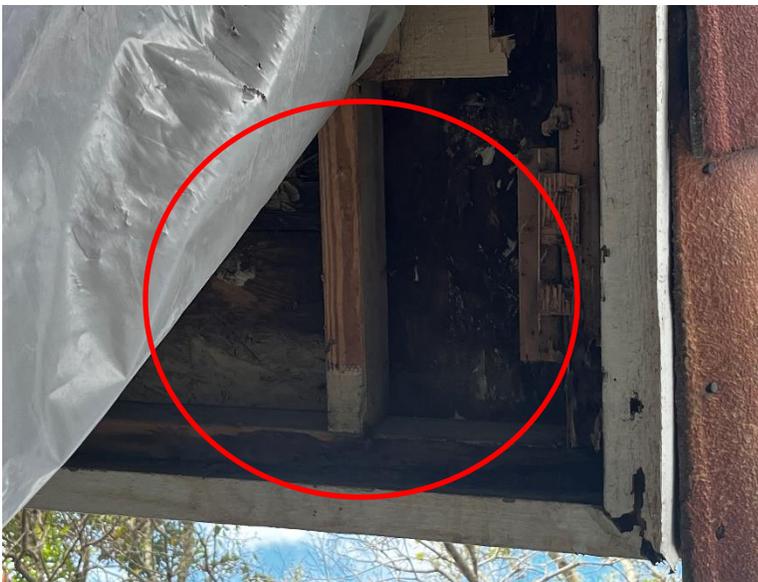
**PHOTOGRAPH #14**

**BUILDING 18  
SECTION B**

Existing roof sheathing has been damaged by leaks and is to be repaired by owners' contractors.

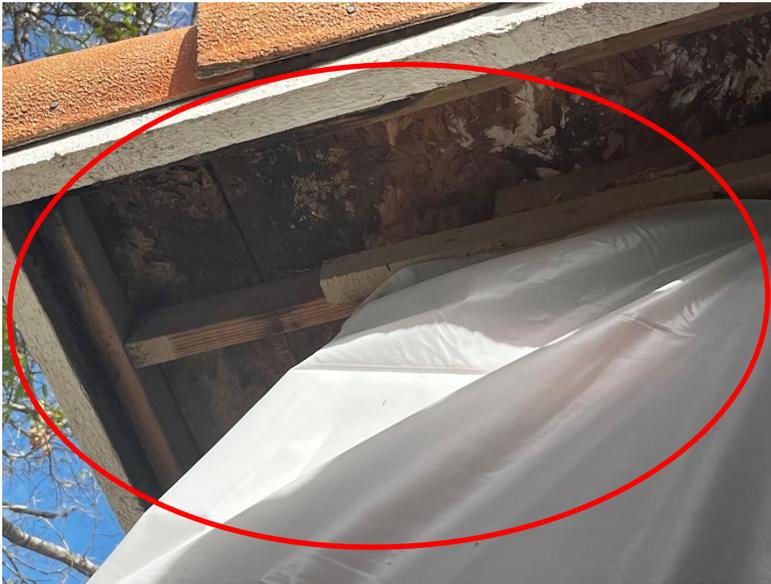
**PHOTOGRAPH #15**

**BUILDING 18  
SECTION B**

Existing roof sheathing has been damaged by leaks and is to be repaired by owners' contractors.

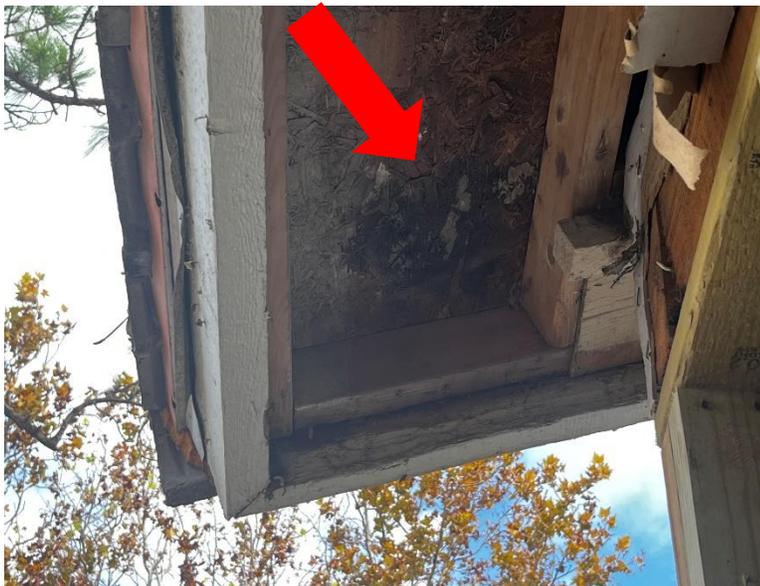
**PHOTOGRAPH #16**

**BUILDING 18  
SECTION E**

Existing roof sheathing has been damaged by leaks and is to be repaired by owners' contractors.
