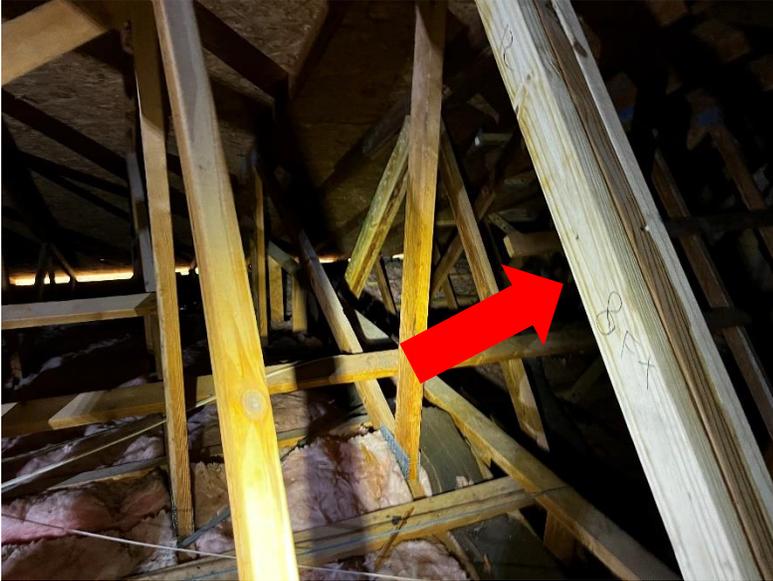
**PHOTOGRAPH #1**

**BUILDING 13  
SECTION H- UNIT #1321**

Contractor has performed scab repairs in attic at damaged trusses as per drawings.

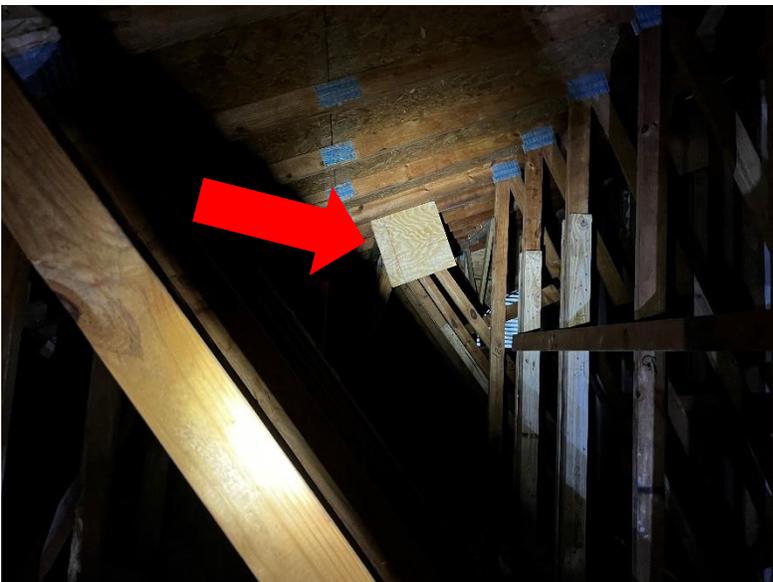
**PHOTOGRAPH #2**

**BUILDING 13  
SECTION H- UNIT #1321**

Contractor has performed gusset repairs in attic at truss connections as per drawings.

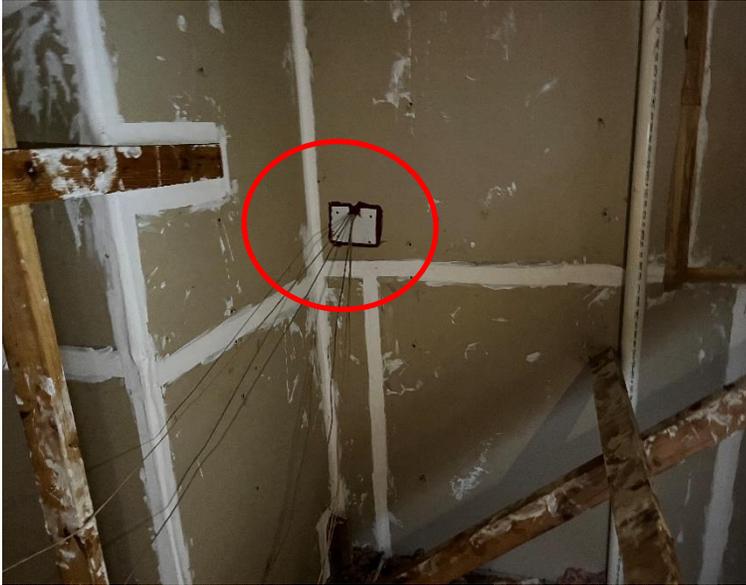
**PHOTOGRAPH #3**

**BUILDING 13  
SECTION H- UNIT #1321**

Contractor has performed fire board repairs in attic as per specifications.

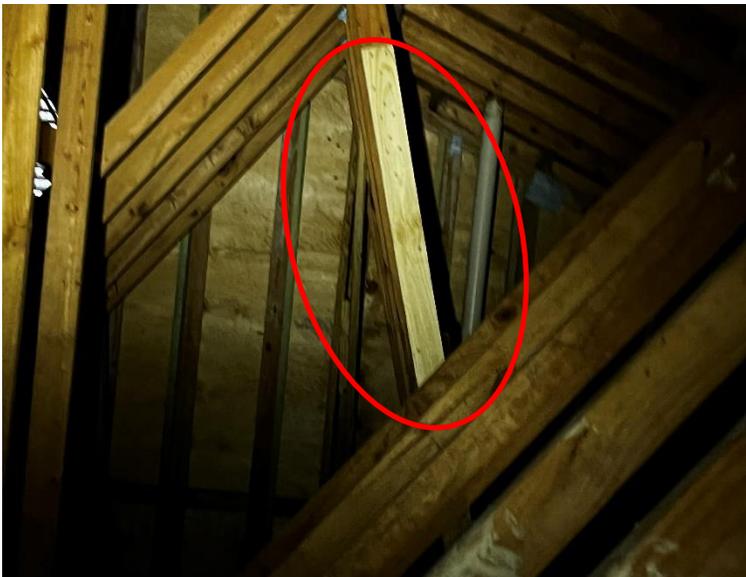
**PHOTOGRAPH #4**

**BUILDING 13  
SECTION H- UNIT #1322**

Contractor has performed scab repairs in attic at damaged trusses as per drawings.

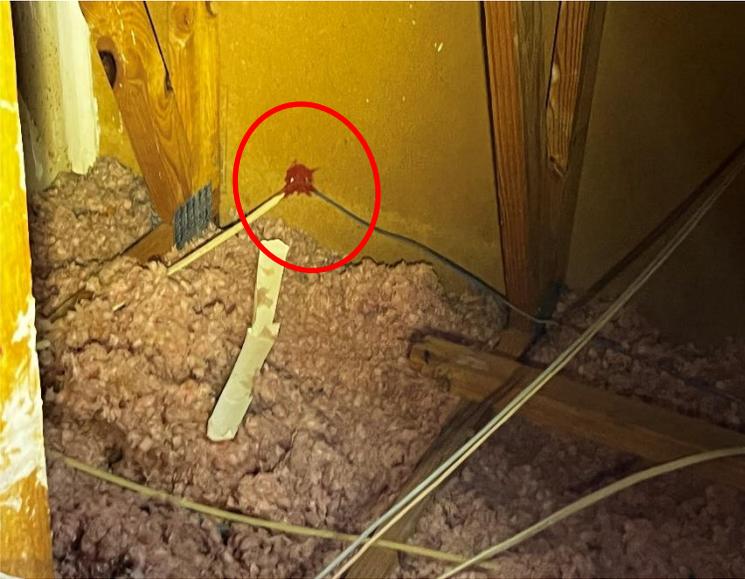
**PHOTOGRAPH #5**

**BUILDING 13  
SECTION H- UNIT #1322**

Contractor has performed fire caulk repairs in attic at fire walls as per drawings.

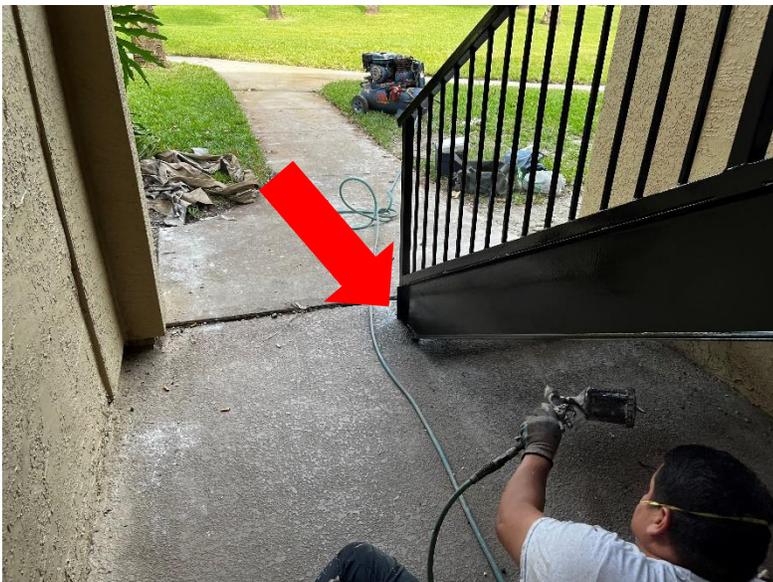
**PHOTOGRAPH #6**

**BUILDING 13  
SECTION G- BREZEWAY**

Contractor applying breezeway railing finish paint with conventional spray equipment.

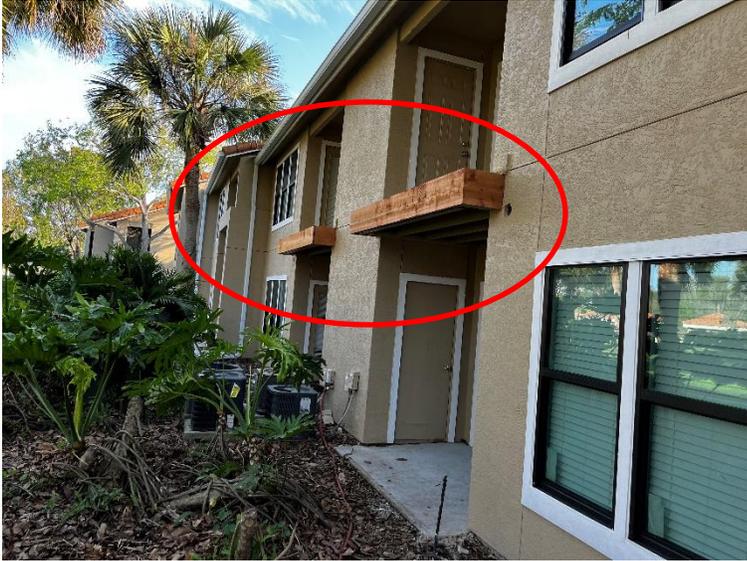
**PHOTOGRAPH #7**

**BUILDING 13  
SECTION F**

Cedar cover boards have been applied to new built-up beam repairs at upper balconies.

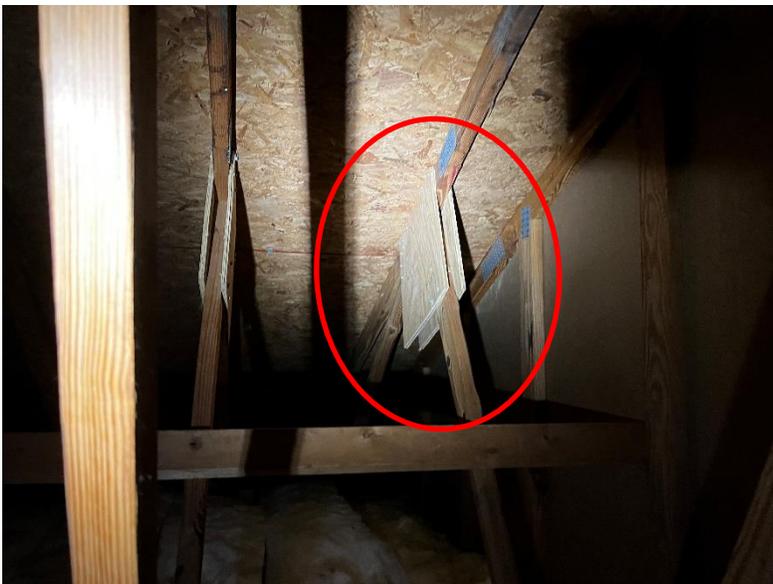
**PHOTOGRAPH #8**

**BUILDING 13  
SECTION F-UNIT #1324**

Contractor has performed gusset repairs in attic at truss connections as per drawings.

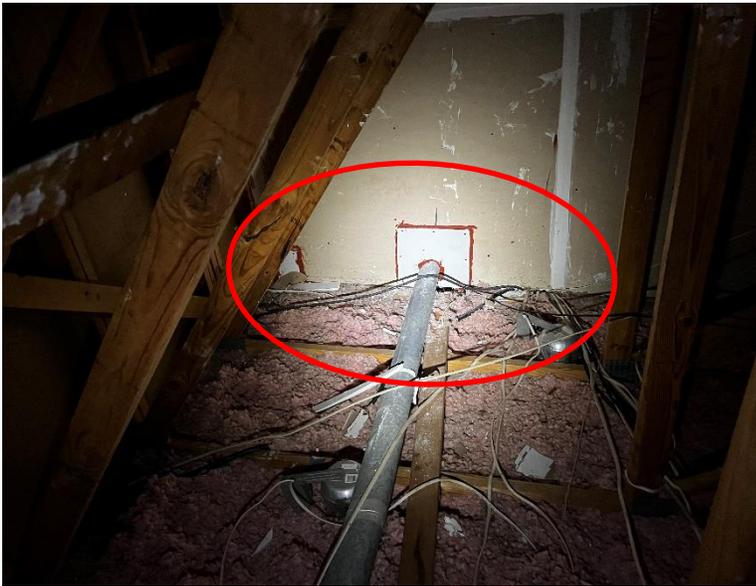
**PHOTOGRAPH #9**

**BUILDING 13  
SECTION F-UNIT #1324**

Contractor has performed fire board repairs in attic at fire walls as per drawings.

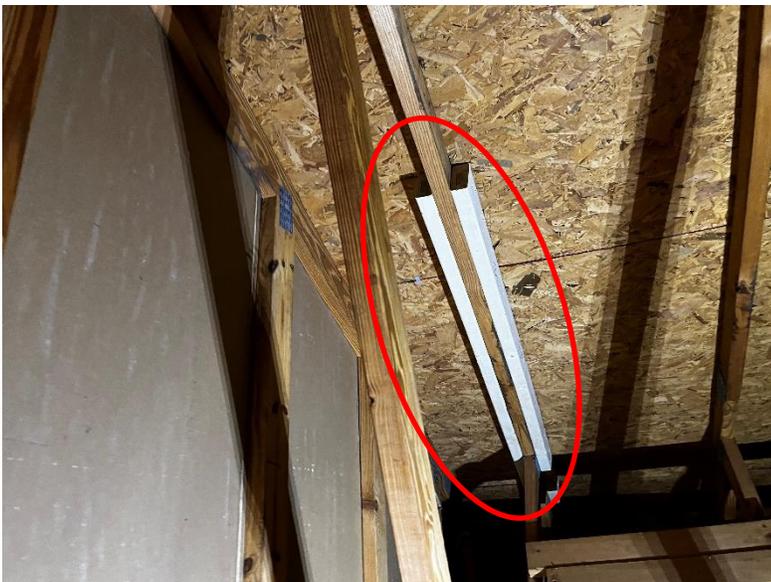
**PHOTOGRAPH #10**

**BUILDING 13  
SECTION F-UNIT #1326**

Contractor has performed scab repairs in attic at damaged trusses as per drawings.

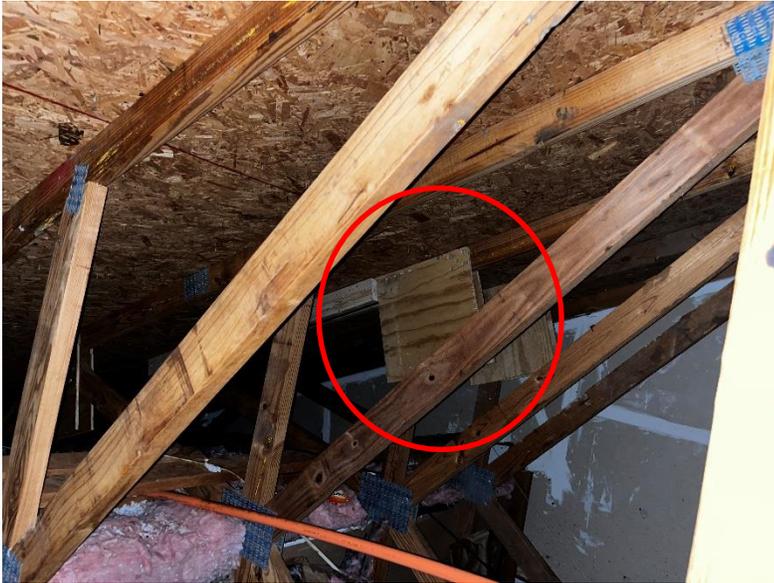
**PHOTOGRAPH #11**

**BUILDING 13  
SECTION F-UNIT #1326**

Contractor has performed gusset repairs in attic at truss connections as per drawings.

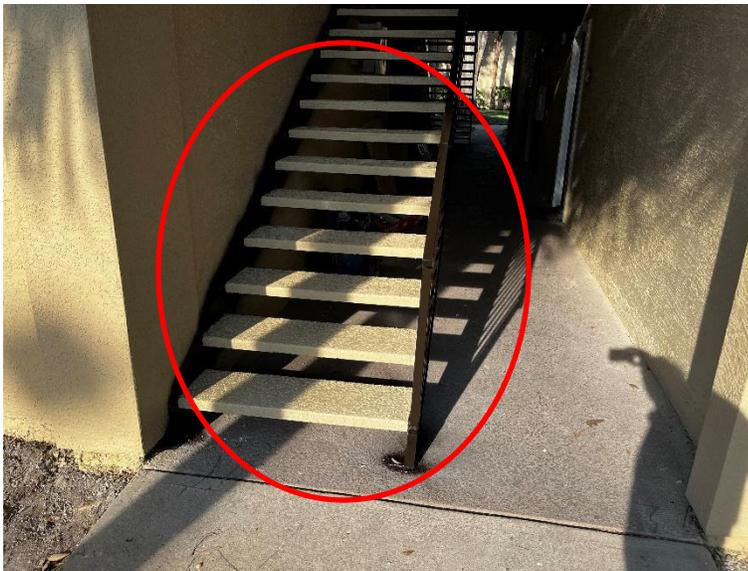
**PHOTOGRAPH #12**

**BUILDING 13  
SECTION E- BREEZEWAY**

Contractor has finish painted breezeway railings and steps with Florida Paint coatings as per specifications.

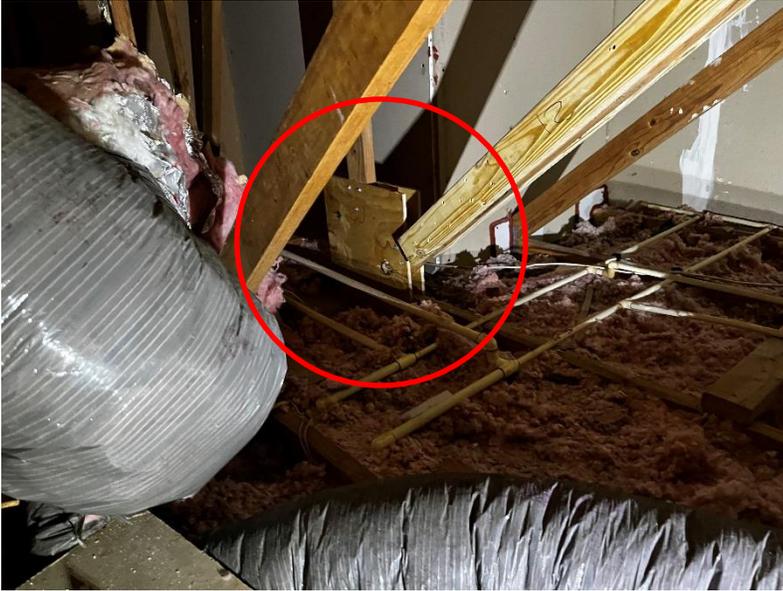
**PHOTOGRAPH #13**

**BUILDING 13  
SECTION D- UNIT #1328**

Contractor has performed gusset repairs in attic at truss connections as per drawings.

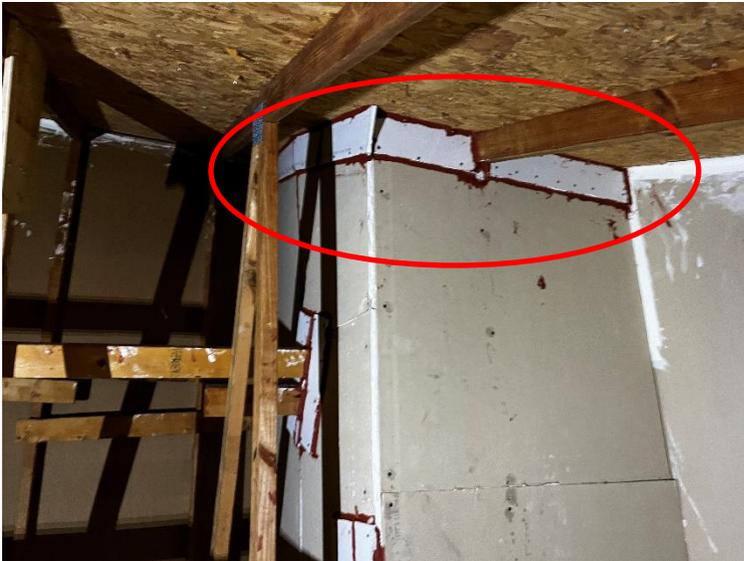
**PHOTOGRAPH #14**

**BUILDING 13  
SECTION D- UNIT #1328**

Contractor has performed fire board repairs in attic at fire walls as per drawings.

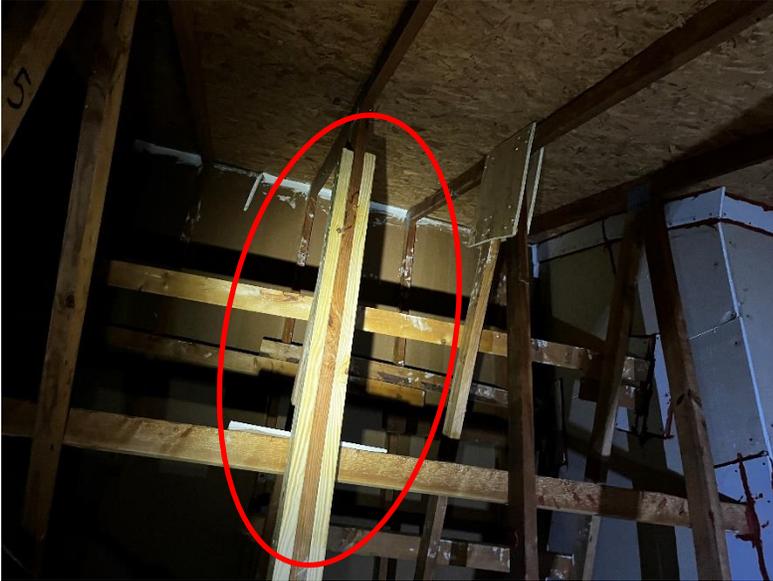
**PHOTOGRAPH #15**

**BUILDING 13  
SECTION D- UNIT #1328**

Contractor has performed scab repairs in attic at damaged trusses as per drawings.

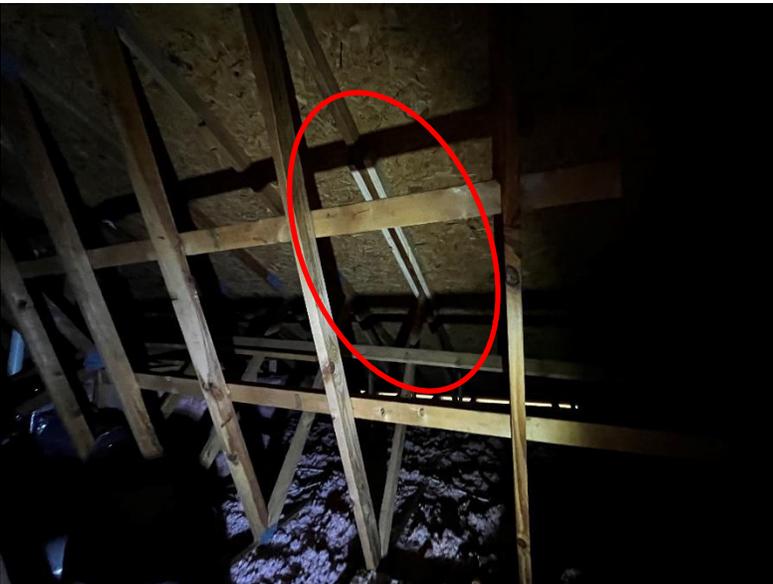
**PHOTOGRAPH #16**

**BUILDING 13  
SECTION B- UNIT #1325**

Contractor has performed scab repairs in attic at damaged trusses as per drawings.

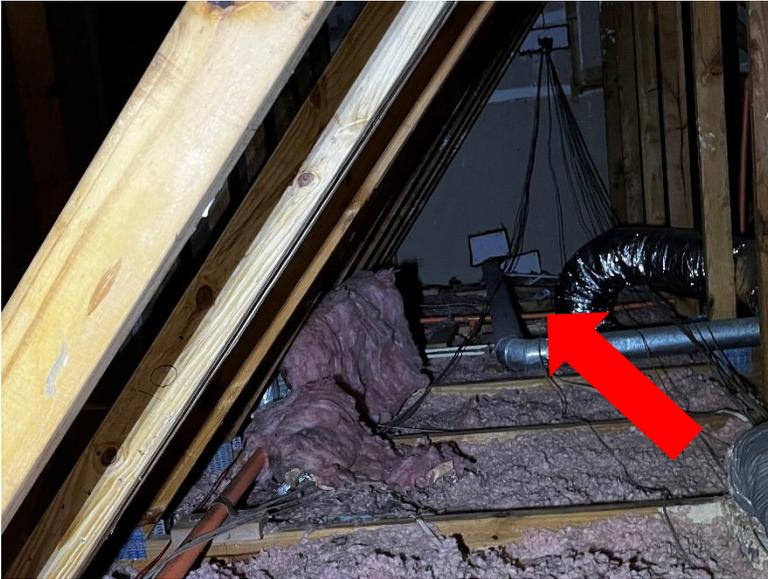
**PHOTOGRAPH #17**

**BUILDING 13  
SECTION B- UNIT #1325**

Contractor has performed fire board repairs in attic at fire walls as per drawings.

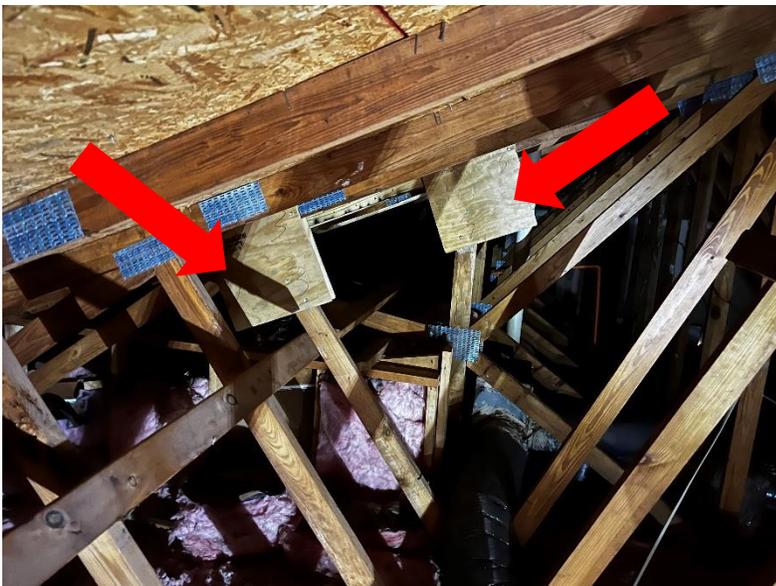
**PHOTOGRAPH #18**

**BUILDING 13  
SECTION B- UNIT #1323**

Contractor has performed gusset repairs in attic at truss connections as per drawings.

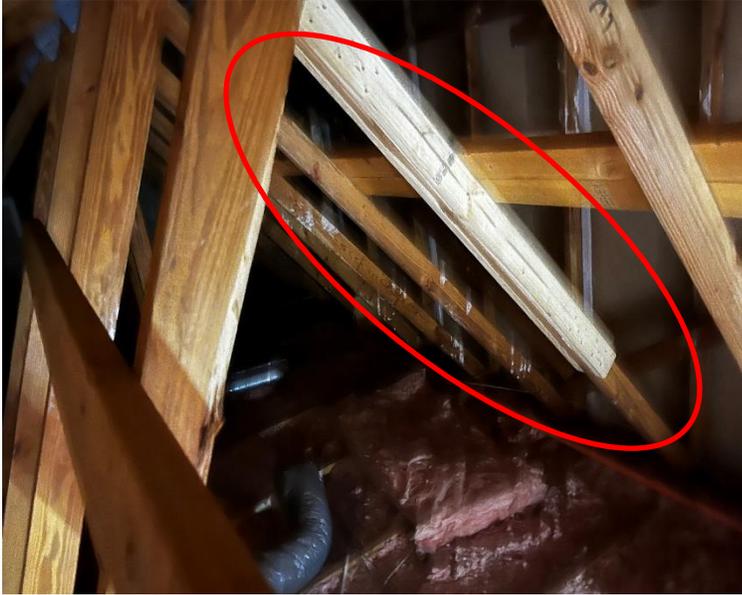
**PHOTOGRAPH #19**

**BUILDING 13  
SECTION B- UNIT #1323**

Contractor has performed scab repairs in attic at damaged trusses as per drawings.

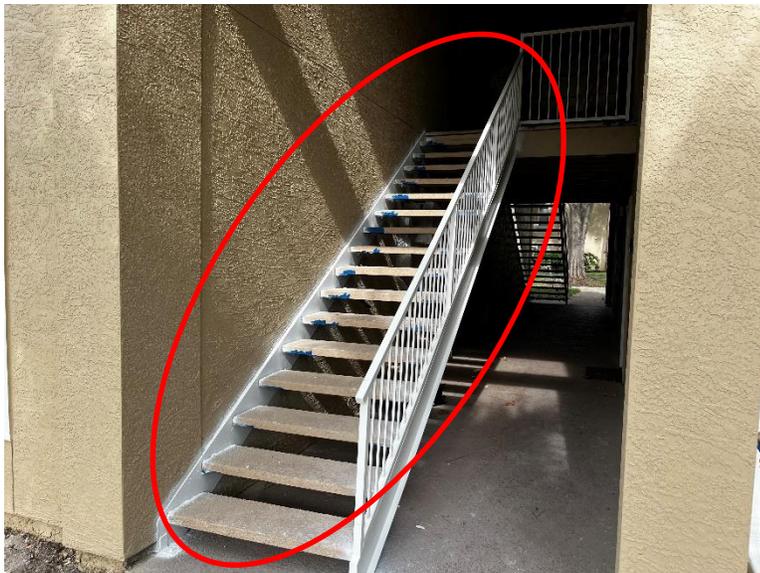
**PHOTOGRAPH #20**

**BUILDING 13  
SECTION A- BREEZEWAY**

Contractor has primed breezeway railings with Florida Paints Encapsulon Epoxy mastic primer.

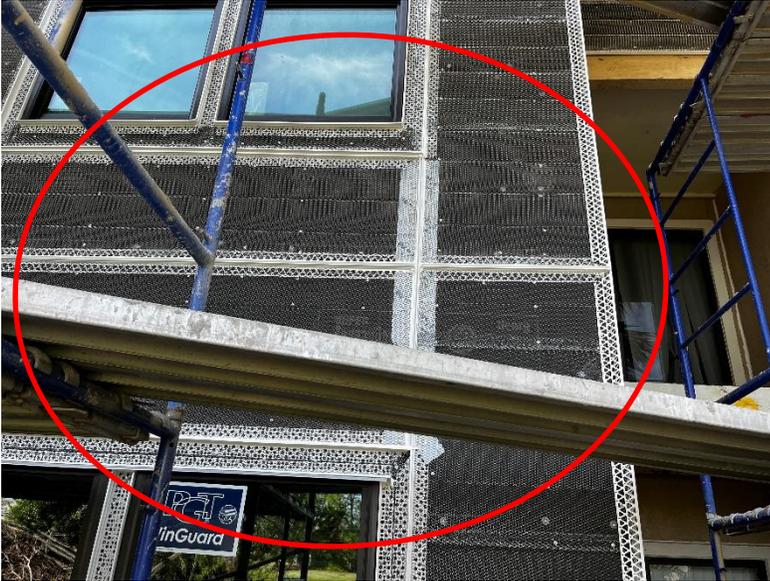
**PHOTOGRAPH #21**

**BUILDING 18  
SECTION F**

Stucco sub-contractors have installed galvanized lath and new vinyl stucco accessories.

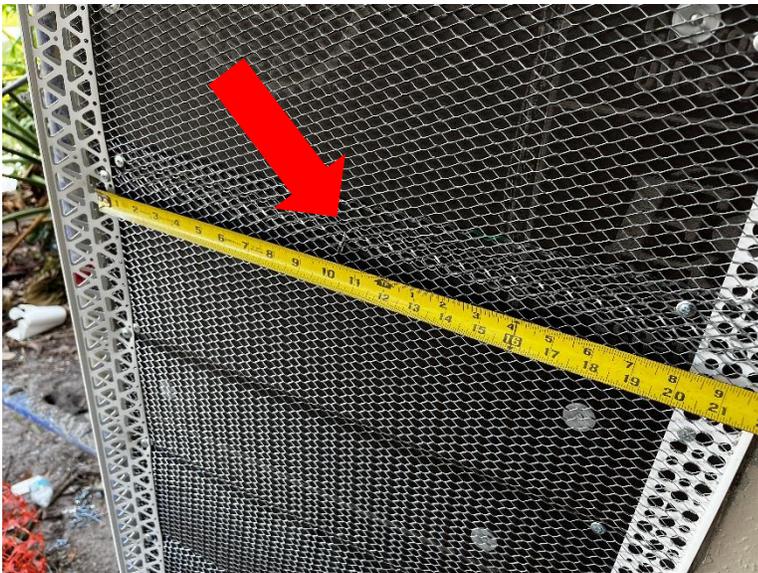
**PHOTOGRAPH #22**

**BUILDING 18  
SECTION F**

Overlapping galvanized lathing is tied between framing studs with SS wire at intervals no more than 9" O.C.

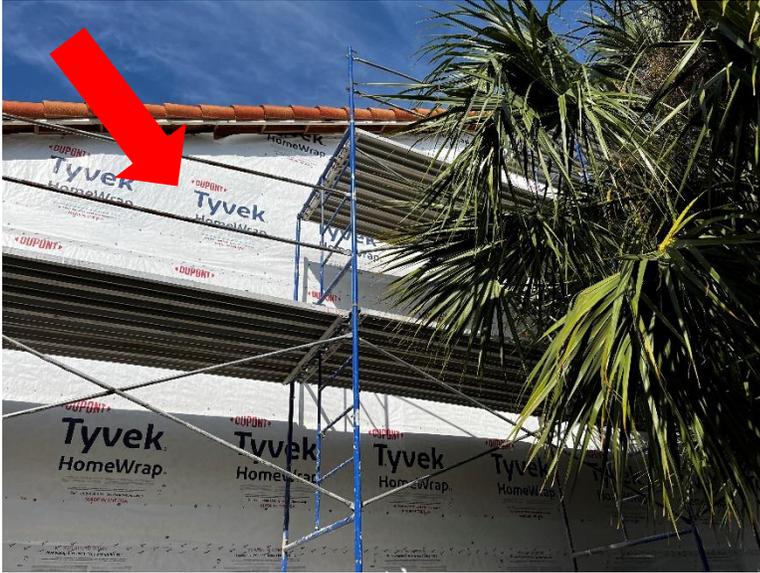
**PHOTOGRAPH #23**

**BUILDING 18  
SECTION D**

Gable end covered with Dupont Tyvek water resistant barrier.

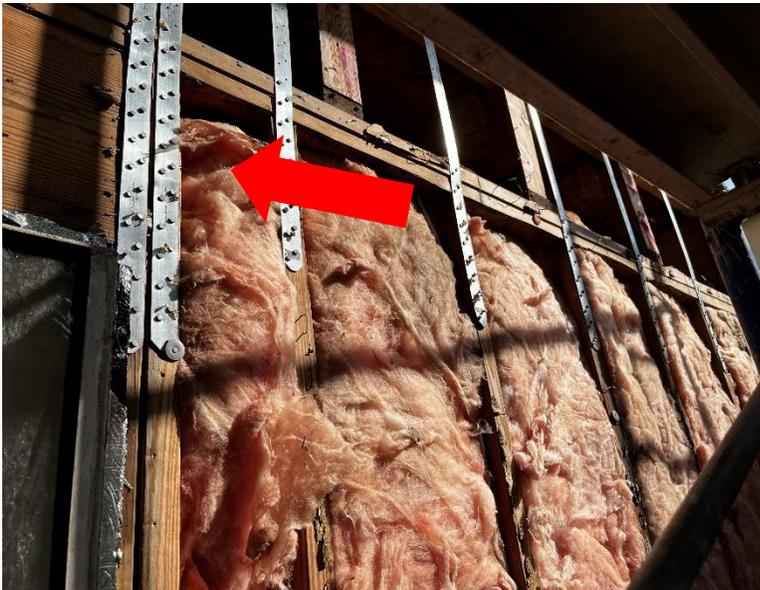
**PHOTOGRAPH #24**

**BUILDING 18  
SECTION C**

Simpsons Strong Tie connector straps installed from framing studs to framing studs first to second level as per drawings.

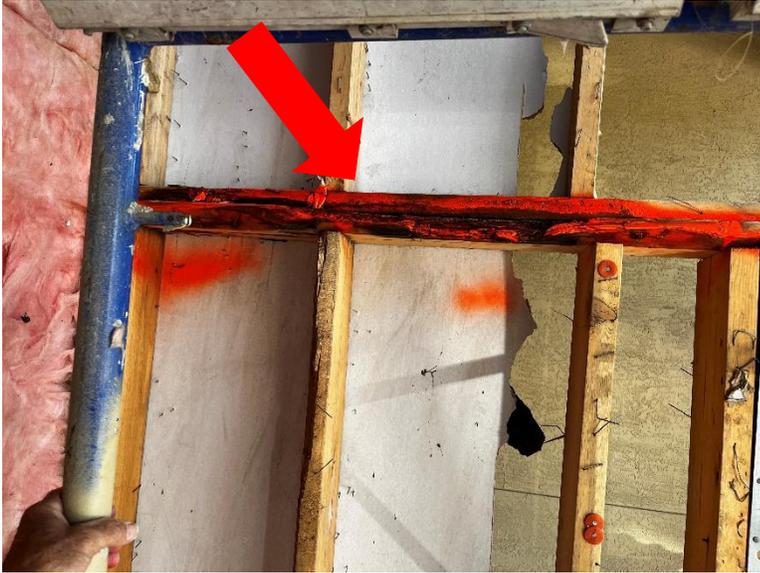
**PHOTOGRAPH #25**

**BUILDING 18  
SECTION C**

Additional damaged framing marked for repairs at breezeway wall.

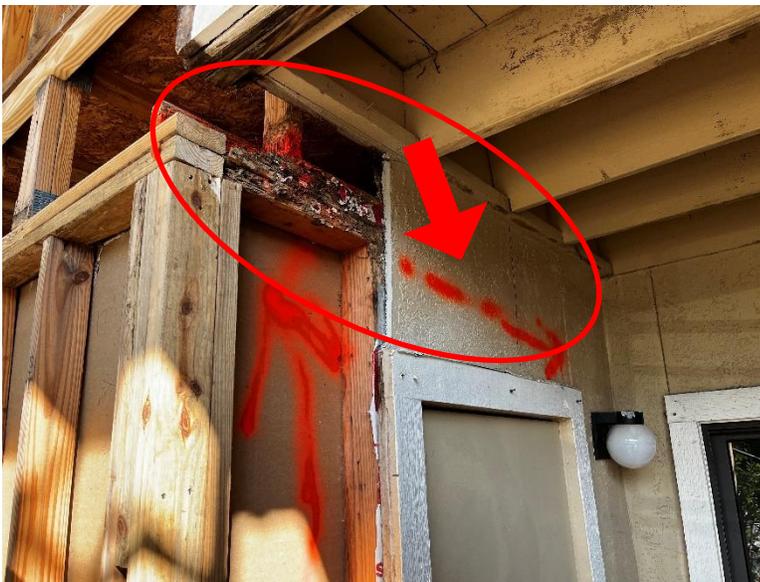
**PHOTOGRAPH #26**

**BUILDING 18  
SECTION A**

Additional damaged top plate framing marked for repairs. Stucco will need to be removed to end of damage for repairs.

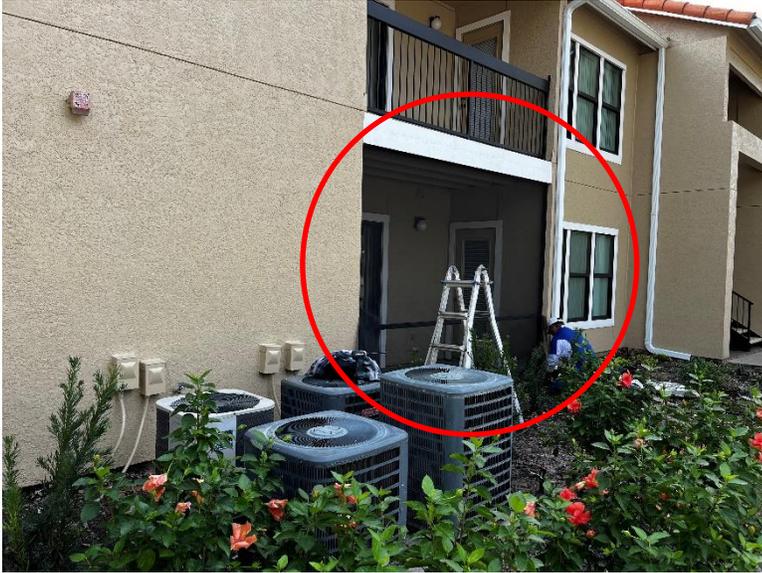
**PHOTOGRAPH #27**

**BUILDING 8  
SECTION B**

Screen enclosure installation in progress  
at lower patio.

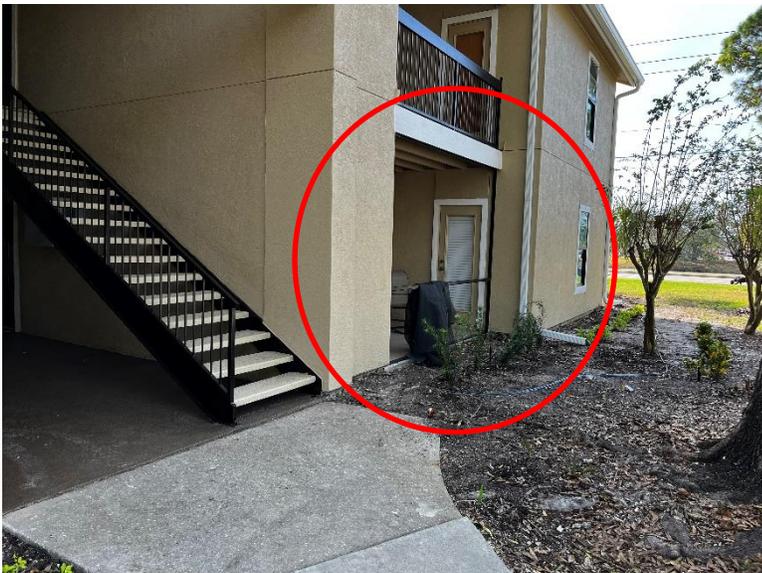
**PHOTOGRAPH #28**

**BUILDING 8  
SECTION C**

Screen enclosure installation in progress  
at lower patio.

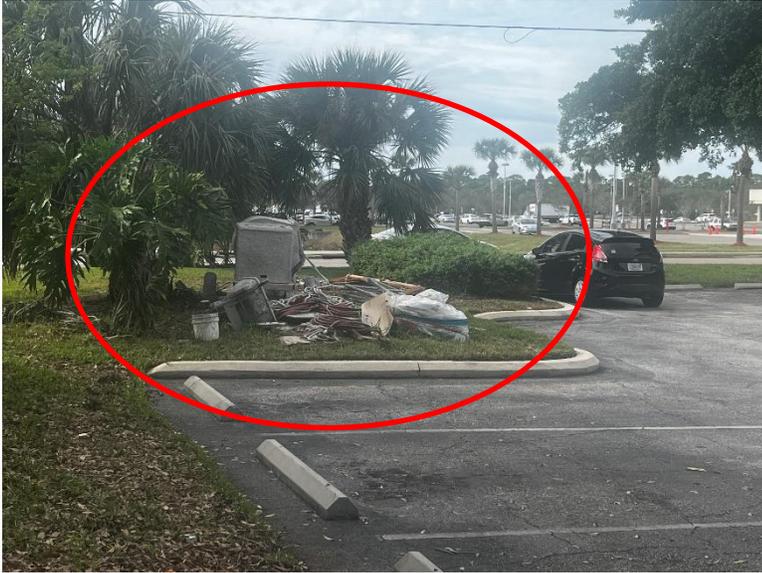
**PHOTOGRAPH #29**

**BUILDING 8  
SECTION C**

Contractors remaining equipment and materials to be removed from grounds.
