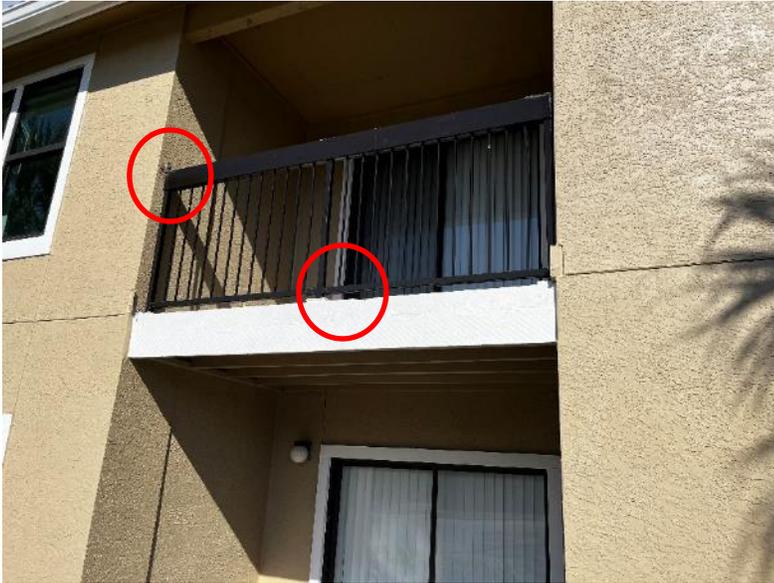
**PHOTOGRAPH #1**

Contractor has Installed railings with anchor bolts at built up balcony beam and wall framing as per drawings.

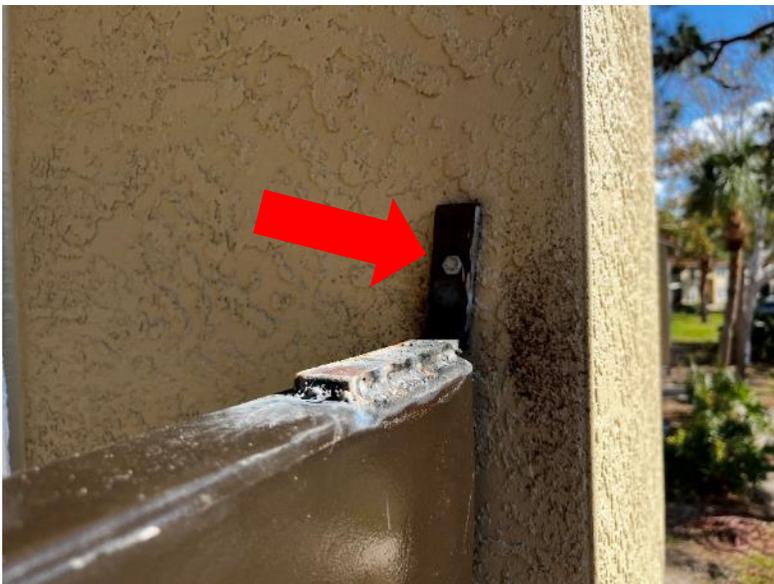
**PHOTOGRAPH #2**

Contractor has Installed railings with anchor bolts at built up balcony beam and wall framing as per drawings.

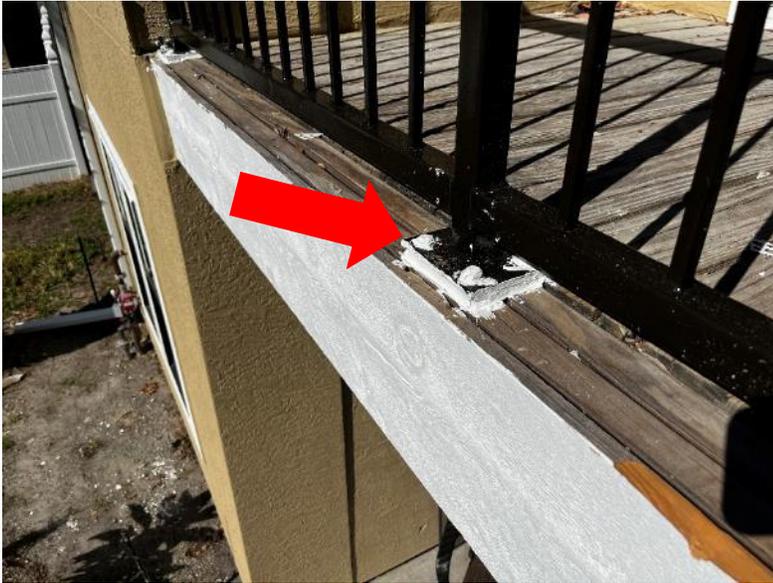
**PHOTOGRAPH #3**

Contractor has Installed railings with anchor bolts at built up balcony beam and wall framing as per drawings.

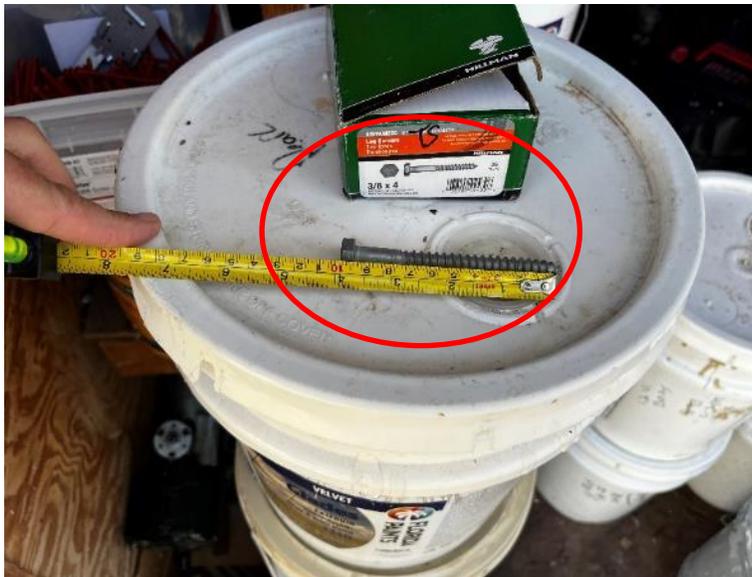
**PHOTOGRAPH #4**

Contractor has Installed railings with anchor bolts at built up balcony beam and wall framing as per drawings.

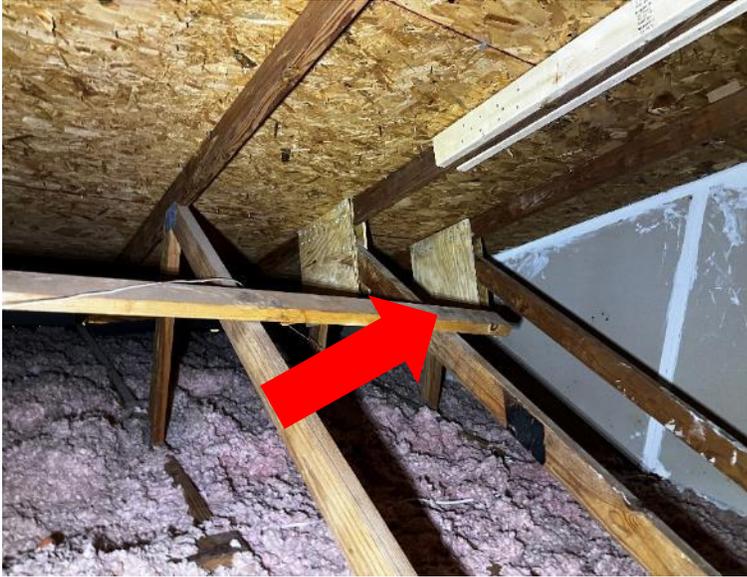
**PHOTOGRAPH #5**

Gusset repairs at roof trusses performed and quantified.

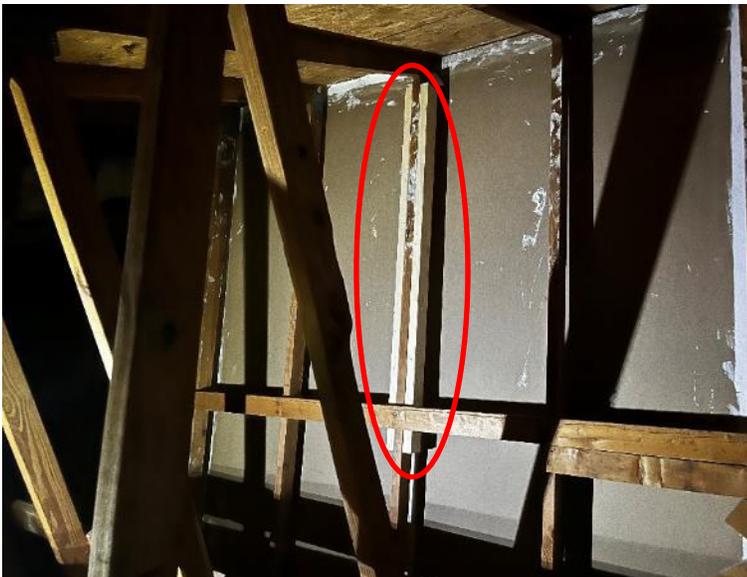
**PHOTOGRAPH #6**

Scab repairs at roof trusses performed and quantified.

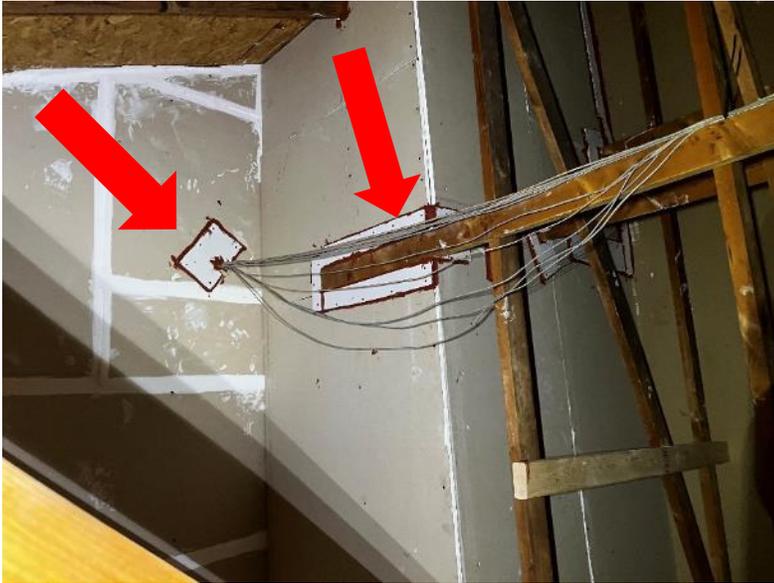
**PHOTOGRAPH #7**

Fire board repairs performed in attic space by contractor and quantified.

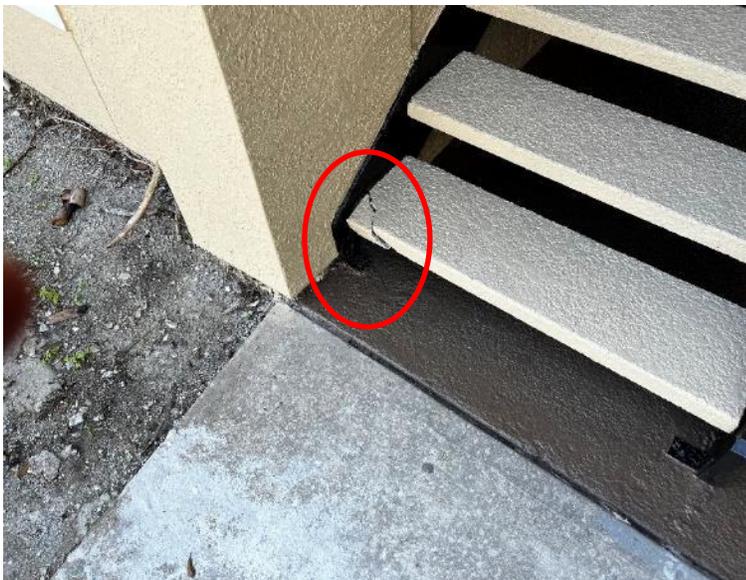
**PHOTOGRAPH #8**

Broken stair pad has not been repaired at breezeway stairway.

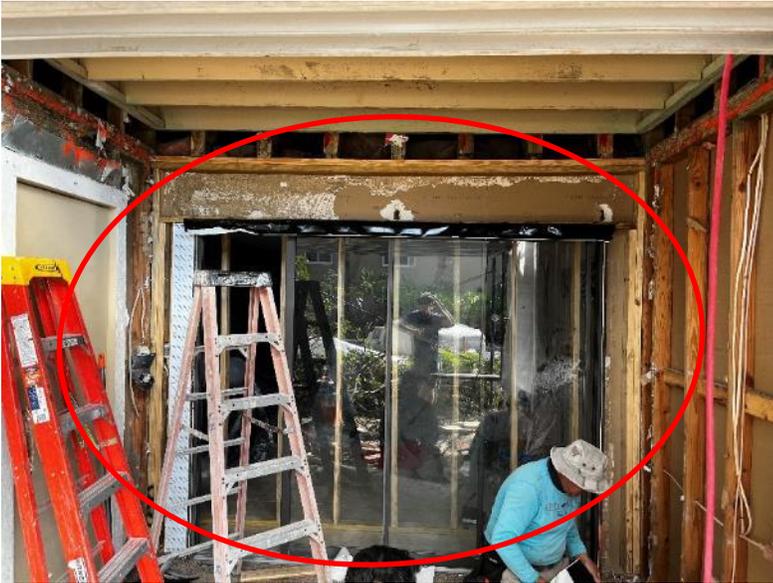
**PHOTOGRAPH #9**

Contractor has shored up wall inside of unit preparing to remove sliding glass doors and replace damaged headers and framing.

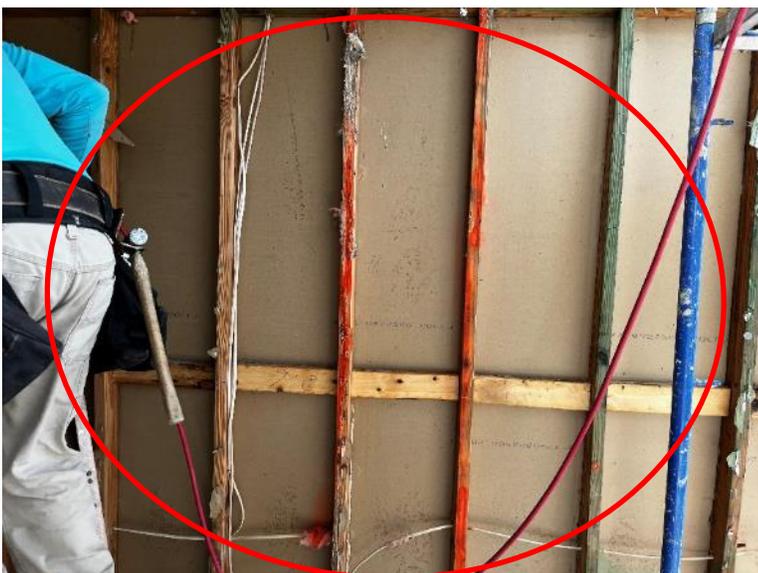
**PHOTOGRAPH #10**

Additional damaged framing studs marked for replacement after stucco was fully removed by contractor.

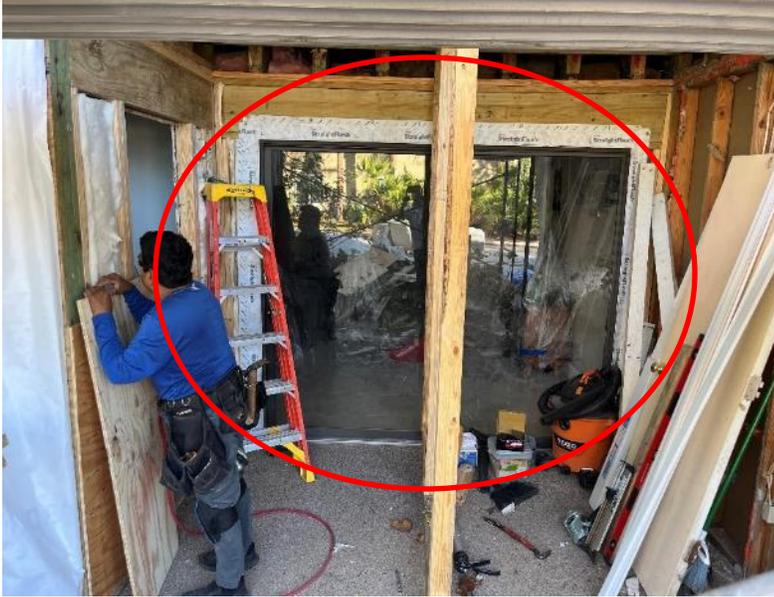
**PHOTOGRAPH #11**

Contractor has replaced damaged headers and reinstalled Sliding glass door.

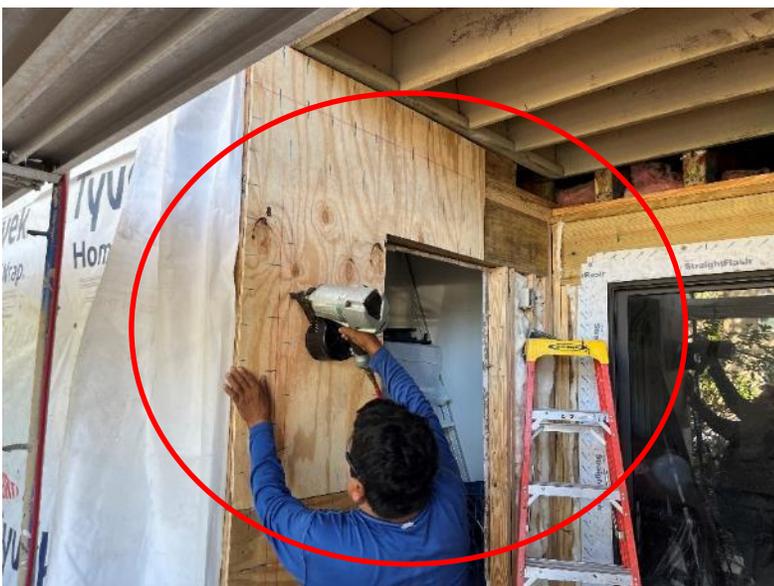
**PHOTOGRAPH #12**

Contractor installing new 15/32" plywood sheathing with fasteners at framing studs 16" O.C. as per drawings and specification.

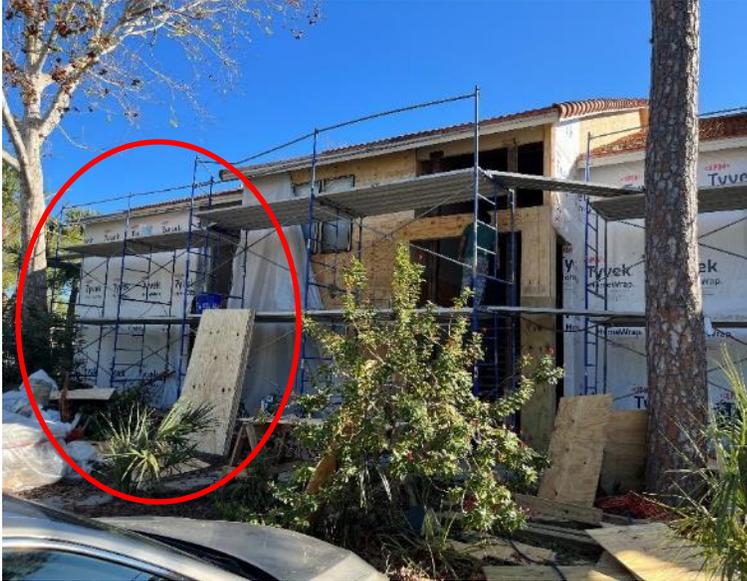
**PHOTOGRAPH #13**

DuPont Tyvek HomeWrap water resistive barrier applied over new plywood sheathing.

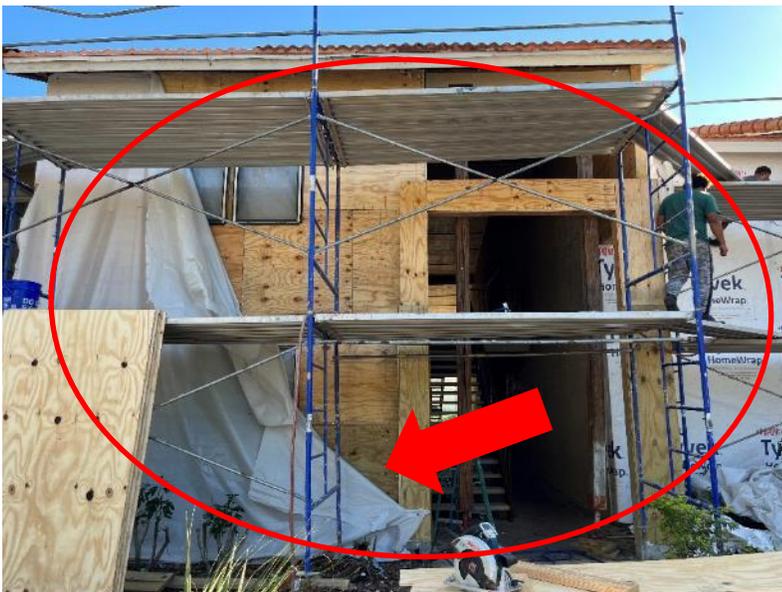
**PHOTOGRAPH #14**

Contractor has installed new 15/32" plywood sheathing using pressure treated plywood at bottom row as per specifications.

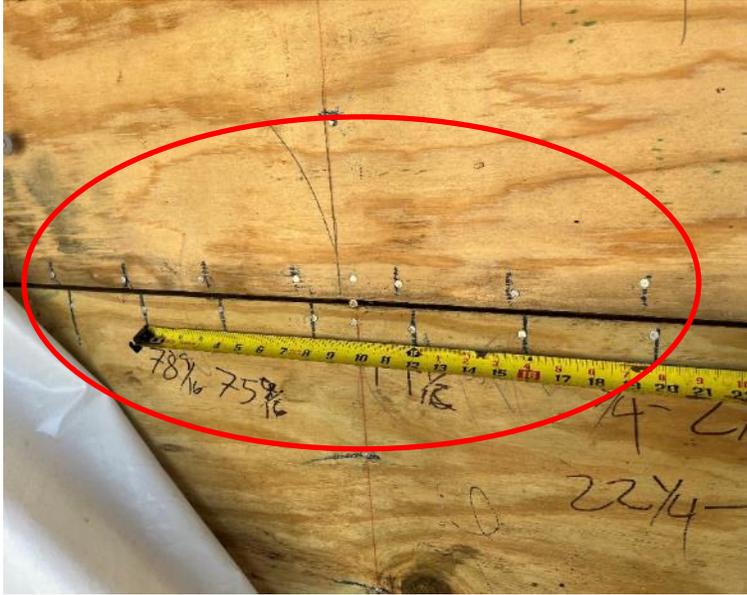
**PHOTOGRAPH #15**

Contractor installing new 15/32" plywood sheathing with fasteners at perimeters at 4" O.C. as per drawings and specification.

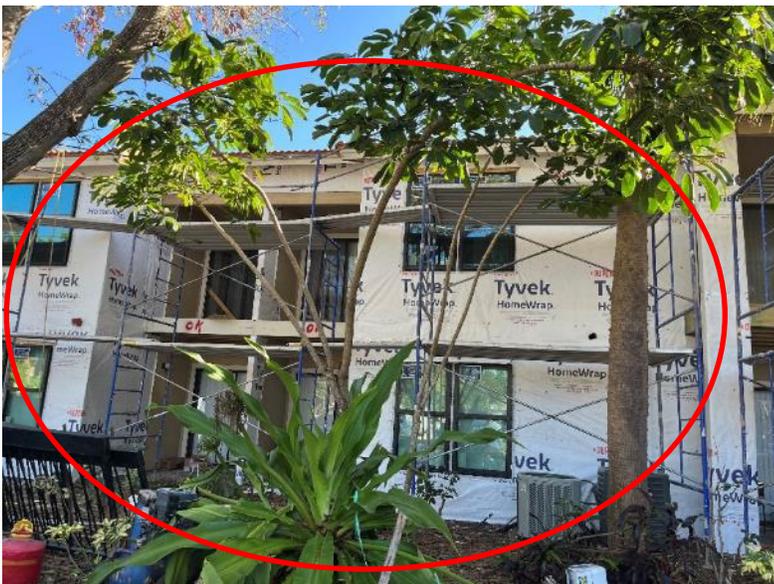
**PHOTOGRAPH #16**

DuPont Tyvek HomeWrap water resistive barrier applied over new plywood sheathing.

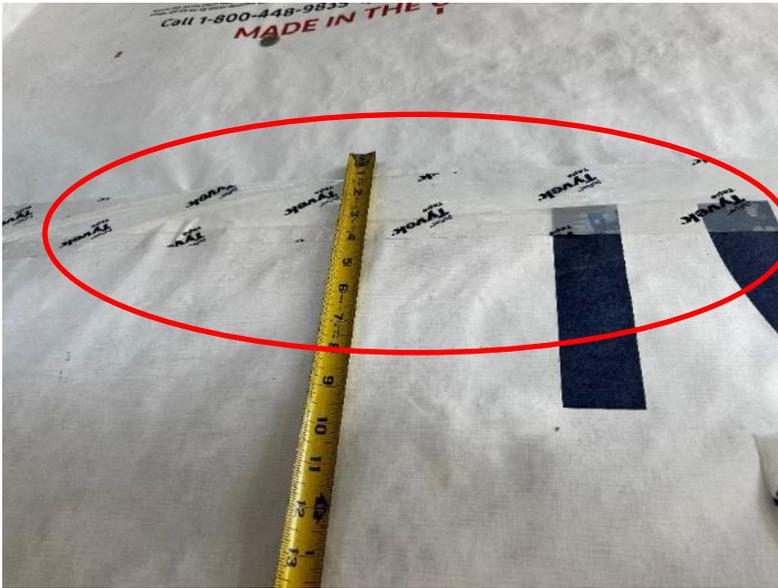
**PHOTOGRAPH #17**

Contractor applied Tyvek 3" tape at overlap of HomeWrap water resistive barrier as per manufacture requirements and specification.

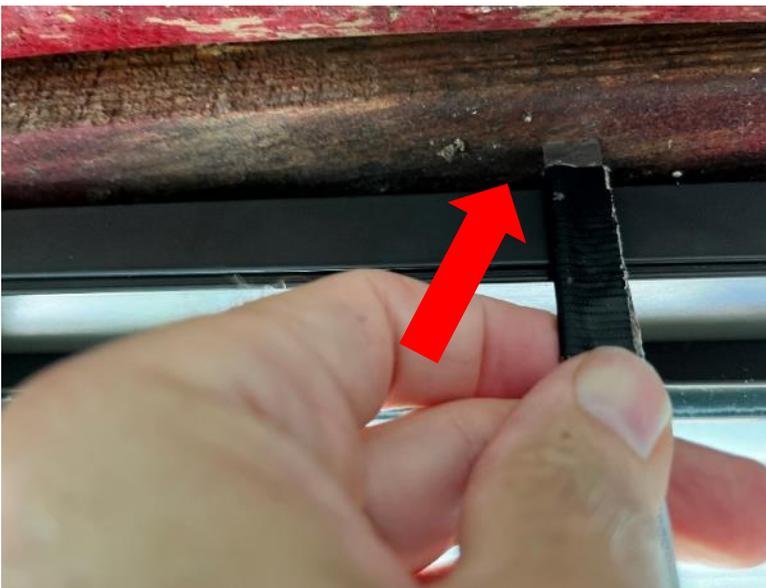
**PHOTOGRAPH #18**

Gap from windows to head framing greater than max. 5/16" allowed by PGT NOA.

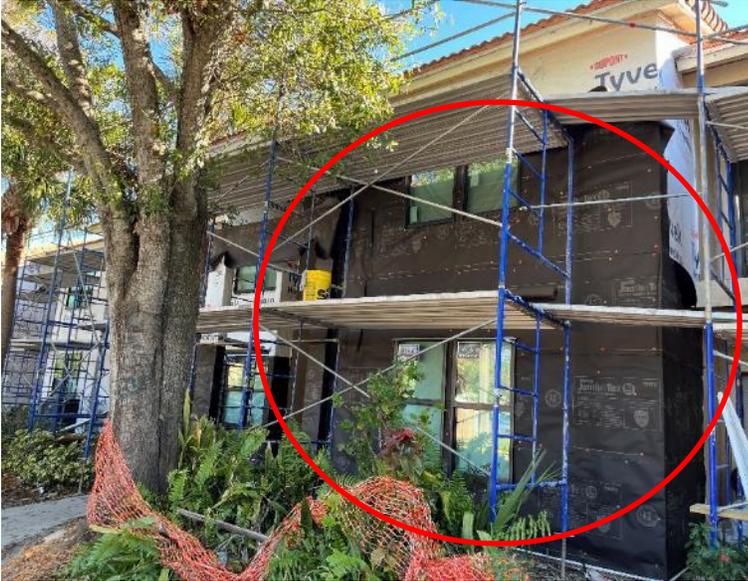
**PHOTOGRAPH #19**

Stucco subcontractor applying Jumbo Tex 60 water resistive barrier over Tyvek HomeWrap WRB.

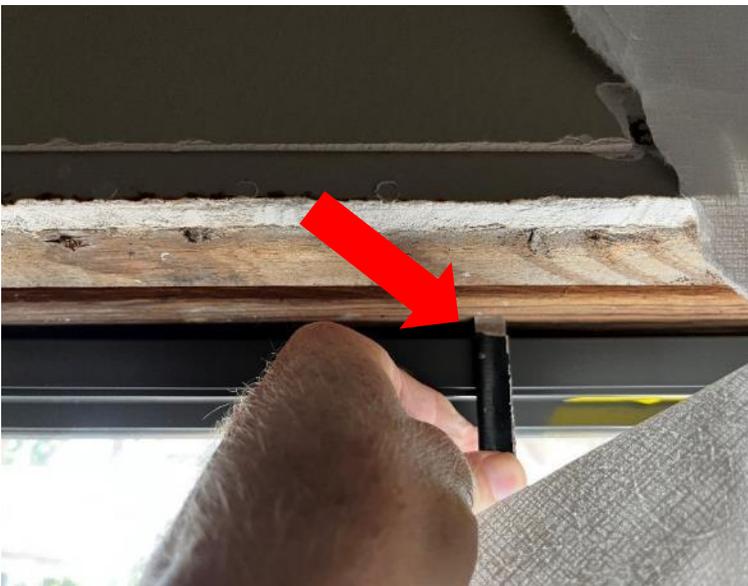
**PHOTOGRAPH #20**

Gap from windows to head framing greater than max. 5/16" allowed by PGT NOA .

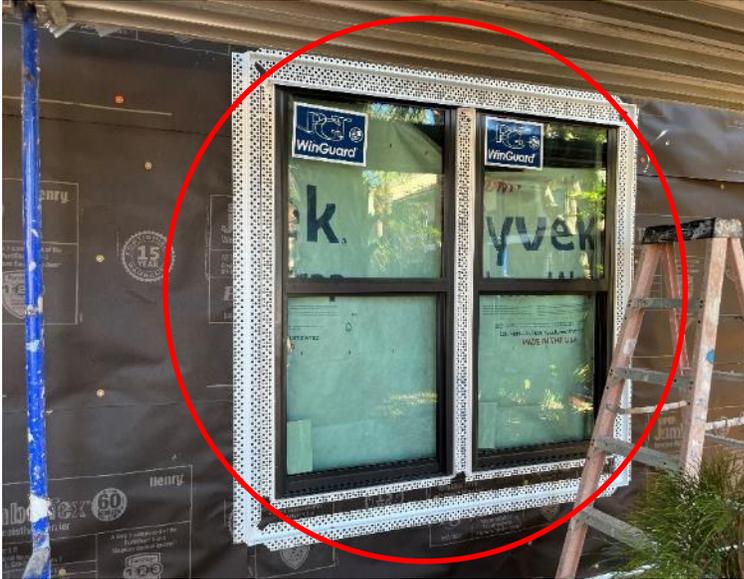
**PHOTOGRAPH #21**

Stucco subcontractor has begun to apply vinyl stucco accessories at window openings over Jumbo Tex 60 water resistive barrier.

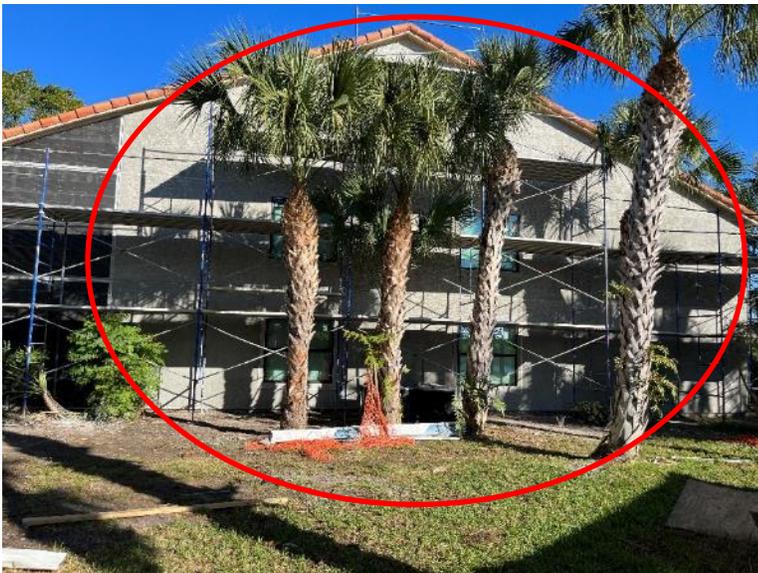
**PHOTOGRAPH #22**

Stucco subcontractor has applied finish coat of stucco as per ASTM C 926.

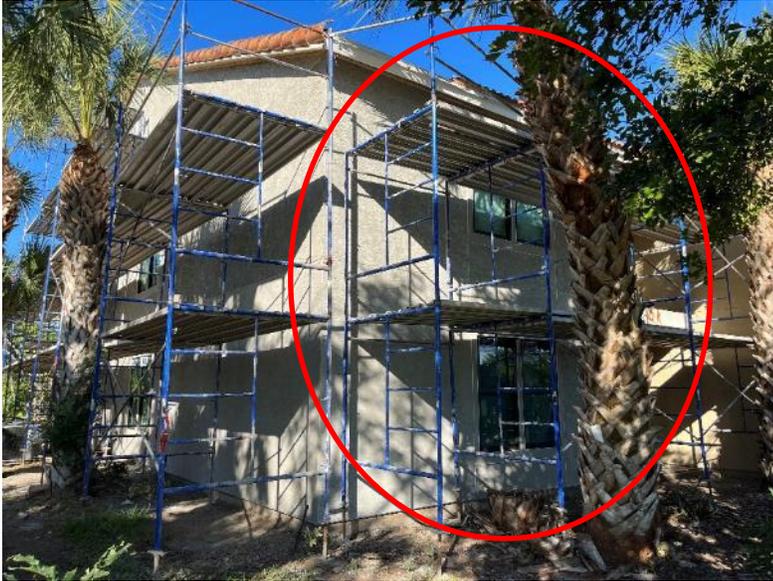
**PHOTOGRAPH #23**

Stucco subcontractor has applied finish coat of stucco as per ASTM C 926.

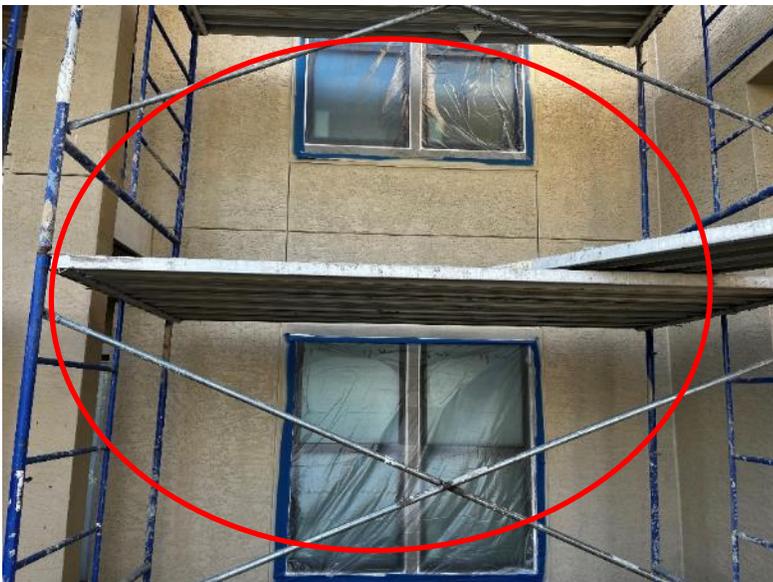
**PHOTOGRAPH #24**

Finish stucco primed with Florida Paints SunFlex Masonry and Concrete acrylic primer.

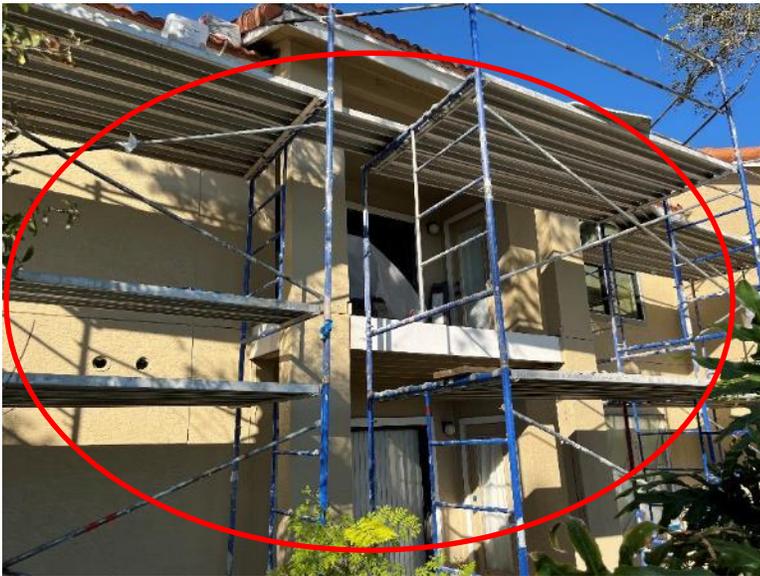
**PHOTOGRAPH #25**

Finish stucco primed and finish coated with Florida Paints Glades Exterior 100% acrylic finish paint.

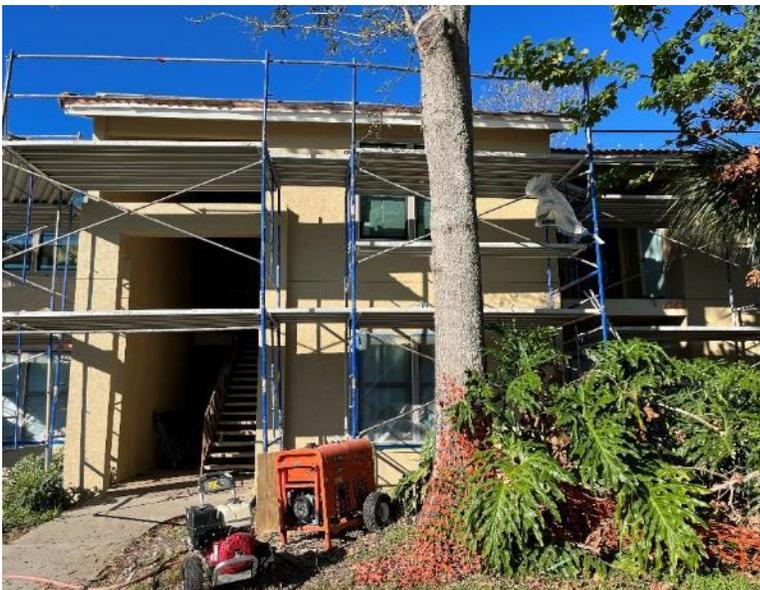
**PHOTOGRAPH #26**

Finish stucco primed and finish coated with Florida Paints Glades Exterior 100% acrylic finish paint.

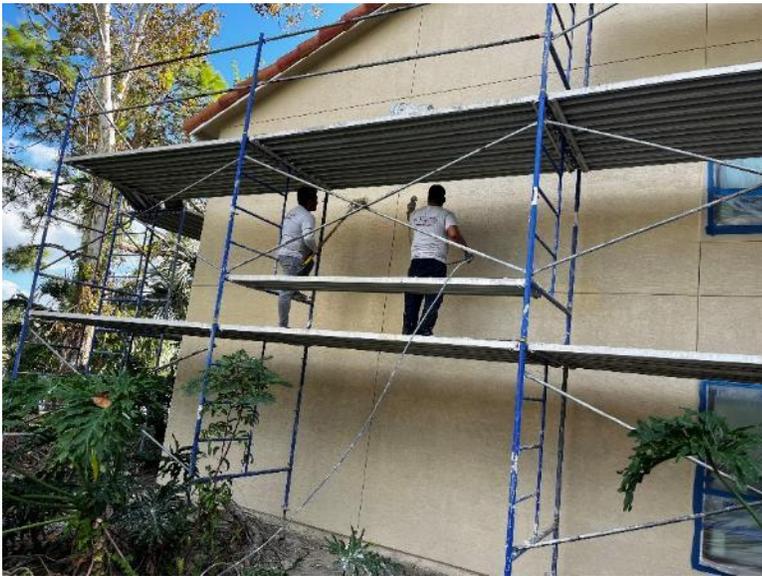
**PHOTOGRAPH #27**

RLJ applying Florida Paints Glades Exterior 100% acrylic finish paint by spray and back rolling technique.

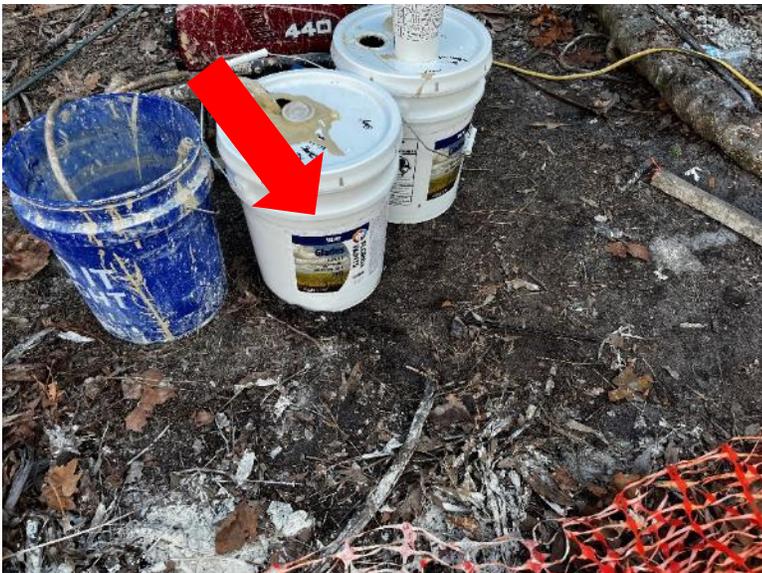
**PHOTOGRAPH #28**

RLJ applying Florida Paints Glades Exterior 100% acrylic finish paint by spray and back rolling technique.
