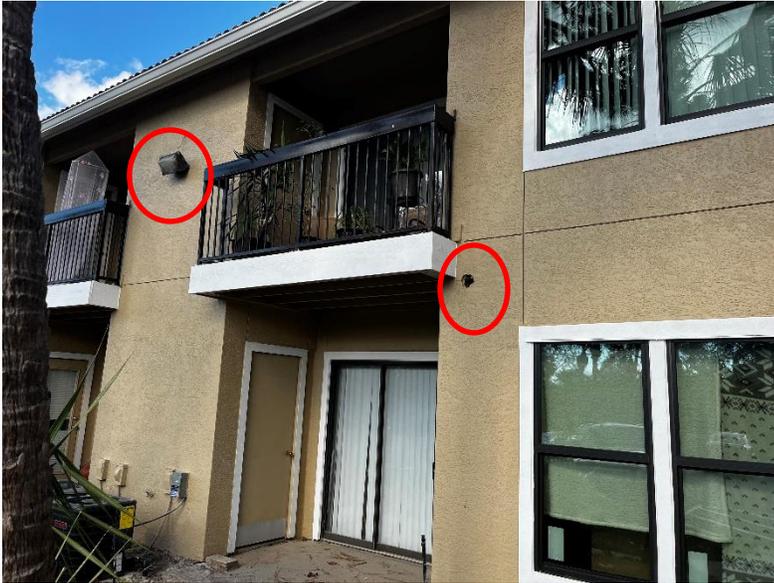
PHOTOGRAPH #1

**BUILDING 13
SECTION F**

Contractor has not yet reattached lights or installed dryer vents.

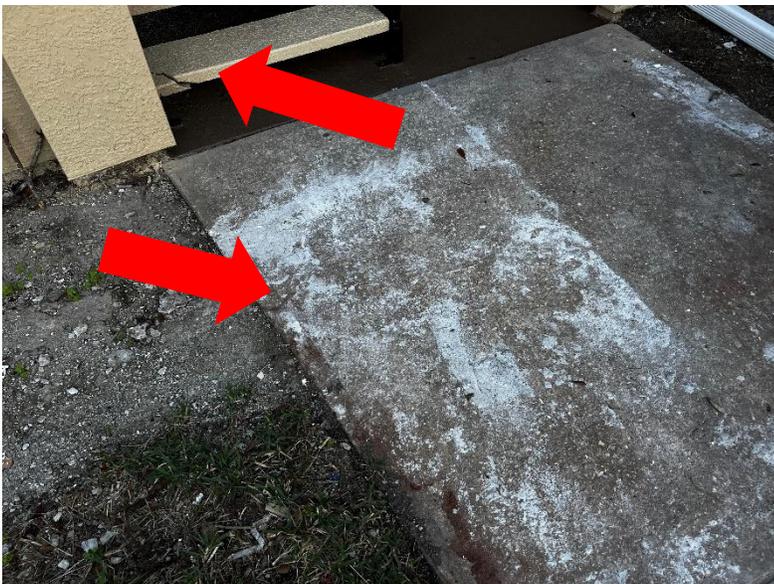
PHOTOGRAPH #2

**BUILDING 13
SECTION E**

Contractor has not yet repaired stair and masonry on sidewalk will require removal.

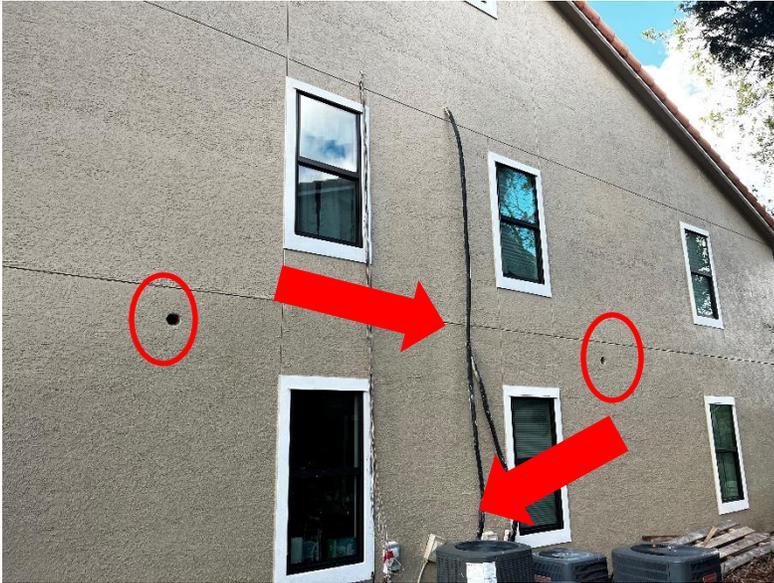
PHOTOGRAPH #3

**BUILDING 13
SECTION D**

Contractor has not yet re attached electrical boxes, covered A.C lines or installed dryer vent.

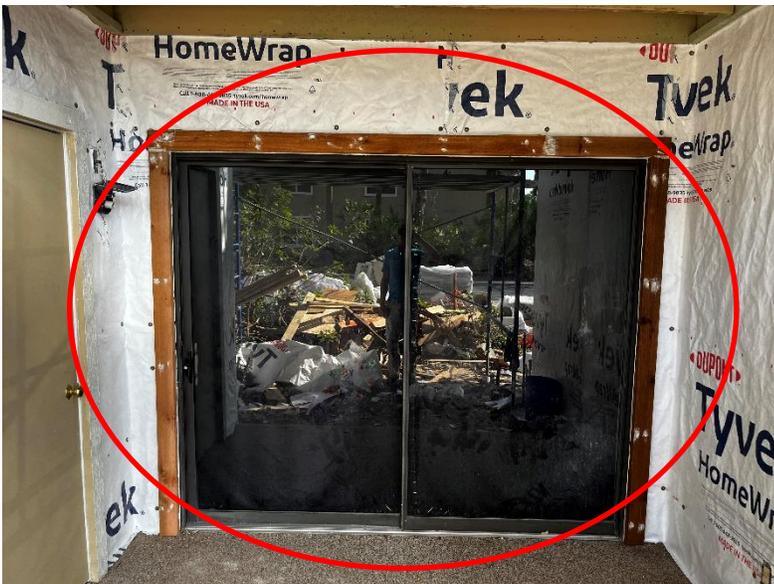
PHOTOGRAPH #4

**BUILDING 18
SECTION A- UNIT #1811**

Contractor re installed sliding glass doors and replaced damaged headers and framing.

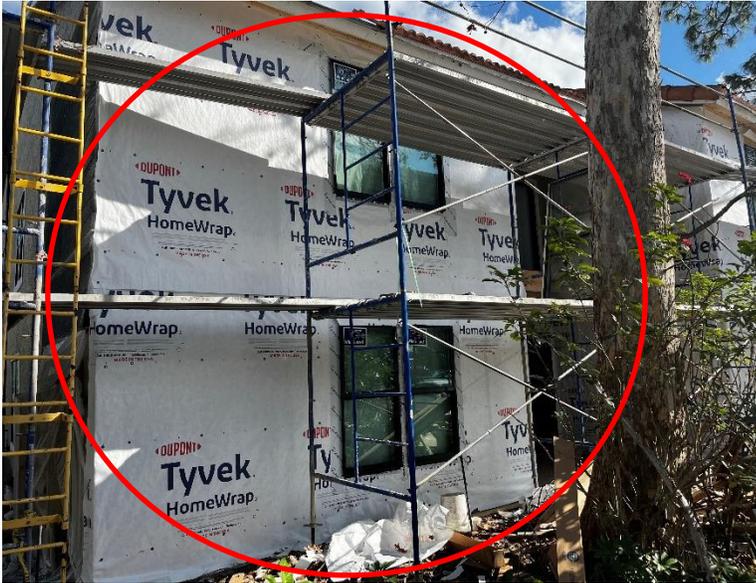
PHOTOGRAPH #5

**BUILDING 18
SECTION A**

New PGT windows installed with Dupont flashing and Tyvek HomeWrap water resistive barrier as per drawings.

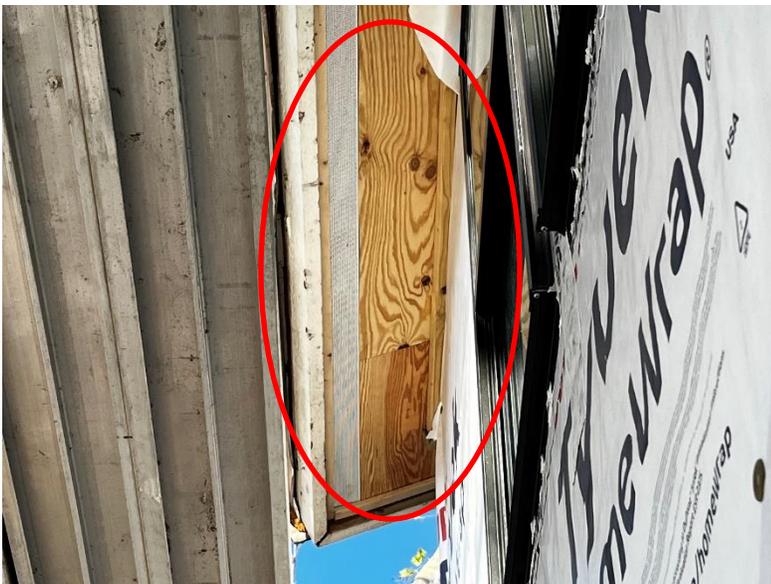
PHOTOGRAPH #6

**BUILDING 18
SECTION A**

New soffit plywood and vinyl vents installed as per drawings.

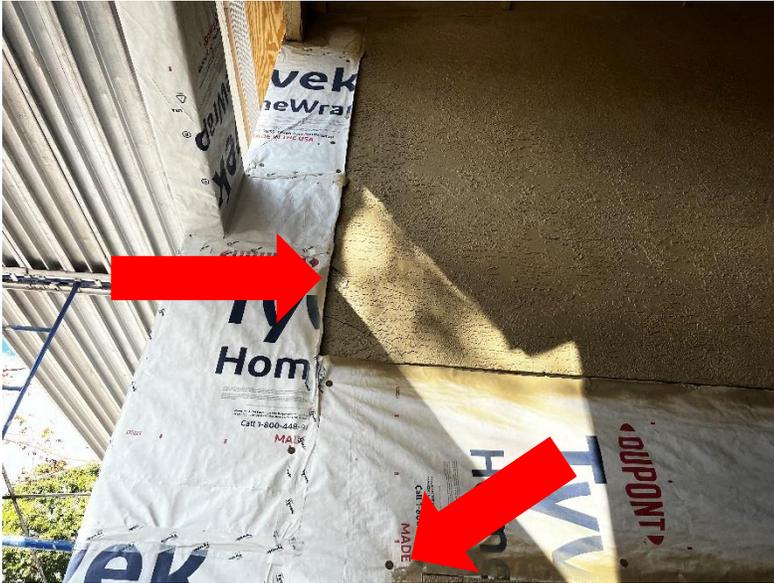
PHOTOGRAPH #7

**BUILDING 18
SECTION A-BREEZEWAY**

Removal of stucco following damaged framing repairs will require additional stucco removal and replacement to line up top to bottom at breezeway wall.

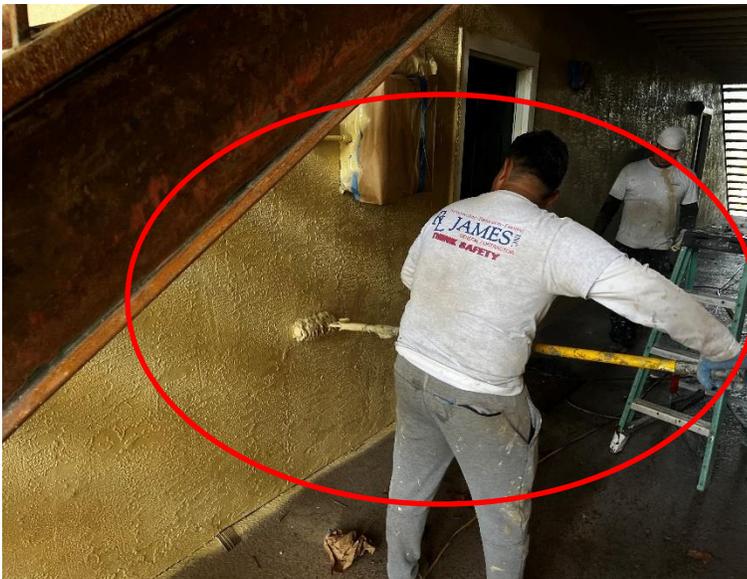
PHOTOGRAPH #8

**BUILDING 18
SECTION A-BREEZEWAY**

Contactor spraying and back rolling new paint at existing breezeway stucco walls .

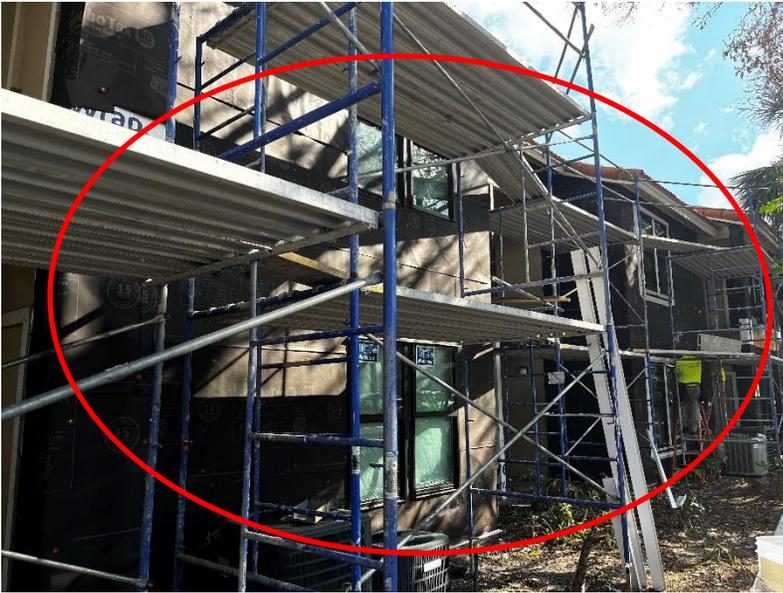
PHOTOGRAPH #9

**BUILDING 18
SECTION B**

Stucco subcontractor installing second water barrier with Henry Jumbo Tex 60 over Tyvek HomeWrap.

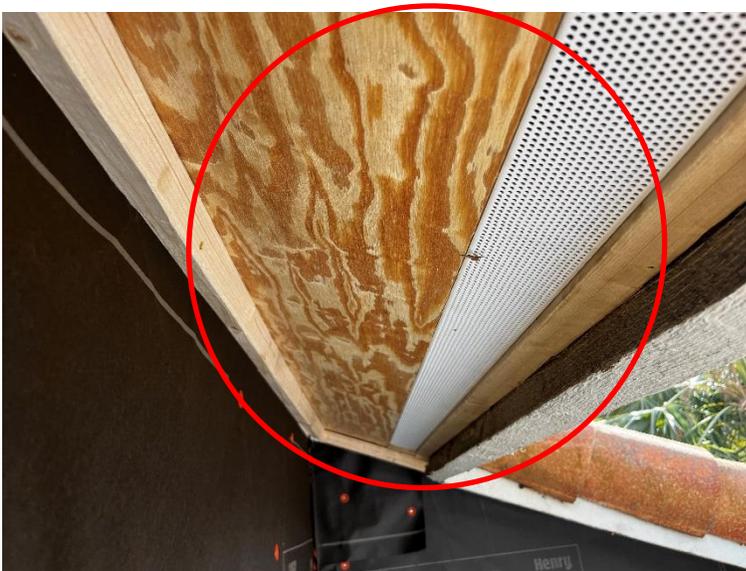
PHOTOGRAPH #10

**BUILDING 18
SECTION B**

New soffit plywood and vinyl vents installed as per drawings.

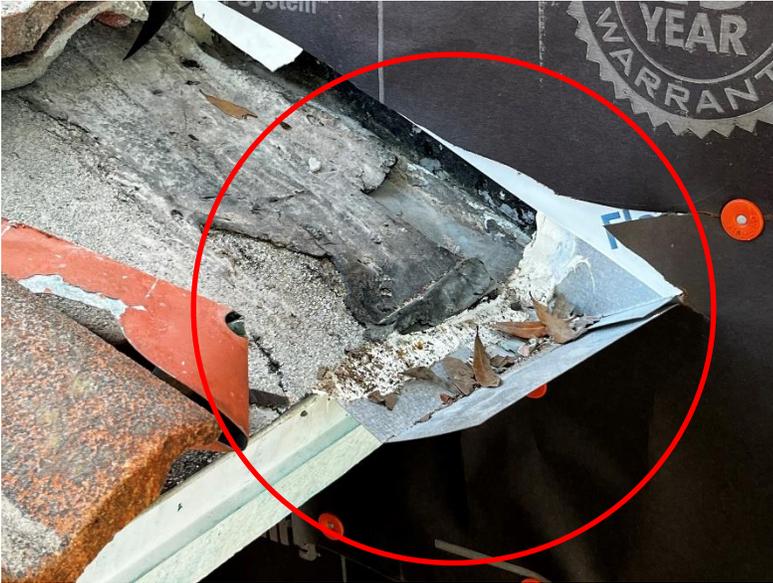
PHOTOGRAPH #11

**BUILDING 18
SECTION B**

New kick out roof flashing installation in process.

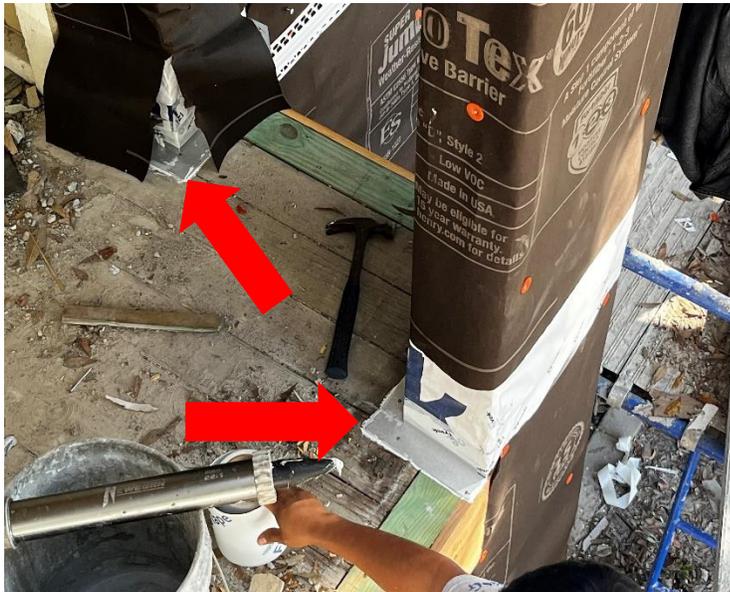
PHOTOGRAPH #12

**BUILDING 18
SECTION B**

Contractor installing galvanized flashing at walls and columns to balcony deck as per drawings .

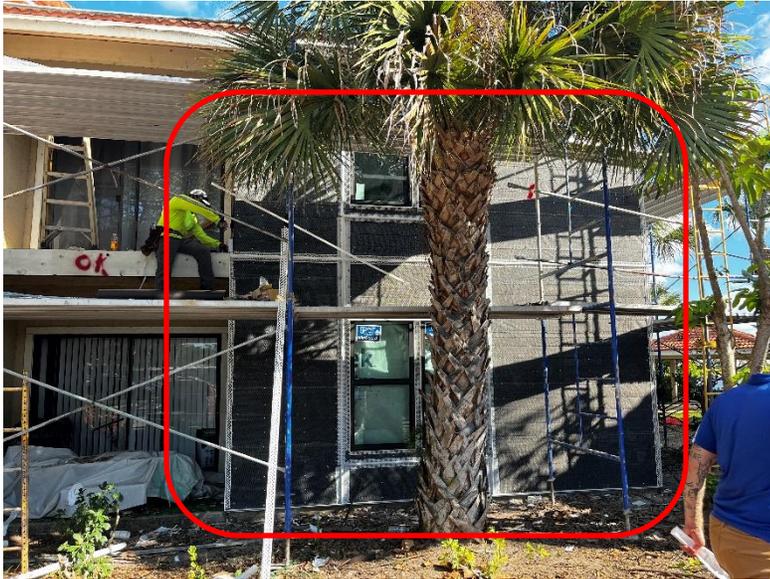
PHOTOGRAPH #13

**BUILDING 18
SECTION C**

Stucco sub-contractor installing vinyl stucco accessories and galvanized lath as per ASTM C1063.

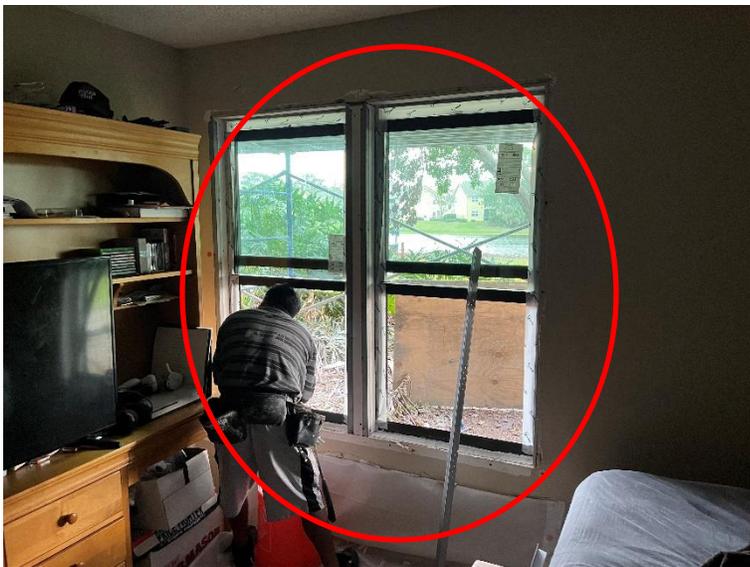
PHOTOGRAPH #14

**BUILDING 18
SECTION D-UNIT #1818**

Contractor repairing interior drywall and windowsills at new PGT windows as per contract.

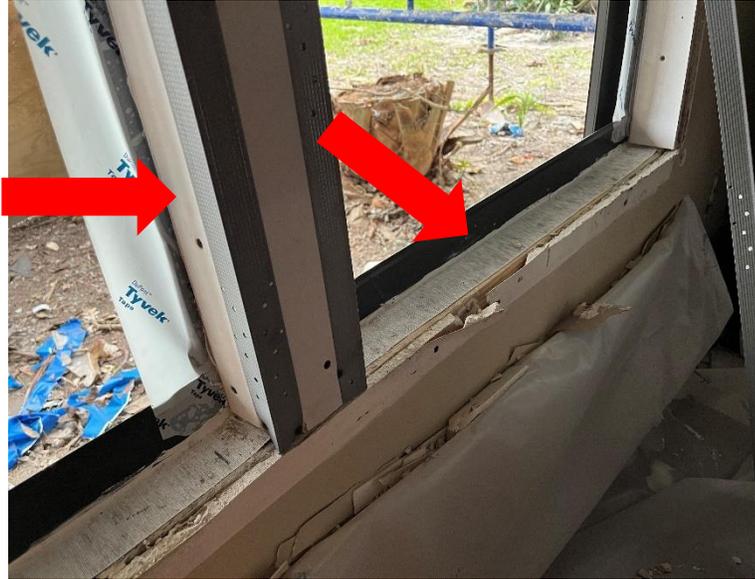
PHOTOGRAPH #15

**BUILDING 18
SECTION D-UNIT #1818**

New sealant applied at PGT window frame to Dupont flashings as per drawings prior to application of new drywall repairs.

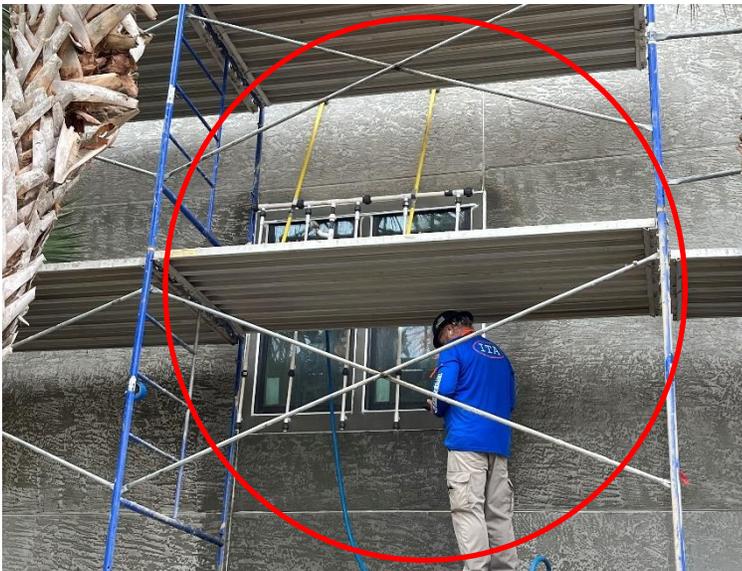
PHOTOGRAPH #16

**BUILDING 18
WATER TEST- UNIT #1828**

Independent Testing Agency performing negative pressure water testing (in compliance with ASTM Test Method E 1105) at double windows of bedroom.

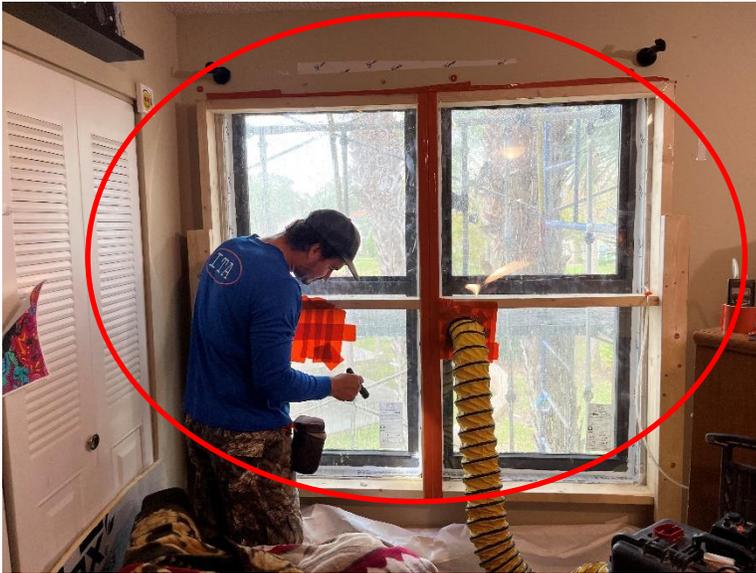
PHOTOGRAPH #17

**BUILDING 18
WATER TEST- UNIT #1828**

Independent Testing Agency performing negative pressure water testing (in compliance with ASTM Test Method E 1105) at double windows of bedroom.

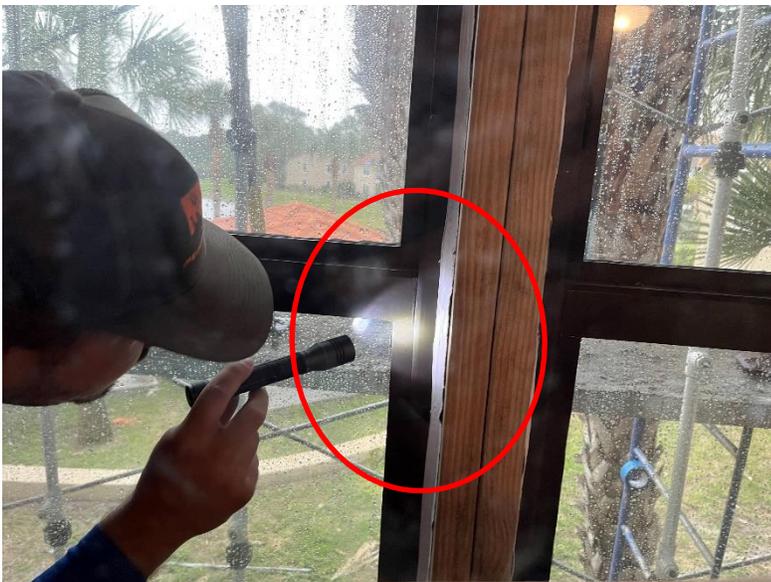
PHOTOGRAPH #18

**BUILDING 18
WATER TEST- UNIT #1828**

After fourth test cycle minor leak occurred at window metal to metal joinery and collected at base of window frame.

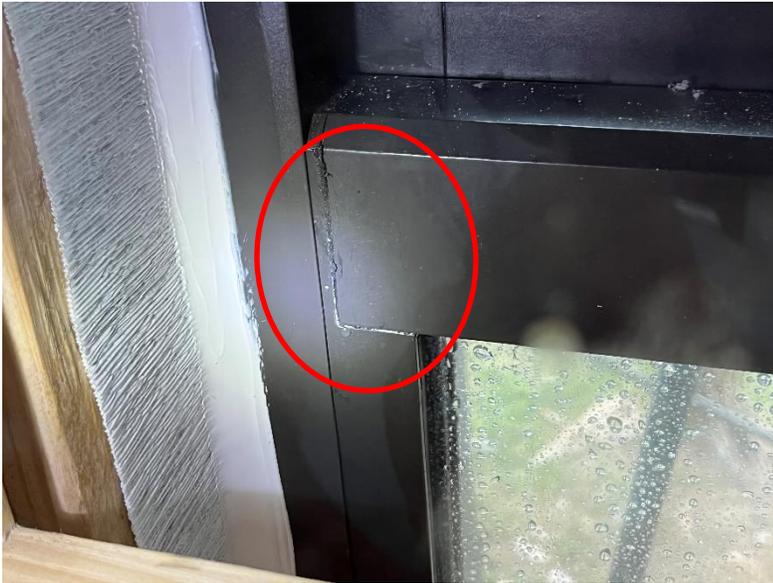
PHOTOGRAPH #19

**BUILDING 18
WATER TEST- UNIT #1828**

After fourth test cycle minor leak occurred at window metal to metal joinery and collected at base of window frame.

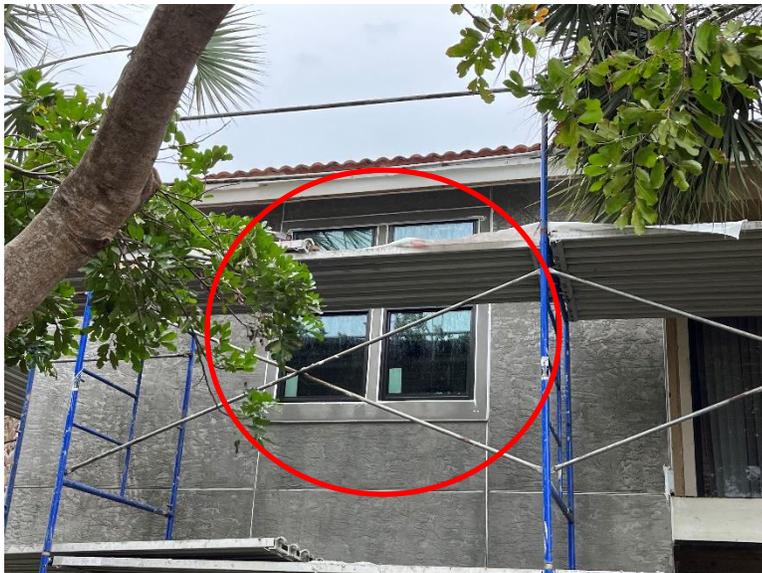
PHOTOGRAPH #20

**BUILDING 18
WATER TEST- UNIT #1828**

Independent Testing Agency performing negative pressure water testing (in compliance with ASTM Test Method E 1105) at double windows of master bedroom.

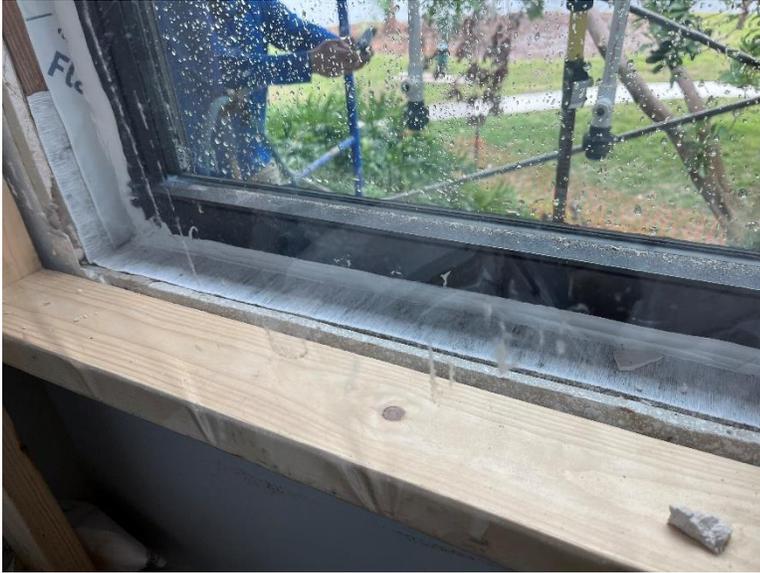
PHOTOGRAPH #21

**BUILDING 18
WATER TEST- UNIT #1828**

Double windows of master bedroom testing resulted in no leaks or failures.

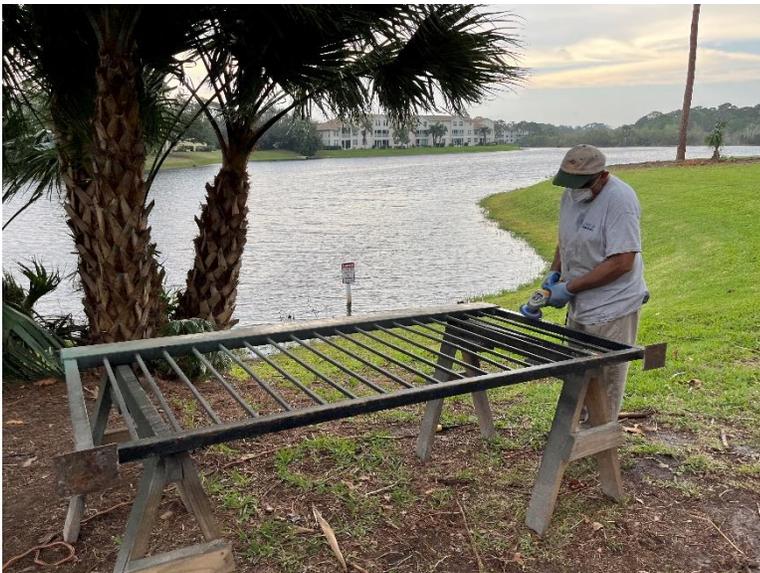
PHOTOGRAPH #22

**BUILDING 18
SECTION F**

RLJ removing loose paints and rust from steel railings by hand grinding surfaces.
