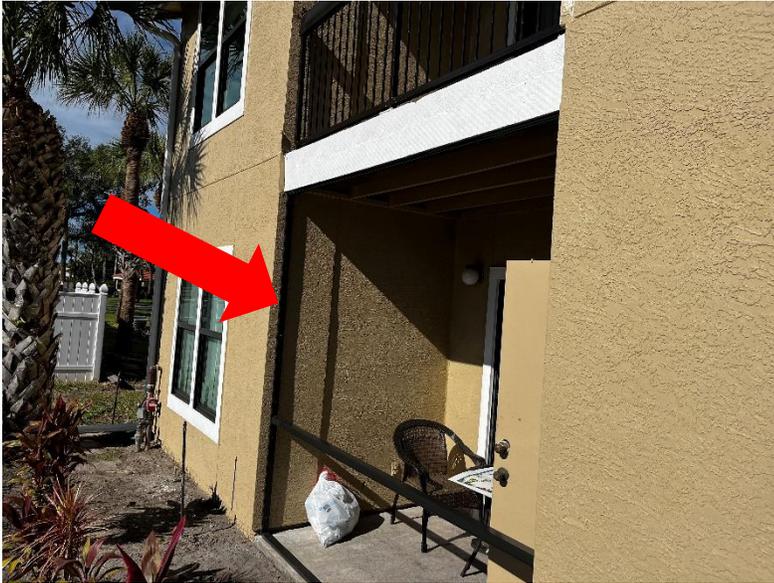
PHOTOGRAPH #1

**BUILDING 13
SECTION A**

Contractor begun replacing aluminum framed screen enclosures at patios and balcony's that previously had screen enclosures.

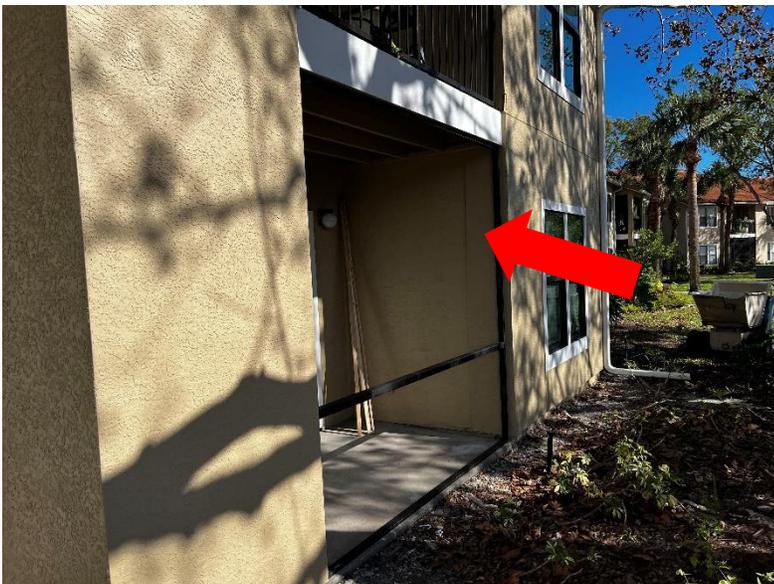
PHOTOGRAPH #2

**BUILDING 13
SECTION C**

Contractor begun replacing aluminum framed screen enclosures at patios and balcony's that previously had screen enclosures.

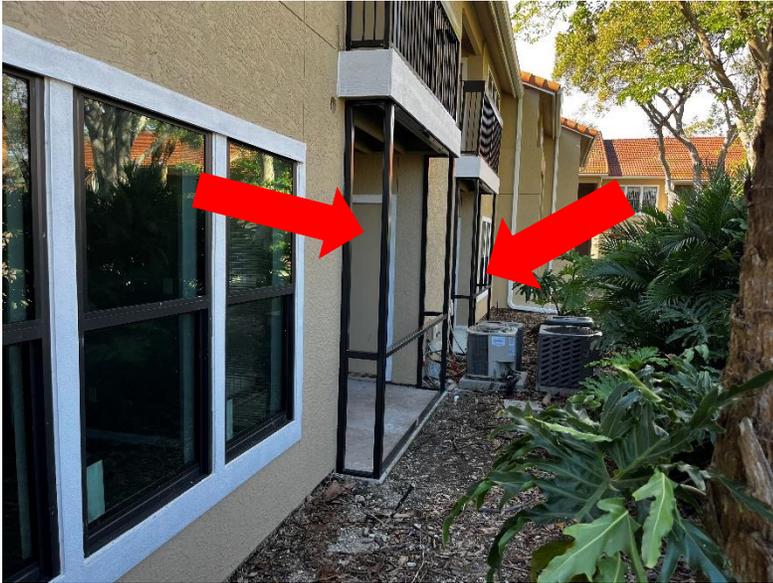
PHOTOGRAPH #3

**BUILDING 13
SECTION F**

Contractor begun replacing aluminum framed screen enclosures at patios and balcony's that previously had screen enclosures.

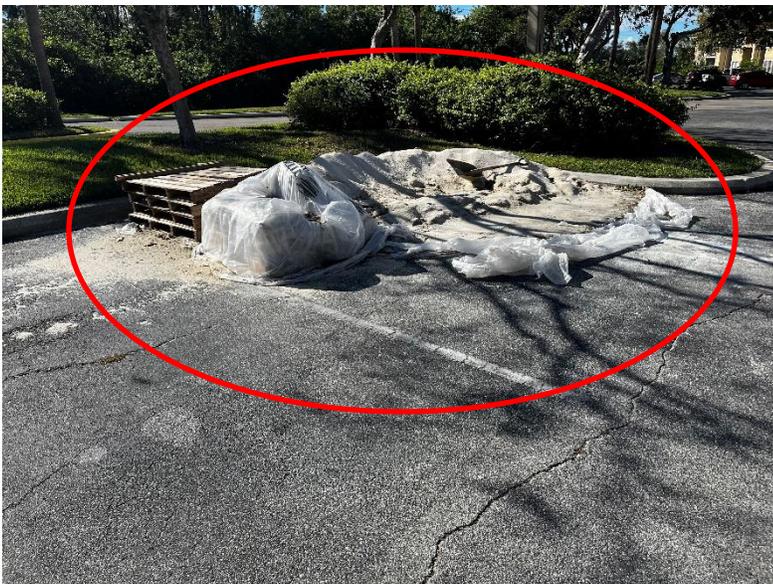
PHOTOGRAPH #4

**BUILDING 13
GROUNDS/PARKING**

Remaining Sand and Stucco materials in parking area.

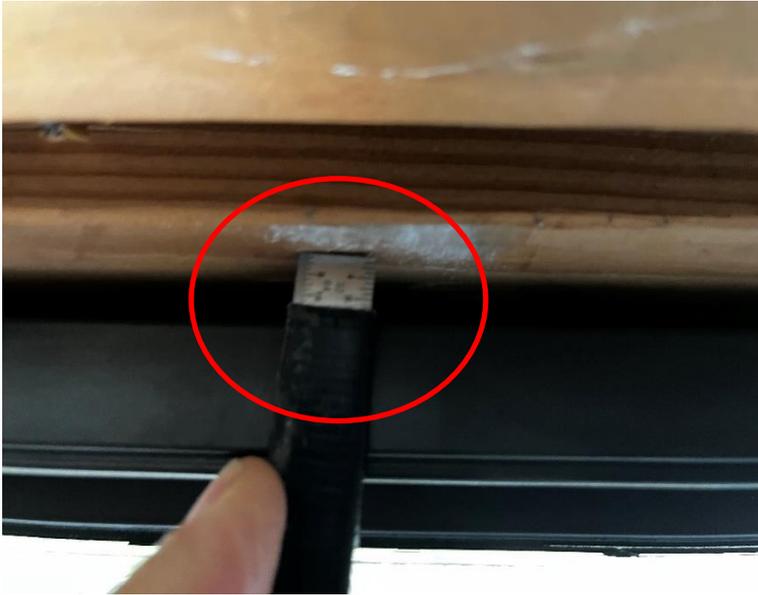
PHOTOGRAPH #5

**BUILDING 18
UNIT #1827**

Gap from window frame to wood header framing greater than max. 5/16" allowed by PGT NOA.

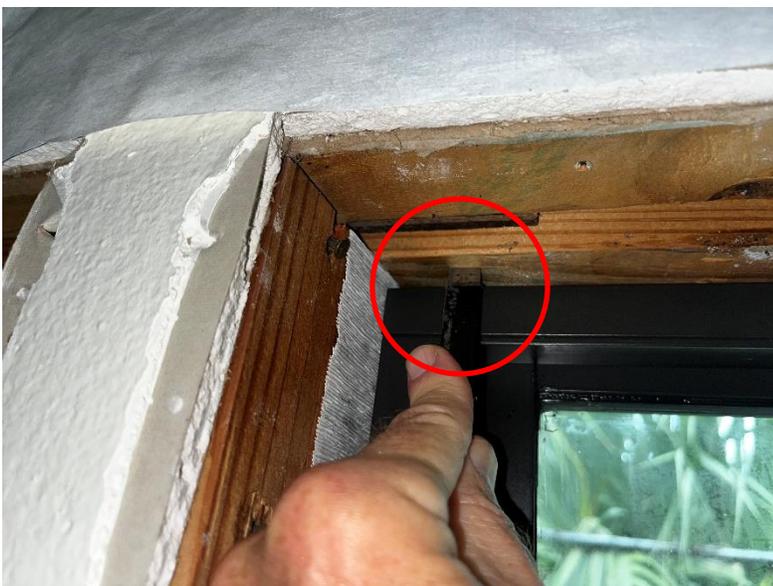
PHOTOGRAPH #6

**BUILDING 18
UNIT #1827**

Gap from window frame to wood header framing greater than max. 5/16" allowed by PGT NOA.

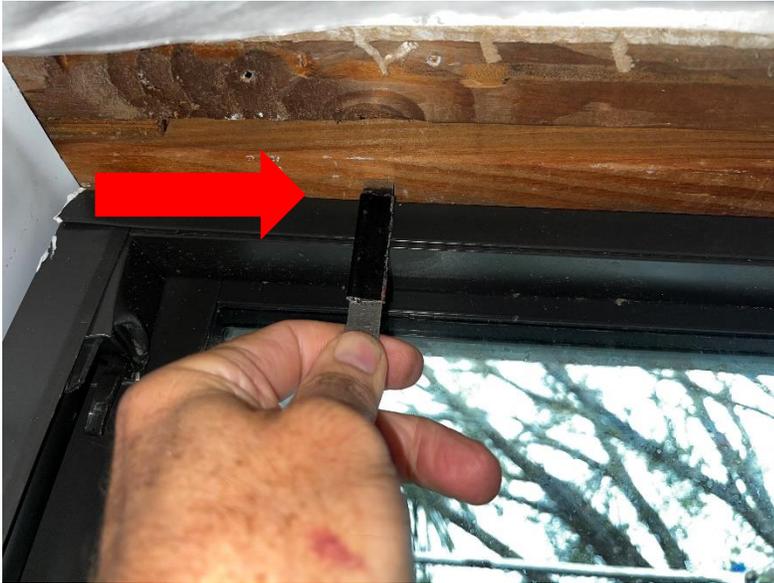
PHOTOGRAPH #7

**BUILDING 18
UNIT #1825**

Gap from window frame to wood header framing greater than max. 5/16" allowed by PGT NOA.

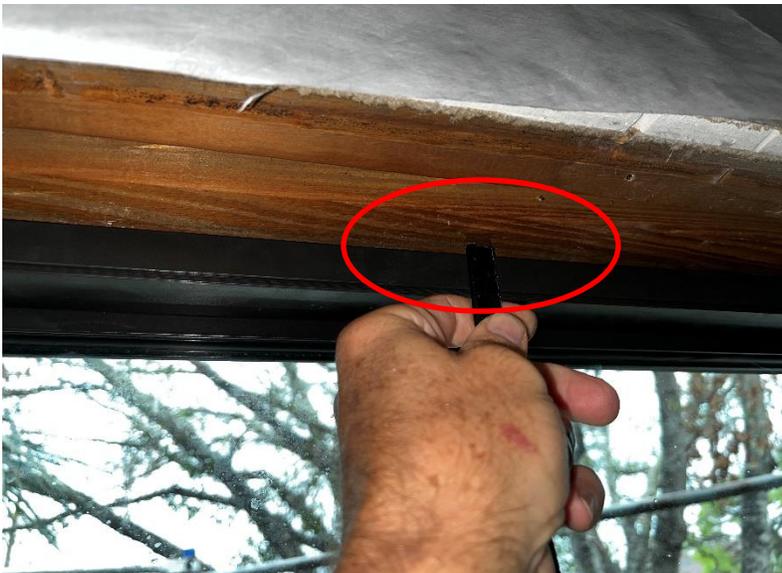
PHOTOGRAPH #8

**BUILDING 18
UNIT #1825**

Gap from window frame to wood header framing greater than max. 5/16" allowed by PGT NOA.

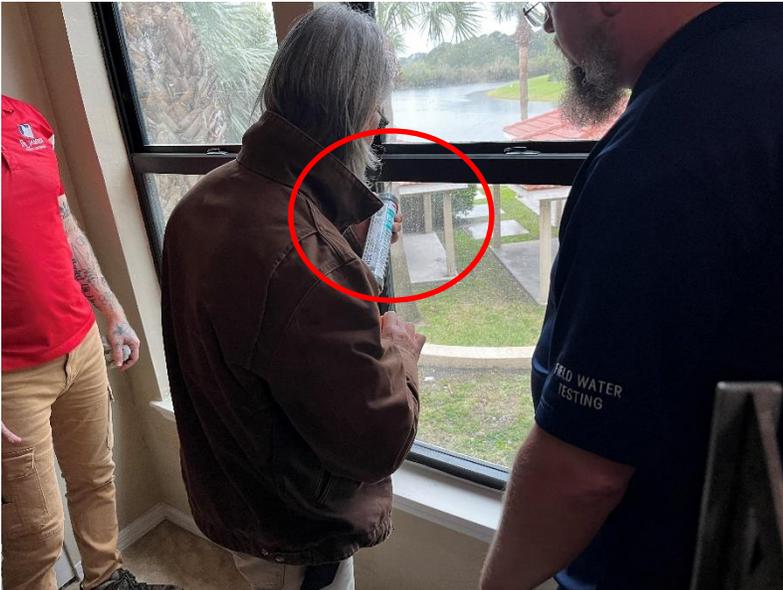
PHOTOGRAPH #9

**BUILDING 18
UNIT #1828**

PGT representative applying silicone sealant at metal-to-metal joinery were minor droplets of water collected during water testing. Testing report clarified that this water did not break the plan of the window during testing and therefore passed test criteria. No additional testing is required.

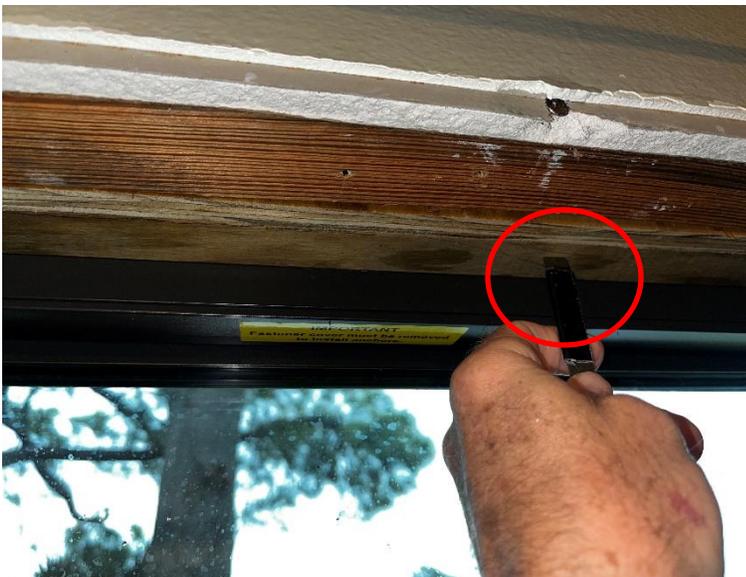
PHOTOGRAPH #10

**BUILDING 18
UNIT #1812**

Gap from window frame to wood header framing greater than max. 5/16" allowed by PGT NOA.

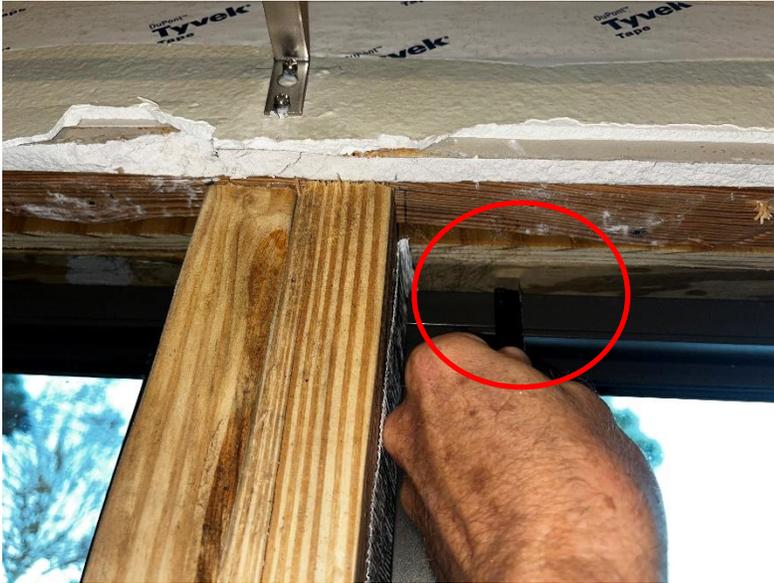
PHOTOGRAPH #11

**BUILDING 18
UNIT #1812**

Gap from window frame to wood header framing greater than max. 5/16" allowed by PGT NOA.

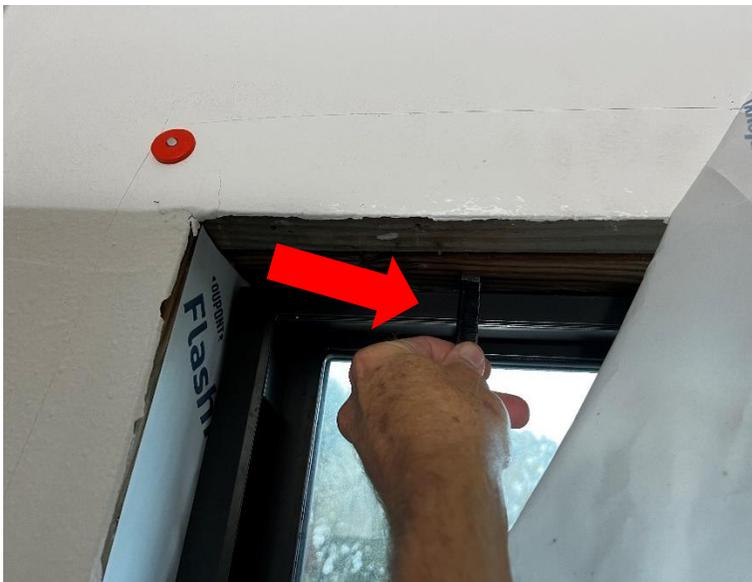
PHOTOGRAPH #12

**BUILDING 18
UNIT #1821**

Gap from window frame to wood header framing greater than max. 5/16" allowed by PGT NOA.

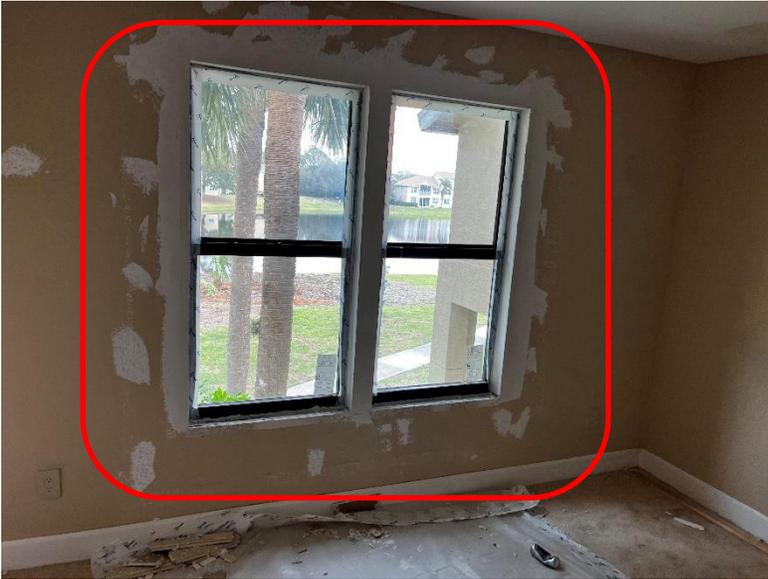
PHOTOGRAPH #13

**BUILDING 18
UNIT #1826**

Interior drywall repair in progress at new PGT window locations.

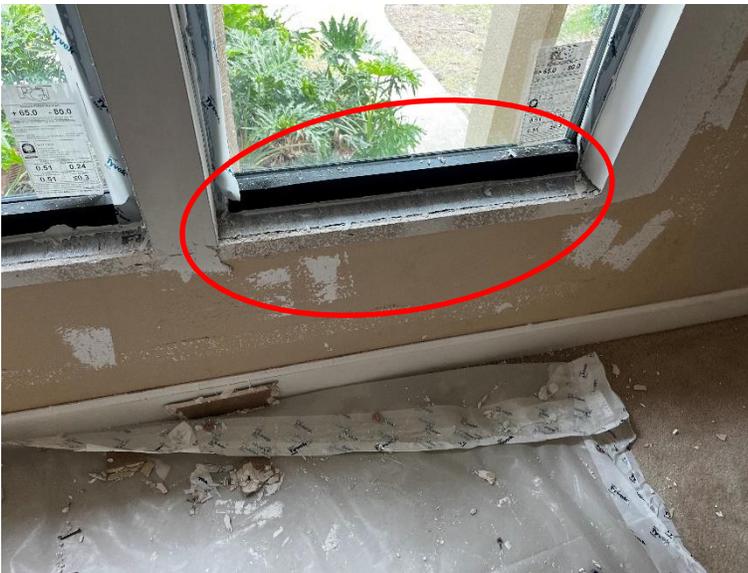
PHOTOGRAPH #14

**BUILDING 18
UNIT #1826**

Contractor applying new urethane sealant from new PGT window frames to Dupont flashings at window openings as per drawings and manufacturers guidelines.

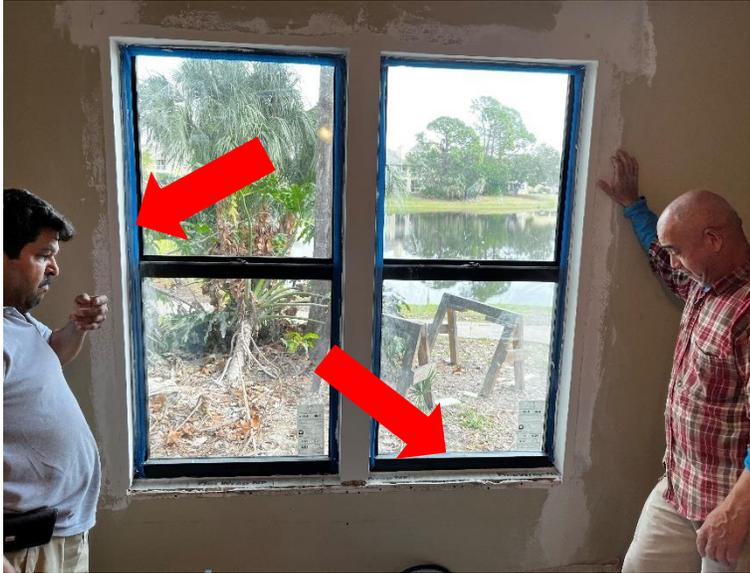
PHOTOGRAPH #15

**BUILDING 18
UNIT #1812**

Interior sealants and drywall repair in progress at new PGT window locations.

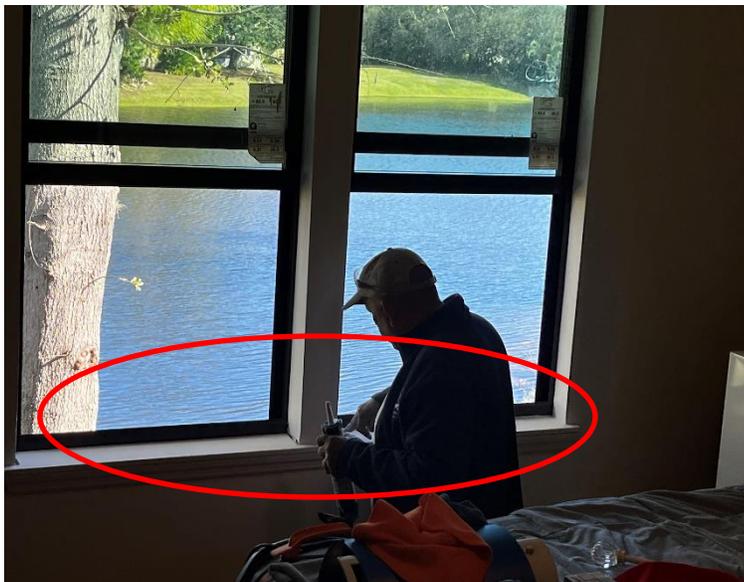
PHOTOGRAPH #16

**BUILDING 18
UNIT #1822**

New wood windowsills installed, sealed, and primed at window openings.

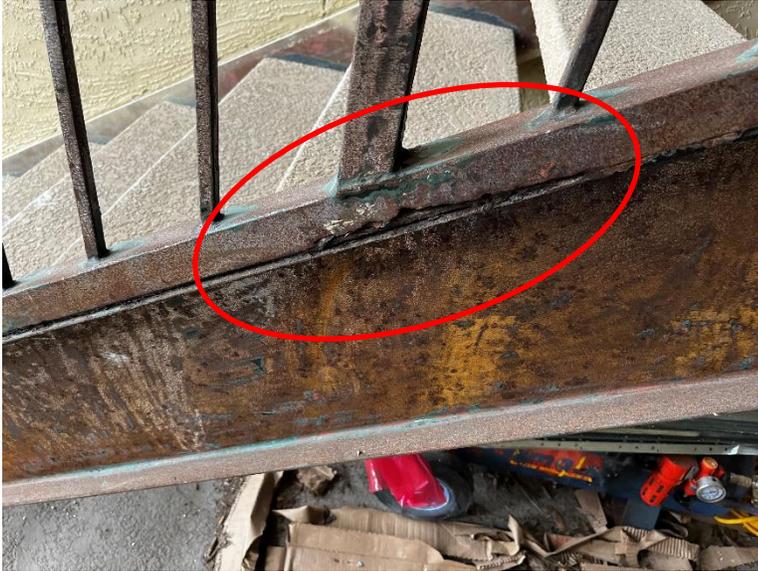
PHOTOGRAPH #17

**BUILDING 18
BREEZEWAY RAILING**

Existing rusted through conditions of steel railings at stringers and railing posts.

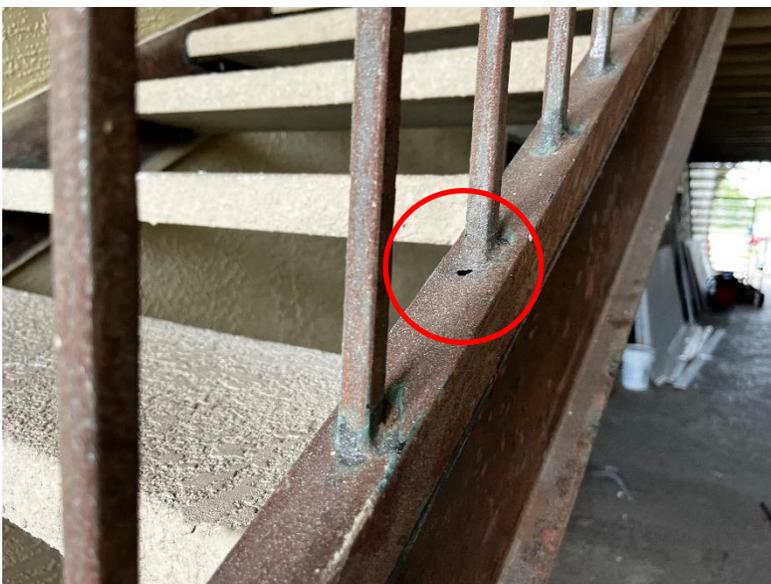
PHOTOGRAPH #18

**BUILDING 18
BREEZEWAY RAILING**

Existing rusted through conditions of steel railings at stringers and railing posts.

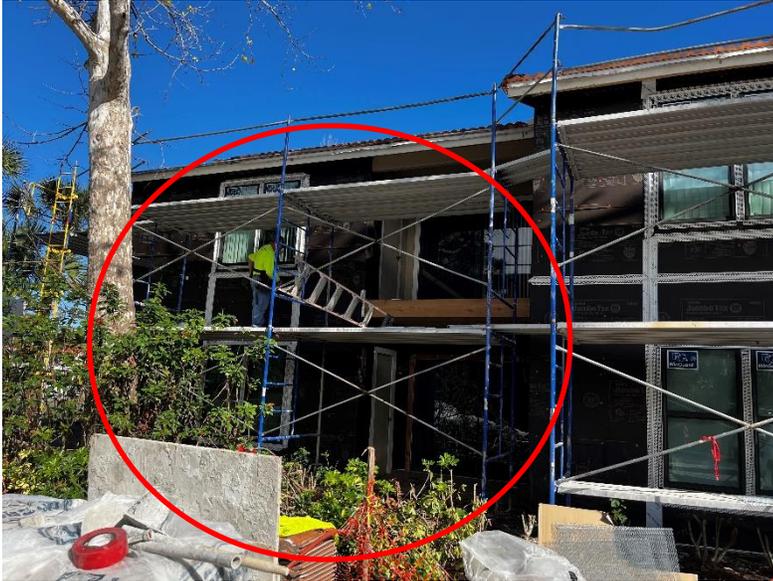
PHOTOGRAPH #19

**BUILDING 18
SECTION A**

Stucco sub-contractor applying vinyl stucco accessories and self-furring galvanized lath in preparation for stucco system.

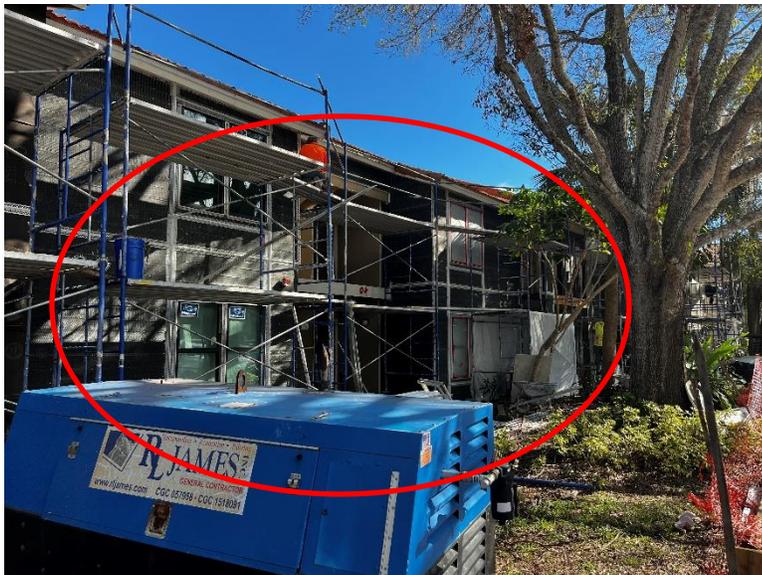
PHOTOGRAPH #20

**BUILDING 18
SECTION B**

Vinyl stucco accessories and galvanized metal lathing inspected and approved to receive 3 coat stucco applications.

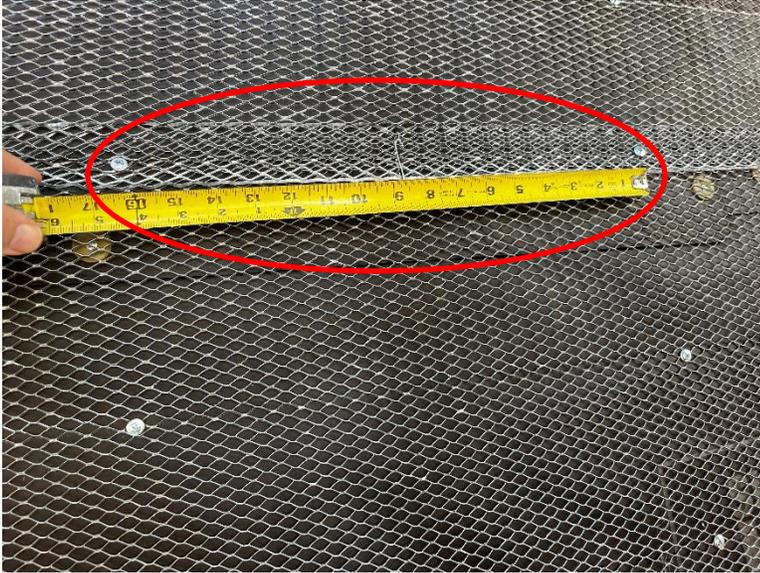
PHOTOGRAPH #21

**BUILDING 18
SECTION B**

Galvanized lath fastened at framing 16" O.C. and wired together at intervals no more than 9" O.C. as per ASTM C1063.

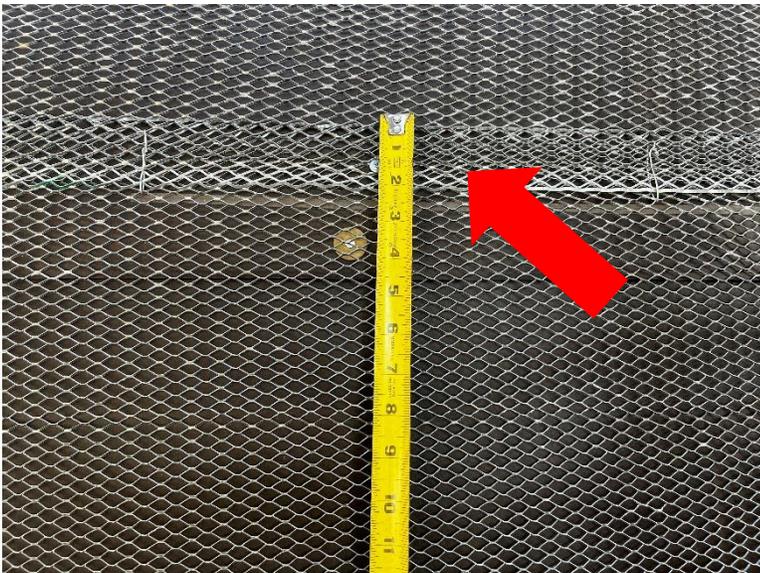
PHOTOGRAPH #22

**BUILDING 18
SECTION B**

Expanded galvanized lath overlapping minimum of 1/2" and sides and 1" at ends as per ASTM C1063.

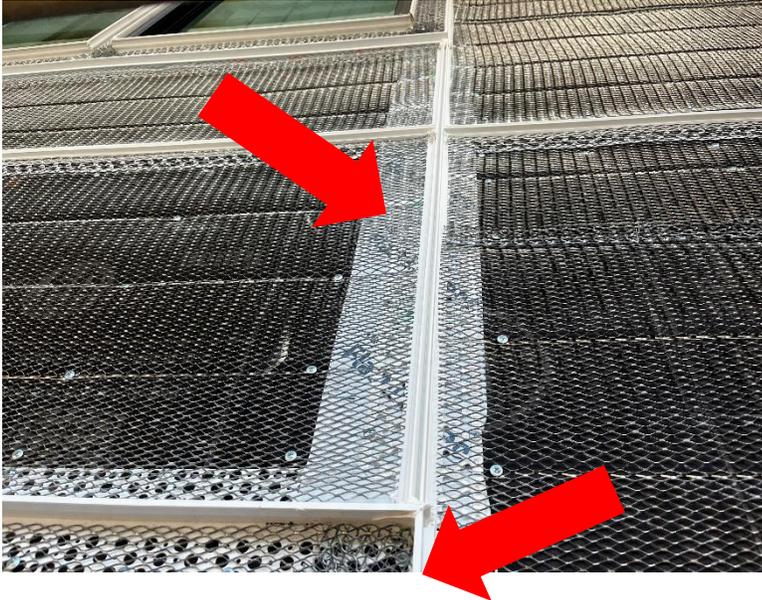
PHOTOGRAPH #23

**BUILDING 18
SECTION B**

Dupont straight flash applied behind vertical control joints and all ends, corners and butts at vinyl stucco accessories sealed with urethane sealant.

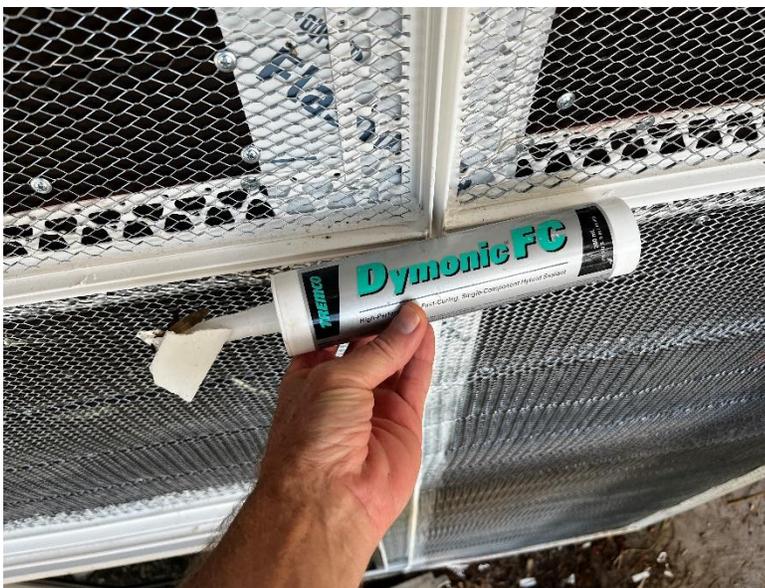
PHOTOGRAPH #24

**BUILDING 18
SECTION B**

Dupont straight flash applied behind vertical control joints and all ends, corners and butts at vinyl stucco accessories sealed with urethane sealant.

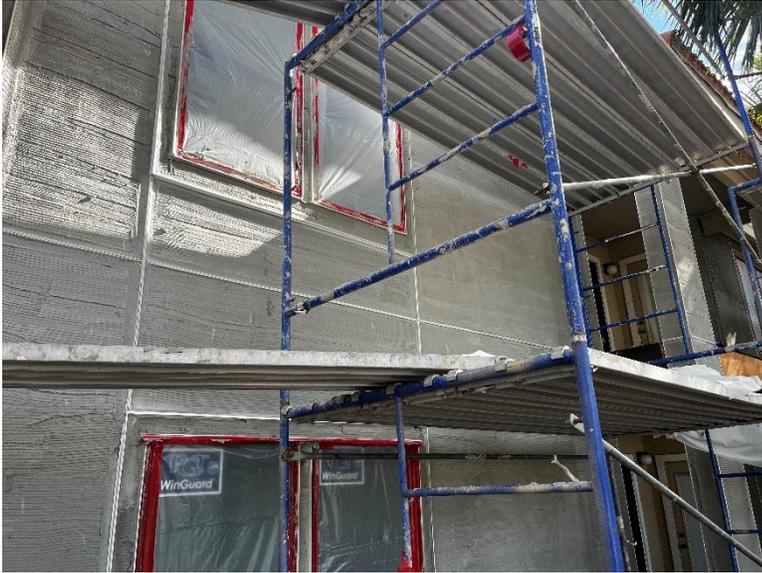
PHOTOGRAPH #25

**BUILDING 18
SECTION B**

Stucco sub-contractor has applied scratch coat of stucco as per ASTM C926.

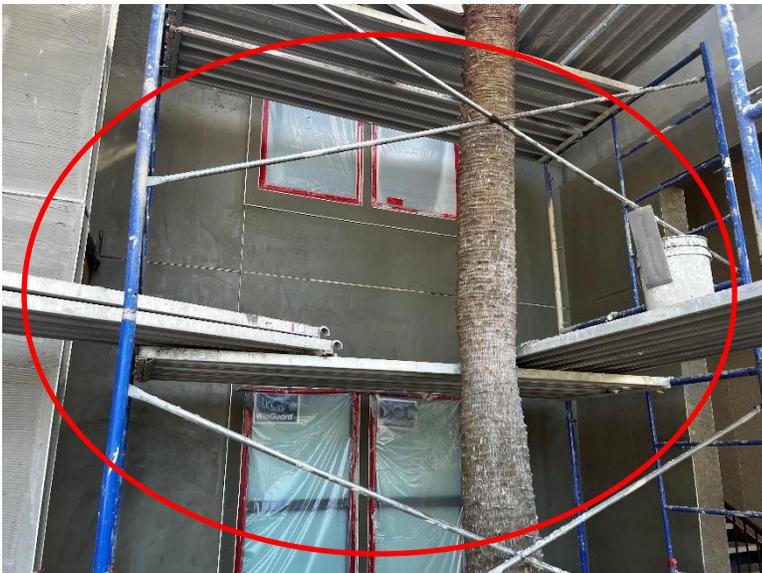
PHOTOGRAPH #26

**BUILDING 18
SECTION B**

Stucco sub-contractor has applied brown coat of stucco as per ASTM C926.

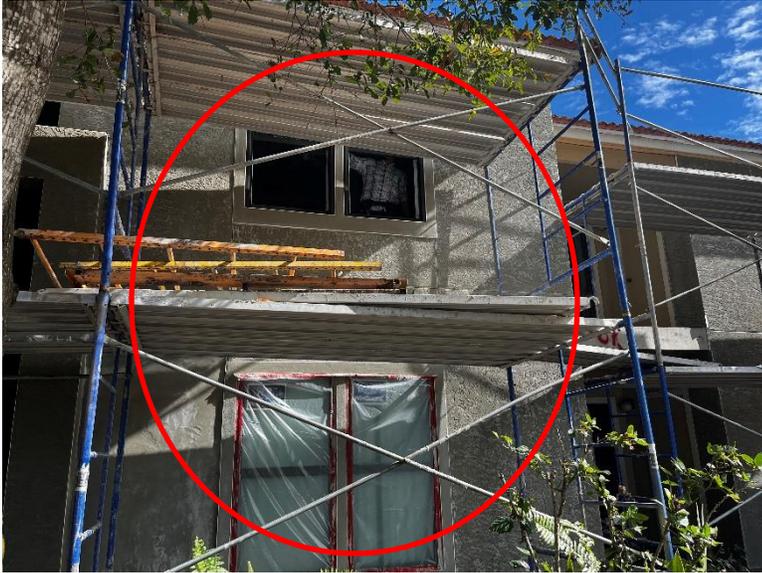
PHOTOGRAPH #27

**BUILDING 18
SECTION B**

Stucco sub-contractor has applied finish coat of stucco as per ASTM C926.

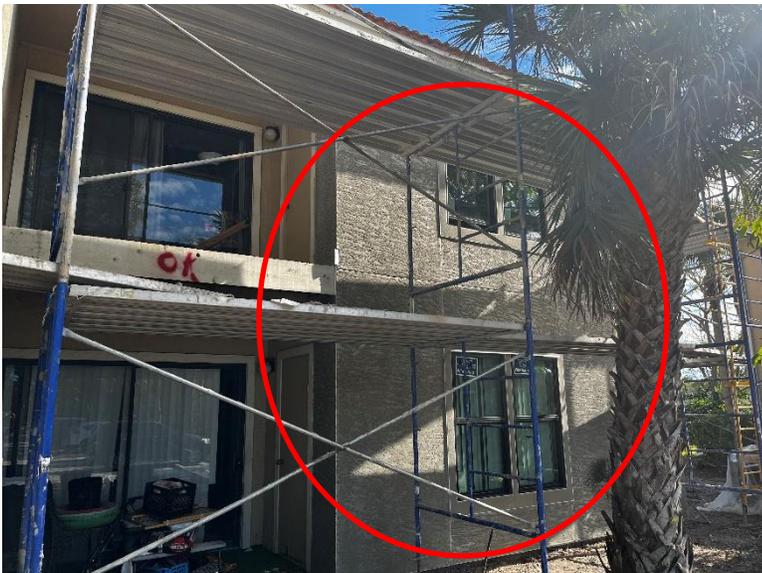
PHOTOGRAPH #28

**BUILDING 18
SECTION C**

Stucco sub-contractor has applied 7/8" three coat system of stucco as per ASTM C926.
