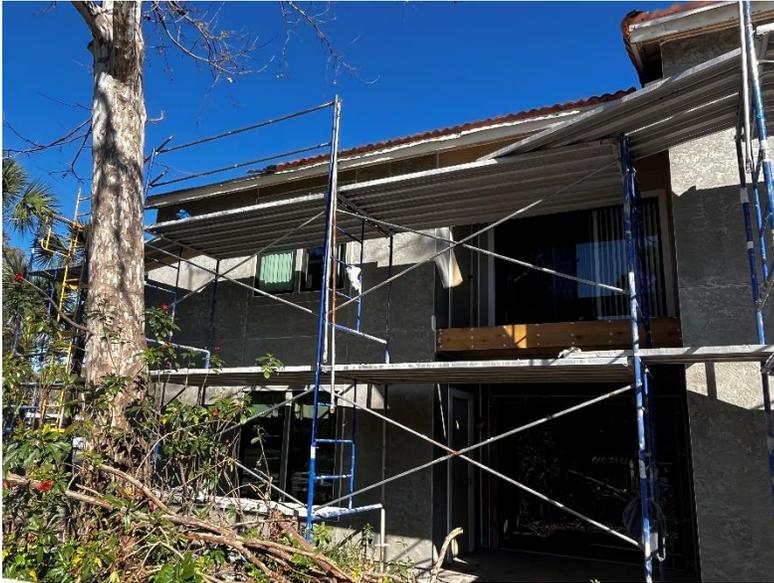
PHOTOGRAPH #1

**BUILDING 18
SECTION A**

Stucco sub-contractor has completed final finish coat stucco.

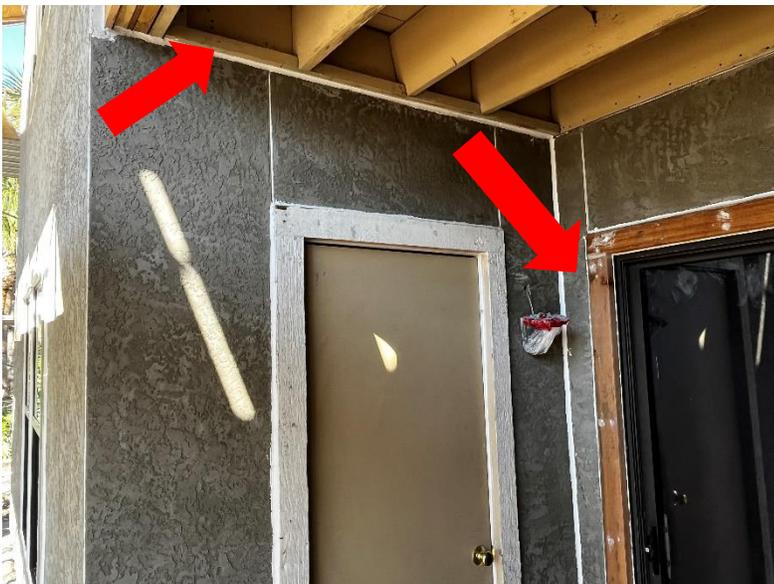
PHOTOGRAPH #2

**BUILDING 18
SECTION A**

New NP 150 BASF sealants applied at stucco transition joints .

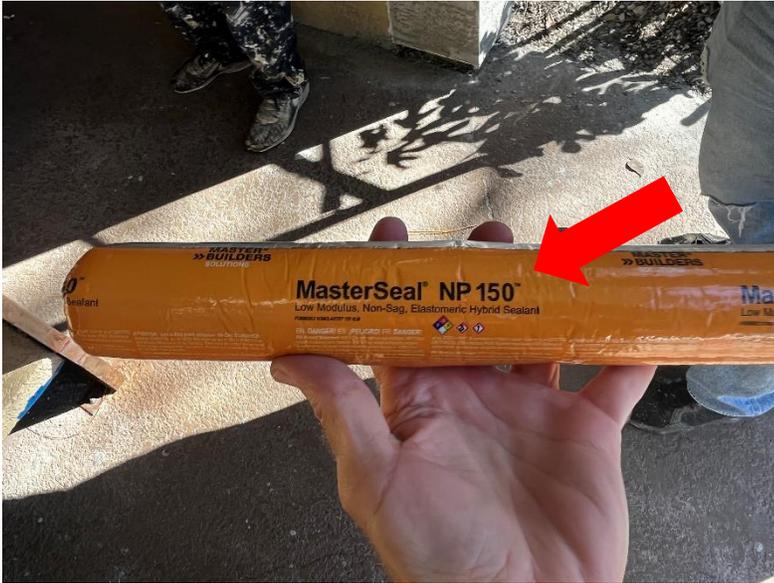
PHOTOGRAPH #3

**BUILDING 18
SECTION A**

New NP 150 BASF sealants applied at stucco transition joints.

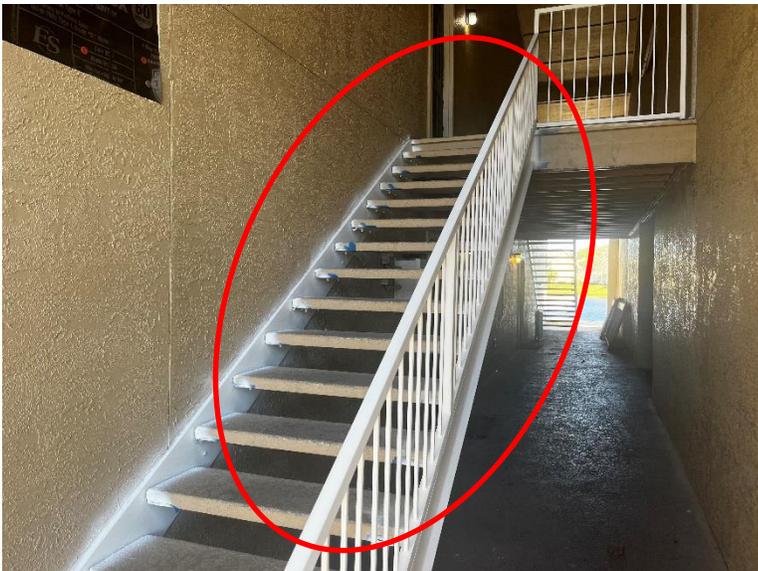
PHOTOGRAPH #4

**BUILDING 18
SECTION B**

Stairway railings prime coated with Florida Paints Encapsulon two-part epoxy.

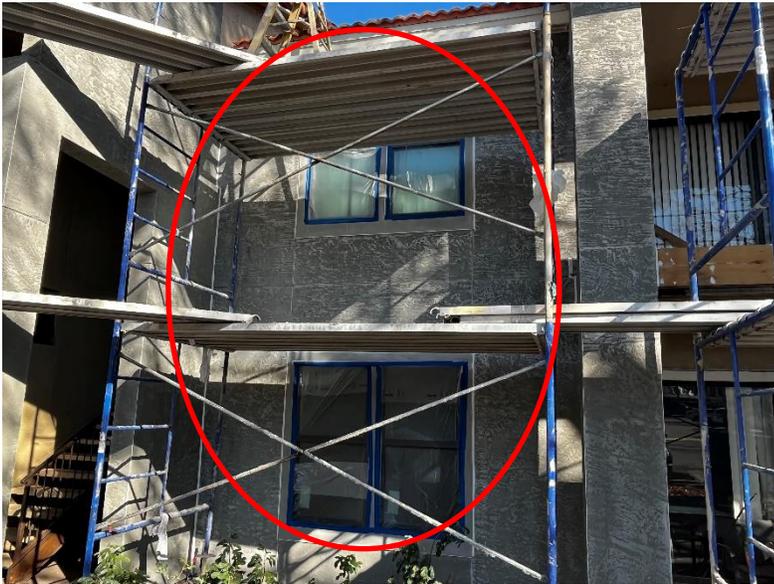
PHOTOGRAPH #5

**BUILDING 18
SECTION B**

Contractor protecting windows with plastic covering prior to stucco paint applications.

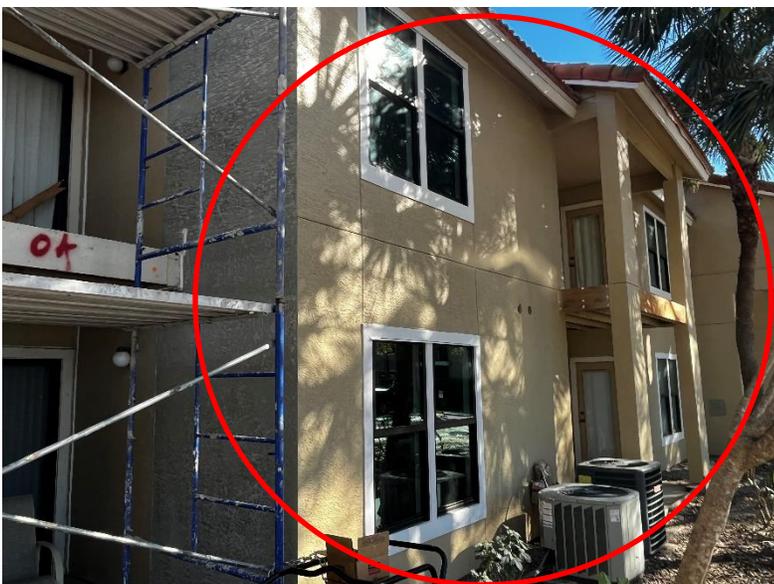
PHOTOGRAPH #6

**BUILDING 18
SECTION B**

Contractor has applying finish coat of Florida Paint Glades Exterior Acrylic.

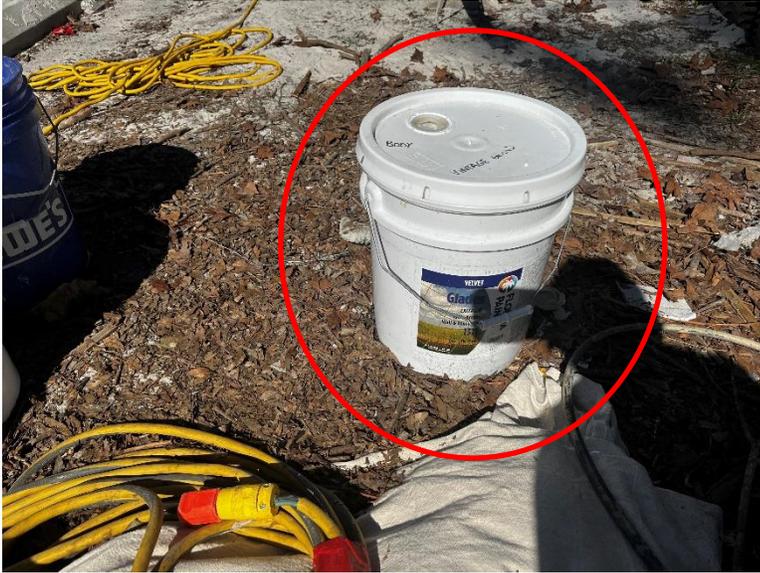
PHOTOGRAPH #7

**BUILDING 18
SECTION C**

Contractor has applying finish coat of Florida Paint Glades Exterior Acrylic.

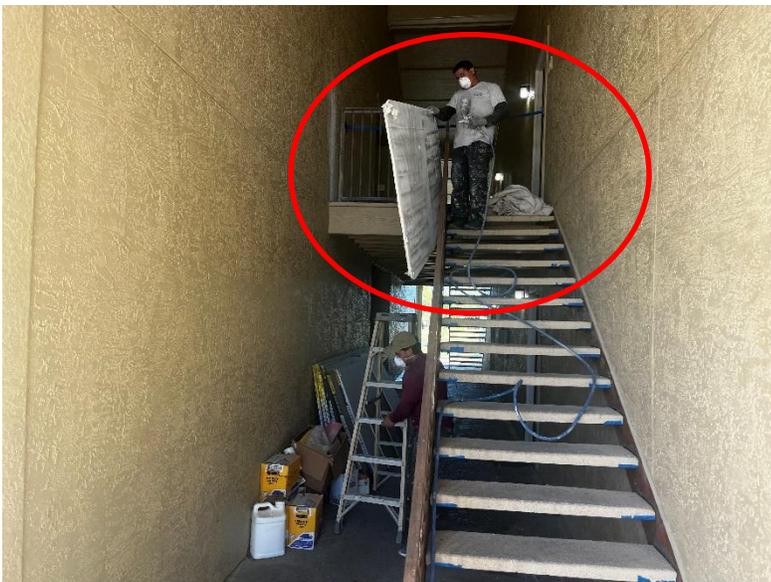
PHOTOGRAPH #8

**BUILDING 18
SECTION C**

Contractor priming stairway railings with Florida Paints Encapsulon two-part epoxy.

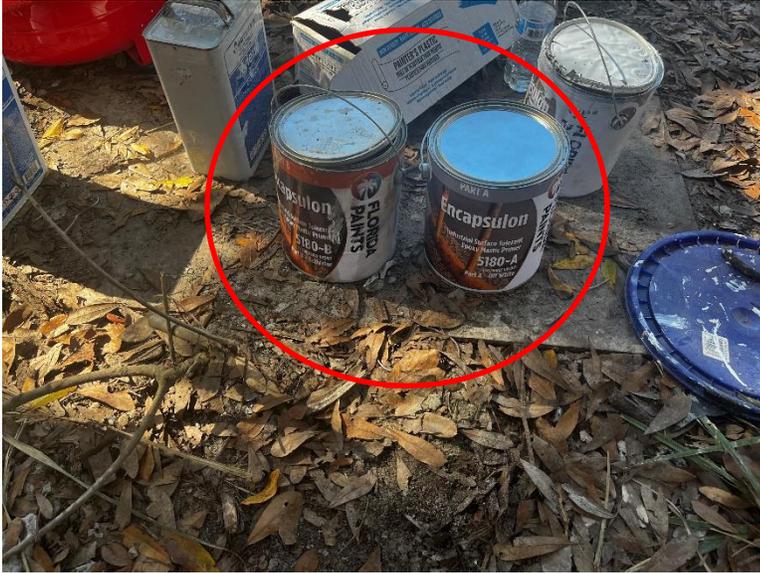
PHOTOGRAPH #9

**BUILDING 18
SECTION C**

Contractor priming stairway railings with Florida Paints Encapsulon two-part epoxy.

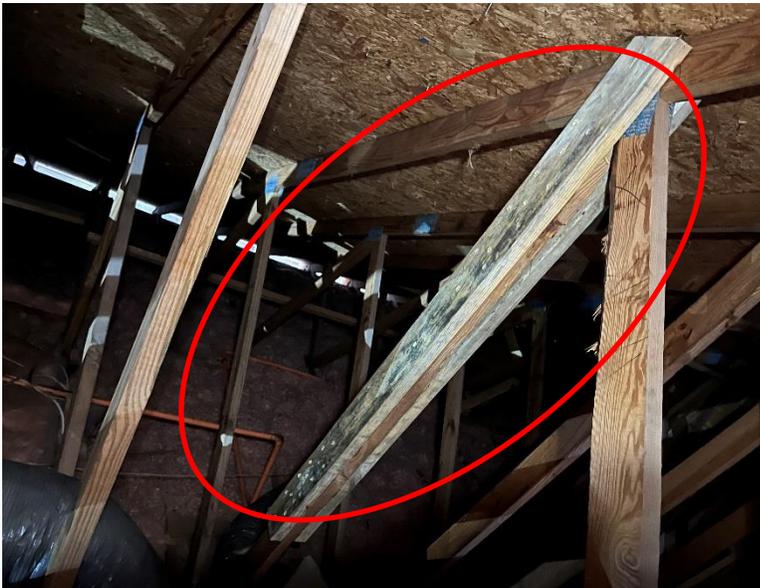
PHOTOGRAPH #10

**BUILDING 18
UNIT #1821- ATTIC**

Contractor has repaired damaged attic truss with scab repair detail as per project drawings.

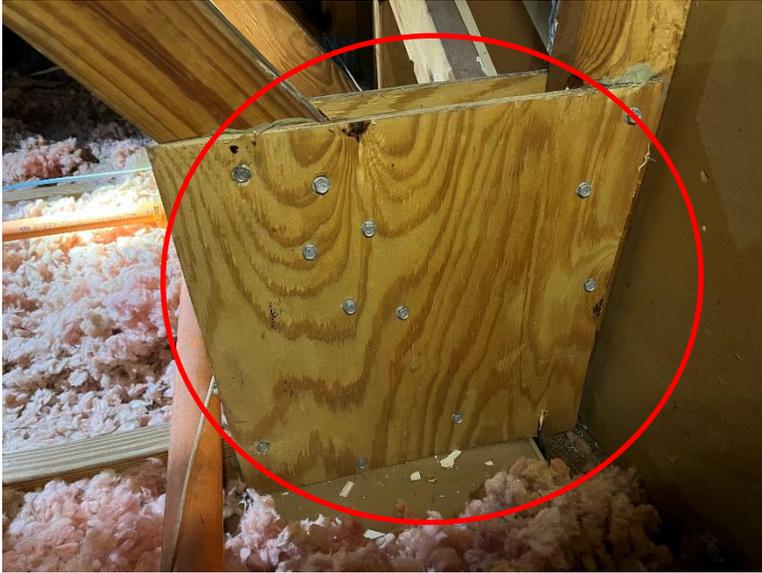
PHOTOGRAPH #11

**BUILDING 18
UNIT #1821- ATTIC**

Contractor has repaired damaged attic truss with gusset repair detail as per project drawings.

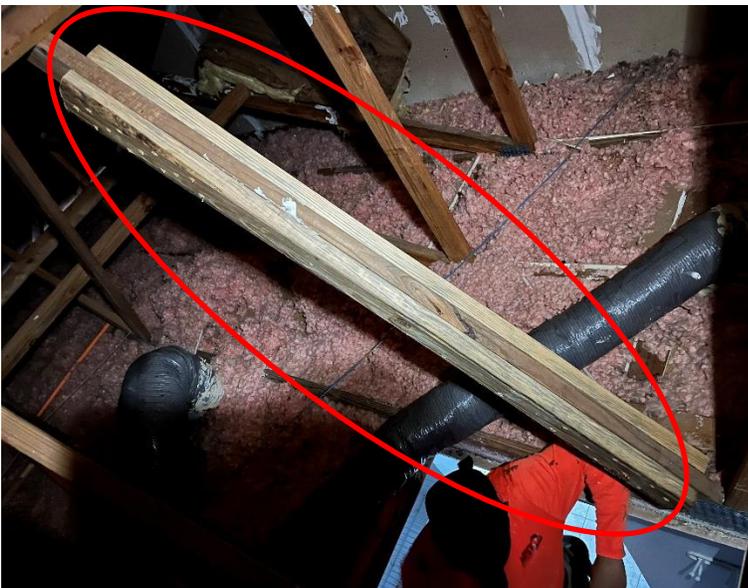
PHOTOGRAPH #12

**BUILDING 18
UNIT #1823- ATTIC**

Contractor has repaired damaged attic truss with scab repair detail as per project drawings.

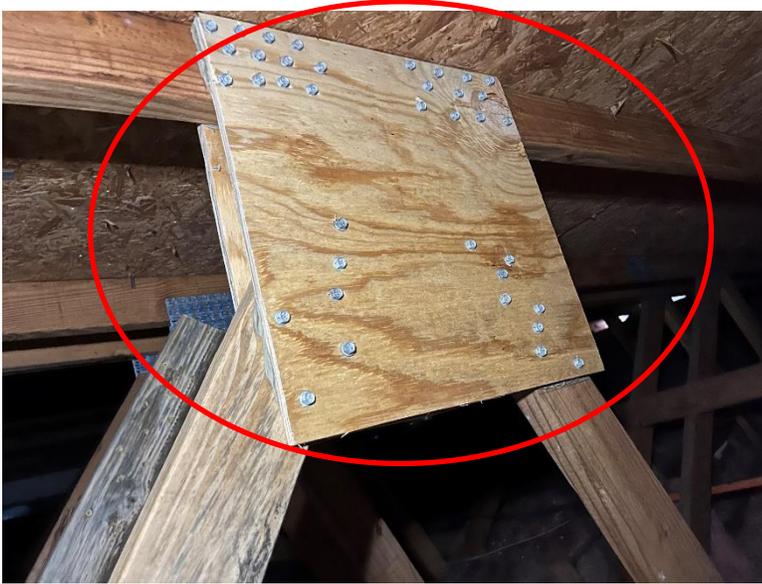
PHOTOGRAPH #13

**BUILDING 18
UNIT #1823- ATTIC**

Contractor has repaired damaged attic truss with gusset repair detail as per project drawings.

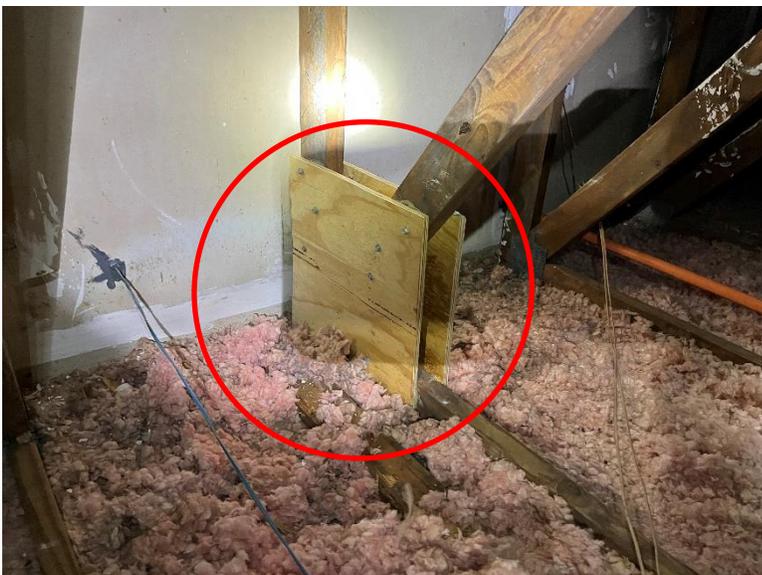
PHOTOGRAPH #14

**BUILDING 18
UNIT #1826- ATTIC**

Contractor has repaired damaged attic truss with gusset repair detail as per project drawings.

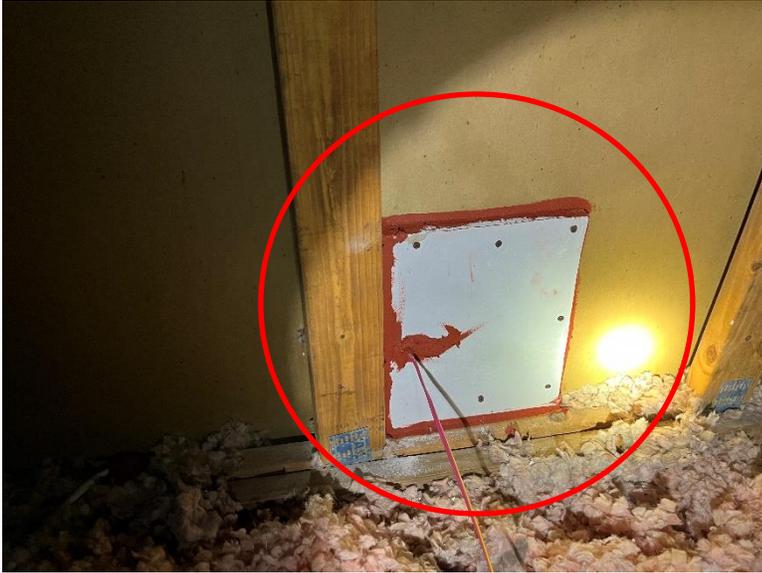
PHOTOGRAPH #15

**BUILDING 18
UNIT #1826- ATTIC**

Contractor has repaired damaged attic fire wall with fire board repair detail as per project drawings.

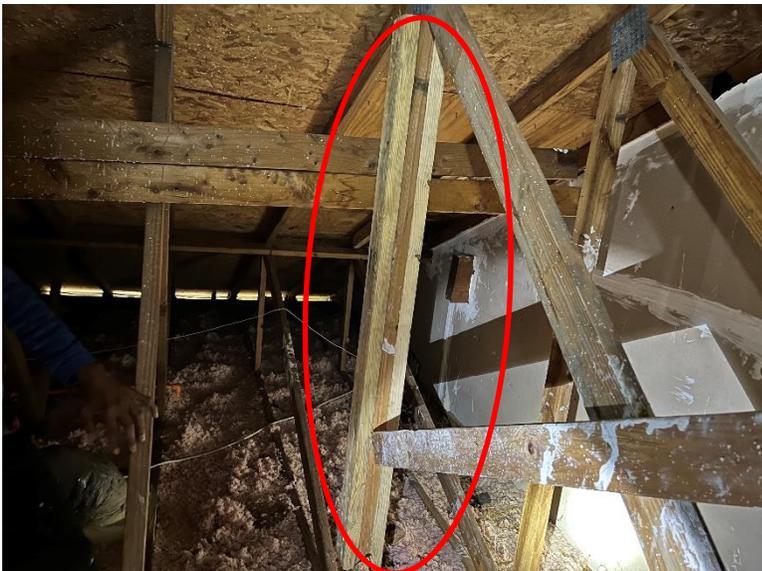
PHOTOGRAPH #16

**BUILDING 18
UNIT #1826- ATTIC**

Contractor has repaired damaged attic truss with scab repair detail as per project drawings.

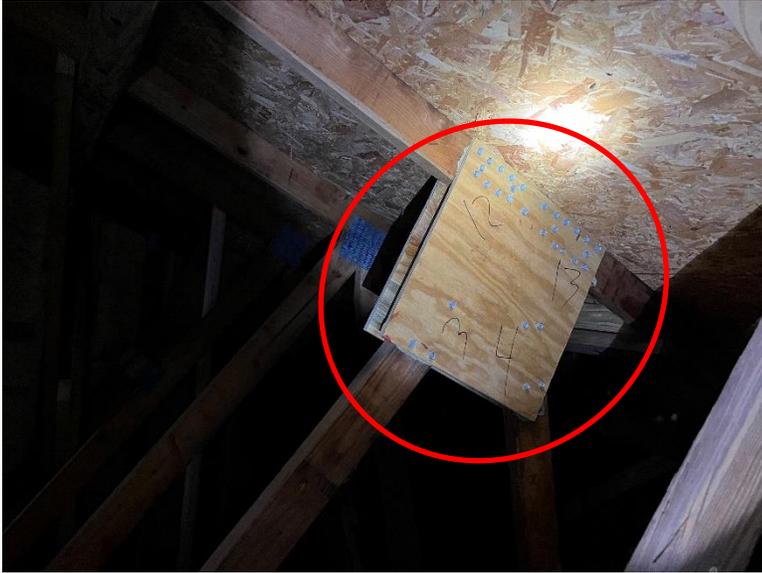
PHOTOGRAPH #17

**BUILDING 18
UNIT #1827- ATTIC**

Contractor has repaired damaged attic truss with gusset repair detail as per project drawings.

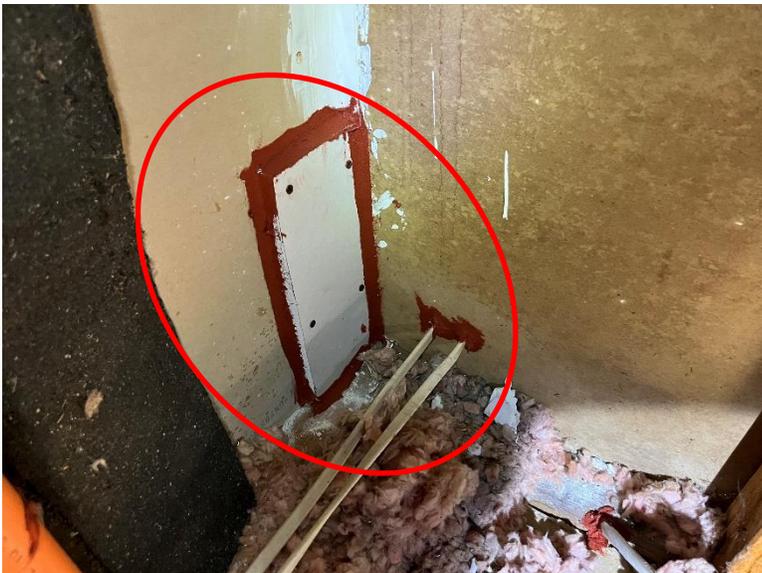
PHOTOGRAPH #18

**BUILDING 18
UNIT #1827- ATTIC**

Contractor has repaired damaged attic fire wall with fire board repair detail as per project drawings.

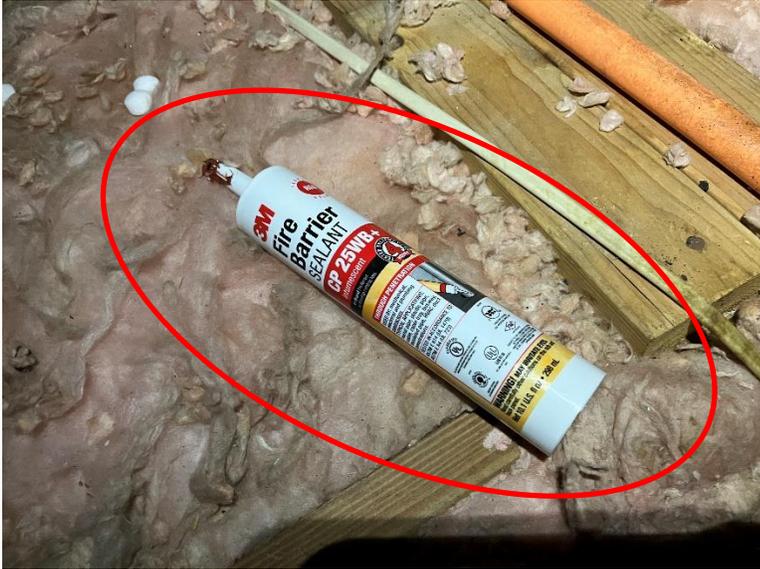
PHOTOGRAPH #19

**BUILDING 18
UNIT #1827- ATTIC**

Fire barrier sealant applied at fire wall penetrations and new fire wall perimeters.

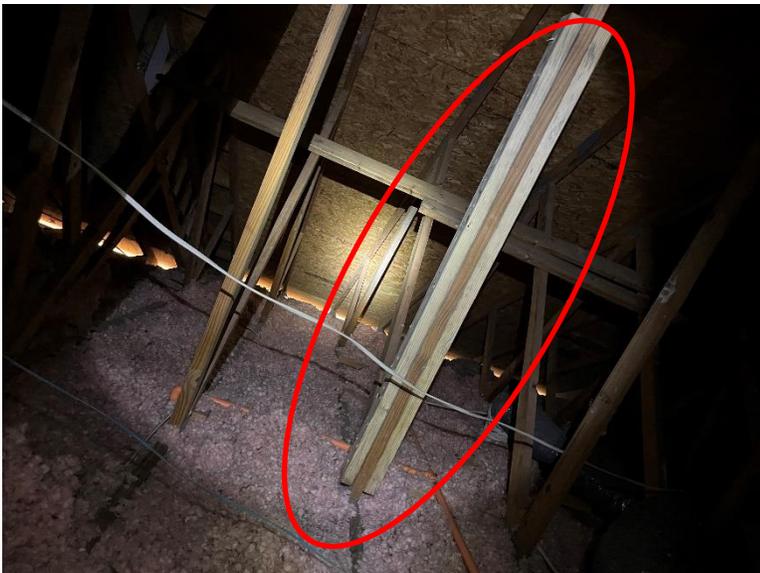
PHOTOGRAPH #20

**BUILDING 18
UNIT #1827- ATTIC**

Contractor has repaired damaged attic truss with scab repair detail as per project drawings.

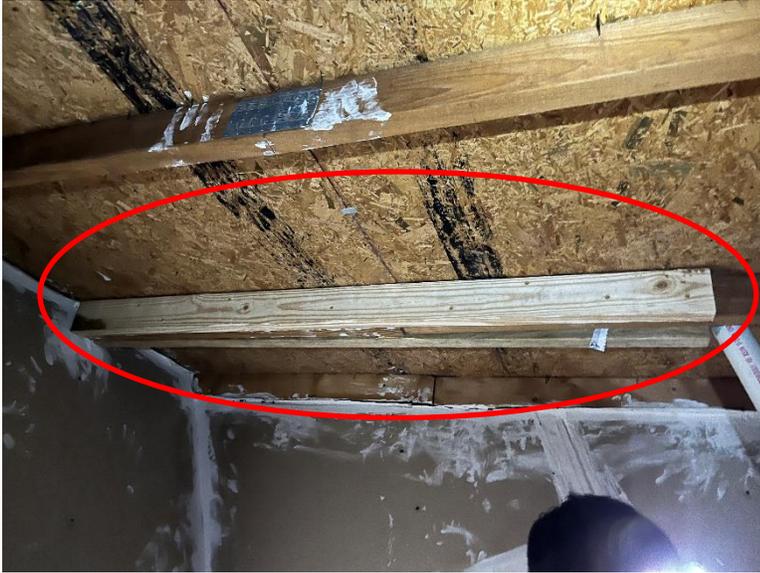
PHOTOGRAPH #21

**BUILDING 18
UNIT #1825- ATTIC**

Contractor has repaired damaged attic truss with scab repair detail as per project drawings.

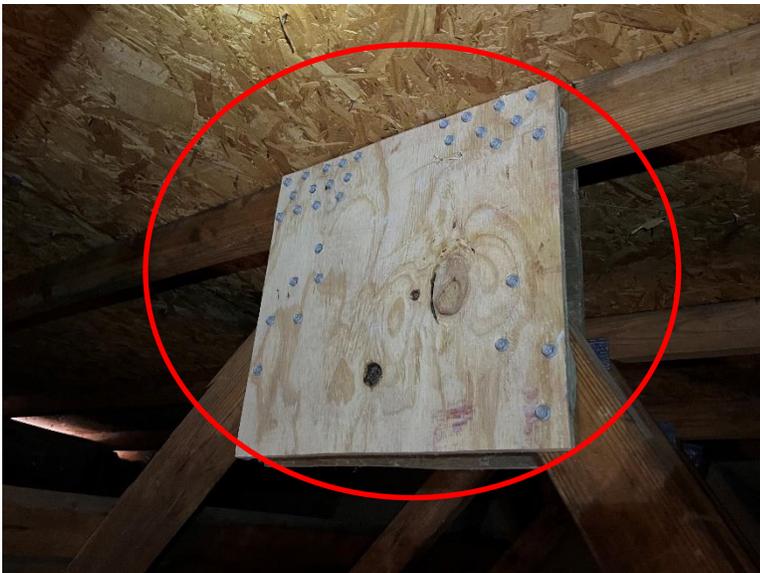
PHOTOGRAPH #22

**BUILDING 18
UNIT #1825- ATTIC**

Contractor has repaired damaged attic truss with gusset repair detail as per project drawings.
