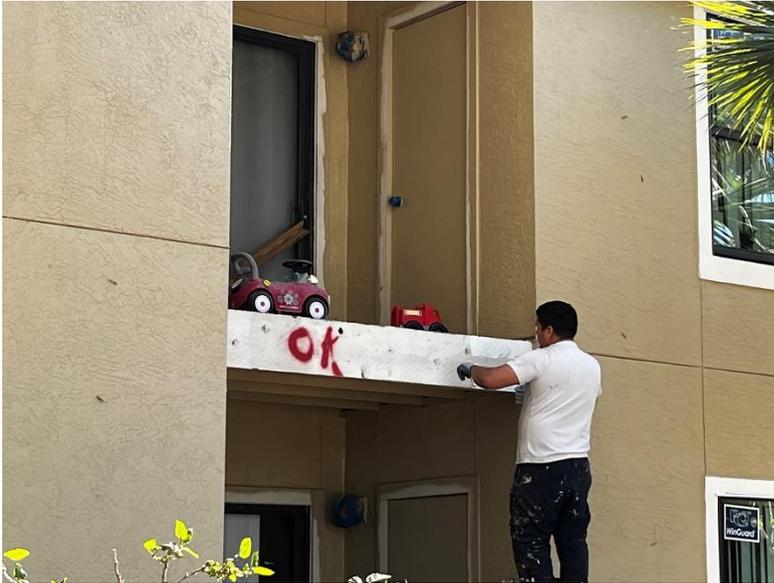
PHOTOGRAPH #1

**BUILDING 18
SECTION C**

Contractor priming and painting cedar facing at balconies built up beams.

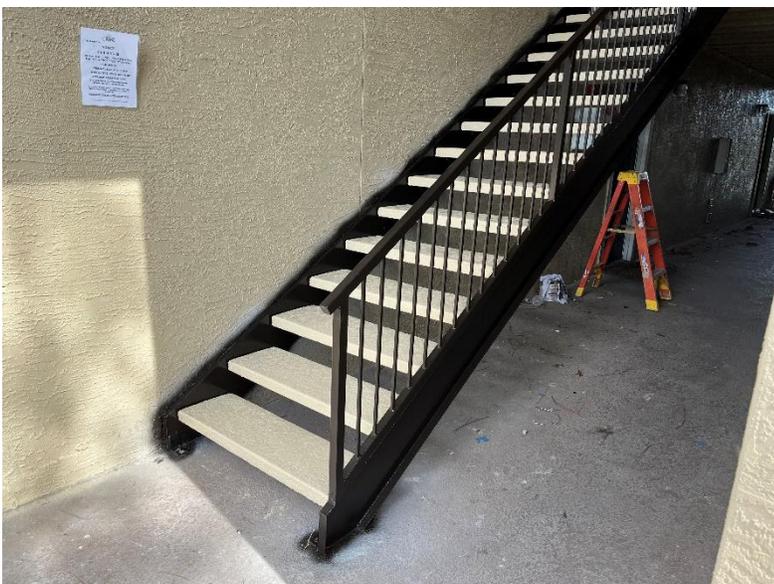
PHOTOGRAPH #2

**BUILDING 18
SECTION G**

Contractor has applied Florida Paints urethane aliphatic gloss enamel paint.

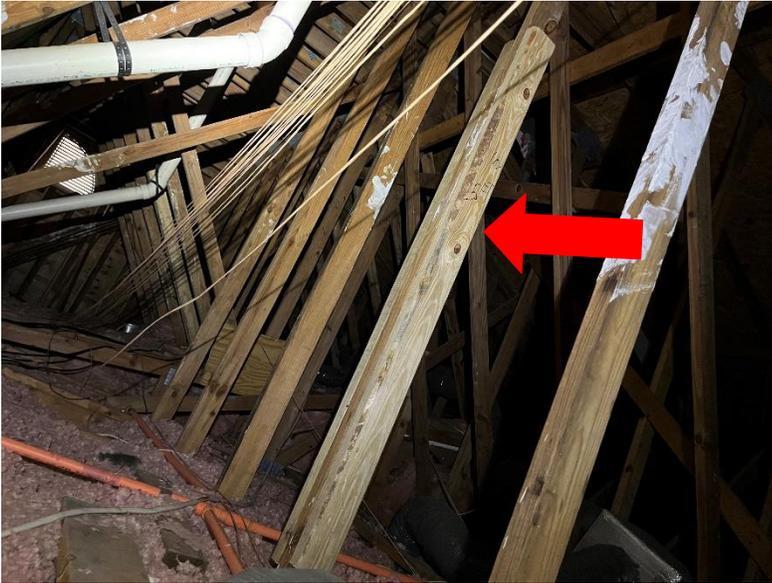
PHOTOGRAPH #3

**BUILDING 18
UNIT #1822- ATTIC**

Contractor has repaired damaged attic truss with scab repair detail as per project drawings.

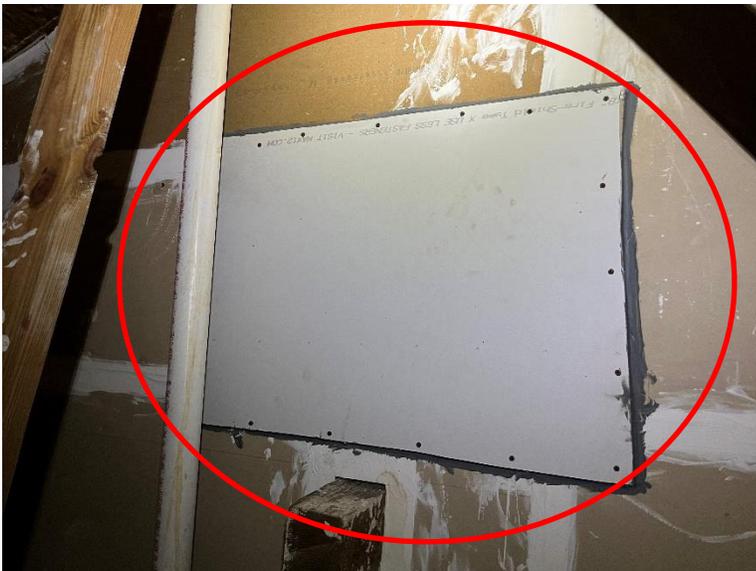
PHOTOGRAPH #4

**BUILDING 18
UNIT #1822- ATTIC**

Contractor has repaired damaged attic fire wall with new fire board repair.

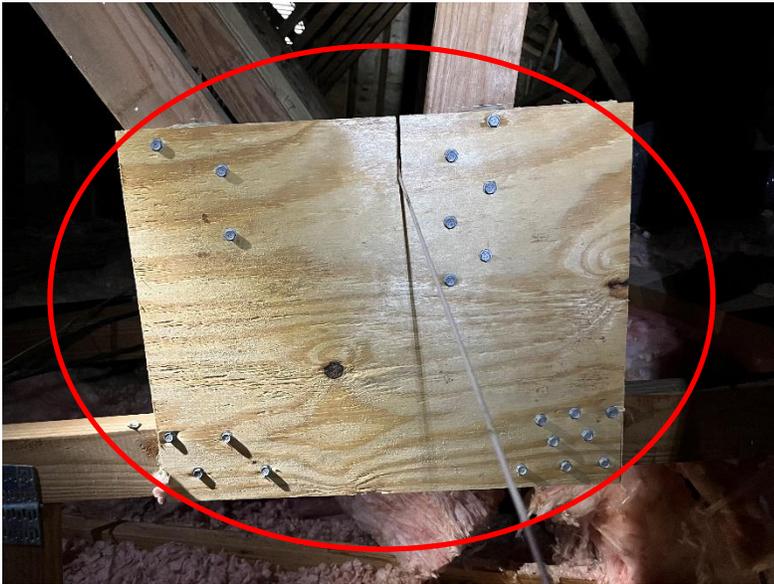
PHOTOGRAPH #5

**BUILDING 18
UNIT #1822- ATTIC**

Contractor has repaired damaged attic truss with gusset repair detail as per project drawings.

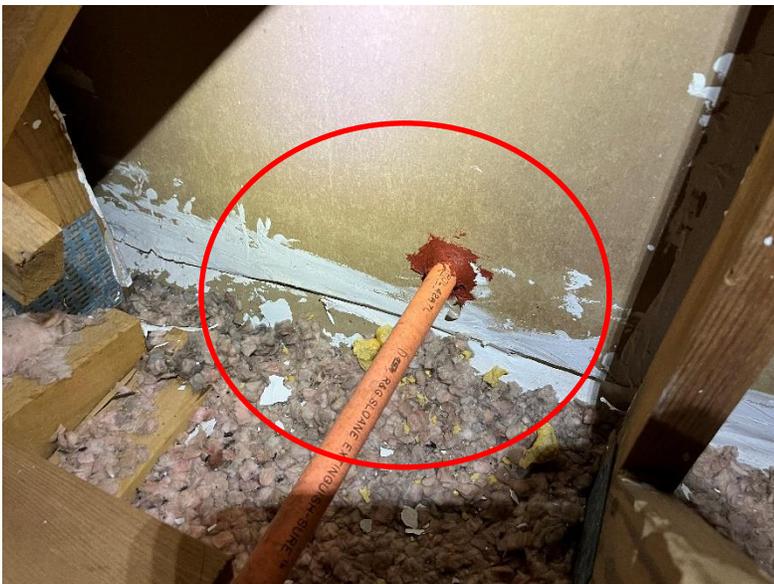
PHOTOGRAPH #6

**BUILDING 18
UNIT #1824- ATTIC**

Fire barrier sealant applied at fire wall penetrations and new fire wall perimeters.

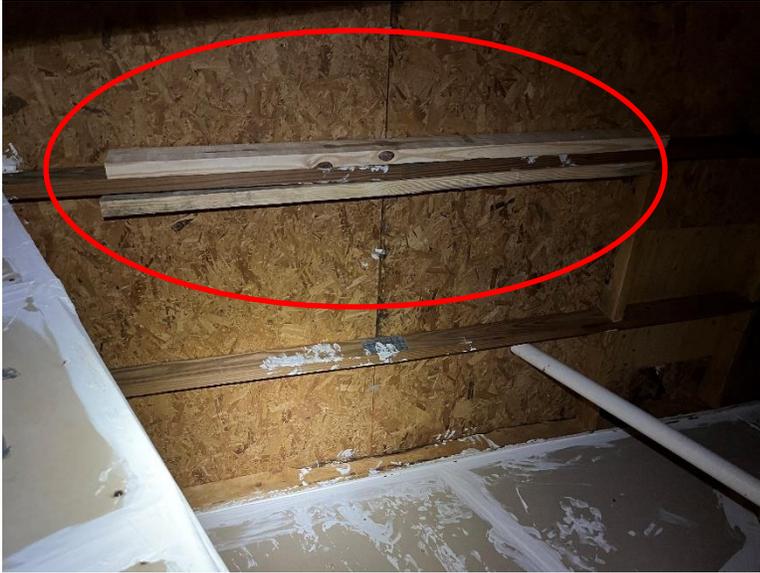
PHOTOGRAPH #7

**BUILDING 18
UNIT #1824- ATTIC**

Contractor has repaired damaged attic truss with scab repair detail as per project drawings.

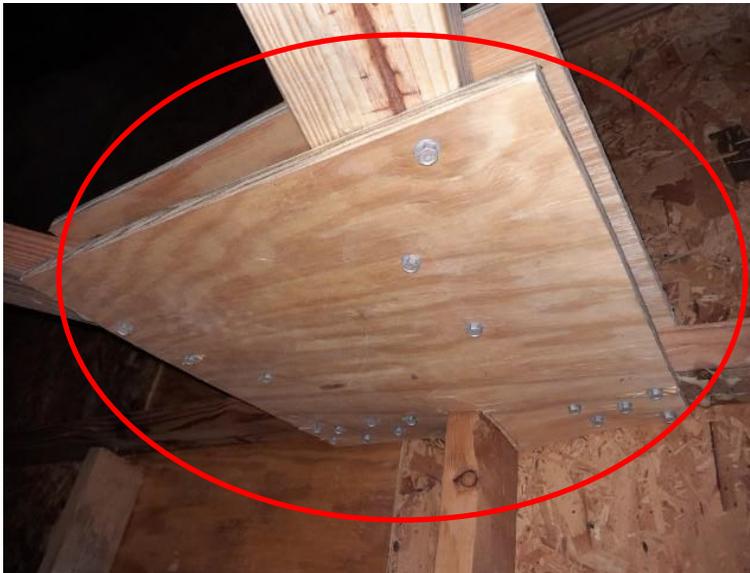
PHOTOGRAPH #8

**BUILDING 18
UNIT #1828- ATTIC**

Contractor has repaired damaged attic truss with gusset repair detail as per project drawings.

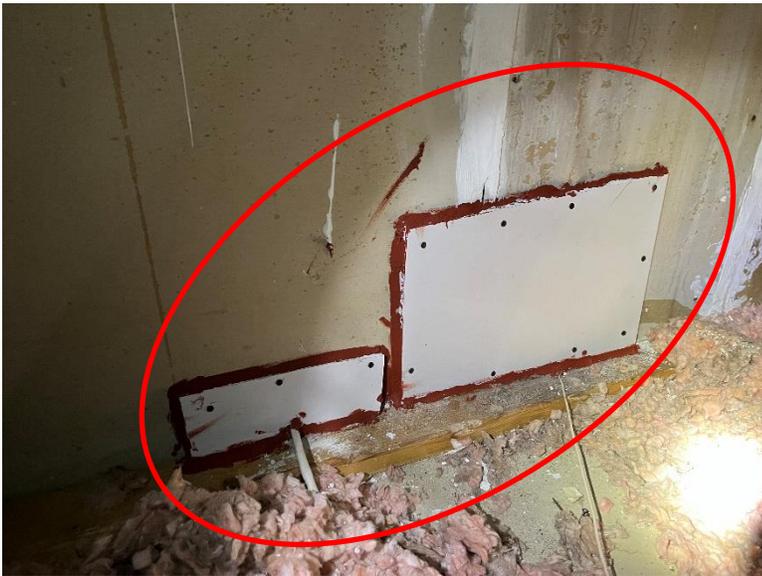
PHOTOGRAPH #9

**BUILDING 18
UNIT #1828- ATTIC**

Contractor has repaired damaged attic fire wall with new fire board repair.

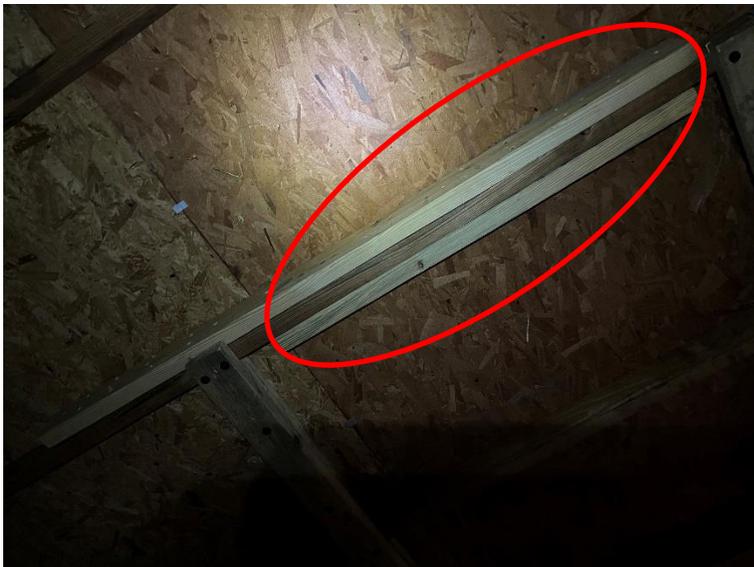
PHOTOGRAPH #10

**BUILDING 18
UNIT #1828- ATTIC**

Contractor has repaired damaged attic truss with gusset repair detail as per project drawings.
