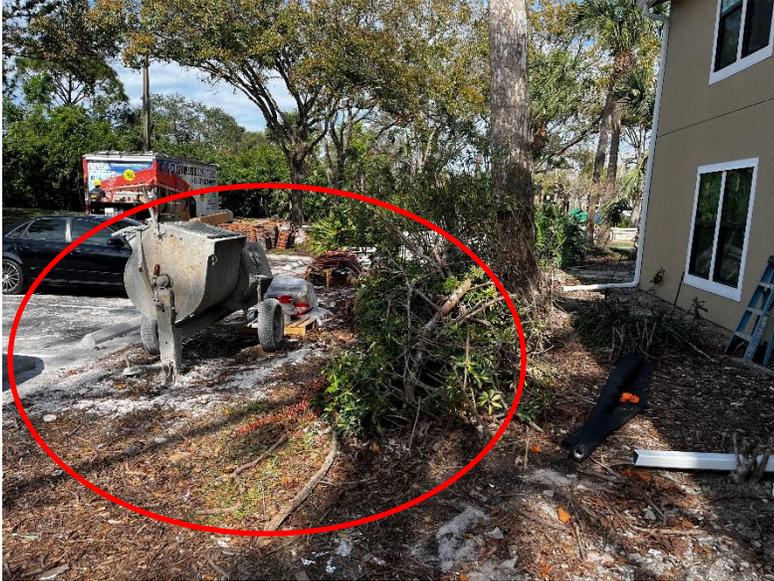
PHOTOGRAPH #1

**BUILDING 18
SECTION A**

Contractor equipment, materials and debris remaining in front of building.

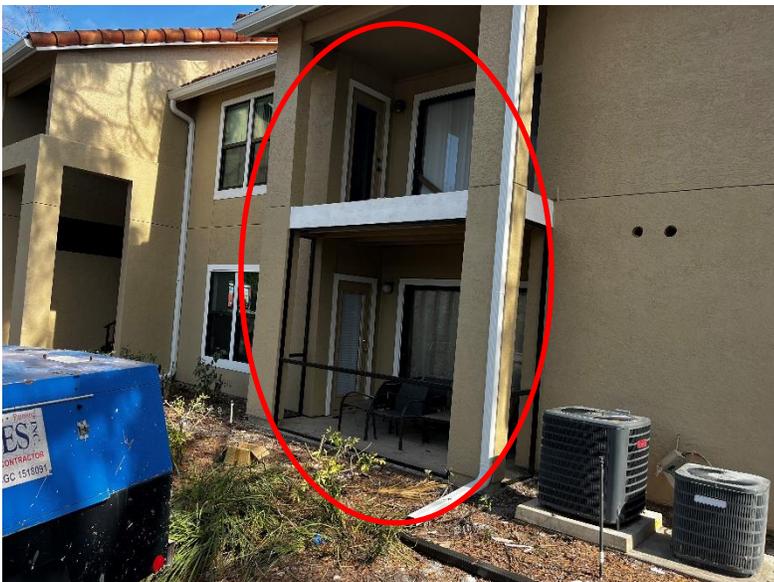
PHOTOGRAPH #2

**BUILDING 18
SECTION B**

Contractor has replaced patio screen enclosure. Balcony railing has not been re installed.

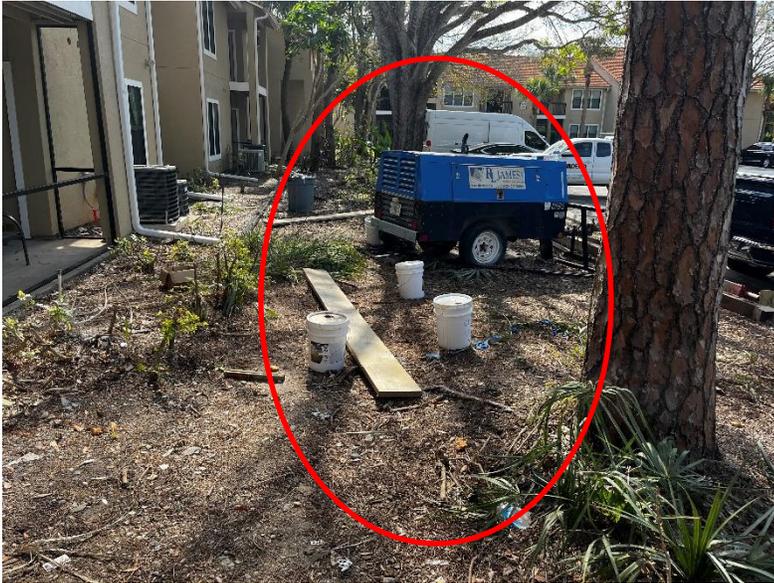
PHOTOGRAPH #3

**BUILDING 18
SECTION B**

Contractor equipment, materials and debris remaining in front of building.

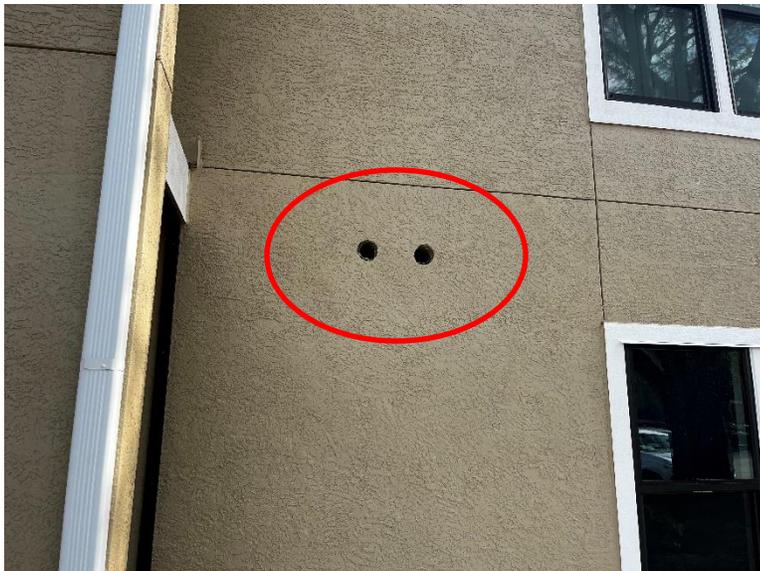
PHOTOGRAPH #4

**BUILDING 18
SECTION B**

Dryer vents have yet to be replaced, sealed, and painted.

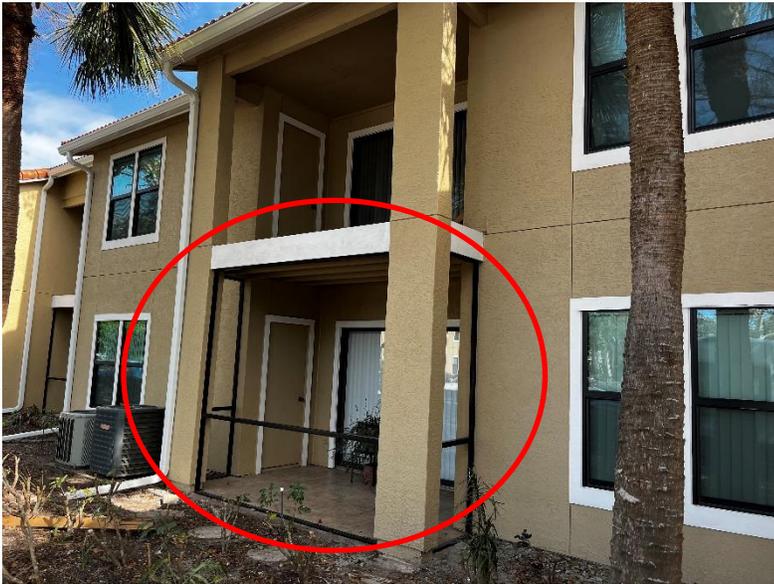
PHOTOGRAPH #5

**BUILDING 18
SECTION C**

Contractor has begun to install new patio screen enclosure. Balcony railing has not been re installed.

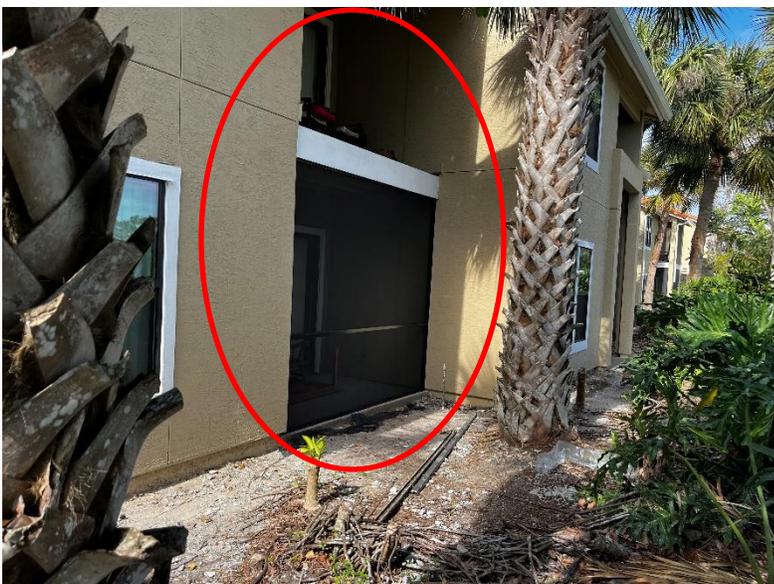
PHOTOGRAPH #6

**BUILDING 18
SECTION E**

Contractor has replaced patio screen enclosure. Balcony railing has not been re installed

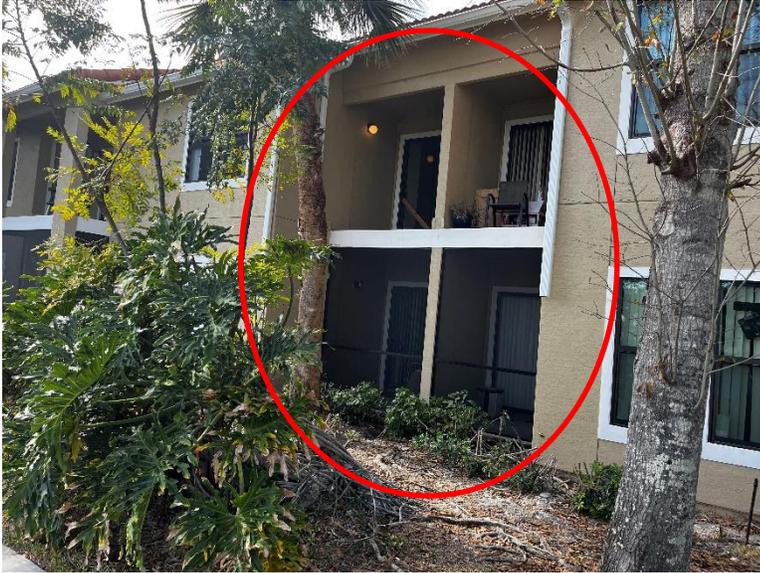
PHOTOGRAPH #7

**BUILDING 18
SECTION F**

Contractor has replaced patio screen enclosure. Balcony railing has not been re installed.

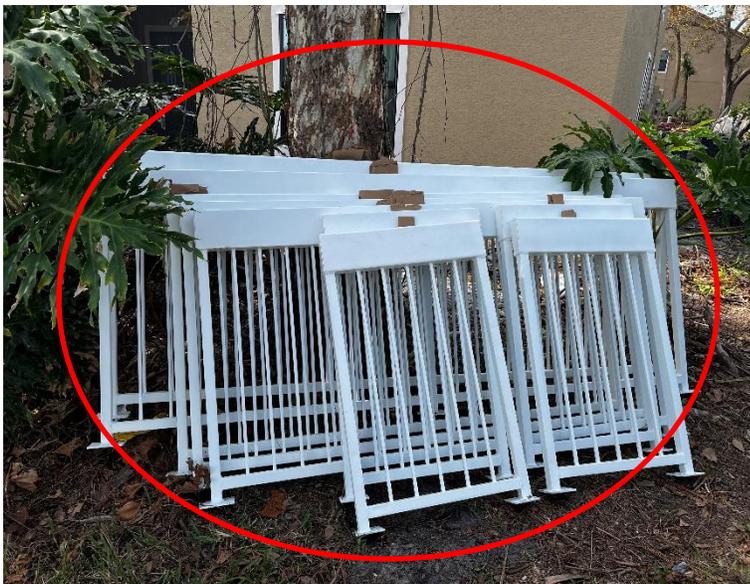
PHOTOGRAPH #8

**BUILDING 18
SECTION G**

Balcony railing primed with Florida Paint Encapsulon epoxy mastic primer.

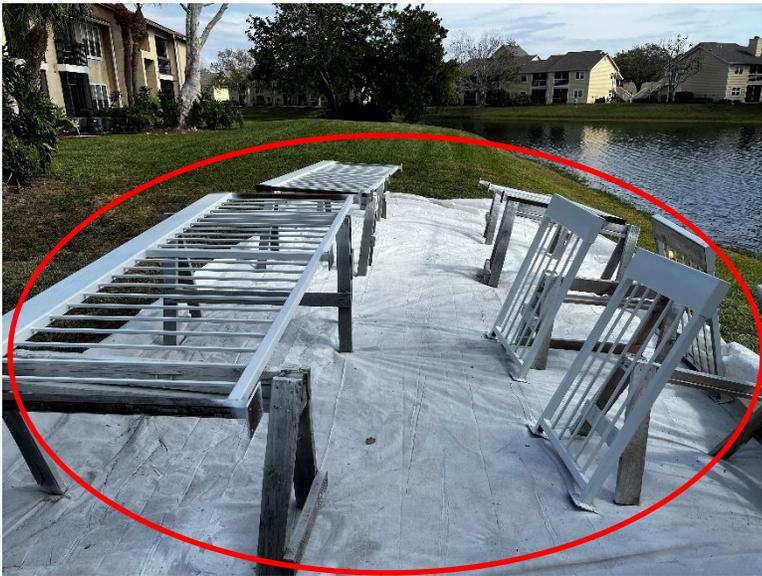
PHOTOGRAPH #9

**BUILDING 18
SECTION G**

Contractor painting balcony railings with Florida Paints Encapsulon epoxy mastic primer.

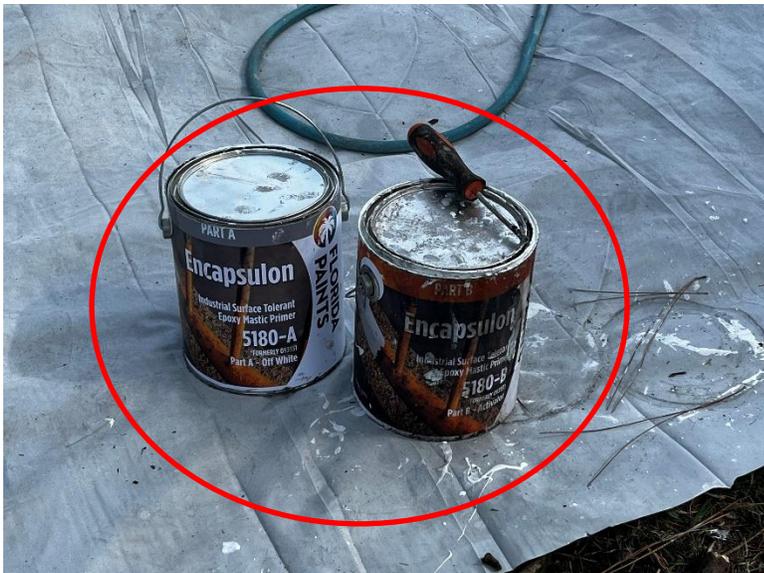
PHOTOGRAPH #10

**BUILDING 18
SECTION G**

Contractor painting balcony railings with Florida Paints Encapsulon epoxy mastic primer.
