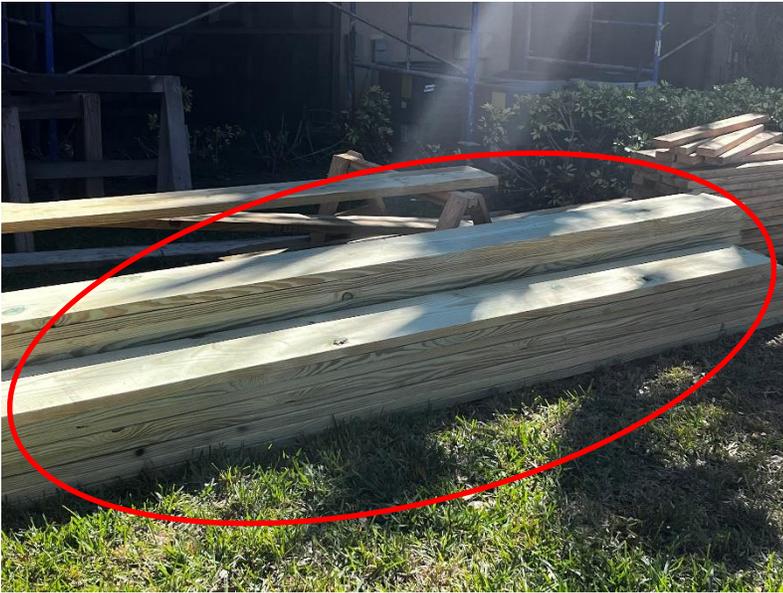
PHOTOGRAPH #1

**BUILDING 11
SECTION B**

Pressure treated repair lumber staged in construction area.

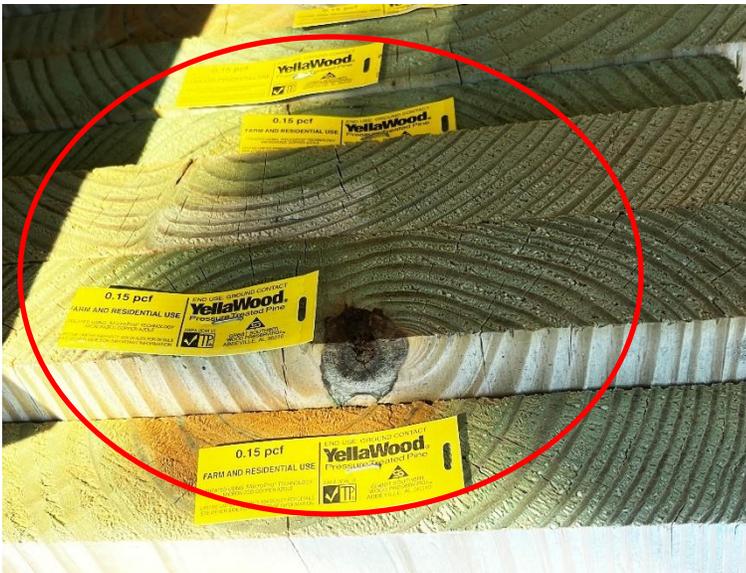
PHOTOGRAPH #2

**BUILDING 11
SECTION B**

Pressure treated repair lumber staged in construction area.

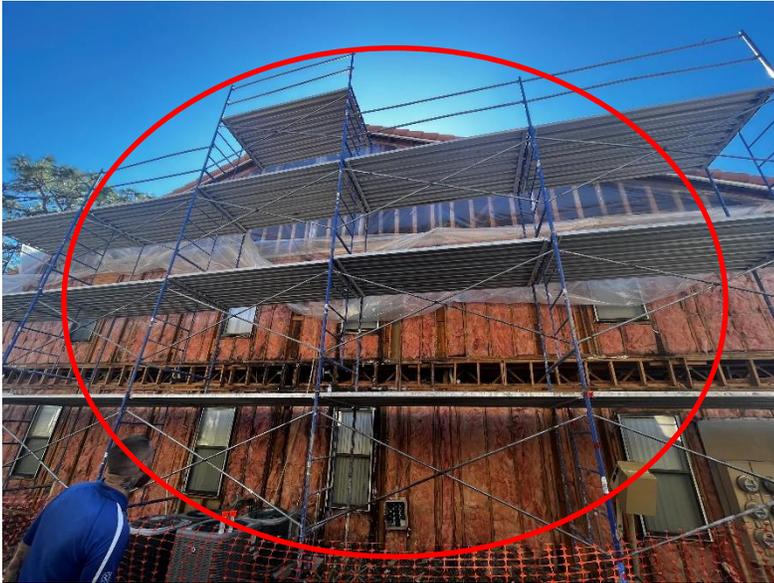
PHOTOGRAPH #3

**BUILDING 11
SECTION H**

Gable end open for investigation and marking of framing repairs.

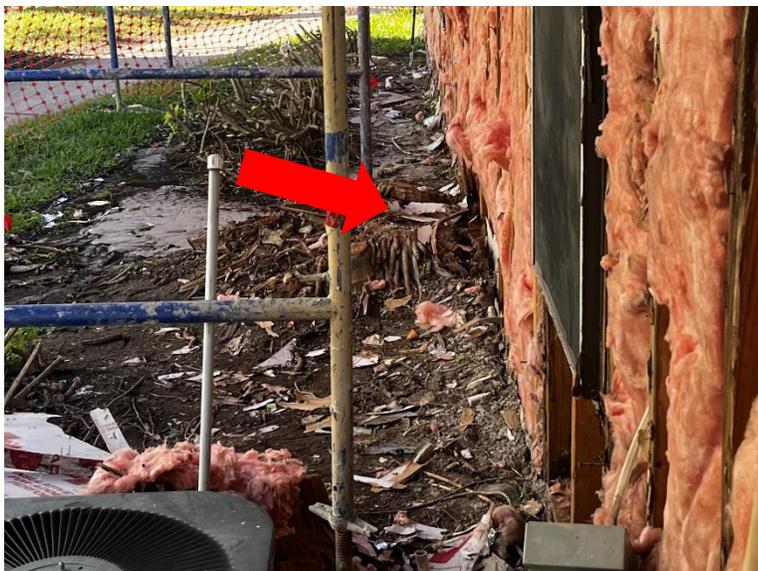
PHOTOGRAPH #4

**BUILDING 11
SECTION H**

Landscaping and grade level is above bottom plate and areas of wall framing. Removal and drainage will be required by owners as per drawings.

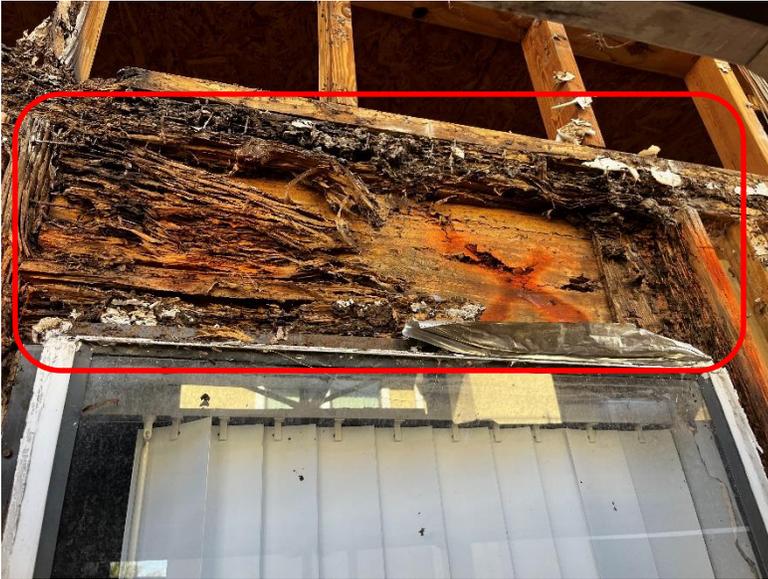
PHOTOGRAPH #5

**BUILDING 11
SECTION H**

Termite damage at window headers and window framing marked for repairs.

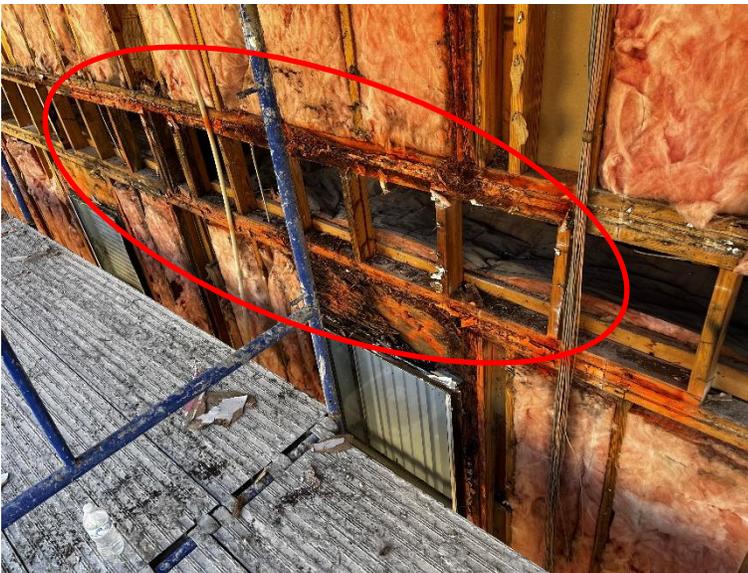
PHOTOGRAPH #6

**BUILDING 11
SECTION H**

Framing damage at floor truss, top plate and bottom plate marked for repairs.

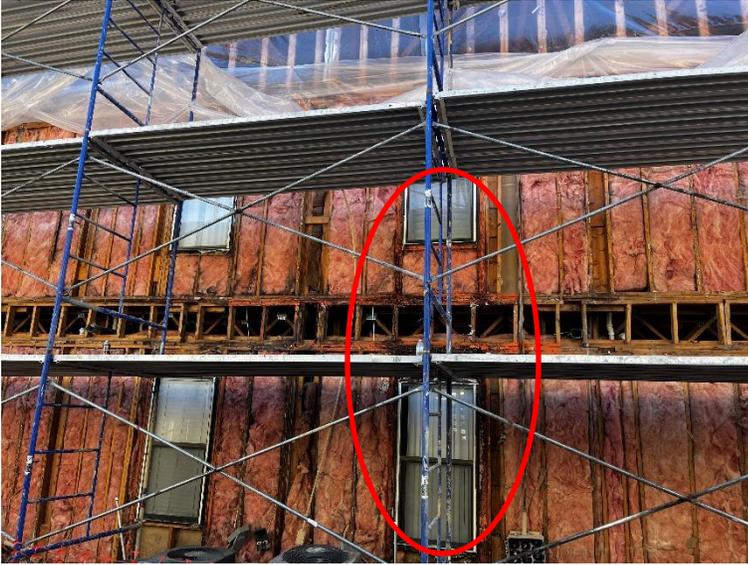
PHOTOGRAPH #7

**BUILDING 11
SECTION H**

Window framing damage marked for repairs.

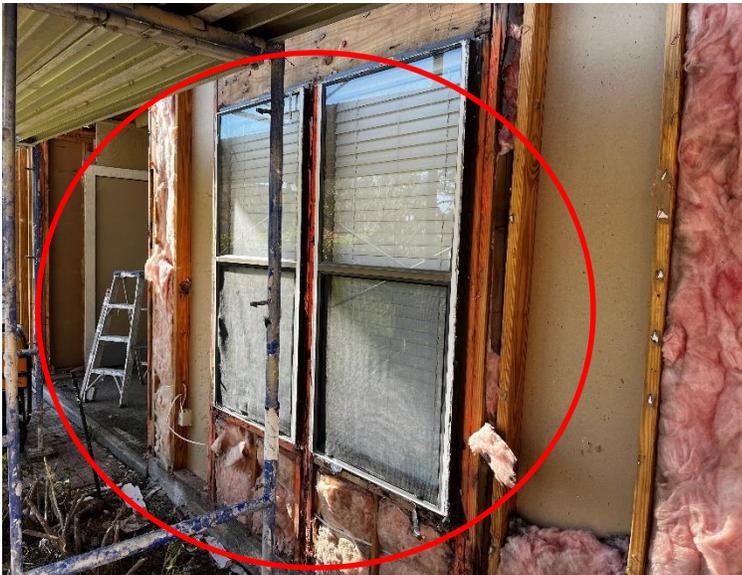
PHOTOGRAPH #8

**BUILDING 11
SECTION G**

Window framing damage marked for repairs.

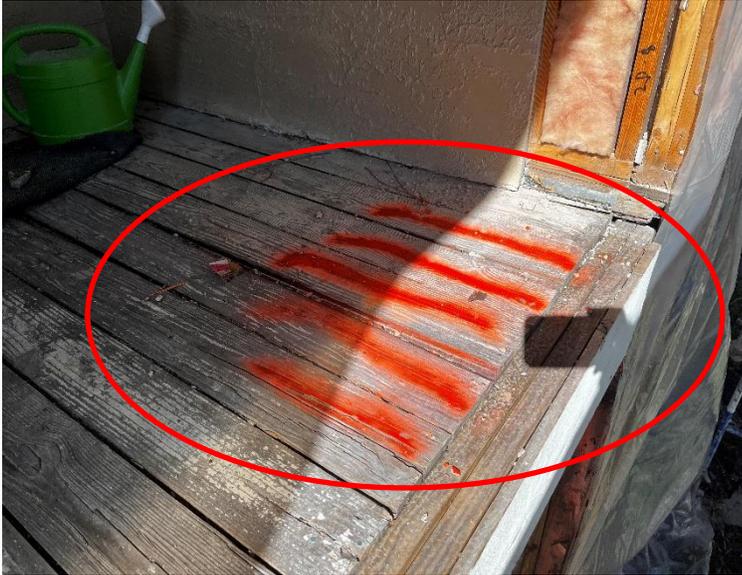
PHOTOGRAPH #9

**BUILDING 11
SECTION G- UNIT #1122**

Damaged balcony deck boards marked to be removed and replaced.

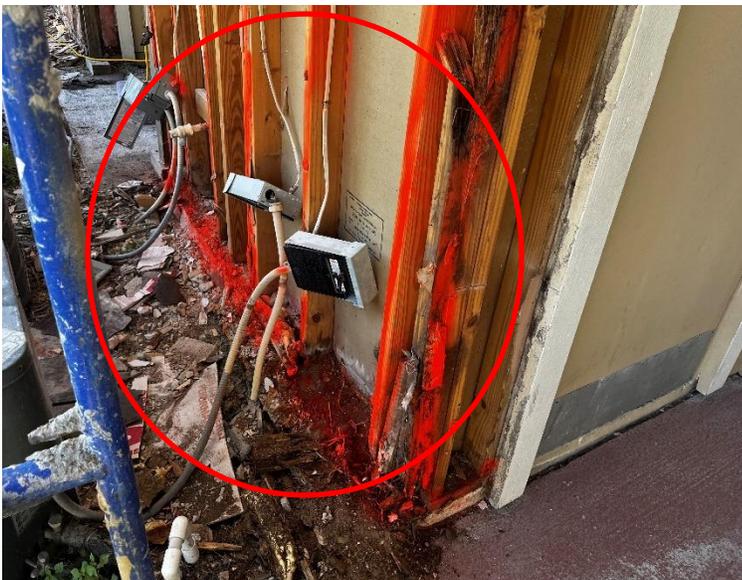
PHOTOGRAPH #10

**BUILDING 11
SECTION F**

Bottom plate and wall framing damage marked for repairs.

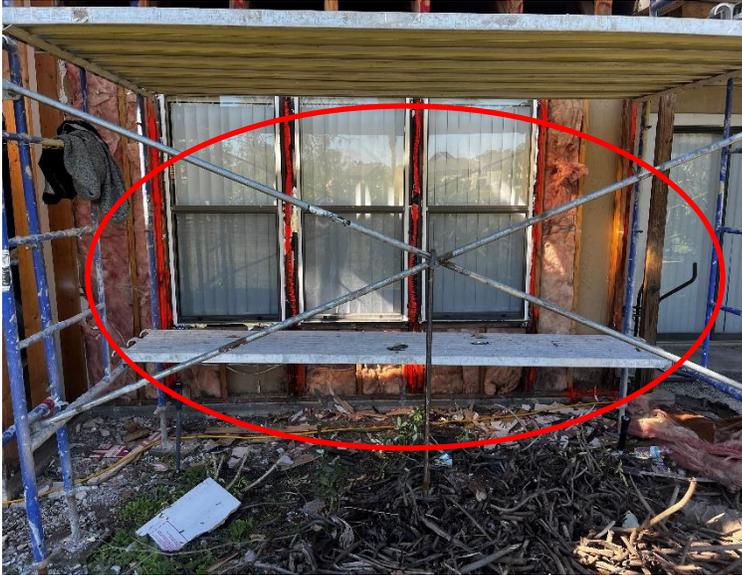
PHOTOGRAPH #11

**BUILDING 11
SECTION F**

Window framing damage marked for repairs.

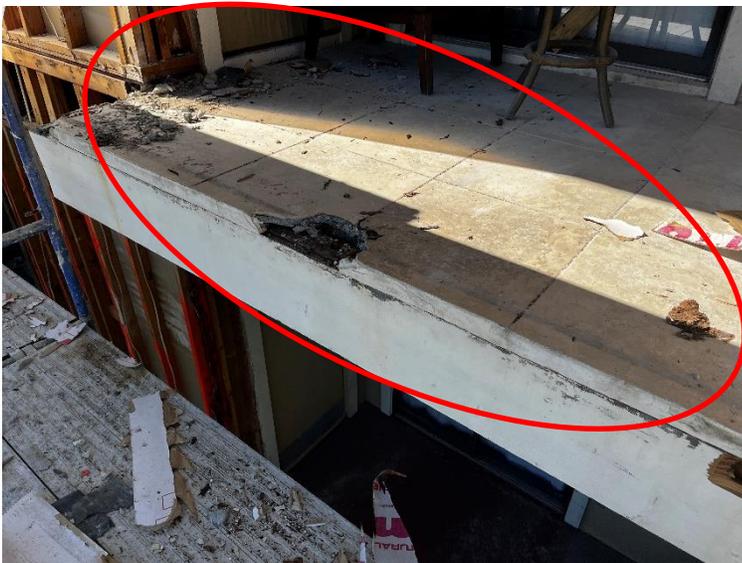
PHOTOGRAPH #12

**BUILDING 11
SECTION F- UNIT #1124**

Owners have covered balcony deck boards with tile.

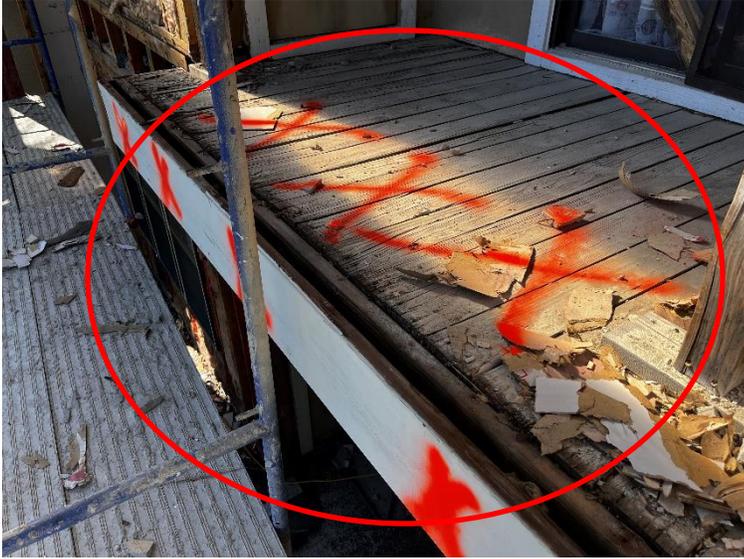
PHOTOGRAPH #13

**BUILDING 11
SECTION F- UNIT #1126**

Damaged balcony decking and built-up beam marked for removal and replacement.

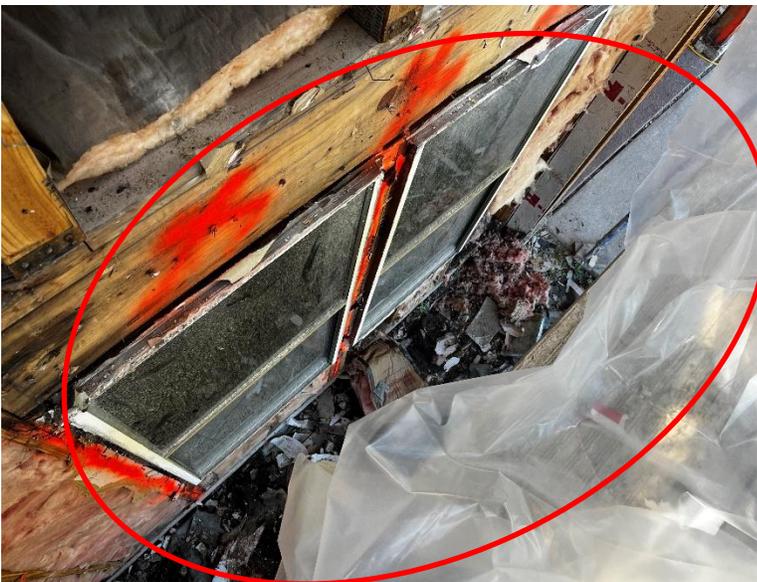
PHOTOGRAPH #14

**BUILDING 11
SECTION F**

Damage at window headers and window framing marked for repairs.

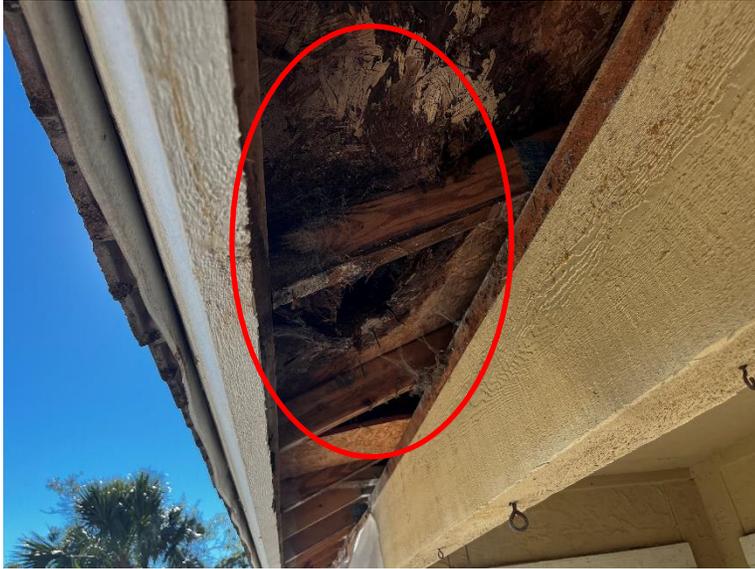
PHOTOGRAPH #15

**BUILDING 11
SECTION F**

Roof sheathing water damage to be repaired by owner's roof contractor.

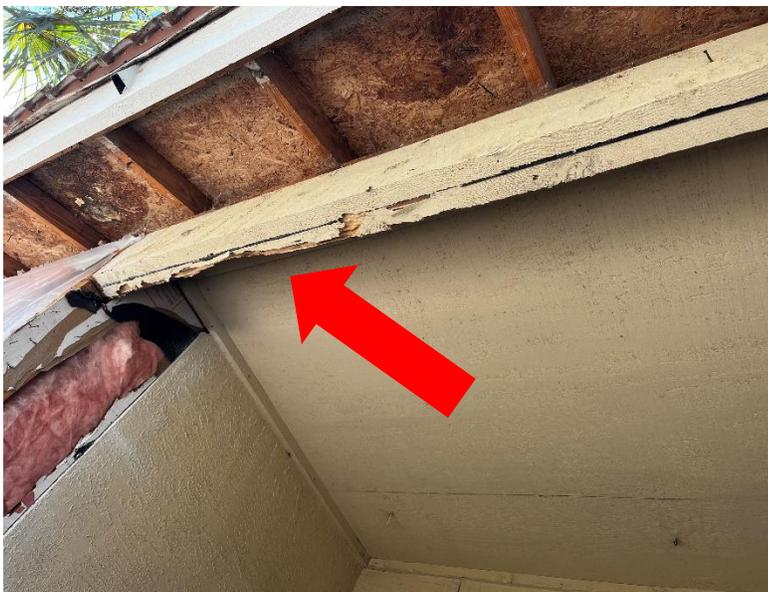
PHOTOGRAPH #16

**BUILDING 11
SECTION E- UNIT #1128**

Upper balcony cedar header damaged by termites marked for removal and replacement.
