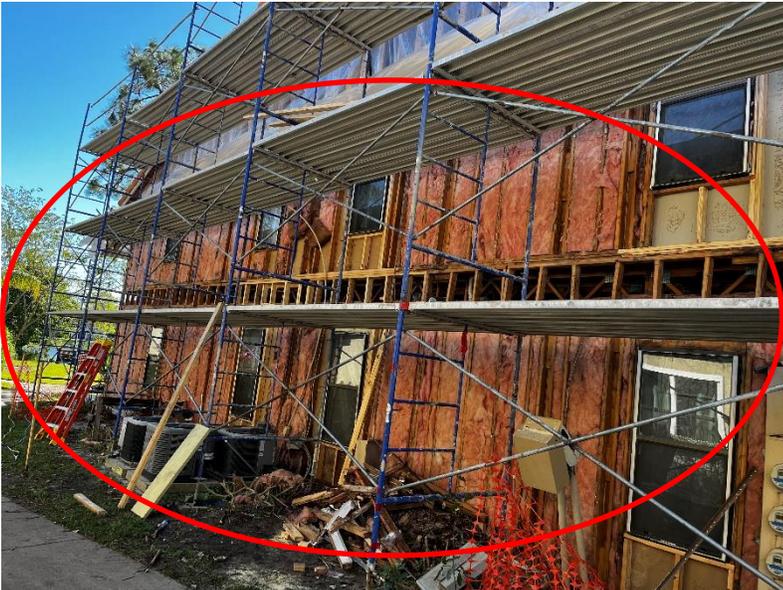
PHOTOGRAPH #1

**BUILDING 11
SECTION H**

Contractor has begun repairs at gable end wall framing.

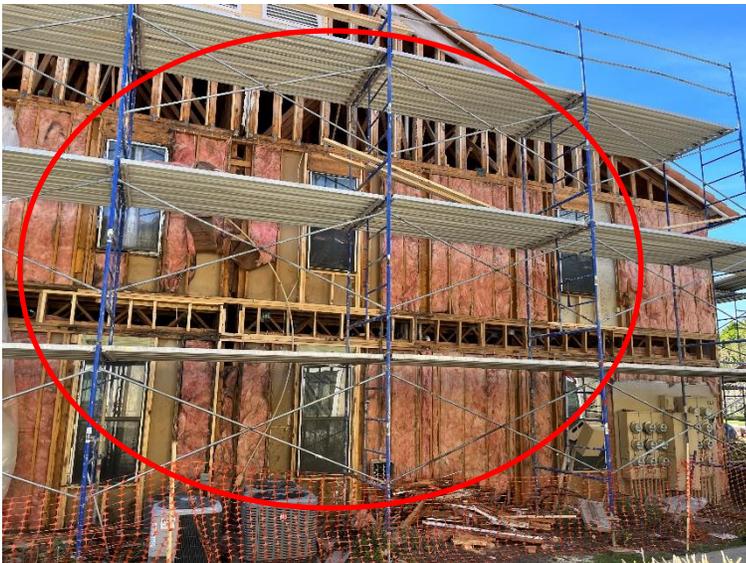
PHOTOGRAPH #2

**BUILDING 11
SECTION H**

Repairs in place and quantified at gable wall framing studs , windows, headers, top plates, and bottom plates .

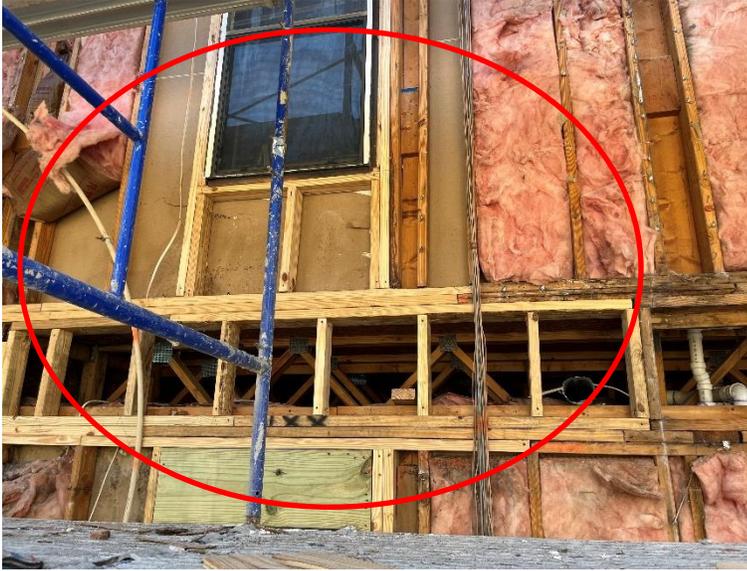
PHOTOGRAPH #3

**BUILDING 11
SECTION H**

Repairs in place and quantified at gable wall framing studs , windows, headers, top plates, and bottom plates .

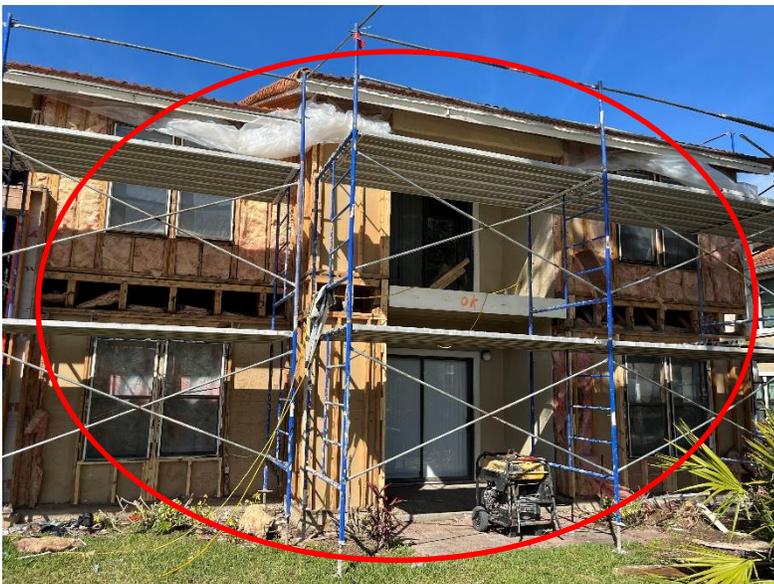
PHOTOGRAPH #4

**BUILDING 11
SECTION G**

Damaged framing repairs in progress at balconies, windows, and wall studs as marked for repair.

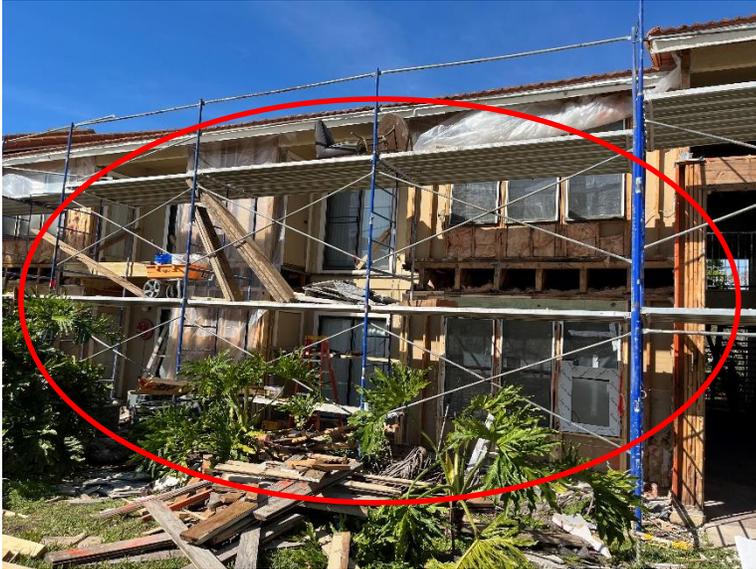
PHOTOGRAPH #5

**BUILDING 11
SECTION F**

Damaged framing repairs in progress at balconies, windows, and wall studs as marked for repair.

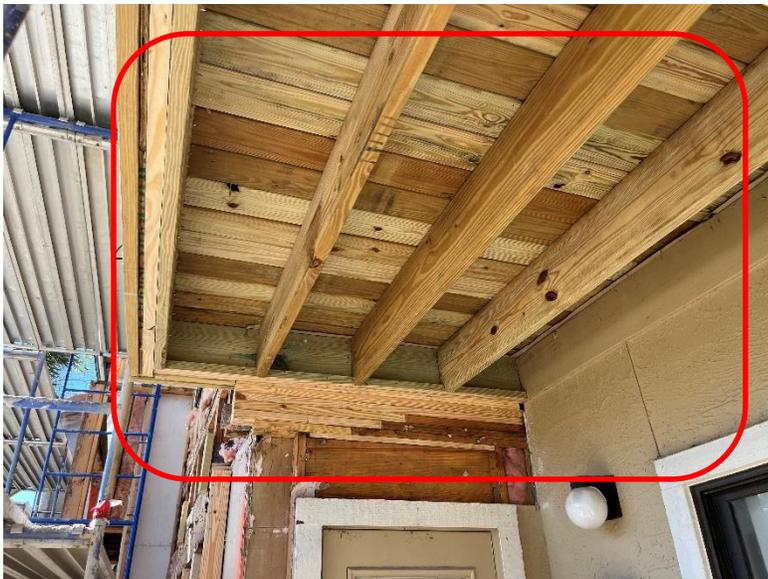
PHOTOGRAPH #6

**BUILDING 11
SECTION F- UNIT #1126**

Contractor has performed full decking replacement and built-up beam repairs.

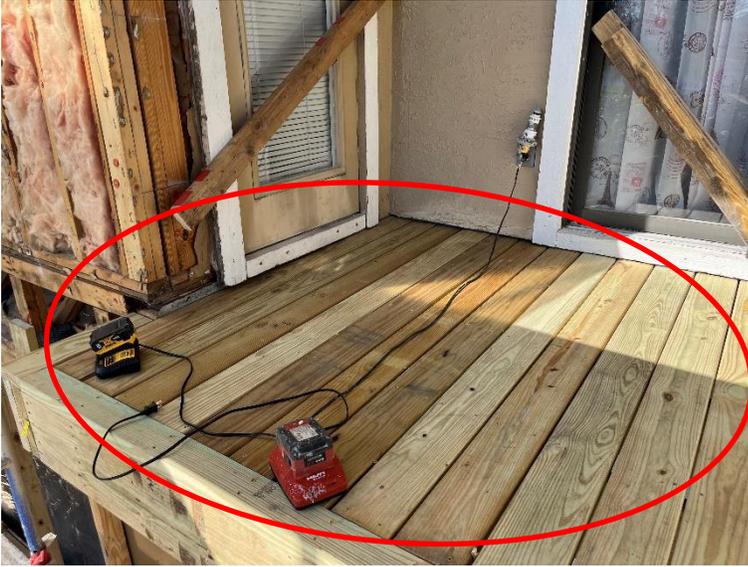
PHOTOGRAPH #7

**BUILDING 11
SECTION F- UNIT #1126**

Contractor has performed full decking replacement and built-up beam repairs.

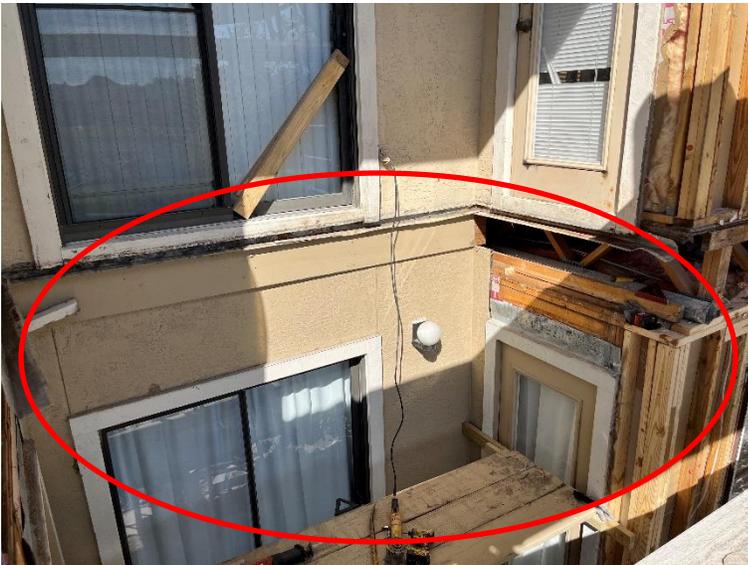
PHOTOGRAPH #8

**BUILDING 11
SECTION F- UNIT #1124**

Contractor has removed balcony decking, built up beam and balcony trusses in preparation for repairs.

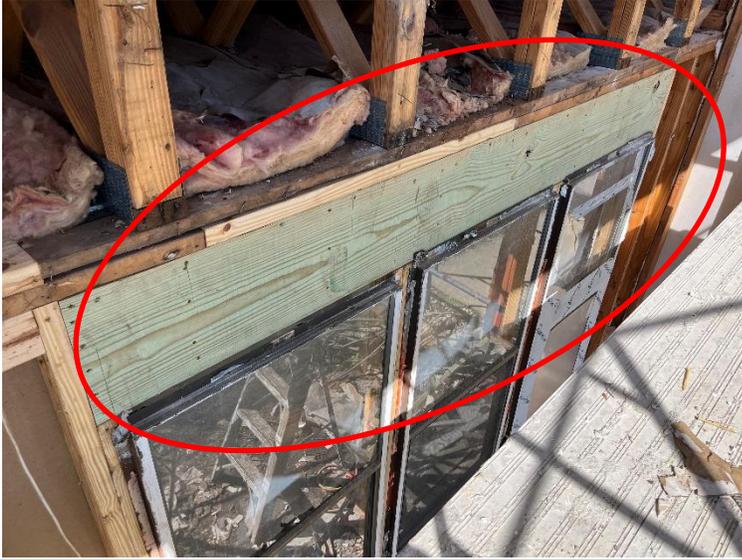
PHOTOGRAPH #9

**BUILDING 11
SECTION F**

Contractor has removed and replaced damaged triple header above triple windows.
