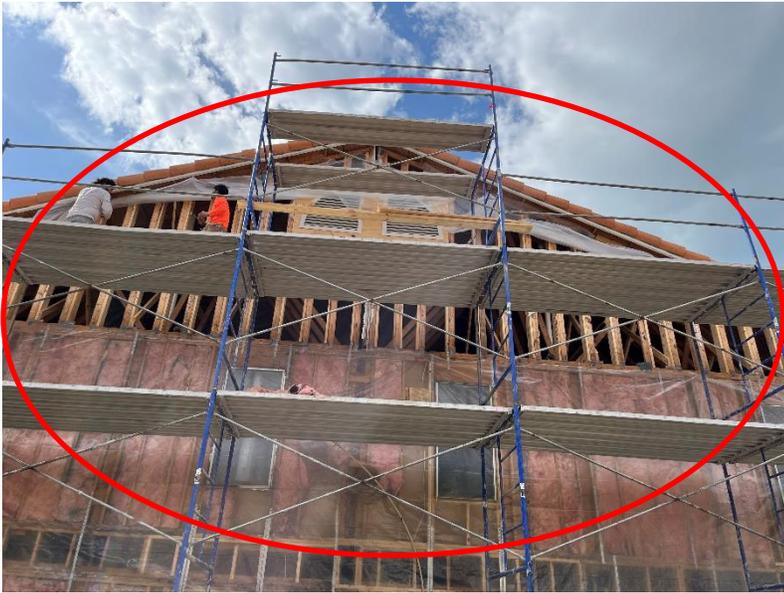
**PHOTOGRAPH #1**

**BUILDING 11  
SECTION H**

Contractor has performed gable end wall bracing repairs and set in place new gable end louvers.

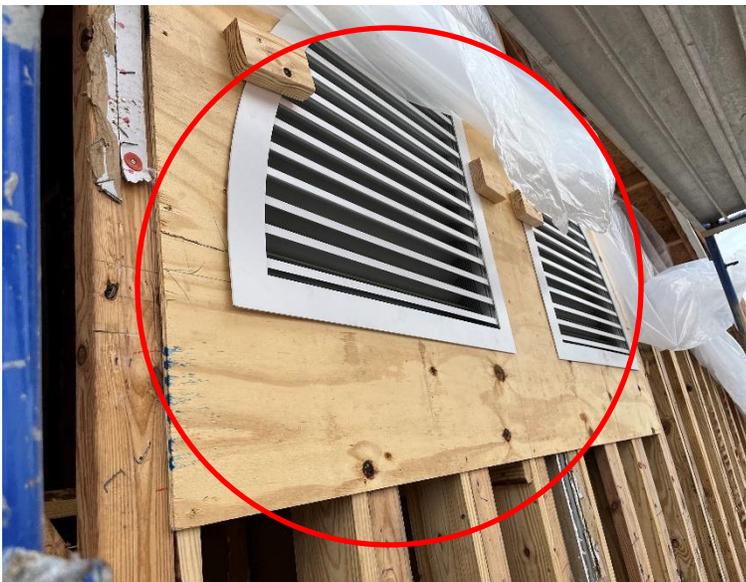
**PHOTOGRAPH #2**

**BUILDING 11  
SECTION H**

Green Heck louvers preset into new framing and structural plywood sheathing.

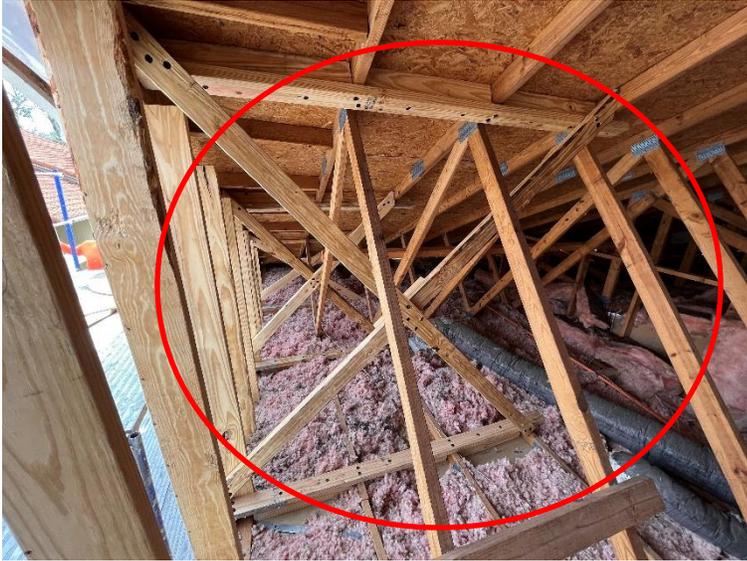
**PHOTOGRAPH #3**

**BUILDING 11  
SECTION H**

Cross bracing @ 48" O.C. fastened to top chord and bottom chord as per drawings.

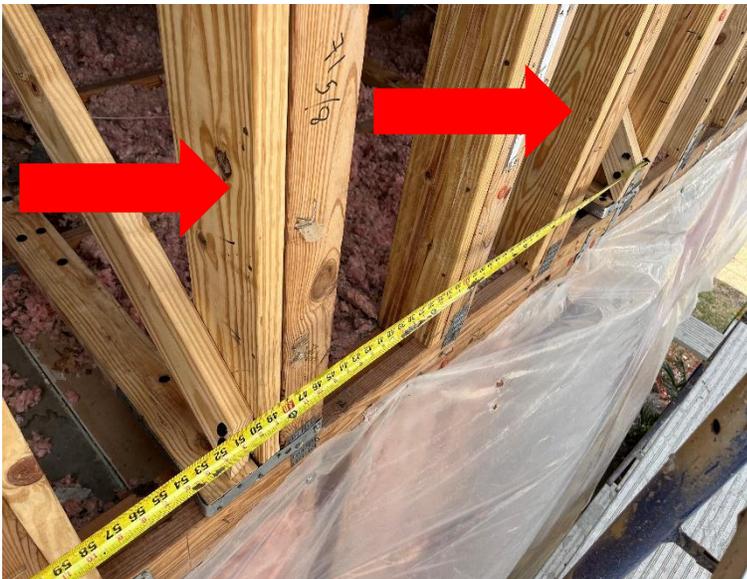
**PHOTOGRAPH #4**

**BUILDING 11  
SECTION H**

New retrofit 2x6 studs nailed to existing vertical 2x4 framing at gable end as per drawings.

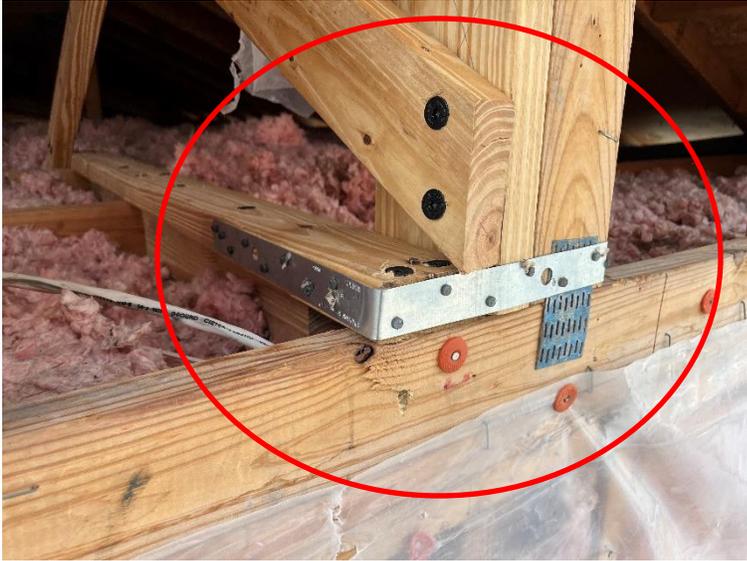
**PHOTOGRAPH #5**

**BUILDING 11  
SECTION H**

Simpson Strong-Tie # LSTA-21 strap fastened at lateral bracing to retrofit studs at gable end framing.

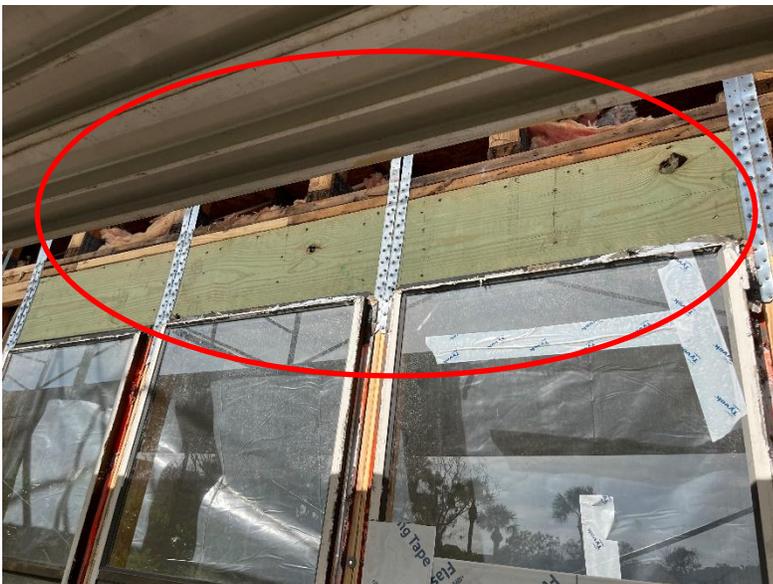
**PHOTOGRAPH #6**

**BUILDING 11  
SECTION F**

Damaged triple header above windows replaced with new header and strapped over with Simpson Strong-Tie MSTA 49 straps.

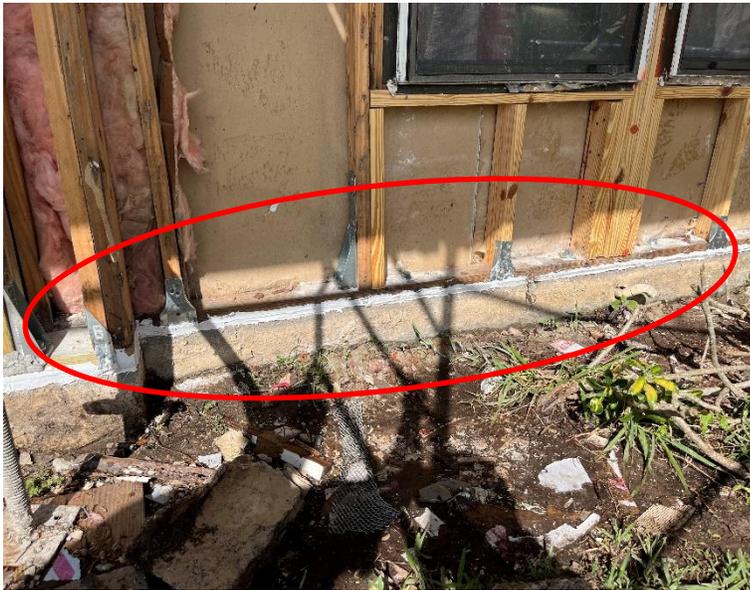
**PHOTOGRAPH #7**

**BUILDING 11  
SECTION F**

Bottom plate sealed to existing concrete footing with BASF MasterSeal NP 150 .

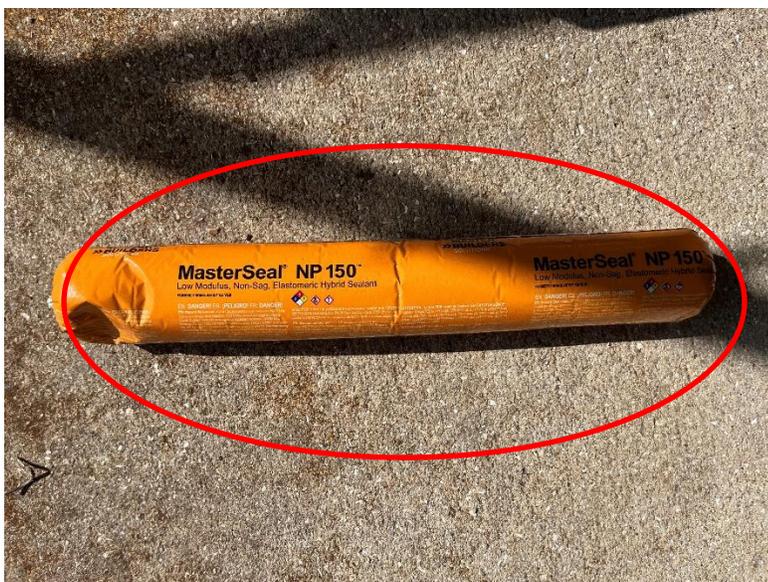
**PHOTOGRAPH #8**

**BUILDING 11  
SECTION F**

Bottom plate sealed to existing concrete footing with BASF MasterSeal NP 150.

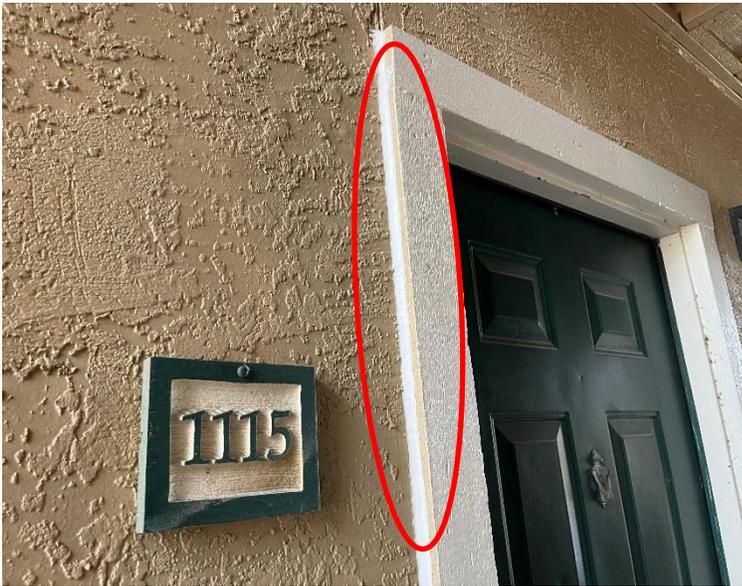
**PHOTOGRAPH #9**

**BUILDING 11  
UNIT #1115**

Contractor has applied new BASF sealant at door frame to stucco transitions.

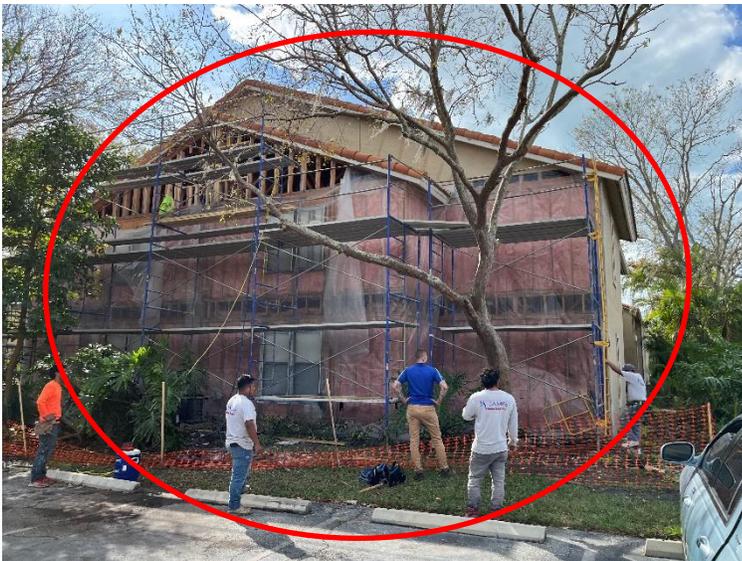
**PHOTOGRAPH #10**

**BUILDING 12  
SECTION H**

Contractor has begun gable end wall bracing repairs and covered open wall with protective plastic.

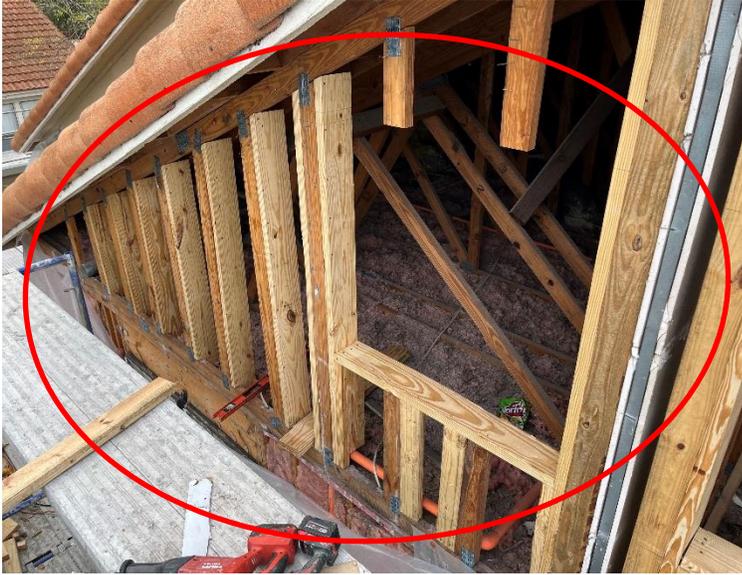
**PHOTOGRAPH #11**

**BUILDING 12  
SECTION H**

Contractor installing new framing for louver vents and providing new retrofit 2x6 studs nailed to existing vertical 2x4 framing at gable end as per drawings.

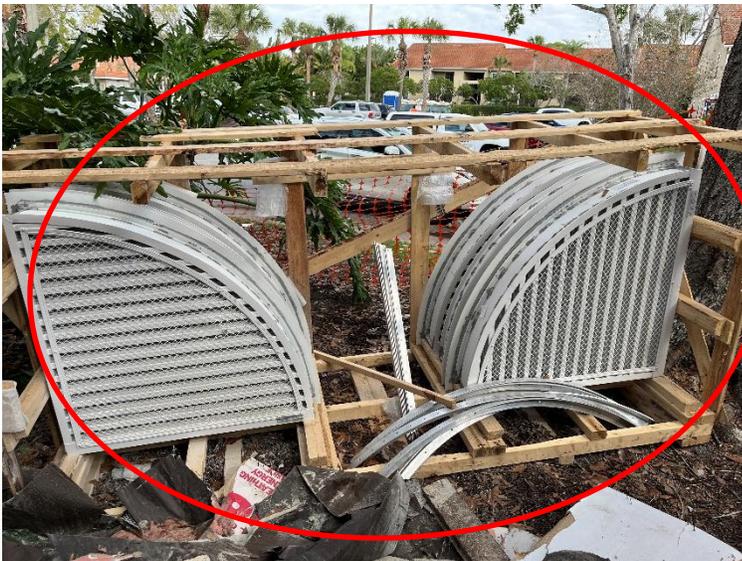
**PHOTOGRAPH #12**

**BUILDING 12  
SECTION H**

New Green Heck E HH 601 louvers ready for installation.

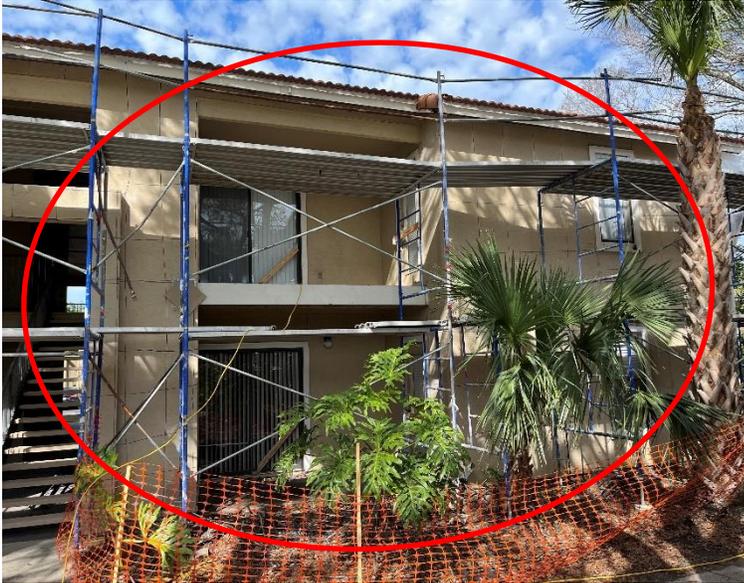
**PHOTOGRAPH #13**

**BUILDING 12  
SECTION G**

Contractor erected access scaffolding, safety fencing and begun cutting stucco for removal.

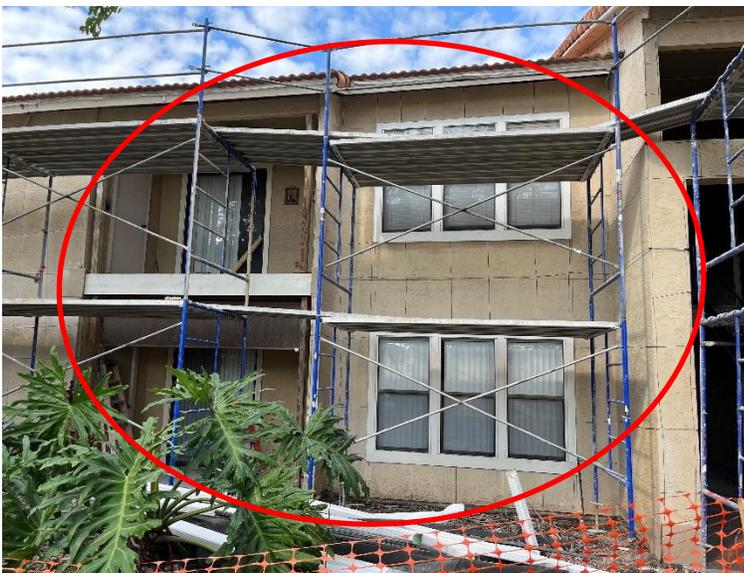
**PHOTOGRAPH #14**

**BUILDING 12  
SECTION F**

Contractor erected access scaffolding, safety fencing and begun cutting stucco for removal.

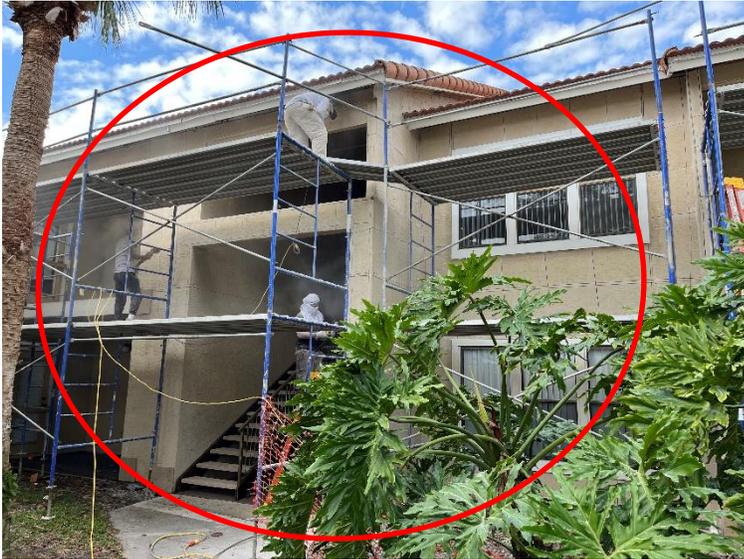
**PHOTOGRAPH #15**

**BUILDING 12  
SECTION E**

Contractor erected access scaffolding, safety fencing and begun cutting stucco for removal.

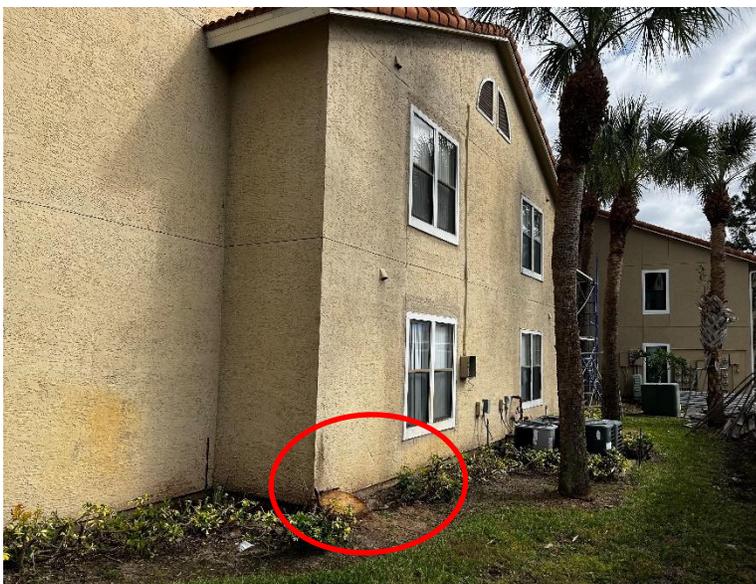
**PHOTOGRAPH #16**

**BUILDING 12  
SECTION D**

Landscaping is above bottom of wall requiring repairs.
