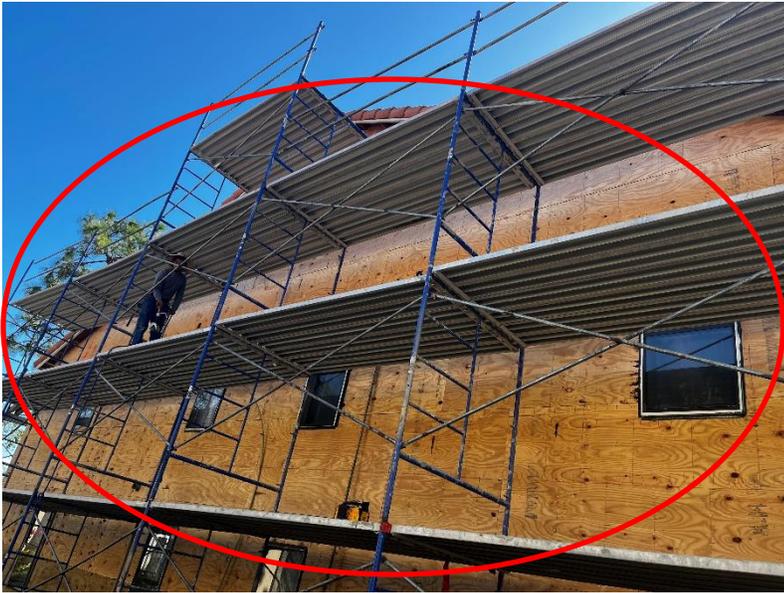
**PHOTOGRAPH #1**

**BUILDING 11  
SECTION H**

Contractor has attached 15/32" exterior rated plywood sheathing at gable end wall.

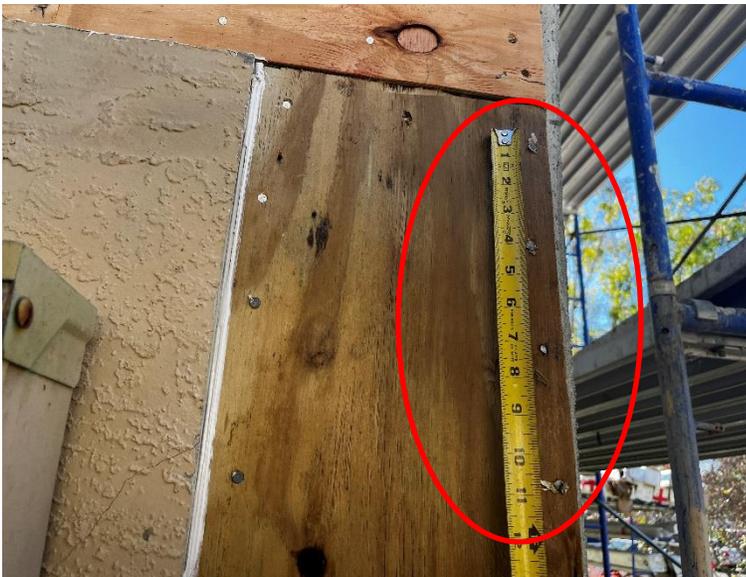
**PHOTOGRAPH #2**

**BUILDING 11  
SECTION H**

Plywood sheathing attached at perimeter end stud @ 4" O.C. spacing with 8d common nails.

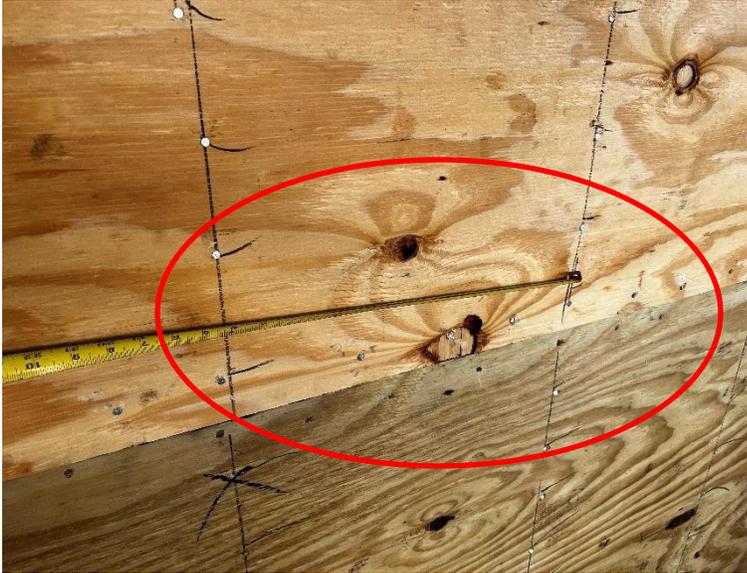
**PHOTOGRAPH #3**

**BUILDING 11  
SECTION H**

Contractor has attached plywood sheathing to framing studs at 16" O.C. with 8d common nails.

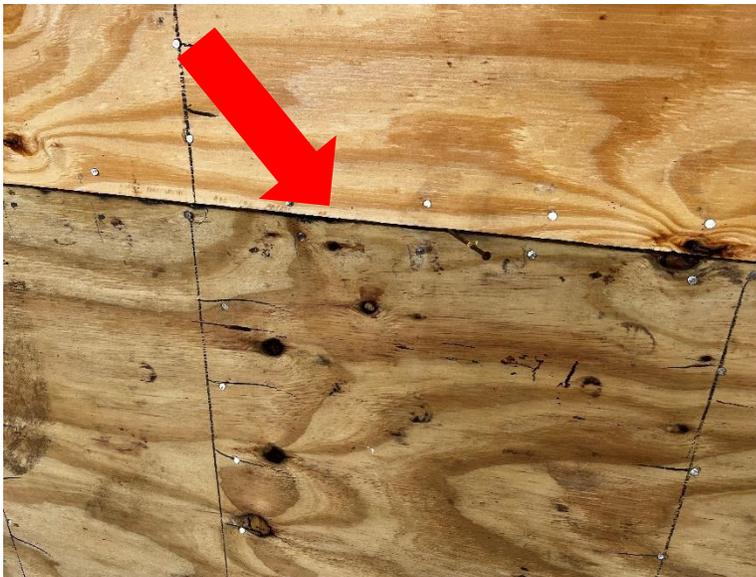
**PHOTOGRAPH #4**

**BUILDING 11  
SECTION H**

Contractor has allowed for movement between sheets of plywood by providing 1/8" spacing.

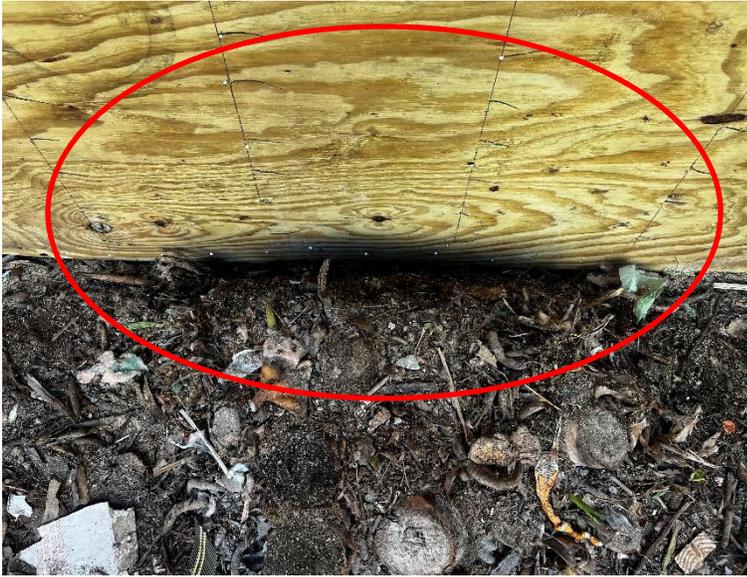
**PHOTOGRAPH #5**

**BUILDING 11  
SECTION H**

Bottom sheet of pressure treated plywood sheathing attached to bottom plate. Landscaping and dirt must be removed for proper application of water barriers and stucco system.

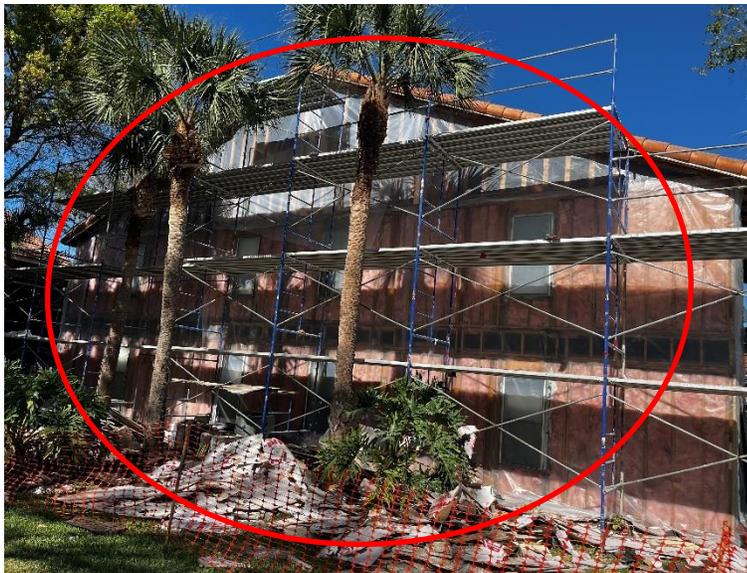
**PHOTOGRAPH #6**

**BUILDING 12  
SECTION H**

Gable end wall covered with protective plastic sheathing.

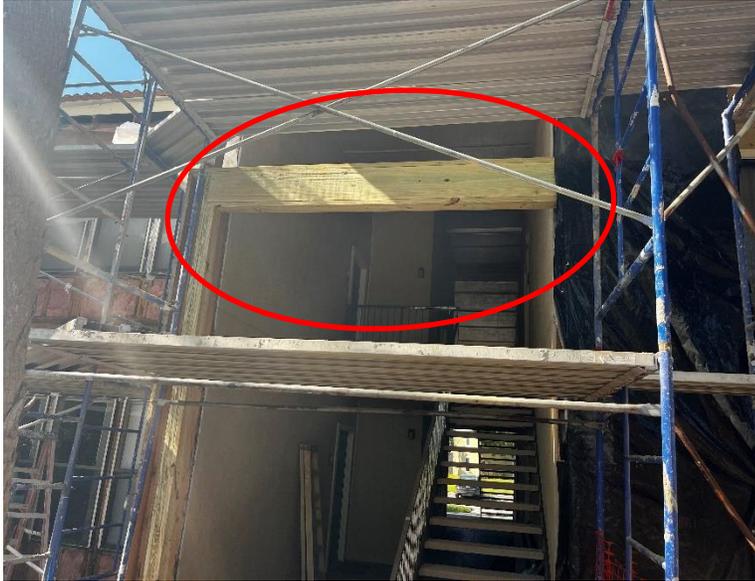
**PHOTOGRAPH #7**

**BUILDING 12  
SECTION G**

Contractor has repaired damaged breezeway header beam marked for repairs as per drawings.

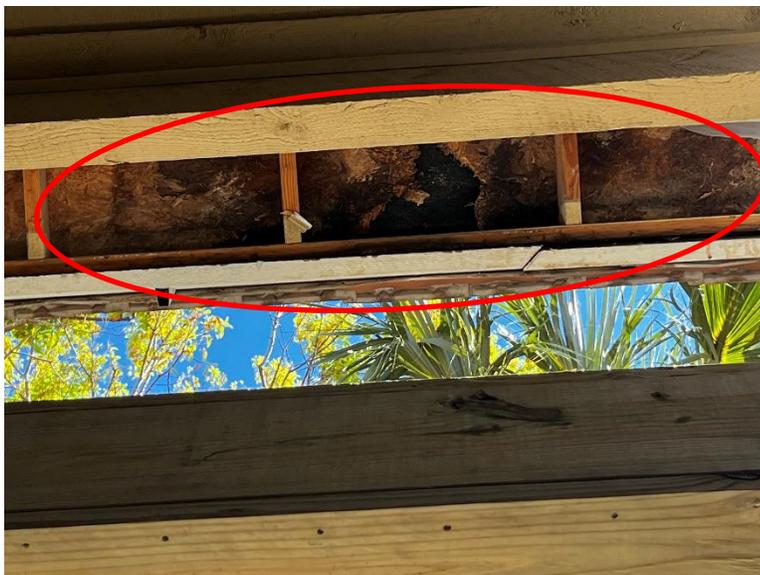
**PHOTOGRAPH #8**

**BUILDING 12  
SECTION G**

Roof sheathing damage from roof leaks to be repaired by owner's contractor.

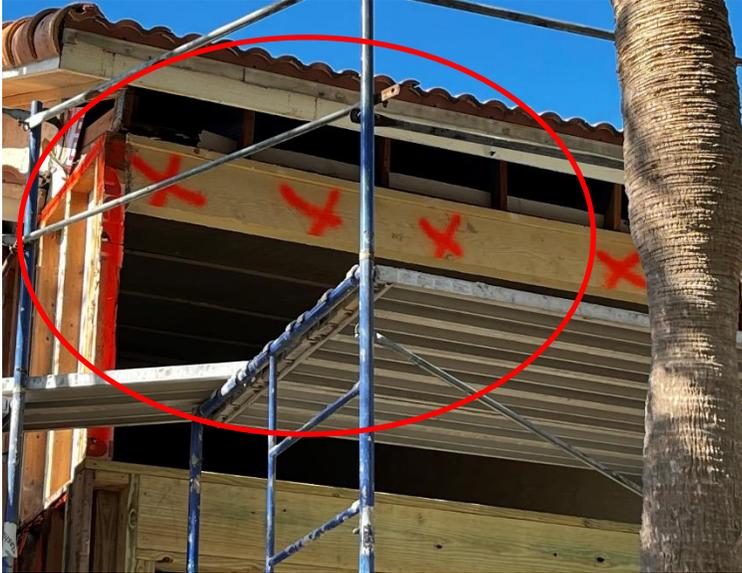
**PHOTOGRAPH #9**

**BUILDING 12  
SECTION G**

Termite damaged cedar beam above breezeway marked for replacement.

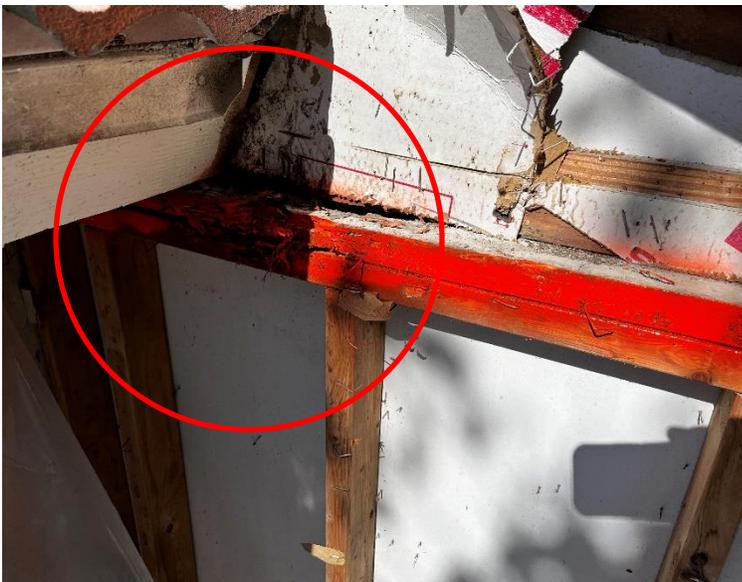
**PHOTOGRAPH #10**

**BUILDING 12  
SECTION G**

Damaged double top plate marked for repairs.

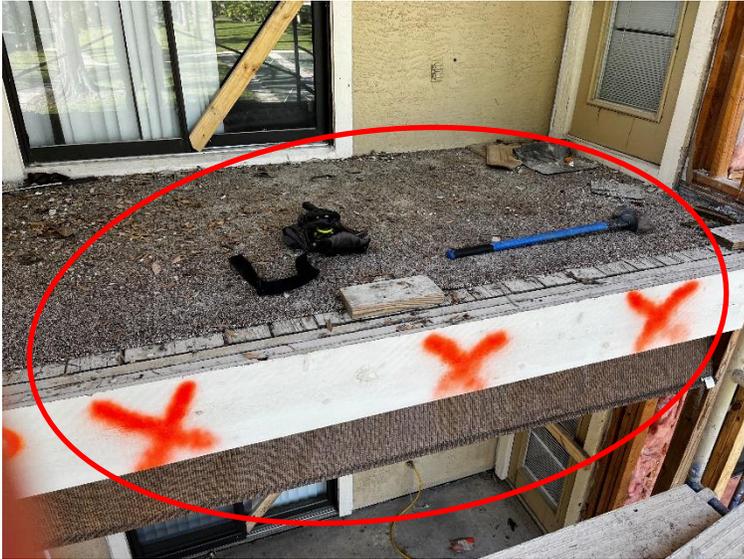
**PHOTOGRAPH #11**

**BUILDING 12  
SECTION F – UNIT #1224**

Balcony built out beam marked for full repairs.

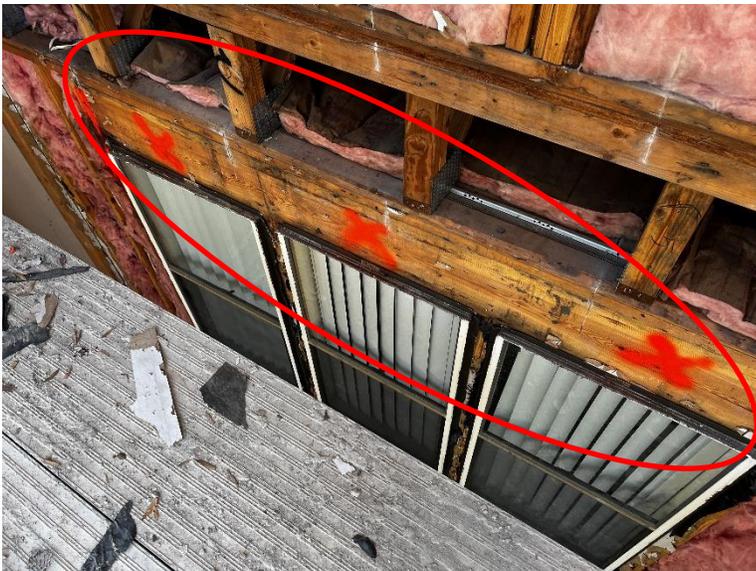
**PHOTOGRAPH #12**

**BUILDING 12  
SECTION F- UNIT #1216**

Damaged header above triple windows marked for repairs.

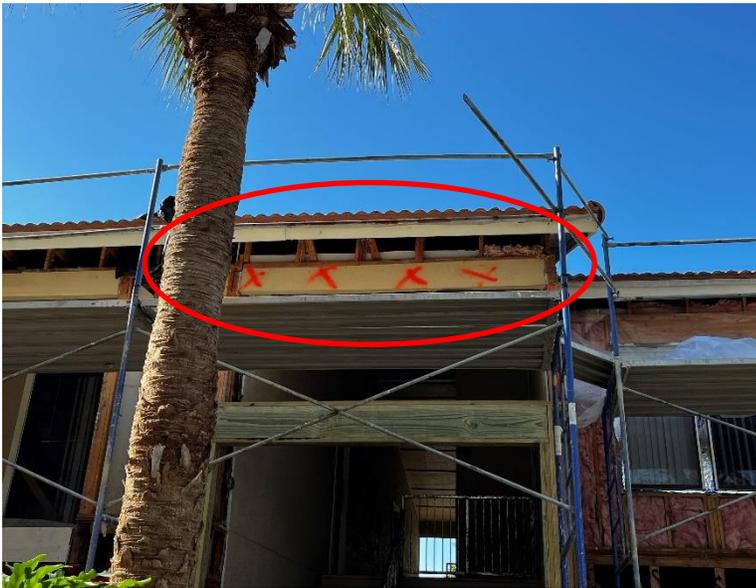
**PHOTOGRAPH #13**

**BUILDING 12  
SECTION E**

Termite damaged cedar beam above breezeway marked for replacement.

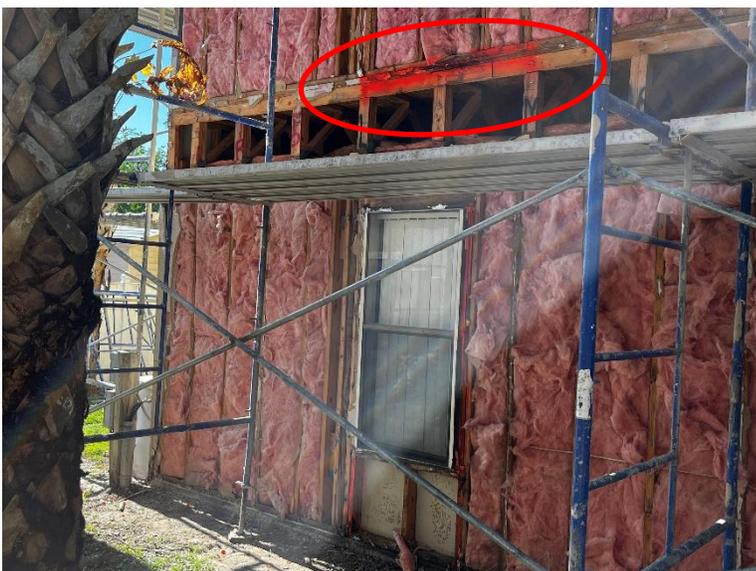
**PHOTOGRAPH #14**

**BUILDING 12  
SECTION E**

2<sup>nd</sup> floor bottom plate and edge framing marked for repairs.
