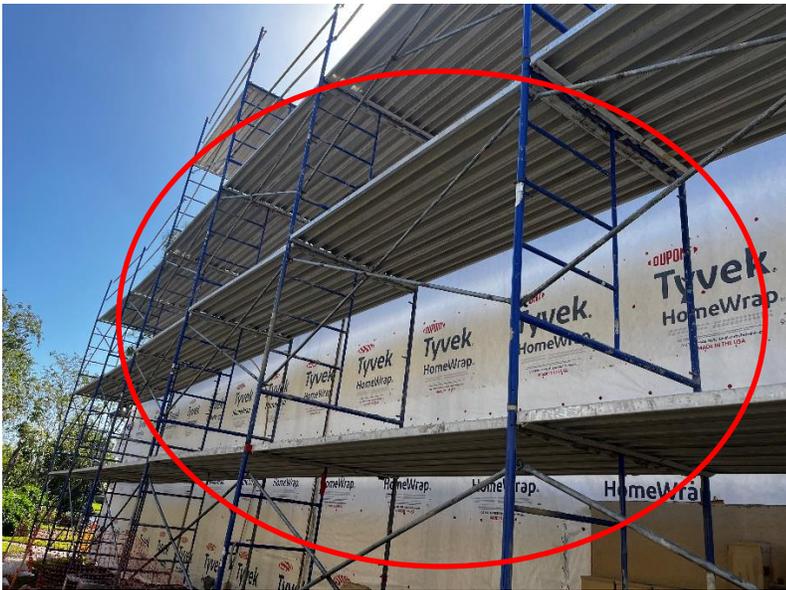
PHOTOGRAPH #1

**BUILDING 11
SECTION H**

Contractor has covered plywood sheathing with Dupont Tyvek HomeWrap water restraint barrier.

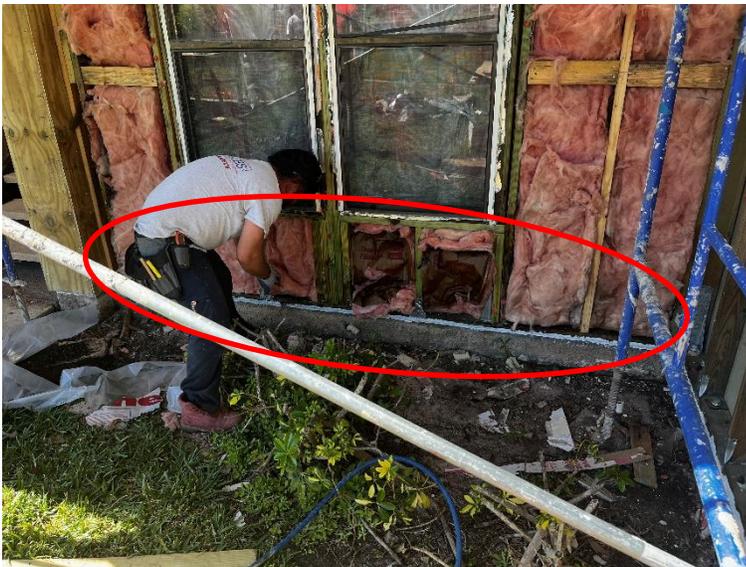
PHOTOGRAPH #2

**BUILDING 11
SECTION G**

Contractor installing Simpson Strong-tie hardware and anchors at base plate.

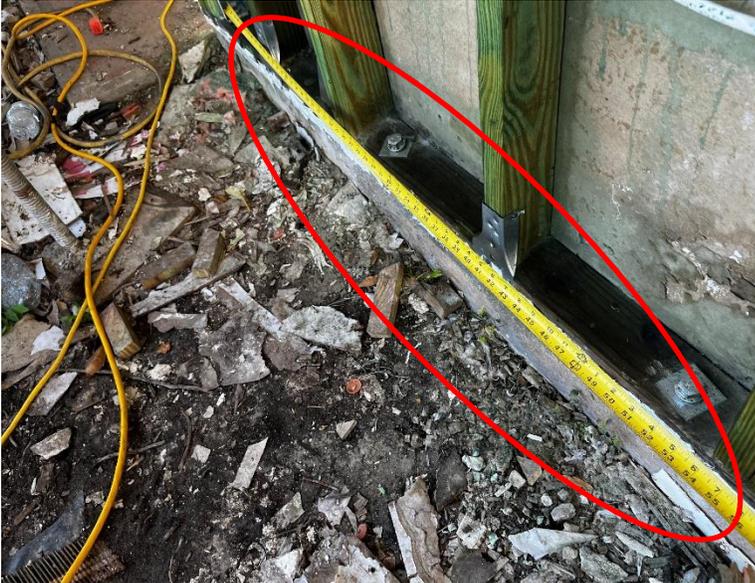
PHOTOGRAPH #3

**BUILDING 11
SECTION G**

Simpson Strong-Tie Titen HD anchors installed at base plate 24" Max. SP1 connector installed at stud to base plate.

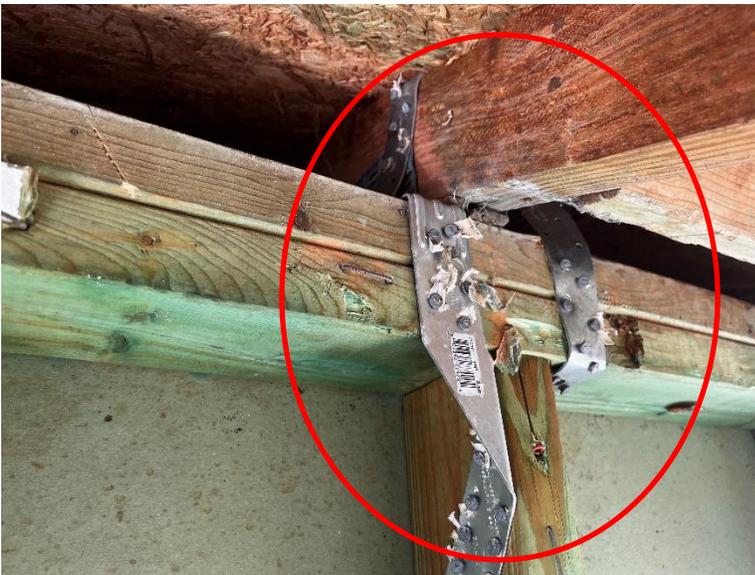
PHOTOGRAPH #4

**BUILDING 11
SECTION G**

Simpson Strong-Tie TSP connector installed from stud to top plate and MTS 18 installed from top plate to roof truss.

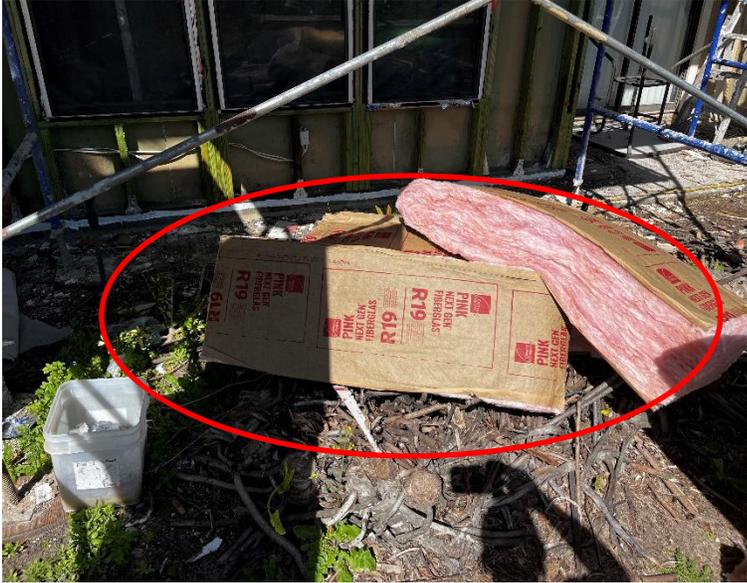
PHOTOGRAPH #5

**BUILDING 11
SECTION G**

Owens Corning R19 insulation installed where there is damaged or missing insulation.

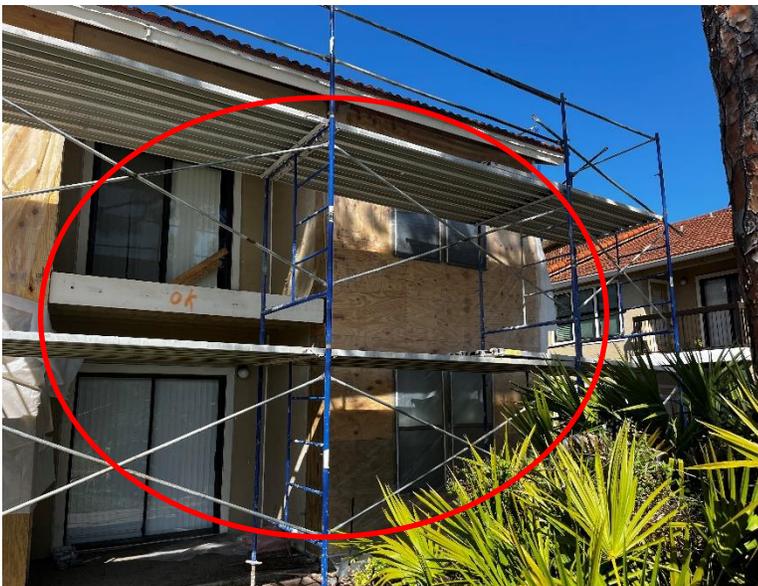
PHOTOGRAPH #6

**BUILDING 11
SECTION G**

Contractor has fastened new 15/32" plywood sheathing to wall framing.

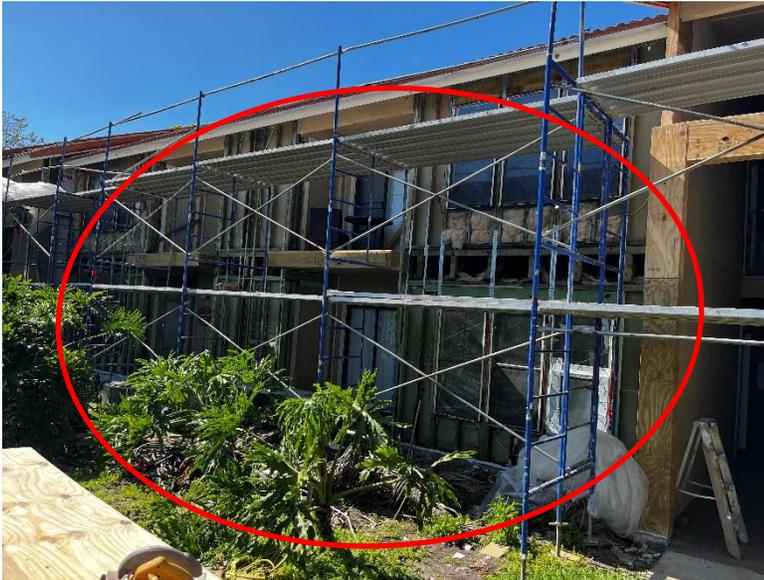
PHOTOGRAPH #7

**BUILDING 11
SECTION F**

Contractor installing Simpson Strong-Tie strap connectors as per drawings.

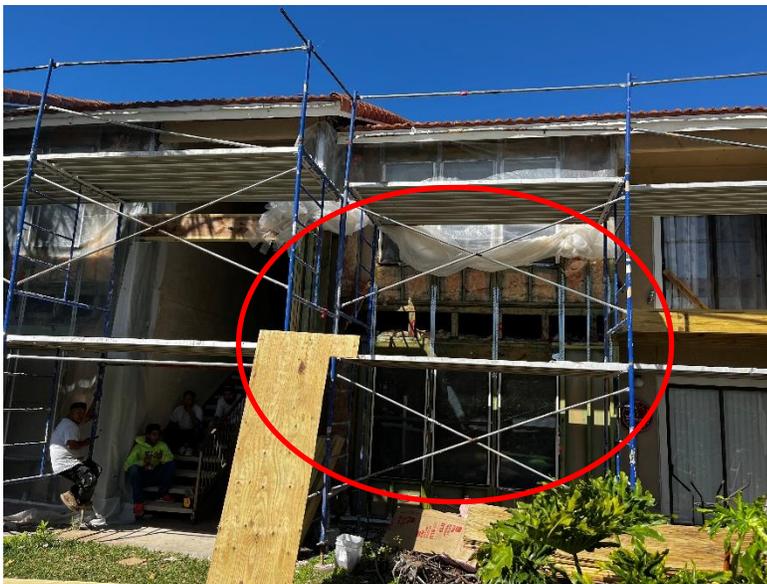
PHOTOGRAPH #8

**BUILDING 11
SECTION F**

Contractor installing Simpson Strong-Tie strap connectors as per drawings.

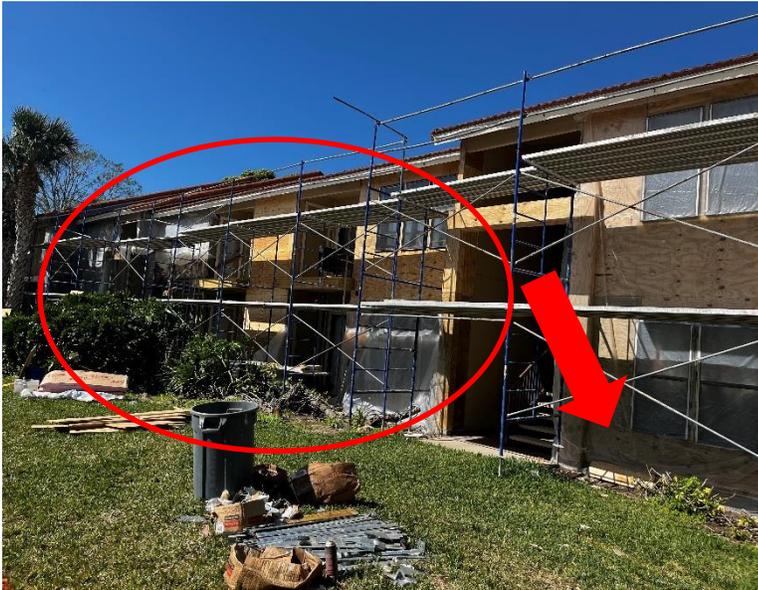
PHOTOGRAPH #9

**BUILDING 11
SECTION F**

Contractor continuing to apply new plywood sheathing with pressure treated plywood at bottom sheet.

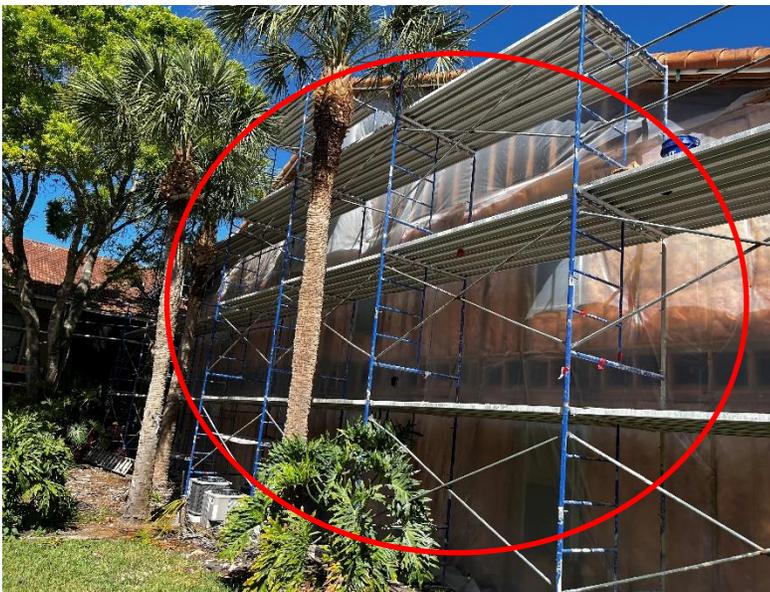
PHOTOGRAPH #10

**BUILDING 11
SECTION D**

Contractor has removed stucco and sheathing and covered with plastic tarps for weather protection.

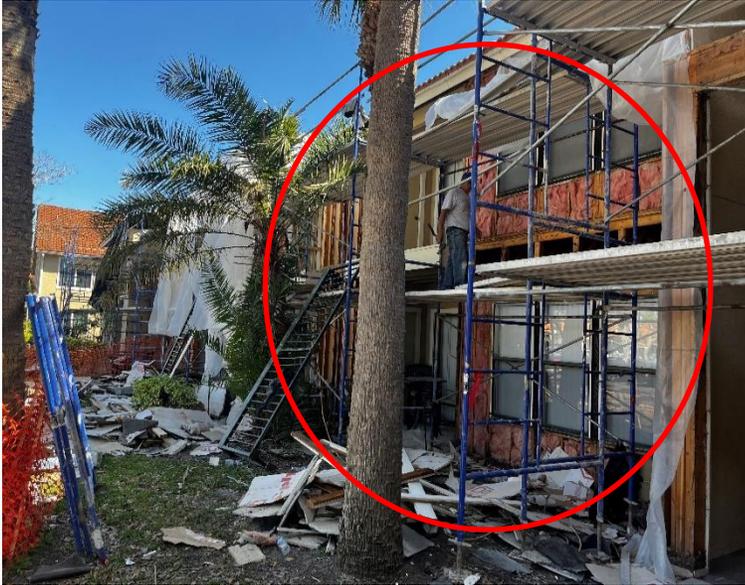
PHOTOGRAPH #11

**BUILDING 11
SECTION B**

Contractor in process of removing stucco and sheathing.

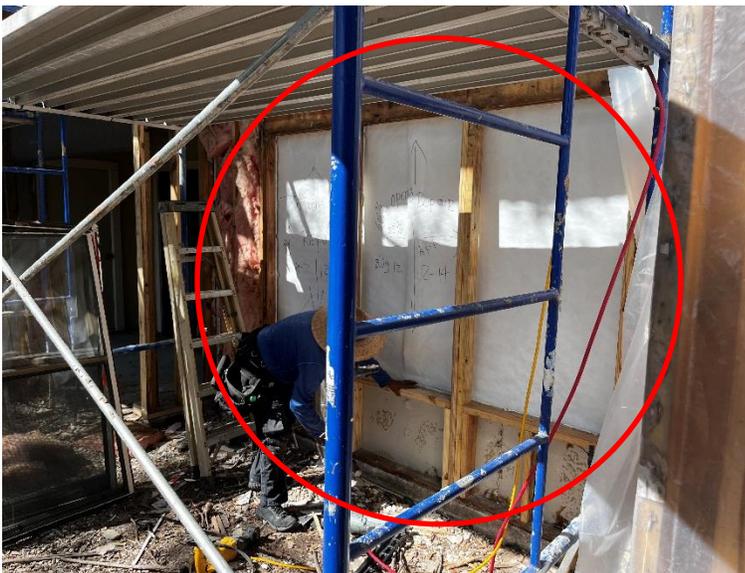
PHOTOGRAPH #12

**BUILDING 12
SECTION G – UNIT #1212**

Contractor replacing damaged framing at window areas as marked for repairs.

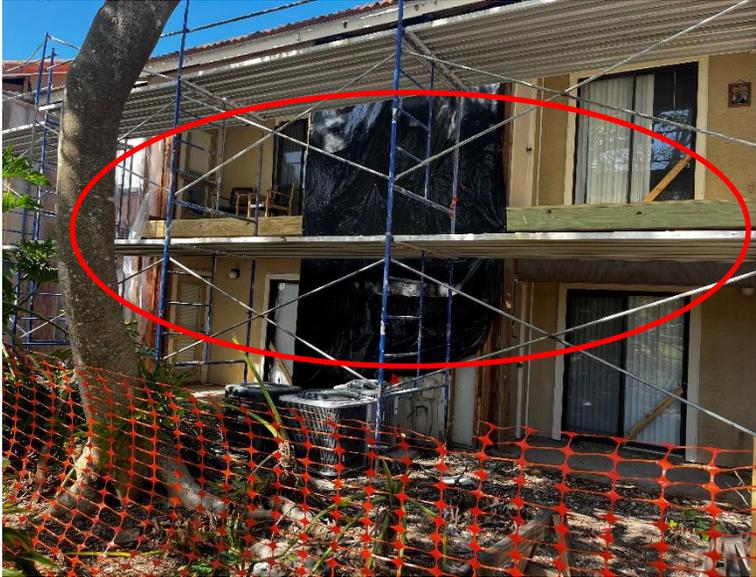
PHOTOGRAPH #13

**BUILDING 12
SECTION F- UNITS #1224 & #1226**

Contractor has performed full built-up beam repairs at type A1 balconies.

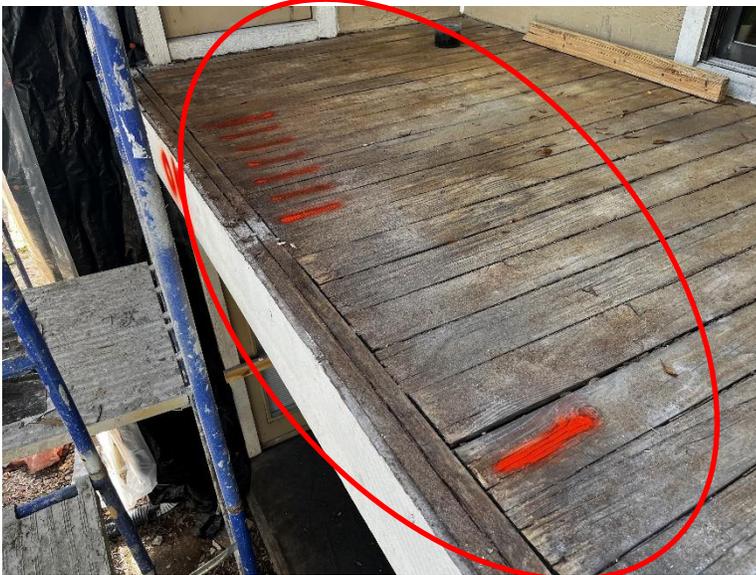
PHOTOGRAPH #14

**BUILDING 12
SECTION E- UNIT #1228**

Damaged deck boards marked for removal and replacement.
