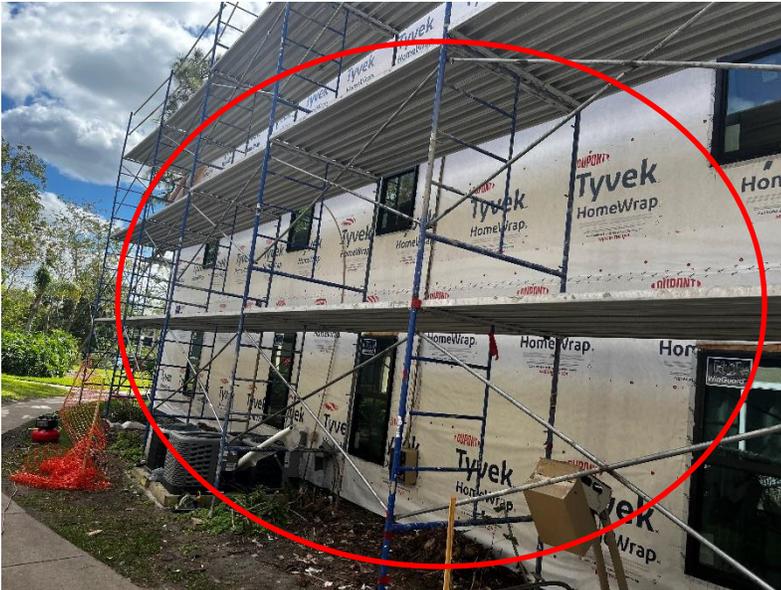
**PHOTOGRAPH #1**

Contractor has installed new PGT windows with Dupont flashings as per manufacturers recommendations and PM drawings.

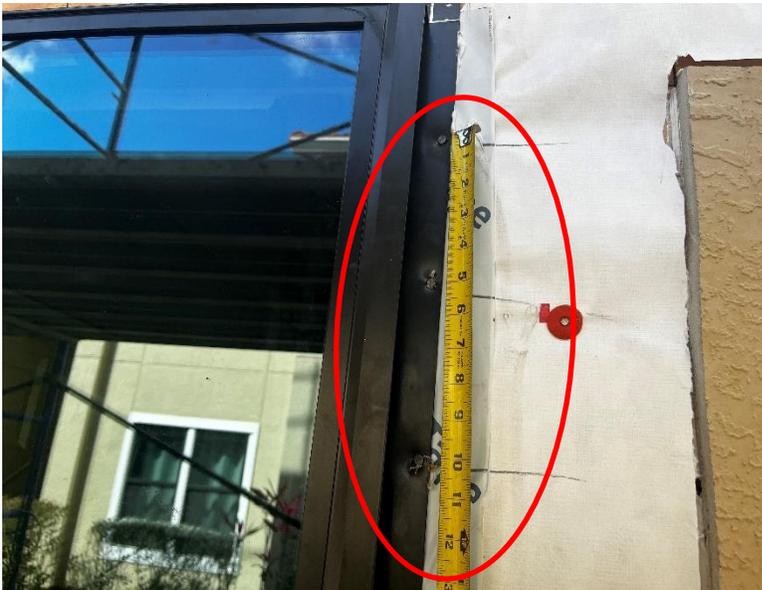
**PHOTOGRAPH #2**

Window flange fastened to framing studs with 2 1/2" 8d common nails 5" O.C.

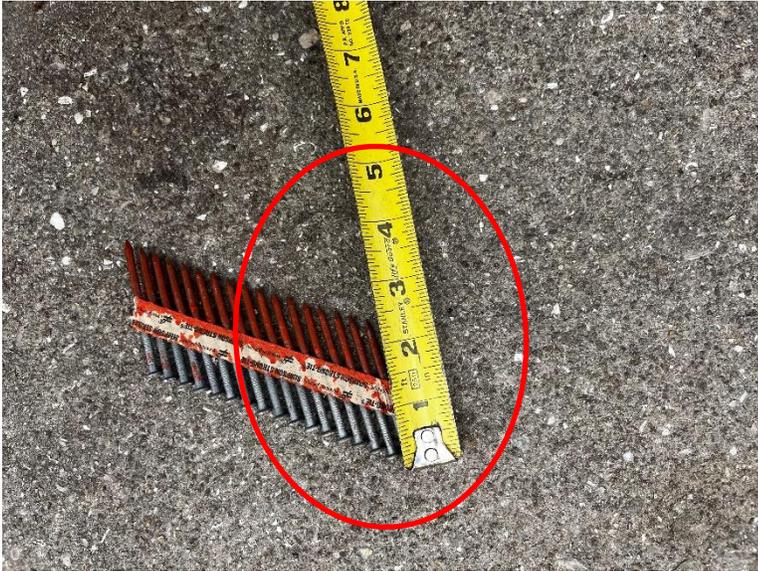
**PHOTOGRAPH #3**

Window flange fastened to framing studs with 2 1/2" 8d common nails 5" O.C.

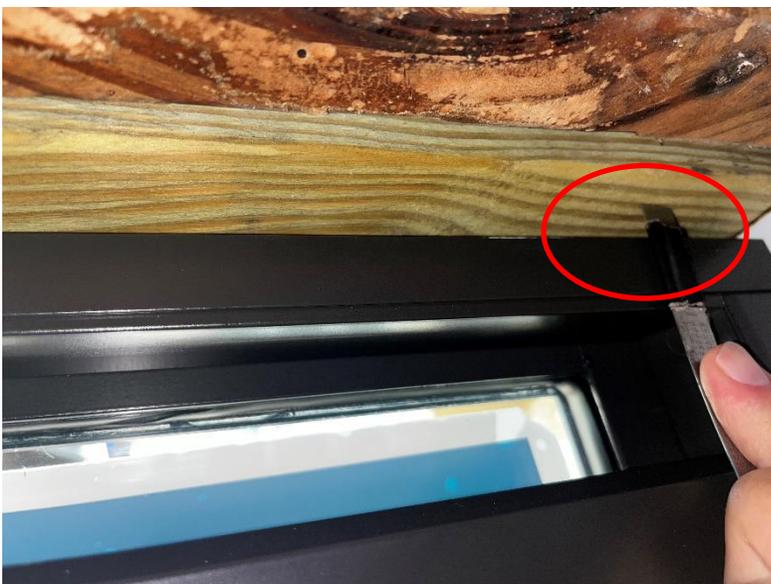
**PHOTOGRAPH #4**

Gap between window header and window frame exceeds maximum 5/16" allowance by manufacturers NOA. And will require corrective measures for approval.

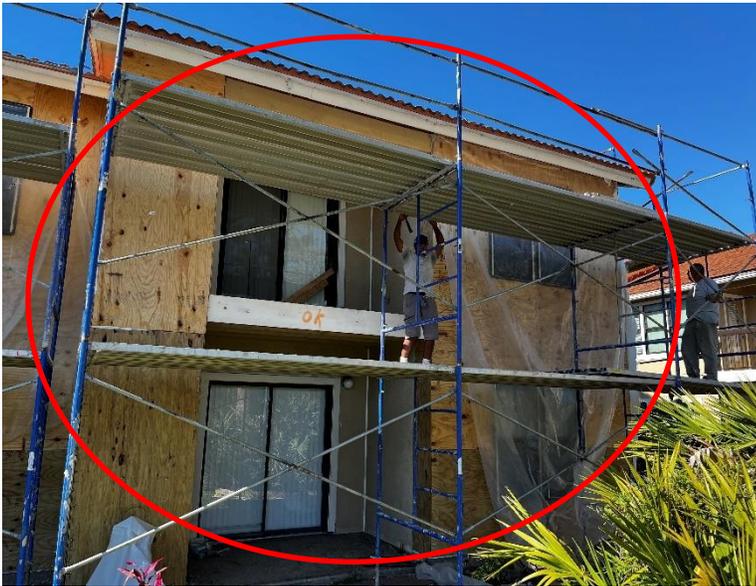
**PHOTOGRAPH #5**

New 15/32" plywood sheathing inspected for approval to cover with water vapor barriers and begin window installation.

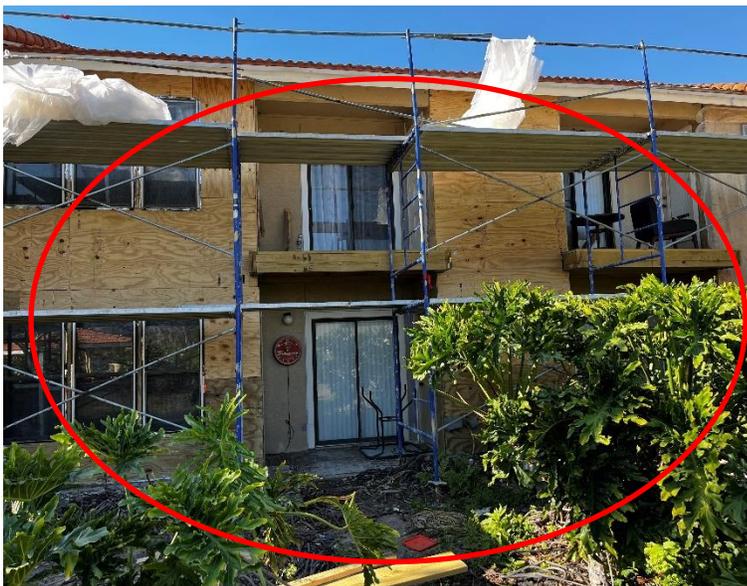
**PHOTOGRAPH #6**

New 15/32" plywood sheathing inspected for approval to cover with water resistant barriers and begin window installation.

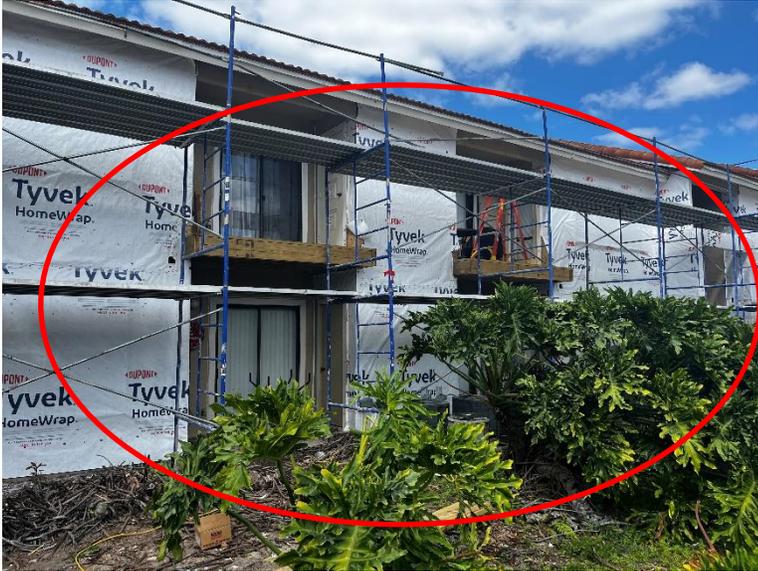
**PHOTOGRAPH #7**

Contractor has covered new sheathing with Tyvek HomeWrap water resistant barrier.

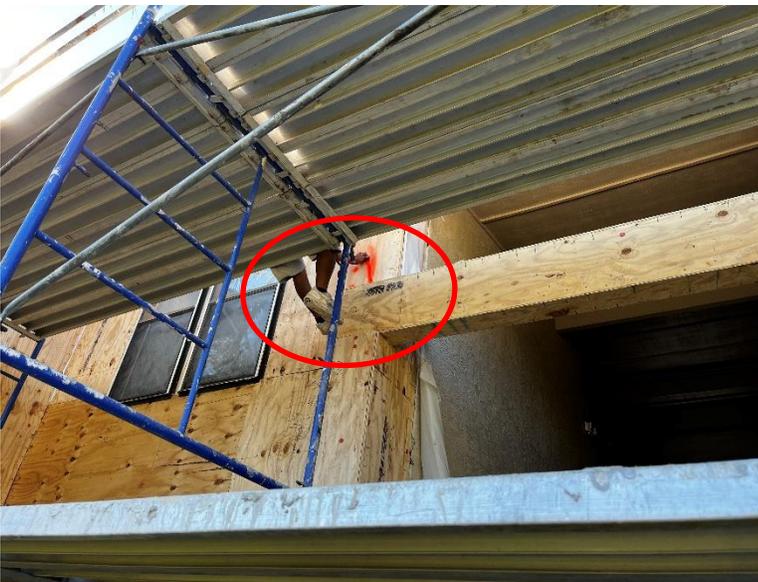
**PHOTOGRAPH #8**

Contractor making fastening corrections at new plywood sheathing marked by Delta.

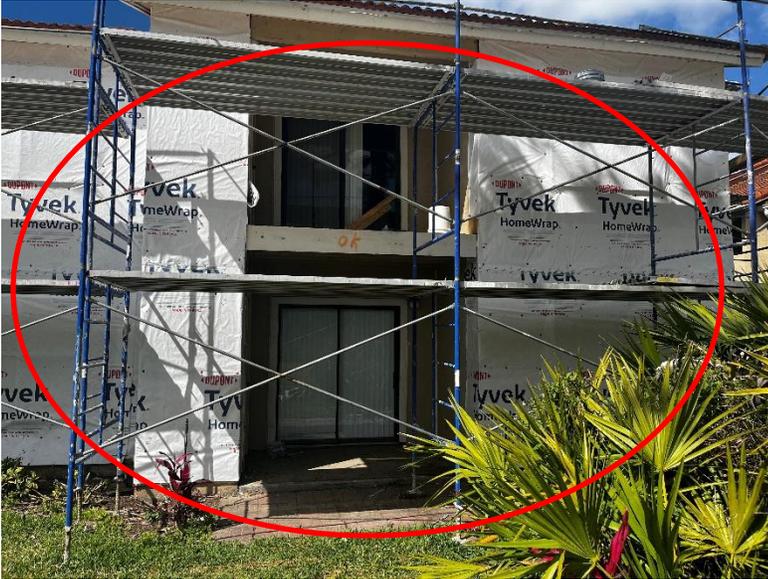
**PHOTOGRAPH #9**

Contractor has covered new sheathing with Tyvek HomeWrap water resistant barrier.

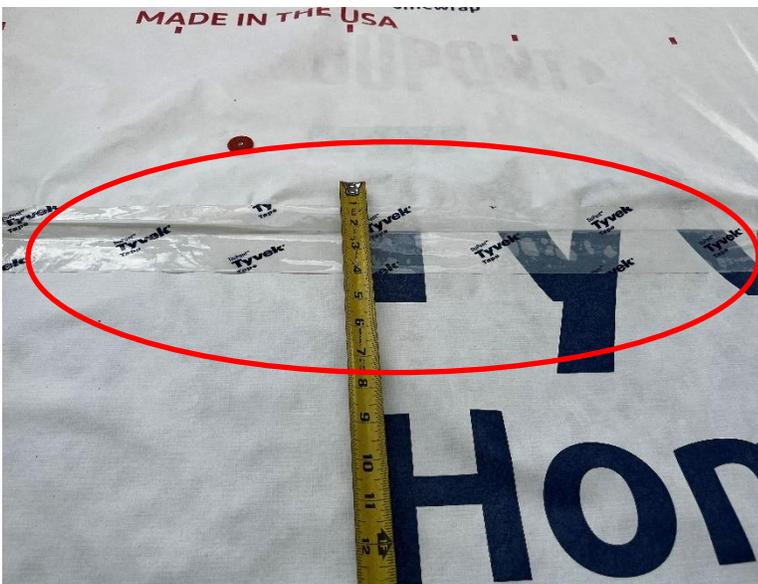
**PHOTOGRAPH #10**

4" Tyvek seam tape used at overlapping water barrier seams.

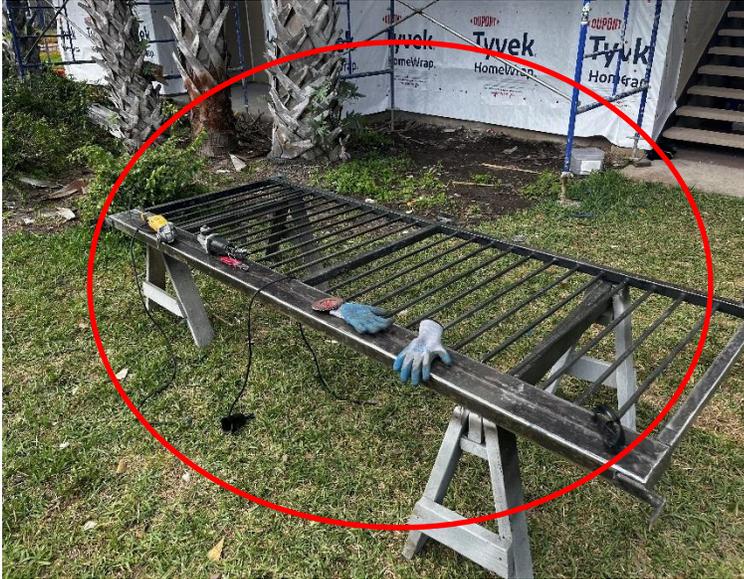
**PHOTOGRAPH #11**

Contractor in process of grinding balcony railings in preparation for new primer and paint finish.

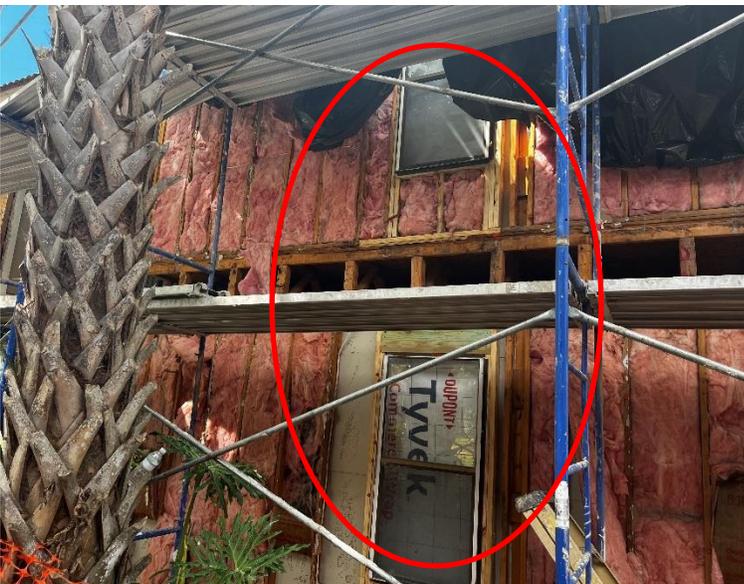
**PHOTOGRAPH #12**

Completed framing repairs quantified and documented for billing.

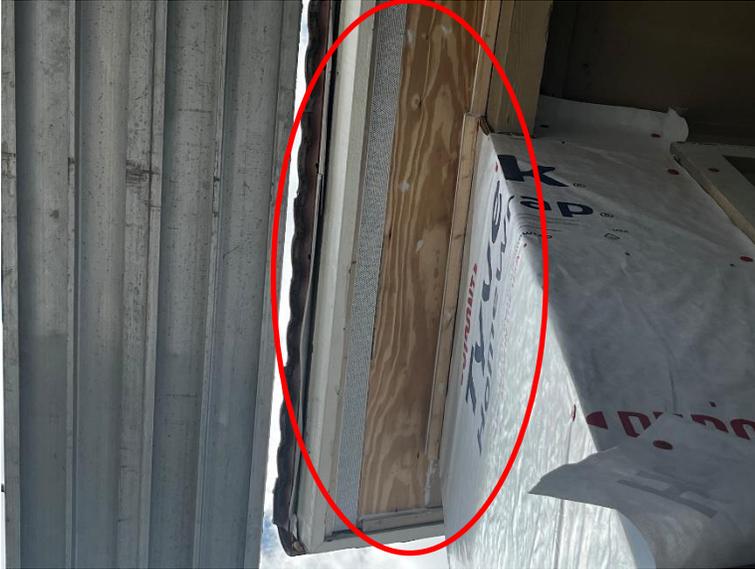
**PHOTOGRAPH #13**

New plywood, trim and venting accessories installed at soffit as per drawings and specifications.

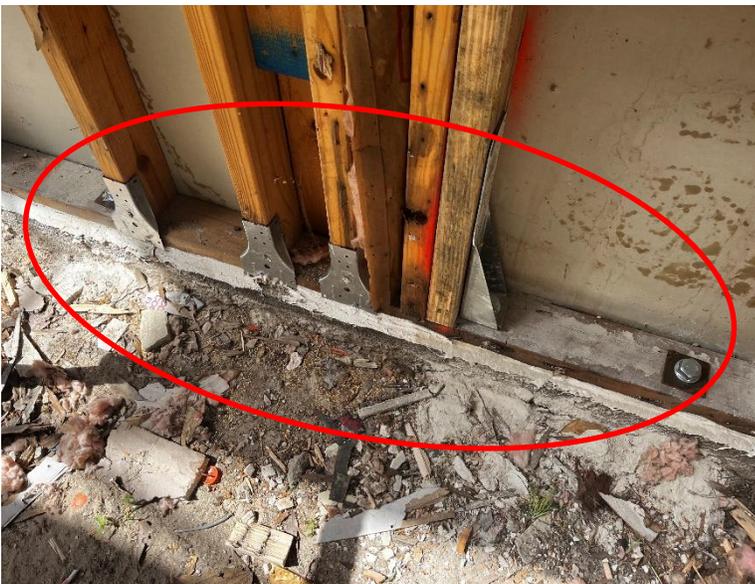
**PHOTOGRAPH #14**

Contractor in process of installing Simson Strong-Tie connectors at framing and base plate.

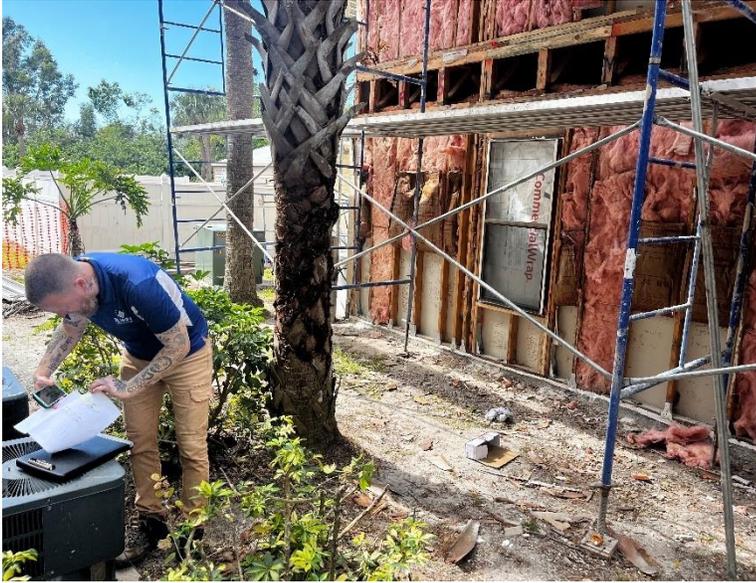
**PHOTOGRAPH #15**

Completed framing repairs quantified and documented for billing.
