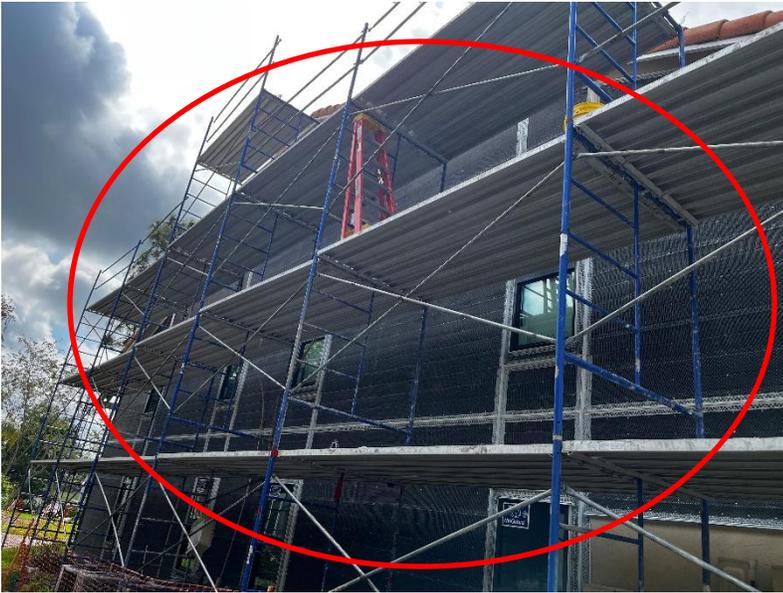
PHOTOGRAPH #1

**BUILDING 11
SECTION H**

Stucco sub-contractor has performed application of stucco lathing and vinyl stucco accessories.

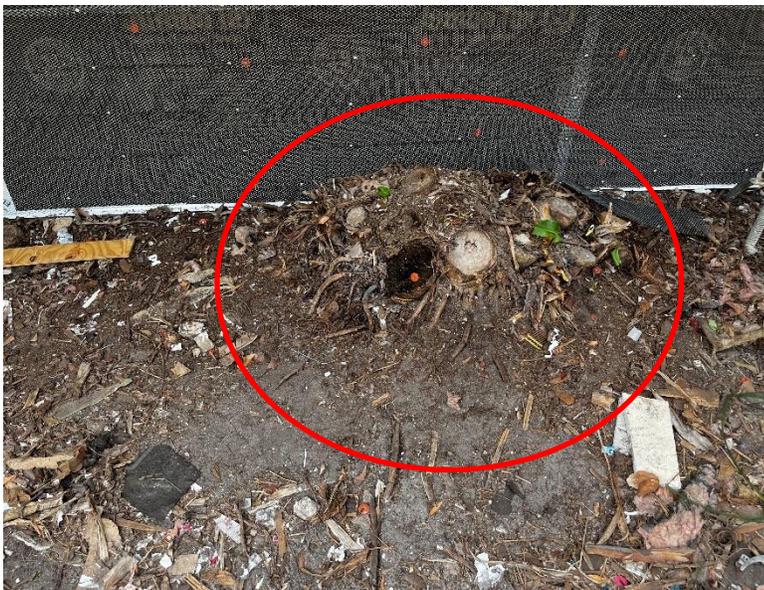
PHOTOGRAPH #2

**BUILDING 11
SECTION H**

Landscaping has yet to be removed in order to apply stucco at base of wall.

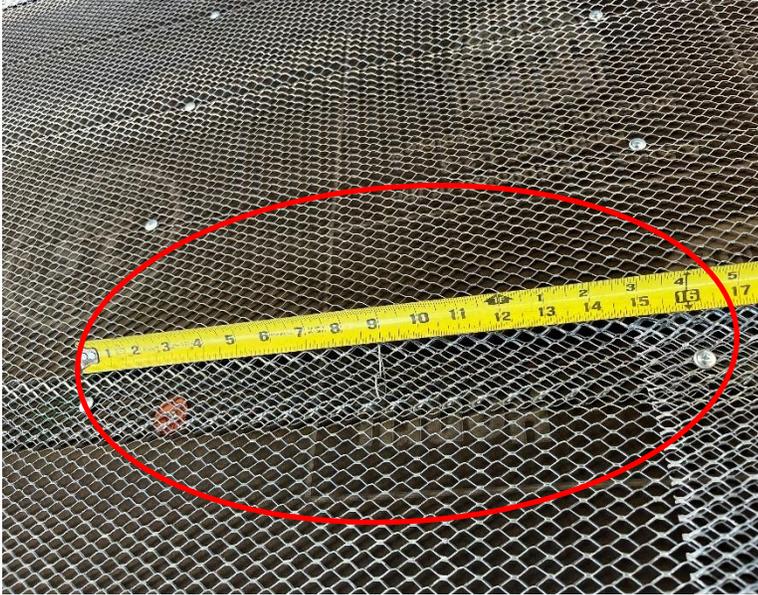
PHOTOGRAPH #3

**BUILDING 11
SECTION H**

New galvanized self-furring lath over lapped, fastened and tied as per drawings to meet ASTM C847.

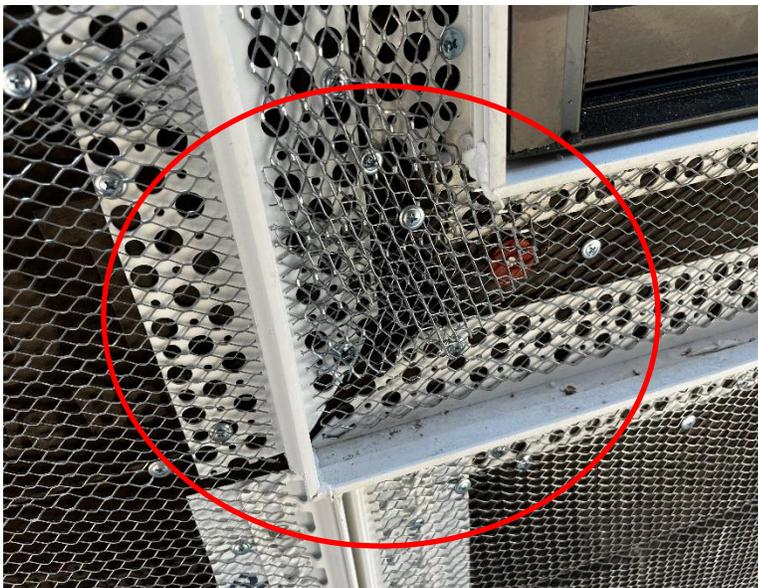
PHOTOGRAPH #4

**BUILDING 11
SECTION H**

2"x4" metal lath Butterfly tied to self-furring lath installed.

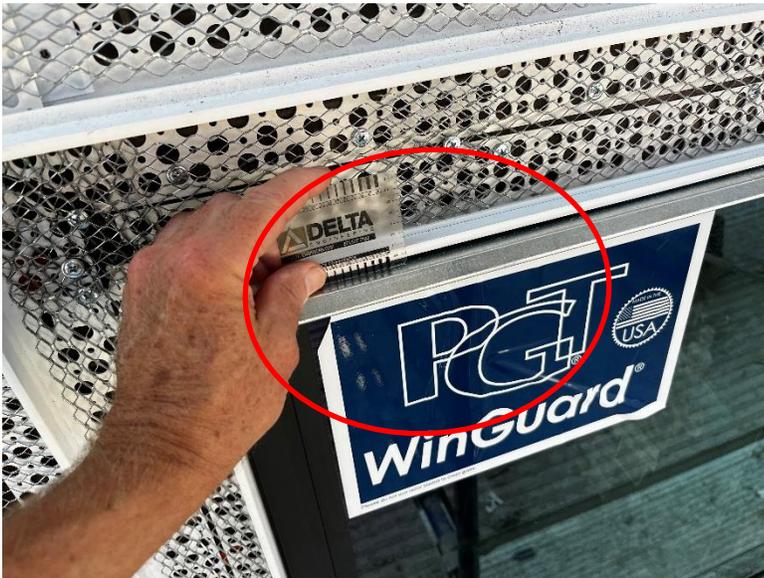
PHOTOGRAPH #5

**BUILDING 11
SECTION H**

Galvanized L- flashing with drip edge spaced 1/4" from J- channel stucco accessory at head of windows.

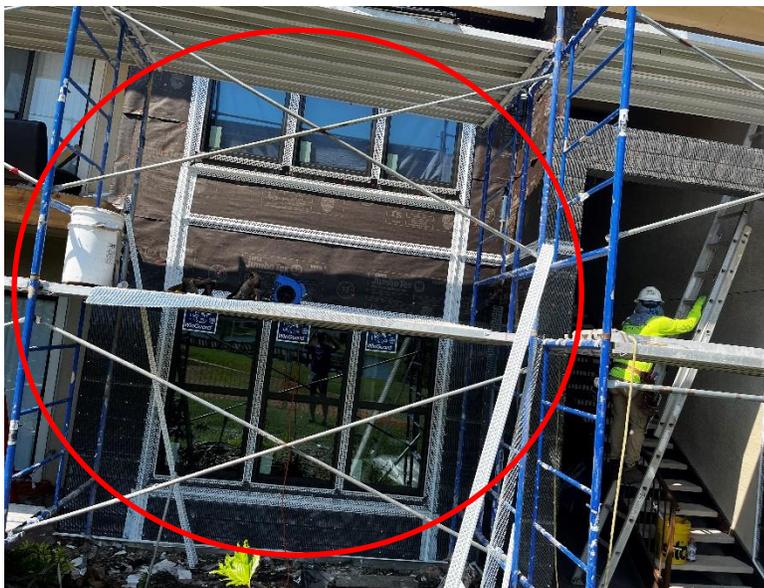
PHOTOGRAPH #6

**BUILDING 11
SECTION F**

Stucco sub-contractor installing control joints and window banding vinyl stucco accessories over secondary WRB as per drawings and details.

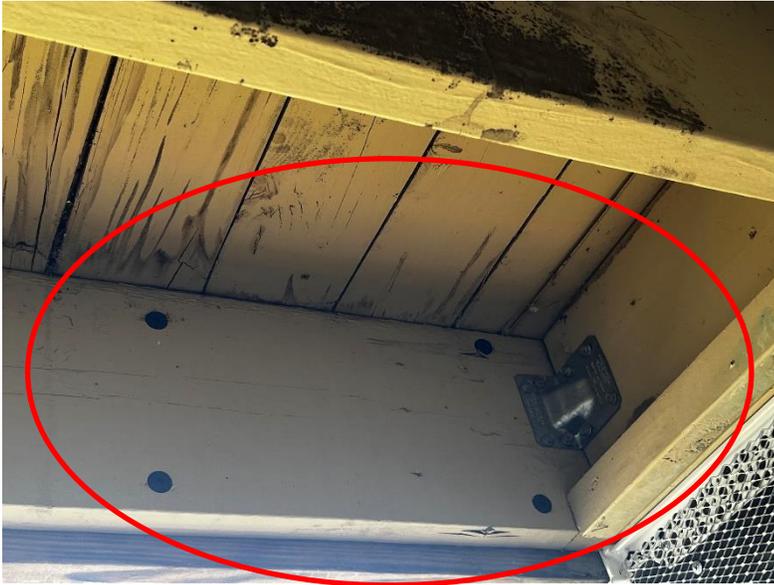
PHOTOGRAPH #7

**BUILDING 11
SECTION F**

Simpson Strong HGA10KT Shear clip and SDW22458 Screws installed at balcony built up beam as per drawings.

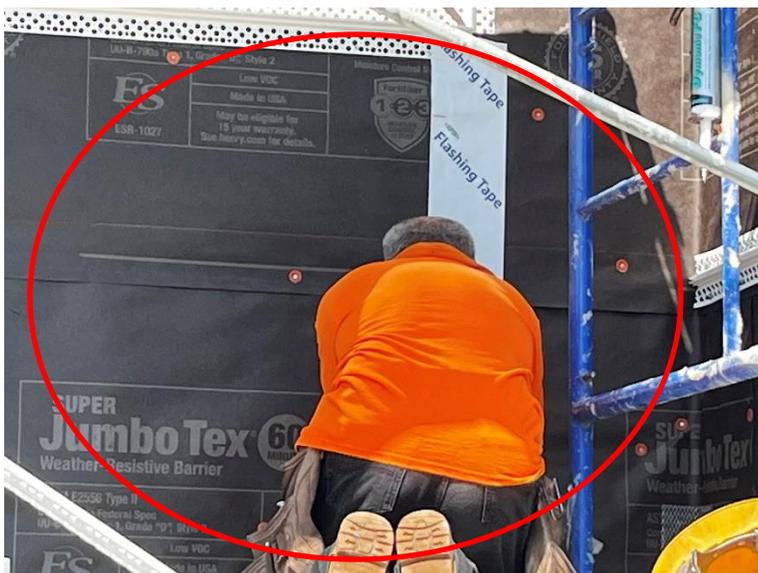
PHOTOGRAPH #8

**BUILDING 12
SECTION F**

6" wide Dupont flashing tape applied over secondary WRB before application of vertical control joint accessory as per drawings.

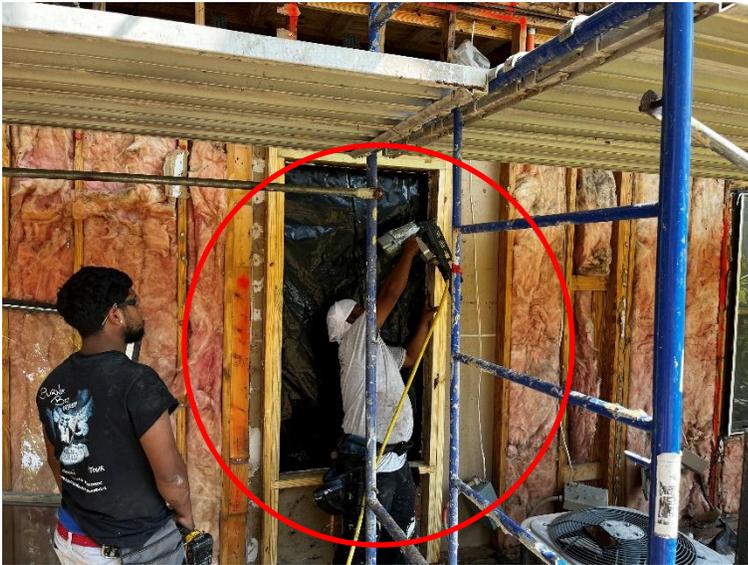
PHOTOGRAPH #9

**BUILDING 11
SECTION D - UNIT 1117**

Contractor replacing damaged window framing with new #2 southern yellow pine 2"X4" framing.

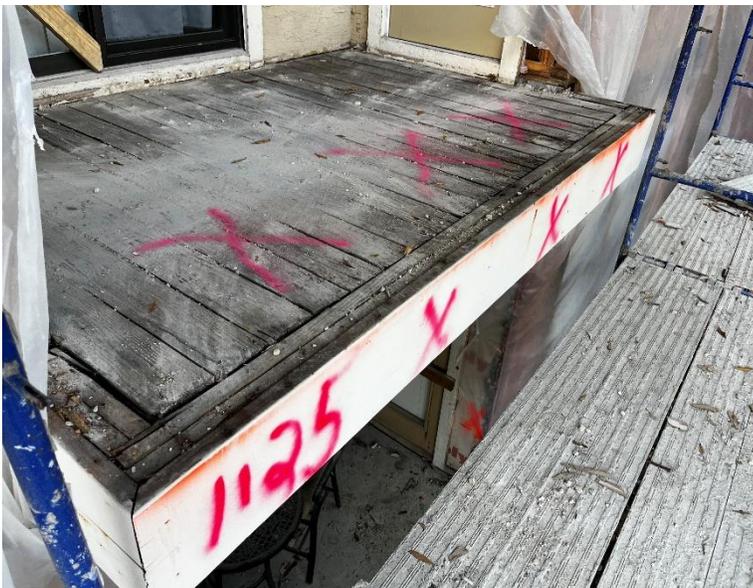
PHOTOGRAPH #10

**BUILDING 11
SECTION B - UNIT 1125**

Delta reviewed upper balcony deck and marked for full built-up beam and deck board replacement.

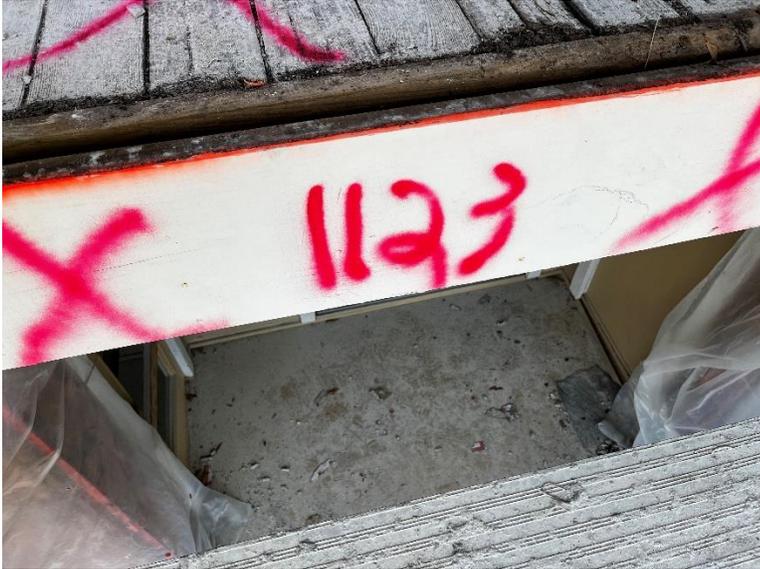
PHOTOGRAPH #11

**BUILDING 11
SECTION B- UNIT 1123**

Delta reviewed upper balcony deck and marked for full built-up beam and deck board replacement.

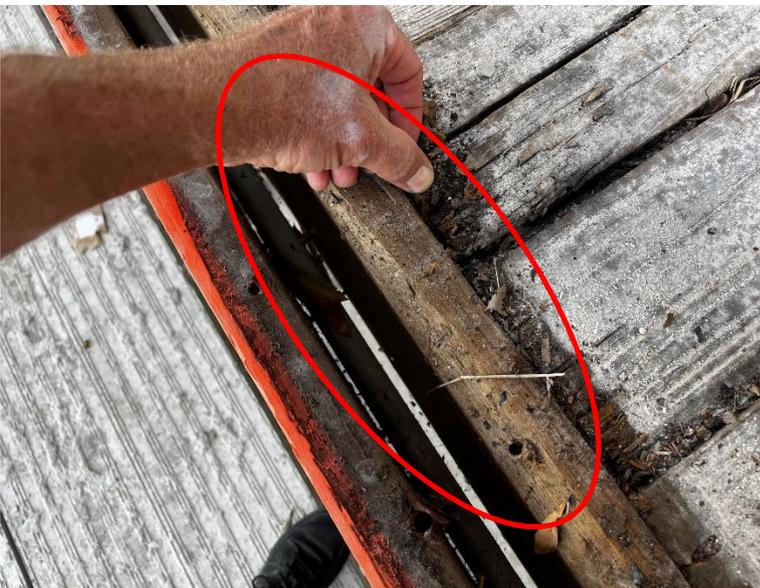
PHOTOGRAPH #12

**BUILDING 11
SECTION B- UNIT 1123**

Delta reviewed upper balcony deck and marked for full built-up beam and deck board replacement.

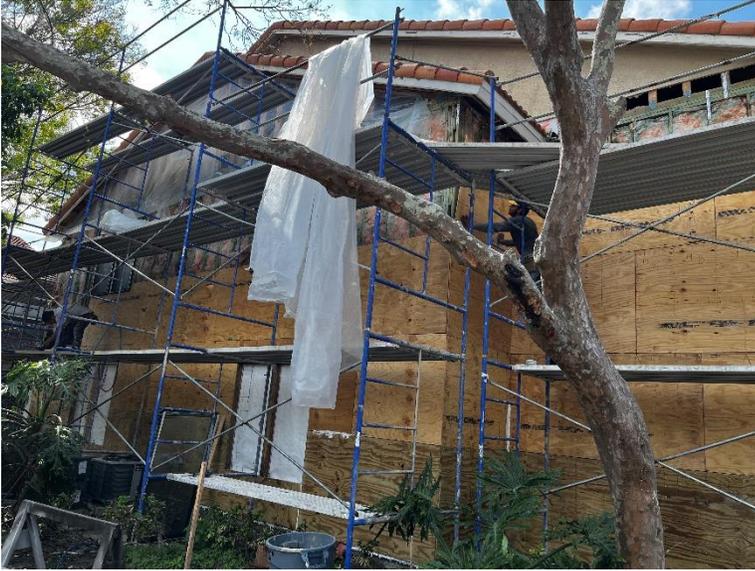
PHOTOGRAPH #13

**BUILDING 12
SECTION H**

Contractor installing new 15/32" plywood sheathing at gable end wall.

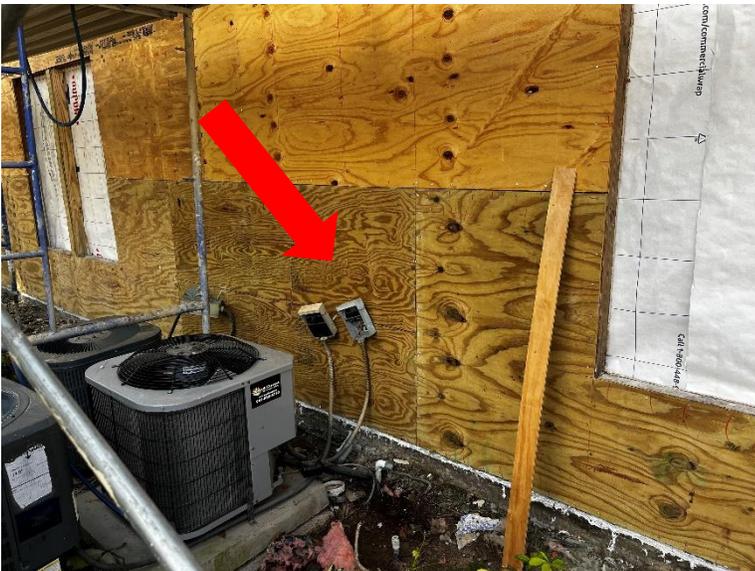
PHOTOGRAPH #14

**BUILDING 12
SECTION H**

Bottom row of plywood sheathing is pressure treated plywood as per PM specifications.

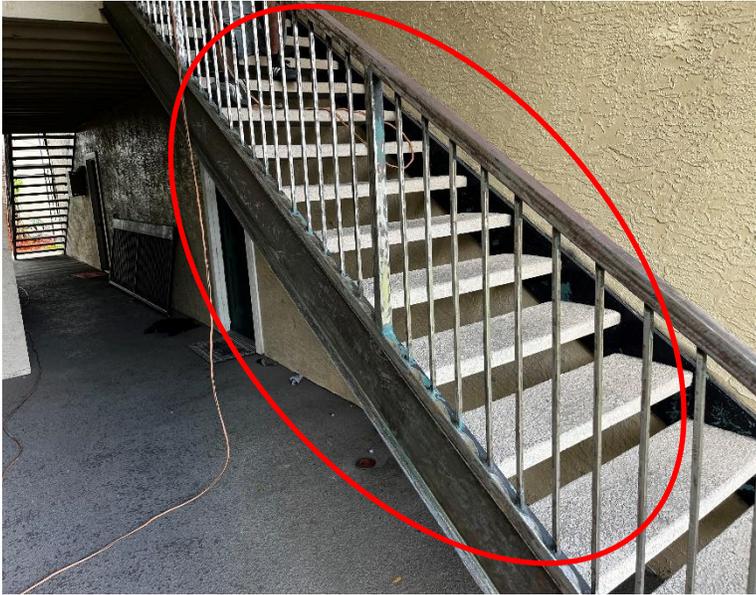
PHOTOGRAPH #15

**BUILDING 12
SECTION G**

Contractor has prepared metal stairway railings for primer and paint by hand grinding.

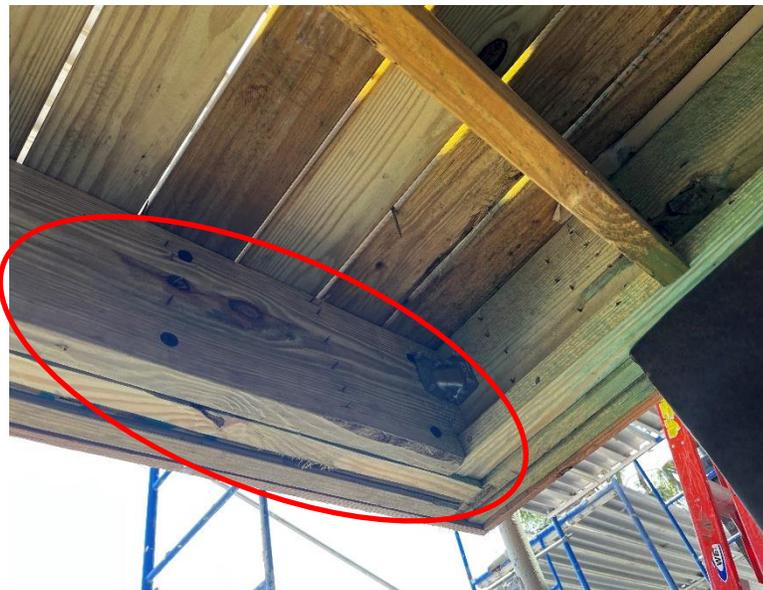
PHOTOGRAPH #16

**BUILDING 12
SECTION F**

Simpson Strong HGA10KT Shear clip and SDW22458 Screws installed at balcony built up beam as per drawings.

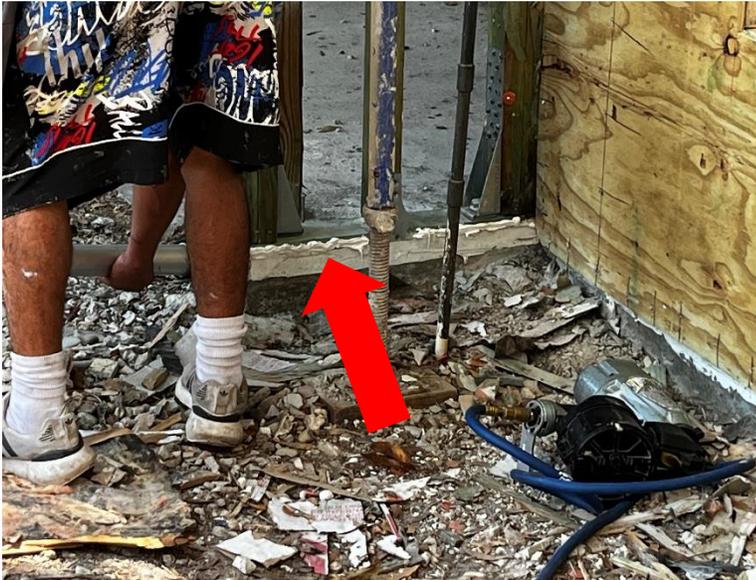
PHOTOGRAPH #17

**BUILDING 12
SECTION F**

Contractor adding additional urethane sealant at bottom plate before attachment of new plywood to seal plywood at the bottom edge.

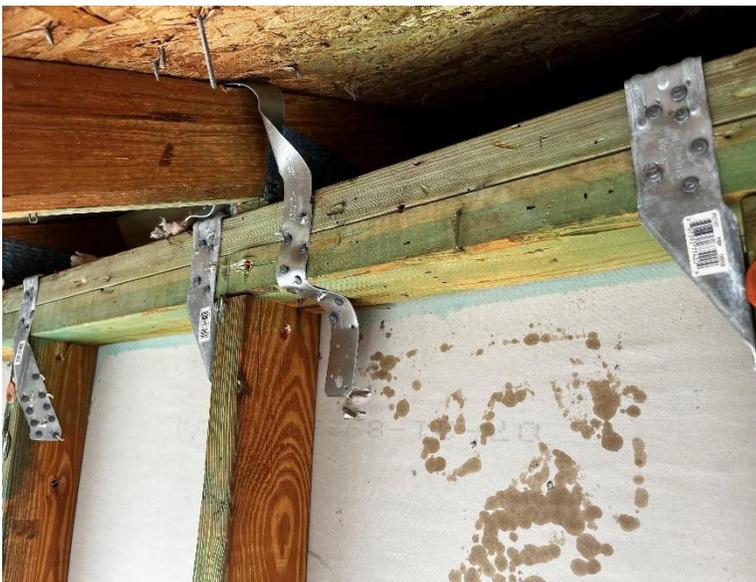
PHOTOGRAPH #18

**BUILDING 12
SECTION F**

Simpson Strong-Tie connectors, straps and screws installed at framing studs to top plate and top plate to trusses.

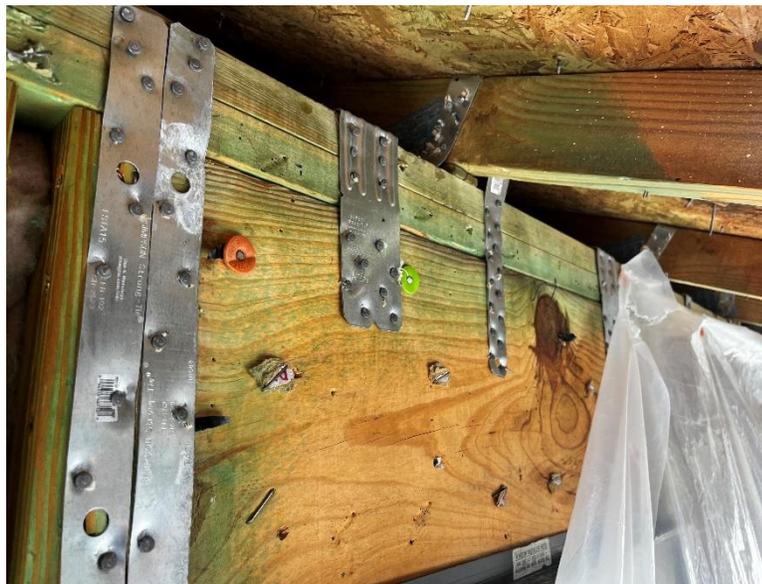
PHOTOGRAPH #19

**BUILDING 12
SECTION F**

Simpson Strong-Tie connectors, straps and screws installed at window headers to top plate and top plate to trusses.

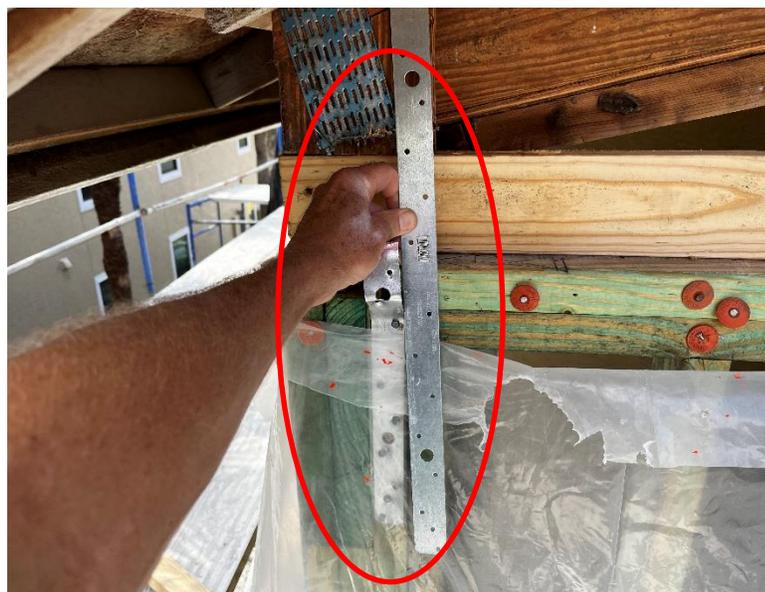
PHOTOGRAPH #20

**BUILDING 12
SECTION F**

Simpson Strong strap connected corner post to top plate but missing connection from top plate to truss.

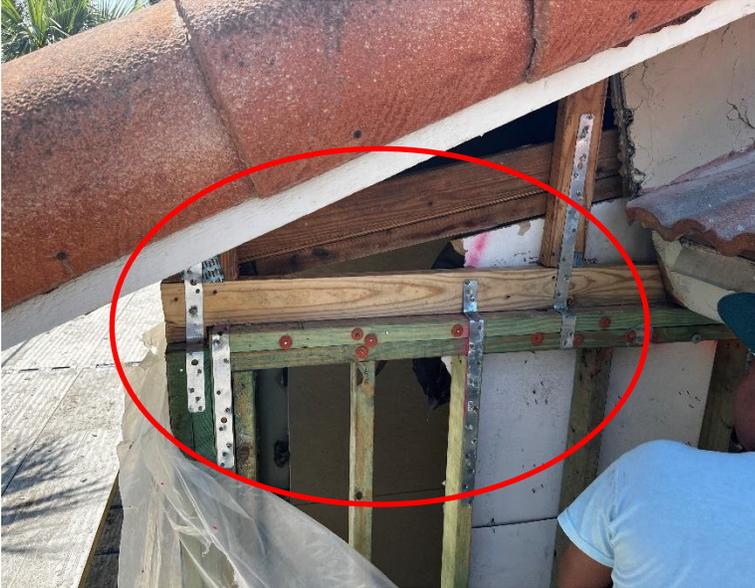
PHOTOGRAPH #21

**BUILDING 12
SECTION F**

Contractor added straps to connect top plate to truss as directed.

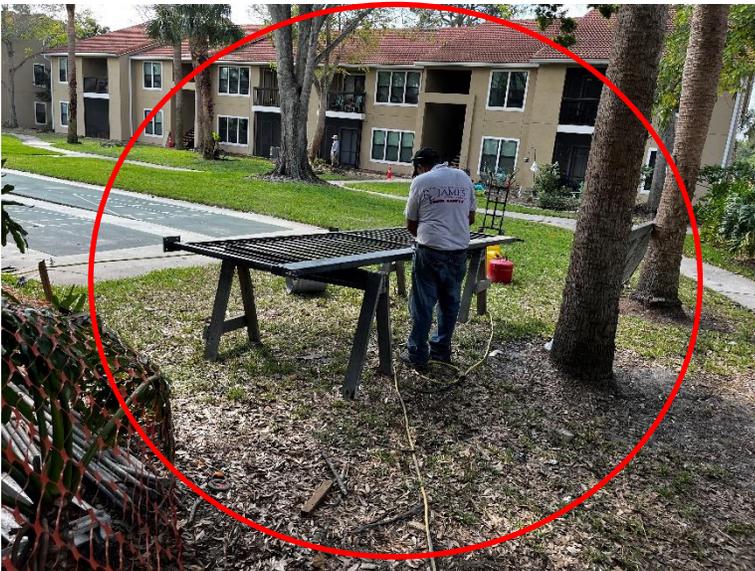
PHOTOGRAPH #22

**BUILDING 12
SECTION F**

Contractor in process of prepared metal balcony railings for primer and paint by hand grinding.
