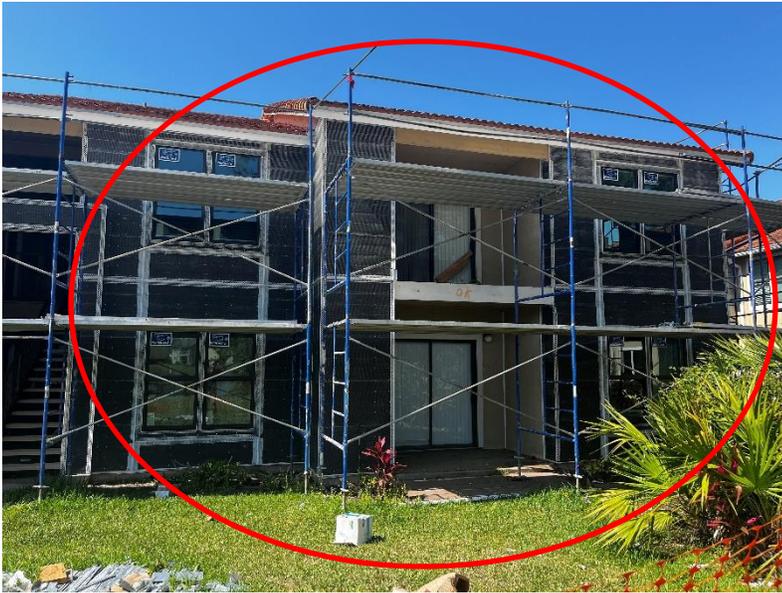
**PHOTOGRAPH #1**

**BUILDING 11  
SECTION G**

Stucco sub-contractor has performed application of stucco lathing and vinyl stucco accessories.

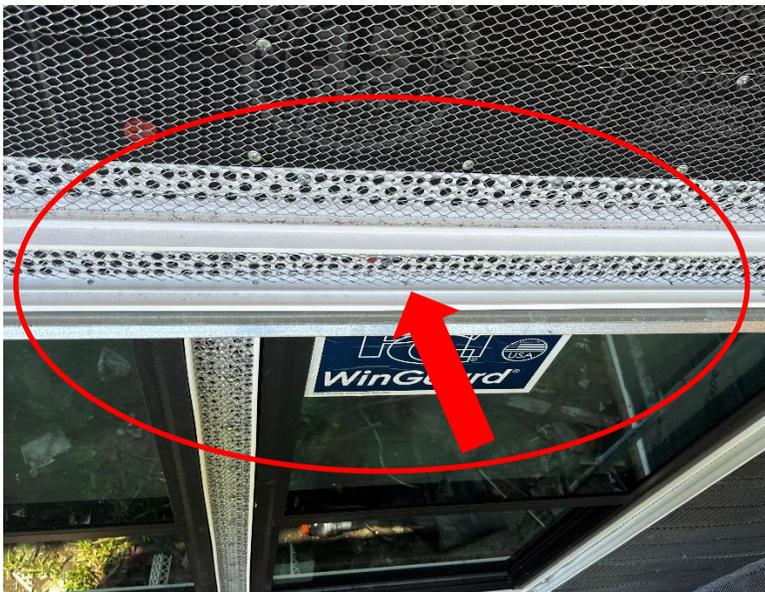
**PHOTOGRAPH #2**

**BUILDING 11  
SECTION G**

Vinyl stucco accessories installed at window bands and heads with weeps over aluminum head flashing as per drawings.

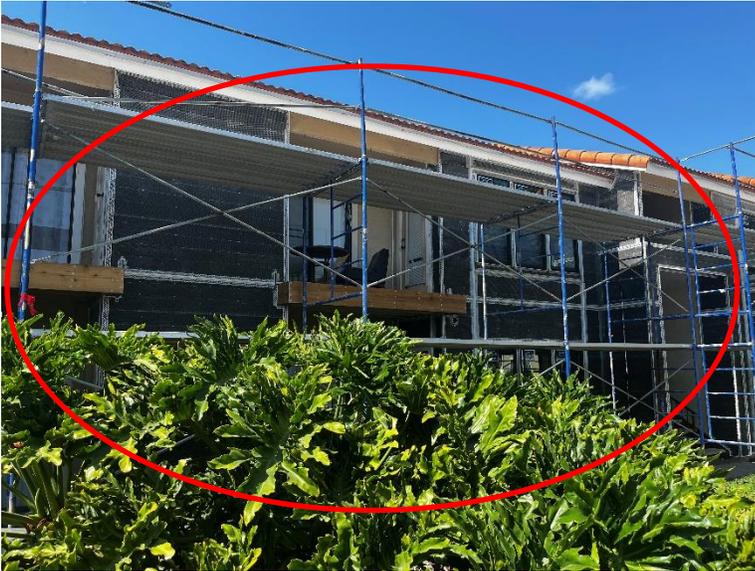
**PHOTOGRAPH #3**

**BUILDING 11  
SECTION F**

Stucco sub-contractor has performed application of stucco lathing and vinyl stucco accessories.

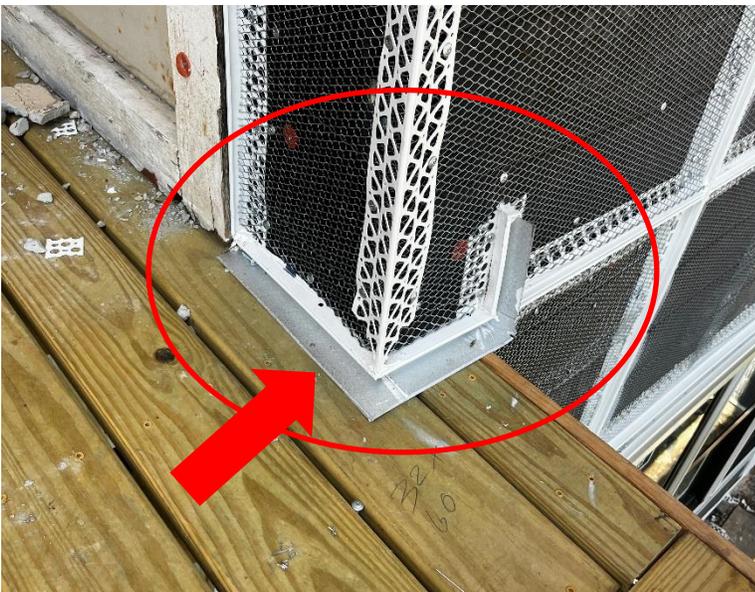
**PHOTOGRAPH #4**

**BUILDING 11  
SECTION F**

Galvanized balconies kick out flashings installed prior to water barriers, lath and stucco accessories. Full bed of sealant under flashing is not evident as called for on drawings.

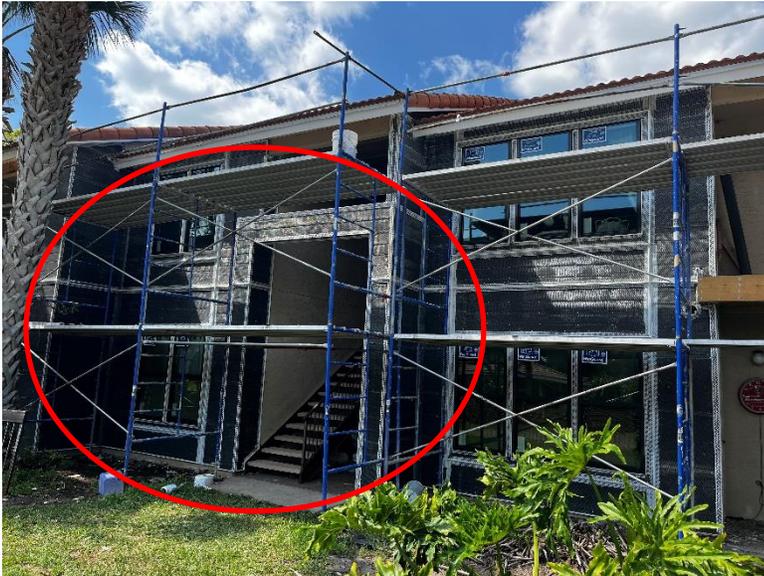
**PHOTOGRAPH #5**

**BUILDING 11  
SECTION E**

Stucco sub-contractor has performed application of stucco lathing and vinyl stucco accessories.

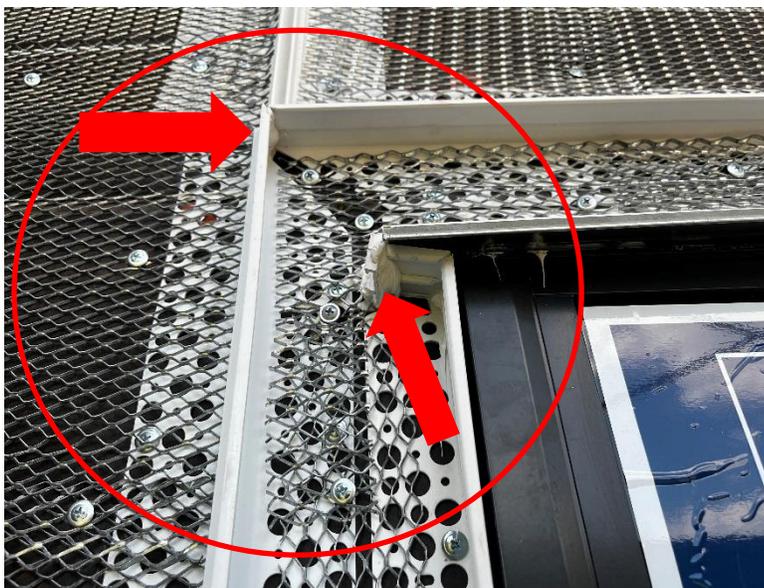
**PHOTOGRAPH #6**

**BUILDING 11  
SECTION E**

Stucco sub-contractor has sealed transitions and butt joints of vinyl accessories with urethane sealant as per drawings and specifications.

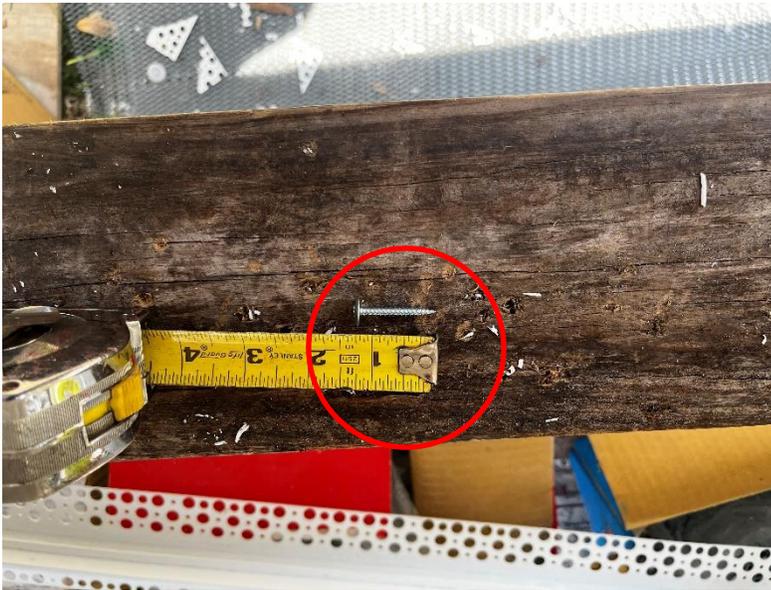
**PHOTOGRAPH #7**

**BUILDING 11  
SECTION E**

1/4" #8 self-tapping wafer pan head screws for attaching new lath to wood framing.

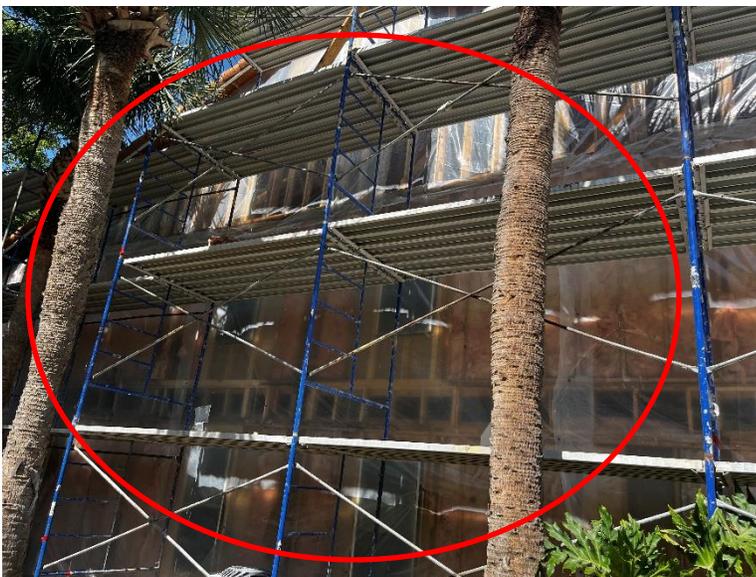
**PHOTOGRAPH #8**

**BUILDING 11  
SECTION D**

Contractor has made framing repairs and covered with protective sheathing.

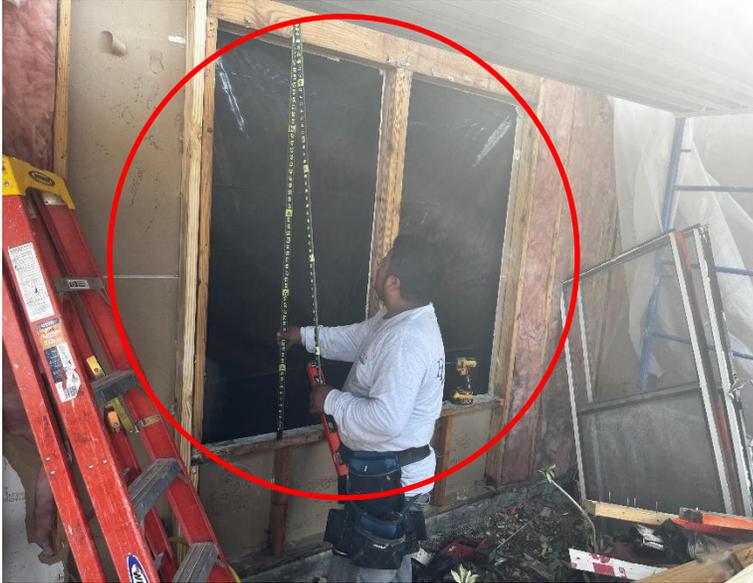
**PHOTOGRAPH #9**

**BUILDING 11  
SECTION C - UNIT 1117**

Contractor replacing damaged window framing with new #2 southern yellow pine 2"X4" framing.

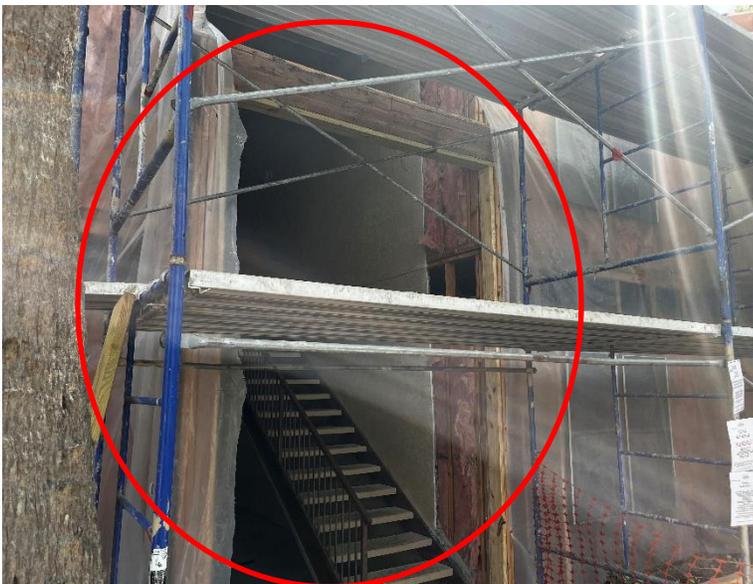
**PHOTOGRAPH #10**

**BUILDING 11  
SECTION C**

Partial replacement of damaged wood at breezeway entrance will be quantified and billed for by contractor as a unit price per unit of 2x6 lumber.

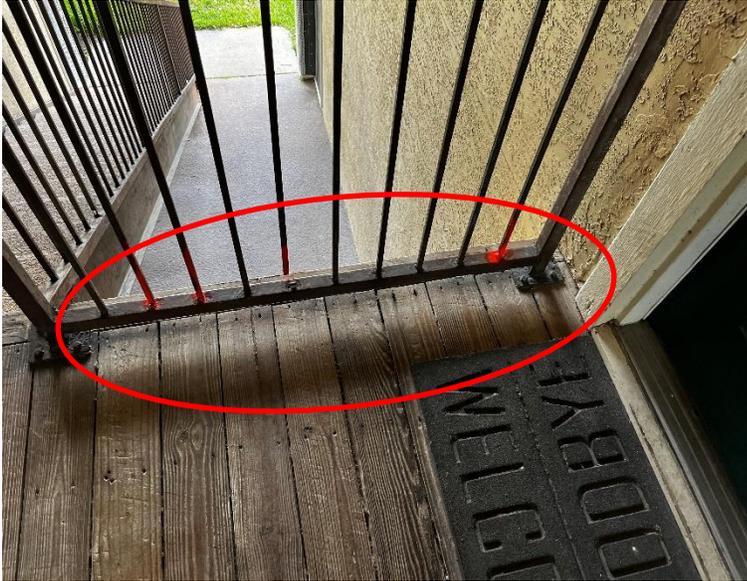
**PHOTOGRAPH #11**

**BUILDING 11  
SECTION C- STAIRLANDING**

Steel repairs and replacement of railing pickets marked for welder to make repairs.

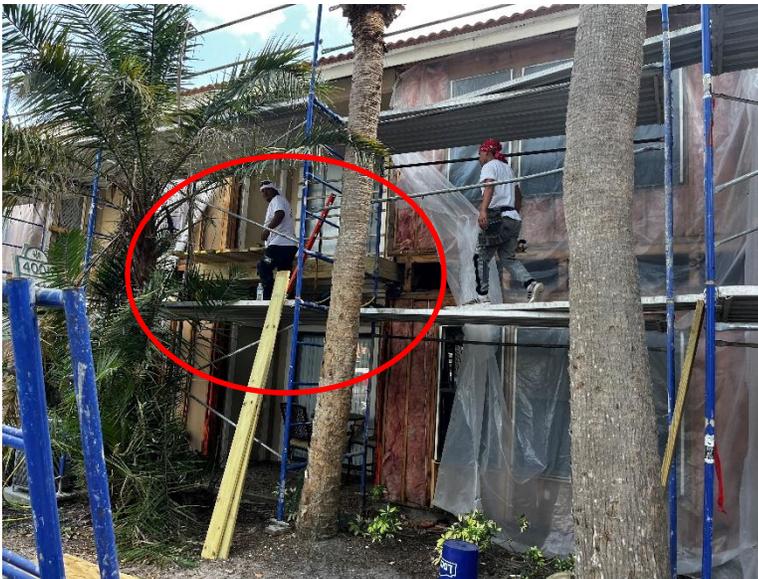
**PHOTOGRAPH #12**

**BUILDING 11  
SECTION B- UNIT 1125**

Contractor in process of balcony built up beam and deck repairs.

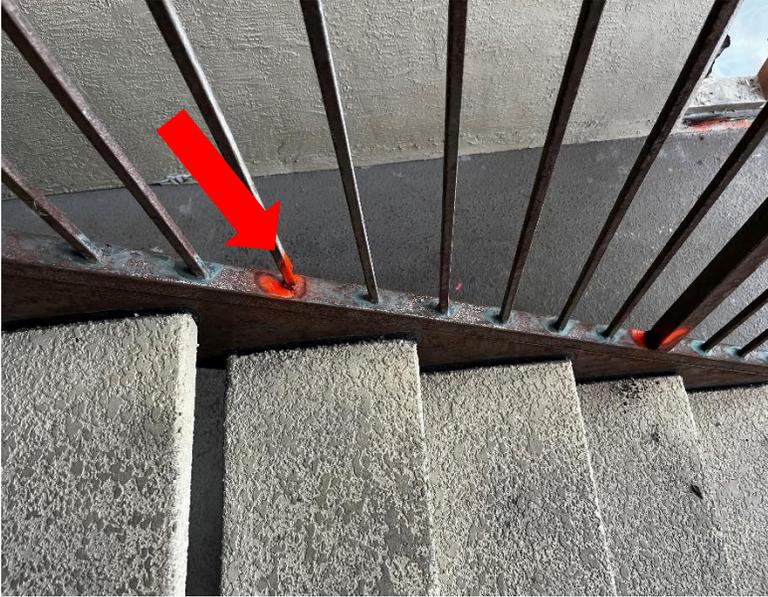
**PHOTOGRAPH #13**

**BUILDING 11  
SECTION A - STAIRWAY**

Steel repairs and replacement of railing pickets marked for welder to make repairs.

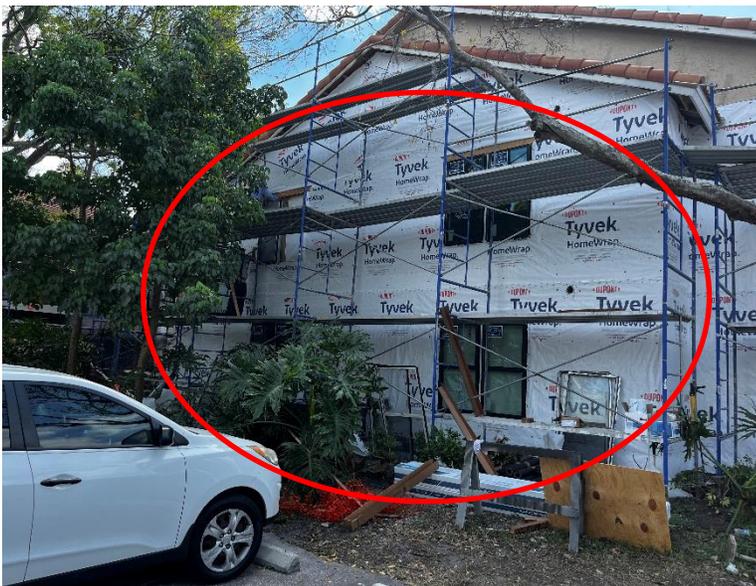
**PHOTOGRAPH #14**

**BUILDING 12  
SECTION H**

Dupont Tyvek water resistant barrier applied and window installation in progress.

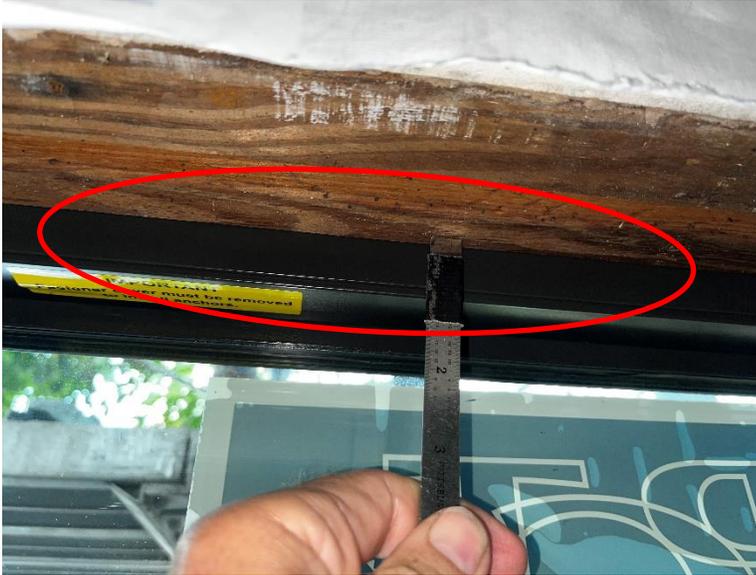
**PHOTOGRAPH #15**

**BUILDING 12  
SECTION H – UNIT 1212**

Windows fit properly into framing to meet requirements of NOA by PGT with gap at all sided at 5/16” or less.

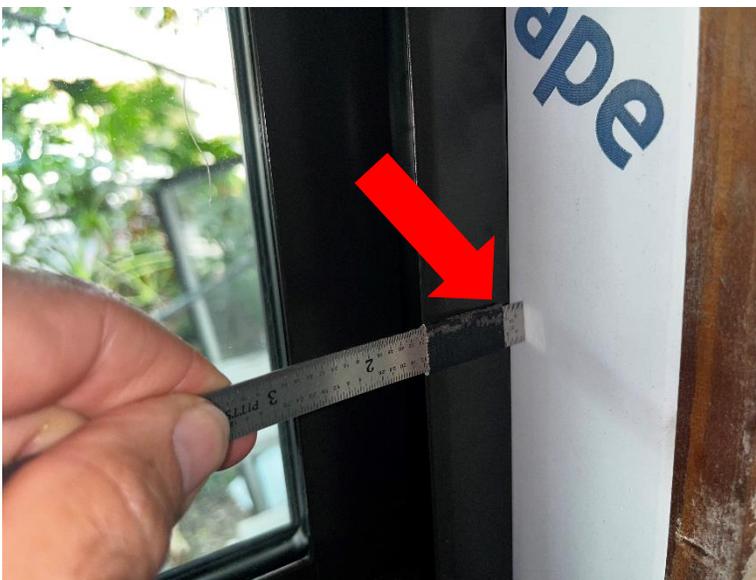
**PHOTOGRAPH #16**

**BUILDING 12  
SECTION H – UNIT 1212**

Windows fit properly into framing to meet requirements of NOA by PGT with gap at all sided at 5/16” or less.

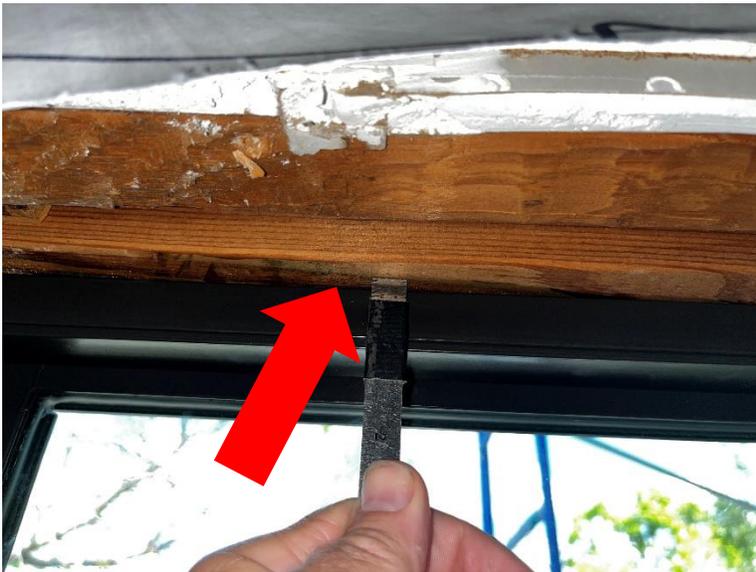
**PHOTOGRAPH #17**

**BUILDING 12  
SECTION H – UNIT 1221**

Windows fit properly into framing to meet requirements of NOA by PGT with gap at all sided at 5/16” or less.

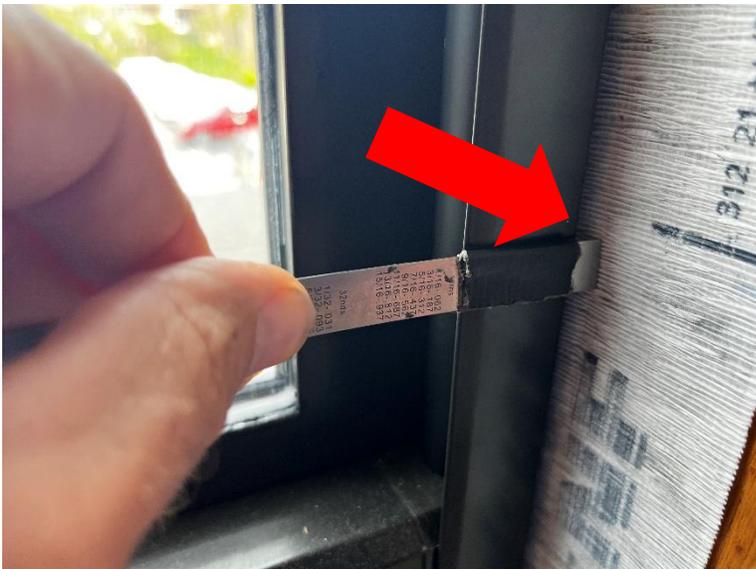
**PHOTOGRAPH #18**

**BUILDING 12  
SECTION H – UNIT 1221**

Windows fit properly into framing to meet requirements of NOA by PGT with gap at all sided at 5/16” or less.

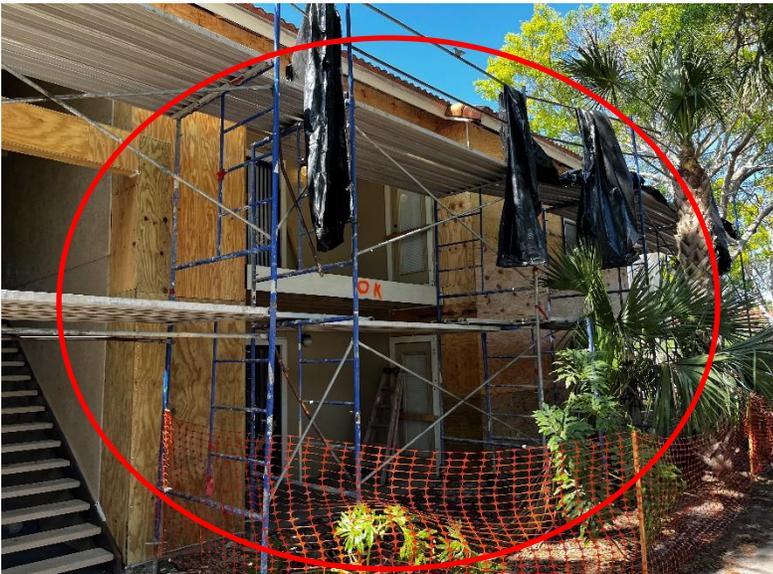
**PHOTOGRAPH #19**

**BUILDING 12  
SECTION G**

New 15/32" plywood sheathing fastened to framing as per drawings and specifications.

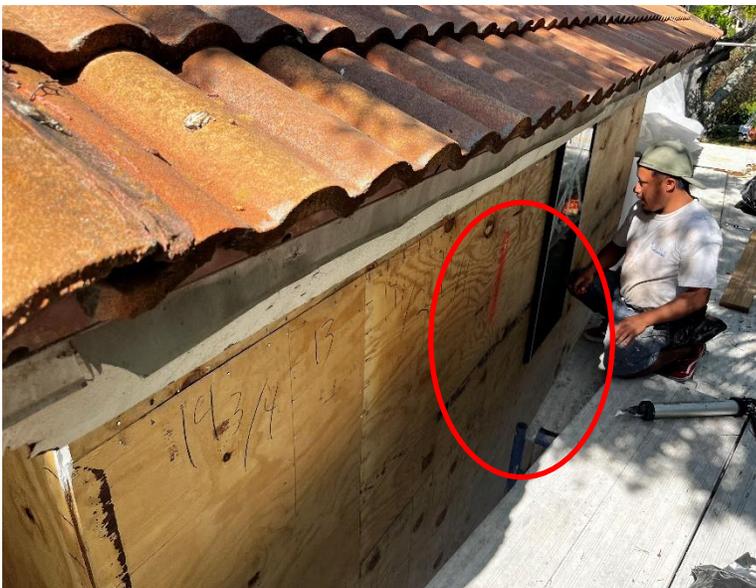
**PHOTOGRAPH #20**

**BUILDING 12  
SECTION G**

Contractor made fastening corrections as marked by Delta.

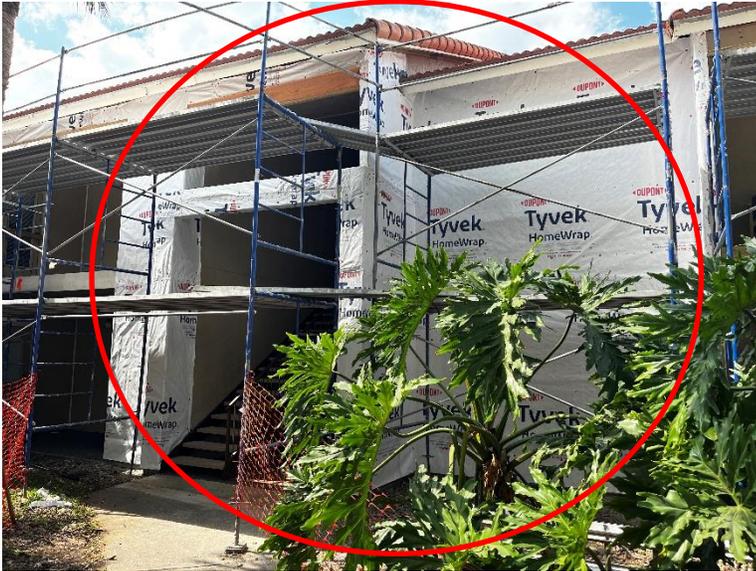
**PHOTOGRAPH #21**

**BUILDING 12  
SECTION G**

Dupont Tyvek HomeWrap water resistant barrier applied and taped at seams and overlaps.

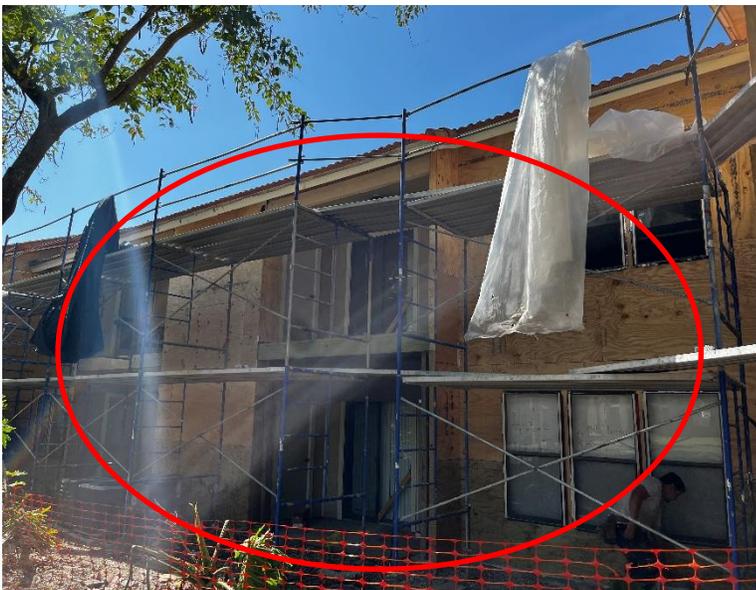
**PHOTOGRAPH #22**

**BUILDING 12  
SECTION F**

New 15/32" plywood sheathing fastened to framing as per drawings and specifications.

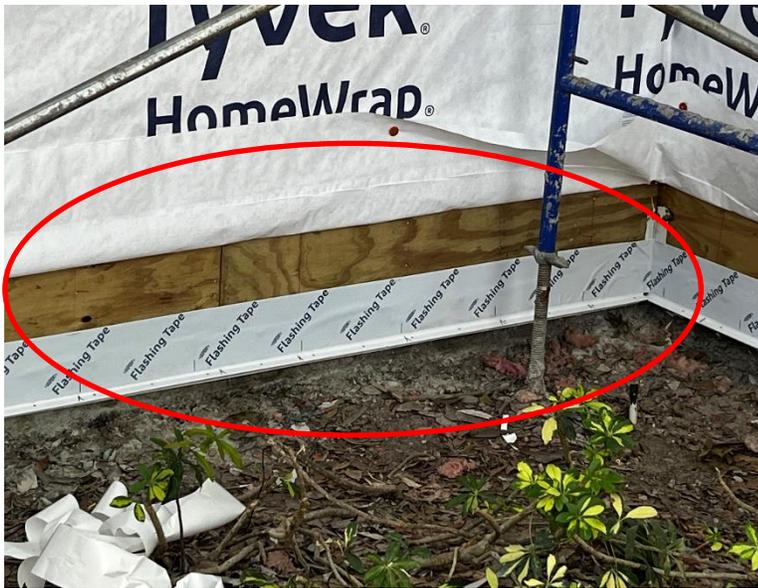
**PHOTOGRAPH #23**

**BUILDING 12  
SECTION F**

Stucco-stop weep accessory installed at base of sheathing and flashed in with Dupont Flashing Tape.

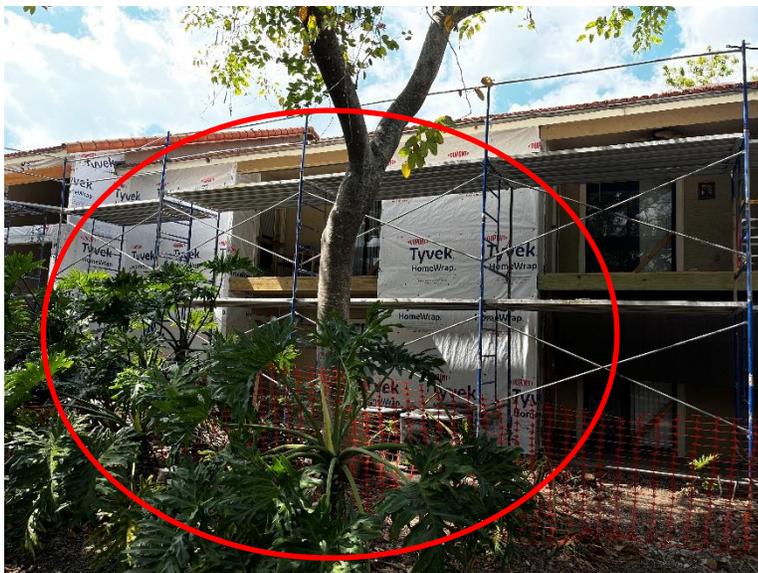
**PHOTOGRAPH #24**

**BUILDING 12  
SECTION F**

Dupont Tyvek HomeWrap water resistant barrier applied and taped at seams and overlaps.

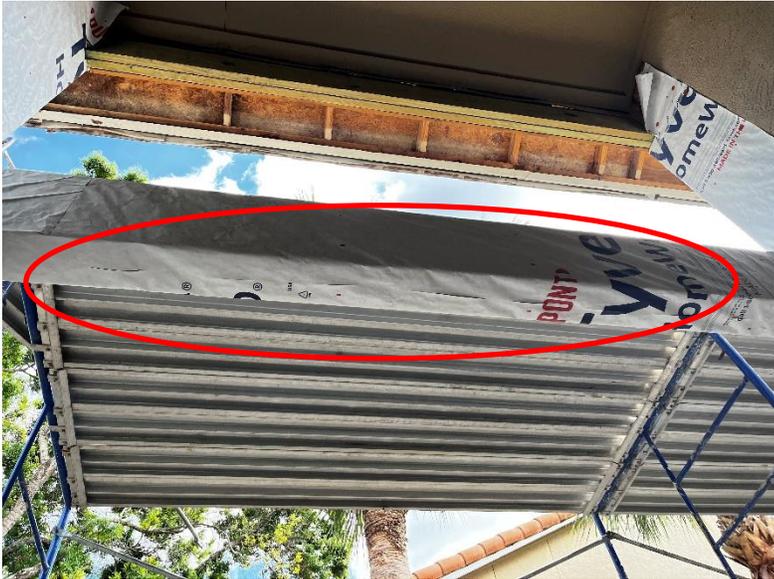
**PHOTOGRAPH #25**

**BUILDING 12  
SECTION E**

Contractor has cut weep slits into WRB at bottom side of beam as recommend by manufacturer.

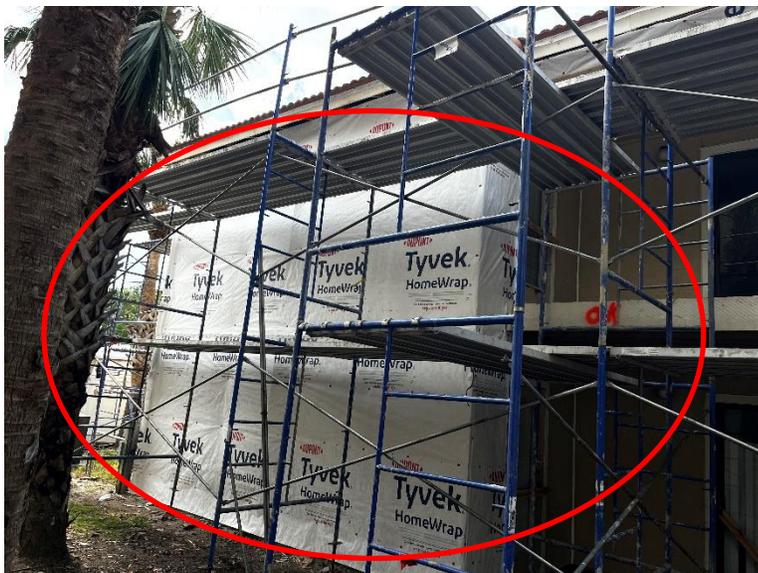
**PHOTOGRAPH #26**

**BUILDING 12  
SECTION E**

Dupont Tyvek HomeWrap water resistant barrier applied and taped at seams and overlaps.

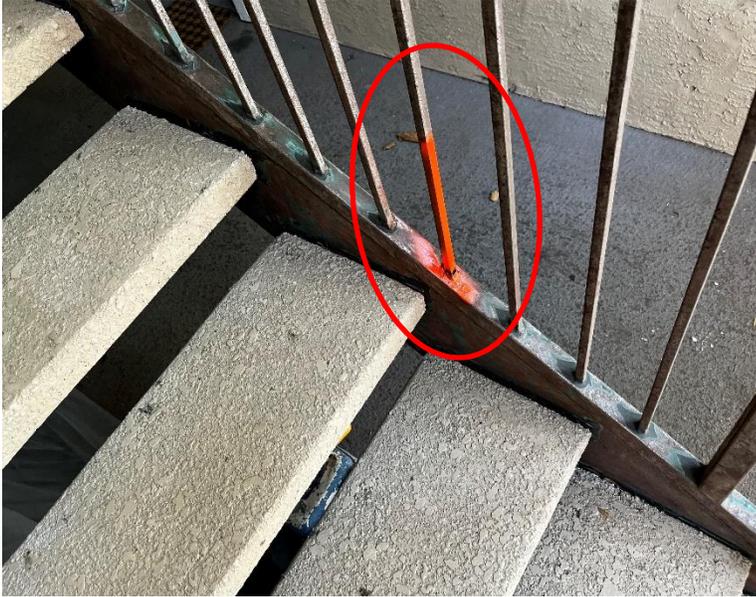
**PHOTOGRAPH #27**

**BUILDING 12  
SECTION E**

Steel repairs and replacement of railing pickets marked for welder to make repairs.
