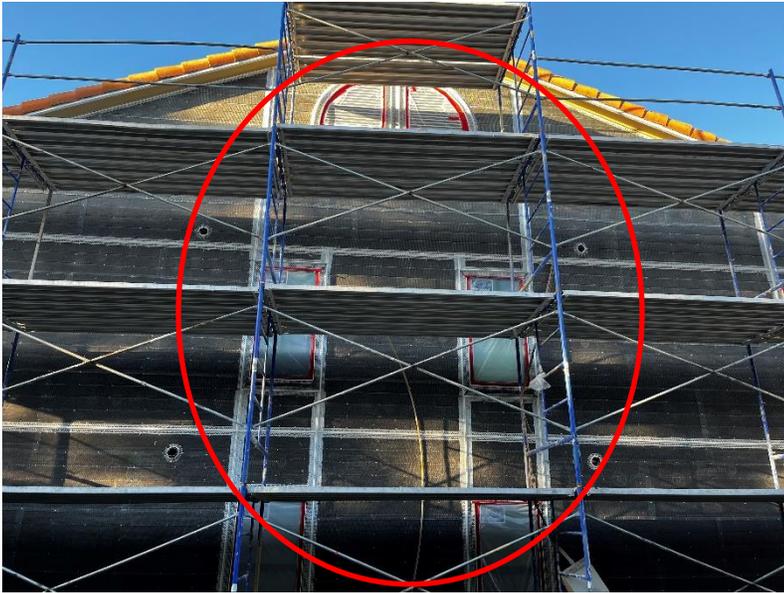
PHOTOGRAPH #1

**BUILDING 11
SECTION H**

Stucco sub-contractors have prepared for stucco applications by protecting new windows and vents.

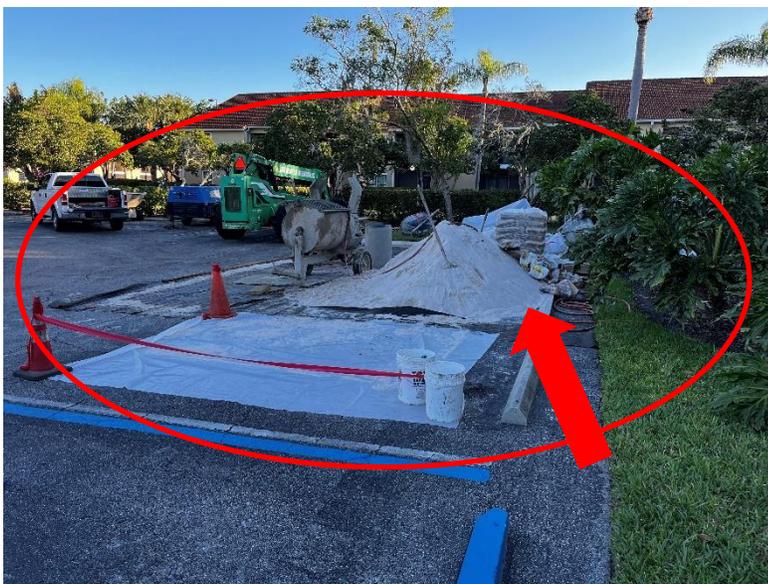
PHOTOGRAPH #2

**BUILDING 11
SECTION H**

Stucco mixing area in parking lot.

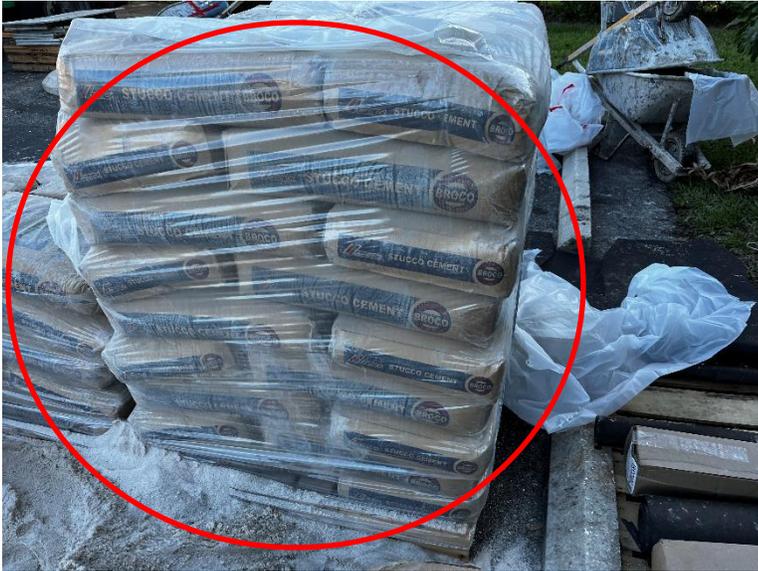
PHOTOGRAPH #3

**BUILDING 11
SECTION H**

Stucco sub-contractor using approved AMEX Broco bagged stucco cement and sand.

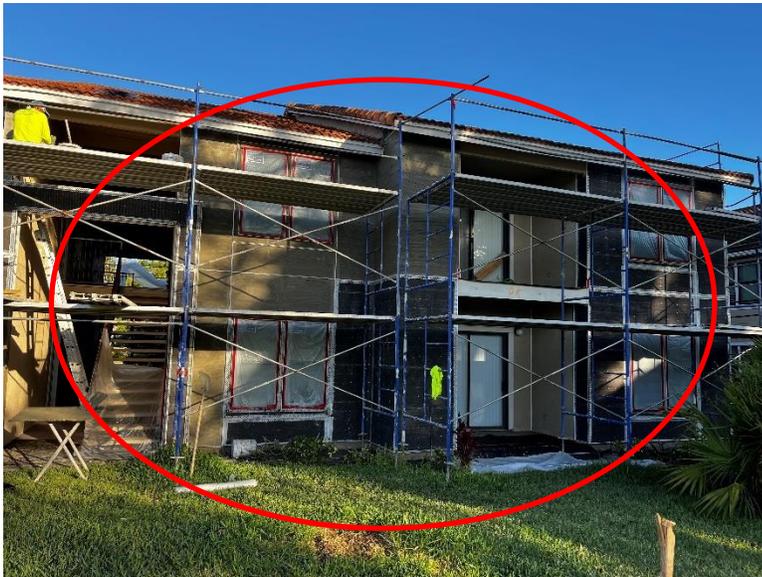
PHOTOGRAPH #4

**BUILDING 11
SECTION G**

Stucco sub-contractor has begun to apply scratch coat of stucco.

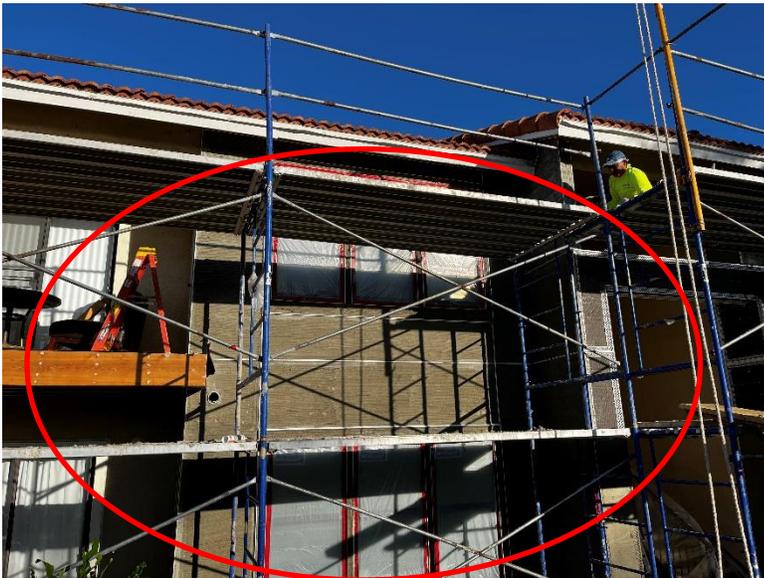
PHOTOGRAPH #5

**BUILDING 11
SECTION F**

Stucco sub-contractor has applied 1st scratch coat of three coat 7/8" stucco system.

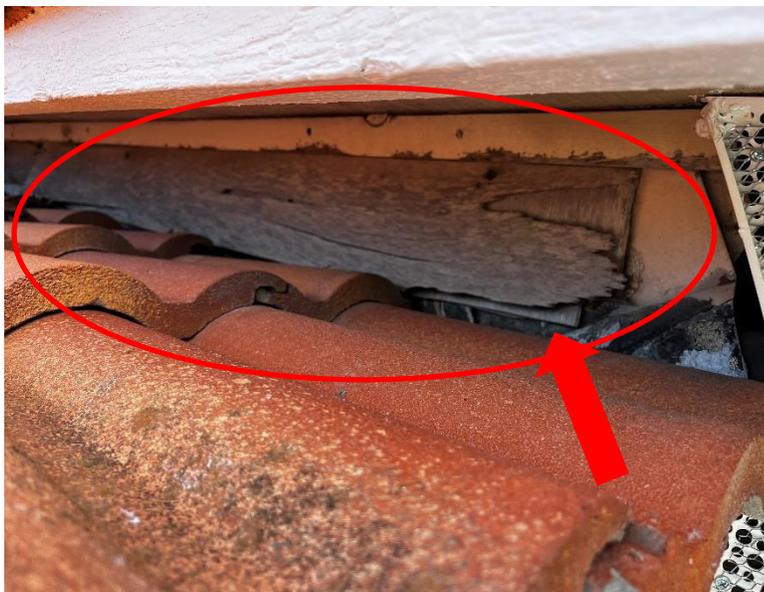
PHOTOGRAPH #6

**BUILDING 11
SECTION F**

Deteriorated conditions at roof flashing areas above roof tiles. These locations are not included in current scope of wall repair work and are to be addressed when roofs are repaired by other contractors.

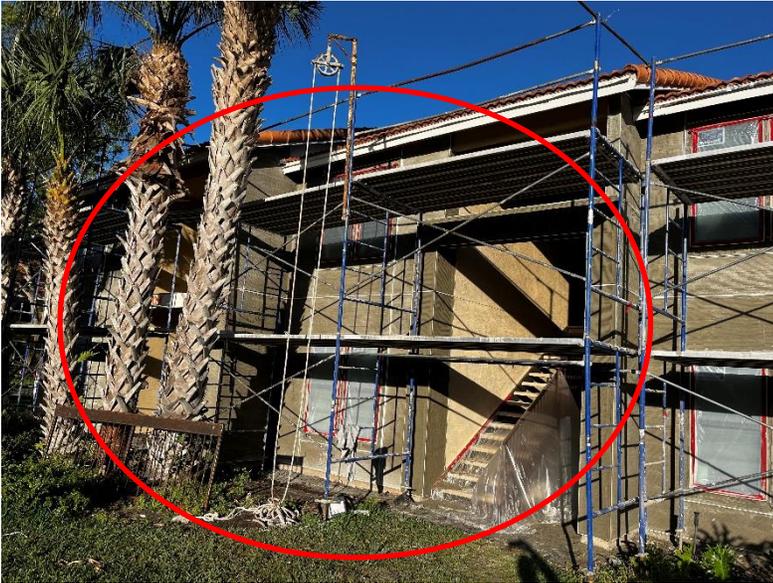
PHOTOGRAPH #7

**BUILDING 11
SECTION E**

Stucco sub-contractor has applied 1st scratch coat of three coat 7/8" stucco system.

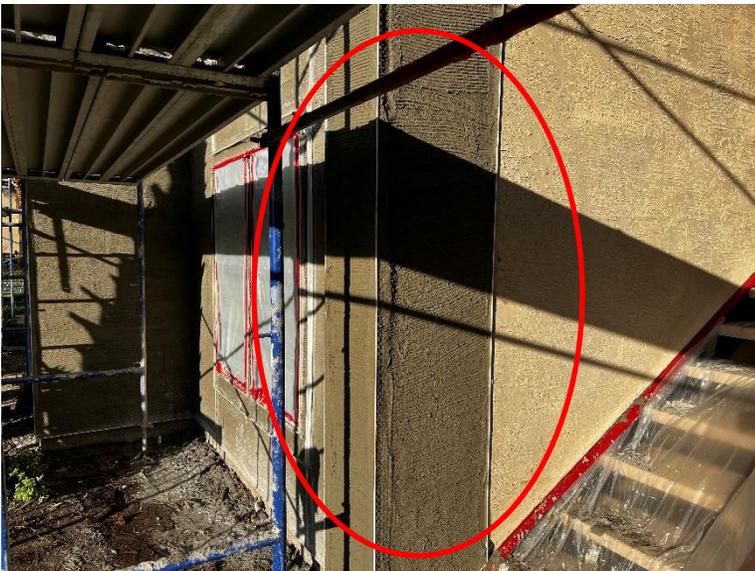
PHOTOGRAPH #8

**BUILDING 11
SECTION E**

Stucco sub-contractor has applied 1st scratch coat of three coat 7/8" stucco system.

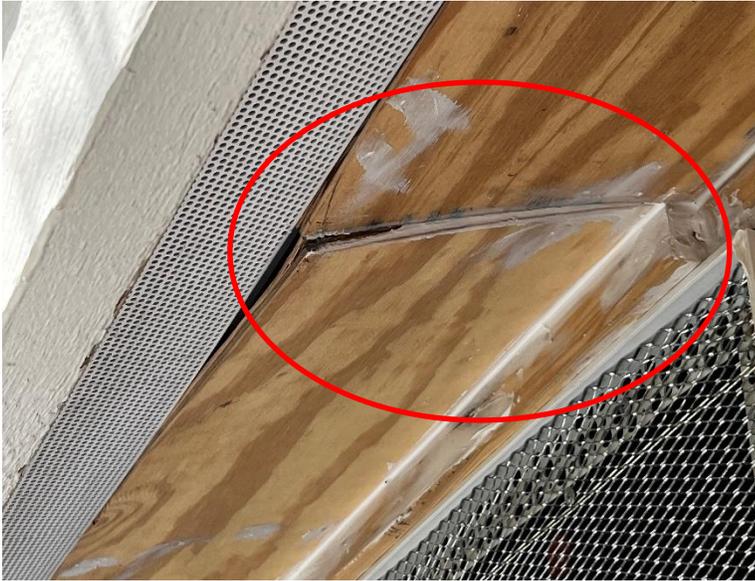
PHOTOGRAPH #9

**BUILDING 11
SECTION E - UNIT 1128**

New plywood soffit has pulled loose and appears to not be fastened to roof truss framing as required.

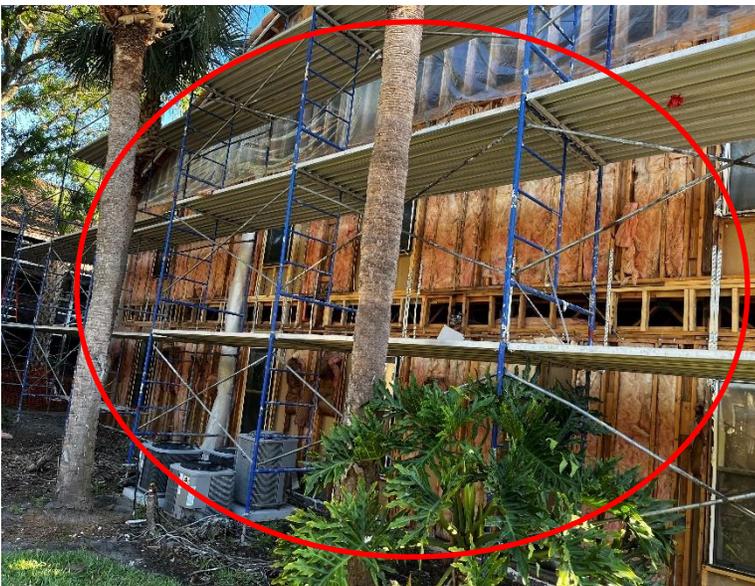
PHOTOGRAPH #10

**BUILDING 11
SECTION D**

Contractor has repaired damaged wood framing and installed Simpson Strong -Tie connectors.

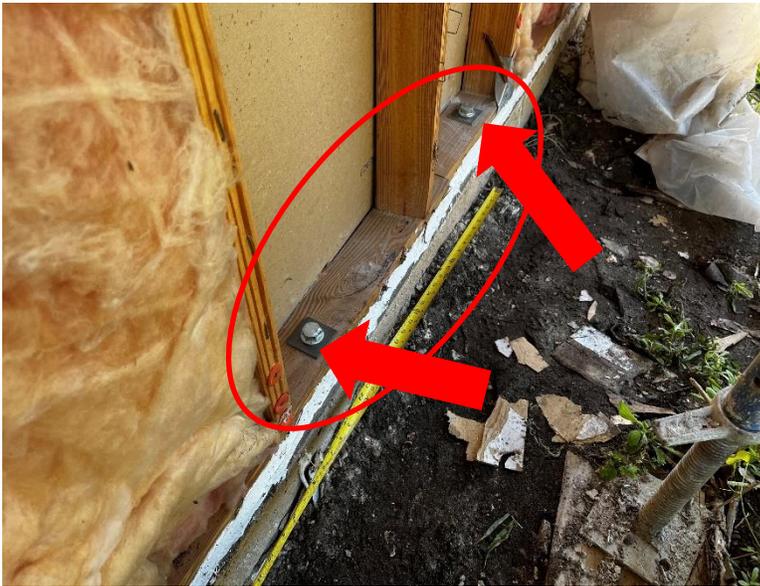
PHOTOGRAPH #11

**BUILDING 11
SECTION D**

New Simson Strong -Tie Titen HD anchors installed at base plate as per drawings.

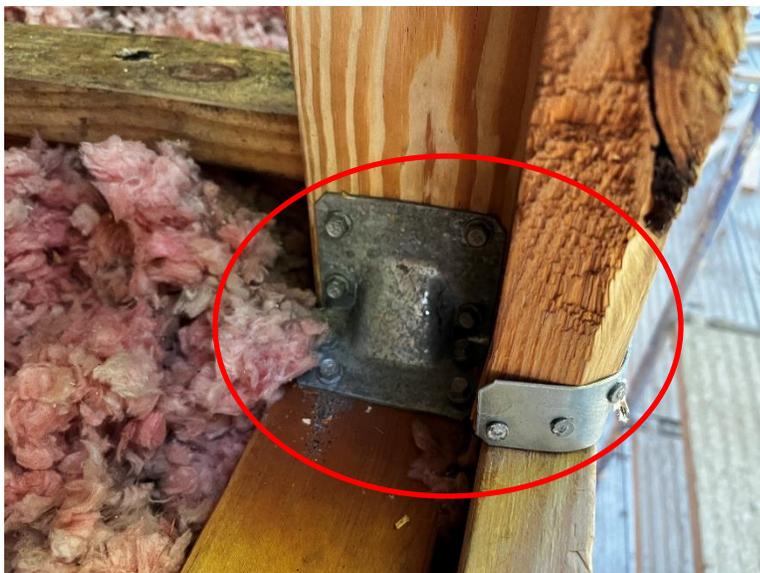
PHOTOGRAPH #12

**BUILDING 11
SECTION D- TRUSS REPAIR**

Contractor has installed new Simpson Strong-Tie connector straps and HGA10 clips at gable end truss repairs as per drawings.

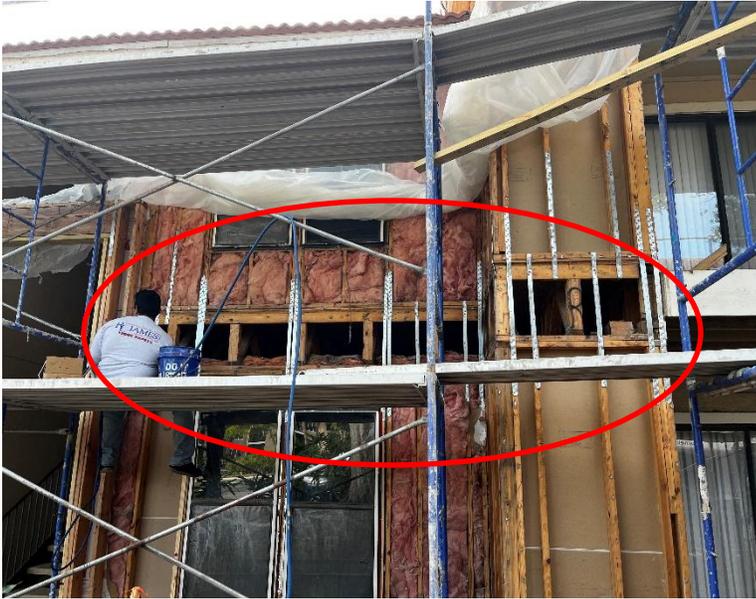
PHOTOGRAPH #13

**BUILDING 11
SECTION C**

Contractor in process of installing new Simpson Strong-Tie MSTA connector straps from floor-to-floor framing.

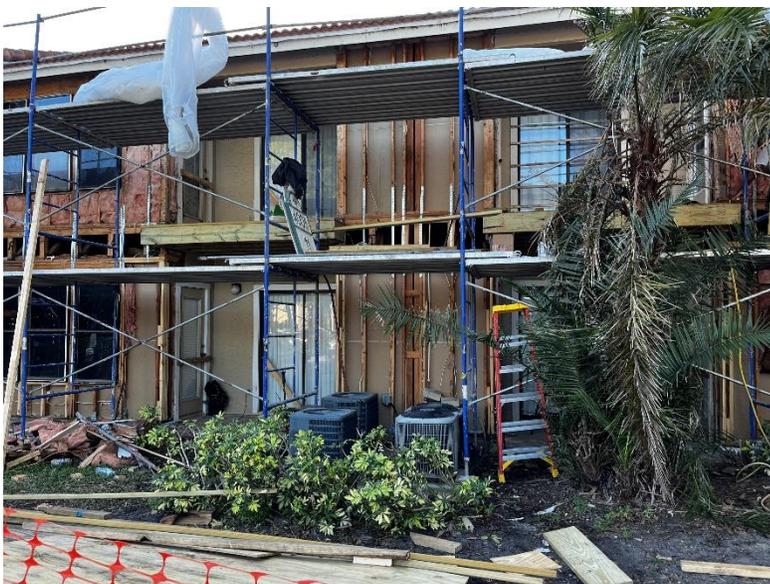
PHOTOGRAPH #14

**BUILDING 11
SECTION B**

Balcony framing repairs and connector installations in progress.

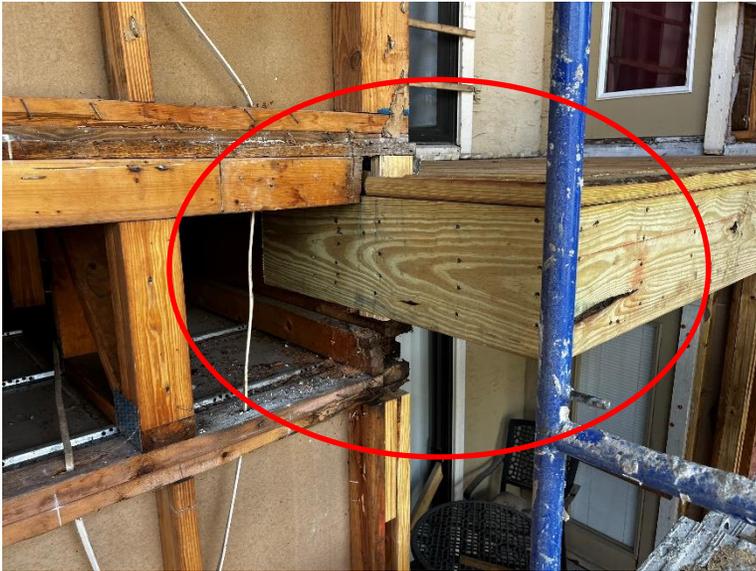
PHOTOGRAPH #15

**BUILDING 11
SECTION B – UNIT 1123**

Contractor has not followed contract drawings for this built-up beam repair and is required to remove and rebuild.

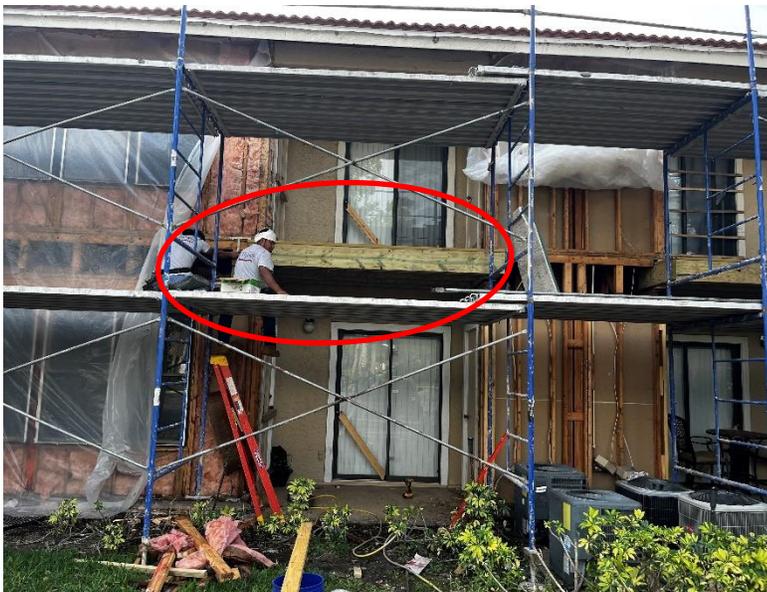
PHOTOGRAPH #16

**BUILDING 11
SECTION B – UNIT 1123**

Contractor has begun to remove, and rebuilding portion of built-up beam improperly repaired.

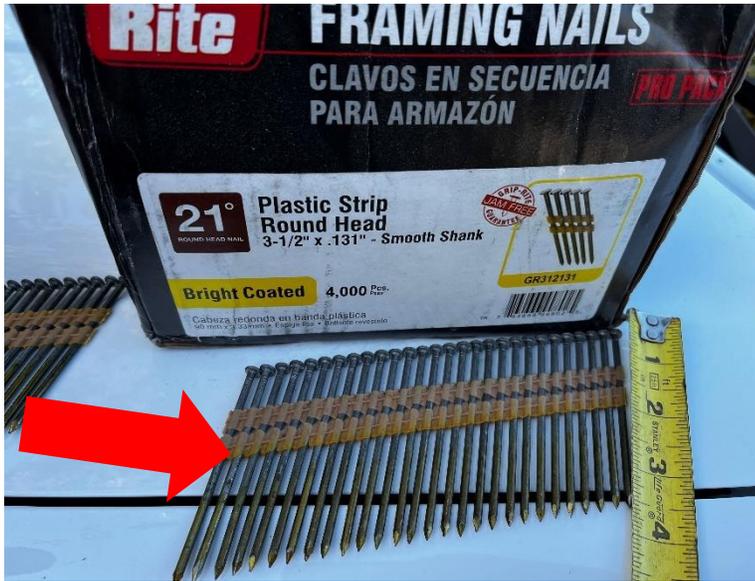
PHOTOGRAPH #17

**BUILDING 11
SECTION B**

16d common nails required for framing being used by contractor.

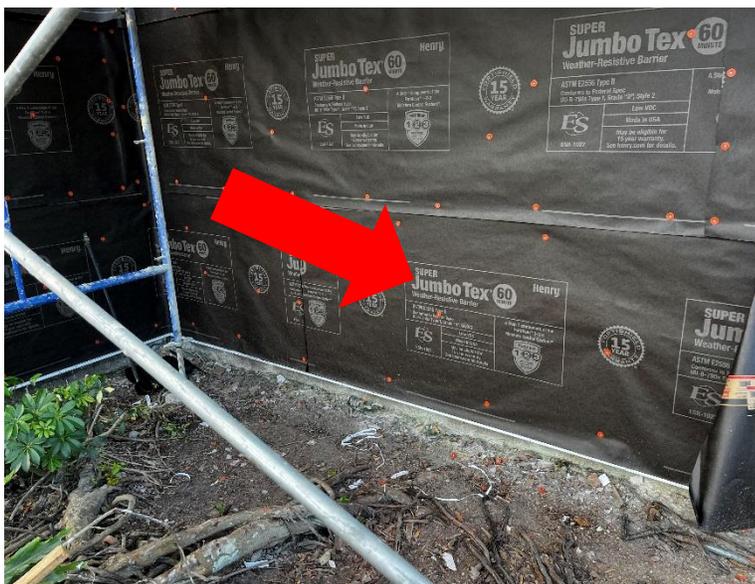
PHOTOGRAPH #18

**BUILDING 12
SECTION H**

Stucco sub-contractor is applying Super Jumbo Tex 60 WRB over new plywood sheathing as per specifications.

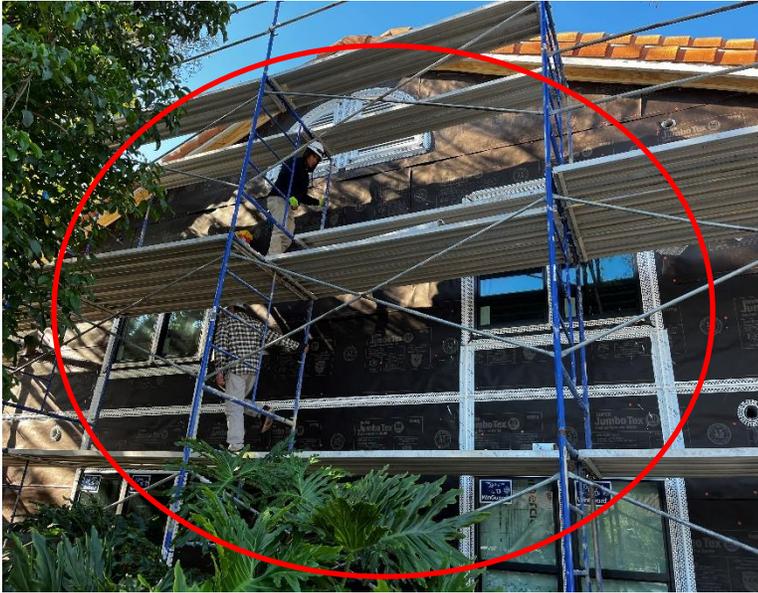
PHOTOGRAPH #19

**BUILDING 12
SECTION H**

Stucco sub-contractor is applying new vinyl control joints and window accessories as per drawings.

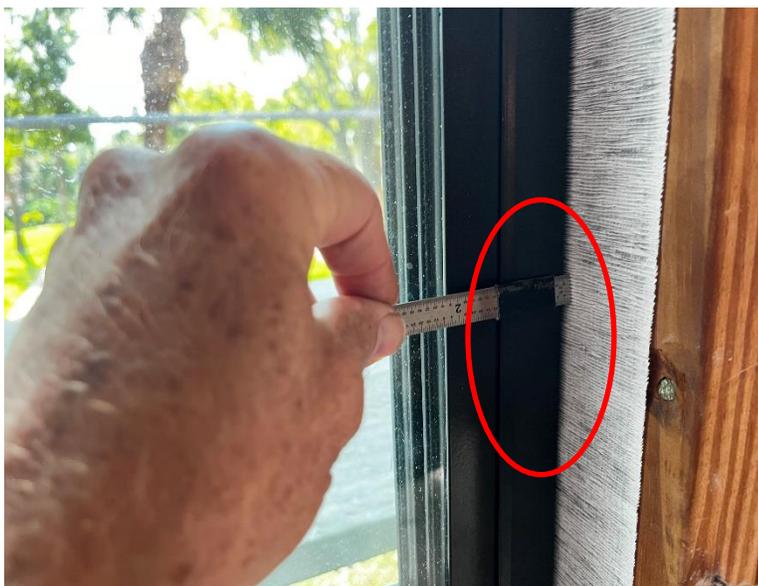
PHOTOGRAPH #20

**BUILDING 12
SECTION F- UINT 1224**

Interior window gap checked for gap maximum spacing to assure meeting window manufacturer's NOAs.

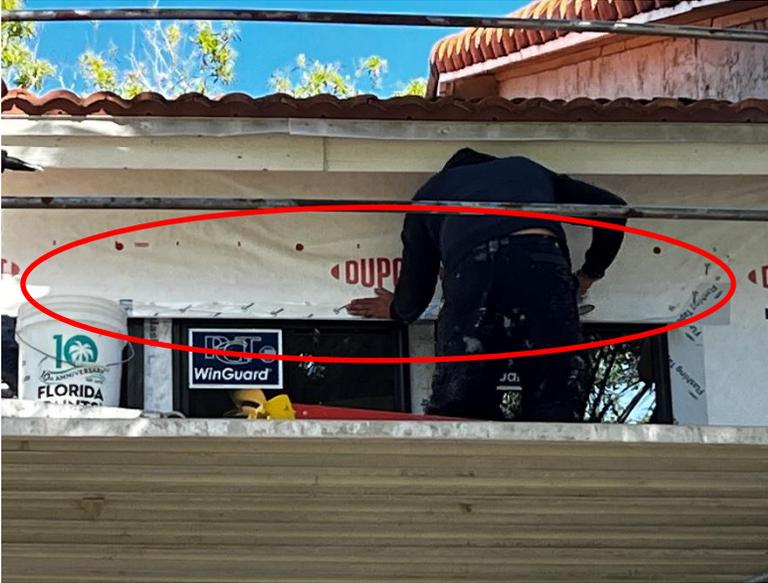
PHOTOGRAPH #21

**BUILDING 12
SECTION F- UNIT 1224**

Contractor completing exterior window flashing process as per manufacturer's specifications.

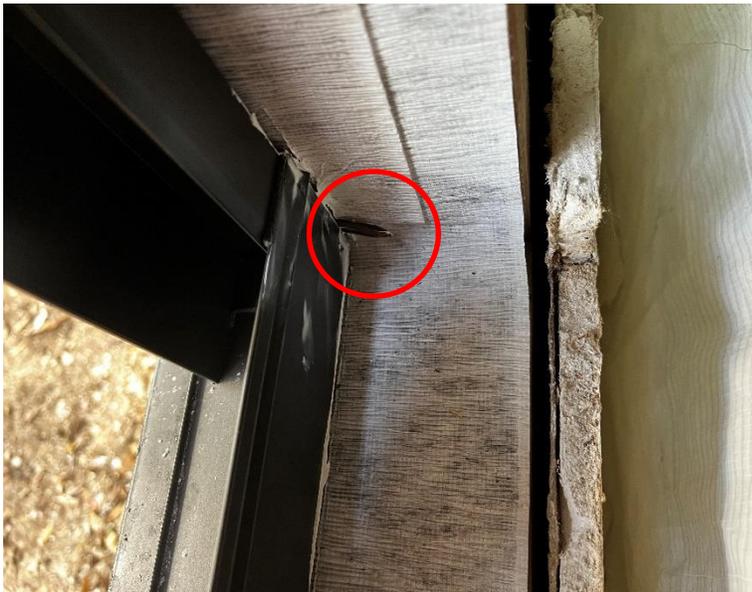
PHOTOGRAPH #22

**BUILDING 12
SECTION F- UNIT 1216**

Nail has penetrated window flashing at interior sill and will require removal, replacement and sealing of window flashing penetration.

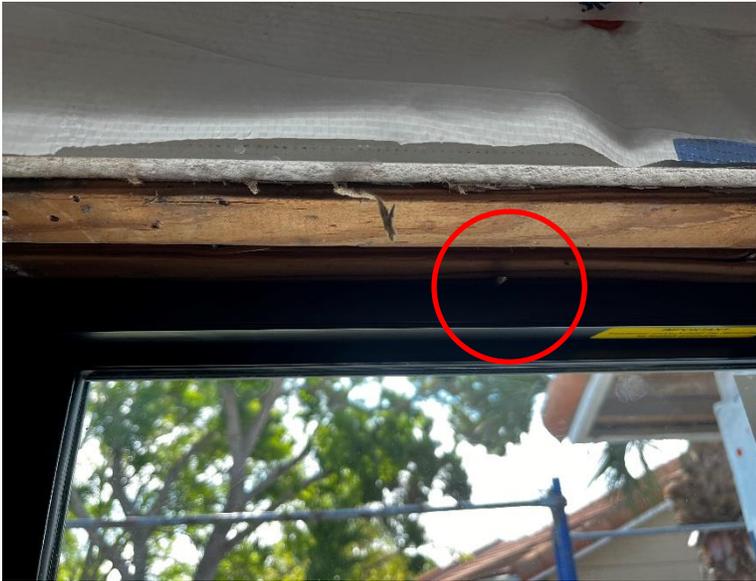
PHOTOGRAPH #23

**BUILDING 12
SECTION F- UINT 1226**

Nail has penetrated window flashing at interior head and will require removal and replacement.

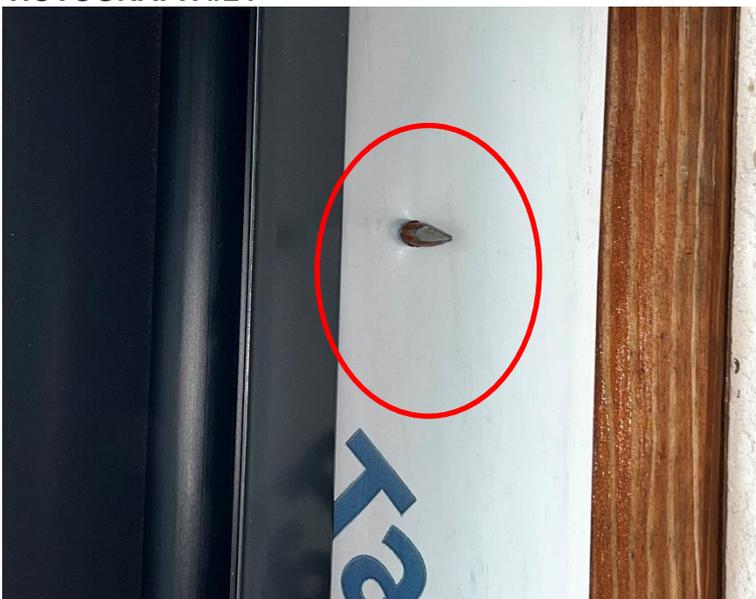
PHOTOGRAPH #24

**BUILDING 12
SECTION F- UINT 1226**

Nail has penetrated window flashing at interior jamb and will require removal, replacement and sealing of window flashing penetration.

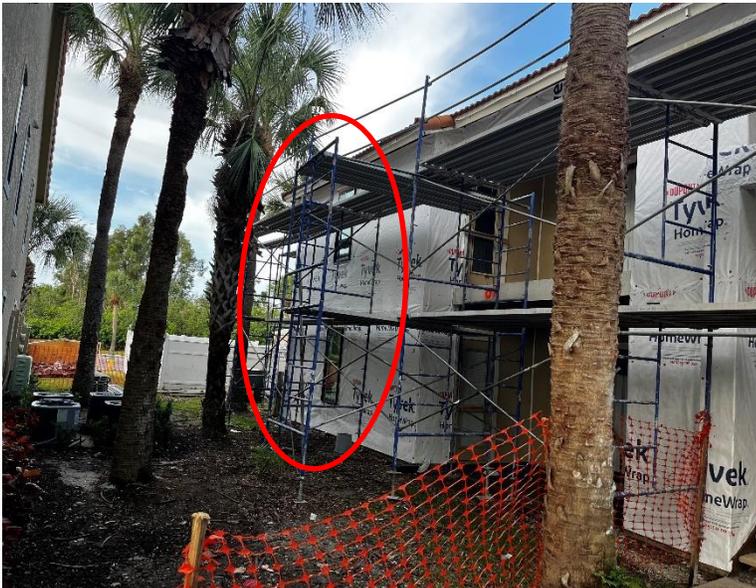
PHOTOGRAPH #25

**BUILDING 12
SECTION E**

New PGT windows installed and flashed with Dupont Tyvek flashings.

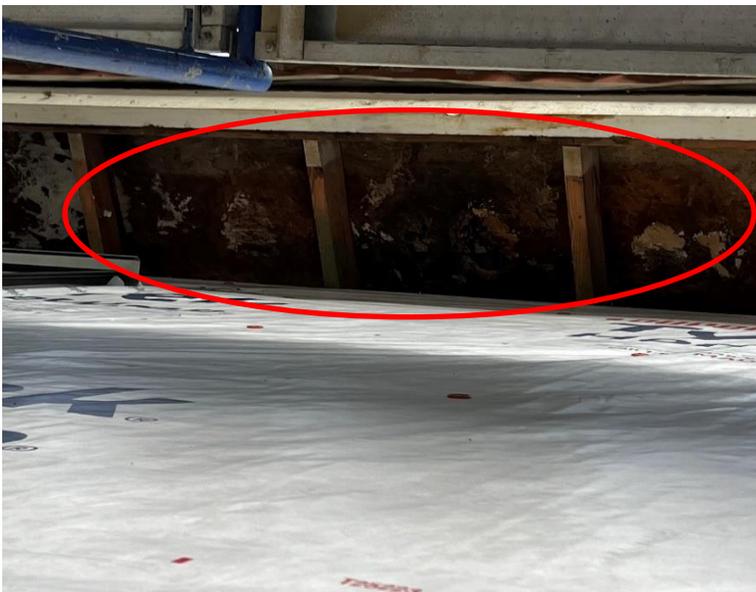
PHOTOGRAPH #26

**BUILDING 12
SECTION E**

Roof sheathing damage observed above soffit from roof leaks to be addressed by other contractors outside of this scope of work.
