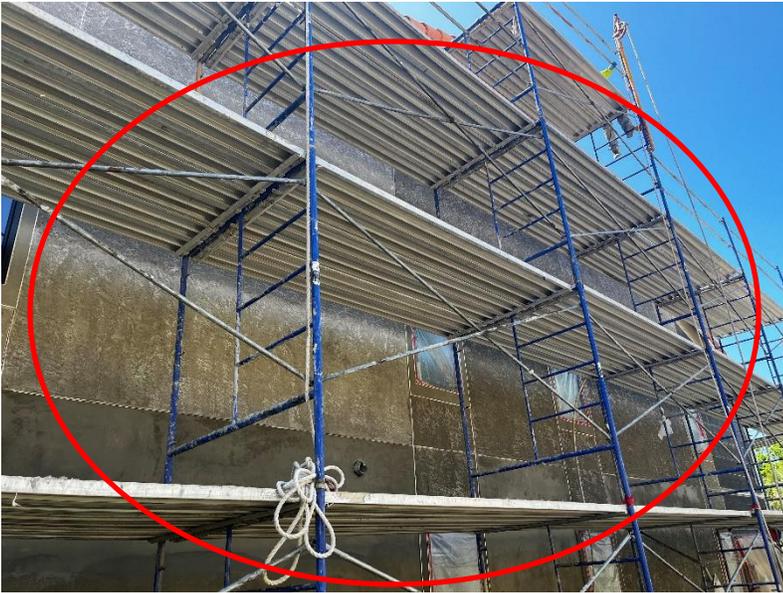
PHOTOGRAPH #1

**BUILDING 11
SECTION H**

Stucco sub-contractors applying finish texture coat of stucco over brown coat.

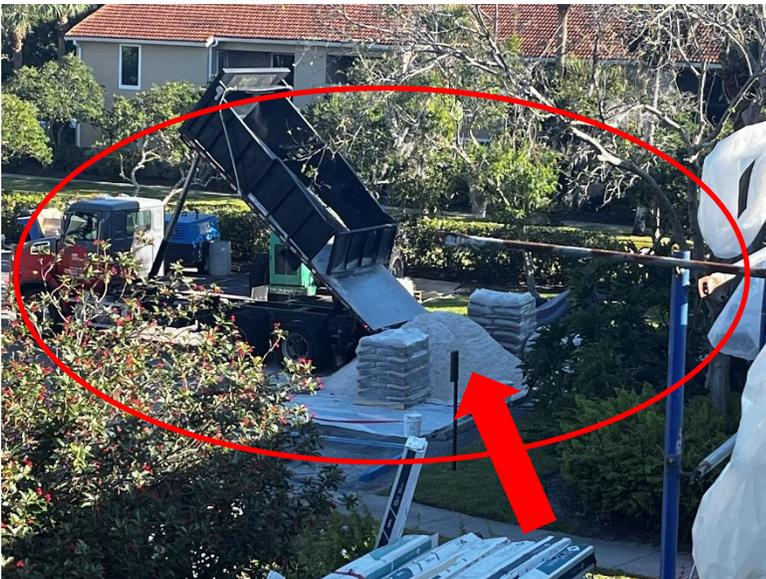
PHOTOGRAPH #2

**BUILDING 11
SECTION H**

Delivery of new sand for stucco mixing in parking lot.

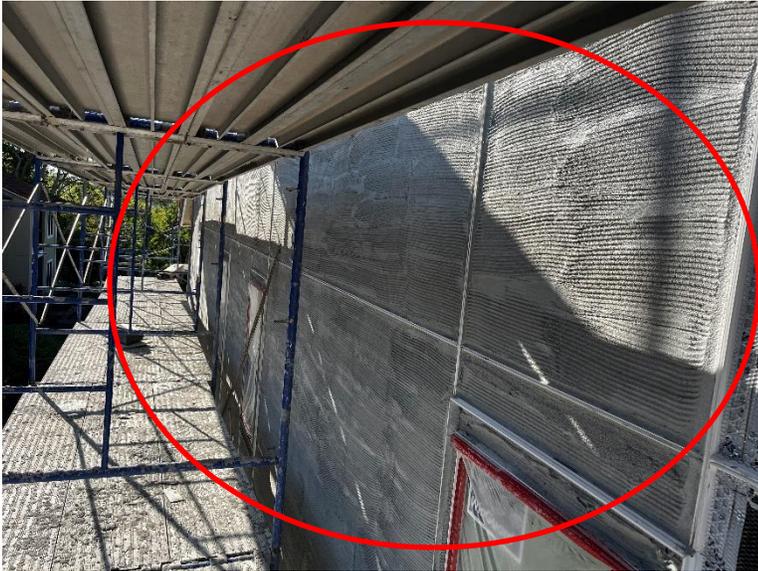
PHOTOGRAPH #3

**BUILDING 11
SECTION H**

Stucco sub-contractor has applied scratch coat of stucco using approved AMEX Broco bagged stucco cement and sand.

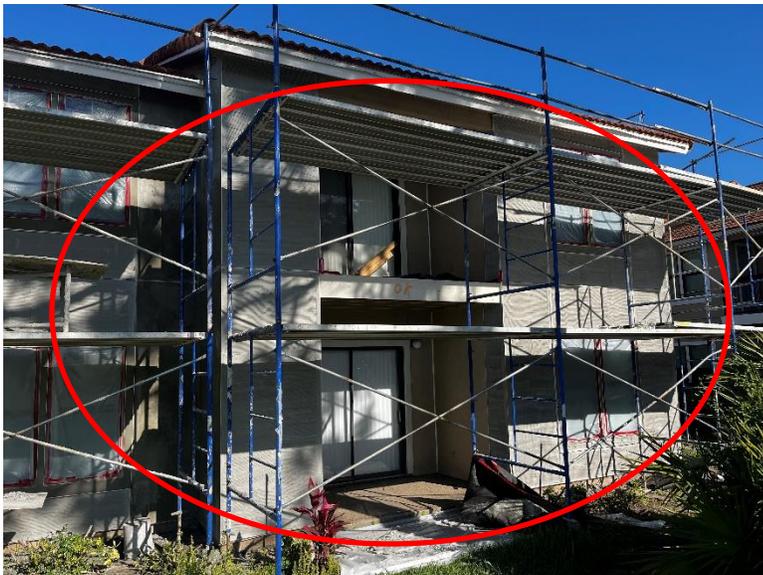
PHOTOGRAPH #4

**BUILDING 11
SECTION G**

Stucco sub-contractor has begun to apply brown coat of stucco over scratch coat.

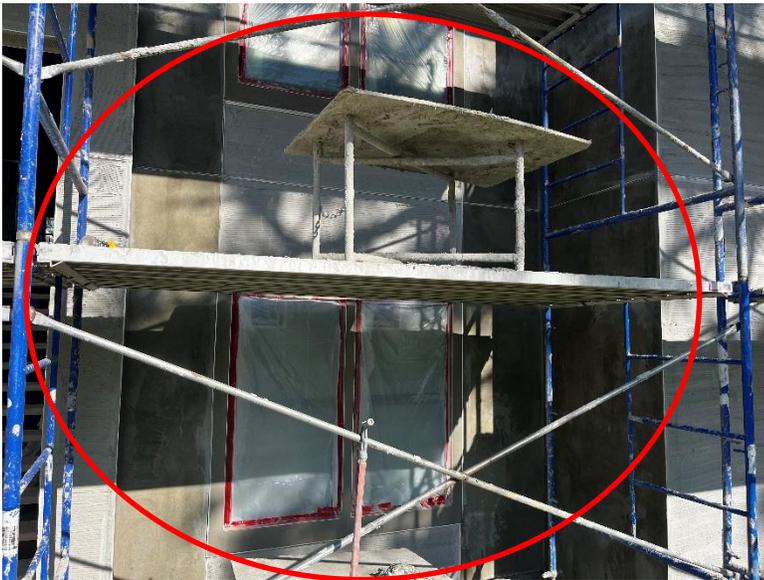
PHOTOGRAPH #5

**BUILDING 11
SECTION G**

Stucco sub-contractor has begun to apply brown coat of stucco over scratch coat.

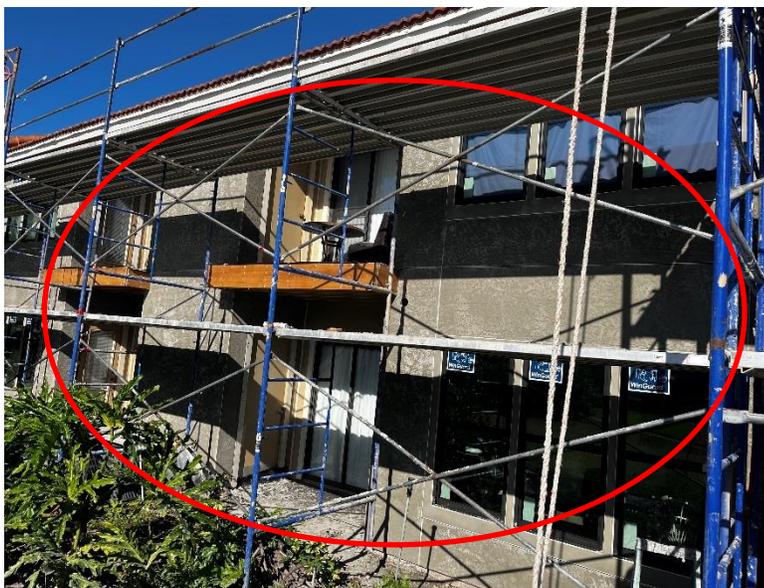
PHOTOGRAPH #6

**BUILDING 11
SECTION F**

Stucco contractor has applied full three coat 7/8" thick stucco system to wall.

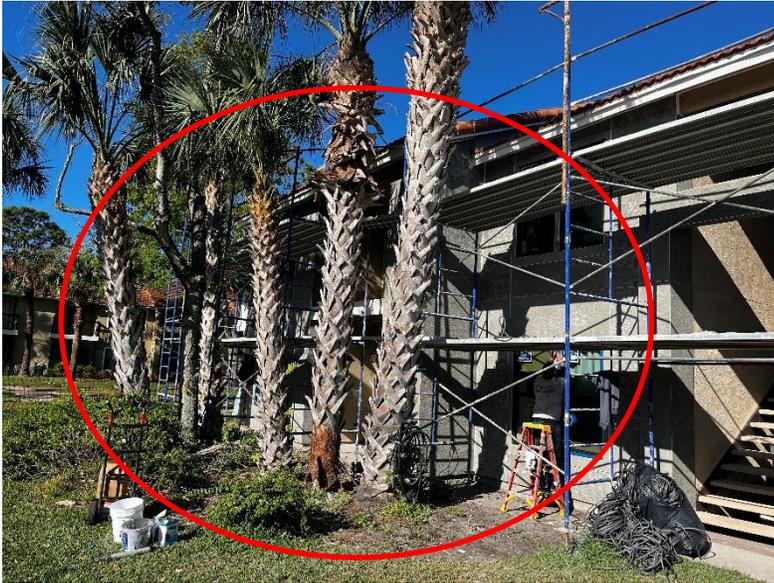
PHOTOGRAPH #7

**BUILDING 11
SECTION E**

Stucco contractor has applied full three coat 7/8" thick stucco system to wall.

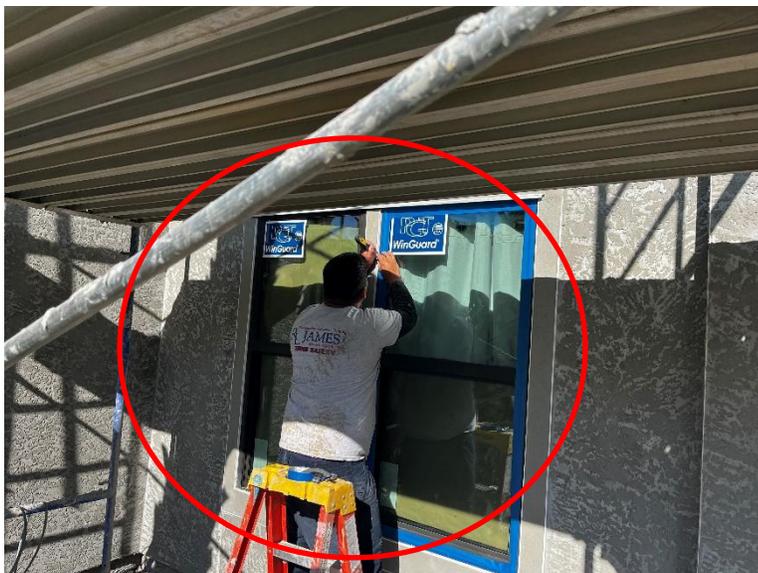
PHOTOGRAPH #8

**BUILDING 11
SECTION E- UNIT 1118**

Windows masked and new backing rod installed in preparation for sealant application at window perimeters.

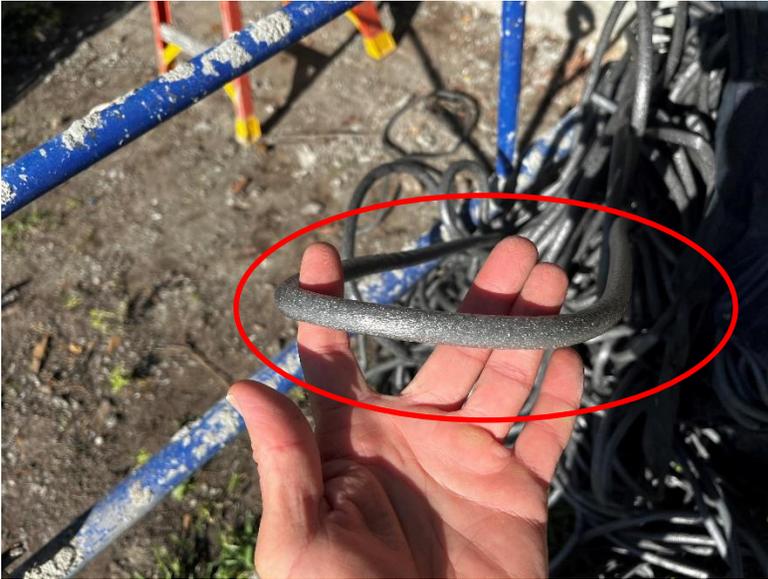
PHOTOGRAPH #9

**BUILDING 11
SECTION E - UNIT 1118**

Soft Cell backing rod used at window perimeters prior to new sealant application.

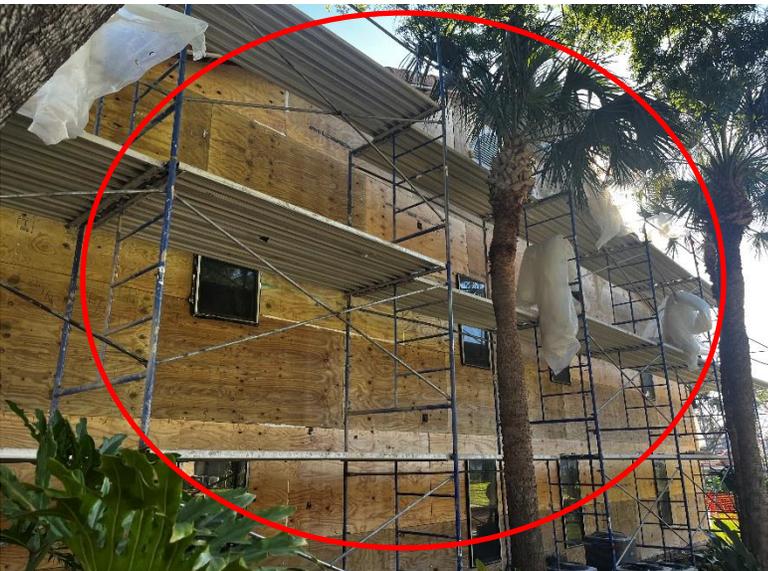
PHOTOGRAPH #10

**BUILDING 11
SECTION D**

Contractor has installed new 15/32" plywood sheathing as per specifications and drawings.

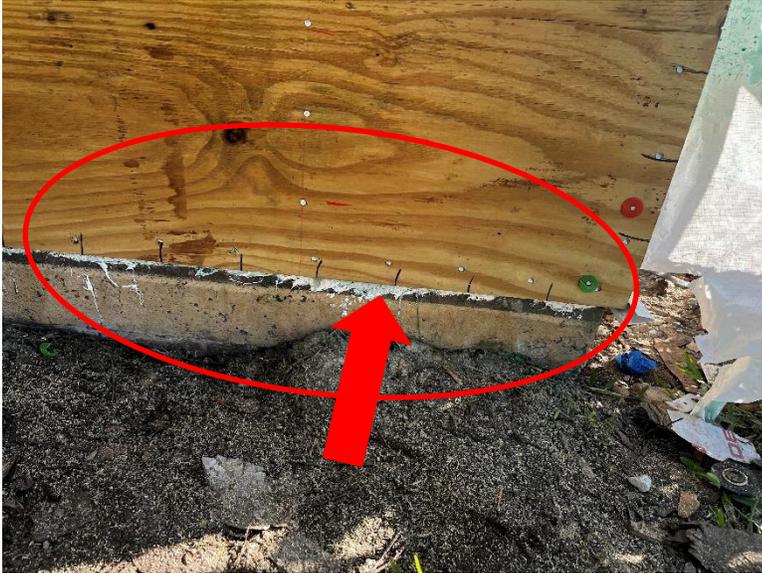
PHOTOGRAPH #11

**BUILDING 11
SECTION D**

Urethane Sealant applied at bottom plate to concrete foundation and bottom plate to new plywood at base as per drawings and details.

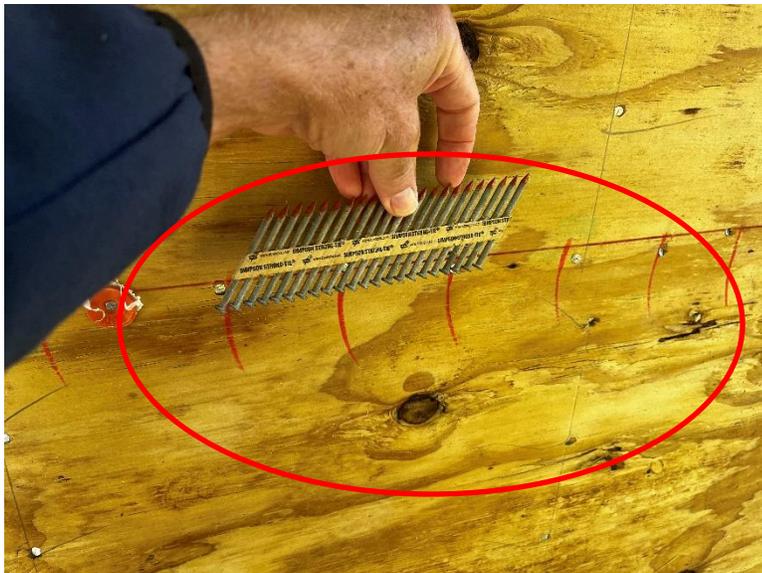
PHOTOGRAPH #12

**BUILDING 11
SECTION D**

Contractor attaching new plywood sheathing to wall framing with Simpson Strong -Tie 8d nails spaced along perimeter at 4"O.C.

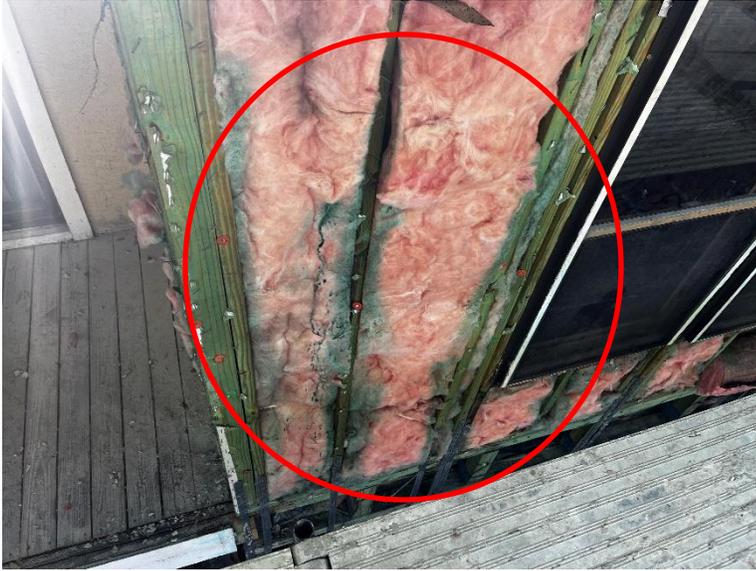
PHOTOGRAPH #13

**BUILDING 11
SECTION C**

Termite contractor has sprayed Bora Care termite treatment on wall framing.

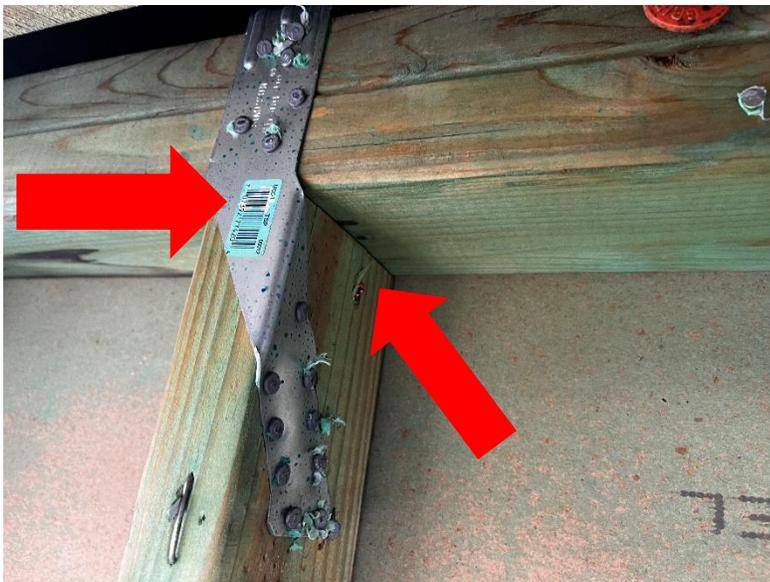
PHOTOGRAPH #14

**BUILDING 11
SECTION B**

New TSP Simpson Strong-Tie connector and SDWC screw installed at wall stud to top plate as per drawings.

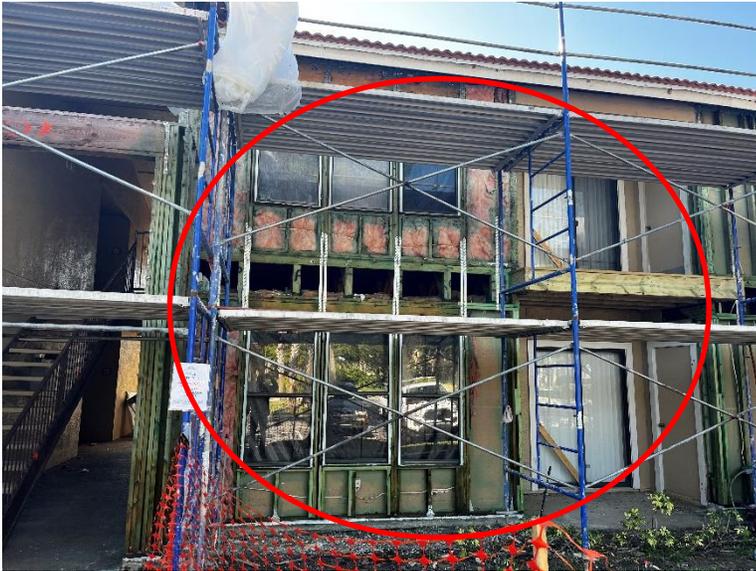
PHOTOGRAPH #15

**BUILDING 11
SECTION B**

Contractor has completed installing straps and connectors at exterior walls as per drawings.

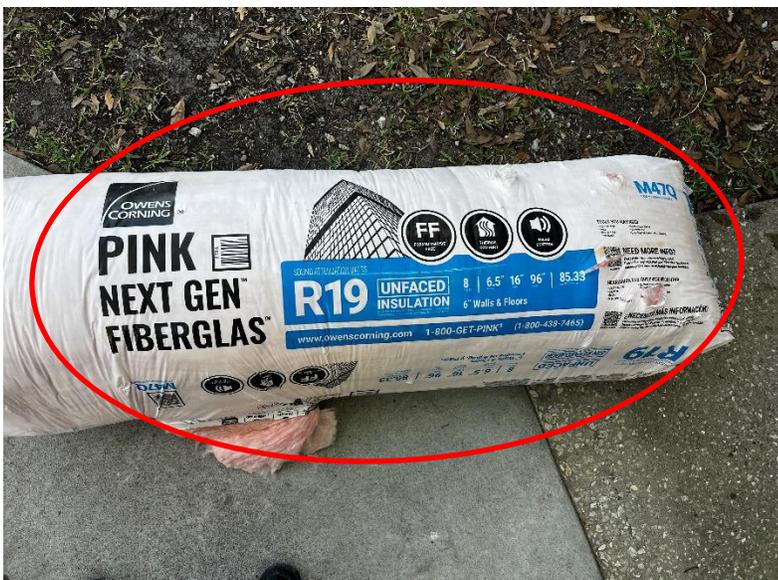
PHOTOGRAPH #16

**BUILDING 11
SECTION B**

OWENS CORNING R19 insulation place between wall framing of interior spacing walls at locations of missing or damaged insulation.

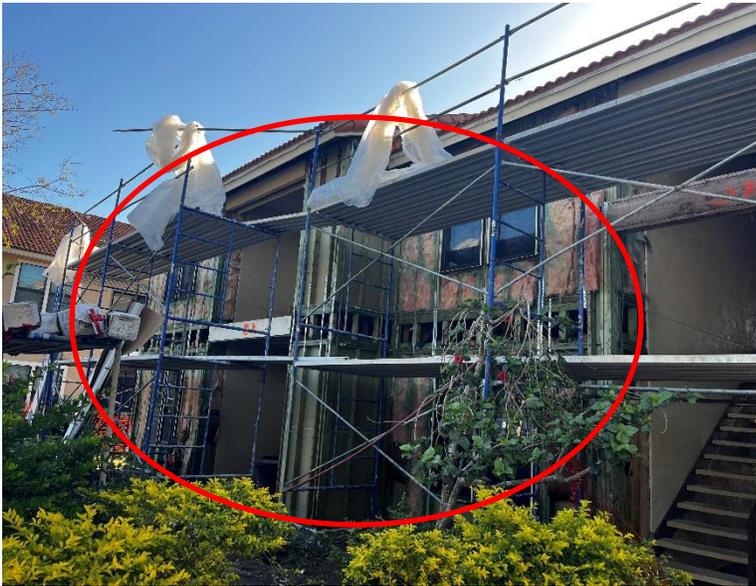
PHOTOGRAPH #17

**BUILDING 11
SECTION A**

Contractor has completed installing straps and connectors at exterior walls as per drawings.

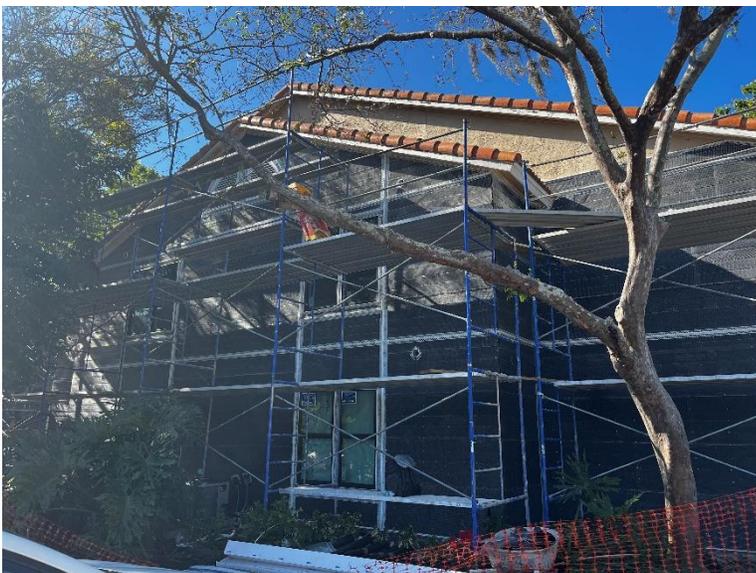
PHOTOGRAPH #18

**BUILDING 12
SECTION H**

Stucco sub-contractor has installed new vinyl stucco accessories and galvanized lathing over water resistant barriers.

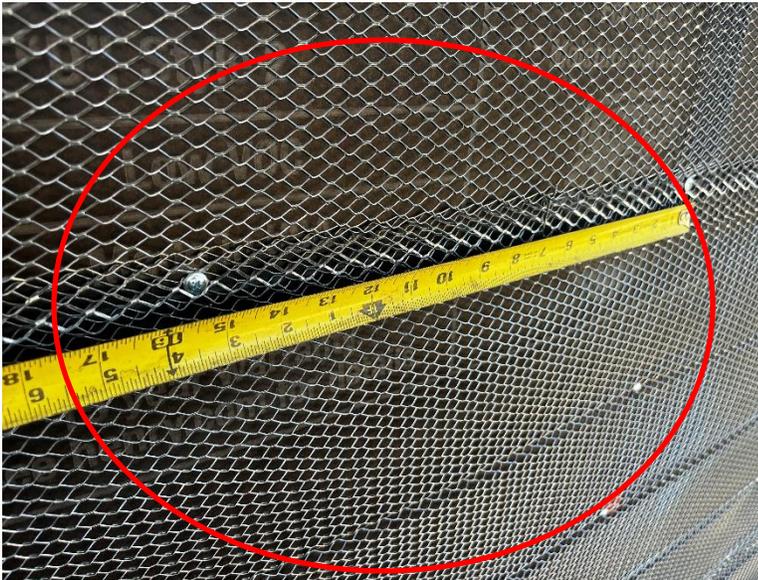
PHOTOGRAPH #19

**BUILDING 12
SECTION H**

Metal lathing fastened to wall framing at 16" O.C. and tied at overlapping between fasteners.

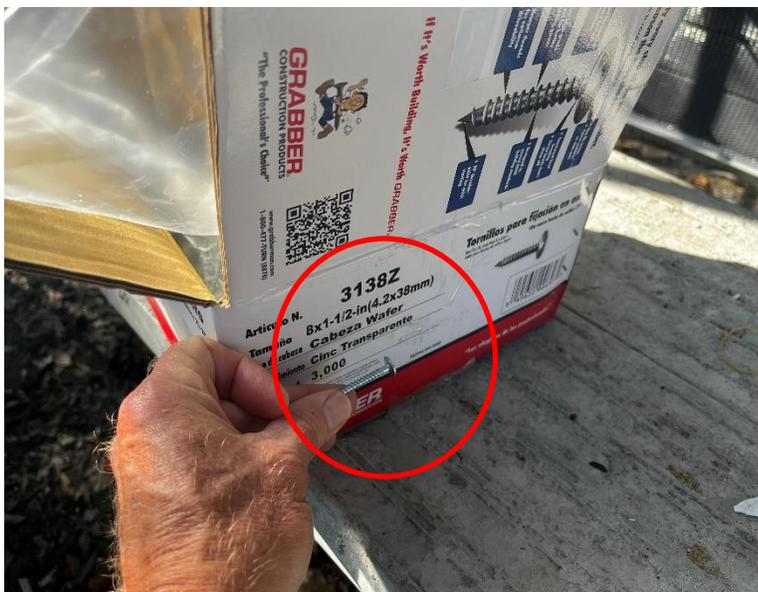
PHOTOGRAPH #20

**BUILDING 12
SECTION H**

#8 - 1½" wafer head self-taping screws used for attachment of galvanized lathing to wall framing.

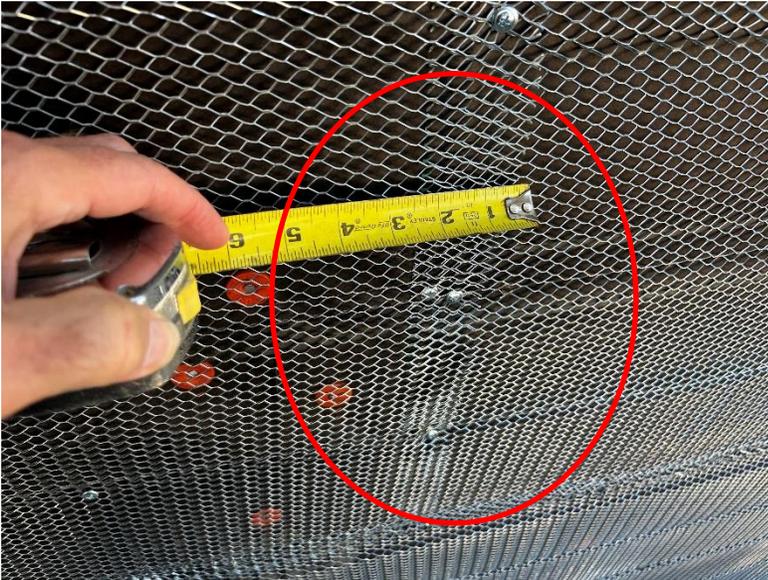
PHOTOGRAPH #21

**BUILDING 12
SECTION H**

Overlapping of galvanized lathing 2" at ends of lathing sheets.

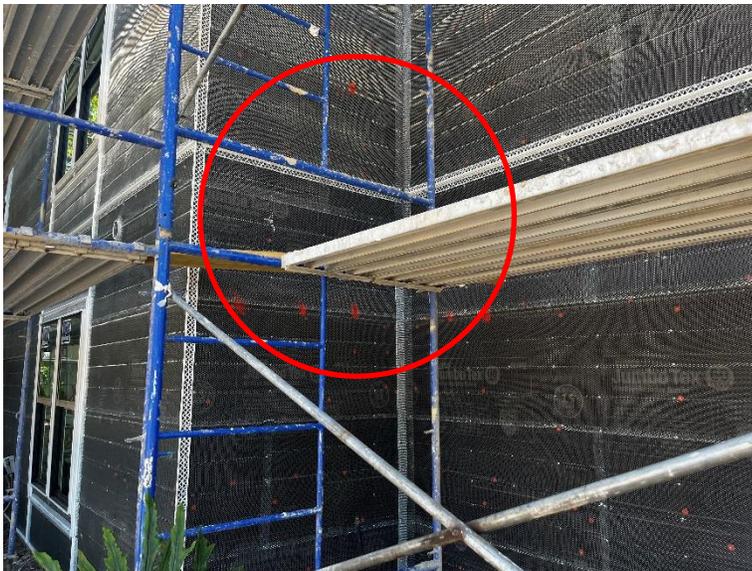
PHOTOGRAPH #22

**BUILDING 12
SECTION H**

Tie wires at overlapping lathing between framing missed and marked for correction by contractor.

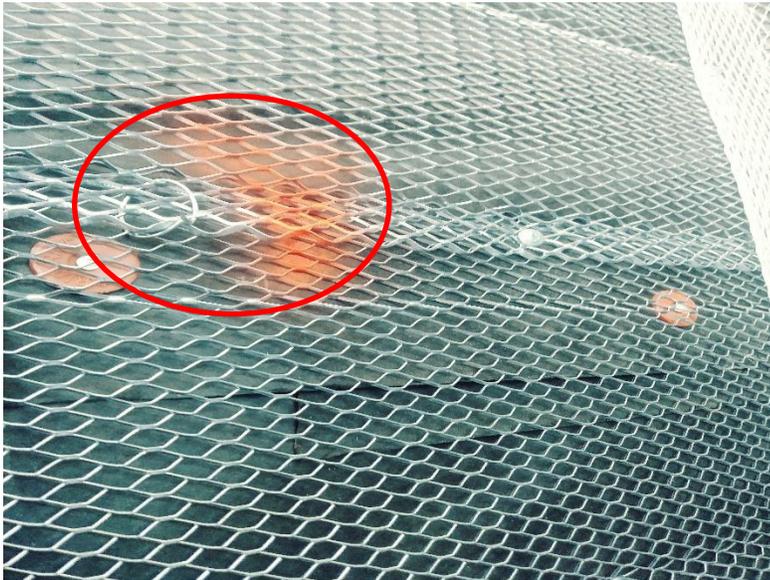
PHOTOGRAPH #23

**BUILDING 12
SECTION H**

Contractor has made corrections by providing tie wires at lathing overlapping as required by ASTM C1063.

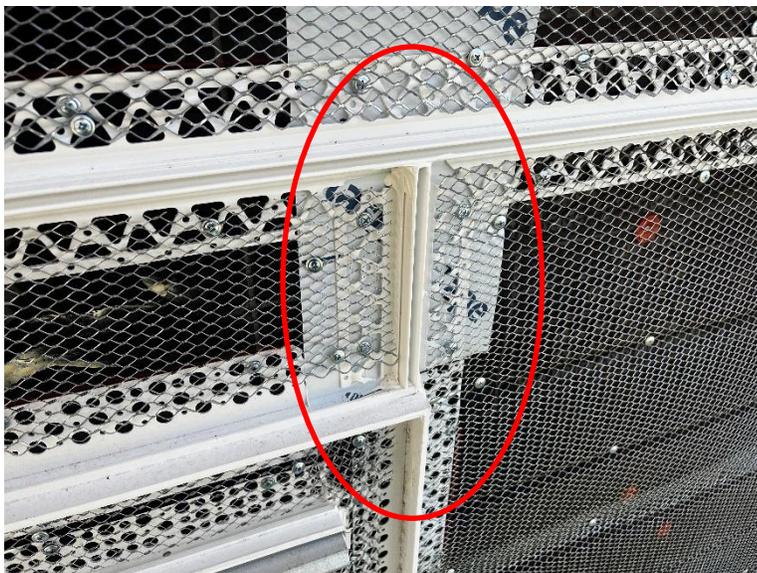
PHOTOGRAPH #24

**BUILDING 12
SECTION G**

New vinyl stucco accessories sealed at butts and transitions with urethane sealant as per drawings.

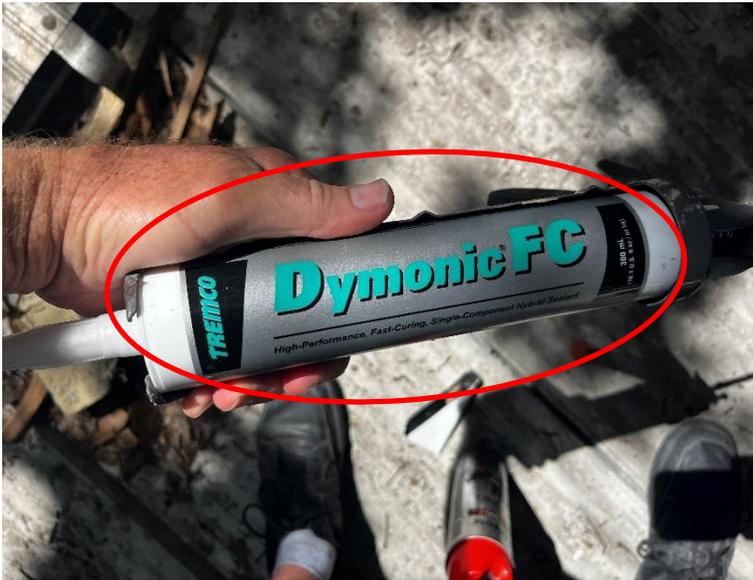
PHOTOGRAPH #25

**BUILDING 12
SECTION G**

New vinyl stucco accessories sealed at butts and transitions with urethane sealant as per drawings.

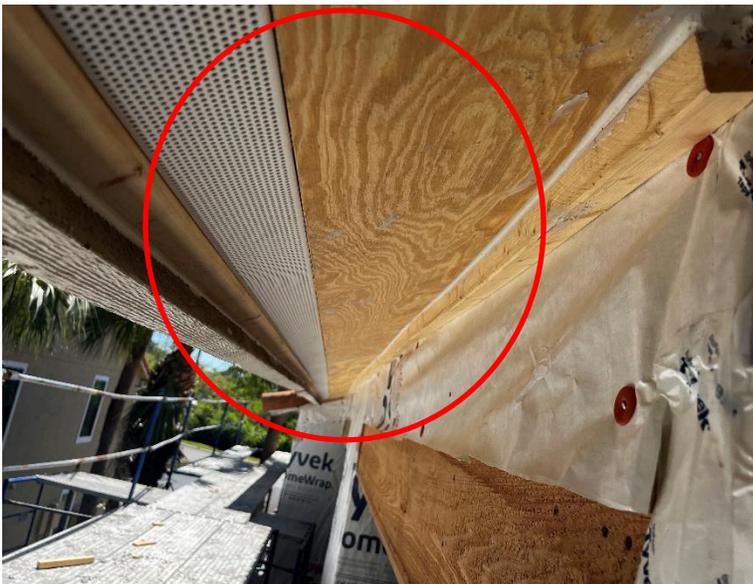
PHOTOGRAPH #26

**BUILDING 12
SECTION F**

New soffit plywood, trim and vinyl venting installed as per drawings.
